**Northern Cross (Yukon) Limited  
Eagle Plain Matting Test Report  
Vegetation, Soil and Permafrost Monitoring Results**

**Northern Cross (Yukon) Limited**  
**Eagle Plain Matting Test Report**  
**Vegetation, Soil and Permafrost Monitoring Results**

**Reference:** Land Use Application at Camp 204, Eagle Plains, Yukon  
Permit Issue Date:  
April 25, 2008; extended March 2, 2009 until June 23, 2011

**Test Period:** April 2008 to September 2009

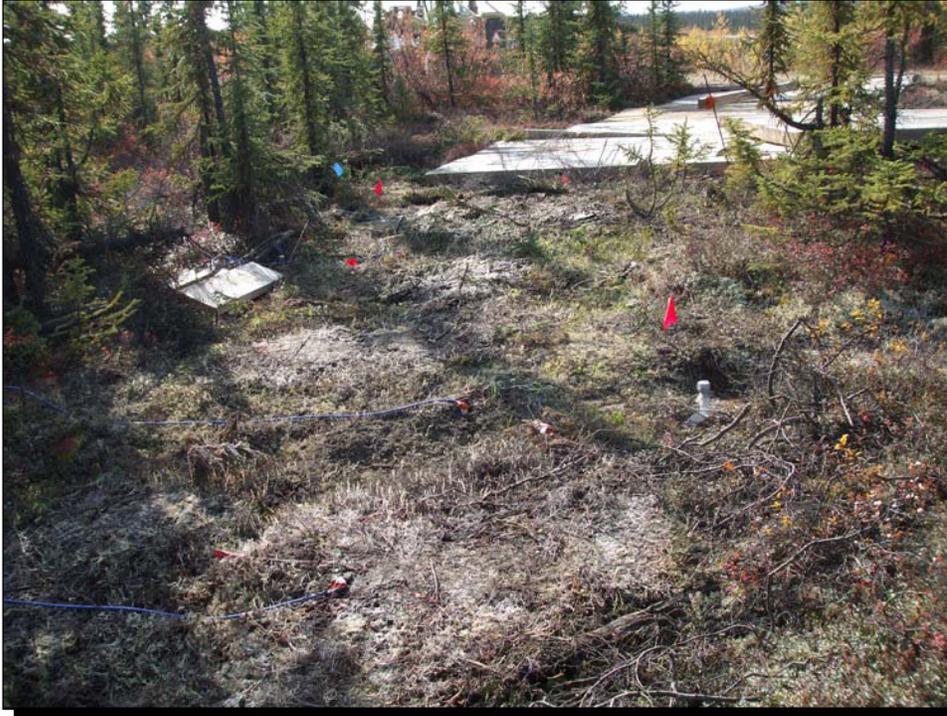
Photo 9

September 5, 2009. Camp 204 access mat application showing ground cover following mat removal

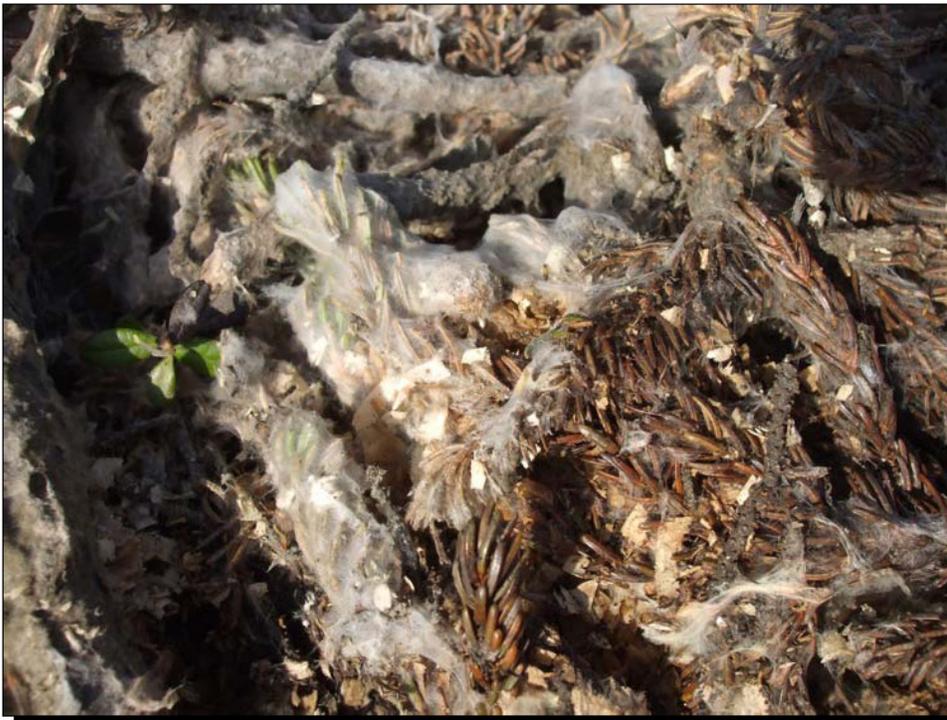
Photo 10

September 5, 2009. Camp 204 access mat application showing insect webs and vole paths that developed under the access mats.

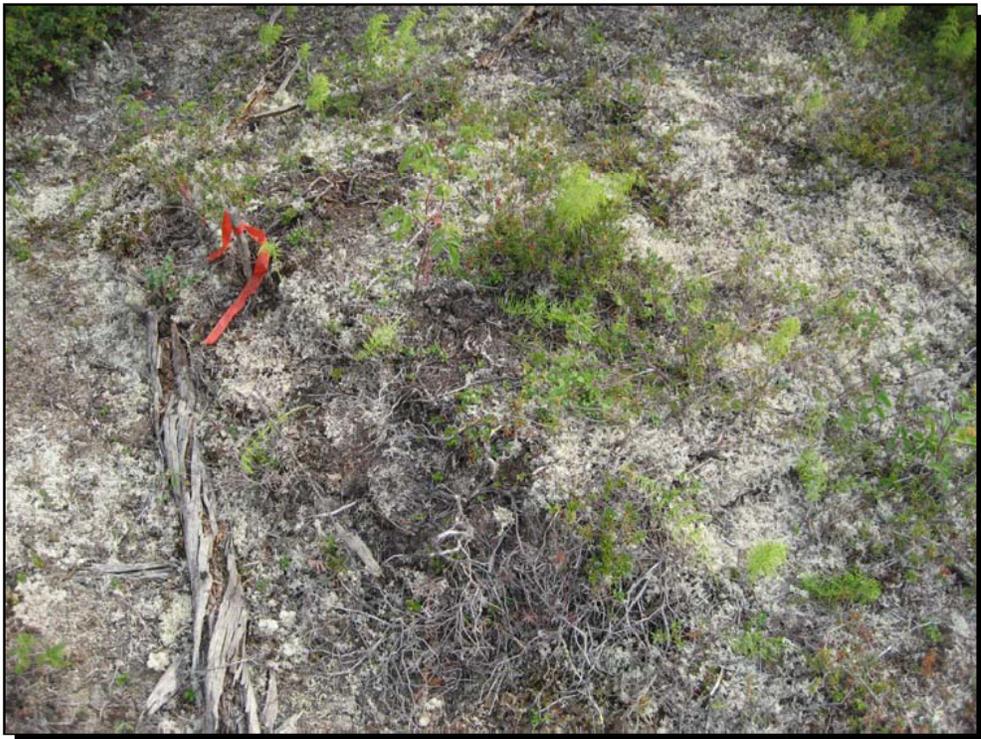
Photo 8  
Matting damage to vegetation– Facing North (July 18, 2009)

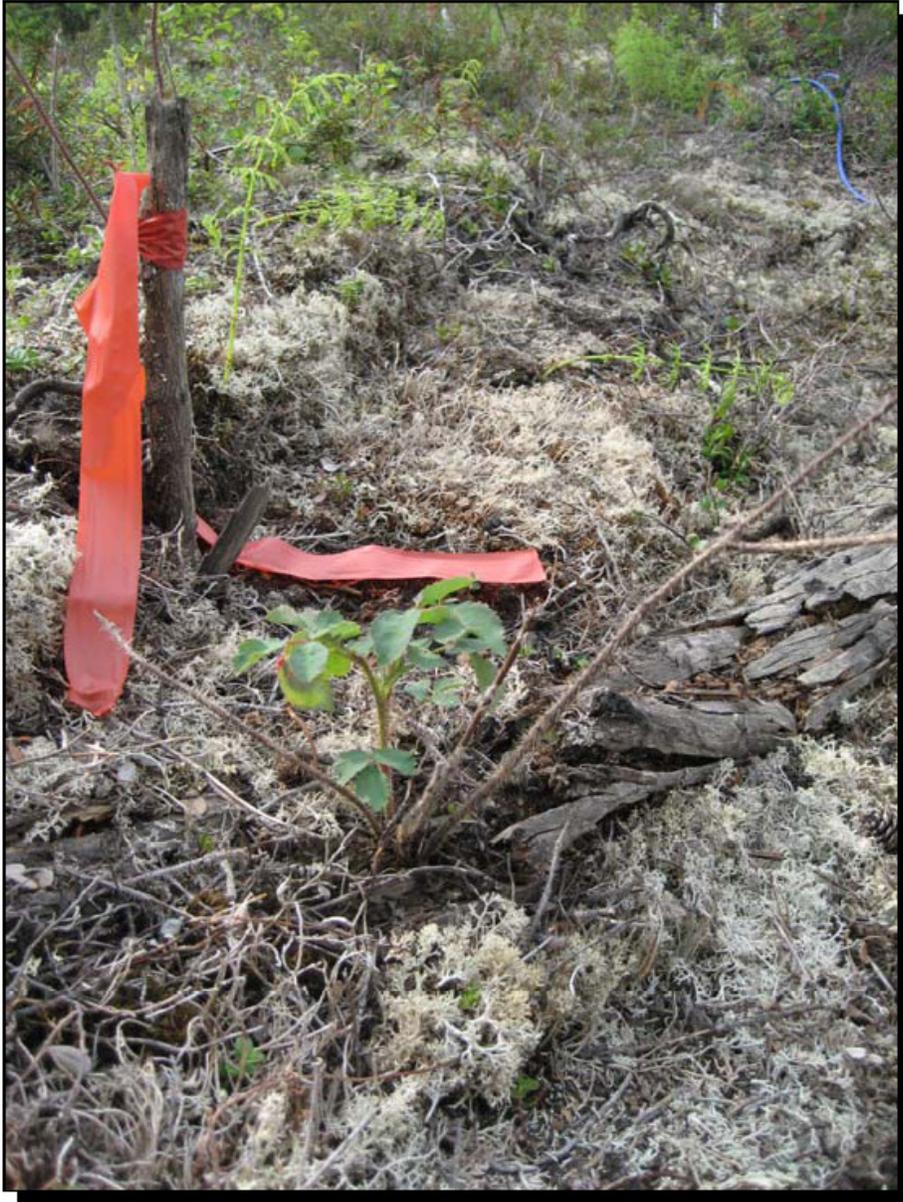
Photo 9  
Close up of matting damage to vegetation– Facing South (July 18, 2009)

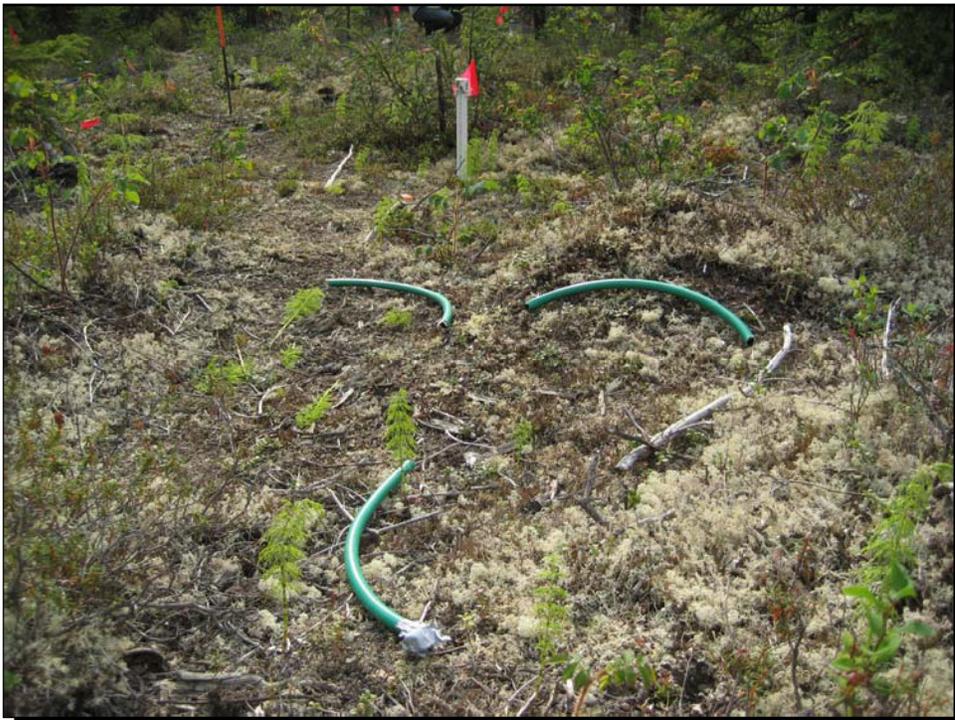
Photo 13  
Damage to iButton Thermistor location TC15 – facing South (July 18, 2009)

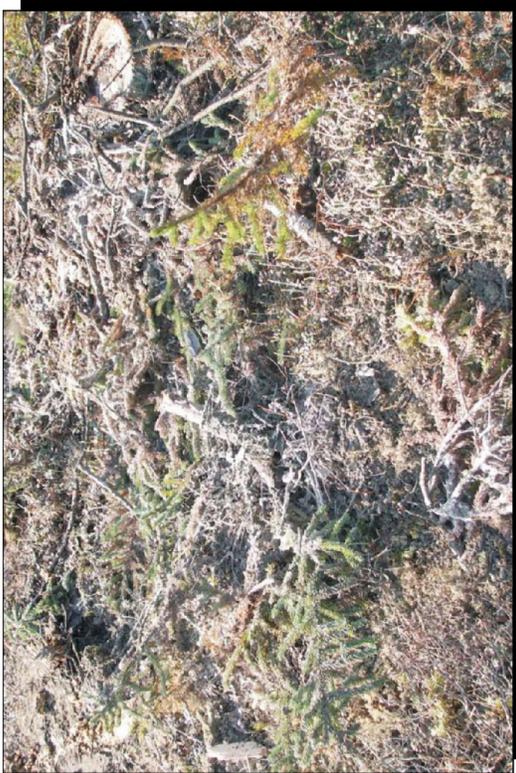
**Photo 14**  
 Photo demonstrating physical damage to spruce trees in the treatment areas. Damage was incurred by tree cutting and physical removal, and branches were left at the location. Photo taken September 5, 2008 in the ice treatment area.

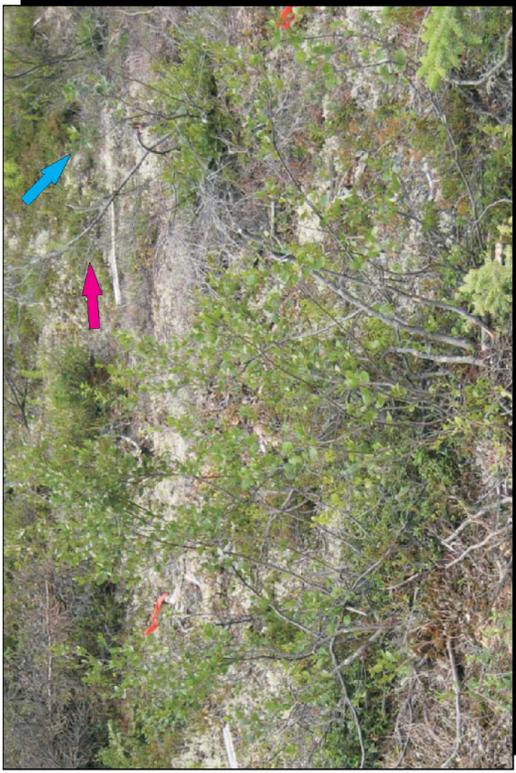
**Photo 16**  
 Photo showing typical damage and recovery to dwarf birch, during the first growing season post-treatment. Unaffected dwarf birch are shown in the foreground, while a damaged shrub is in the background (ice treatment). Dead stems are shown with a red arrow, while limited regrowth is shown with a blue arrow. Photo taken July 18, 2009.

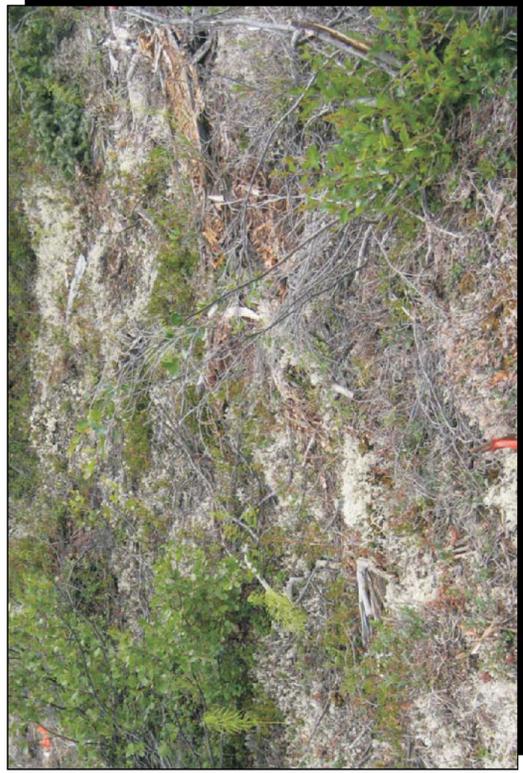
**Photo 17**  
 Photo showing willow regrowth during the first season post-test (2009). In the right foreground is are several damaged willow stems (mixed with birch), with moderate new growth from root shown (new shoots). Photo taken July 18, 2009.

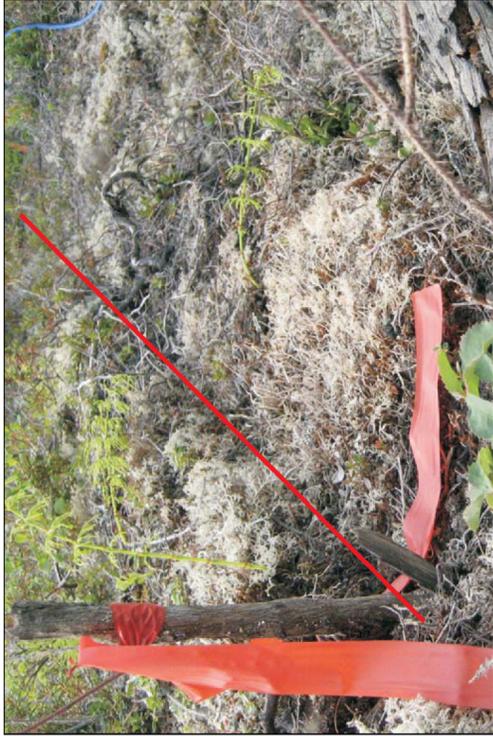
**Photo 20**  
 Photo showing physical damage to reindeer lichen resulting from mat placement. The red line in the photo represents the approximate edge of mat (which extended to the right). Note the crushed lichen from beneath the mat, with limited regrowth noticeable. Photo taken July 18, 2009.
