**Gladstone Lakes
Terrestrial Environment Baseline Studies**

2009 and 2010 Mammal Surveys

Yukon Energy Corporation
and
AECOM Canada Ltd.

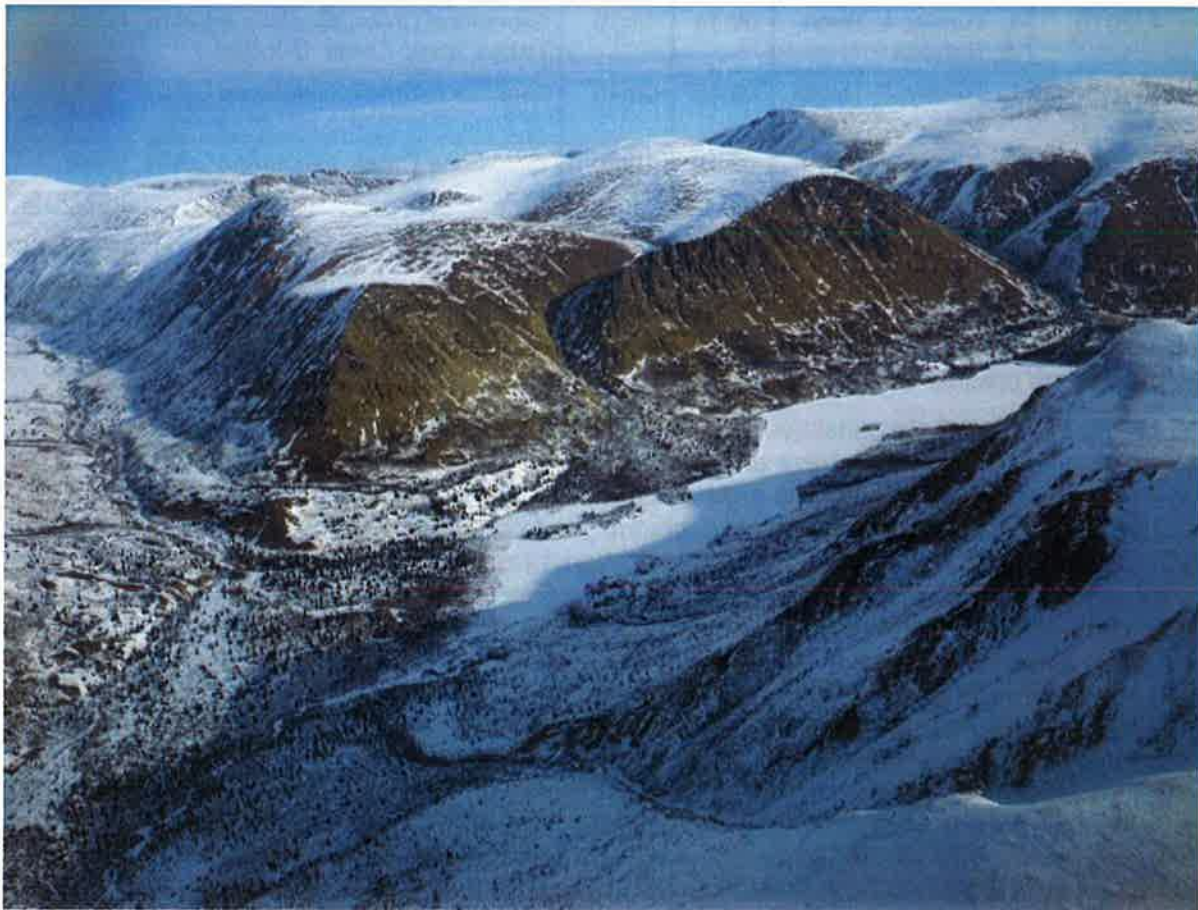
Figure 2. Late winter conditions in the Gladstone Lakes Study Area on March 22, 2010.

The March survey also allowed documentation of late winter conditions within the Gladstone Lakes Study Area. The majority of the water bodies within the Gladstone and Isaac drainages were completely frozen over at this time, the only exceptions to this were a few small openings along the Gladstone and Isaac Creeks. The snowpack within the study area was less than one meter with large wind-swept areas that were nearly free of snow. In general, the deepest snowpack (up to one meter) was found on the north-facing slopes, while the south-facing slopes were almost bare. On the valley floor, tree and shrub habitats on level slopes were covered in approximately half a meter of snow. The snowpack did have a crust on it as smaller animals were able to stay on top but larger animals (e.g. ungulates) appeared to be breaking through this crust. Figure 2 shows the winter conditions observed during the March survey with a photo looking northeast across the Gladstone valley and Gladstone Lake A.

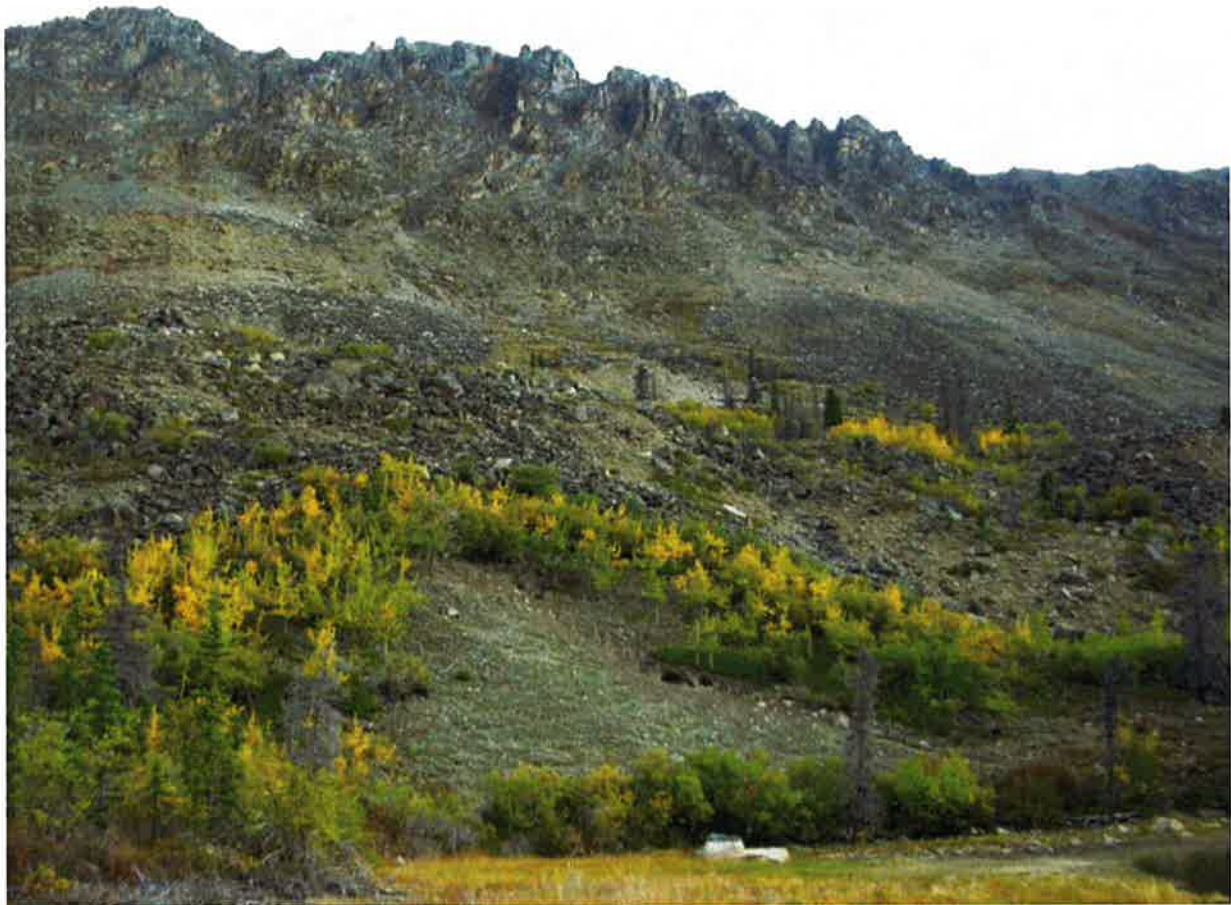
Figure 11. Location of Gladstone Lake A Mineral Lick site.

The Gladstone Lake A Mineral Lick is located at the base of the north wall of the Gladstone Valley at an elevation of 1180 m approximately half-way along Gladstone Lake A (Figure 11). The lick area is somewhat dome-shaped and appears to be a remnant from glacial deposition. There are five main sites within the lick area from which animals appear to be accessing minerals (Figure). Soil samples were taken at four of these sites from the layer that the

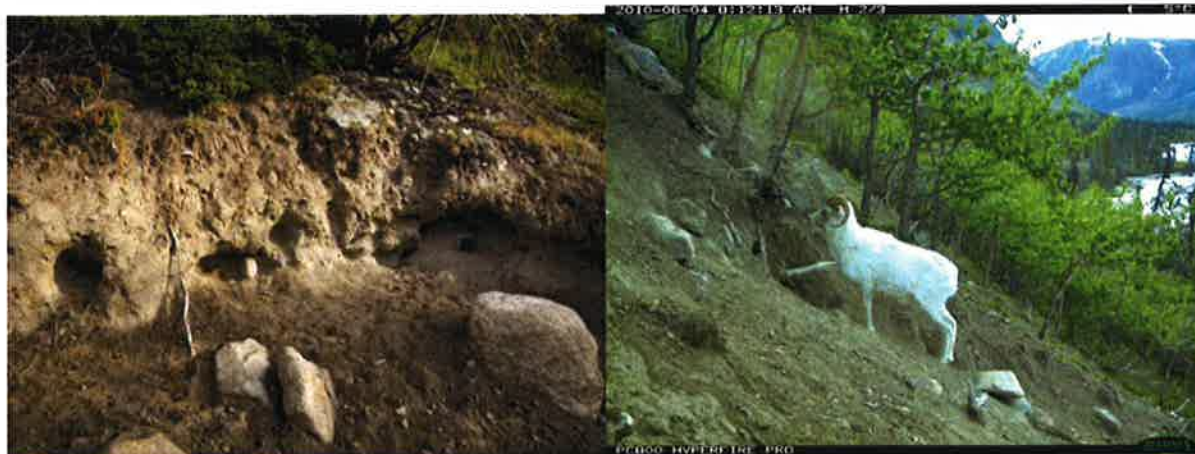
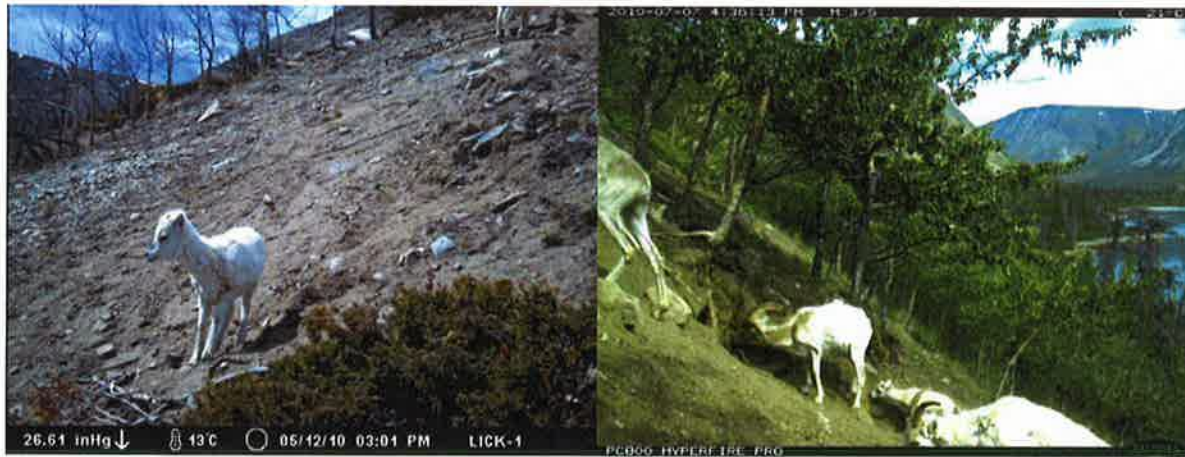
Figure 12. Photos of the Gladstone Lake A Mineral Lick and Dall's sheep at the site.

animals have excavated. Controls were also acquired at these same sites from soil layers above the dug-out areas and two additional controls were sampled above and beside the lick area. Preliminary analysis of the trace minerals results (see Appendix C) indicates that the lick soils contain higher levels of many trace minerals as compared to both the in-lick and outside controls. For example, the lick soils contain roughly twice as much calcium and sodium as the control soils. Photos acquired from the motion-detecting camera at this site indicate that the lick is used almost exclusively by Dall's sheep, with groups of 20+ animals observed at the site.

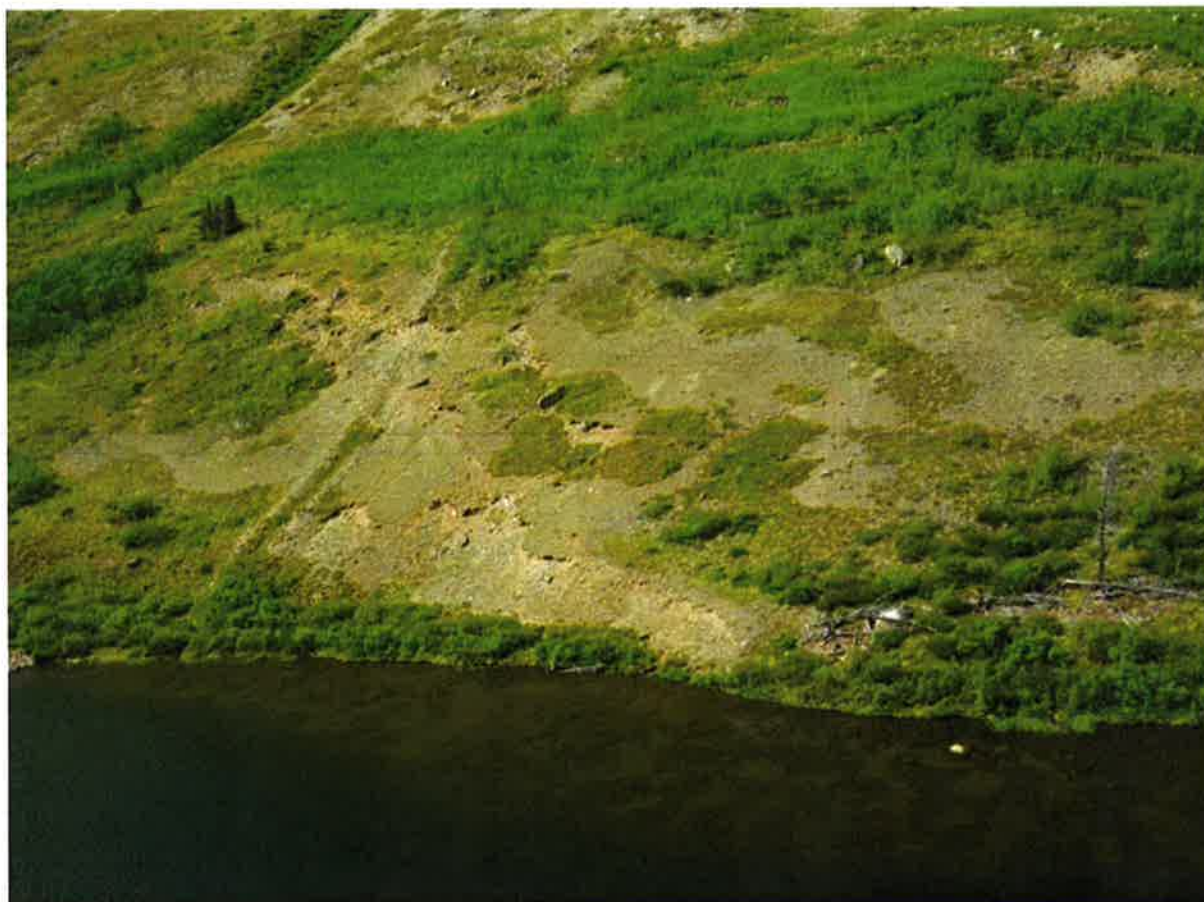
Figure 13. Location of the Gladstone Lake B Mineral Lick site.

The Gladstone Lake B Mineral Lick sits at the base of the north wall of the Gladstone Valley just off the lake at an elevation of approximately 1187 m (Figure 13). There are eight main sites within the lick area from which animals appear to be accessing minerals. Soil samples were obtained from four of these sites to analyse. At each lick site, two soil samples types were collected, one from the target layer and a control sample from the soils closer to the surface which did not appear to be utilized by the animals. Preliminary analysis of the trace metals data (see Appendix C) reveals that the lick soils have approximately three times more calcium than the controls, 1.4 times more potassium, and over 2.5 times more sodium and strontium than the controls. As with the Gladstone Lake A Mineral Lick, motion-detecting camera at the Gladstone Lake B Mineral Lick was used almost exclusively by Dall's sheep (Figure 14).

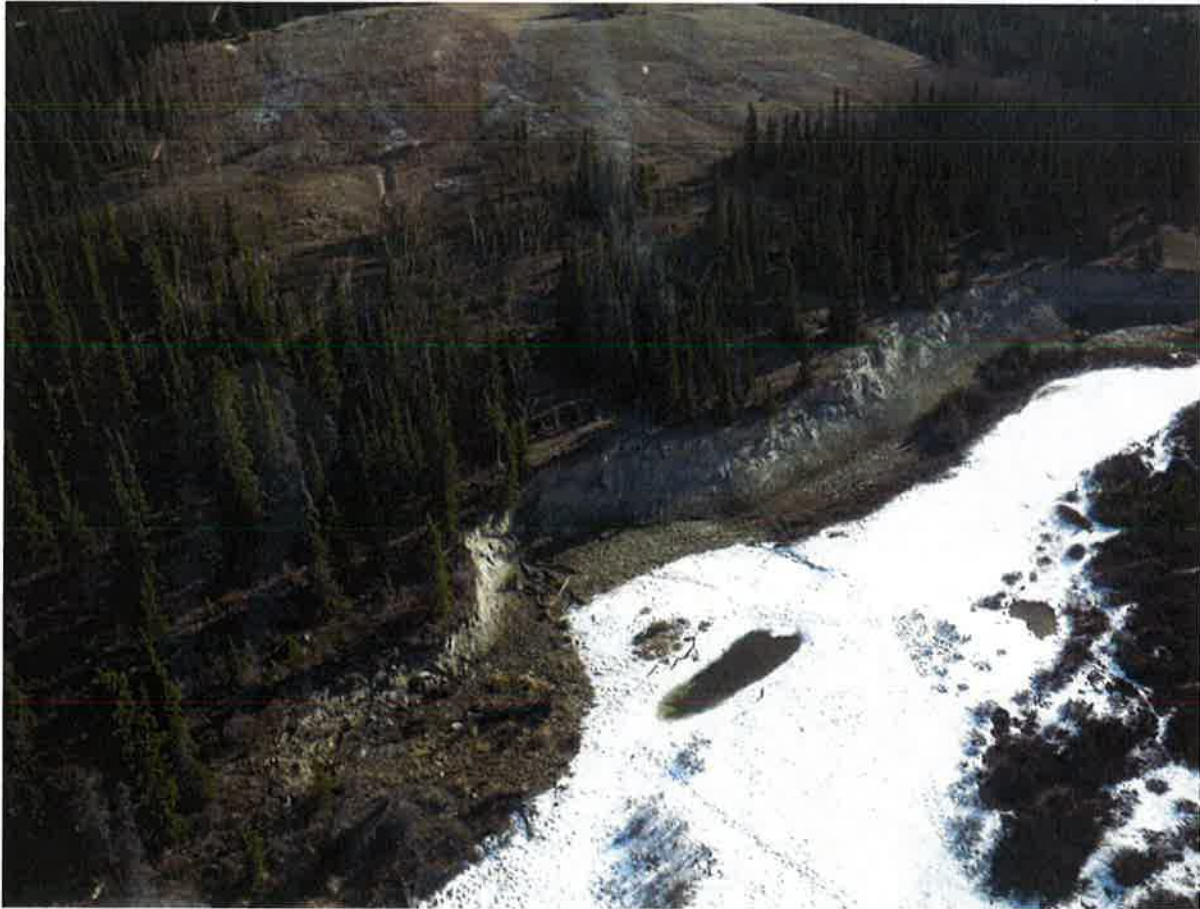
Figure 15. Location of the Isaac Creek Mineral Lick site.

The Isaac Creek Mineral Lick is on the north side of Isaac Creek at an elevation of approximately 1070 m, where erosion from the creek has exposed the mineral soils. The formation of the lick appears to be similar to the Gladstone Lake A and B Mineral Licks in that glacial deposits have created a dome-shaped lobe of fine textured soils (Figure 15). Based on the motion-detection camera images, the Isaac Creek Mineral Lick appears to be frequented by a more diverse array of species than the two Gladstone Lakes licks (Figure 16). This is likely due to the site being adjacent to Isaac Creek, which appears to be used as a travel route. The camera captured bison, caribou, moose and Dall's sheep licking at the lick soils, and photographed grizzly bear, wolf, porcupine and a coyote moving along the wildlife trail beside the lick.
