MPERG Report 2007-4

Shrub Trial Plots – Brewery Creek Mine 2006 Follow-up Monitoring Report

Shrub Trial Plots – Brewery Creek Mine

2006 Follow-up Monitoring Report

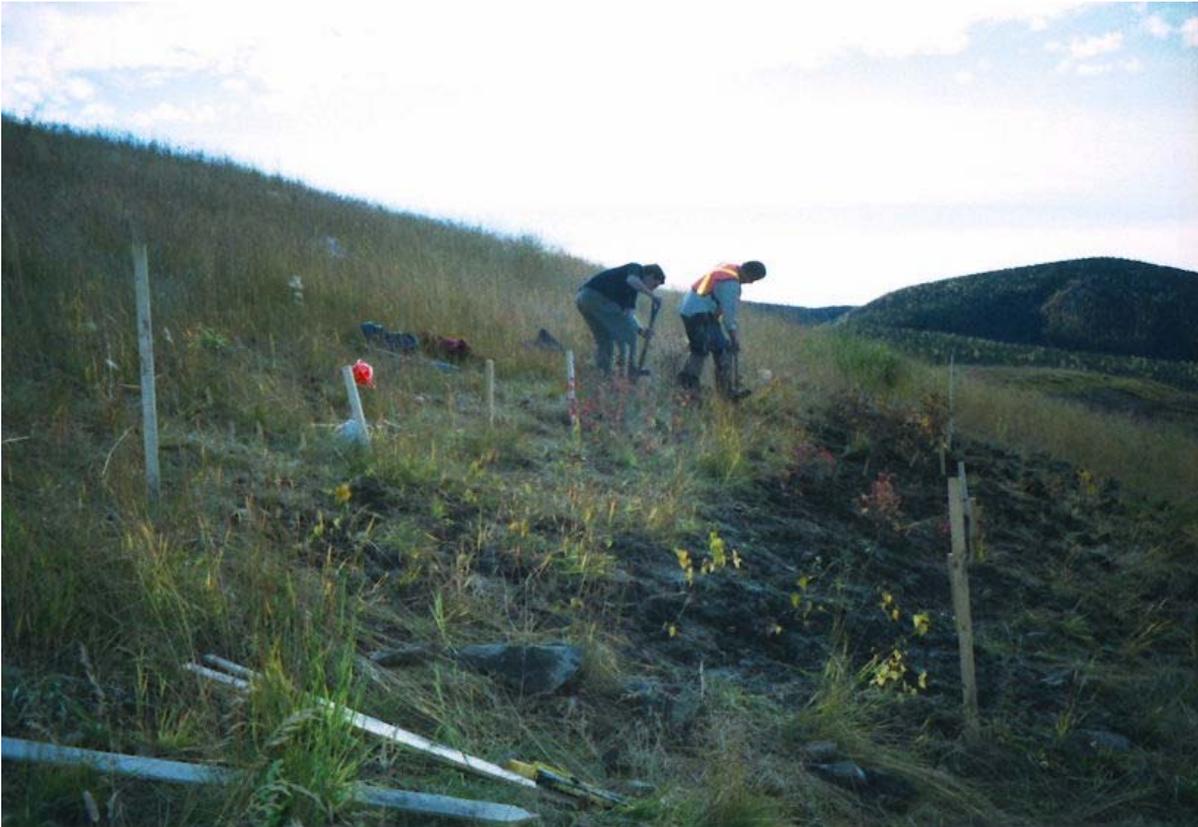
Site C-1. Looking west along the plots during transplanting, September 2000. Alaska birch plot in foreground.

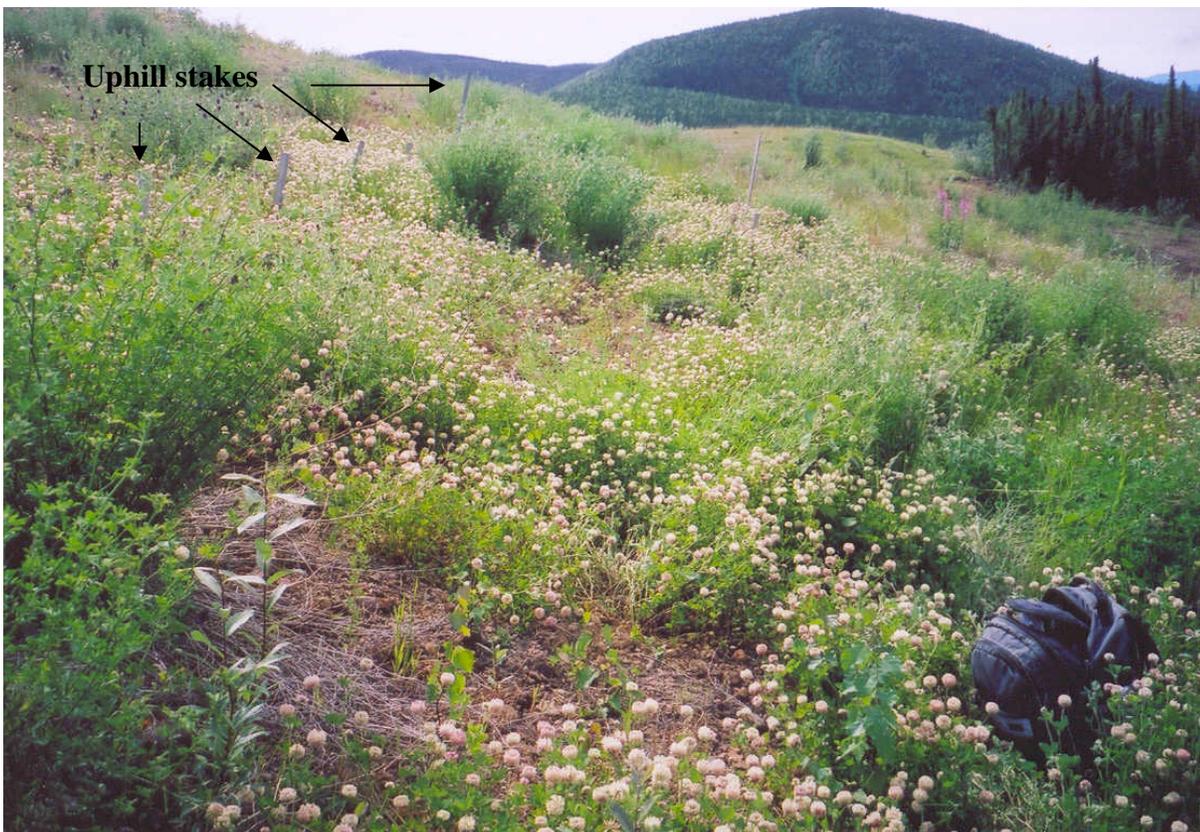
Site C-1. Looking west along the plots, Alaska birch plot in foreground, July 20, 2006. Note the increase in growth of clover and alfalfa throughout the area, which has covered the cleared half of the plots as well.

Since the last survey, there has been a significant increase in the growth of clover and alfalfa throughout the plots. The transplanted species are discussed individually, with a summary of the survival in each plot over time presented in Table 1.

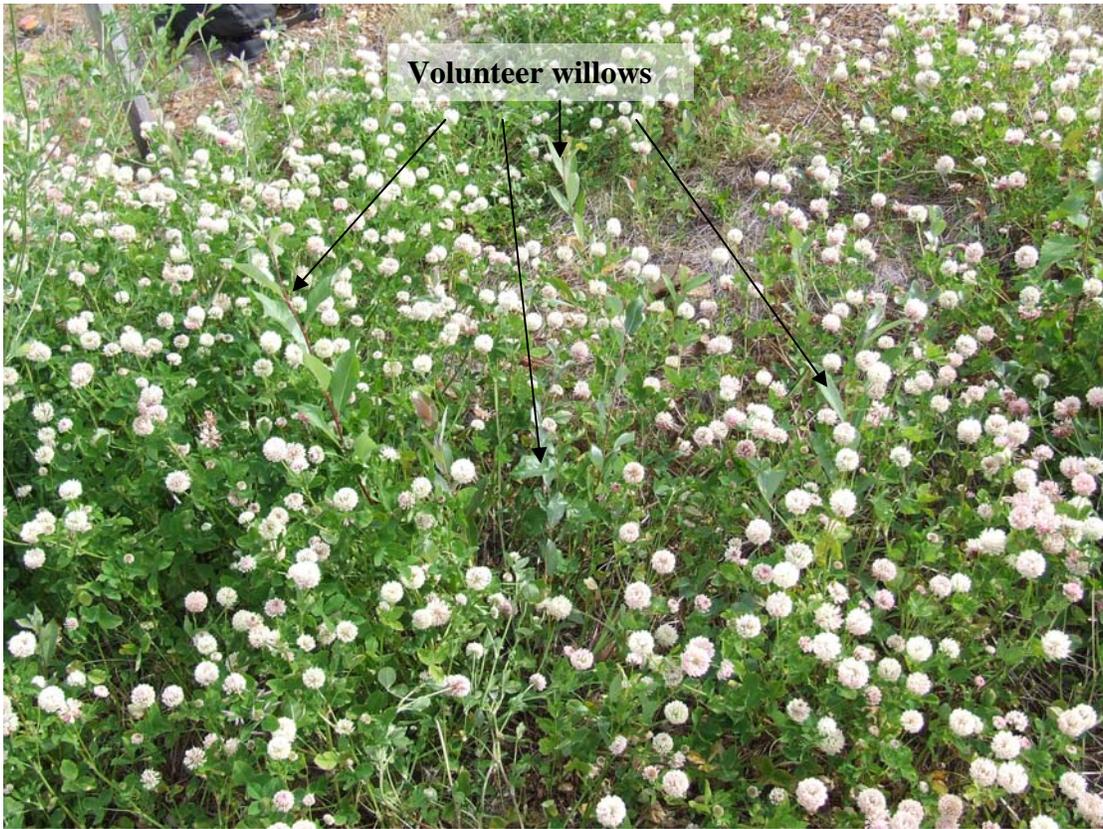
Site C-1. Volunteer willow plants growing in the plot, July 20, 2006.

None of the Bebb's willow stem cuttings had survived when first surveyed in 2001, and the original dead plant material was still evident. There were however several volunteer willows growing in this plot and adjacent plots, as well as in the general area. These young plants were not in flower and could not be readily identified.

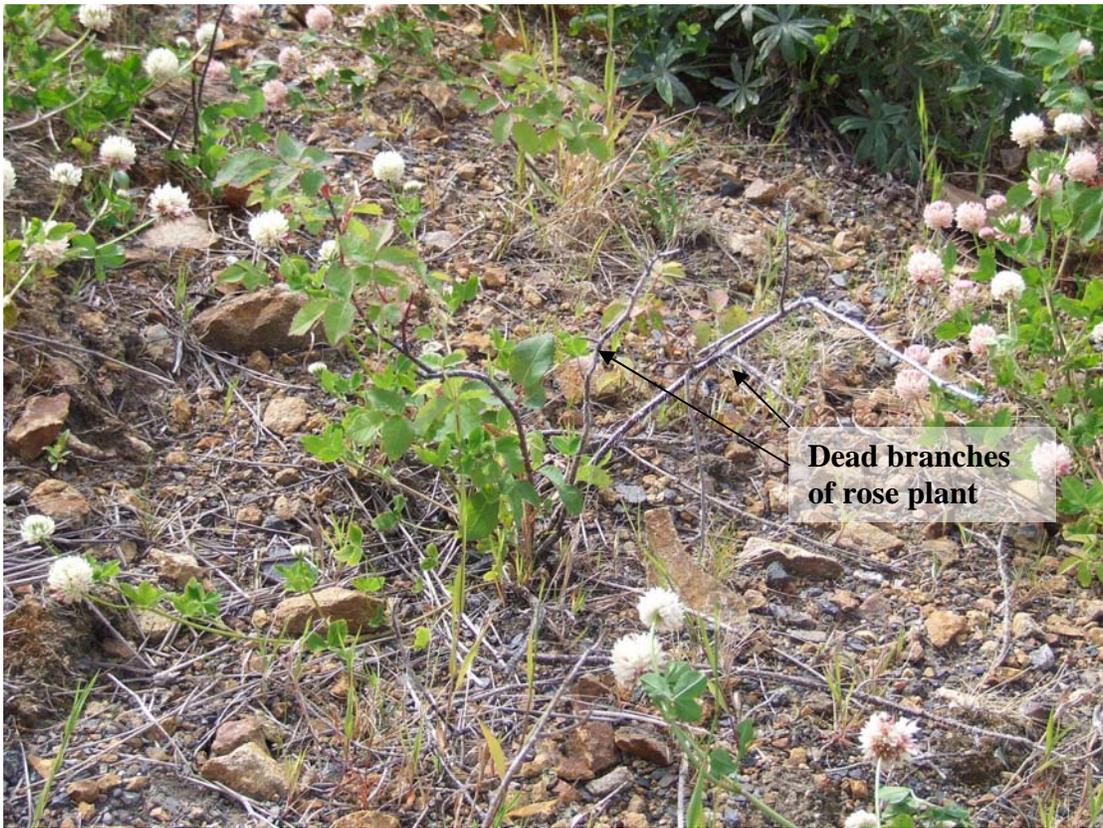
Site C-1. Rose transplants are surviving but not thriving.

The surviving prickly rose transplants do not appear to be healthy. The maximum height was 21 cm. Although there was a good survival rate up to 2002, the rose plants do not appear to be thriving.

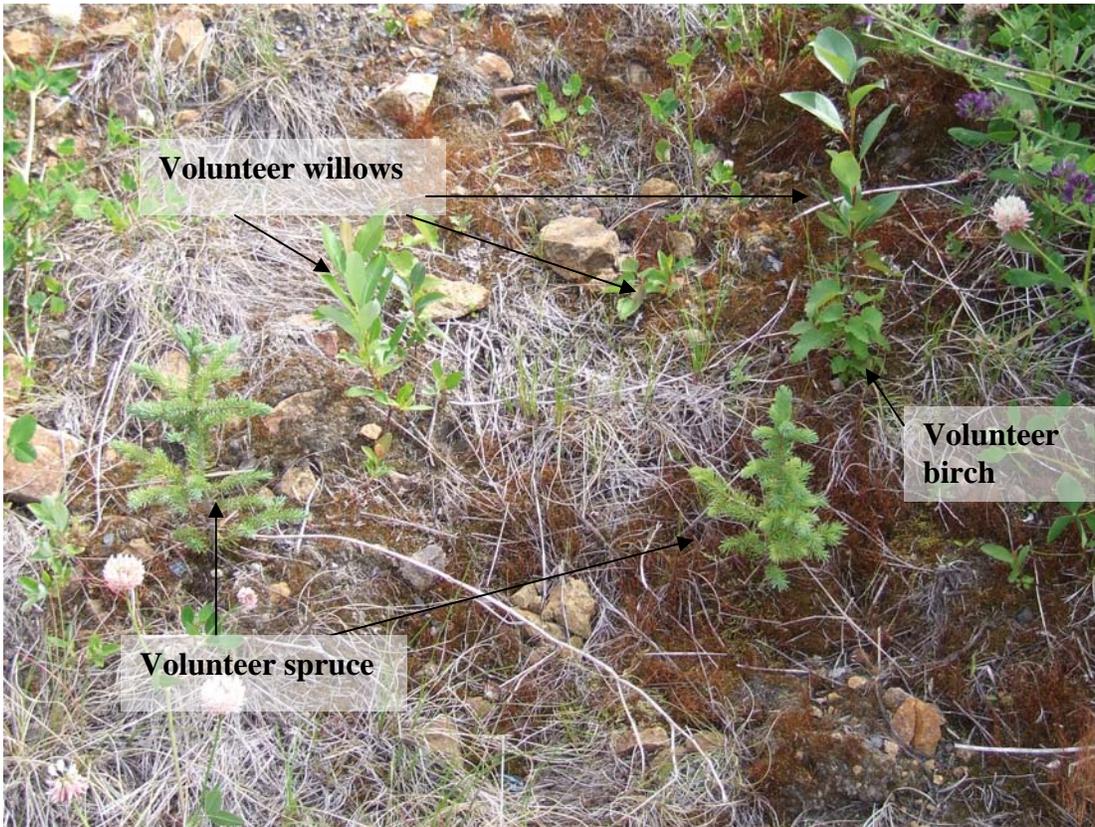
Site C-1. Volunteer spruce, willows and Alaska birch growing just upslope of the plots, July 20, 2006.

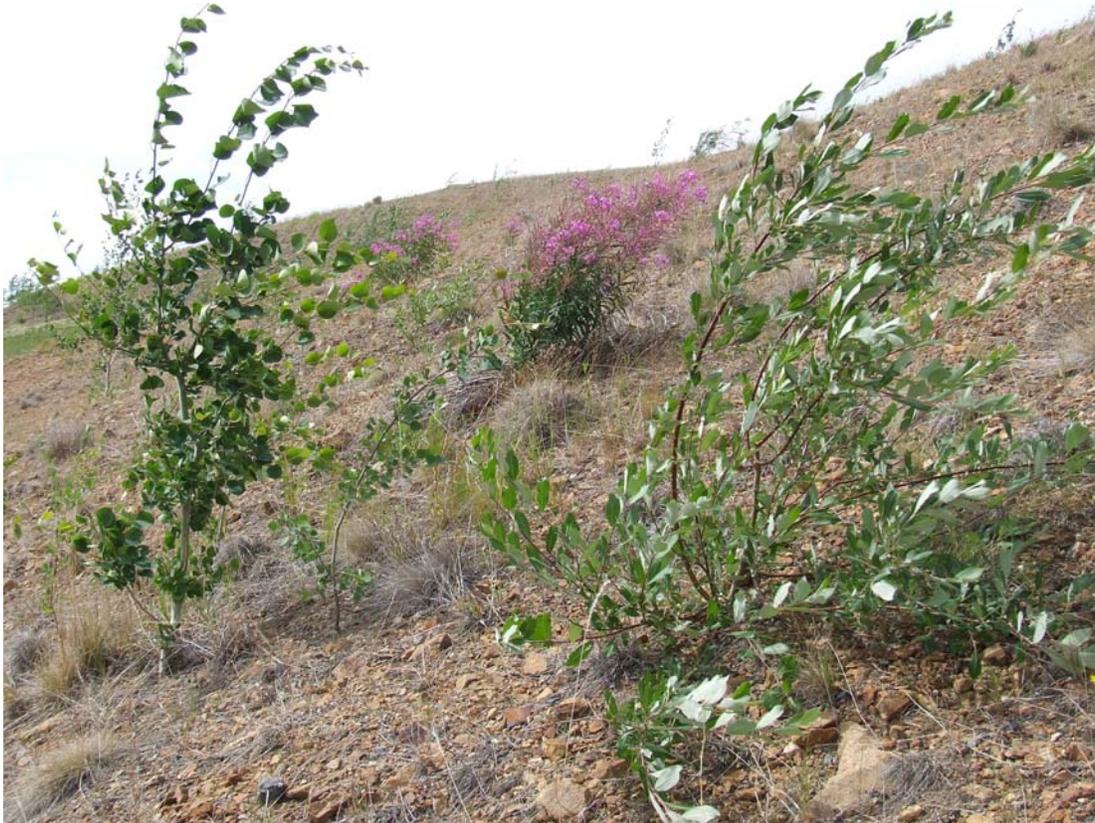
Site C-2. Volunteer aspen and willow growing adjacent to the plots, July 20, 2006.

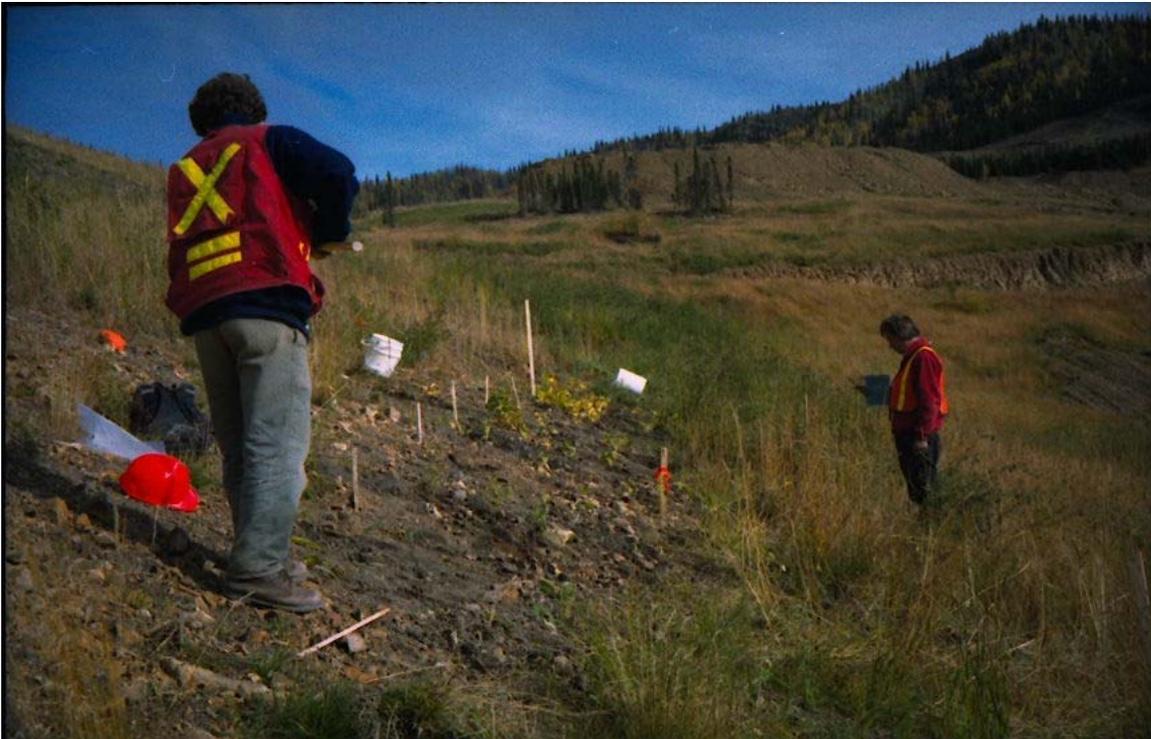
Site C-2. Looking east along plots during transplanting, September 2000.

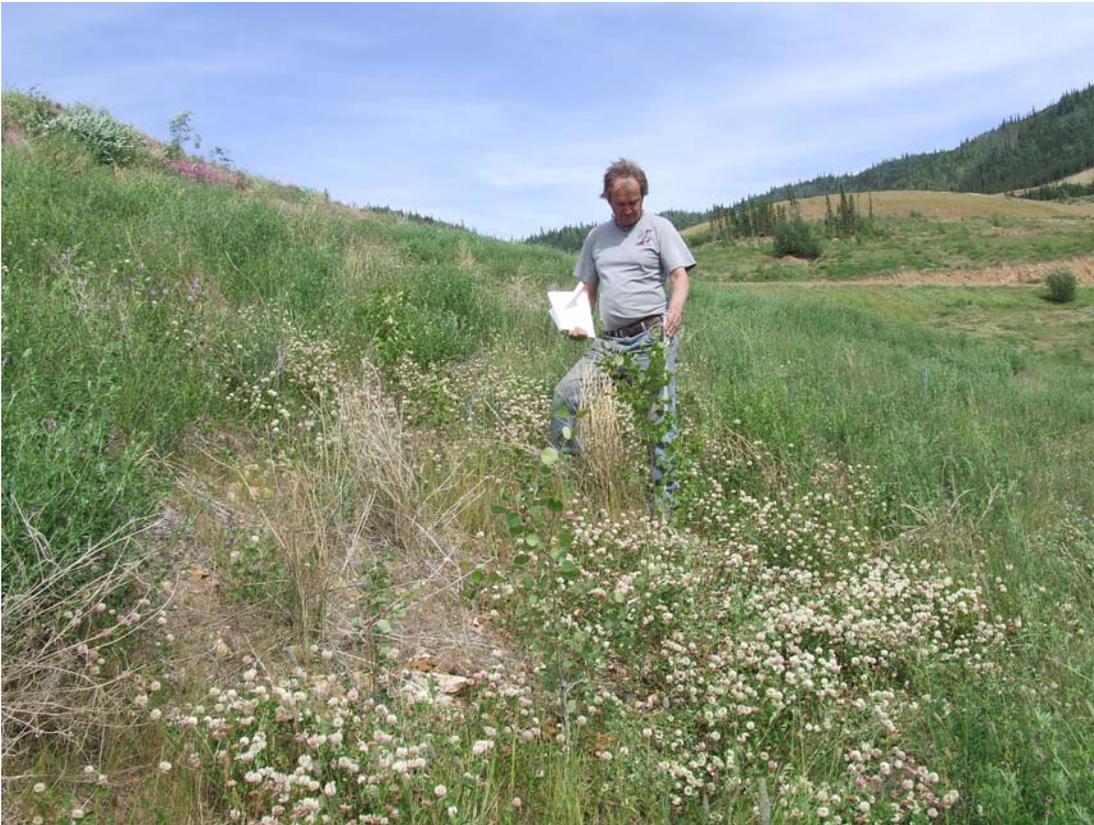
Site C-2. Looking east along plot. Stu is standing by one of the aspens, July 20, 2006. Note increased growth of clover and alfalfa.

Since the last survey (July 2002), there has been a significant increase in the growth of clover and alfalfa throughout the plots. The transplanted species are discussed individually, with a summary of the survival in each plot over time presented in Table 2.

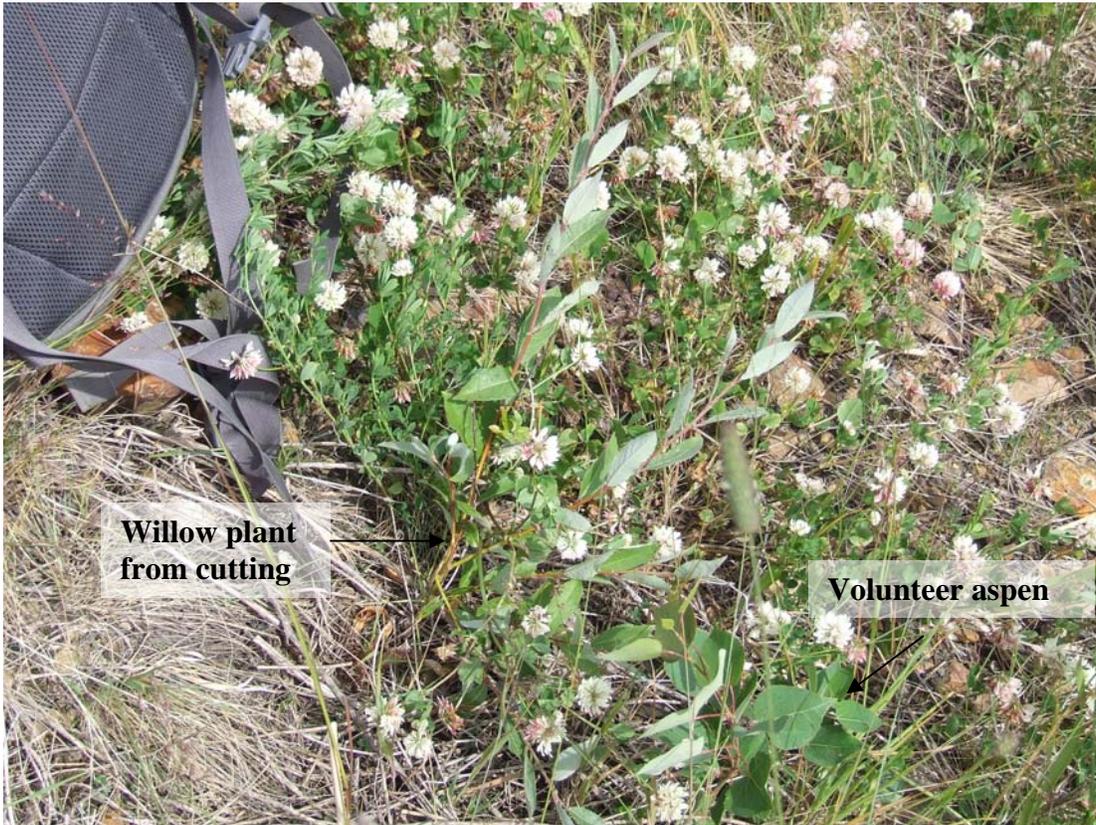
Site C-2. The lone willow survivor, July 20, 2006.

None of the willow stem cuttings planted on the cleared portion of the plot had survived at the time of the 2001 survey, while one was still growing on the vegetated part of the plot in 2006.

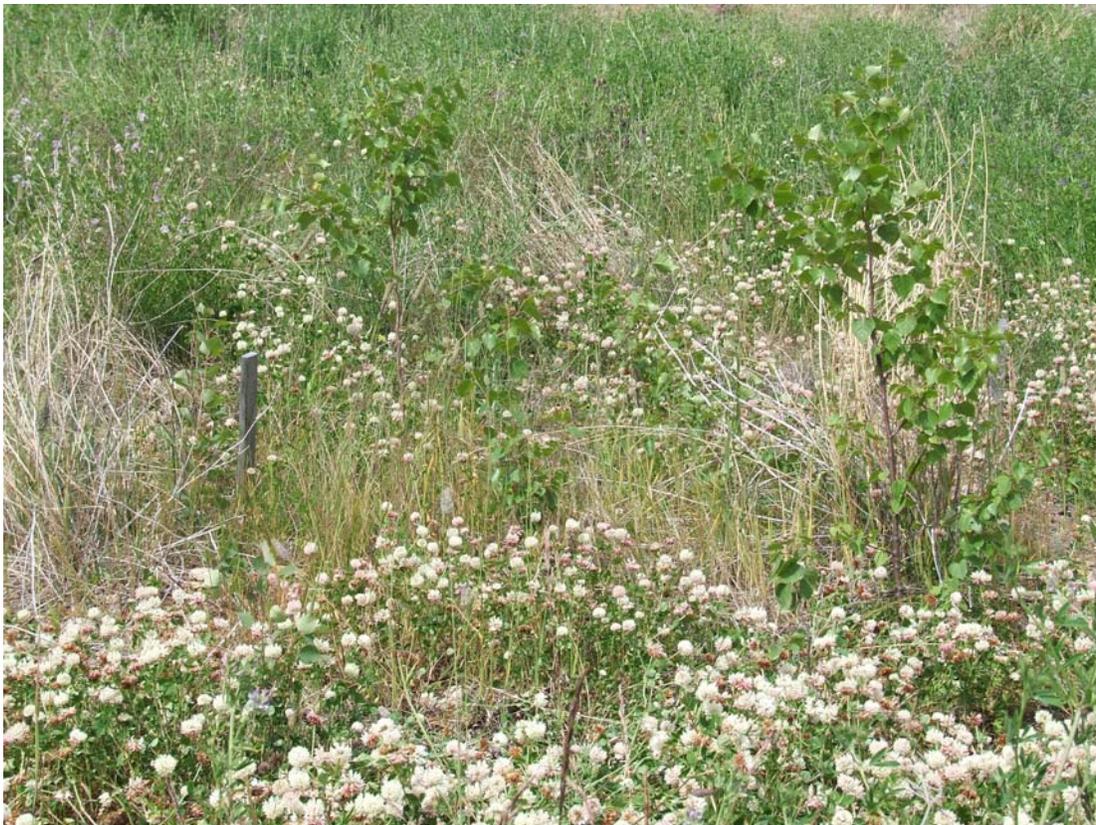
Site C-2. The Alaska birch transplants are doing very well, July 20, 2006.

In 2006, only one of the ten Alaska birch transplanted on the cleared portion of the plots was surviving, following a 100% survival rate up to July 2002. Five of the seven transplanted on the vegetated portion were growing well, along with five new seedlings. The maximum height of the birch transplants was greater than one metre.

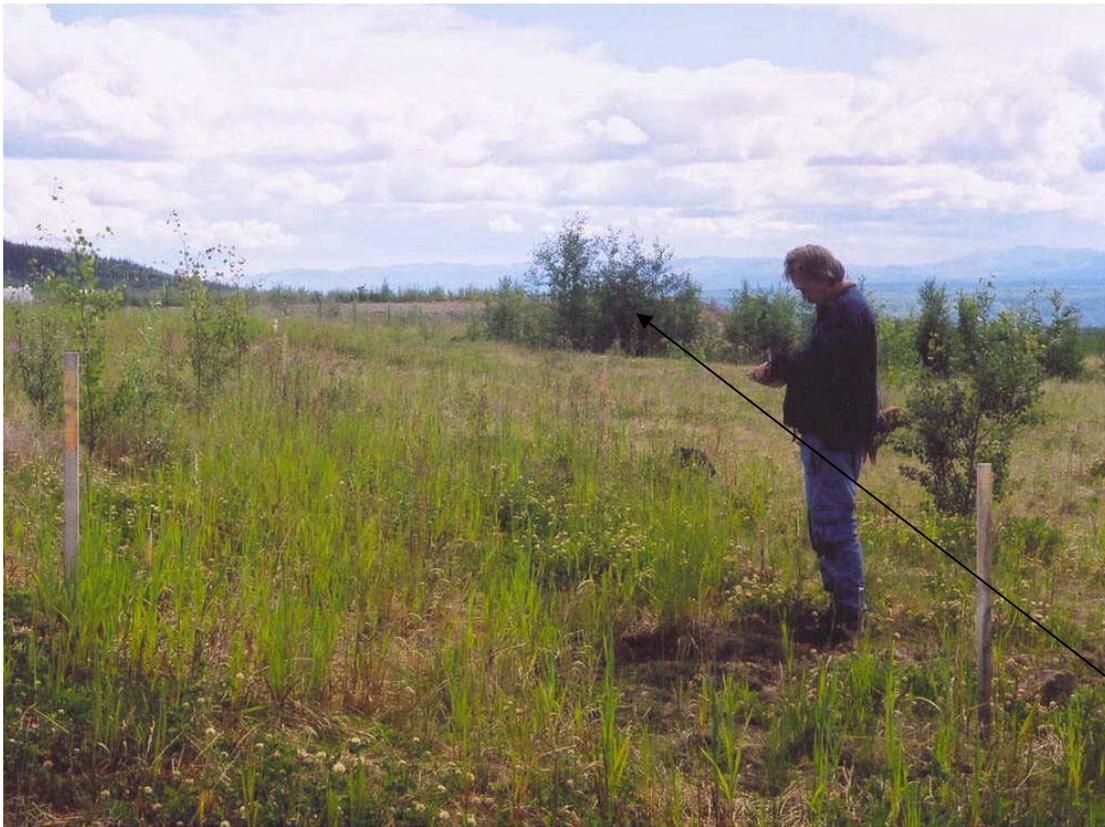
Site LP-1. Looking along plot, July 2002.

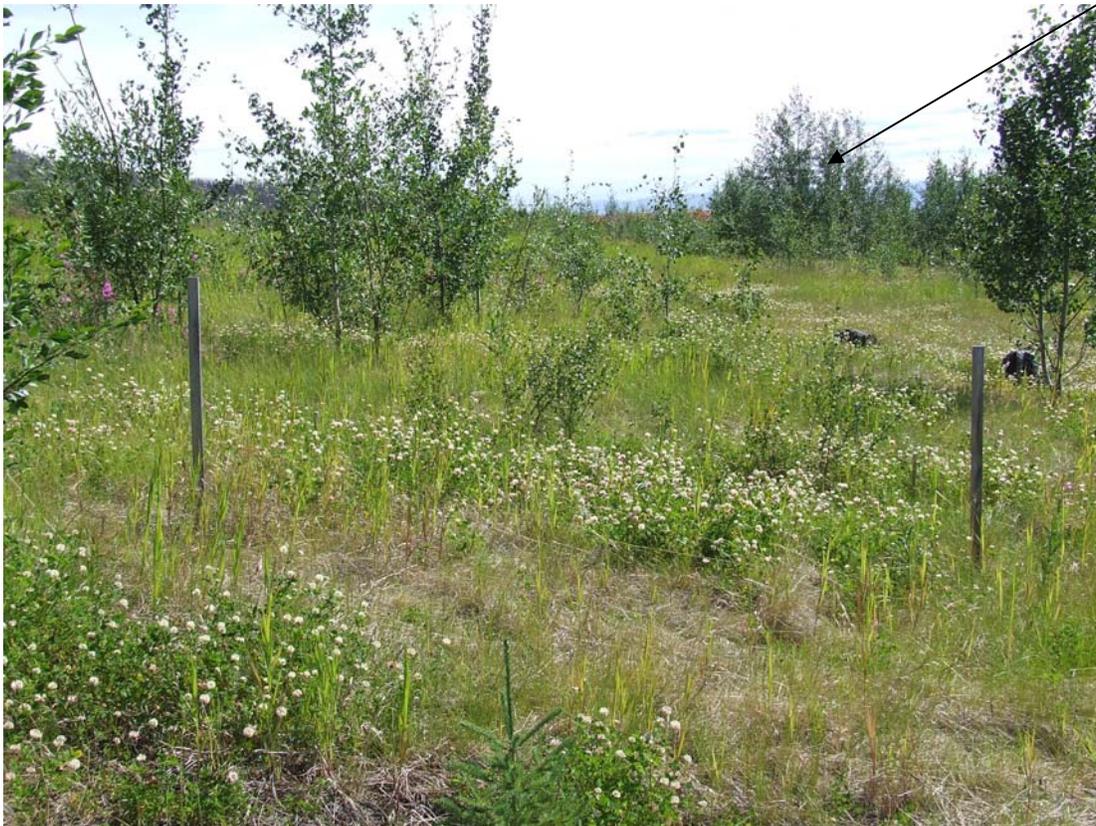
Site LP-1. Looking along plot, July 20, 2006. Growth of clover and aspens is much thicker and more robust than in July 2002.

There was an increase in the growth of clover throughout this area. The volunteer aspens and willows growing beyond the plots show robust growth and are propagating and spreading naturally. The species transplanted in the plots are discussed individually, with a summary of the survival over time presented in Table 3.

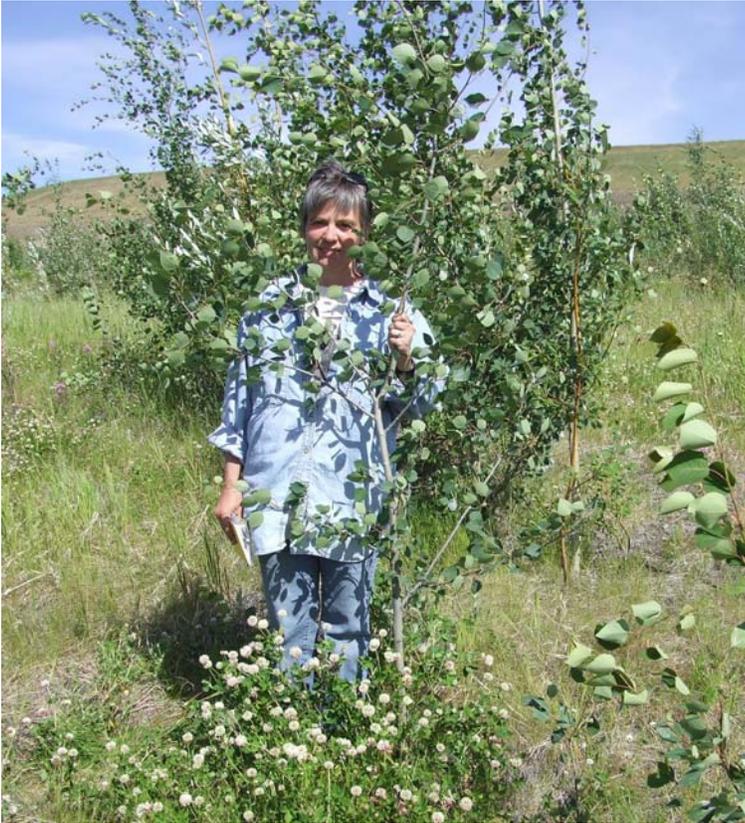
Site LP-1. One of the aspen trees which has grown from a root cutting is now well over 2 m high. July 20, 2006.

The trembling aspens (five in the cleared portion of the plot and 4 in the vegetated portion) are growing well with a maximum height of 2.5 metres. In 2002, only one aspen was growing in the vegetated area, so these aspens are likely reproducing through root suckering.

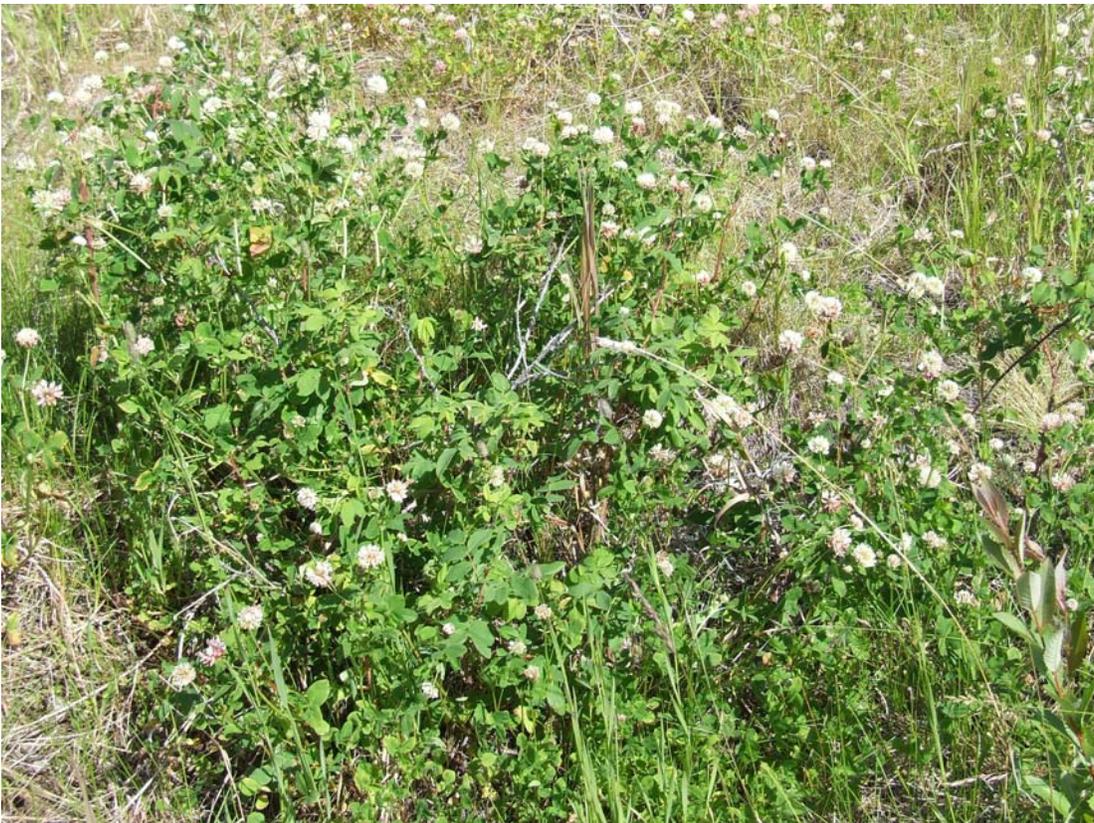
Site LP-1. Healthy rose plants in the plot, July 20, 2006.

The surviving prickly rose transplants are growing well with a maximum height of 45 cm. These transplants are reproducing, probably from seed, with eight additional rose plants observed growing throughout the plot.

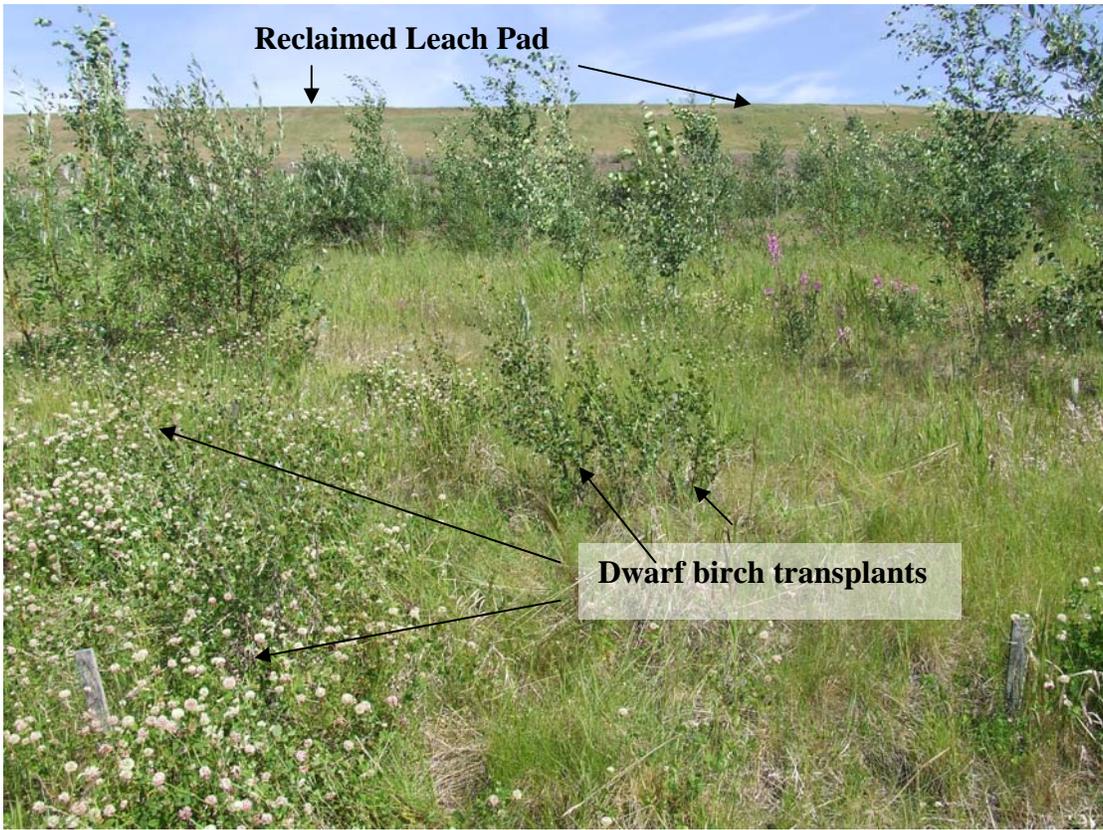
Site LP-1. Healthy dwarf birch plants thriving in the plot, July 20, 2006.

The surviving dwarf birch transplants are growing well with a maximum height of 120 cm. The transplants on the vegetated portion of the plot are reproducing, probably from seed.

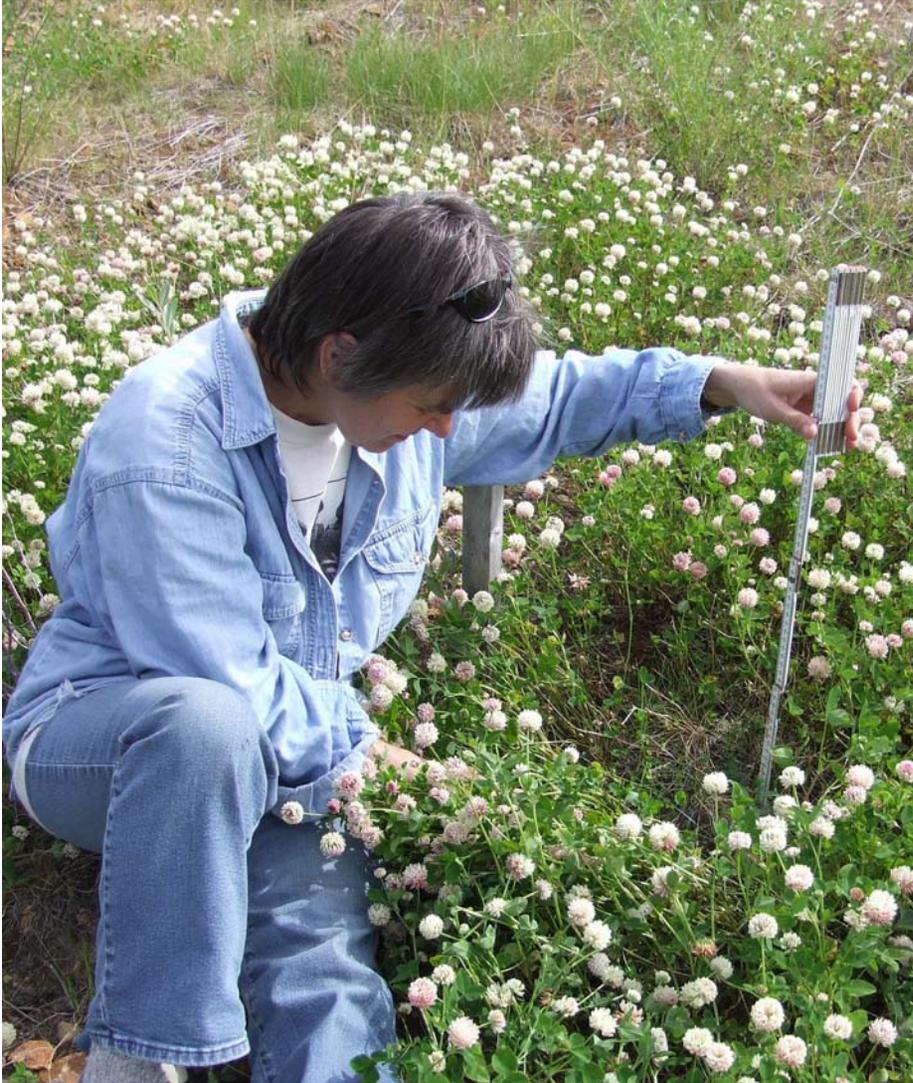
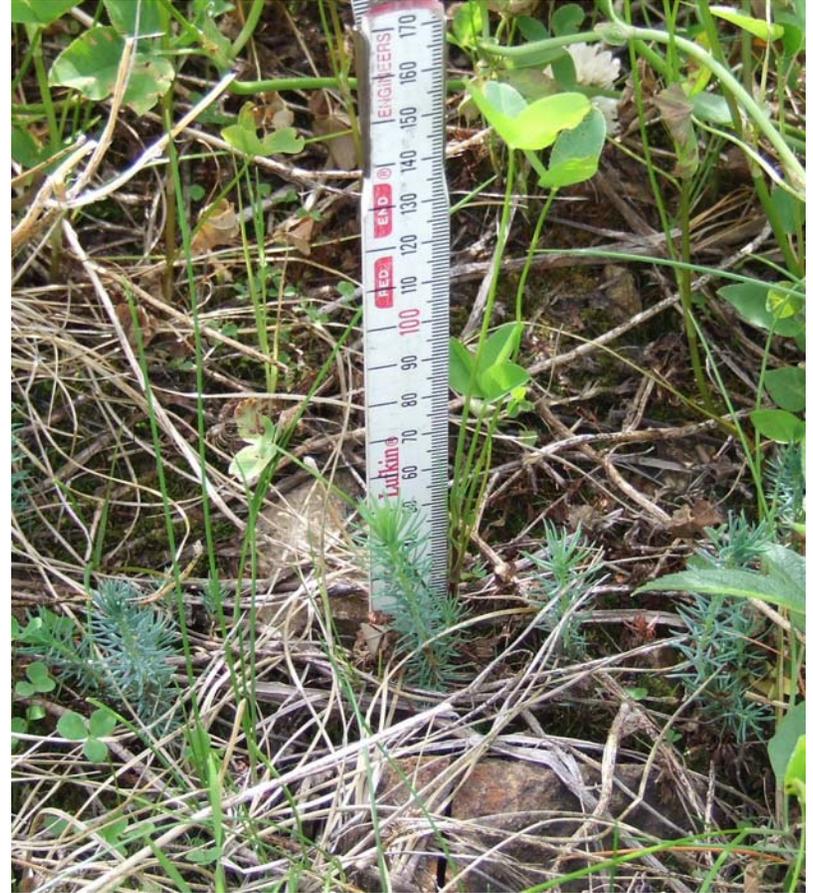
Site C-1. Black spruce seedlings grown from seeds, July 2006.

Approximately 20 black spruce seedlings were growing on the vegetated portion of the plot at the time of the 2006 survey. Some of the seeds had germinated when surveyed in August 2001, the majority in the cleared half of the plot, and a few of these were still alive when surveyed in July 2002.
