YGS Miscellaneous Report MR-22

Greater Whitehorse area permafrost characterization

L.-P. Roy, F. Calmels, C. Laurent and N. Vogt Yukon University
P.S. Lipovsky and J. Humphries Yukon Geological Survey

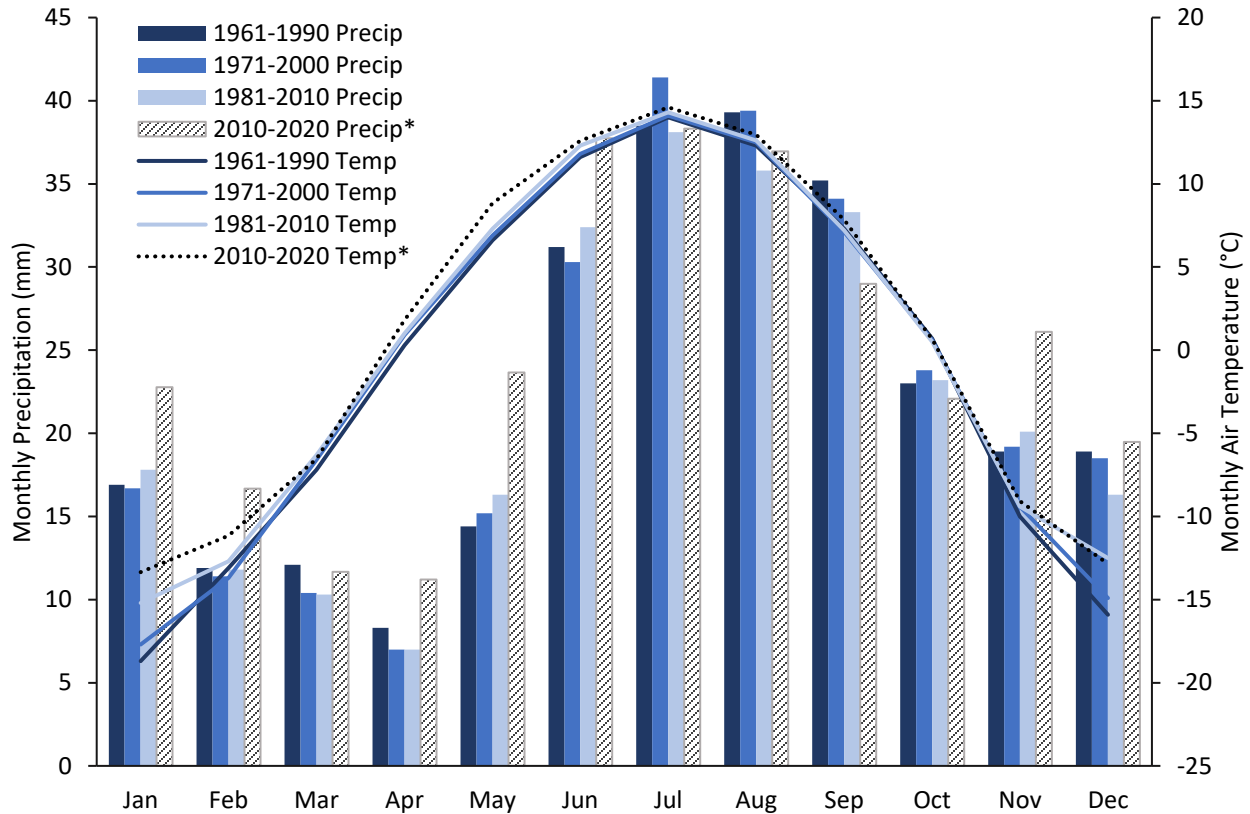
Figure 2.1 Monthly air temperature and precipitation normals for Whitehorse airport (Whitehorse A), 1960–2010 (ECCC, 2021b). *Mean monthly air temperature and precipitation for 2010–2020 were calculated from Whitehorse AUTO (located 3 km north of airport) daily data (ECCC, 2021a).

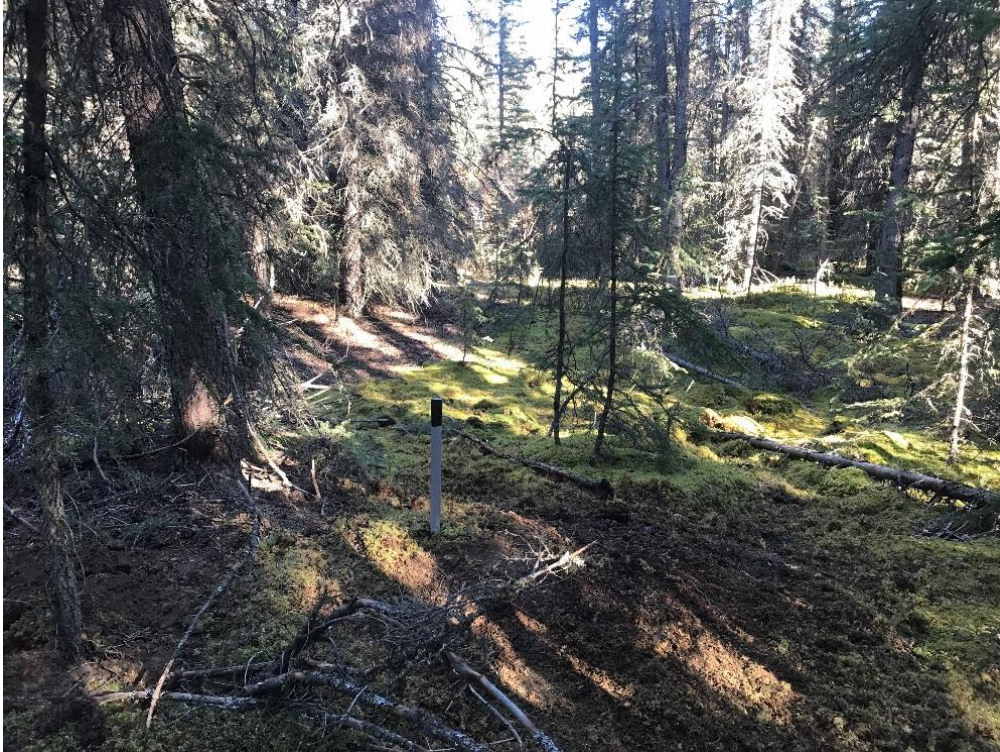
Figure 3.4 Location of borehole CC_BH2 and surrounding vegetation cover.

A second 5 m borehole, CC_BH2, was drilled and instrumented on 29 September 2018 on the top of a small permafrost mound. The borehole was cased with a sealed 1-inch PVC pipe, instrumented with two 4-channel Hobo loggers to record ground temperatures at eight depths (Table 3.1), and backfilled with earth to the surface (Fig. 3.4). CC_BH2 is ~20 m southeast of CC_BH1, and 42 m along the ERT survey (CC_ERT1). Vegetation at the site consists of mature white spruce forest up to about 20 m high, with a 0.05 m thick ground cover of moss and lichen. Bare mineral soil was also observed at the surface in the vicinity of the borehole (Fig. 3.4). Prior to drilling from the frost table, the unfrozen active layer was excavated by shovel to 0.80 m depth, then hand augered to the thaw front at 1.2 m depth. The unfrozen active layer primarily comprises fine-grained silty-sand.

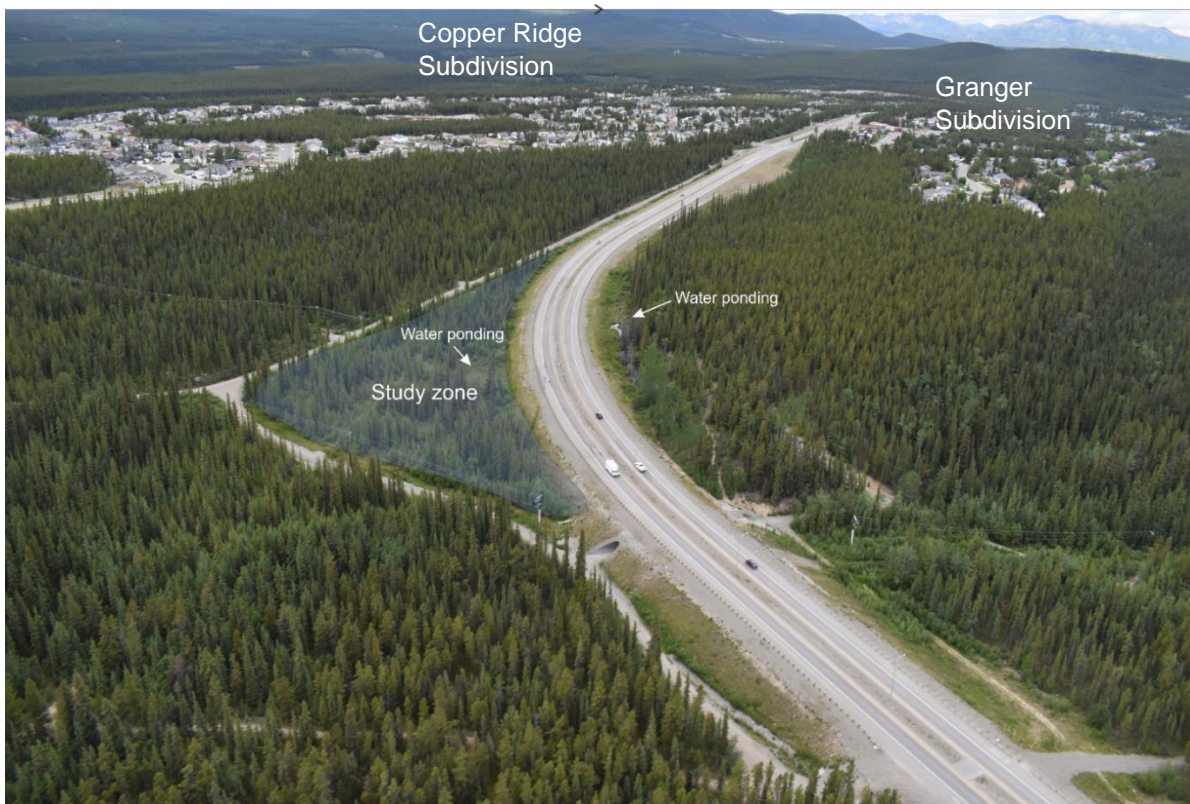
Figure 4.2 Oblique aerial view of study site, shaded blue, with Copper Ridge and Granger subdivisions visible to the north.

The Hamilton Boulevard case study site is located near the Copper Ridge and Granger subdivisions in the central portion of the City of Whitehorse limits (Fig. 4.1). The site is 750 m southeast of Falcon Drive on the southwest side of Hamilton Boulevard. The area investigated is the triangular-shaped area bounded between Hamilton Boulevard to the northeast and a gravel road to the southwest (Fig. 4.2). The site lies at an elevation of ~750 m asl and slopes gently to the northeast at less than 5°. Drainage is poor as the site is located within a local depression with hummocky microtopography. The site is surrounded by linear disturbances including a paved road, cutline, power lines and a gravel road (Fig. 4.1).

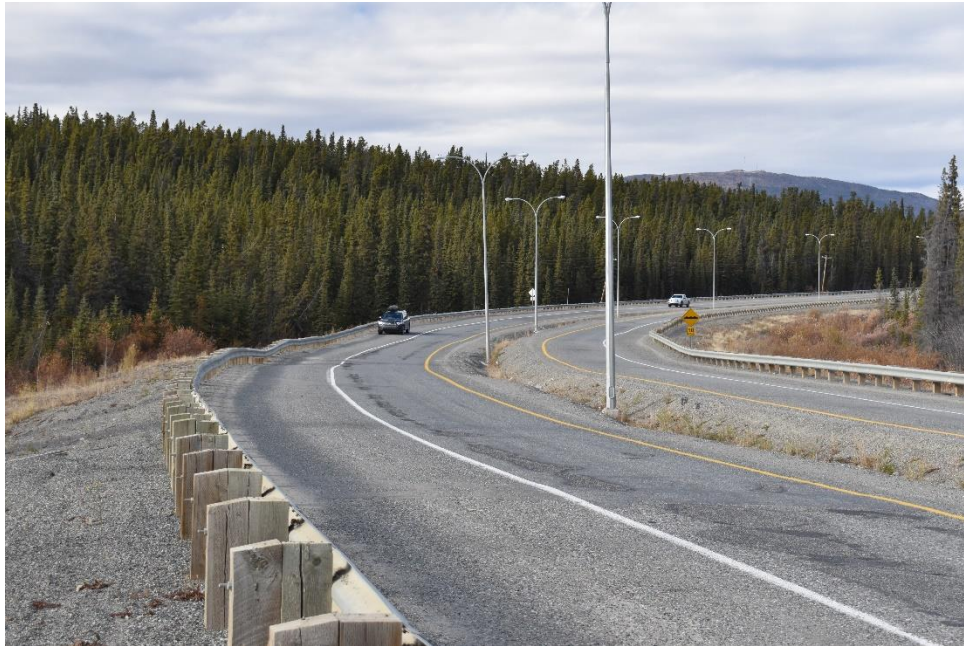
Figure 4.5 Example of differential road settlement (4 October 2018).

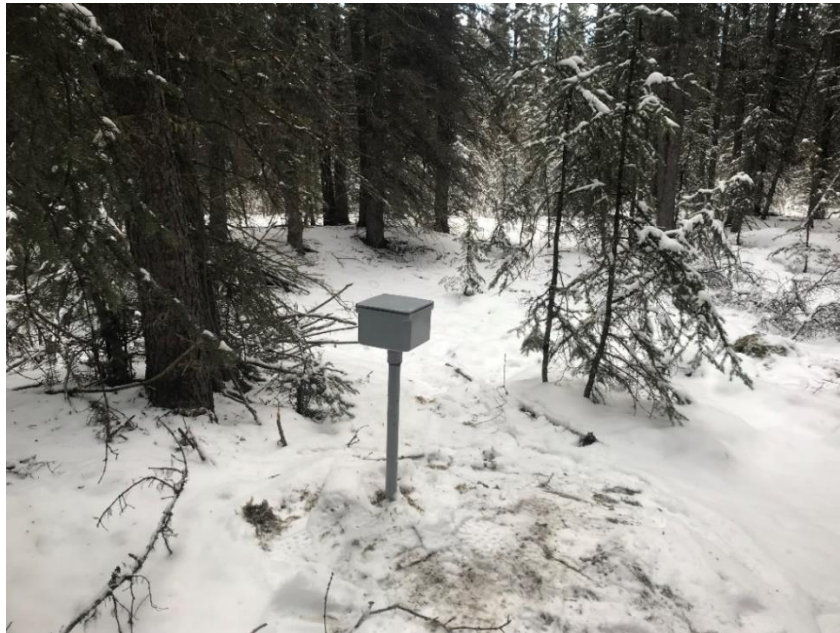
Figure 4.6 Borehole HB_BH1 in surrounding forest.

The cryostratigraphical profile of HB_BH1 (see Figure A2) shows an initial layer of peat 0.66 m thick confirming drilling was within undisturbed ground. This was underlain by a cobble-rich layer from 0.66 to 1.23 m depth. Dense till with varying amounts of coarse fragments and fine-grained material were encountered from 1.23 to 2.18 m depth. The borehole ended at 2.18 m in ice-poor gravelly sediment. Crustal-ice coating gravel was observed in some of the samples, and the volumetric excess ice content ranged from 0 to 53% (Table 4.2). The cobble-rich horizon from 0.66 to 1.23 m depth decreased the average excess ice content. Overall, the borehole has a mean volumetric excess ice content of 36%, which represents a potential subsidence of 0.54 m if permafrost were to thaw entirely from 0.5 to 2 m depth.

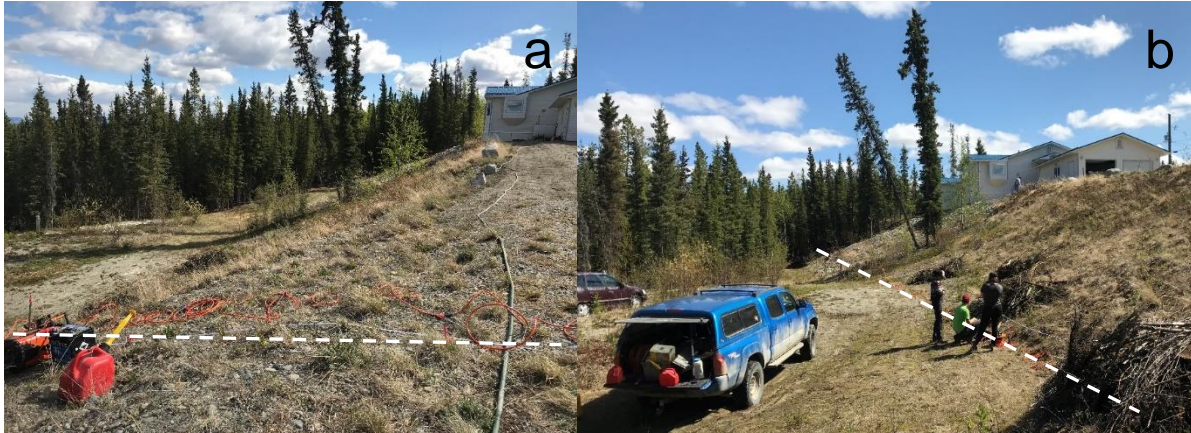
Figure 5.2 North-facing cleared escarpment at Hidden Valley case study site, showing (a) south end of HV_ERT1 transect running across the driveway and grass slope, and (b) west end of HV_ERT2 transect running along the bottom of the steep escarpment. Dashed lines show approximate locations of the ERT transects.

The Hidden Valley case study site is located on private property in the Hidden Valley Subdivision ~16 km north of downtown Whitehorse, immediately west of the North Klondike Highway and south of the Takhini River (Fig. 5.1). The house and main driveway are off Soapberry Lane and lie on a cleared bench at 655 m elevation on the upper (southern) portion of the property. This bench is a remnant of the glacial lakebed that has been eroded away on all sides by a tortuously meandering channel of the former Takhini River. From the north side of the house (on the bench), elevation falls ~5 m over a steep (~25–30°) cleared escarpment (Fig. 5.2). This transitions to a gentle (~6–10°) north-facing forested slope which falls another 5 m in elevation on the northern half of the property (Fig. 5.2).

Two ERT surveys, HV_ERT1 and HV_ERT2, were conducted on 17 and 24 May 2018, respectively (Table 5.1). HV_ERT1 was oriented from south to north starting from the upper bench and running down the escarpment and gentle slope below (Fig. 5.1 and 5.2a). HV_ERT2 was oriented from west to east, extending along the base of the escarpment (Fig. 5.1 and 5.2b). For each of the two surveys both the Wenner and dipole-dipole array were measured. The results obtained with the Wenner and dipole-dipole arrays show a similar distribution of resistivity in the ground, however the dipole-dipole shows more detail in low resistivity areas. Very high-resistivity areas, shown in dark blue, are generally attributable to ice-rich fine-grained sediment, and/or colder permafrost at depth. Low resistivity values could be attributable to ice-

The first ERT survey, HV_ERT1, ran from south to north, across a gravel driveway and down a slope (Fig. 5.2b and 5.10). High resistivity zones, represented as dark blue shades, were located on top of the slope towards the beginning of the profile and under a grassy mound at 53 m (Fig. 5.10b). The thicker organic cover on this mound likely contributes to the preservation of the underlying permafrost by insulating the ground. A higher resistivity pocket (A) can also be observed at 30 m at the intersection with HV_ERT2 (Fig. 5.10b) and may be evidence of what is left of the ice-rich soil excavated at the base of the slope in 2008. Below 5 m depth, it appears most of the profile is unfrozen (Fig. 5.10b).

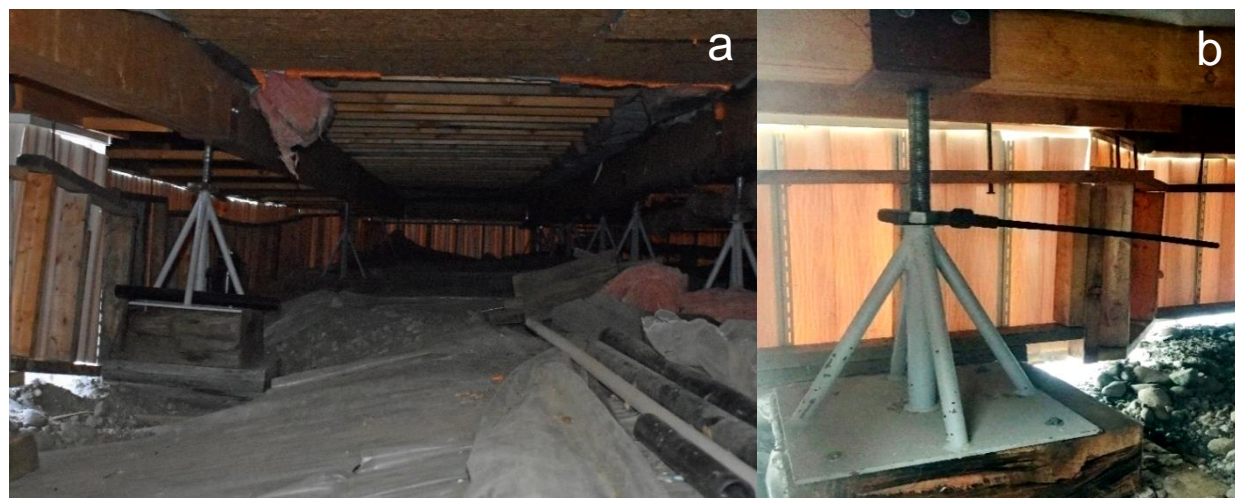
Figure 5.5 (a) Foundation jack located under the house, where (b) a wrench is used to raise or lower the support beams.

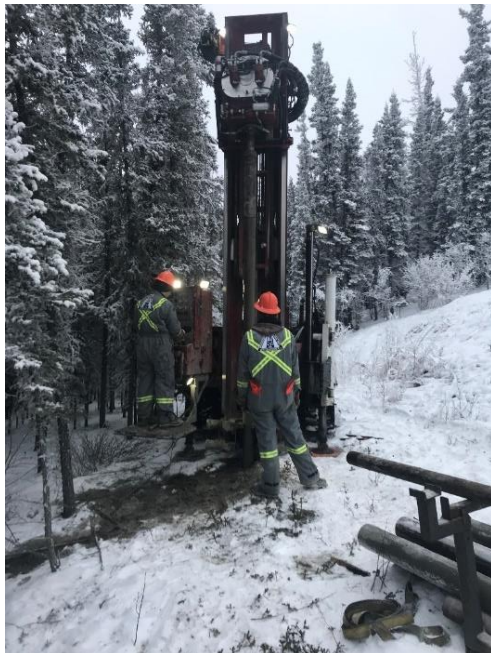
Figure 5.6 Midnight Sun Drilling at borehole HV_BH1 using a sonic drill.

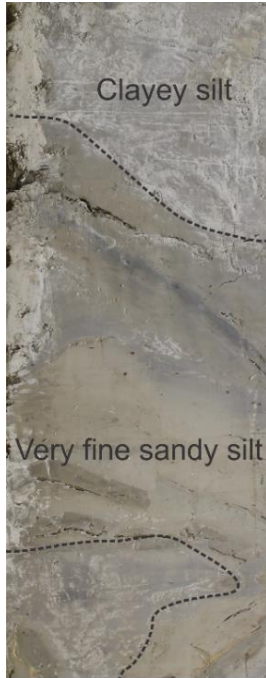
Figure 5.7 Permafrost core containing gray sandy clayey silt alternating with very fine sandy lenses at HV_BH1.

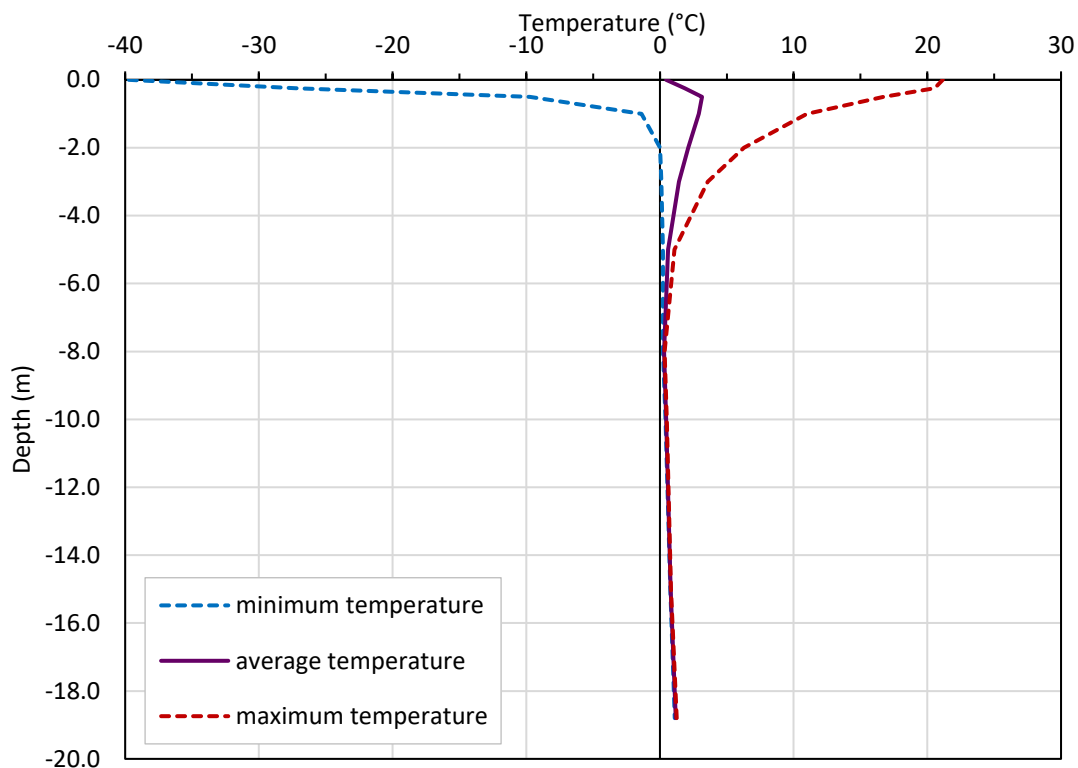
Figure 5.9 Hidden Valley ground temperature envelope at HV_BH1 for the period 31 August 2019 to 30 August 2020.

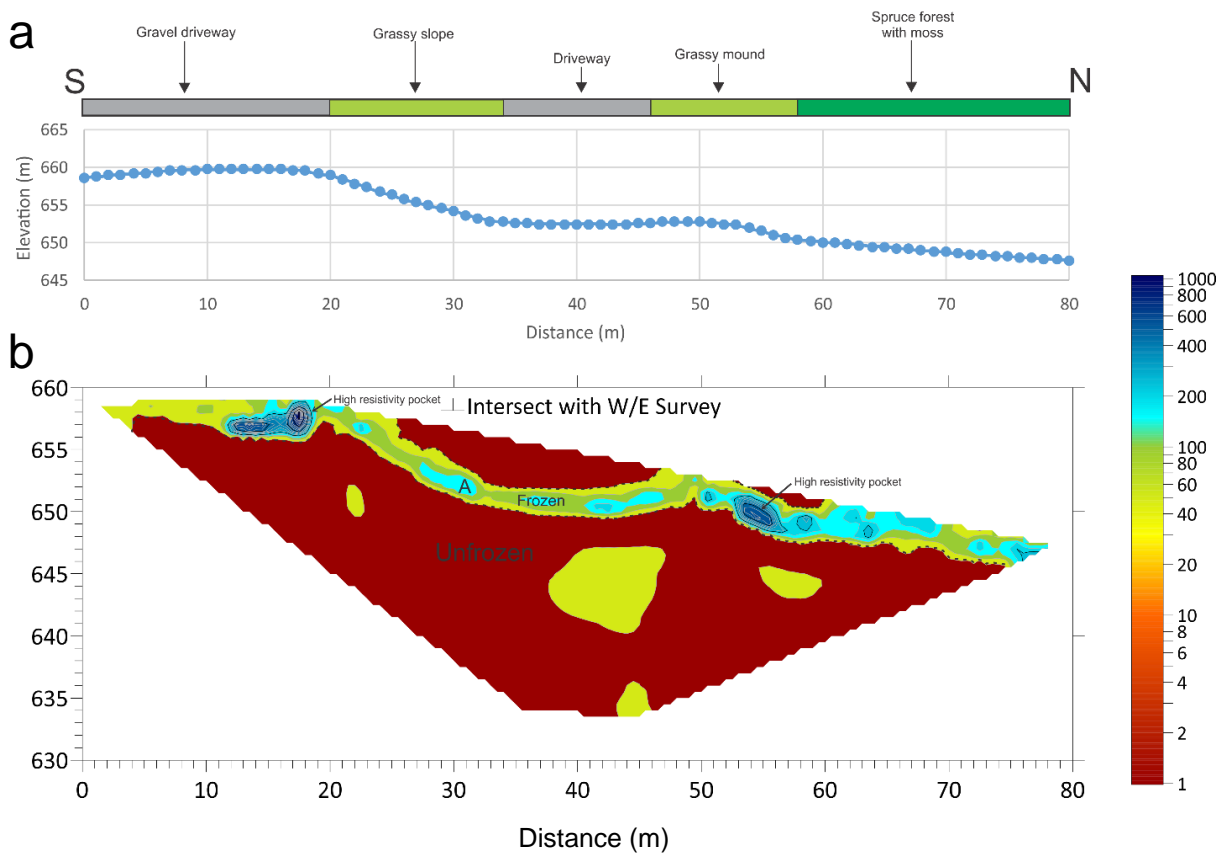
Figure 5.10 Hidden Valley S-N ERT survey (HV_ERT1) showing the (a) elevation profile and (b) ERT profile using dipole-dipole array, 5th iteration, RMS error = 4.0%. Figure (b) is annotated and homogenized to differentiate between ground material interpreted as frozen (greenish blue to dark blue) and unfrozen (red).

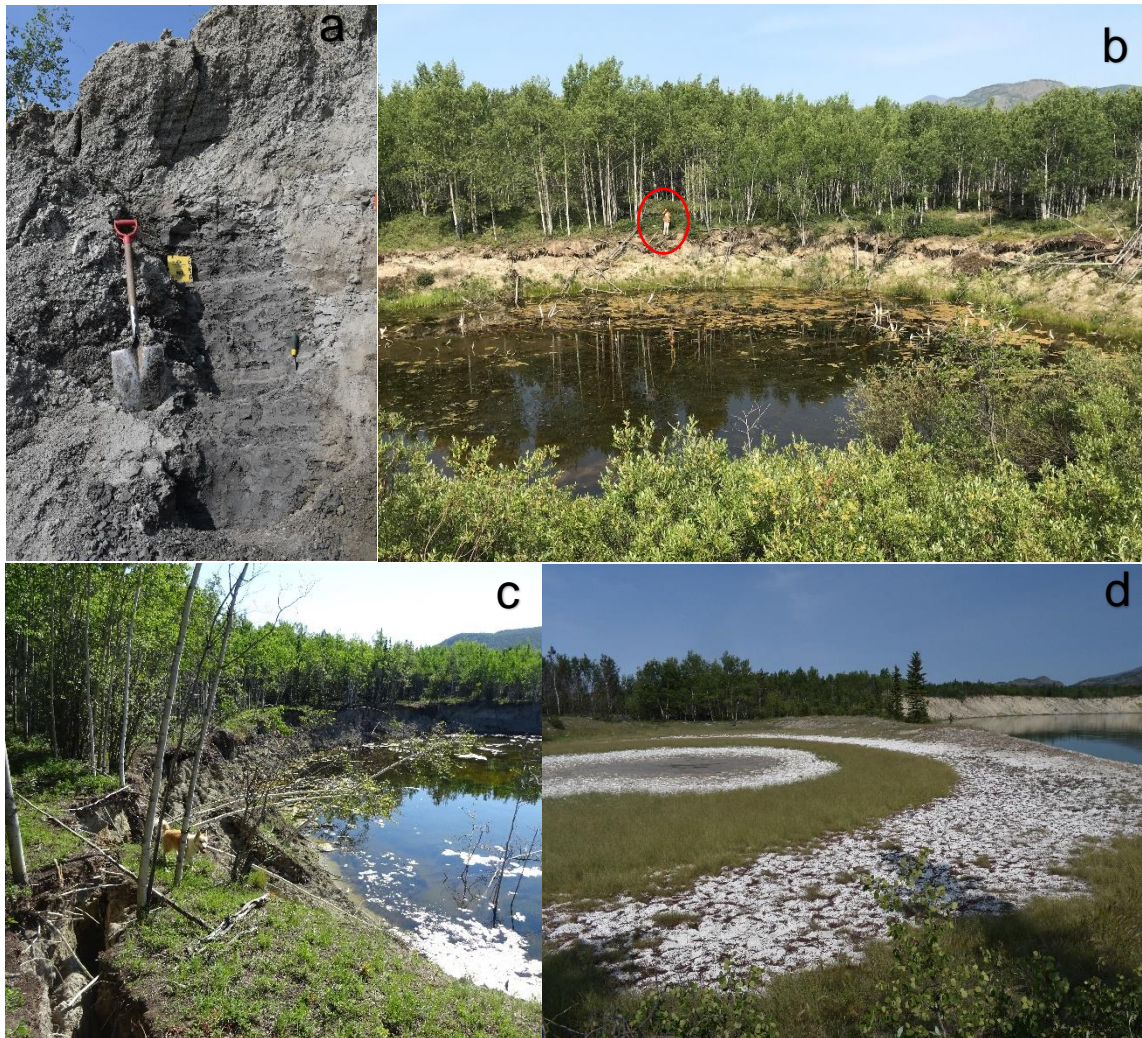
Figure 6.2 a) Interbedded glaciolacustrine silt and clay exposed in nearby Takhini River cutbank, b) typical thermokarst lake (note person circled for scale) with actively collapsing south-facing banks, c) fresh tension cracks and slumping along south-facing bank of thermokarst depression, and d) salt flats commonly develop in drained thermokarst lakes, such as this one along the banks of Takhini River.

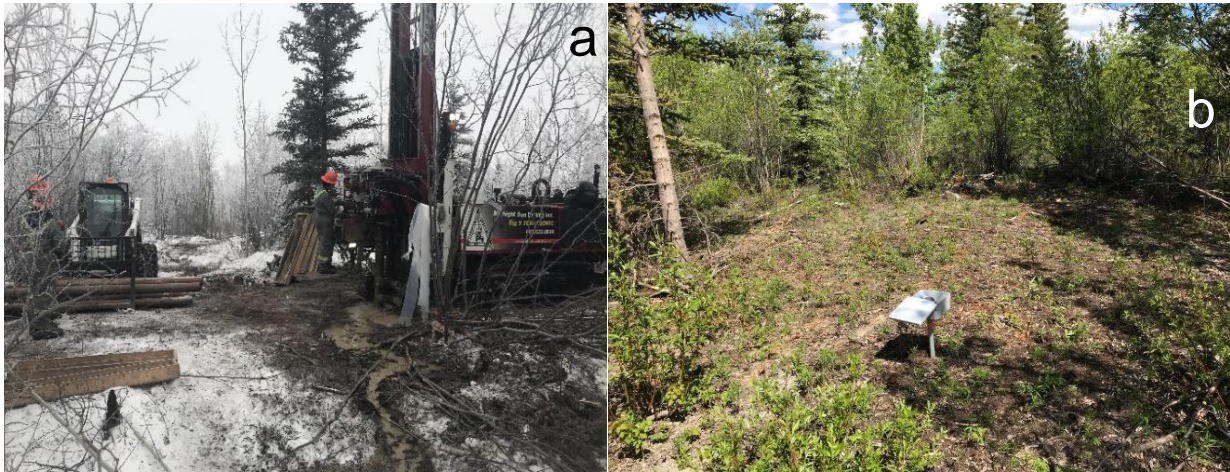
Figure 6.4 Midnight Sun Drilling Sonic drill rig (a) and instrumented borehole (b) at IV_BH1.

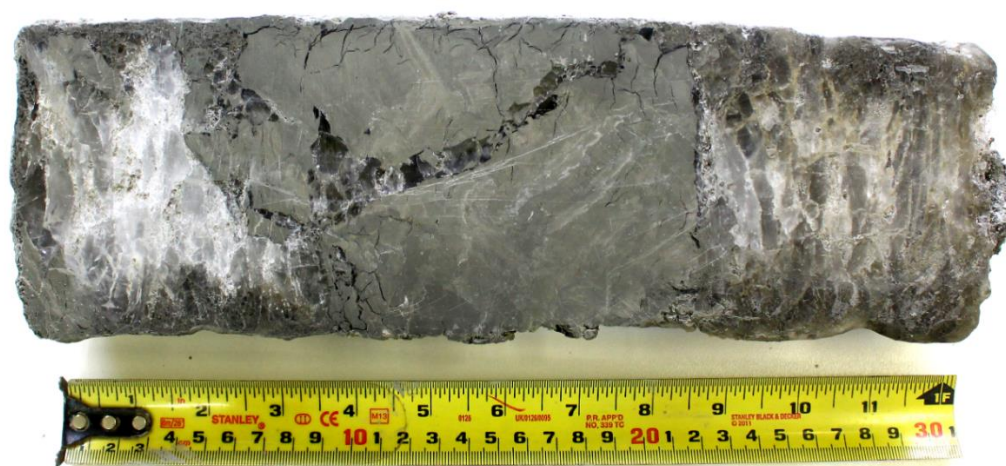
Figure 6.5 Ice-rich permafrost core taken from IV_BH1 at 6 m depth.

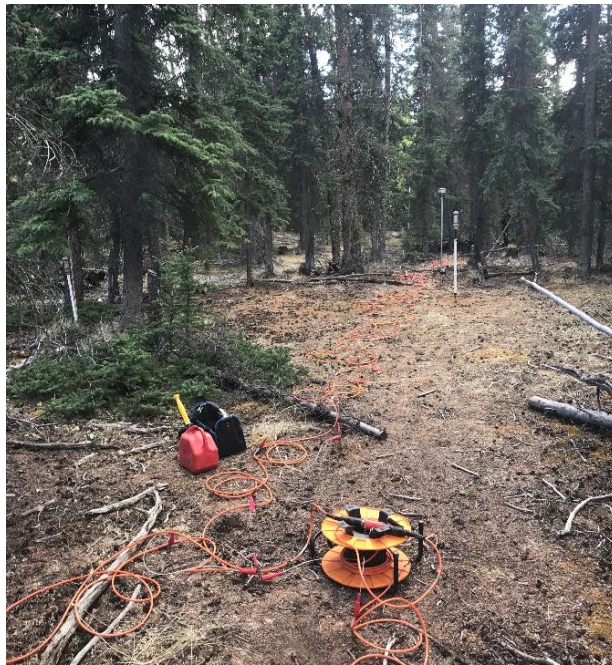
Figure 6.8 ERT transect (IV_ERT1) at Forest site, intercepting the Forest_BH borehole.

Survey IV_ERT1 was completed at the Forest site and ran north to south, through undisturbed spruce forest (Fig. 6.8). The forest cover was open in the first third of the profile (~40 m) and dense in the last two thirds (Fig. 6.9a). The ERT survey intercepted Forest_BH at 35.5 m along the survey line (Fig. 6.9a). Both Wenner and dipole-dipole array show similar patterns (dipole-dipole results are shown in Fig. 6.9; see Figure C4 for Wenner results). It appears the high resistivity areas, shown as dark blue shades, are primarily located towards the north end of the profile from 30 to 38 m along the transect up to 5 m depth (Fig. 6.9b). It is possible that thicker organic cover along this portion of the transect could be preserving the permafrost below. No evidence of ice-rich permafrost was observed at the surface.

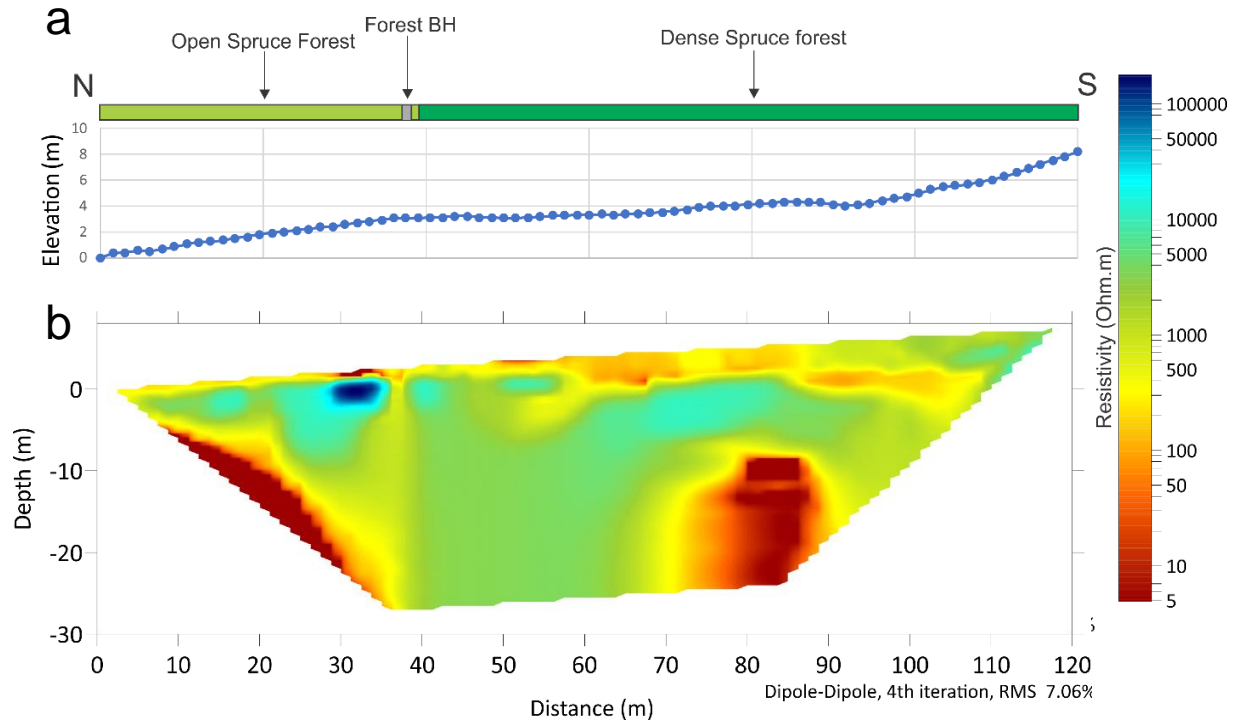
Figure 6.9 Ibx Valley ERT survey at the Forest Site (IV_ERT1) showing the (a) topographic profile, and (b) ERT profile using dipole-dipole array, 4th iteration, RMS error= 7.1%. In (b) green to blue shades are interpreted as permafrost, and orange to red shades most likely represent unfrozen ground.

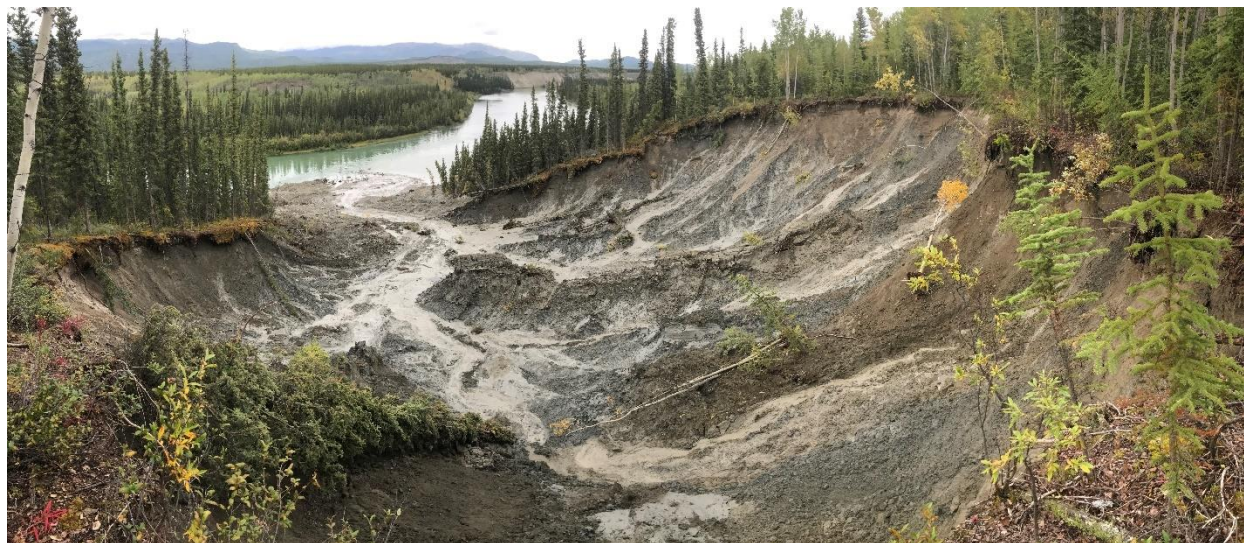
Figure 7.2 Panoramic view of thaw slump bowl on 24 August 2020, looking northeast. The headscarp retreats as mudflows transport thawed material into Takhini River.

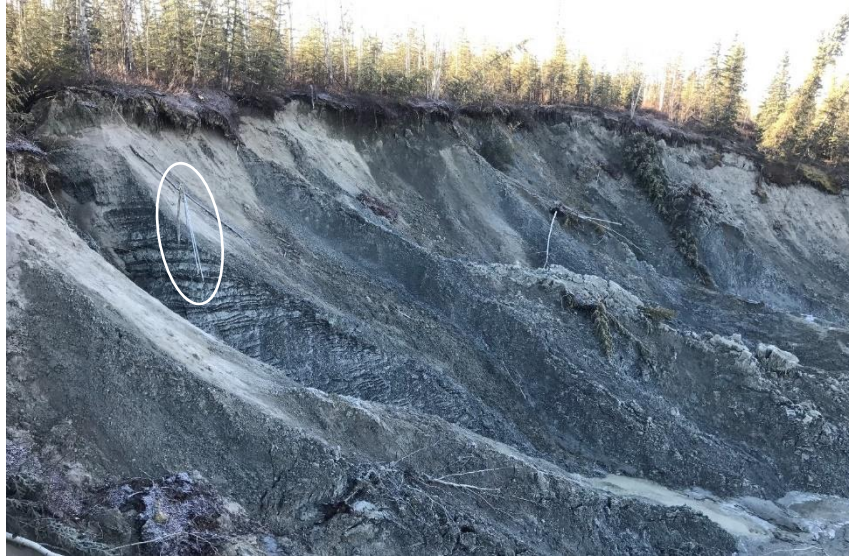
Figure 7.5 Roughly 8 m of laminated glaciolacustrine sediments are exposed in the thaw slump headwall near borehole WH_1456_BH3, 15 October 2020. Broken borehole casing is circled.

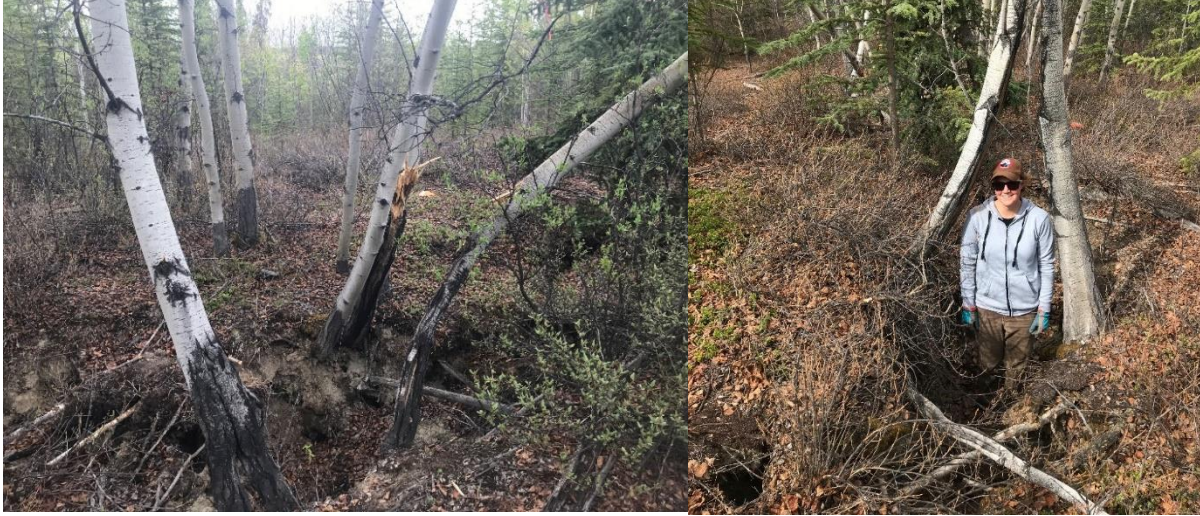
Figure 7.8 Tension cracks (a) splitting trees, with (b) person for scale.

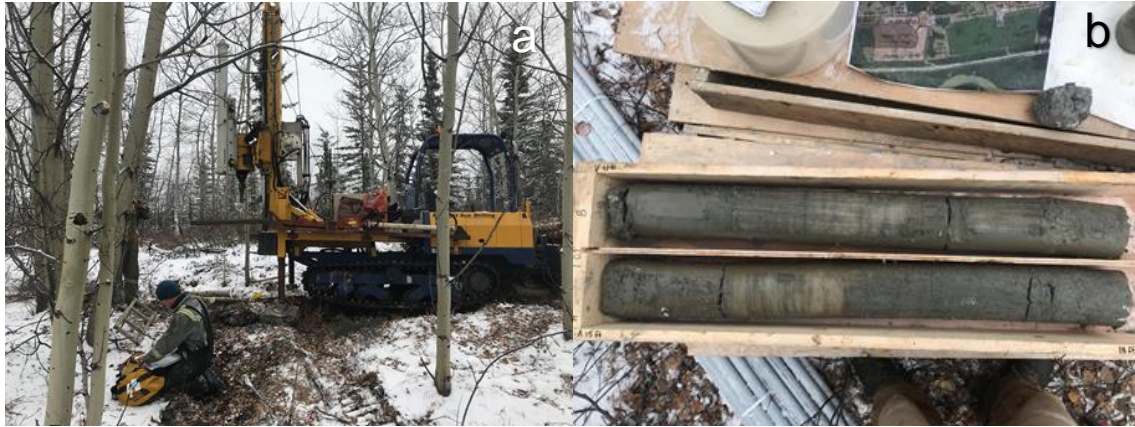
Figure 7.11 (a) Midnight Sun Drilling CRREL drill rig and (b) permafrost cores at WH_1456_BH1.

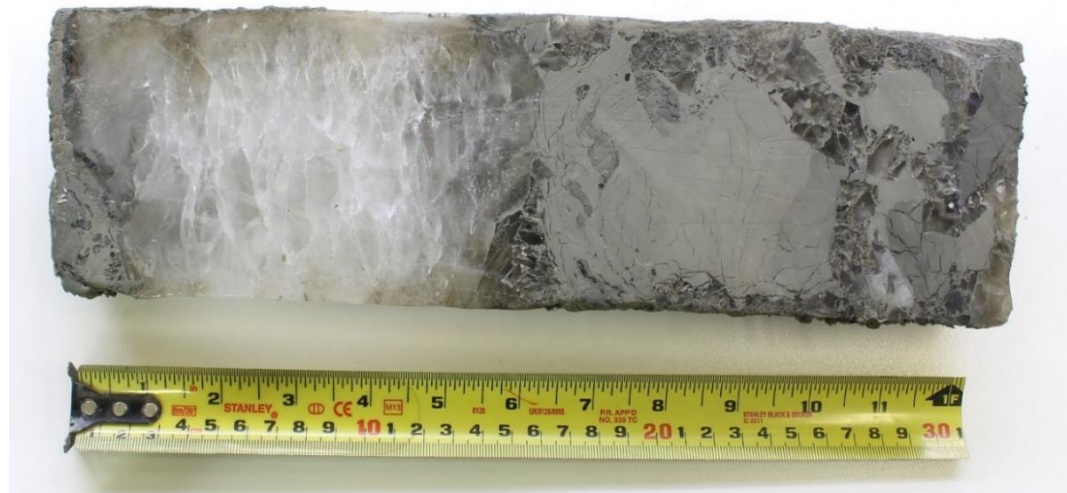
Figure 7.12 Ice-rich permafrost showing thick layered (left) and suspended (right) cryostructures in a core from WH_1456_BH1 at 6.57 m depth.

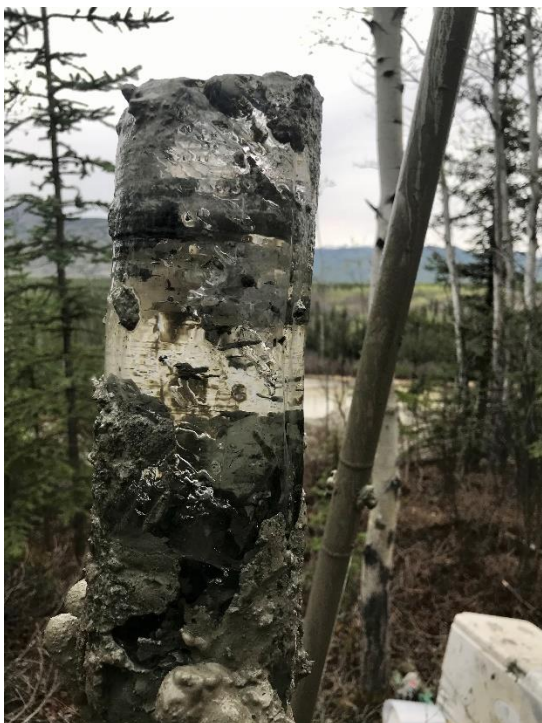
Figure 7.13 Ice-rich permafrost core from WH_1456_BH3, showing glaciolacustrine sediment suspended within ground ice.

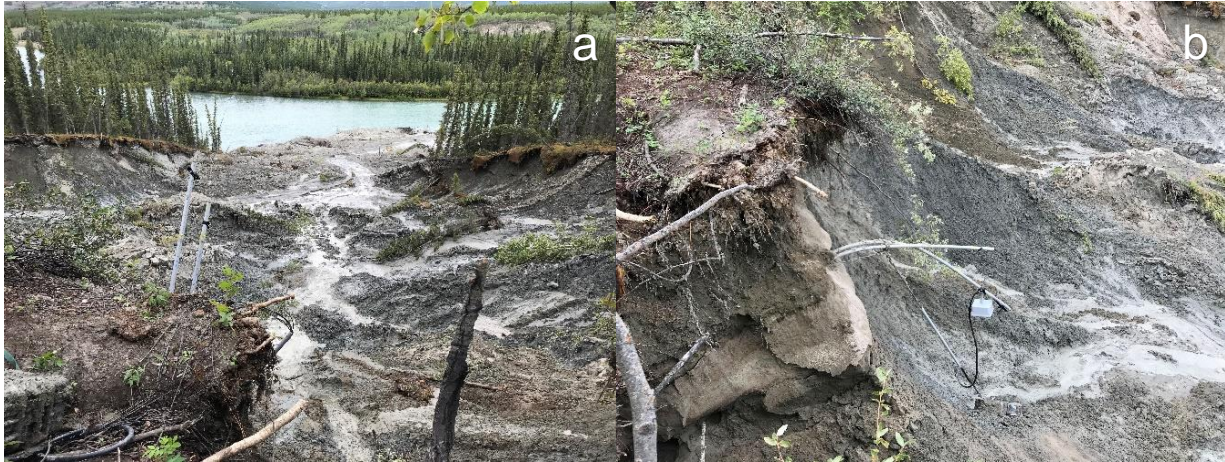
Figure 7.14 WH_1456_BH3 borehole casing and instrumentation (a) prior to, and (b) following collapse into the slump on 13 August 2020.

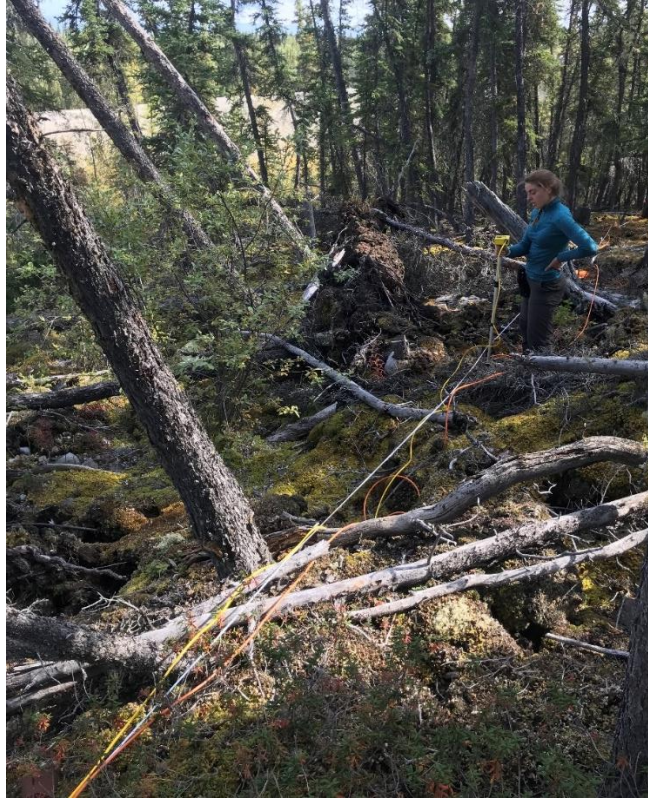
Figure 8.7 WH_1446_ERT1 survey, along margin of degrading permafrost mound (lithalsa), at $X = \sim 150$ m.

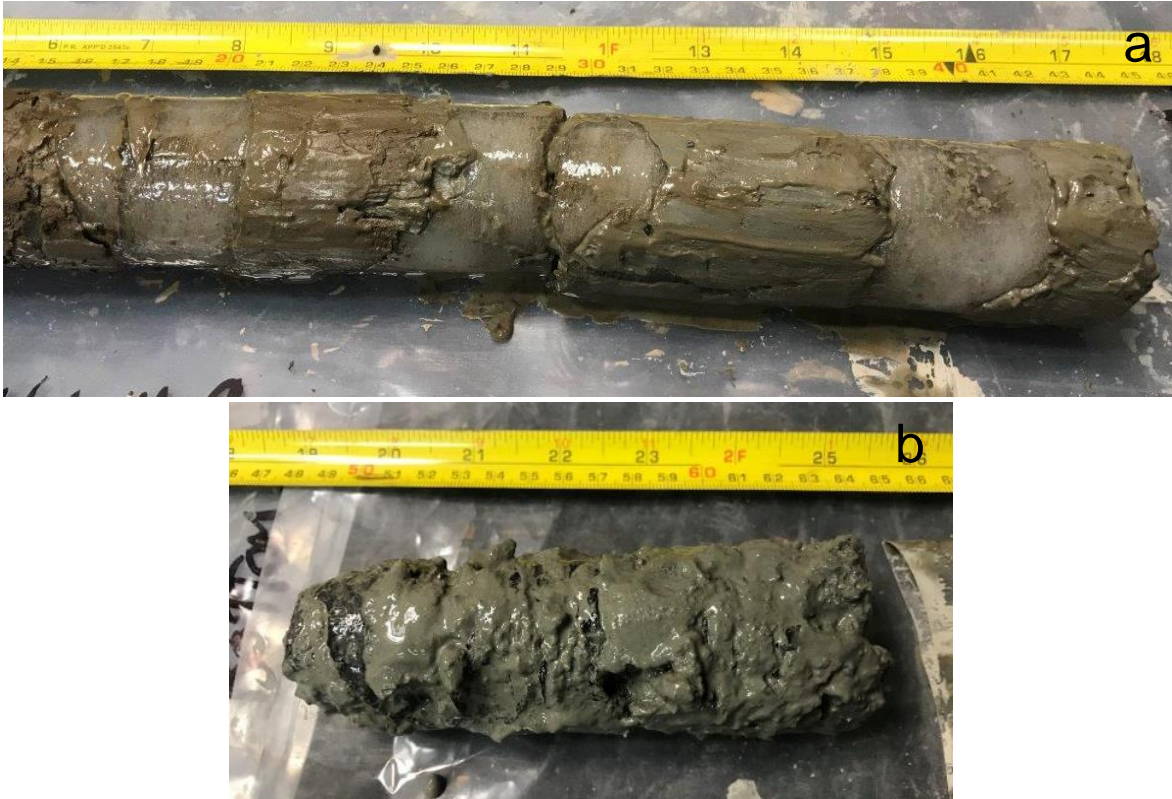
Figure 9.6 Ice-rich permafrost core WH_FL_BH1, showing a) thick lenticular cryostructures in a core from 3.36 to 3.73 m depth, and b) lenticular cryostructure collected from the till at the base of borehole at a depth of 4.11 m.

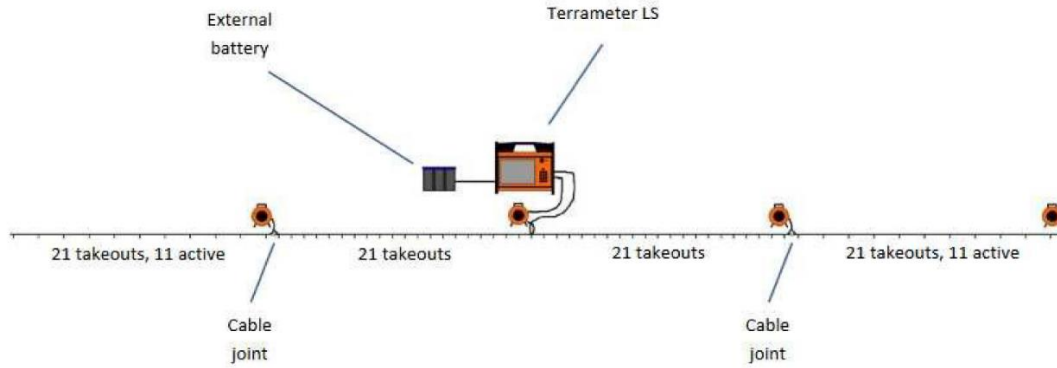
Figure 1. Instrument set-up for ERT surveying.

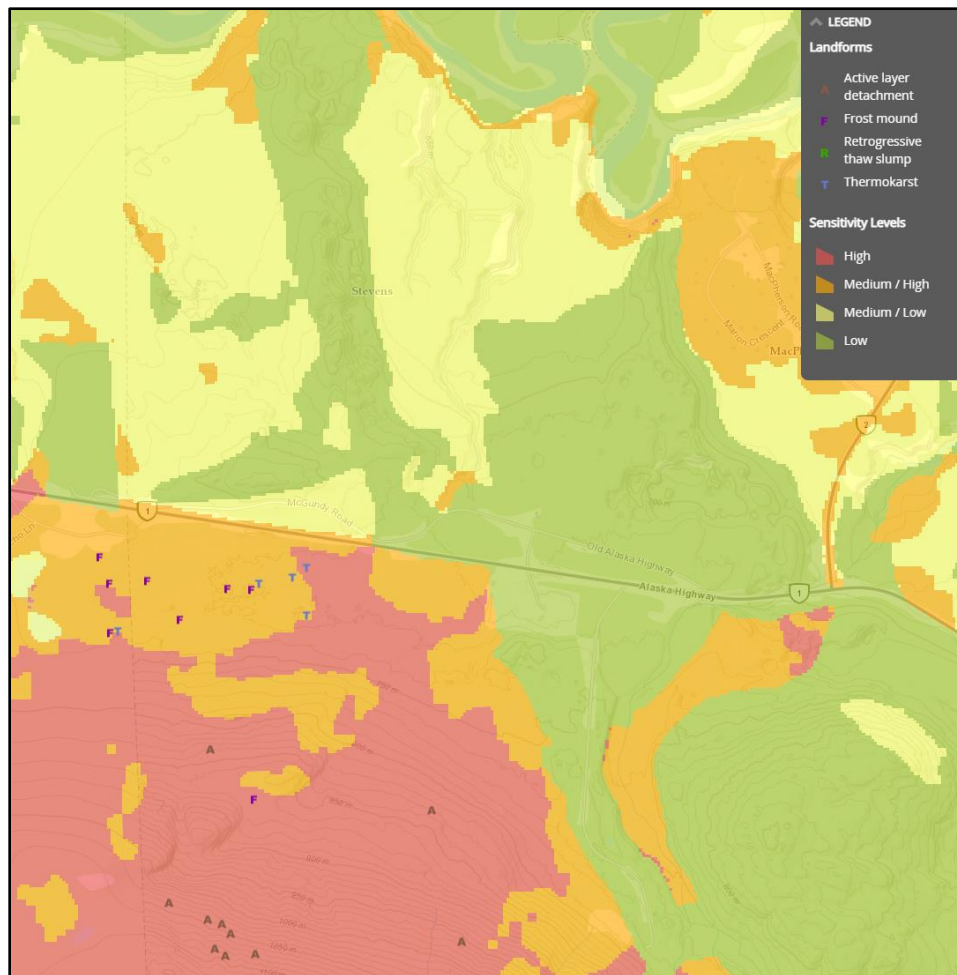
Figure 3. Sample of the permafrost thaw sensitivity webmap for the area near the junction of Alaska Highway and North Klondike Highway.

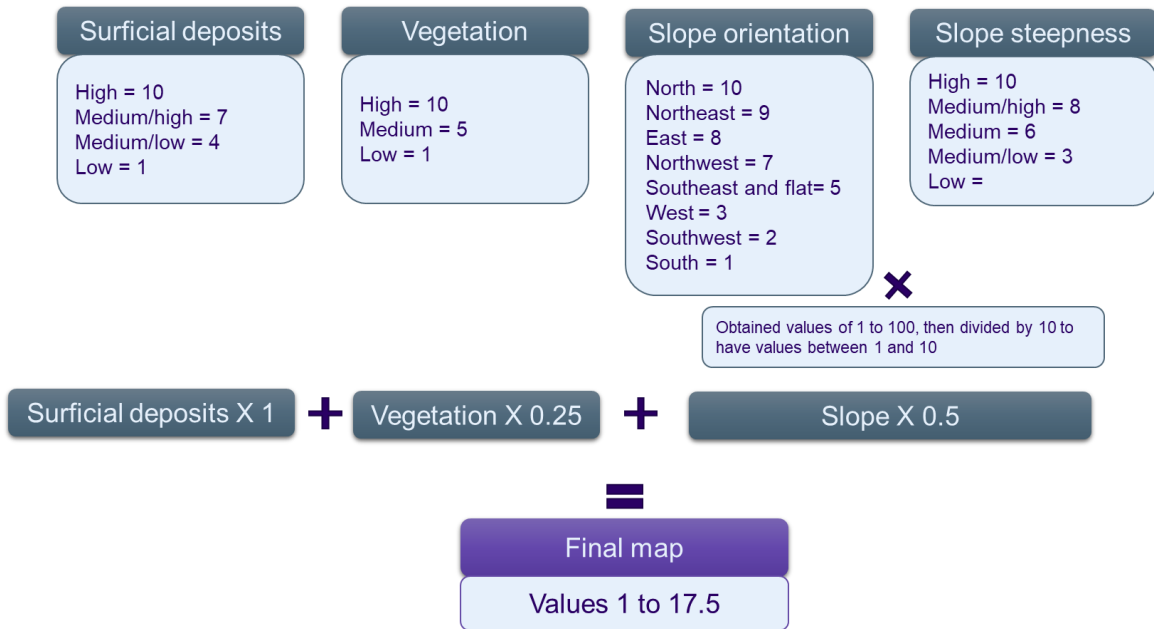
Figure 7. Layer rankings and weights applied to the final permafrost thaw sensitivity model.
