YGS Miscellaneous Report 20

Carmacks surficial geology and community hazard susceptibility mapping

D.C. Cronmiller, D.J. McParland, K.M. Goguen and R.J. McKillop

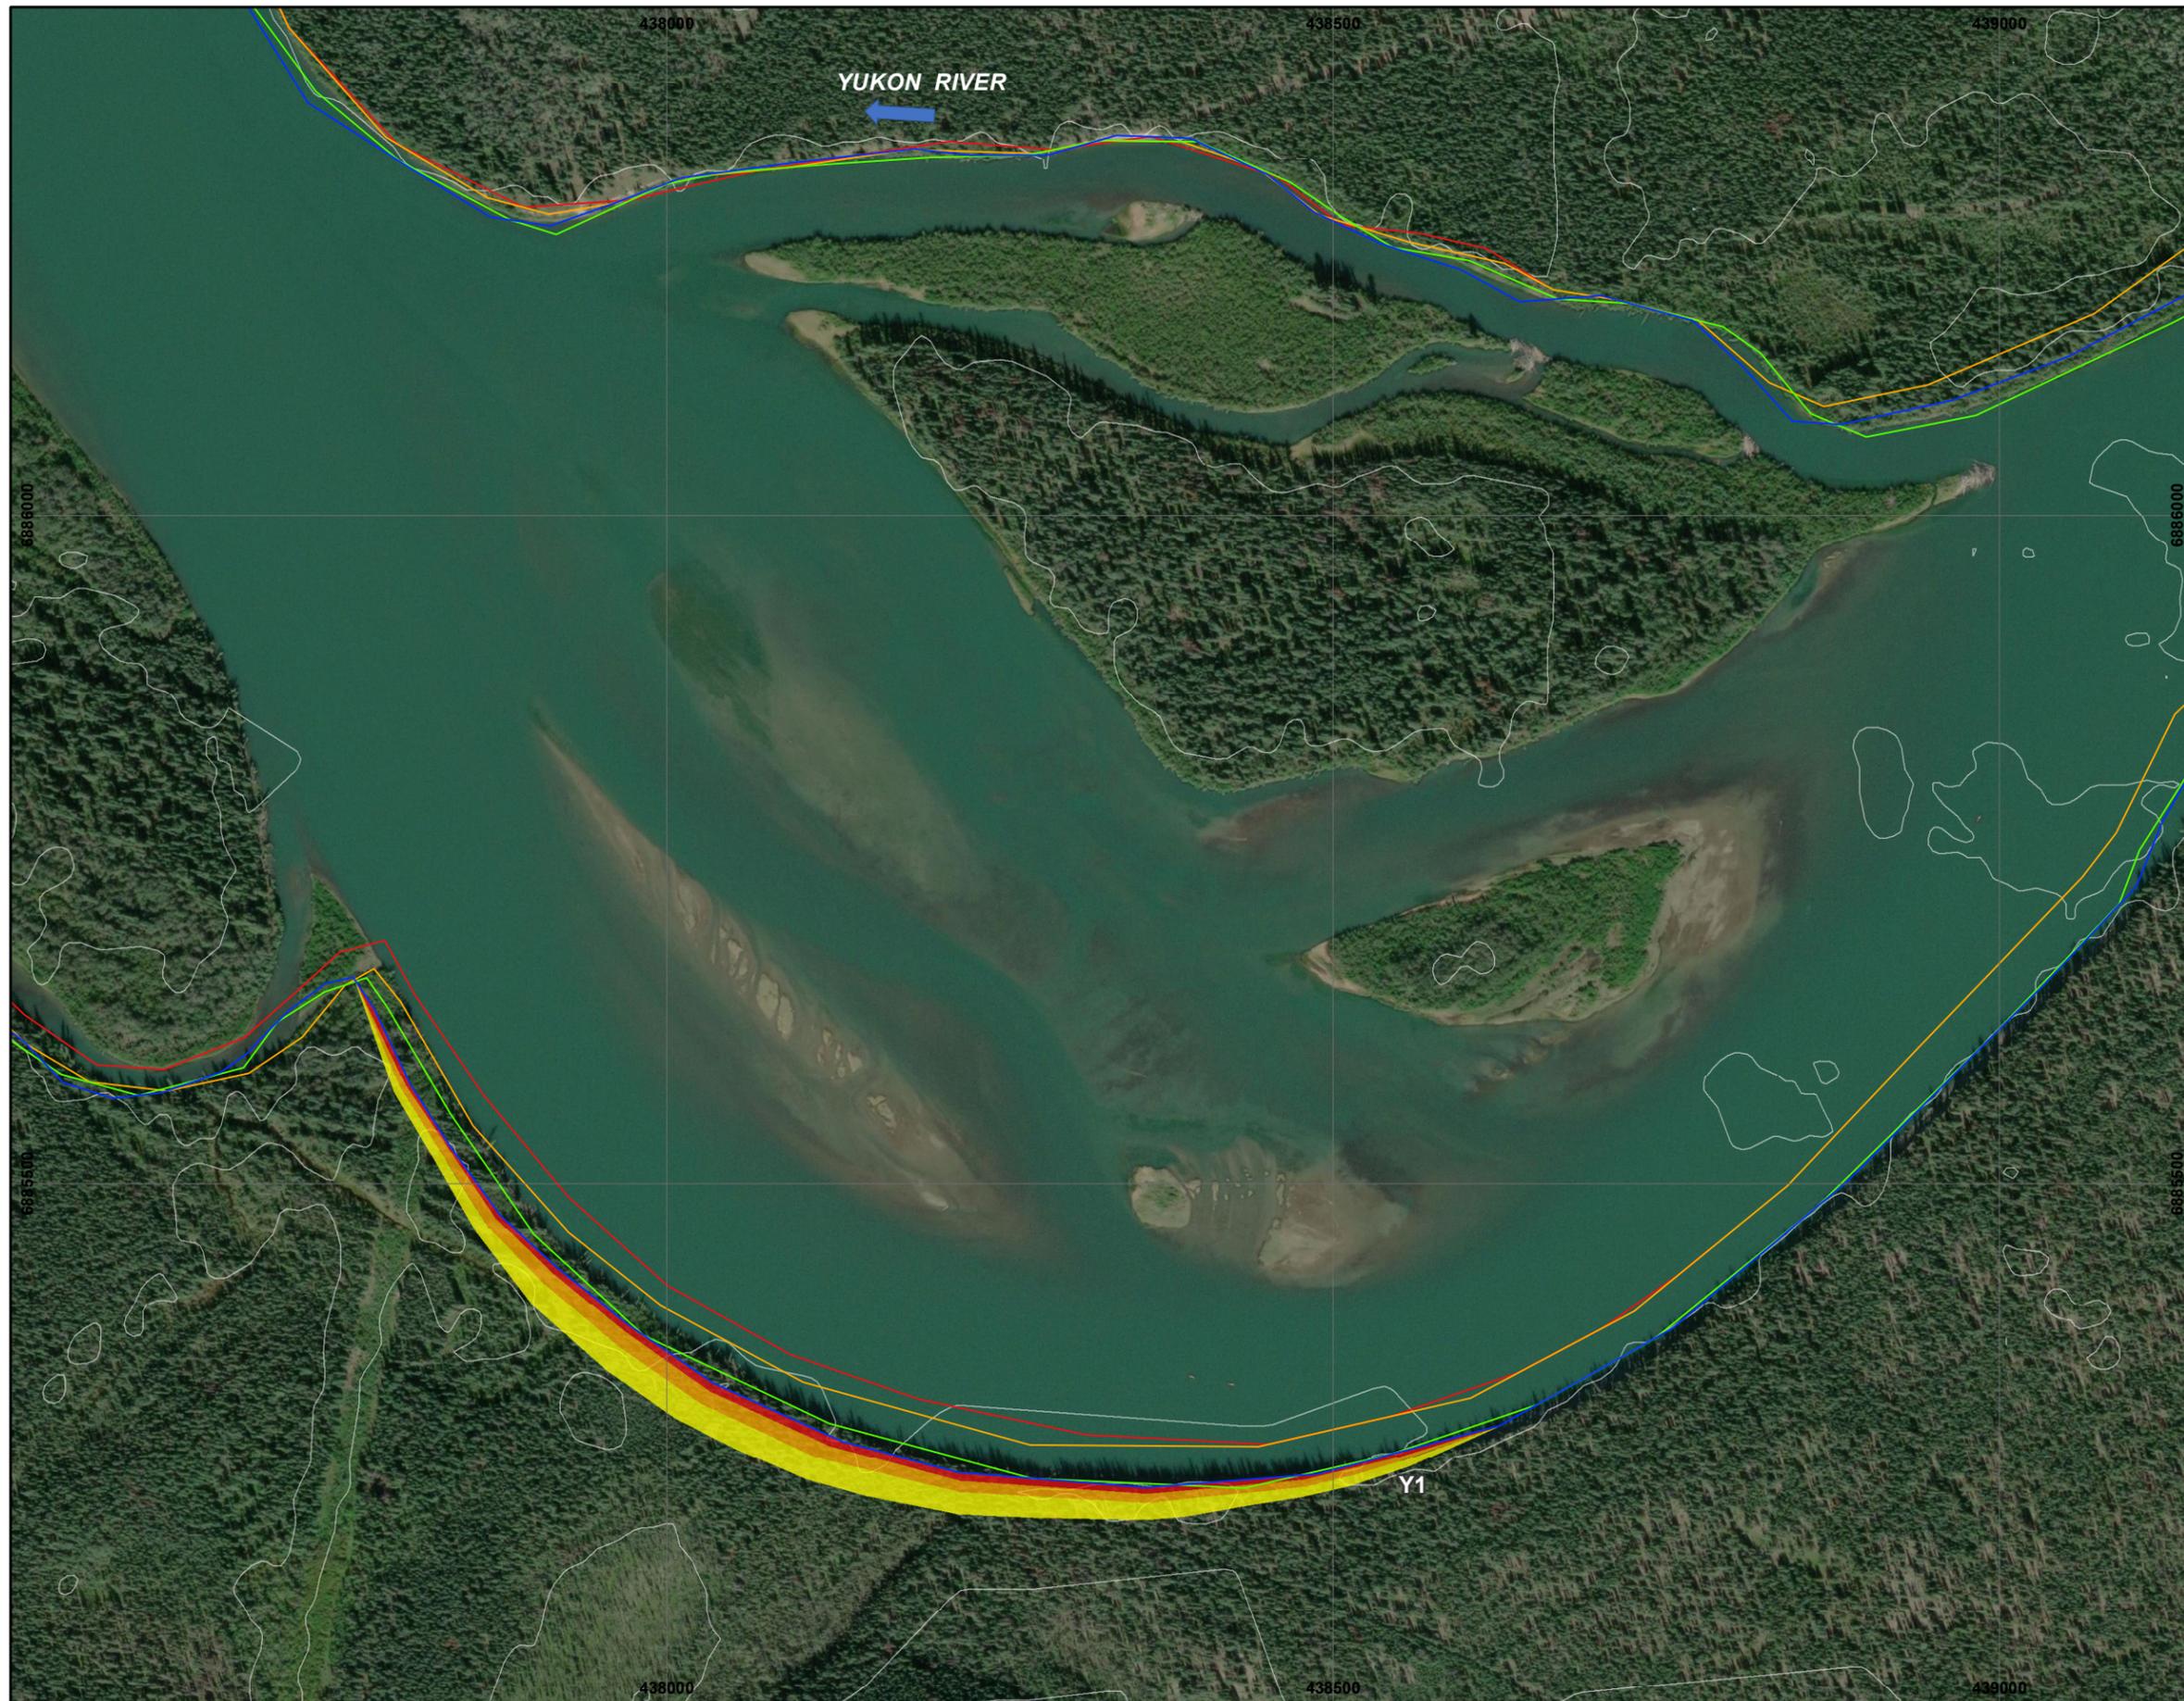
PROJECT NO.	1201716
	MAP A-1	REVISION:

TITLE: Erosion Hazard Zones

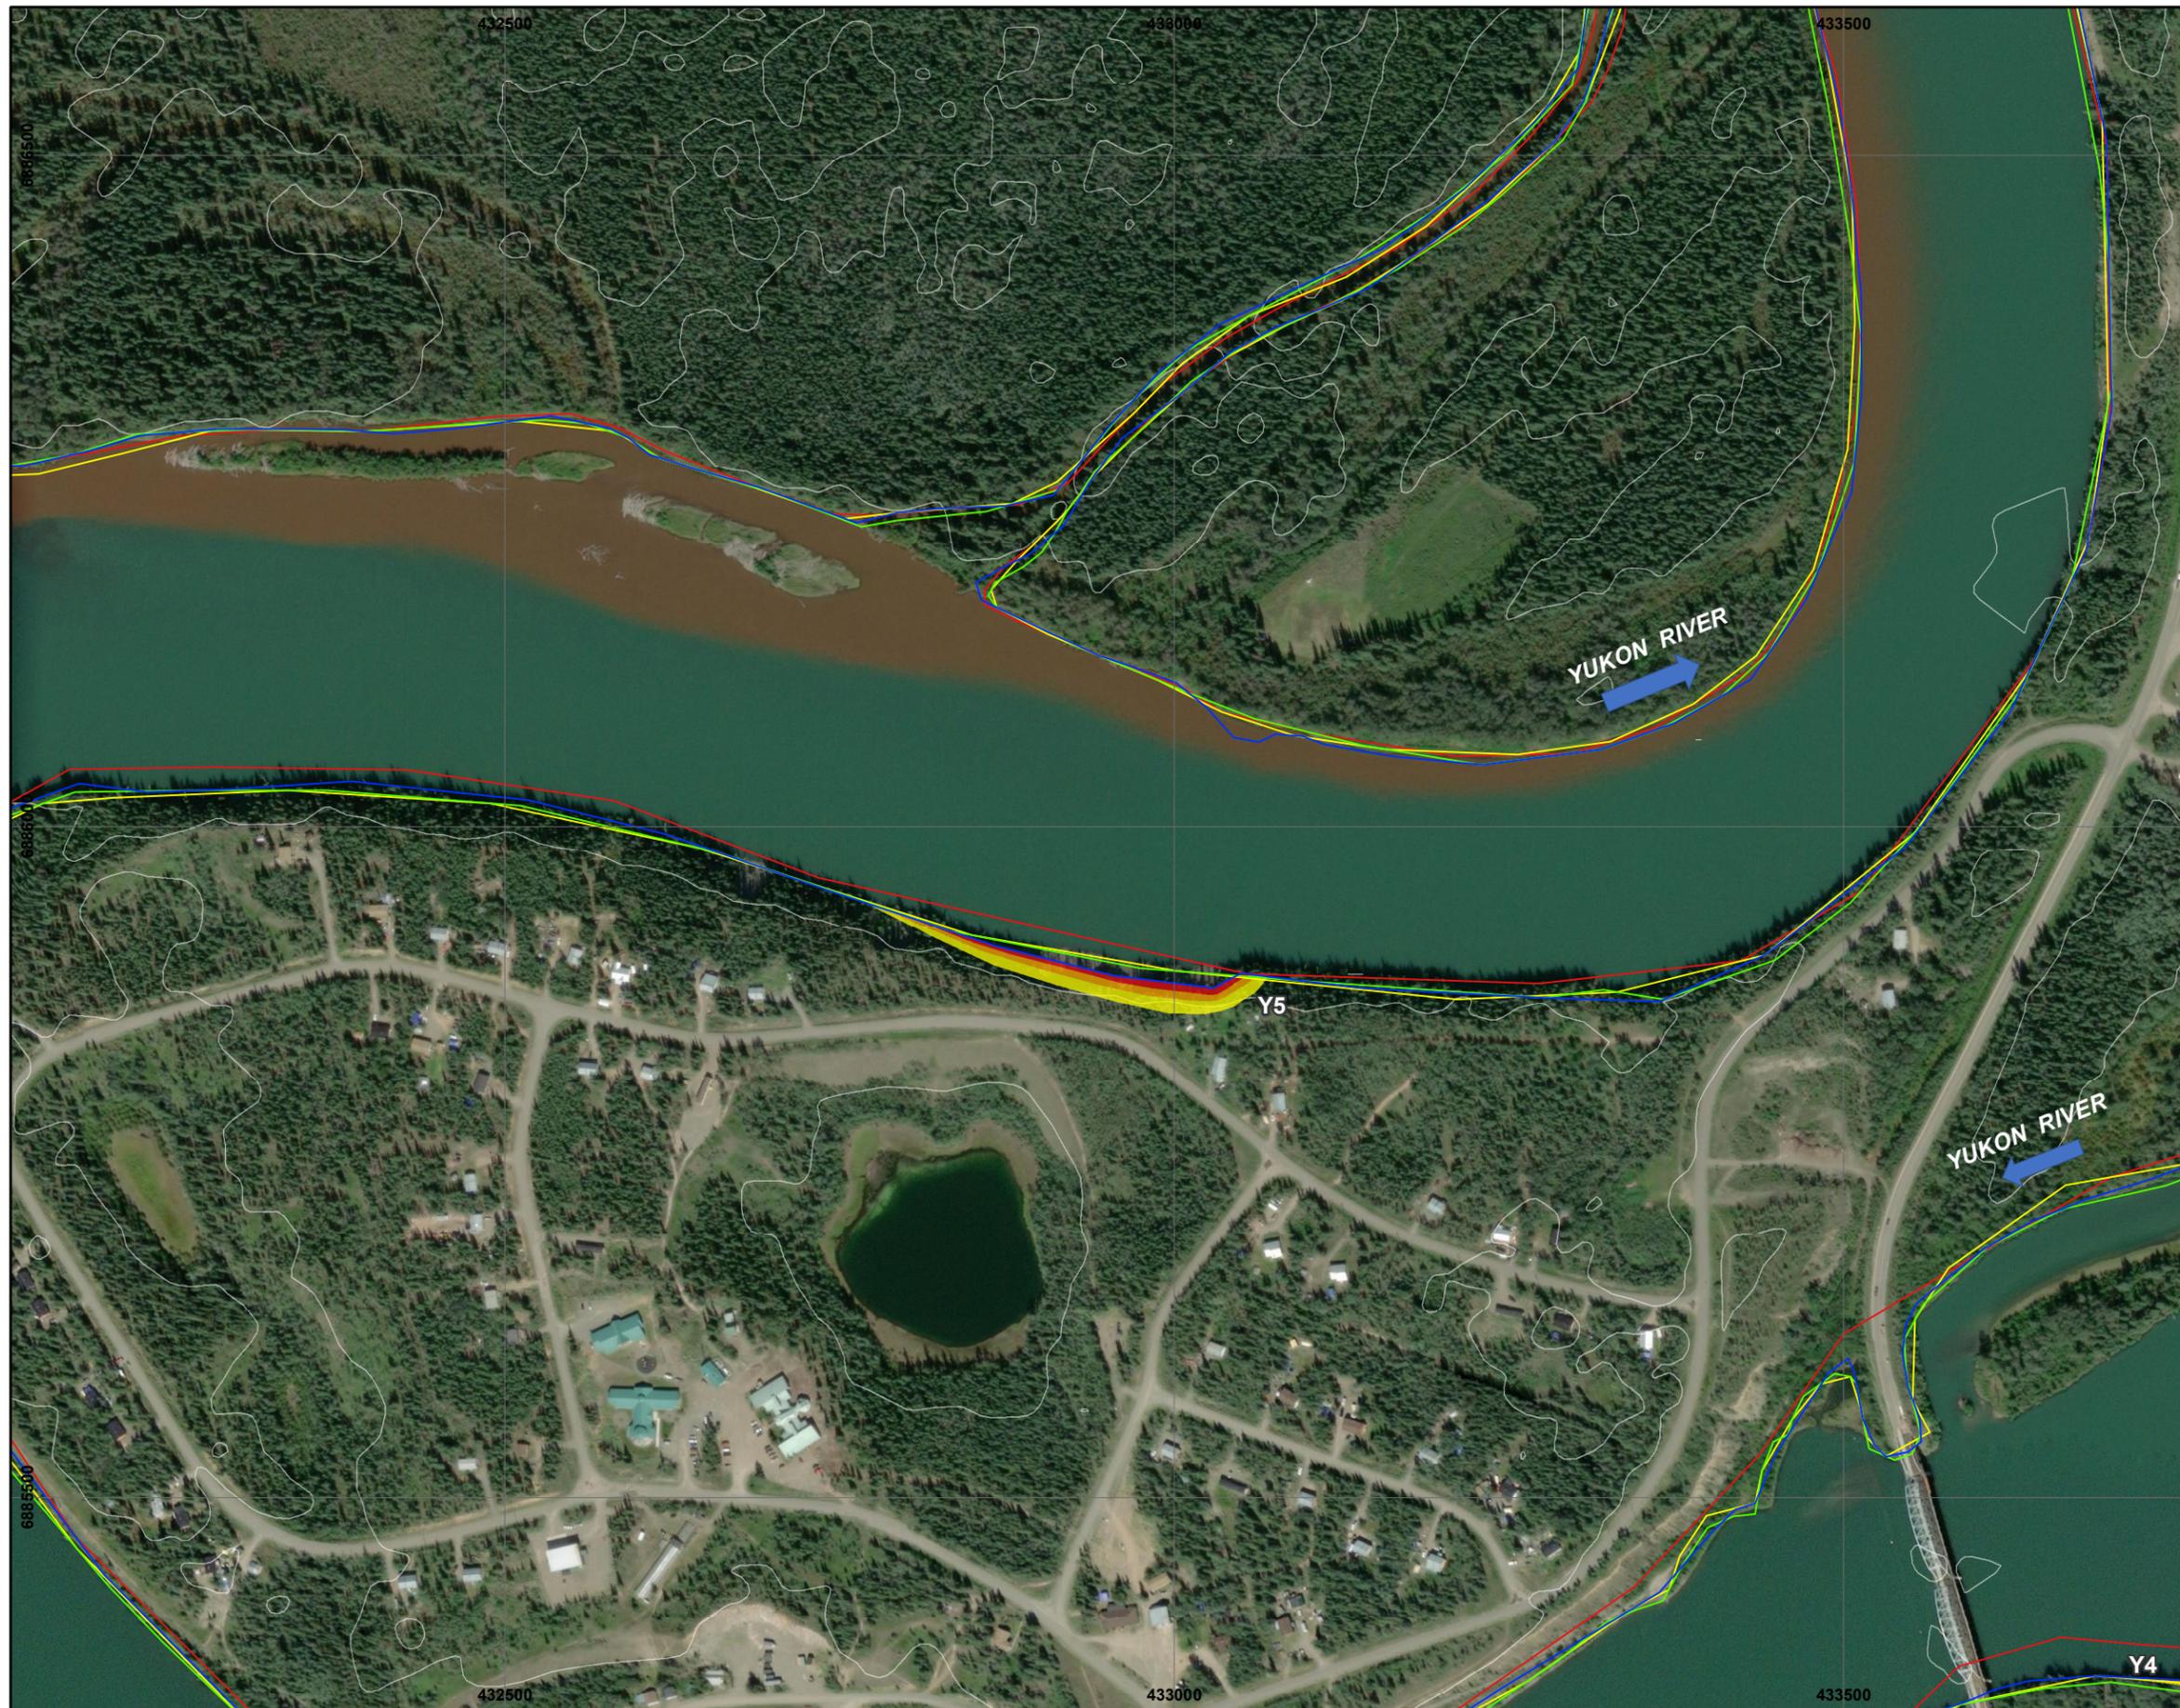
PROJECT NO.	1201716
	REVISION:	1-1

TITLE: Erosion Hazard Zones
