**TECHNICAL REPORT FOR THE UPPER LIVINGSTONE CREEK SUMMER PLACER
ACTIVITIES:**

Two Mile placer lease 8861. Latitude 61° 12.5' : Longitude 134° 20'

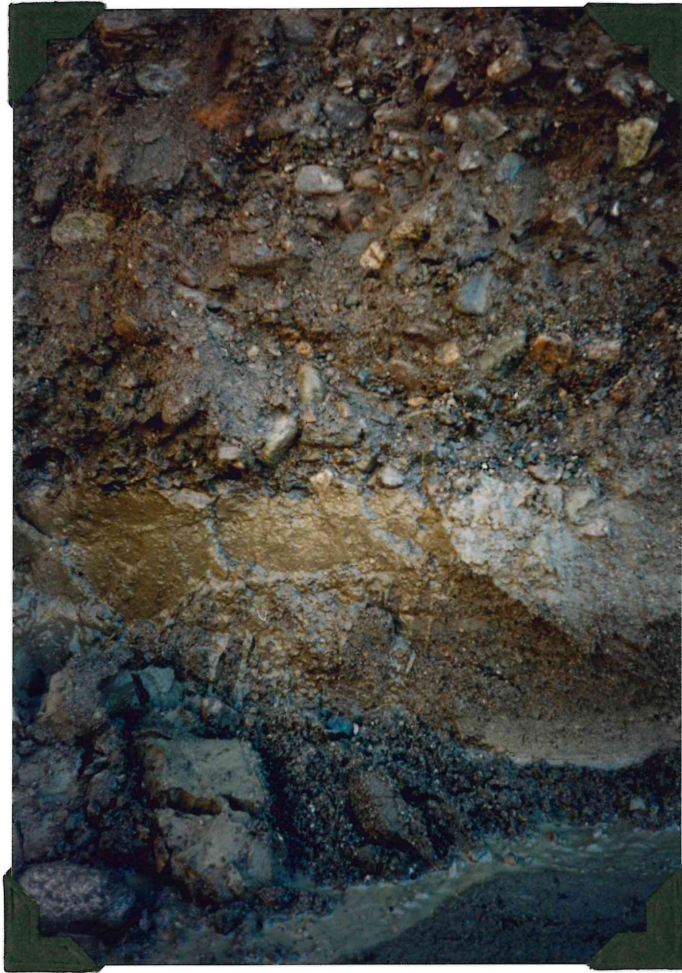
LIVINGSTON CREEK
LEASE # 8861

SLICEABLE
MATERIAL JUST ABOVE CLAY

← CLAY SEAM

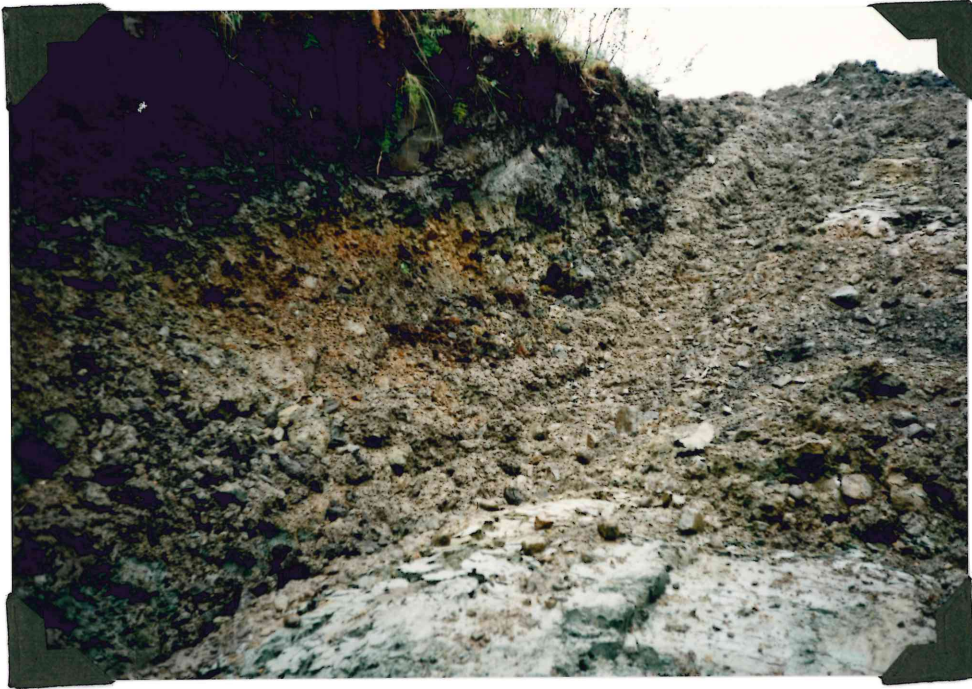
CLAY SEAM
