Secret Creek

Target Evaluation

T-101 - 2006

Vern Evans & Walter Malickey

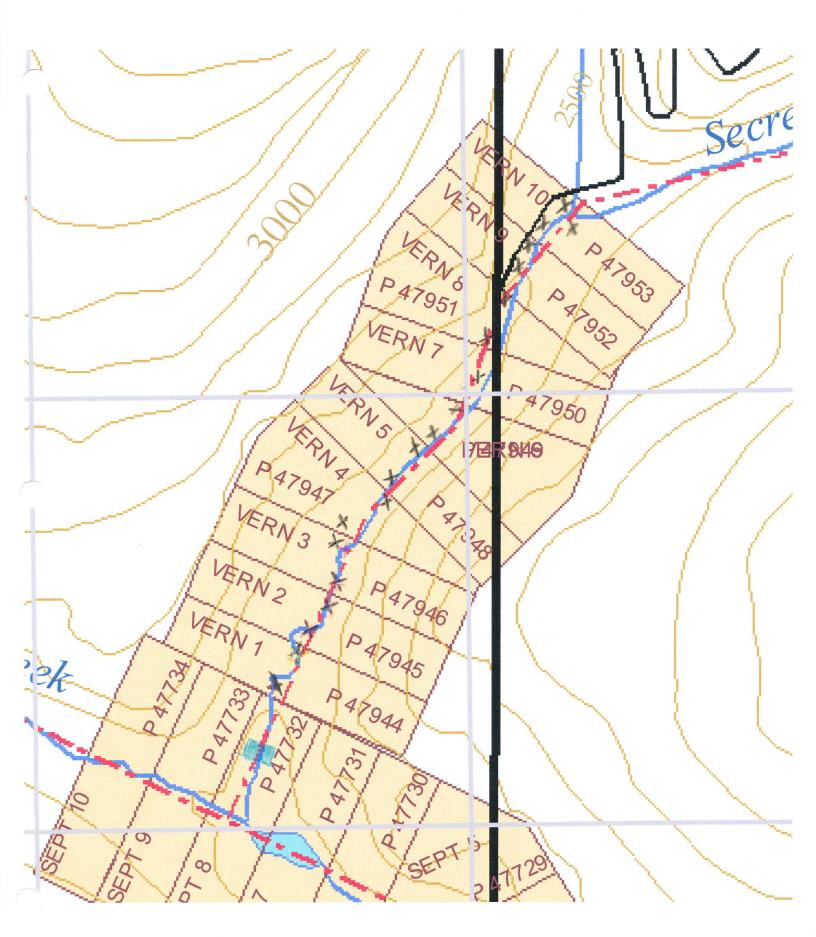
Legend: Blue Square – T-101 Target Black X's – Test Sample Sites

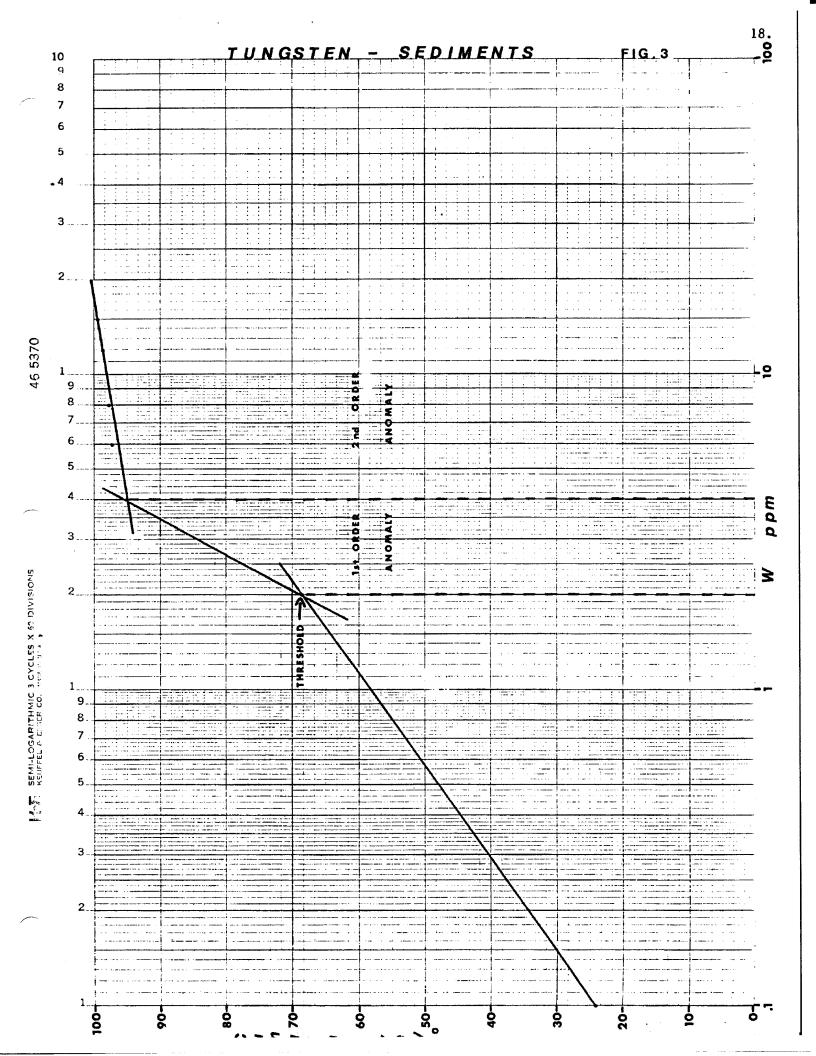
Tungsten (see Figure 3 and Map 3)

The background readings for tungsten in sediment samples are 2 ppm or less. Virtually all drainages within and surrounding the claim area register background readings. The threshold break for tungsten is 2 ppm while first order anomalies range between 2 and 4 ppm's. Only a few second order anomalies (greater than 4 ppm's) are found in the stream sediments. Map 3 is contoured and colour coded according to the order of the anomaly. Second order anomalies

for the most part are single sample anomalies and no connection to a possible source area can be made. A 22 ppm sample occurs on a creek located west of Secret Creek is a case in point. Sample No. S-151 is the sample in question. Two streams that have second order anomalies that are relatively continuous are located on Secret Creek near Swede No. 3 claim and on a northwesterly trending stream that crosses the Swede 38 and 40 claims near Haggart Creek. These two areas may be underlain by scheelite bearing skarn horizons and require further investigation in the form of deeper sampling and possibly some trenching.

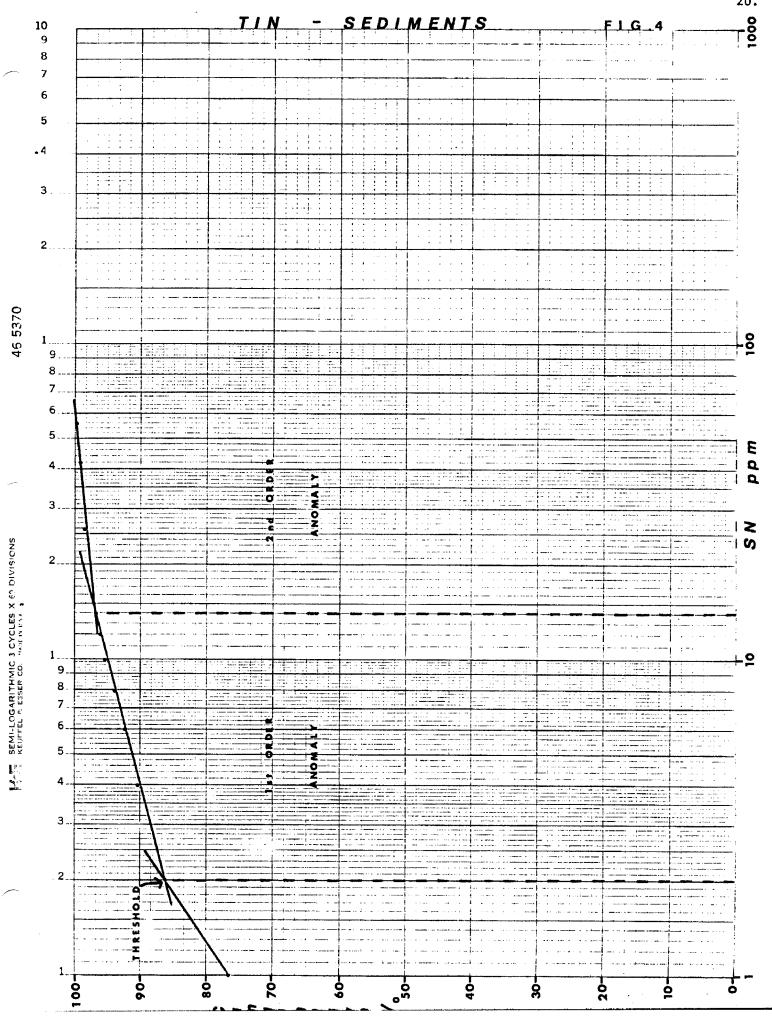
Tin (see Figure 4 and Map 4)

The Secret Creek claims have numerous first and second order anomalies primarily along Secret Creek and Swede Creek southeast and downstream from its confluence with Secret Creek. The anomalous values continue into Haggart Creek.

As tin is the most randomly distributed element on the property it may highlight underlying geologic features better than all the other elements. With abundant 2nd order anomalous stream samples occurring it is felt by the writer that an overburden covered tin bearing intrusive may be found on the slopes flanking Secret Creek.

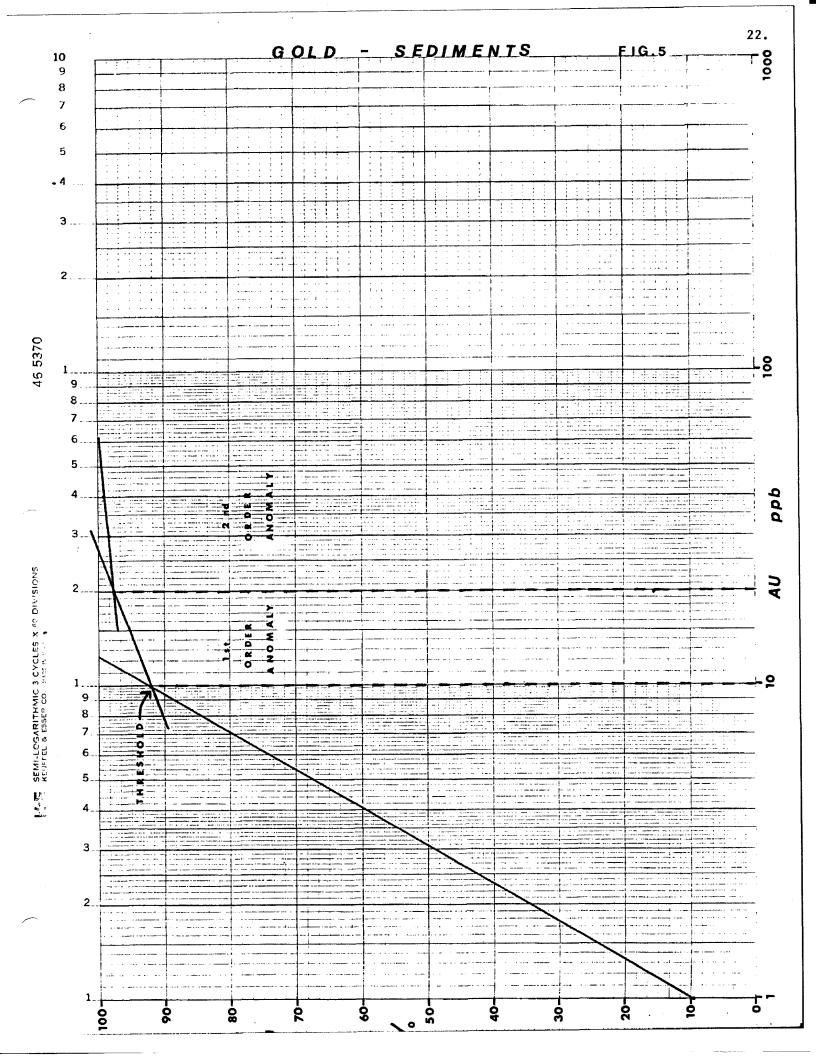
Gold (see Figure 5 and Map 5)

From the graph on Figure 5 the sediments of the Secret Creek -Swede Creek claims have a background of less than 10 p.p.b. The threshold break occurs at 10 p.p.b. Another break in slope is clearly evident at 20 p.p.b. First order anomalies range between 10 and 20 p.p.b.'s while second order anomalies are greater than 20 p.p.b.'s. No further breaks in the slope of the line occur beyond 20 p.p.b.'s which suggests only one source for the gold. Three second order anomalies occur in stream sediments. The first anomaly is located near the mouth of a creek (also called Secret Creek) where it flows into Swede Creek on the S.A. - 14 claim. The sample range from 10 p.p.b.'s to 70 p.p.b.'s. The second anomaly is located on Swede Creek southeast of where Secret Creek joins in. This anomaly ranges from 10 p.p.b.'s to 140 p.p.b. This is in the locale of the Swede #4 and #6 claims. The third anomaly occurs along a northwesterly trending stream near its confluenic with Haggart Creek. The Swede #37, 38 and #40 claims cover this anomaly. This anomaly ranges from 10 p.p.b.'s to 70 p.p.b. All of these anomalies appear to represent downstream concentration of gold as they occur near the mouths' of creeks. Underlying gold quartz veins may be outlined by these anomalies.

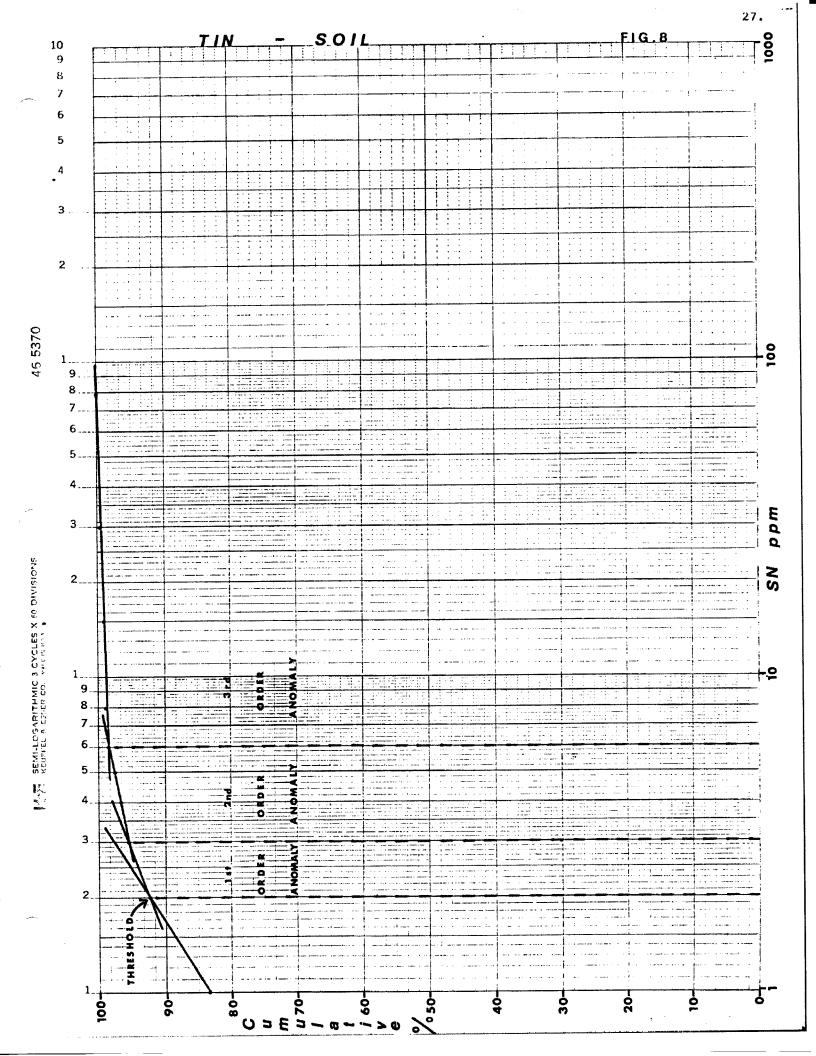
Tin (see Figure 8 and Map 4)

Most of the tin anomalies in the claim area are found in stream sediment. Secret Creek, Swede Creek (S.E. of its junction with Secret Creek) and a small creek west of the S.A. claims (crossing S.A. #5) all have first to third order anomalies. Many of the stream samples have in excess of 10 p.p.m. tin while soil samples rarely exceed 6 p.p.m. tin. Tin is much more mobile is sediments than in soils. 26.

In soil smaples the background values are less than 2 p.p.m. The threshold break is at 2 p.p.m. while two more breaks in slope at 3 and 6 p.p.m. indicate the second order and third order anomaly breaks respectively. This is quite different than the graph for sediment samples shown on Figure 4.

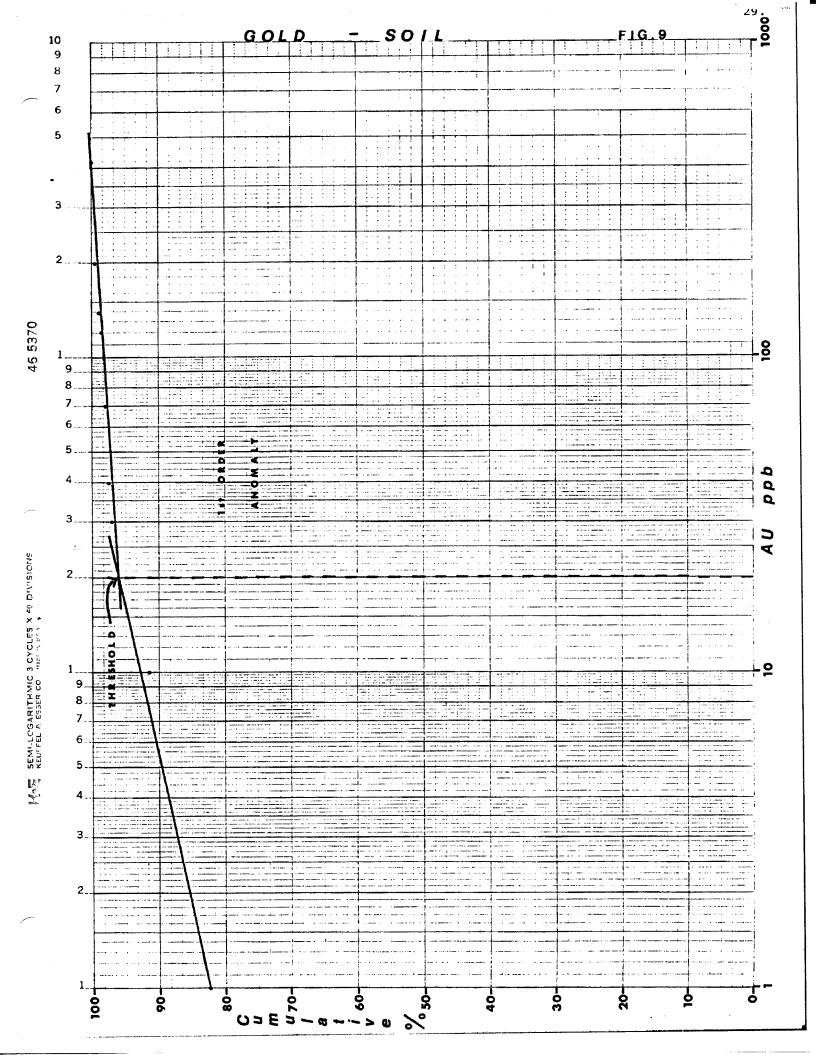
From Figure 9 it can be seen that background levels for soil samples are less than 20 p.p.b. The threshold break is at 20 p.p.b. and any values greater that this are considered anomalous.

Five anomalies of greater than 20 p.p.b. are found on the claims. The first one is a very significant one and is located on the S.A. 9 and 10 claims. Two samples make up this anomaly and have values of 120 and 180 p.p.b. respectively. This anomaly

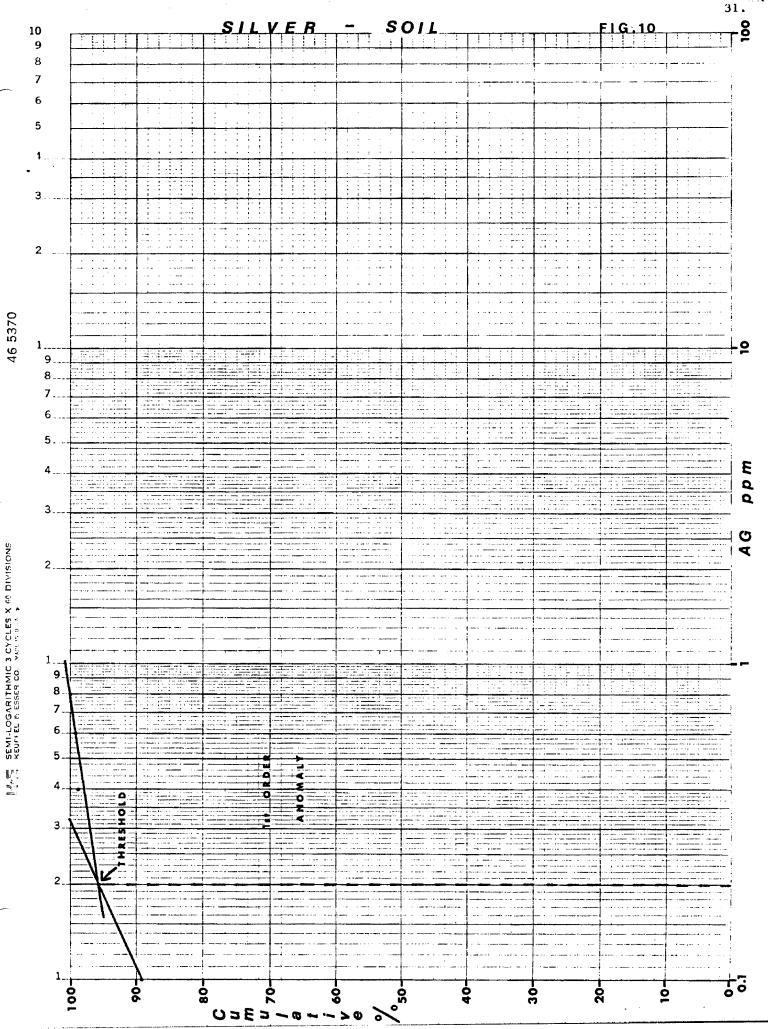
Silver (see Figure 10 and Map 6)

The background readings for soil samples in the claims area is .1 p.p.m. and the threshold break occurs at .2 p.p.m. Values over .2 p.p.m. are considered anomalous. Only two streams (described previously) have anomalous readings of significance. Five soil anomalies of greater than .2 p.p.m. Ag, are found on the claims. The first anomaly is located on the S.A. #28 and #30 and Swede #2 claims. The readings range from .2 p.p.m. to .4 p.p.m. This anomaly is located on the nose of a ridge which

has anomalous samples in tin and gold near top of the ridge. The second and third anomalies are single sample anomalies located on the Swede #3 and #5 claims. These samples both have values of .4 p.p.m. and are nearly coincident with the previously described third and fourth gold anomalies. The fourth silver anomaly is located on the Swede #25, #26, #27 and #28 claims. The sample range in value from .2 p.p.m. to .6 p.p.m. Ag. The fifth anomaly lies to the west of the fourth anomaly and the samples range in value from .2 p.p.m. to 4 p.p.m. Ag. It is significant to note that the fourth and fifth silver anomalies lie along an east-west trend that may outline a buried silver bearing vein system similar to those on the Peso claims lying to the northeast. More detailed soil sampling and a small amount of cat trenching if results warrant it should be considered.
