**Candace Creek Placer Property
Dawson Mining District, Yukon Territory**

Final Report for YMEP Grant YMEP15-043

***PLACER CLAIM GRANTS VAN 1 – 42
P508833 – P508842; P 515264 – P 515295***

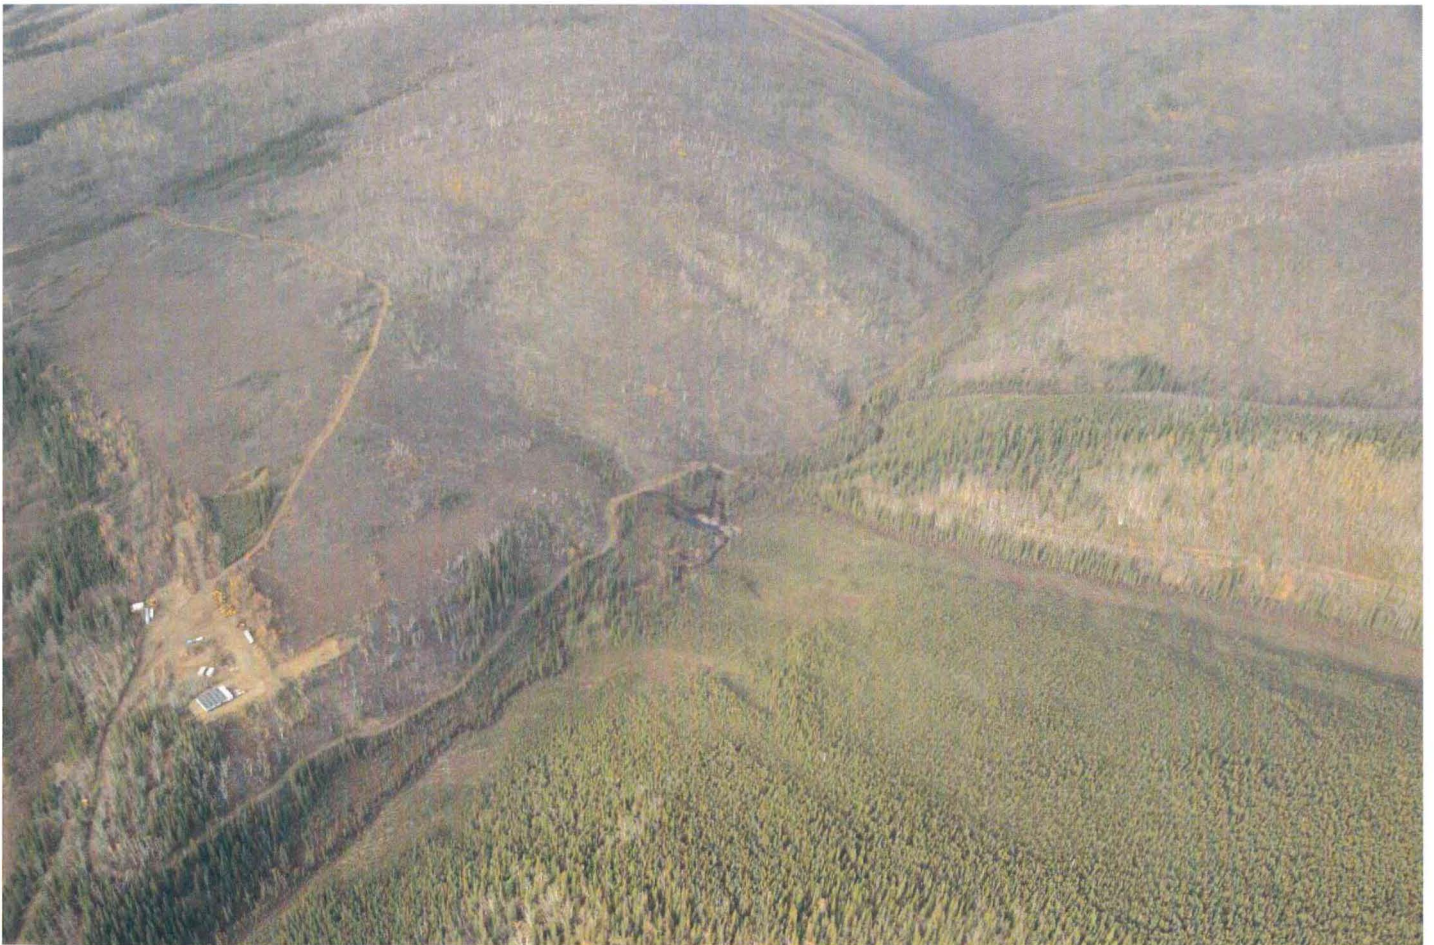
Plate 1 – View looking northeast upstream on Candace Creek, September 20, 2015. Candace Creek joins Maisy May Creek in the lower left part of photo. The camp shown is that of Maisy May miner Bedrock Mining Company Inc.

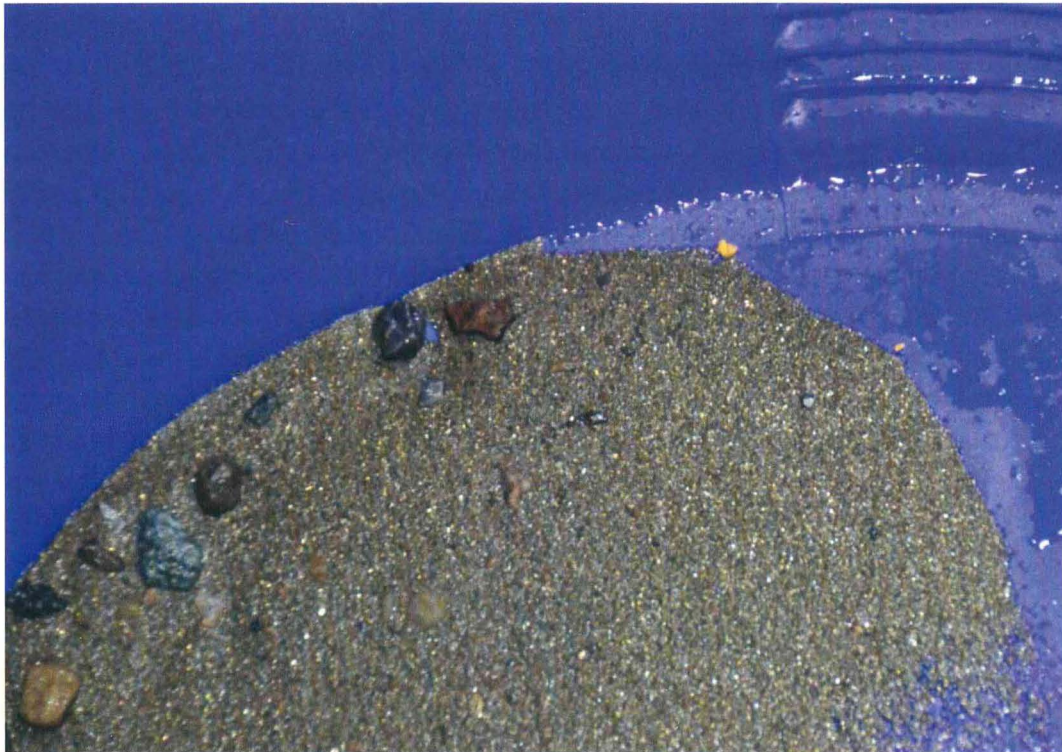
Plate 2 - Gold found in the BD-3 test pit in 2013 was "chunky" and tabular, not flat. Heavy minerals were a bi-modal mixture of fine-grained pyrite and coarse-grained magnetite, rutile, pyrite, garnet and scheelite.

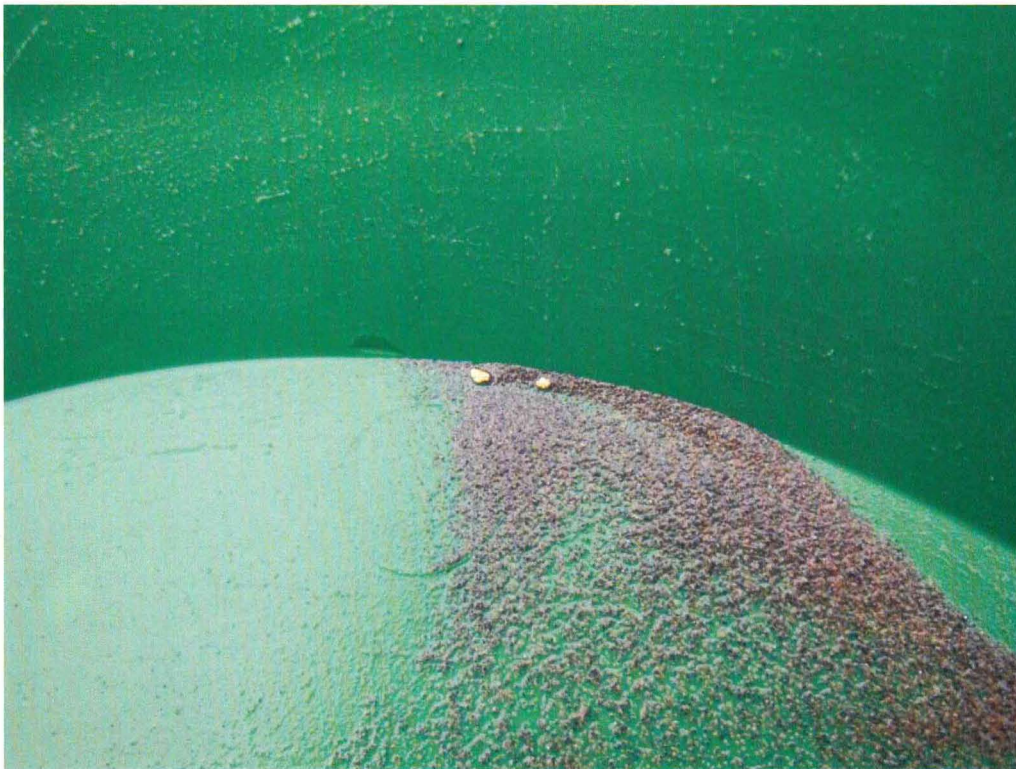
Plate 3 – In 2014, tabular, moderately-coarse gold grains were obtained from sample WL14-03, from excavator pit CAN14-01.

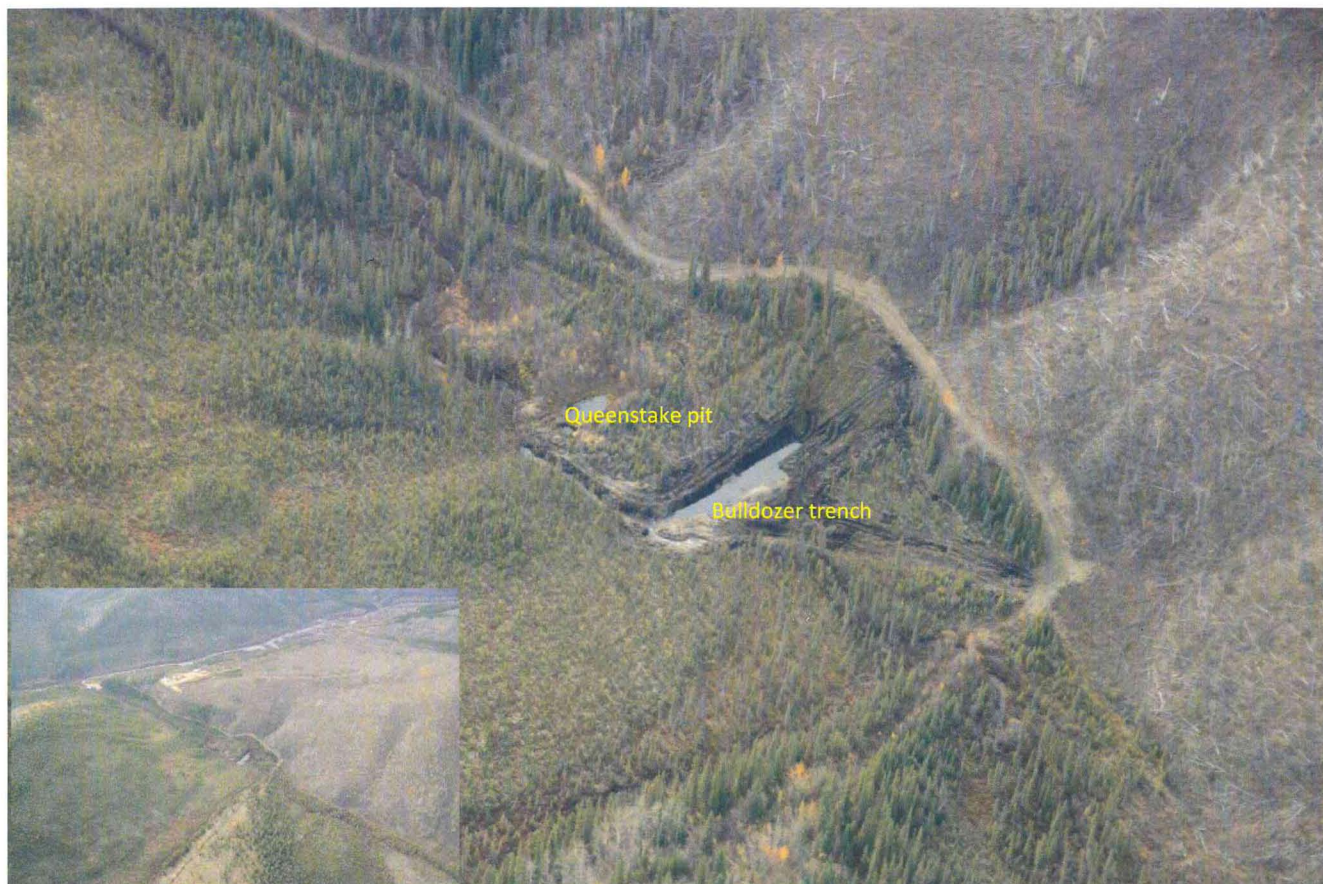
Plate 4 - View showing bulldozer trench on Candace Creek on September 20, 2015. Inset photo shows location of trench across Candace Creek.

A test pit lies approximately 120 feet upstream from Post #1 on Placer Claim Van 1. The pit has approximate dimensions of 90 feet by 40 feet, and is shown on Plate 4. This pit was excavated by Queenstake Resources Ltd. during their activity in the area from 1984 to 1987, as a Prospecting Lease was held by them at this location during that time (Queenstake Resources, 1987). No written results are known from this pit, although local miners and former Queenstake workers have stated that it had a grade of 1.4 ounces per 100 cubic yards (0.014 ounces per cubic yard; 0.569 grams per cubic metre). This compares favourably to the 0.012 ounces of fine gold per cubic yard (0.488 grams per cubic metre) grades that Queenstake reported on the main valley of Maisy May Creek.

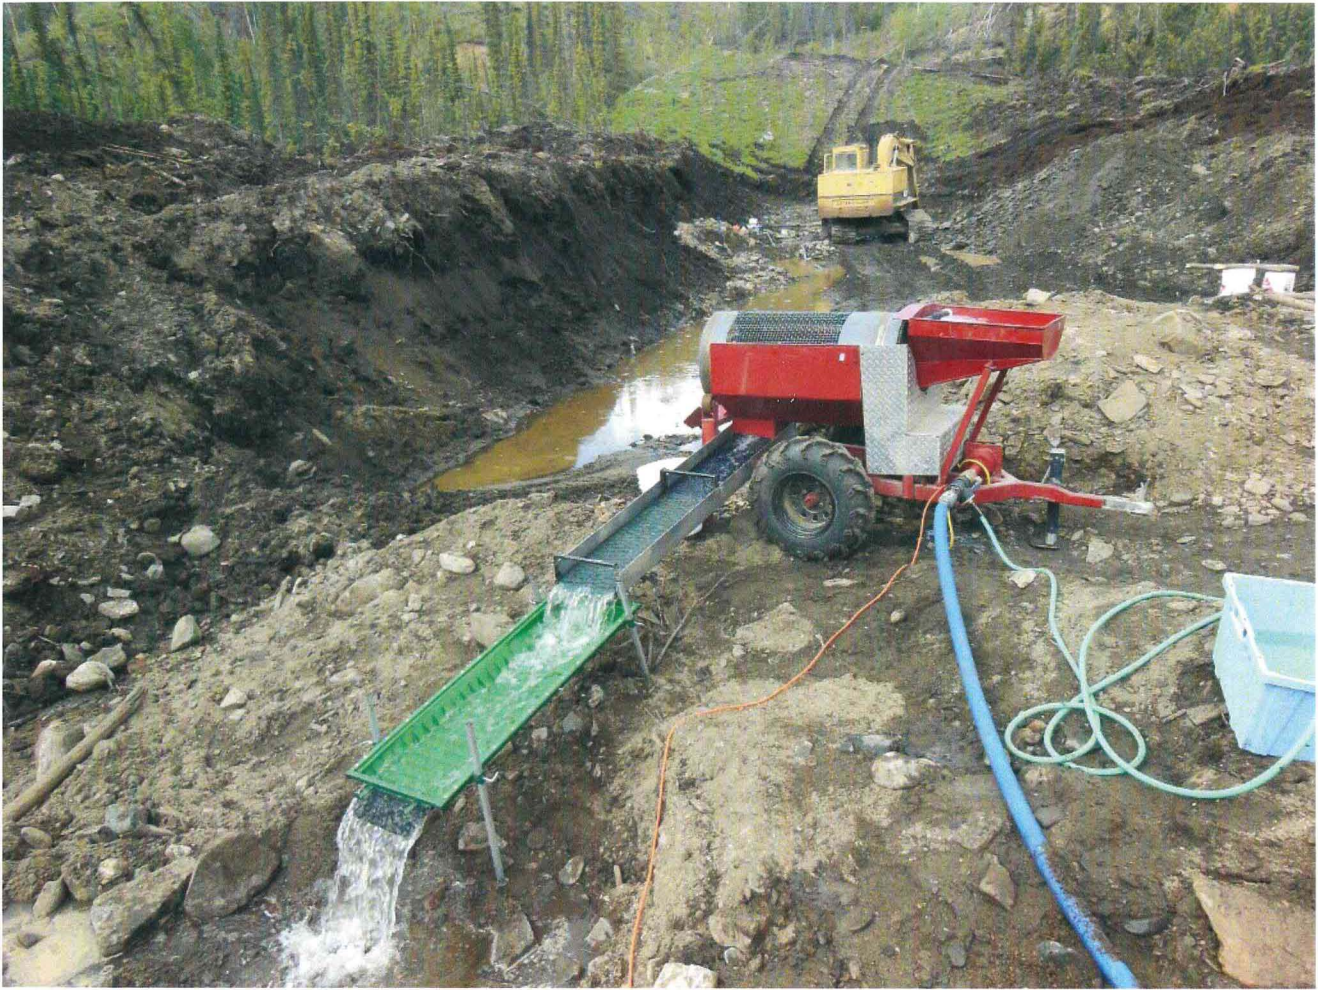
Plate 6 – The test trommel was mounted on an ATV-portable frame and had a $\frac{1}{2}$ inch screen. Powered by an electrical motor with water supplied by a 1.5 inch pump, sluiced material was fed to a 6 foot aluminum sluice run with expanded metal riffles over unbacked Nomad matting, followed by 4 feet of a "Le Trap" sluice run.

Samples from the excavator test-pits were processed using a custom-made ATV-portable trommel. The trommel was powered by a generator-powered electric motor and equipped with a $\frac{1}{2}$ inch screen which fed to a 6 foot sluice run lined with unbacked Nomad matting and expanded metal riffles, followed by a 4 foot "Le Trap" long tom sluice run (Plate 6). A Honda 1.5 inch pump supplied the water for sluicing and panning. Sluice concentrates were hand-panned to recover final gold and heavy minerals.

The small trommel proved inadequate for processing a large bulk sample. Therefore, further testing on a larger scale is recommended. A wash plant with a minimum capacity of over 50 cubic yards an hour should be used to process material from the present 20 cubic yard stockpile and from new trenches on upstream reaches of Candace Creek. Test areas should be stripped and drained several weeks (or up to one season) ahead of time to ensure adequate washing of the materials.
