**YEIP
2018
-012**

Alluvium 2018
Yukon Mineral Exploration Program
Final Report
Alluvium Gold Mining Inc.

Author: Richard E. Nagle

Date: November 7, 2018

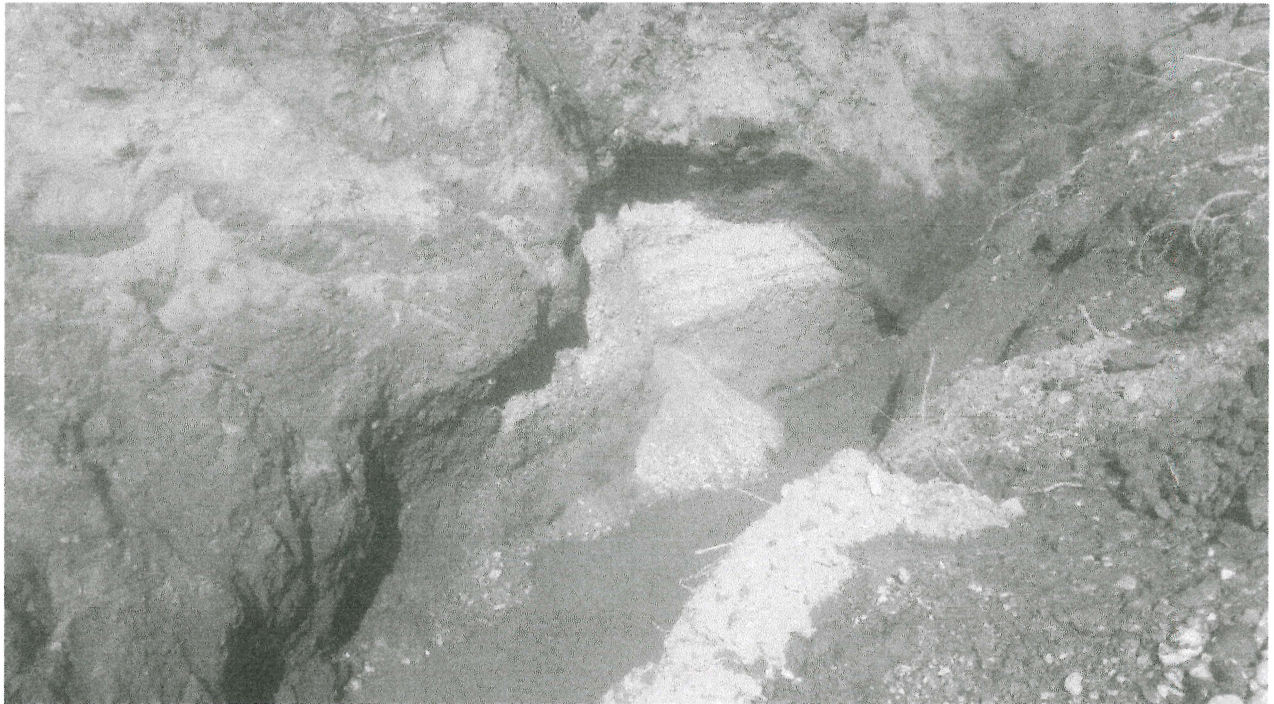
figures 3 and 4

As mentioned on page 4 in Dates of Work, Test Trench #1 revealed a virgin strip of Red gravels that were 10 feet deep and 30 feet wide between the dredge #6 cut and Mr. John Brown's cut from the 1980's. Under this layer was found to be a two foot layer of white channel gravels, followed by one foot of heavily decomposed bedrock, then small fractured bedrock which contained very little gold (one to three very small pieces of gold per pan). One cubic yard of the red gravel/ white channel interface from Test Trench #1, hand shoveled into a highbanker yielded .782 Grams of fine gold averaging ~25 mesh in size. While one cubic yard of the decomposed/ fractured bedrock interface, hand shoveled through the same highbanker yielded only .042 Grams of much finer gold. In both tests, visible magnetite, pyrite and garnets were found but just like the gold, much more was found above the decomposed bedrock layer than below it.

Figure 3 – Test Trench #1 virgin red gravel/ white channel.

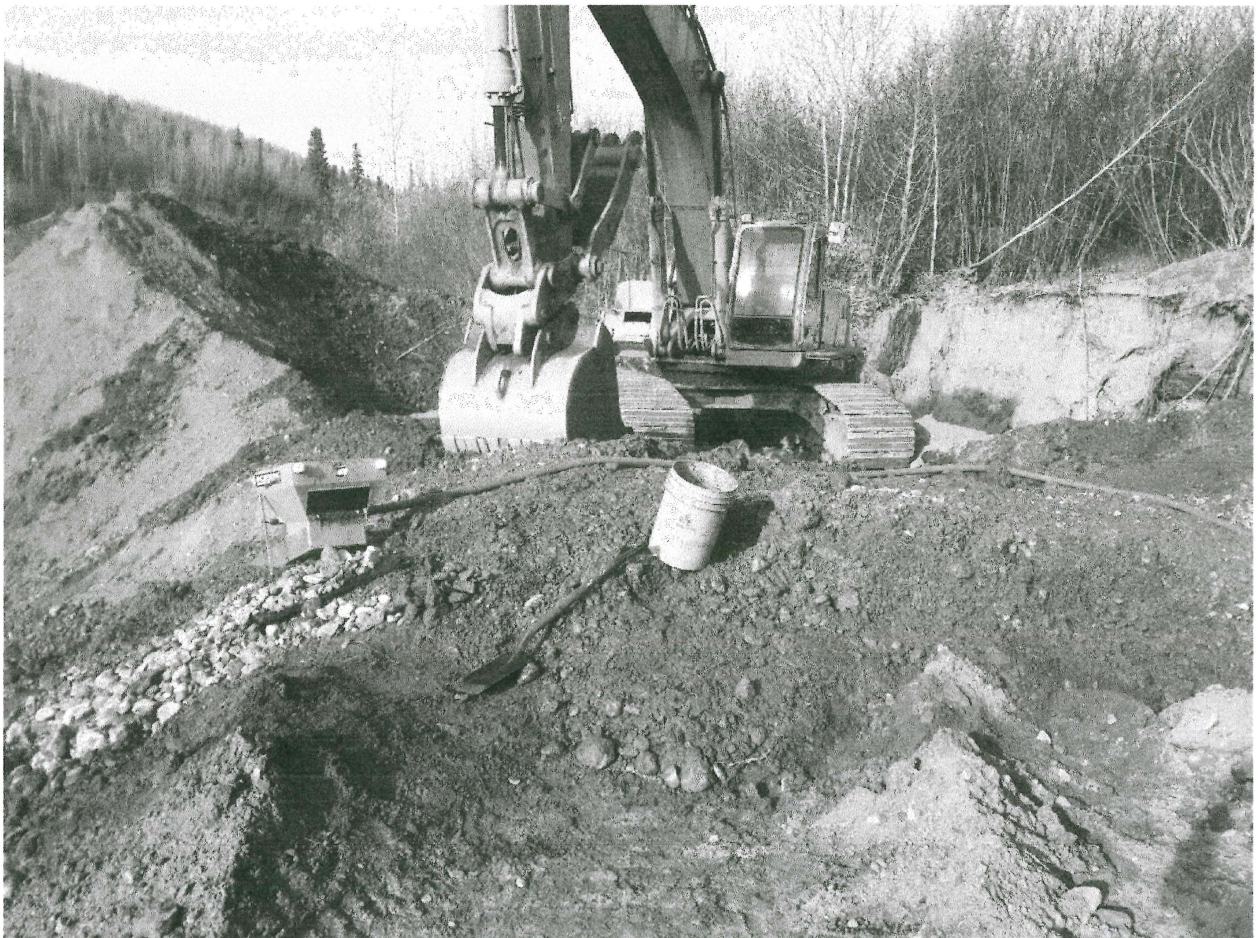
Figure 4 – Test Trench #1 highbanker with virgin placer gravels

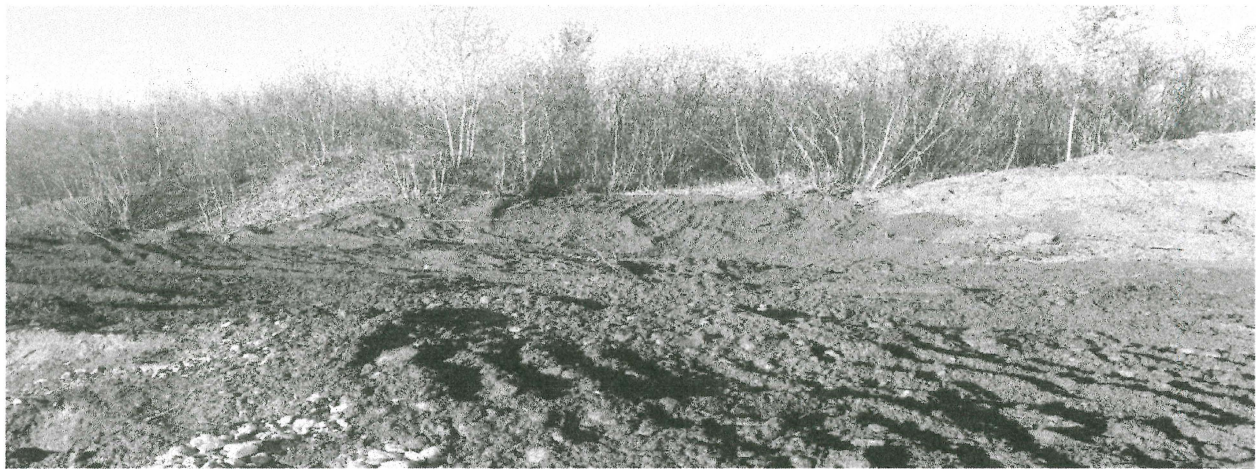
Figure 5 – Reclamation completed on Test Trench #1

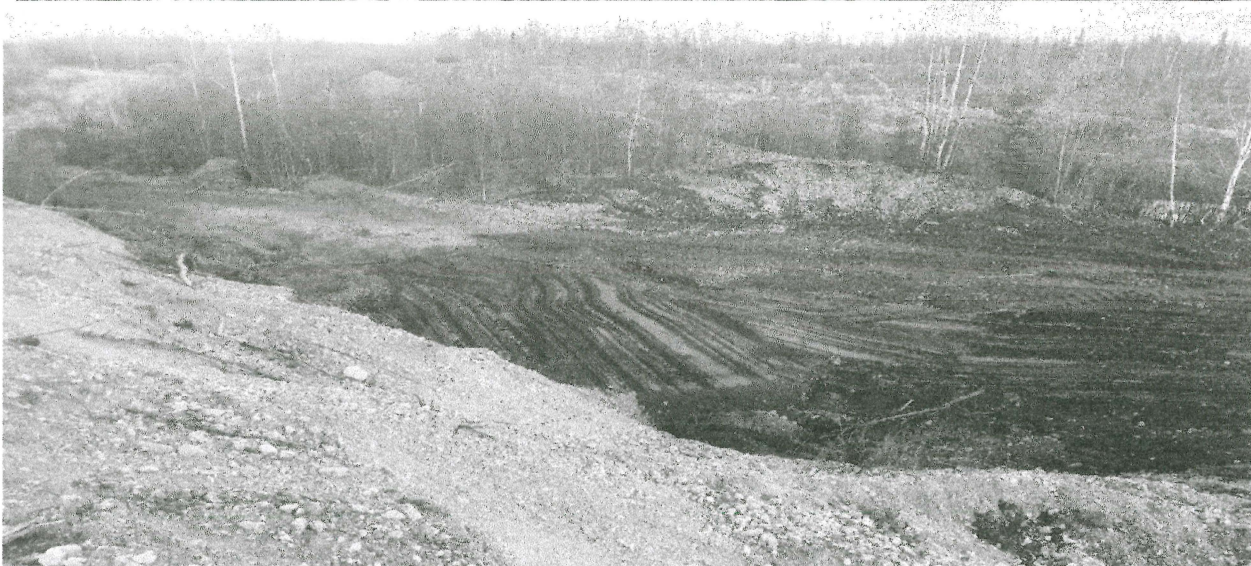
Figure 6 – Reclamation completed on Test Hole #1

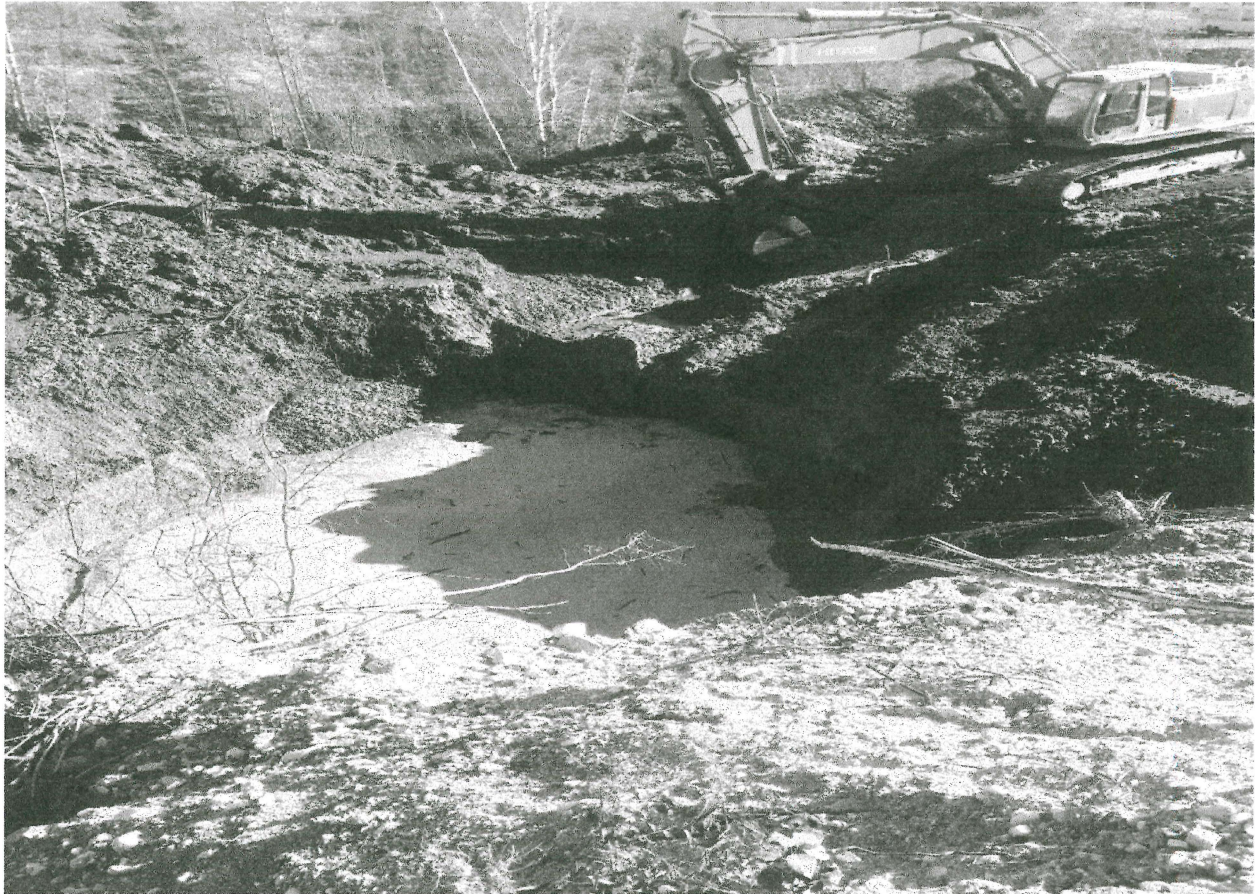
Course dredge tailings were encountered 10 feet below previously disturbed sand overburden in Test Hole #1. These dredge tailings were found to be getting finer as the hole was excavated down another 15 feet until solid bedrock was reached. Periodic test panning of the dredge

small pieces of gold per pan. Because of these negative results, no additional highbanker testing was performed. Test Hole #1 measured 40 feet in diameter and was a total of 25 feet deep.

Figure 7 – Test Hole #1 quickly filled with water after reaching bedrock

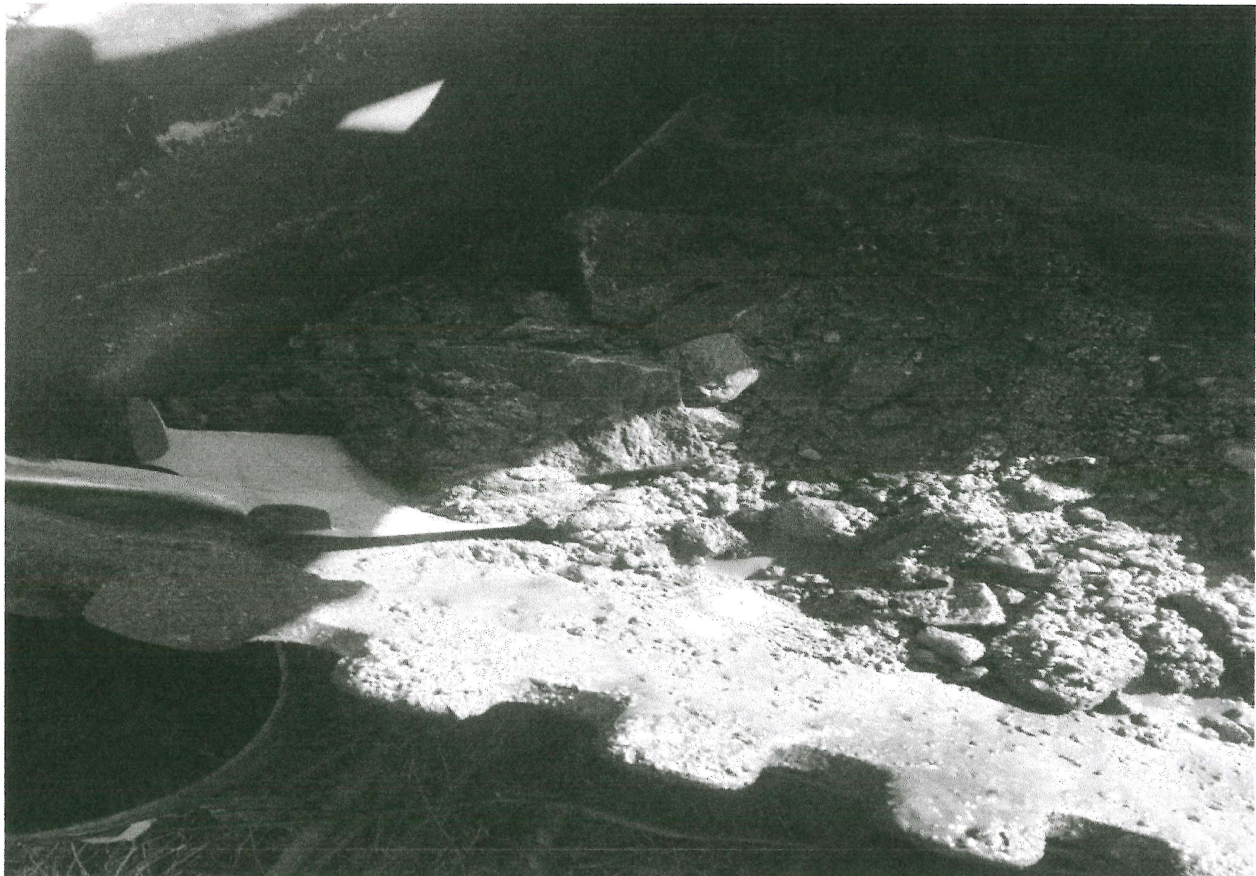
Test Hole #3 was the only 2018 exploration target outside of claim #P00687. It was excavated 300 feet West of Test Trench #1, on the bench claim #P45395. This hole was located on the West side of Mr. John Brown's 1980's known cut and approx. 400 feet away from any known dredge tailings, resulting in very little ground water. This location had 8 feet of undisturbed sand overburden followed by 10 feet of Red gravels, down to a 1 foot layer of decomposed bedrock then finally highly fractured bedrock. Further to the West and up the bench lies virgin gravels with an additional 40 feet of undisturbed sand overburden on top. After panning with good results, one cubic yard from the red gravel/bedrock interface was hand shoveled into a highbanker yielding .327 Grams of fine gold with magnetite, pyrite and garnets prevalent.

Figure 8 – Fractured Bedrock sample from Test Hole #3

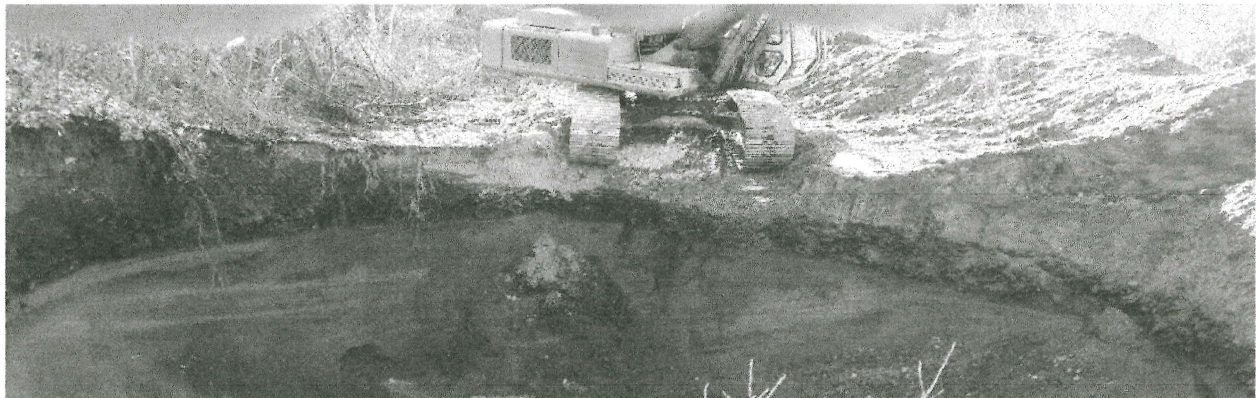
Figures 9 and 10

Test Trench #2 was excavated beginning at the Eastern side of Mr. John Brown's 1980's known cut, heading East for 80 feet into known dredge tailings from the mid 1900's. Mr. John Brown's historic cut was composed of silt, which had filled the cut after his mining was complete. The remainder of the trench was composed of 8 feet of Mr. John Brown's organic overburden on top of 12 feet of strictly fine dredge tailings, and then solid bedrock. Again, test panning was performed throughout the duration of trenching and magnetite, pyrite and garnets were present, but only one fleck of gold was found for every two pans tested in the dredge tailings.

Figure 9 – Fine dredge tailings in Test Trench #2

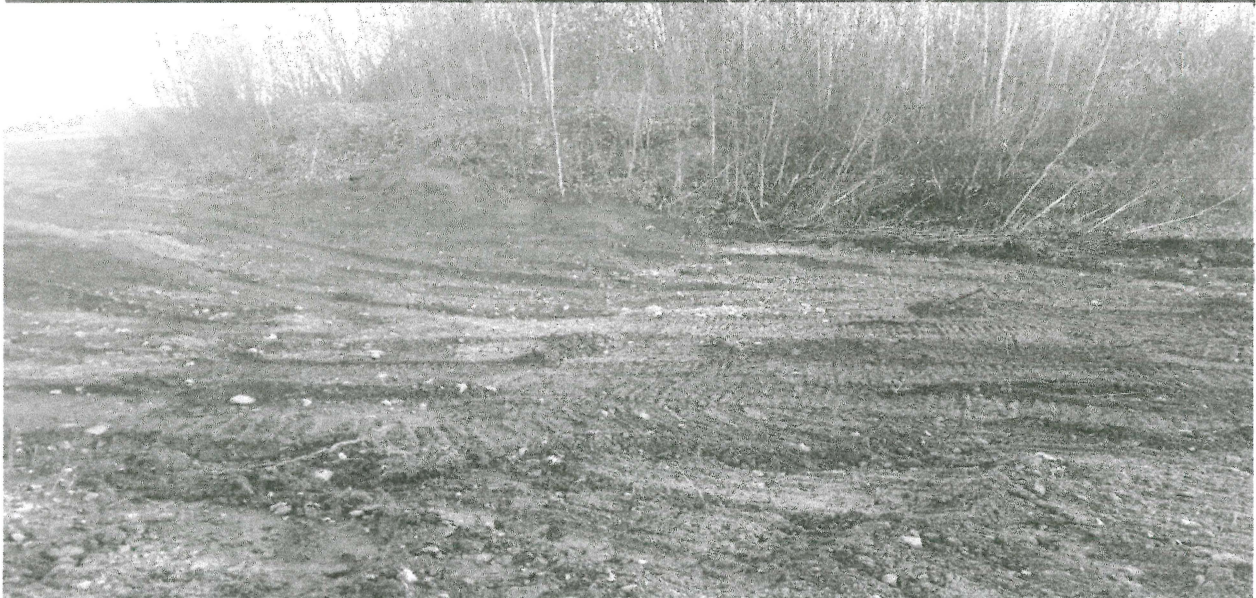
Figure 10 – Test Trench #2 reclamation completed
