YGS Open File 2023-1

# Surficial geology and geohazards of the greater Whitehorse area

P.S. Lipovsky

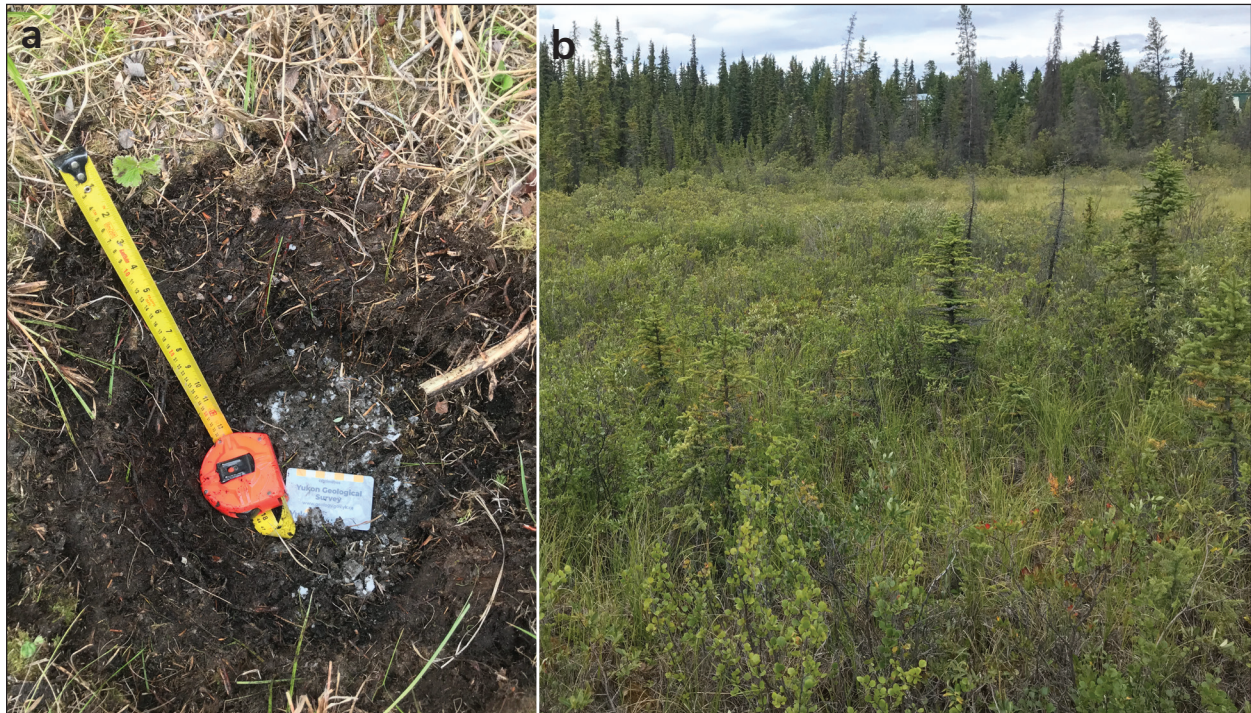
**Figure 5. (a)** Thick organic material (peat) and **(b)** associated wetland vegetation near Hillcrest subdivision (20PL021; August 4, 2020). The frost table was encountered at a depth of 35 cm at this location, which is likely very close to the top of permafrost (note white patches of ice at bottom of soil pit).

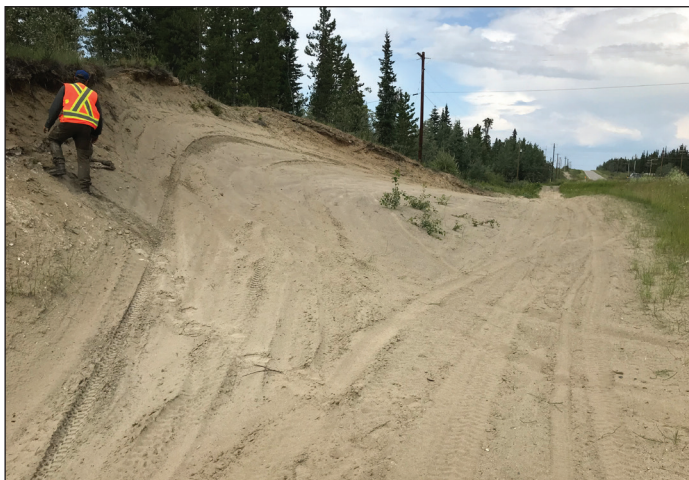
**Figure 7.** Sand dunes exposed along road cut near North Klondike Highway near Takhini Hot Springs Road (19PL027).

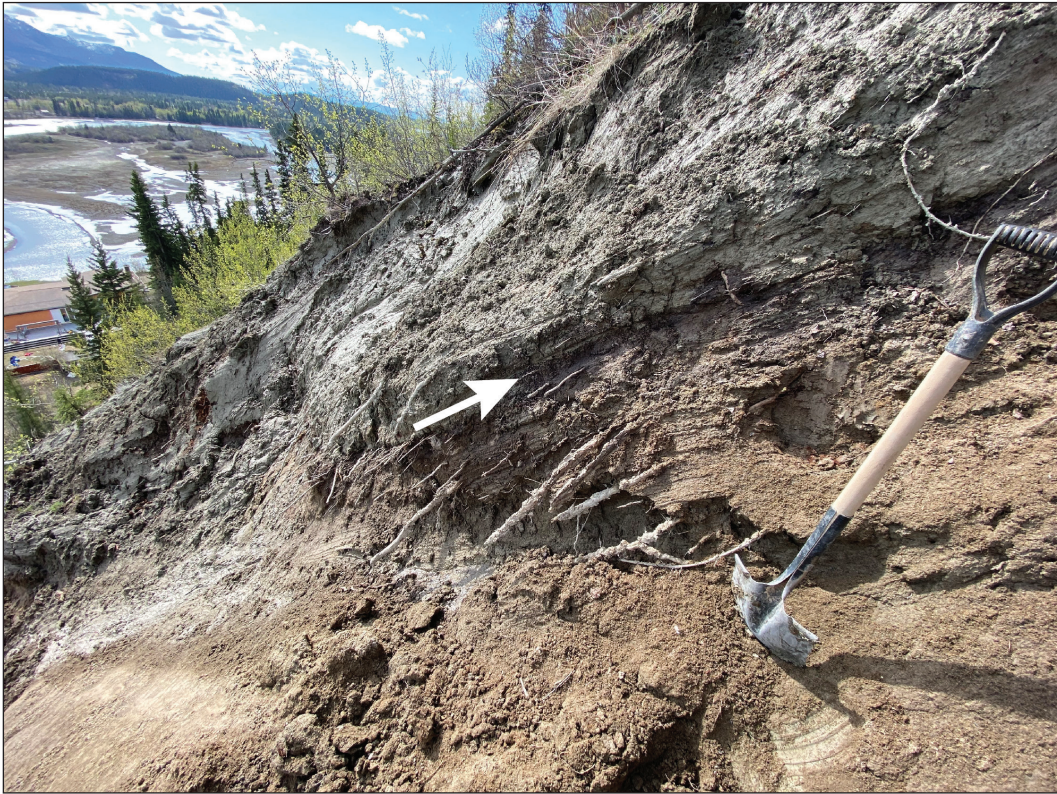
**Figure 8.** Fine-grained colluvium exposed on the Whitehorse escarpment on the south lateral margin of the 2022 Drury Street landslide initiation zone (J. Bond photo). Note buried organic horizon (arrow) and bedding structure parallel to the slope angle.

Colluvium is material that was transported and deposited by downslope, gravity-driven mass movement processes such as creep, landslides and snow avalanches. The texture and composition of colluvium varies widely and depends on the transport mechanism, distance transported, and source parent material. Colluvial materials deposited by rapid mass movement processes, such as rock falls, debris flows, and avalanches, are typically found on steep to moderate slopes. Conversely, colluvium deposited by slower processes such as creep and seepage, occurs on more gentle to moderate slopes. Colluvium is commonly crudely stratified parallel to the slope angle, and may incorporate layers or fragments of organic material (Fig. 8).

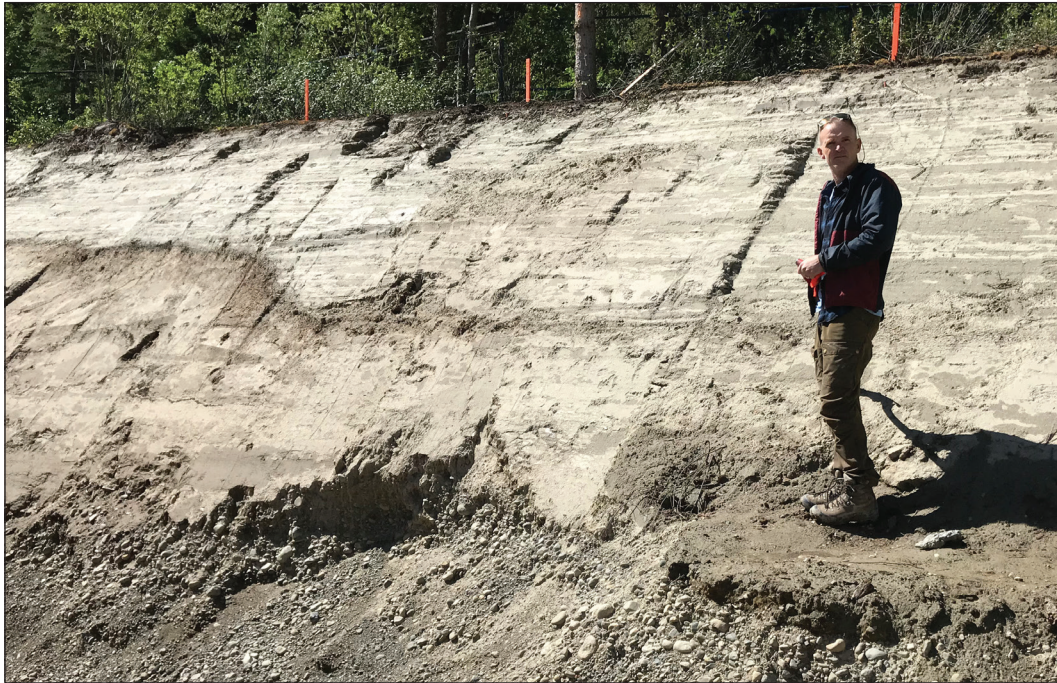
**Figure 9.** Apron of fine-grained colluvium (~2 m thick) exposed above fluvial sand and gravel in a foundation excavation, at the base of the Whitehorse escarpment near Main Street (18PL004b). Colluvial fans and aprons along the toe of the escarpment are generally comprised of similar material, which has accumulated from successive mud flow and landslide events.

Colluvial veneers (Cv) and blankets (Cb) are widespread on hillslopes throughout the study area, and commonly overlie till and/or bedrock. Thinner (<1 m) colluvial veneers are found on steeper upper slopes, while thicker (>1 m) blankets are found on gentler, mid to lower slopes. Colluvial fans (Cf) and aprons (Ca; complexes of laterally coalescing fans) commonly occur in slope toe positions (Fig. 9).

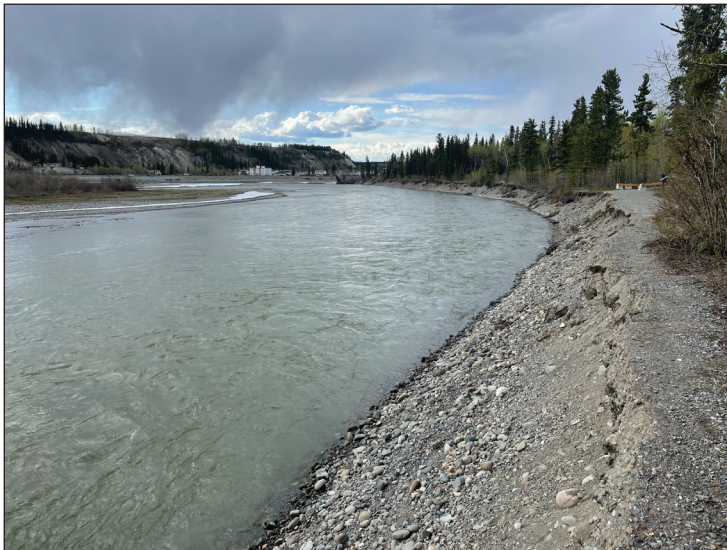
**Figure 10.** Fluvial terrace sand and gravel (gsFt) exposed in a bank of the Yukon River in Riverdale subdivision. Shrubby gravel bar on opposite side of the river is considered part of the active floodplain (gsFAp). Note undercutting of bank occurring on outside of river bend.

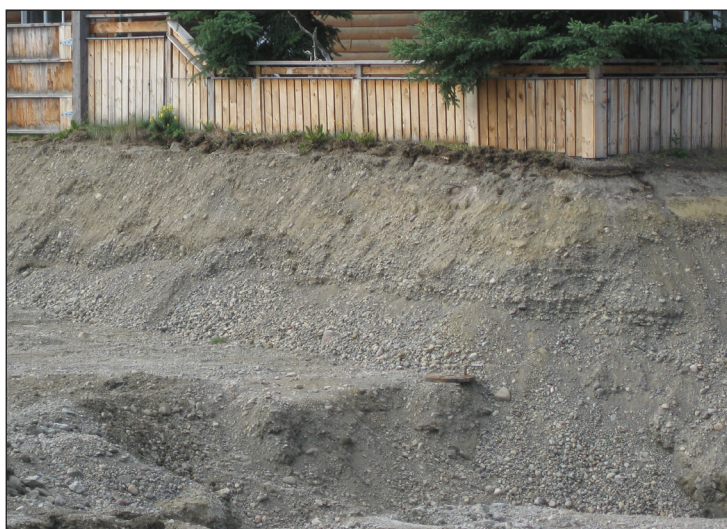
**Figure 11.** Fluvial sand and gravel exposed in infrastructure excavation near Wheeler St. and 6th Ave. This material underlies much of downtown Whitehorse, which is built on a terrace of the Yukon River (gsFt).

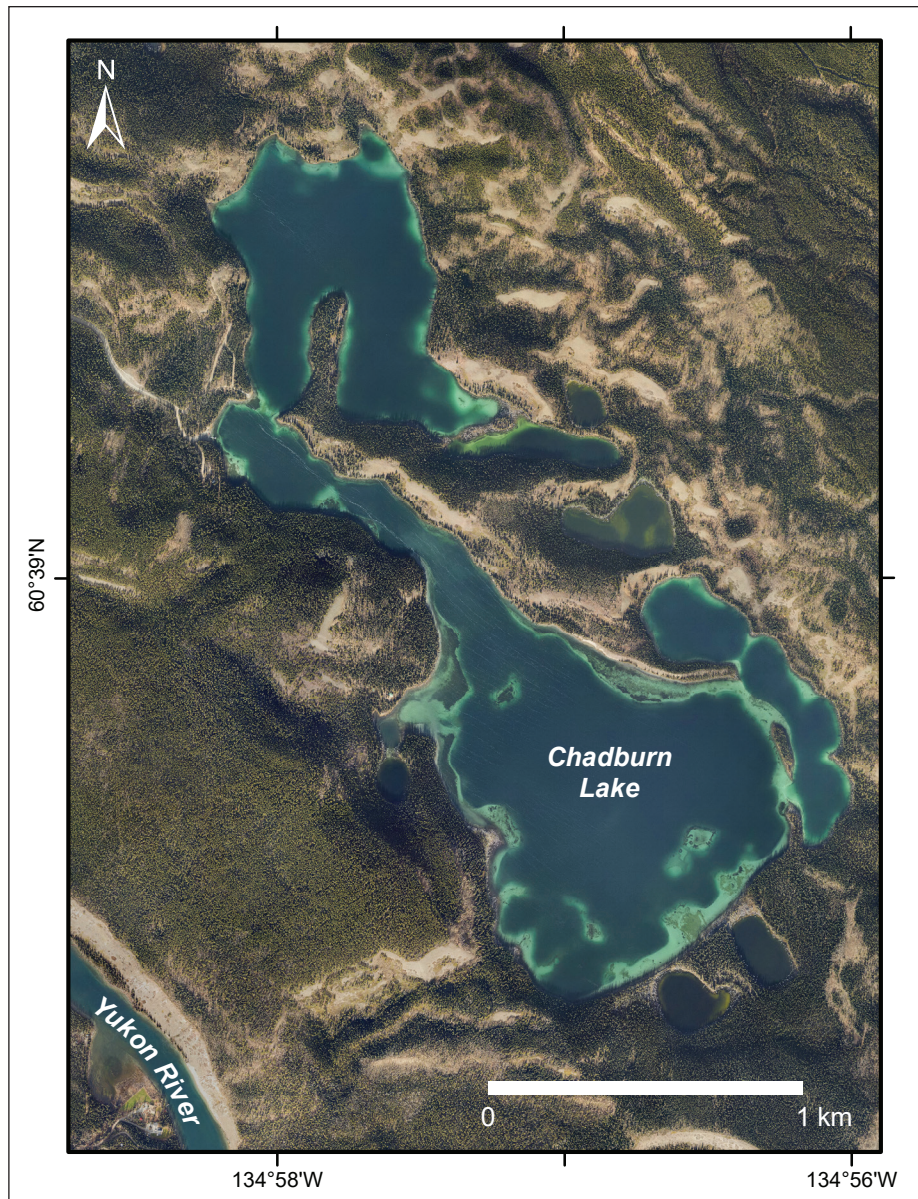
**Figure 12.** The turquoise colour in shallow portions of Chadburn Lake are due to marl deposits on the lakebed. The chaotic (hummocky, ridged and kettled; gsFGhrd-HT) nature of the surrounding terrain is the result of glacier ice stagnation in the area. 2019 orthophoto background.

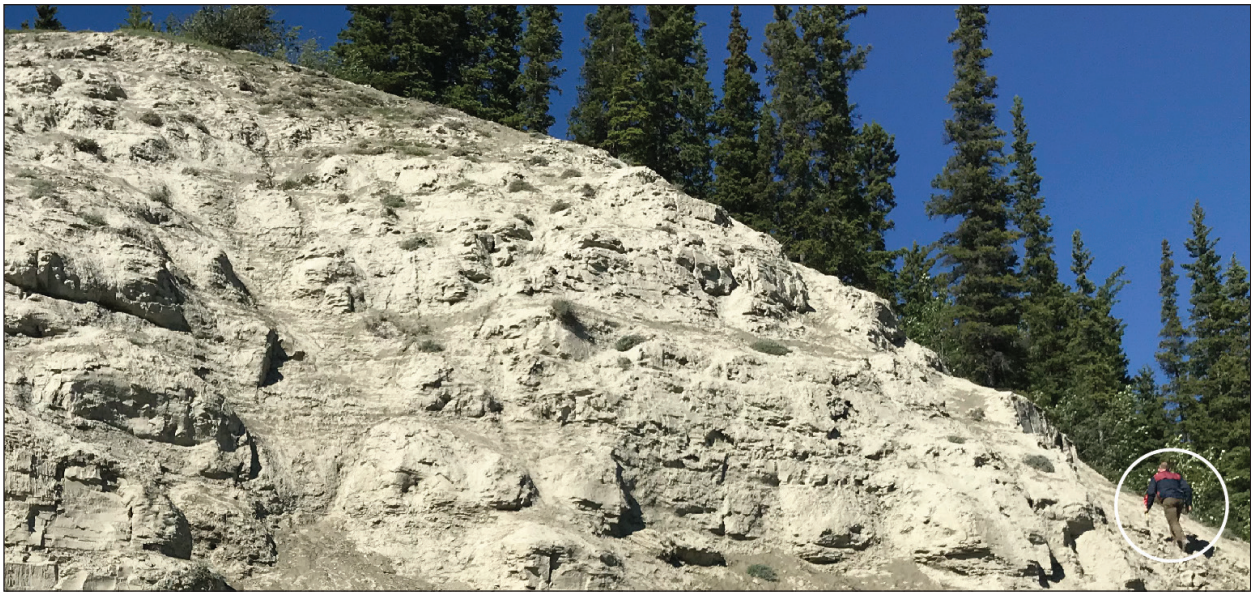
**Figure 13.** Glaciolacustrine sediments exposed in the Whitehorse escarpment above Hawkins Street (20MK018a) primarily consist of horizontally bedded silt. Note person circled for scale.

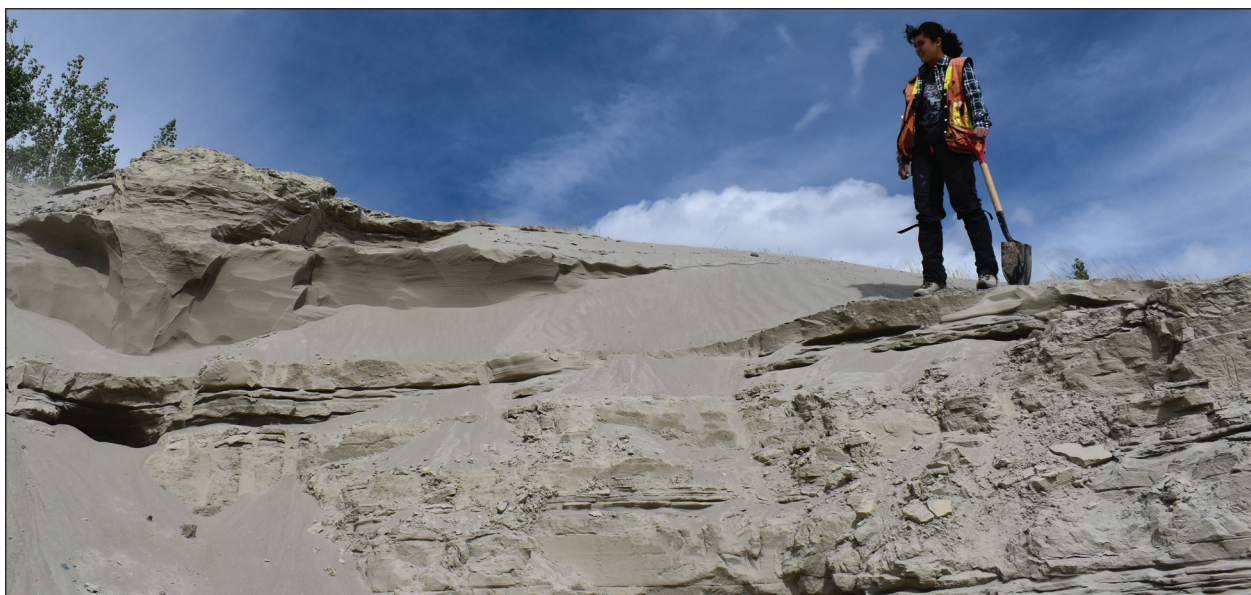
**Figure 14.** Glaciolacustrine sand exposed in a quarry near the Yukon Wildlife Preserve (18PL075).

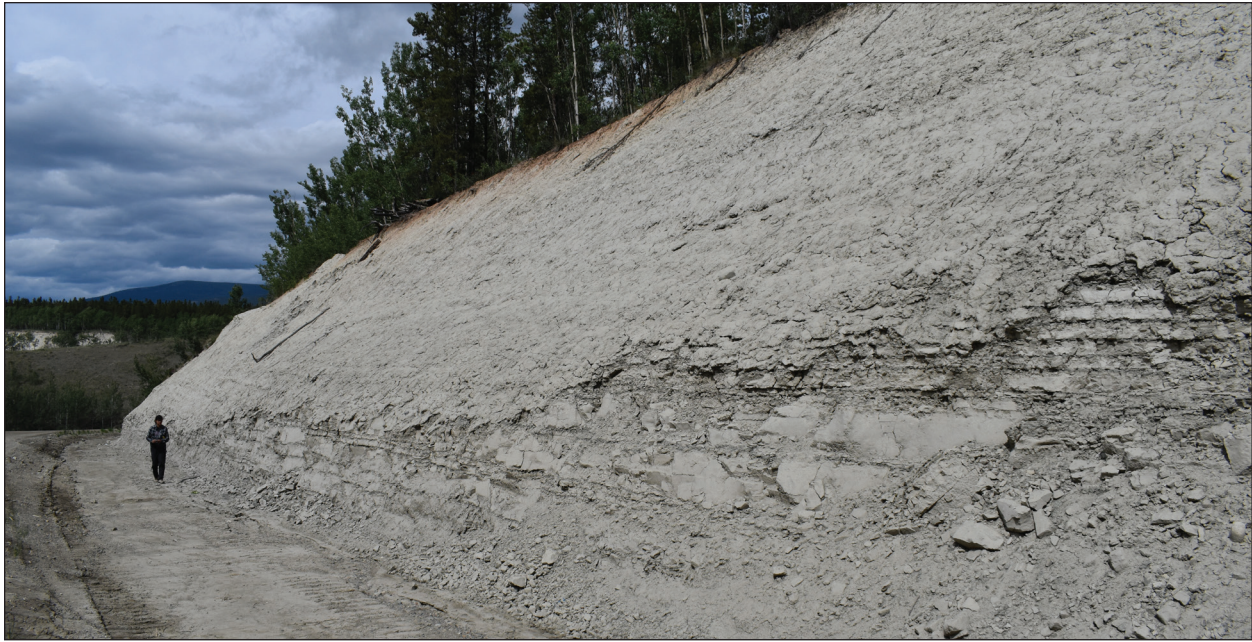
**Figure 15.** Glaciolacustrine sediments exposed in a roadcut along Takhini River Road (18PL074) consist of horizontally laminated layers of silt (thicker, lighter coloured layers) and clay (thinner, darker coloured layers up to approximately 5 cm thick). These sediments are easily eroded and are subject to gullying and piping in this area.

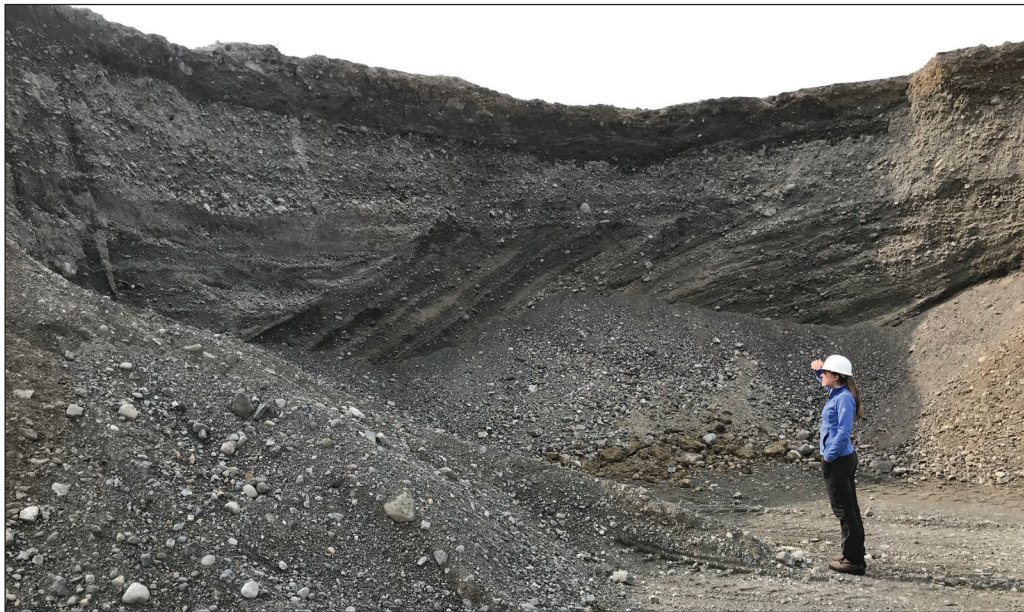
**Figure 16.** Stratified and cross-bedded glaciofluvial gravel exposed in a pit north of Haeckel Hill (19PL043a).

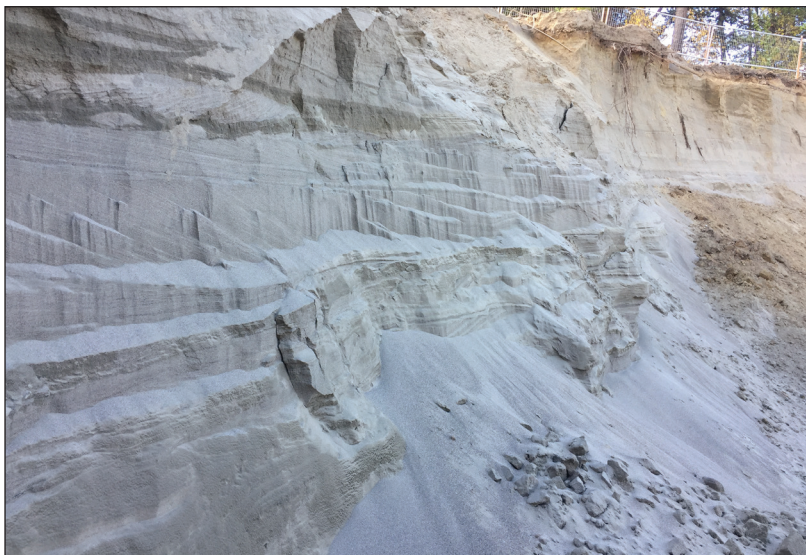
**Figure 17.** Approximately 5 m of well-sorted deltaic (glaciofluvial) sand exposed in a foundation excavation in the Takhini North subdivision (20PL038).

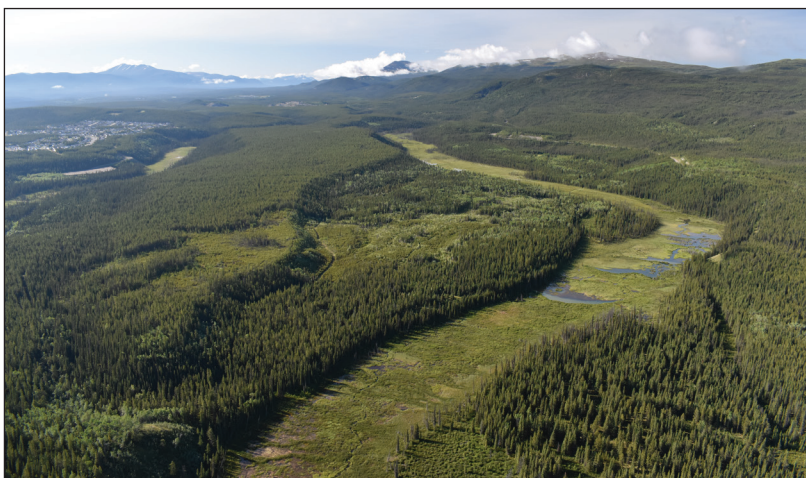
**Figure 18.** Upper McIntyre Creek is an underfit stream that occupies the floor of a large meltwater channel. View is to the south, with Copper Ridge subdivision in the background.

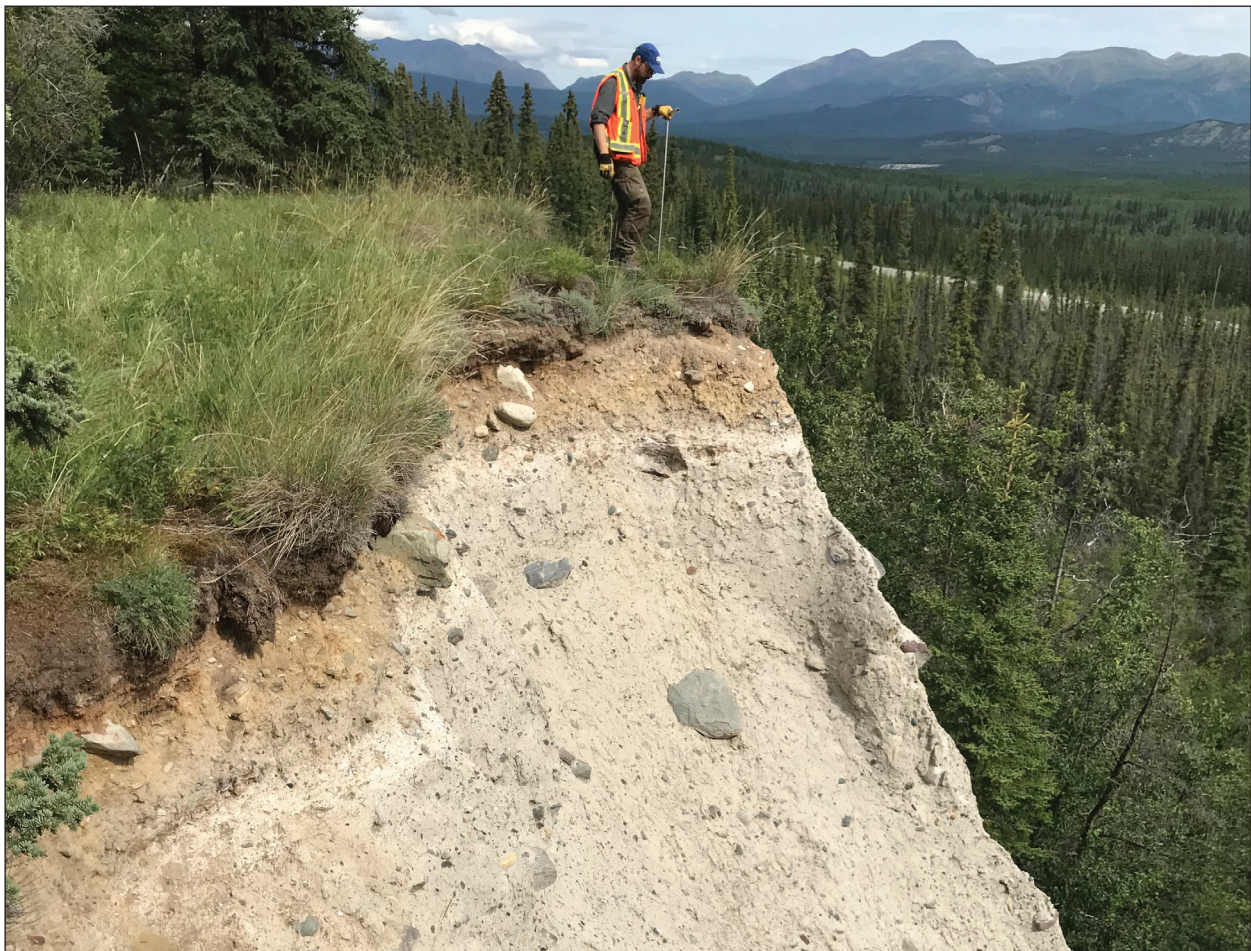
**Figure 19.** Thick exposure of lodgement till diamict near the Old Alaska Highway (19PL021). Note the wide range of clast sizes from boulders to pebbles, which are supported in a dense, fine-grained matrix.

Morainal (till) materials are deposited by either primary glacial processes such as lodgement, deformation and ablation (melt-out), or secondary glacial processes caused by gravity and water (e.g., flow tills). Till generally consists of a diamict made up of poorly sorted, subangular to subrounded pebble to boulder sized clasts of mixed rock types in a sandy-mud matrix (i.e., texture “dsm”; Fig. 19).

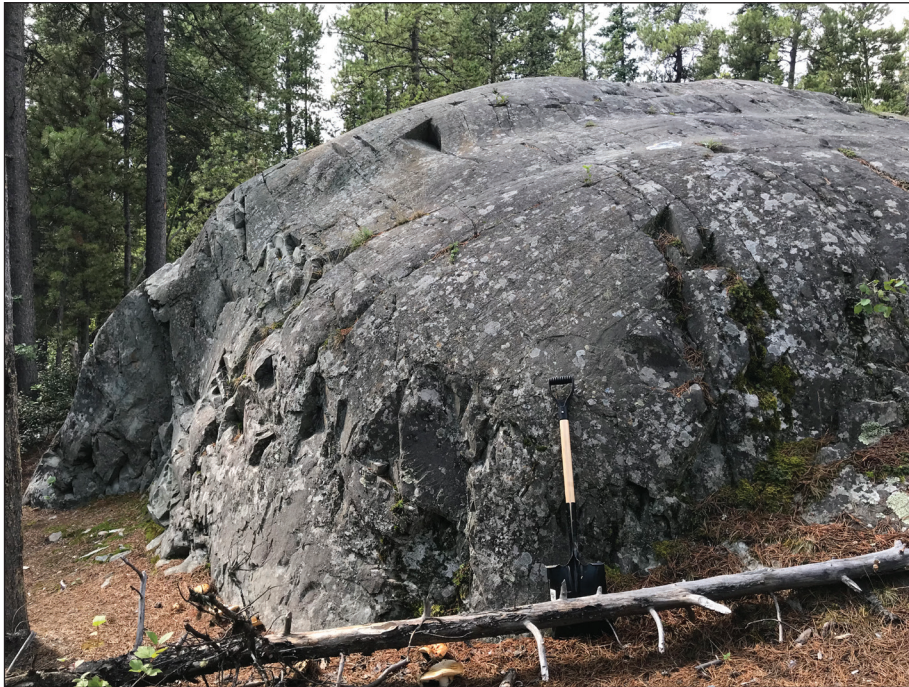
**Figure 20.** Sandstone outcrop (Mandanna member of the Lewes River Group Aksala formation) near Porter Creek Secondary School (20PL026a). Crag and tail streamlined morphology and striations on the rock surface indicate that the ice-flow direction was northwesterly. Abundant limestone outcrops exposed on Grey Mountain in background.

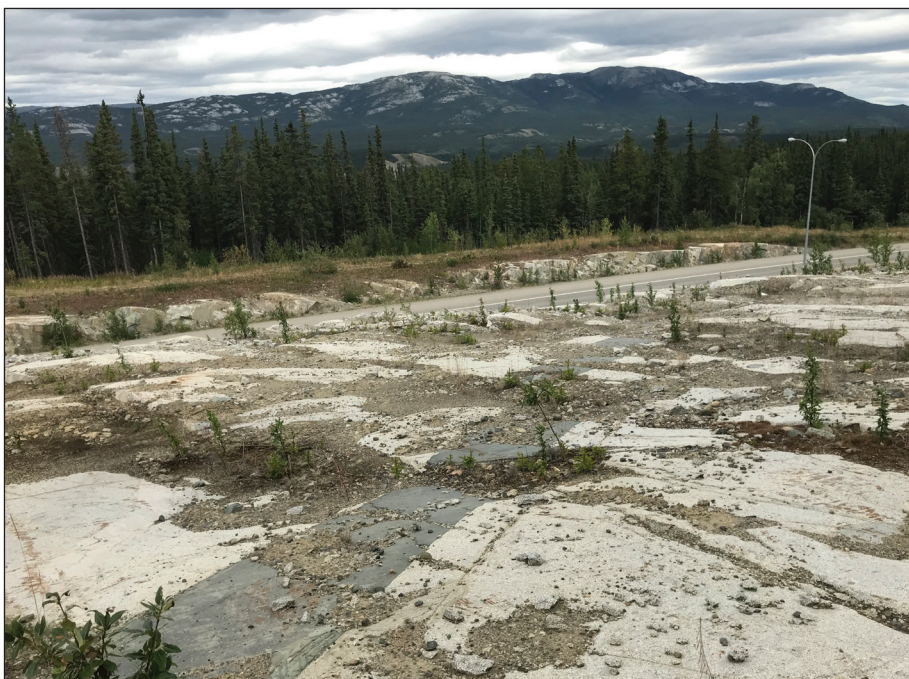
**Figure 21.** Scoured granodiorite with crosscutting dikes exposed after stripping thin overburden along the Hamilton Boulevard extension.

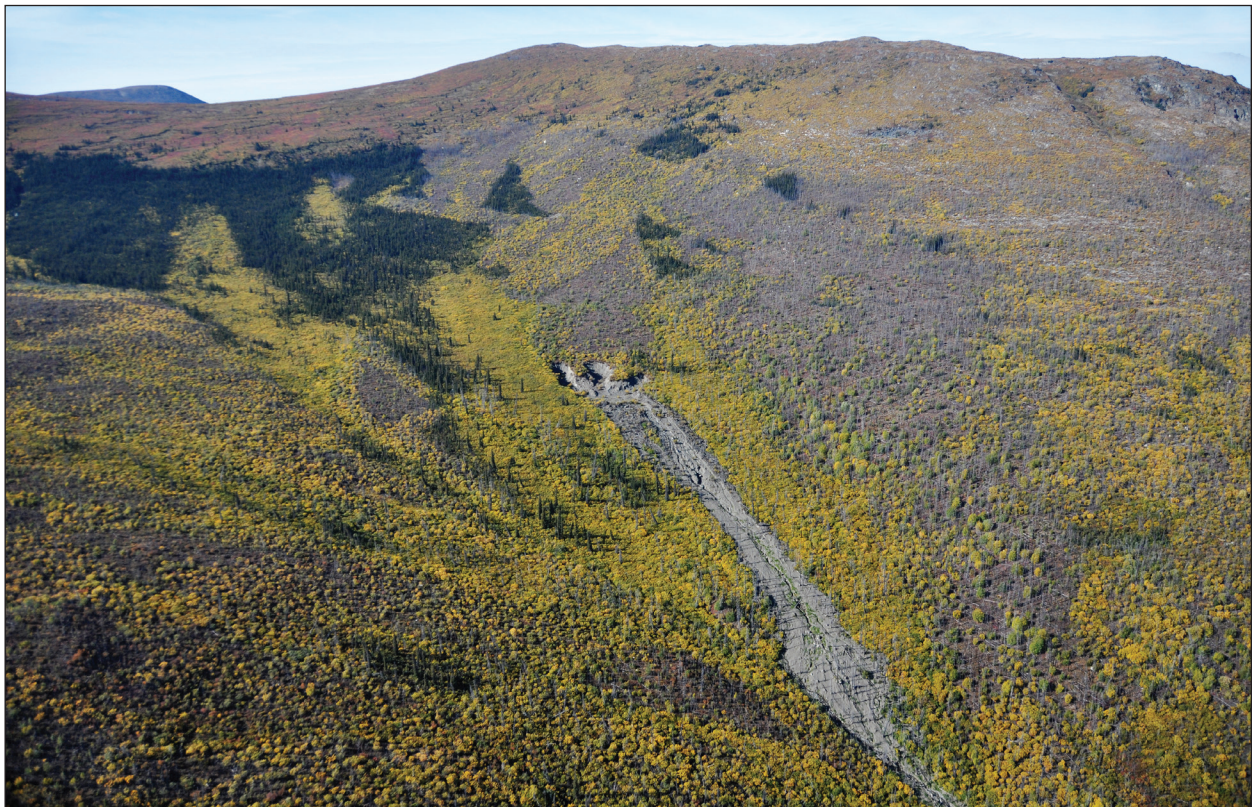
**Figure 25.** This landslide occurred in May 2010 on the eastern flanks of Haeckel Hill. The slide adversely impacted water quality in Little Takhini Creek. Approximately 10 m of till was exposed in the headscarp. While permafrost was not confirmed in the headscarp, the morphology and site characteristics suggest it is a retrogressive thaw flow. September 2010 photo by Cameron Eckert.

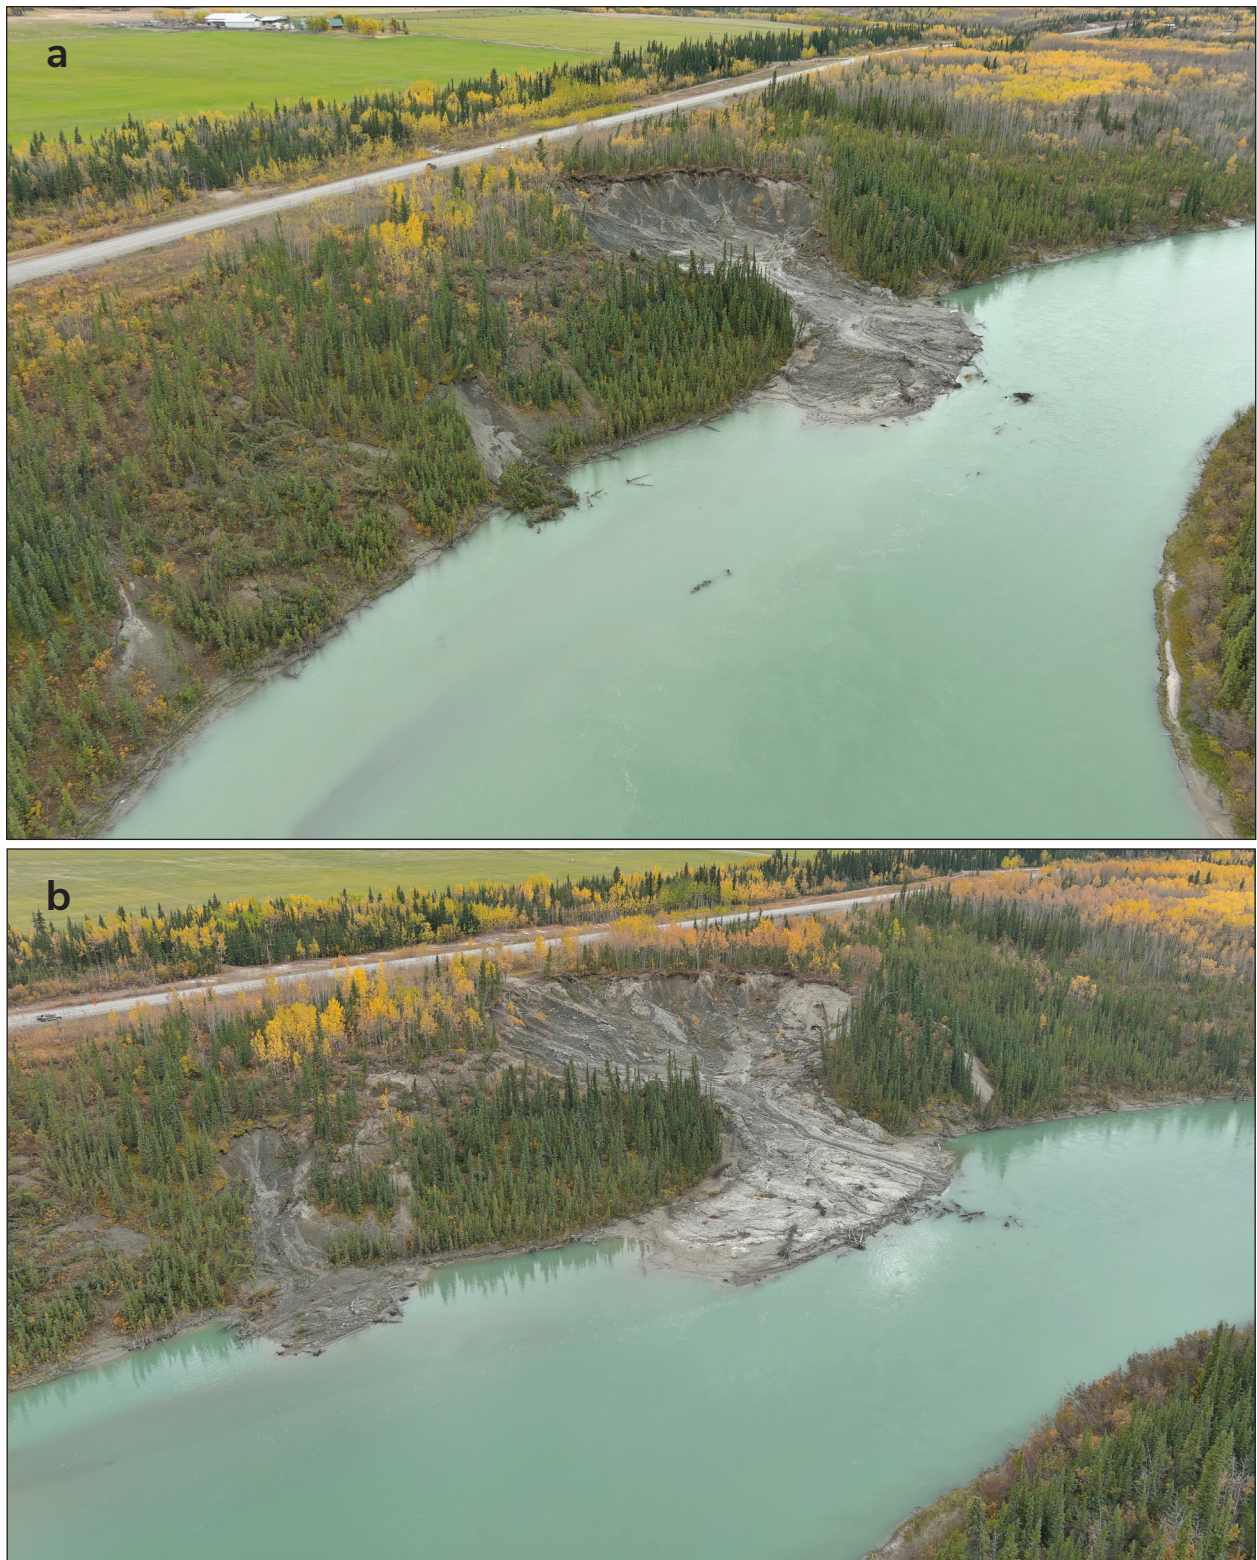
**Figure 26.** Oblique UAV photos of Takhini River retrogressive thaw flow, September 21, 2021 (**a**) and September 21, 2022 (**b**); Peter von Gaza photos. View is to the southwest, looking upstream; note vehicle on highway for scale (**a**). The thaw flow initiated in 2014 as a small failure similar in size to the one in the lower left corner of the upper photo. This smaller slide initiated as an active layer detachment in September 2021, and transitioned into a retrogressive thaw flow the following year.

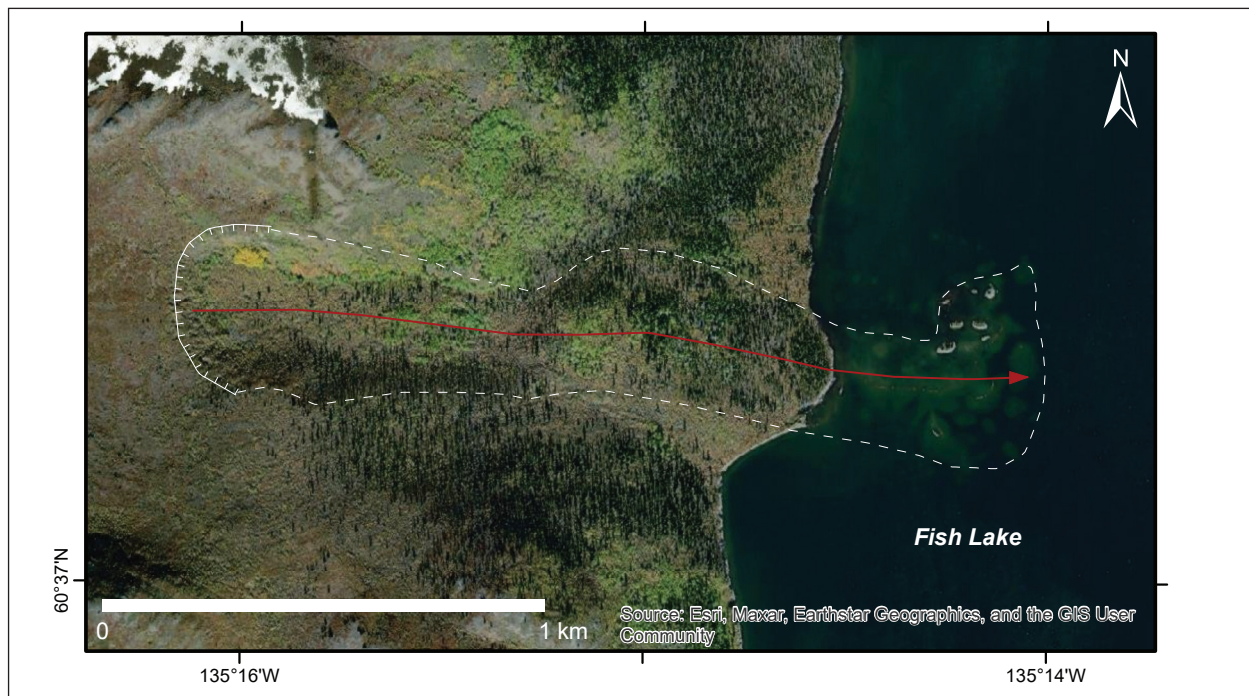
**Figure 28.** A 2 km long ancient landslide on the west side of Fish Lake. Small islands are formed from the landslide debris. September 20, 2018, WorldView2 satellite image background.

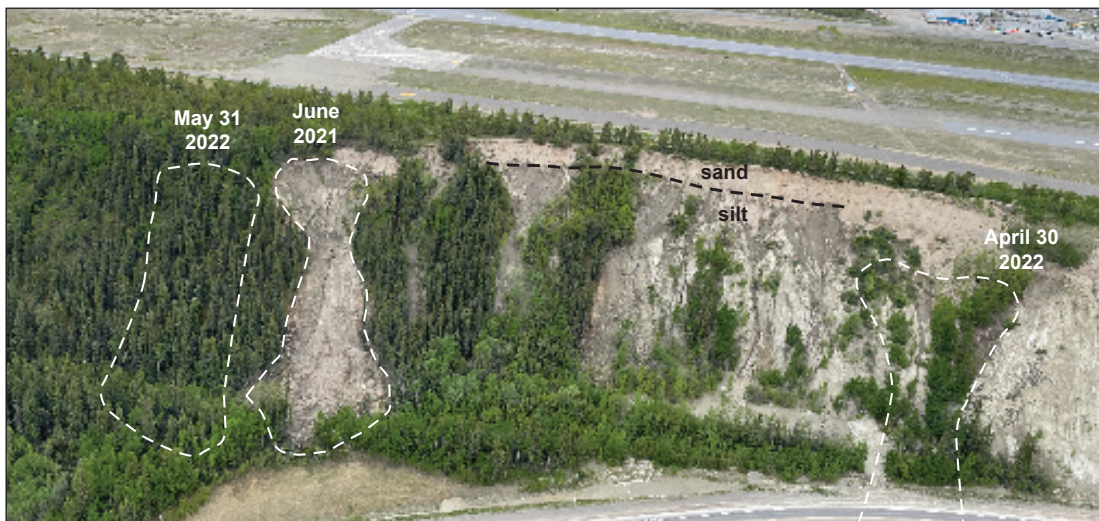
**Figure 30.** The early June 2021 earthflow initiated in a pre-existing gully bowl and ran out within 35 m of Robert Service Way (June 11, 2021 photo). Approximate locations of 2022 slides are also outlined to highlight pre-failure slope conditions. Approximate boundary between sand and silt marked by black dashed line.

- a large earth flow on Robert Service Way in early June 2021 (Fig. 30);
- a large slide in July 2000 below Takhini East subdivision and above Marwell industrial area (Fig. 31; EBA, 2002);
- two slides in June and July 1953 which damaged roads and buildings at the heads of Hoge St. and Steele St. (Fig. 32; Legget and Johnston, 1959); and
- two major events in July 1949 (Legget and Johnston, 1959).

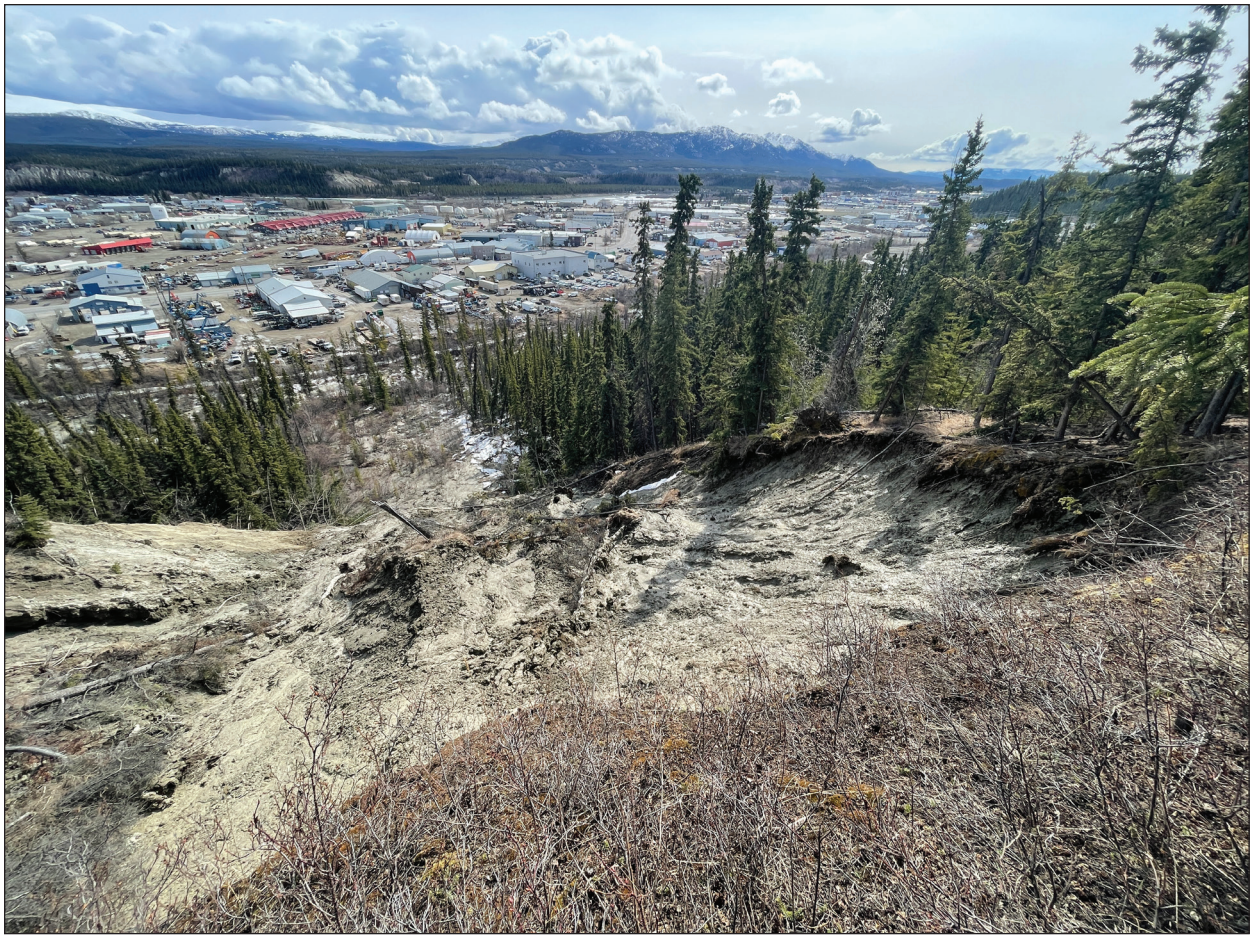
**Figure 31.** The headscarp area of the July 2000 Takhini East slide continues to actively retreat (May 5, 2022 photo).

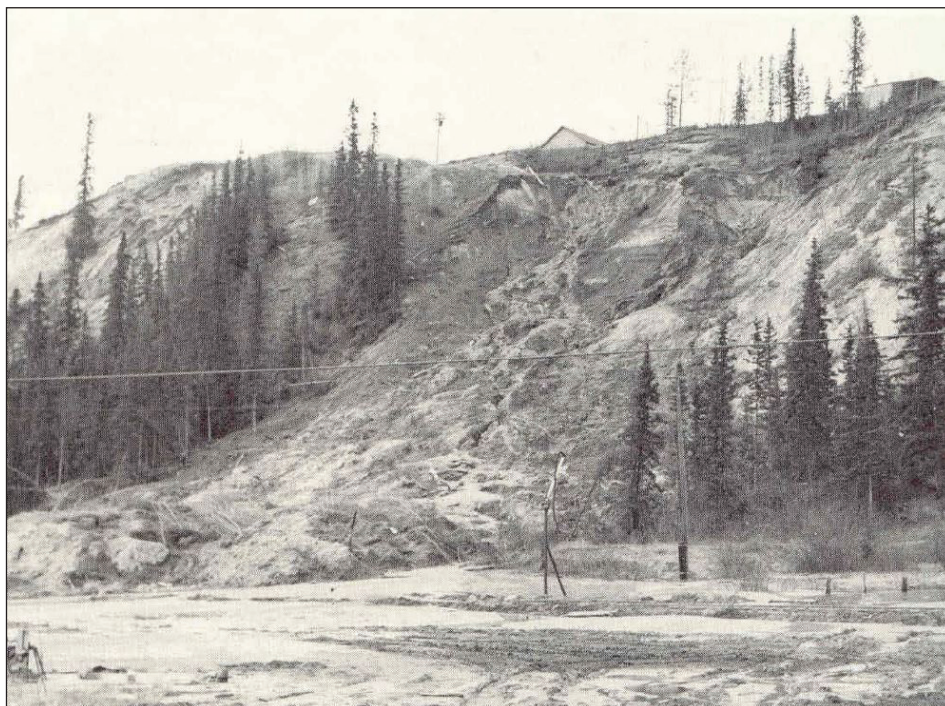
**Figure 32.** June 1953 slide near Hoge Street (1957 photo in Legget and Johnston, 1959).

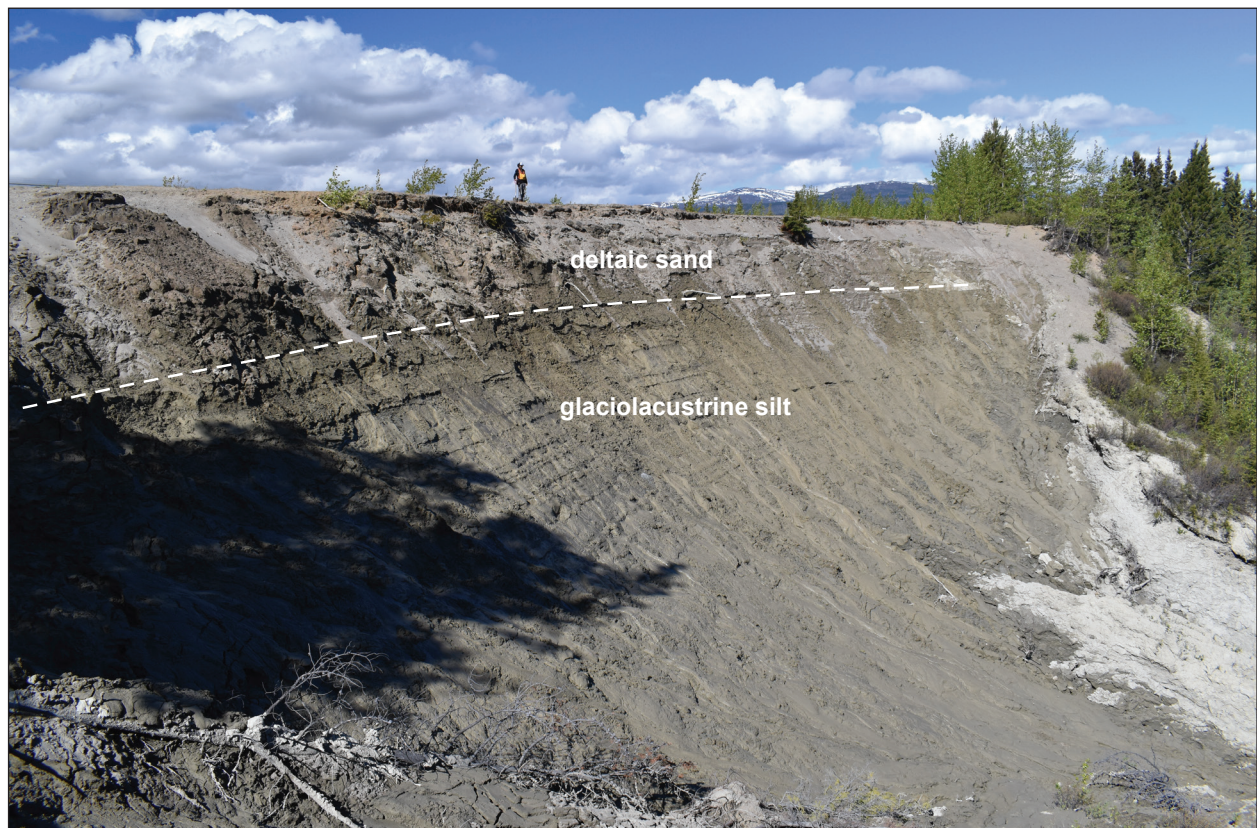
**Figure 33.** Exposure of deltaic sand overlying horizontally bedded glaciolacustrine silt on the upper slope of the Whitehorse escarpment above Main Street (18PL004). Note person at the top of the escarpment for scale.

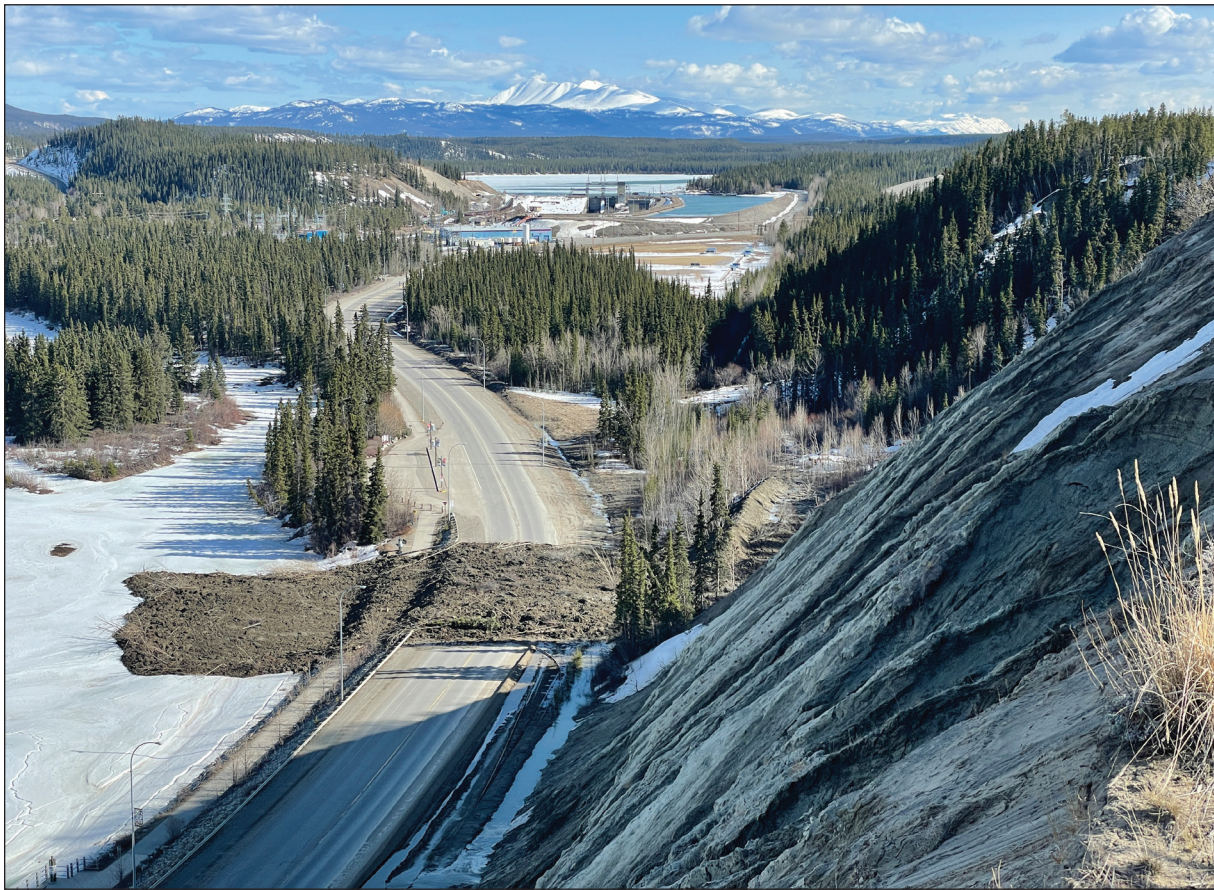
**Figure 34.** Slide debris extending across Robert Service Way and Millenium Trail on April 30, 2022.

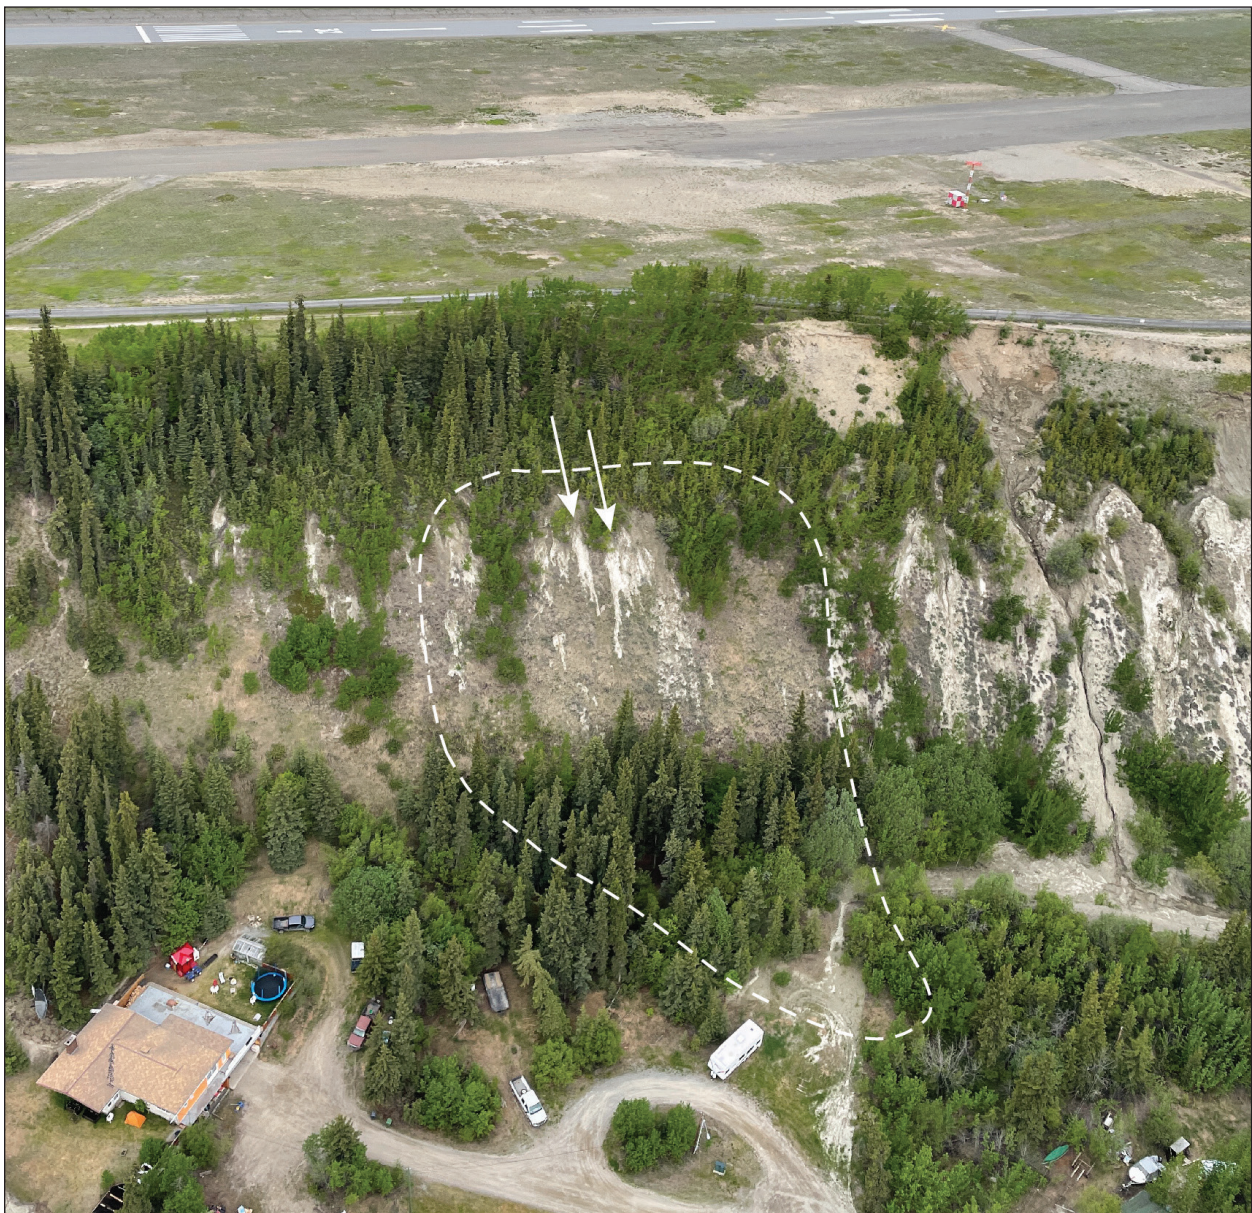
**Figure 35.** Drury Street slide area (outlined) prior to the May 25th, 2022 event (June 2021 photo). Arrows highlight recent colluvial activity in the initiation zone area.
