YGS Open File 2023-1

# Surficial geology and geohazards of the greater Whitehorse area

P.S. Lipovsky

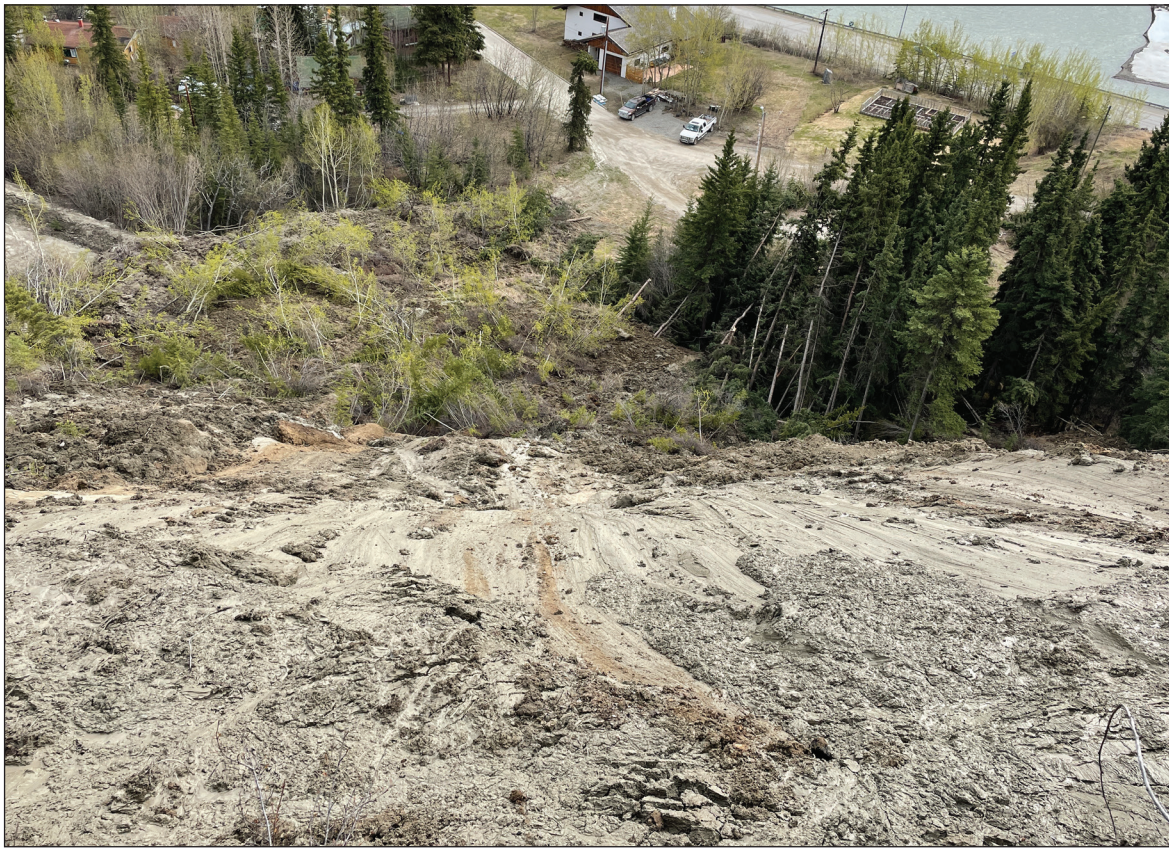
**Figure 36.** View looking down Drury Street slide from the headscarp (May 27, 2022 photo).

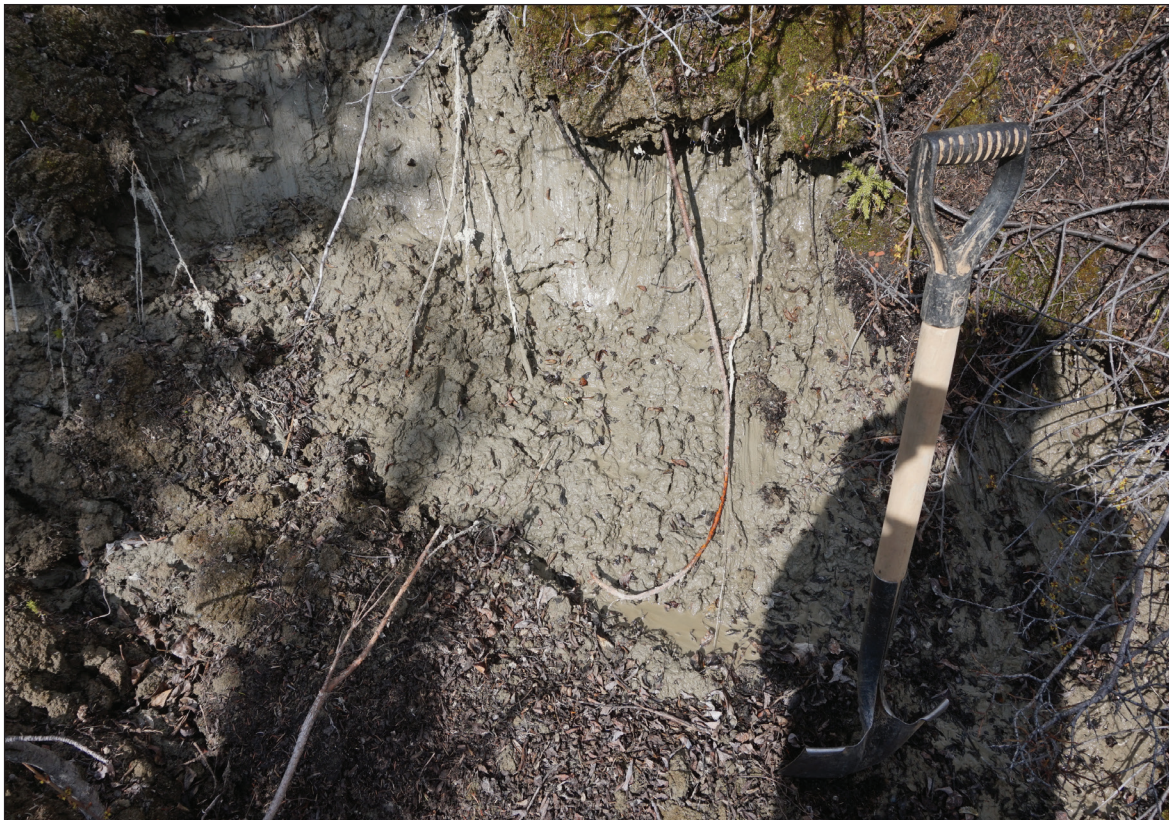
**Figure 37.** Tension crack in saturated ground adjacent to Drury Street slide source zone (May 26, 2022; Jeff Bond photo).

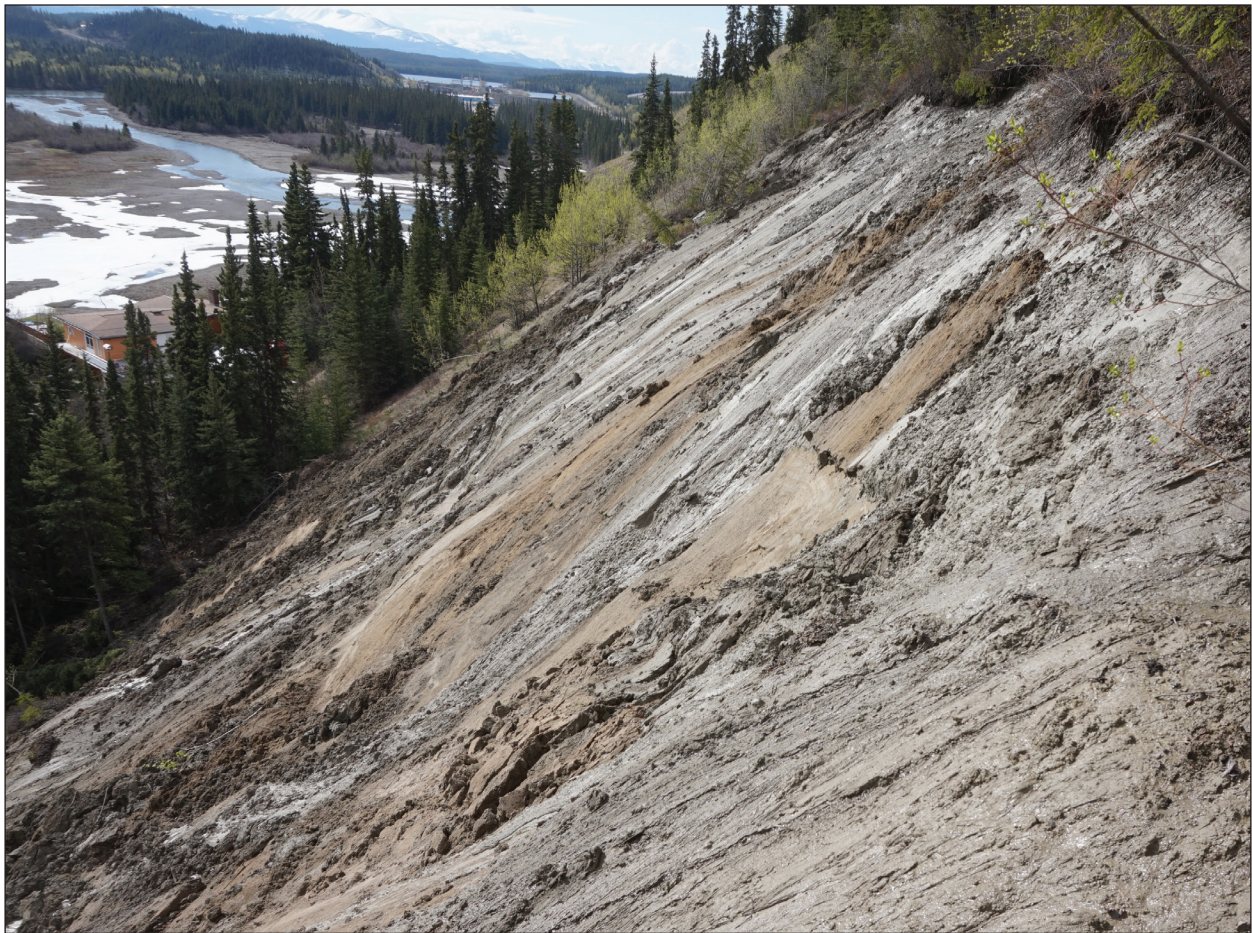
**Figure 38.** Drury Street slide source zone (May 26, 2022; Jeff Bond photo).

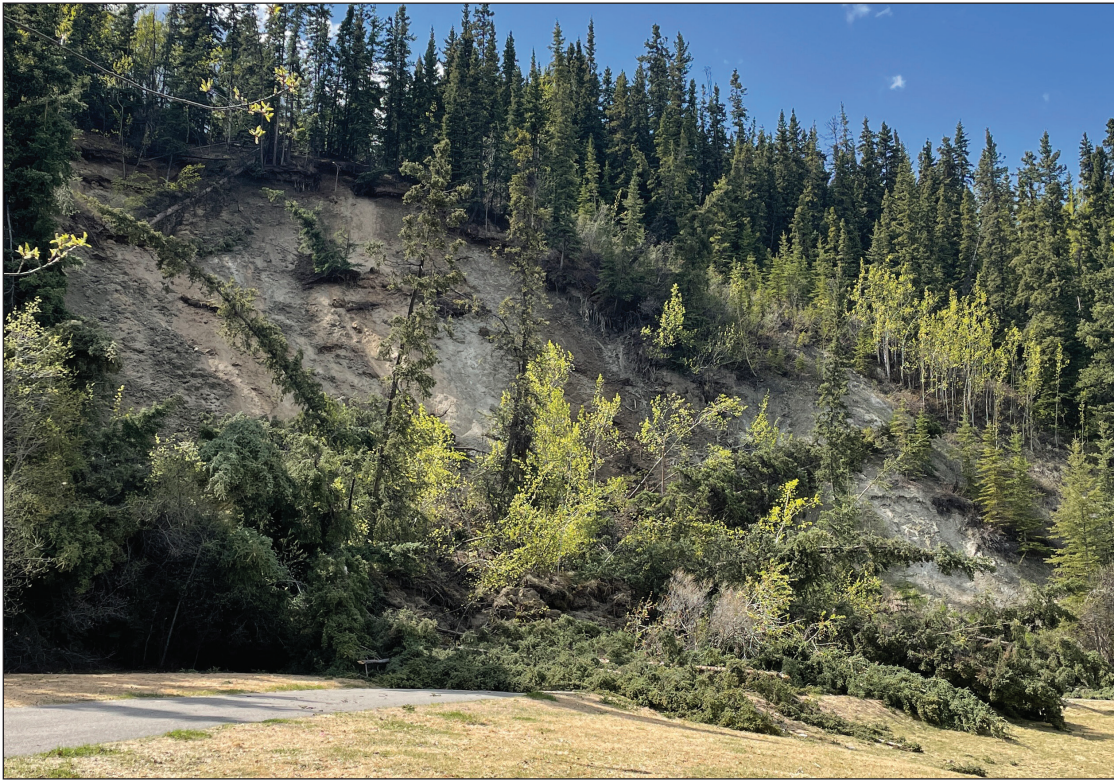
**Figure 39.** The May 27, 2022 Wood Street slide did not travel far past the base of the escarpment, but nonetheless, pushed mature trees across a recreational path.

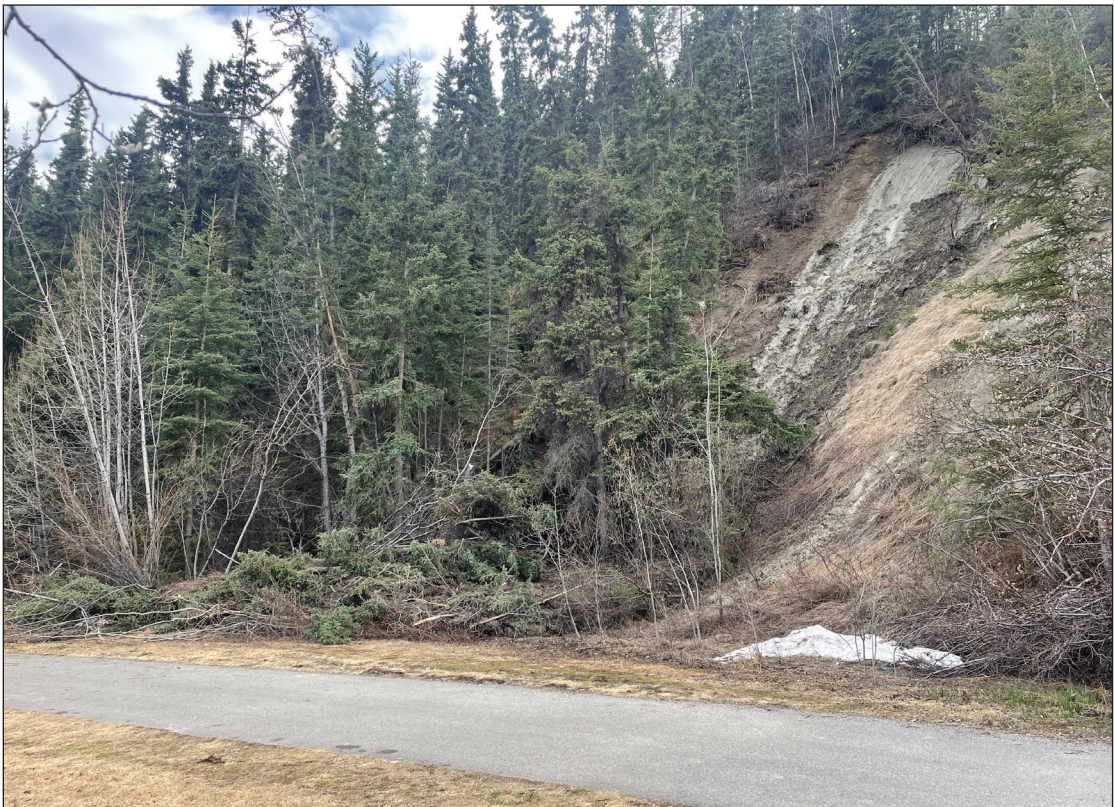
**Figure 40.** A small precursor slide occurred on May 18, 2022 on the north flank of the May 27, 2022 Wood Street slide.

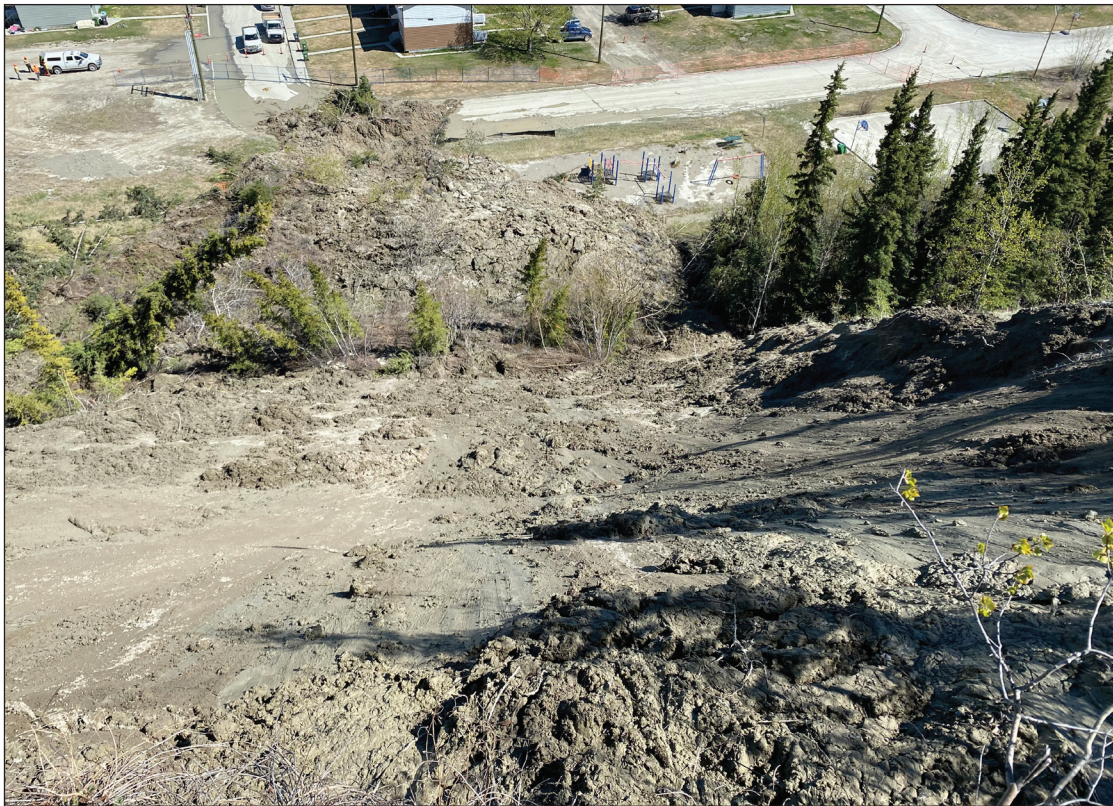
**Figure 41.** View looking down Jeckell Street slide from the headscarp (May 28, 2022 photo).

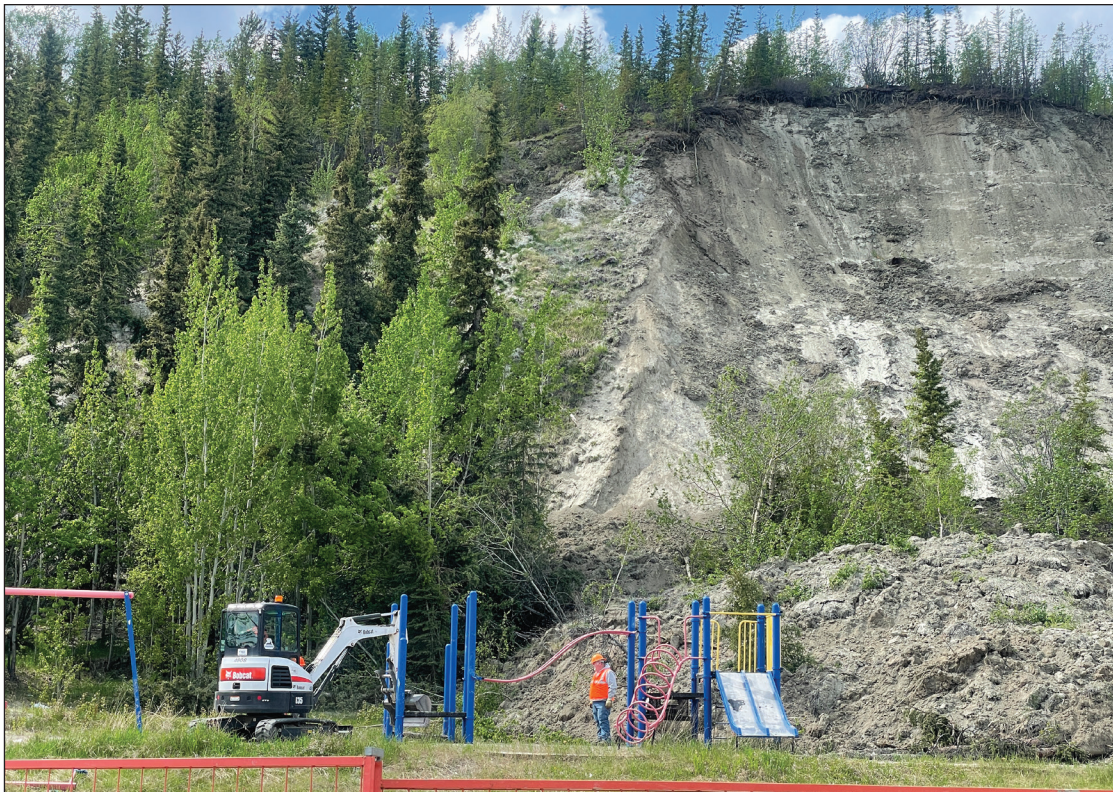
**Figure 42.** View of Jeckell Street slide debris, which engulfed a playground swing set. Initiation zone and failure plane are visible in the background.

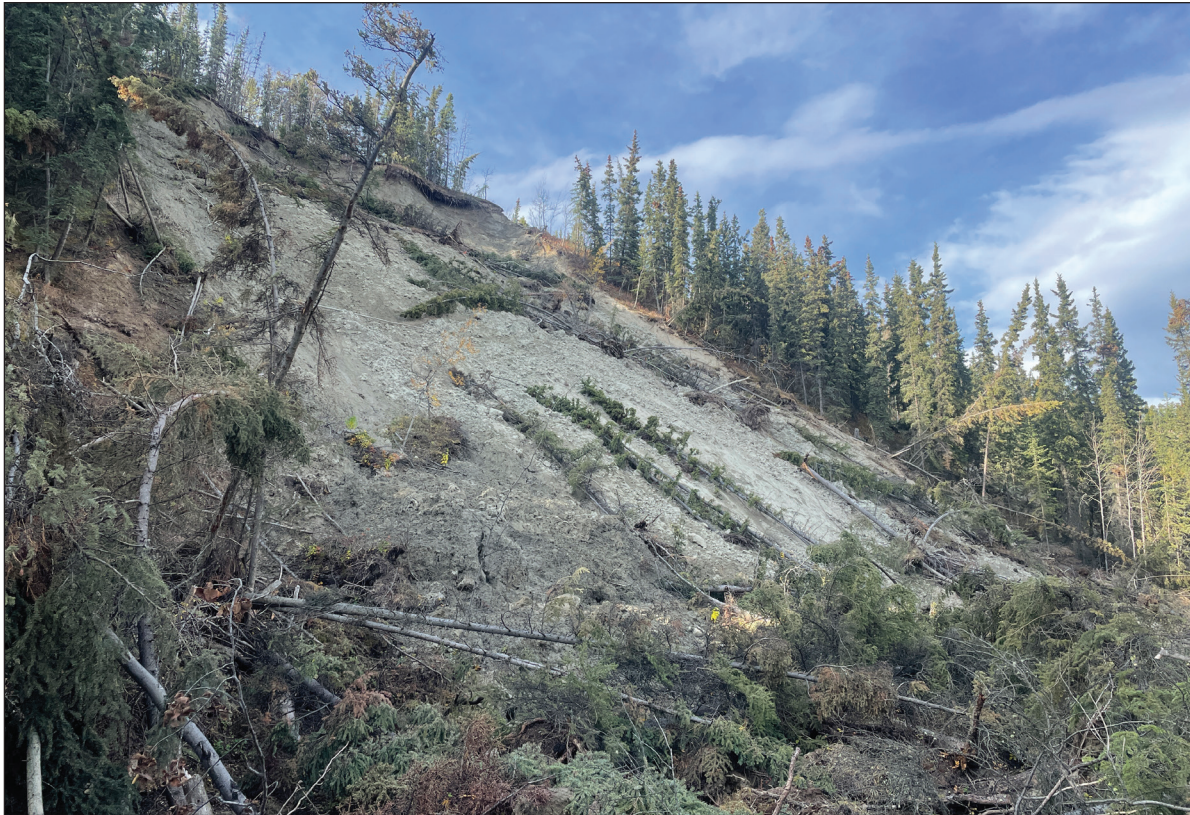
**Figure 43.** Initiation zone and failure plane of May 31, 2022 earth slide off Robert Service Way (October 10, 2022 photo).

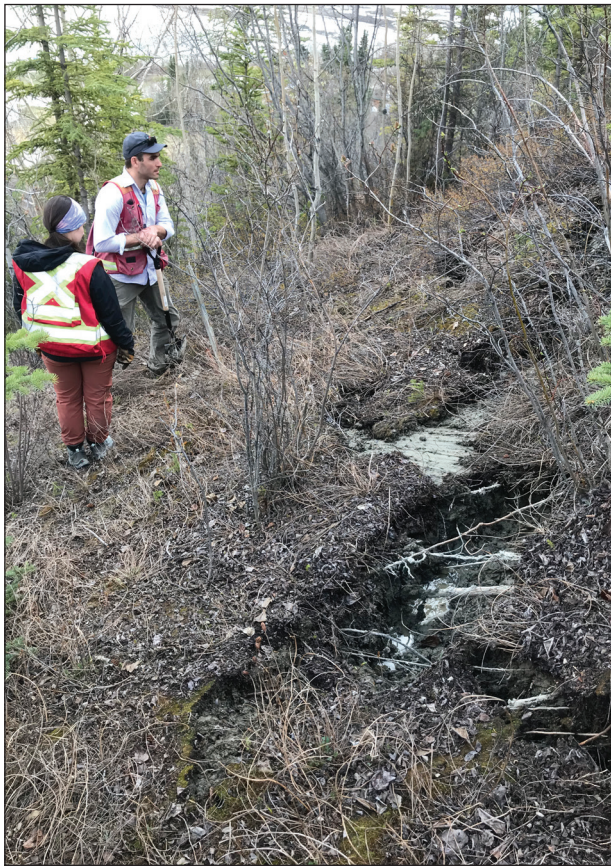
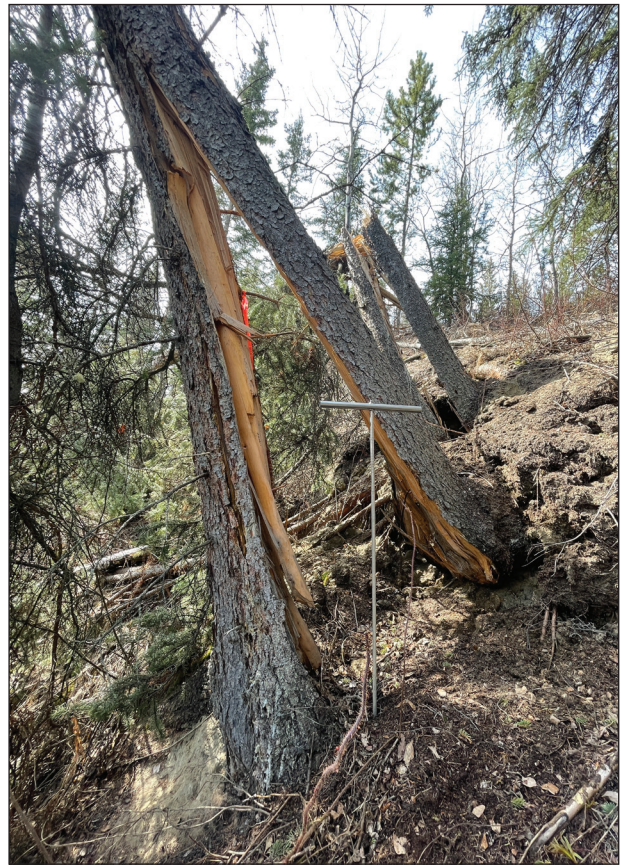
**Figure 44.** Indicators of active slope instability include fresh tension cracks, often spanned by outstretched roots (left) and split trees (right). May 2022 photo taken just south of slide in the Takhini East subdivision.

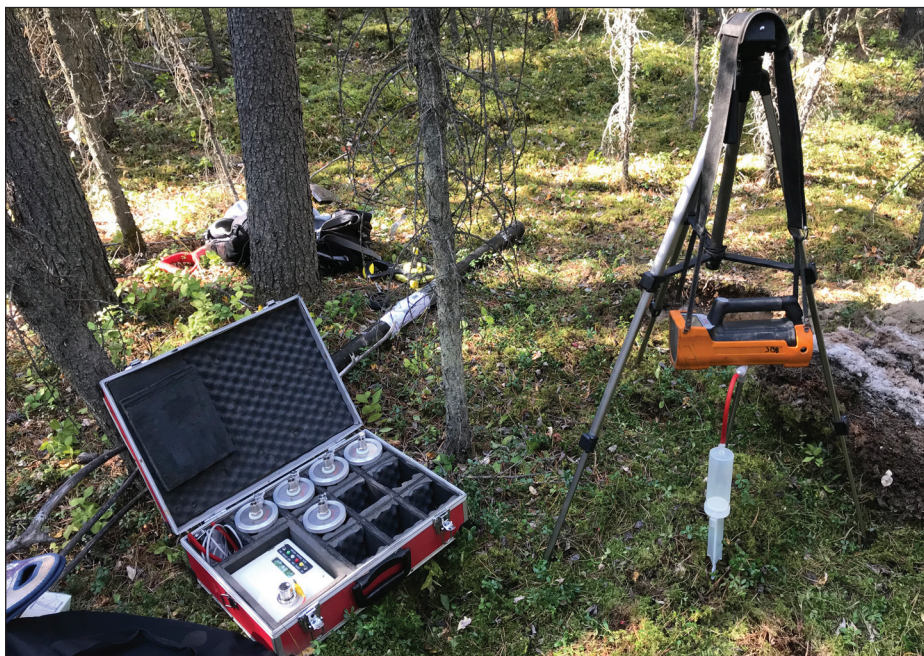
**Figure 46.** Radon soil gas control site in till substrate near Squatter's Row subdivision (19PL051).

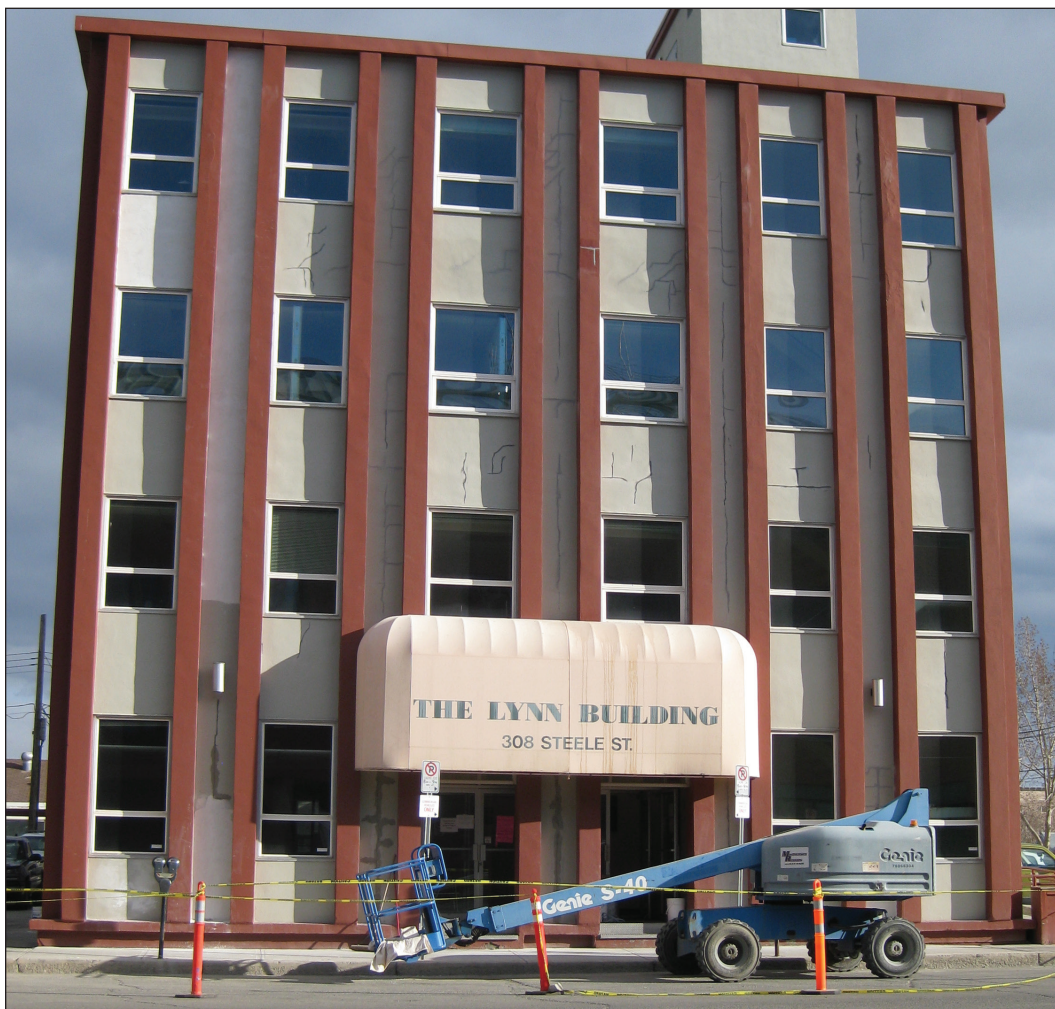
**Figure 47.** Repairing cracks on the exterior of a downtown Whitehorse building, following the May 1, 2017 earthquake (May 9, 2017 photo).

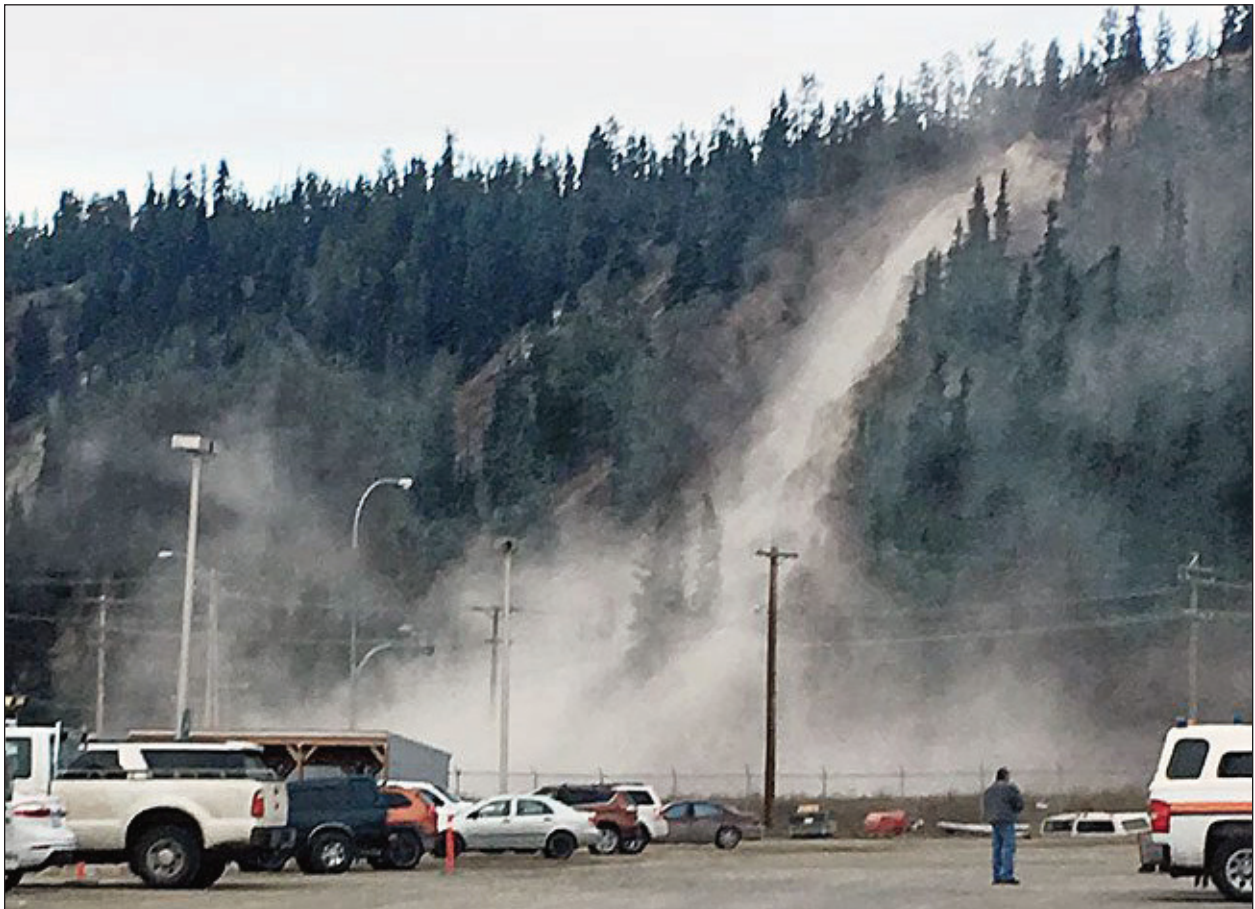
**Figure 48.** Landslide on the Whitehorse escarpment during the May 1, 2017 earthquake (Angie Dickson photo).

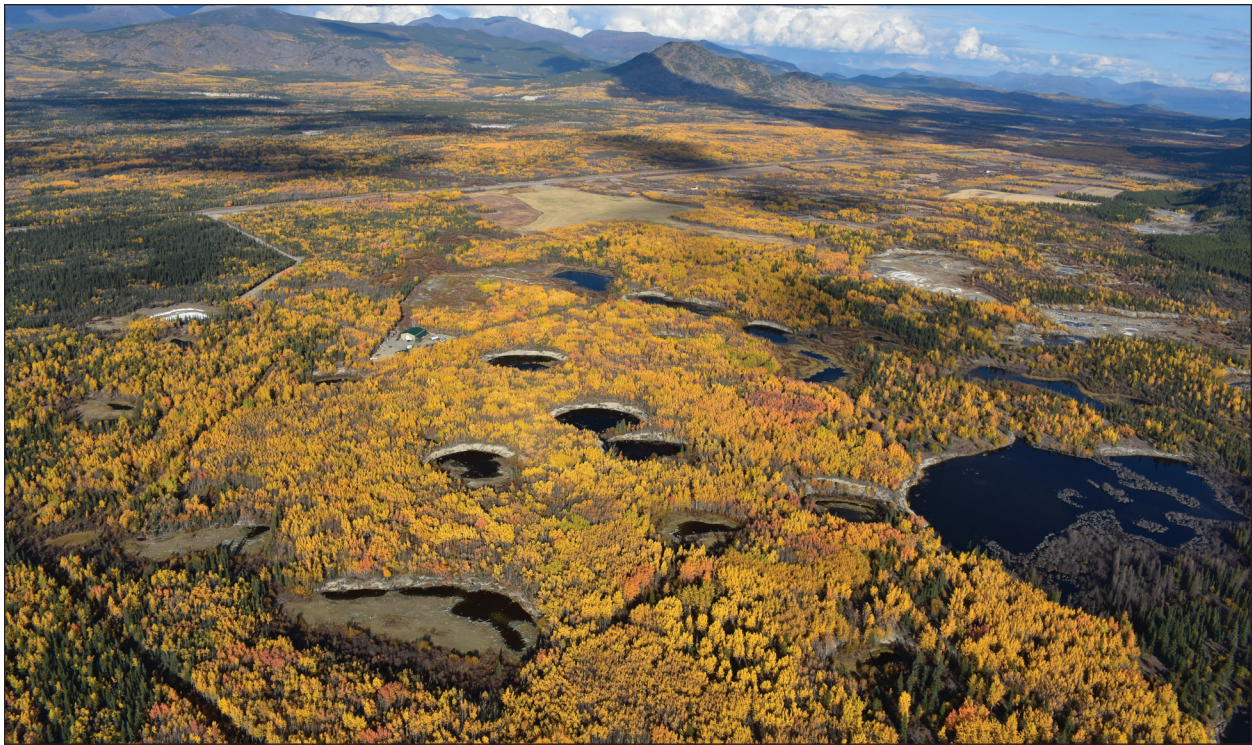
**Figure 49.** Thermokarst ponds are abundant in the Ibex Valley agricultural area, and are an excellent indicator of degrading ice-rich permafrost (17DA01-17DA04).

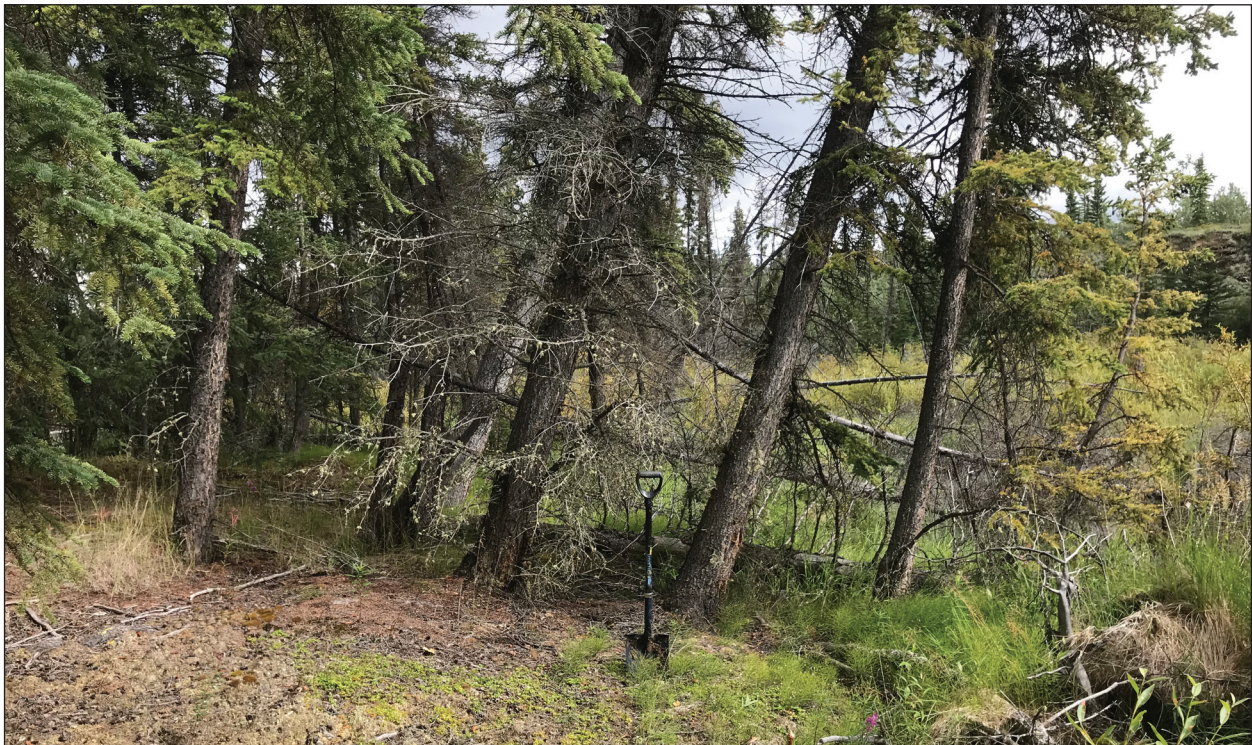
**Figure 50.** Permafrost mound in lower Cowley Creek wetland (20PL017). Leaning (drunken) trees indicate degrading permafrost.

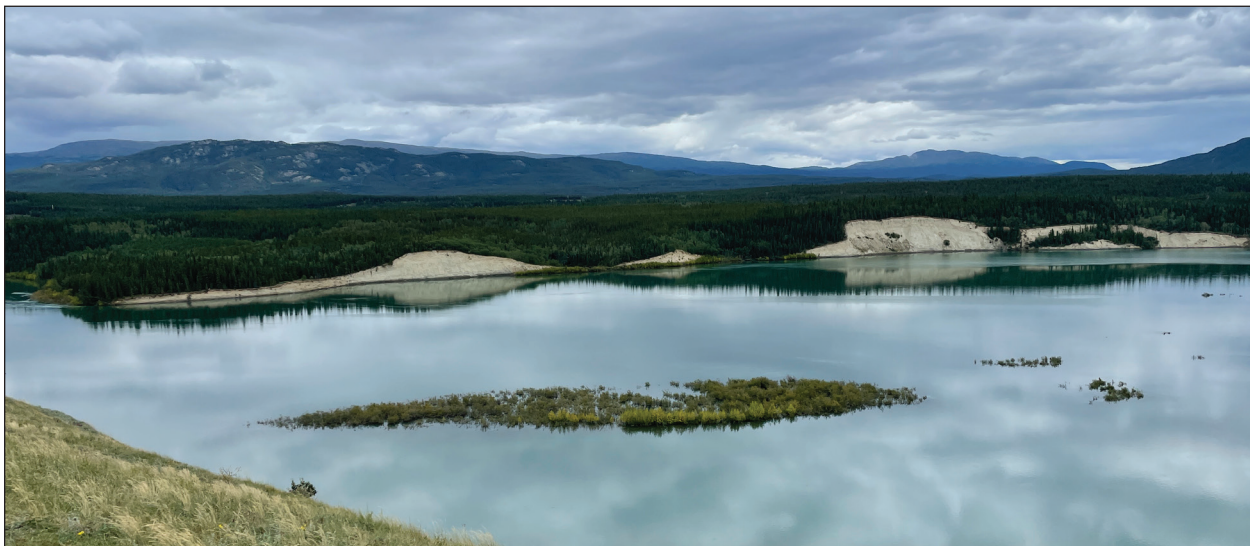
**Figure 51.** Yukon River in flood near Whistle Bend, August 14, 2021.

The record flood level on Lake Laberge reached 628.01 m (CGVD2013 datum)/627.72 m (CGVD28 datum) on July 16, 2021. The previous record flood level reached 627.57 m (CGVD2013) on August 19, 2007 (Morrison Hershfield, 2022b).

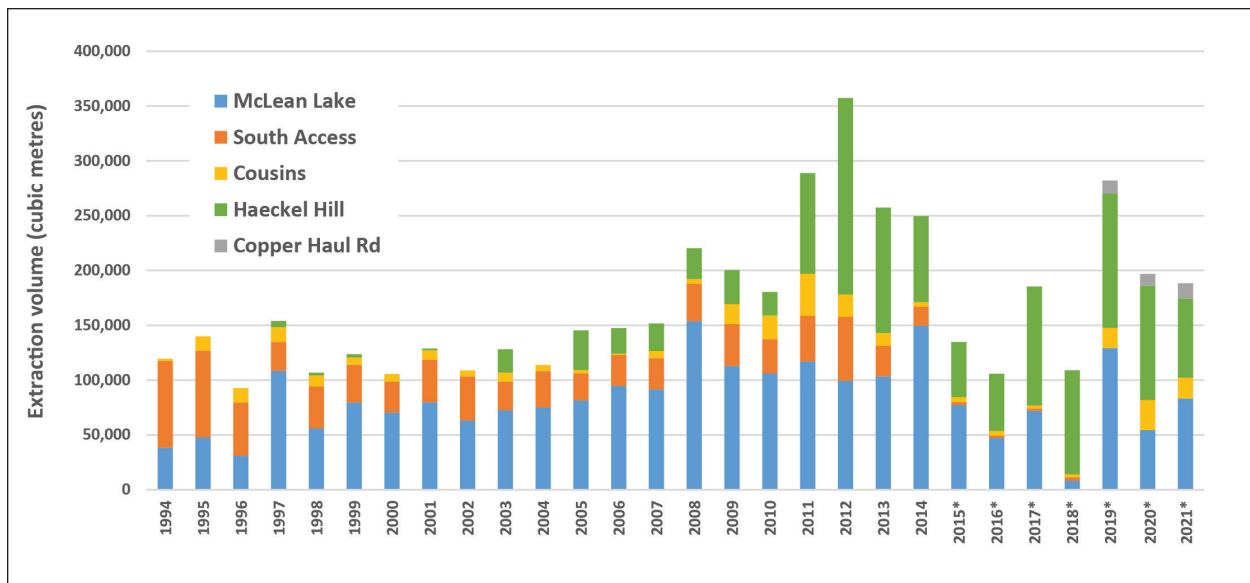
**Figure 52.** Annual aggregate extraction volumes from active Whitehorse quarry leases in primary aggregate areas. Data sources: 1994–2014 from Inukshuk (2015); \*2015–2021 values were self-reported by lease holders to Energy Mines and Resources’ Lands Branch and are incomplete for the McLean Lake area in 2018.

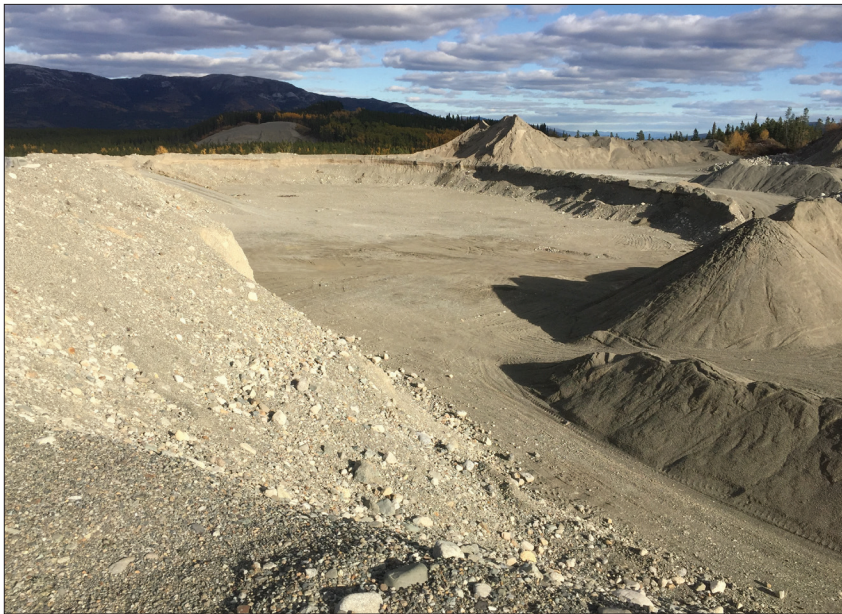
**Figure 53.** McLean Lake quarry pit (September 2020).

Annual aggregate extraction in the Whitehorse area fluctuated from approximately 100 000 to 350 000 m<sup>3</sup>/year between 1994 and 2014 (Fig. 52). Key extraction areas within city limits have included the McLean Lake (Fig. 53), Ear Lake (South Access Rd.), Haeckel Hill (Fig. 54), and Cousins airstrip (Fig. 55) areas. Inukshuk (2015) estimated that remaining reserves in active quarries in the McLean Lake and South Access Rd. areas were approximately 9.5 million m<sup>3</sup>, which would be expected to last until about 2050, assuming an average annual extraction rate of 250 000 m<sup>3</sup>/yr. Stevens Quarry and the Whitehorse Tank Farm area also contain large aggregate resources. Various aggregate studies that have been completed in the greater Whitehorse area are summarized in Table 6.

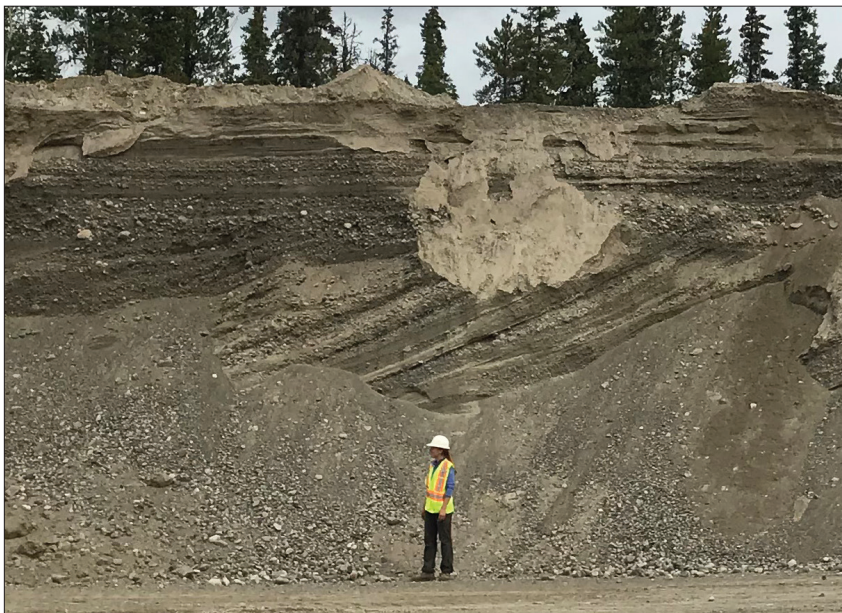
**Figure 54.** Thick deposits of glaciofluvial gravel exposed in Castle Rock quarry pits, near Haeckel Hill.

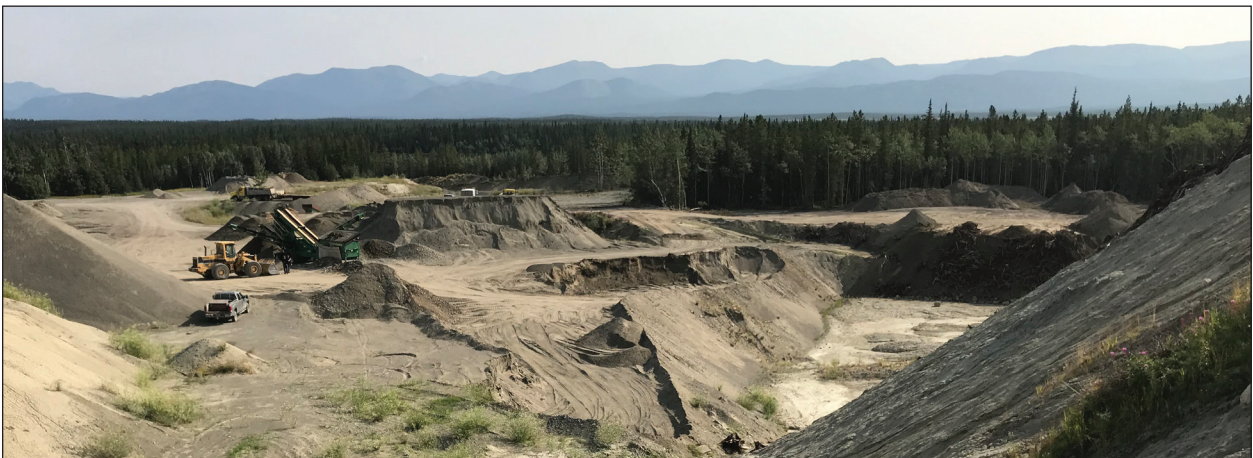
**Figure 55.** Yellow Truck Excavating sand quarry, located near Cousins Airstrip.
