# Active-layer detachments following the summer 2004 forest fires near Dawson City, Yukon

Lipovsky, P.S., Coates, J., Lewkowicz, A.G. and Trochim, E., 2006. Active-layer detachments following the summer 2004 forest fires near Dawson City, Yukon. *In: Yukon Exploration and Geology 2005*, D.S. Emond, G.D. Bradshaw, L.L. Lewis and L.H. Weston (eds.), Yukon Geological Survey, p. 175-194.

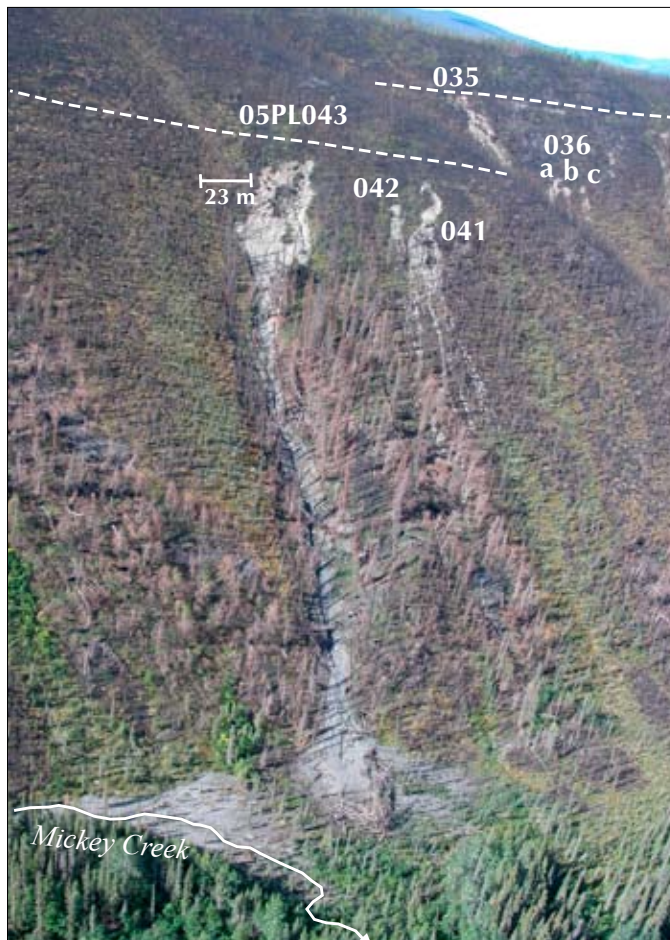
**Figure 5.** Oblique aerial photograph of numerous failures originating along the scarp of a Pre-Reid glaciofluvial terrace (see dotted lines) on upper, northeast-facing slopes. View is to the southwest. Numbers represent active-layer detachments surveyed near Mickey Creek.

Seventeen of the surveyed detachments initiated at, or near the edge of, a narrow (~20-m-wide) Pre-Reid distal glaciofluvial terrace. The terrace is located on the upper, moderately steep, northeast-facing slopes in the lower portion of the watershed. The failures exposed light-coloured gravel which contrasted well with the burned surface and readily defined the existence of the terrace, which was otherwise difficult to detect (Fig. 5).

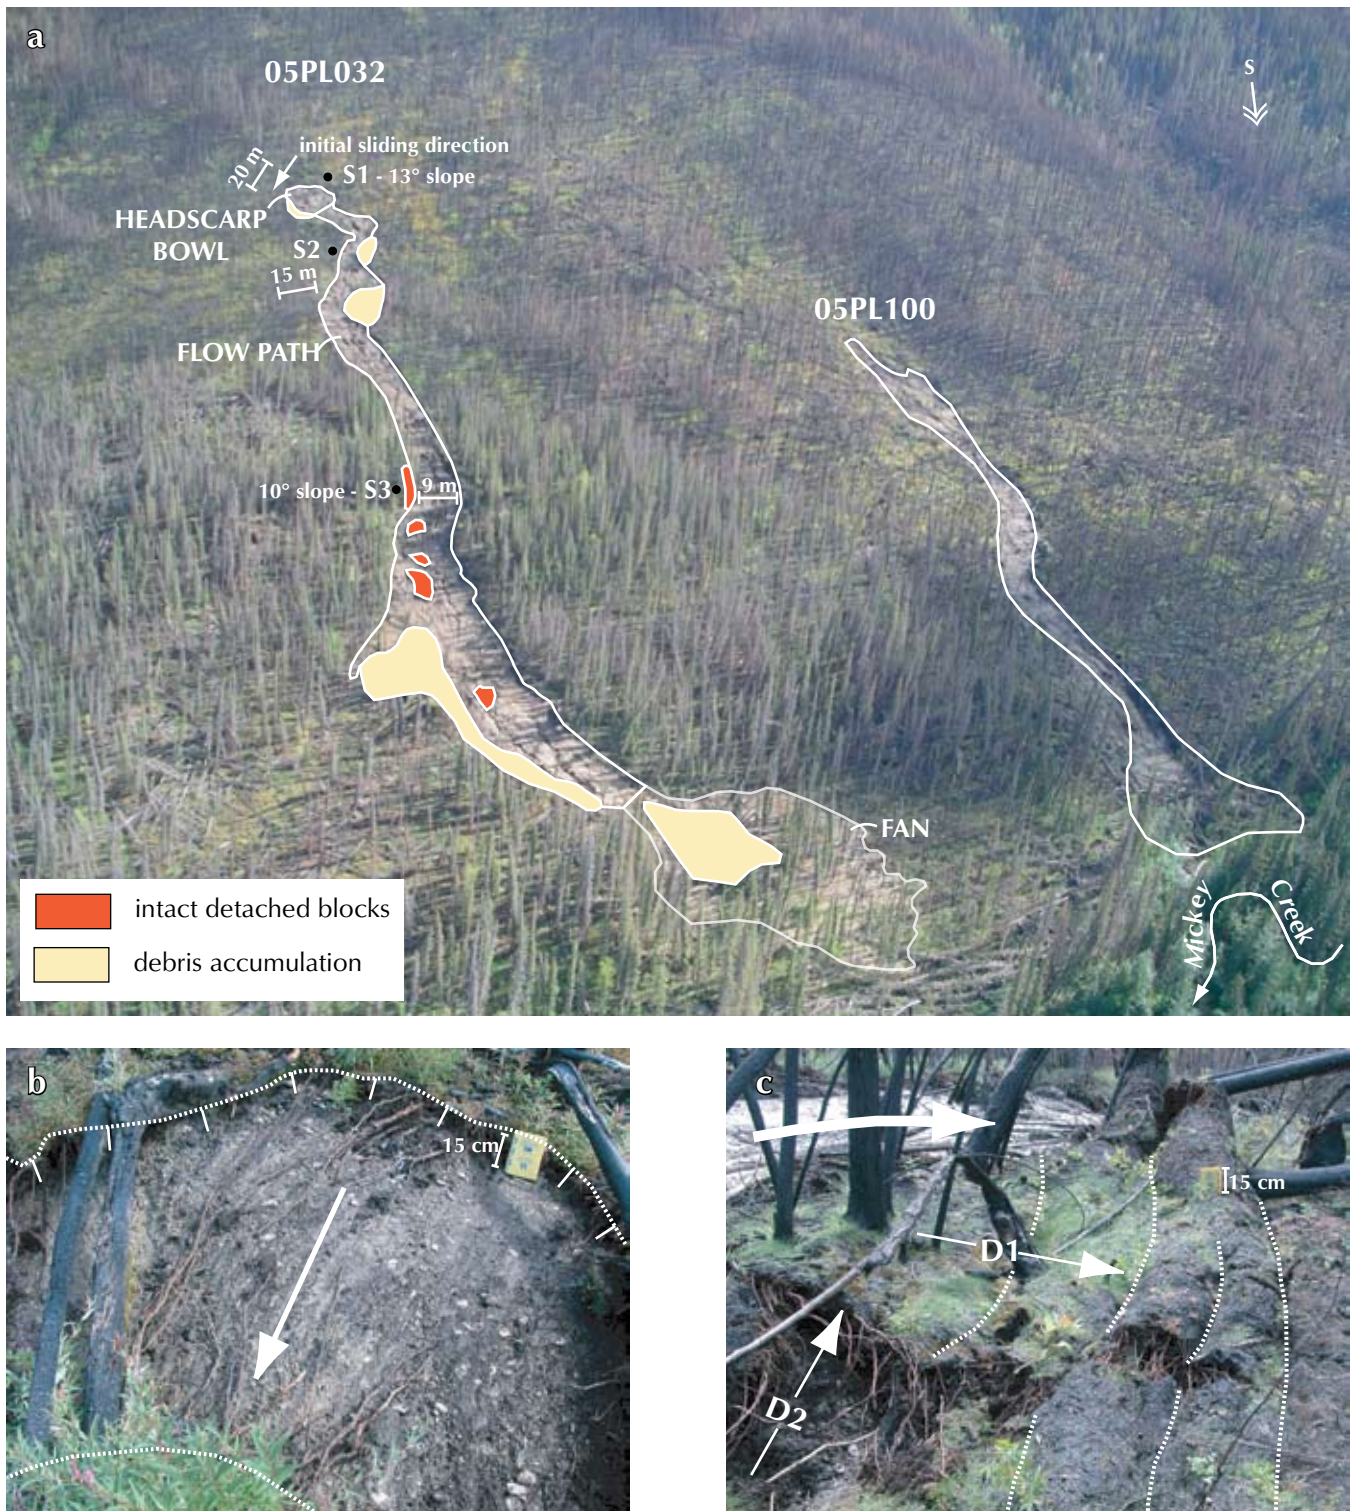
**Figure 6.** (a) Oblique aerial view of two detachments (05PL032 and 05PL100) that occurred on a gentle south- to southwest-facing slope. The larger failure is over 200 m long and initiated only a few days prior to these photos being taken on July 20, 2005. (b) Detachment of organic mat exposed in tension cracks above the headscarp (location S1 in Figure 6a). Roots are stretched in the direction of sliding. (c) Deformed organic mat (location S3 in Figure 6a), marginal to flow path (heavy arrow). The mat was initially compressed (direction D1) to form folded compression ridges (small dotted lines). It was then torn away from the surrounding mat (direction D2).

A fresh detachment (05PL032) was observed on July 20, with material still actively flowing (Fig. 6). The detachment was not visible in photographs taken 7 days earlier and it is likely that the detachment occurred within a day or two of the field visit. The failure began with a small slide in a 20-m-wide headscarp bowl, on a southwest-facing, gentle (13°), lower slope. The initial sliding depth was between 10 cm and 50 cm, just below the bulk of the root mat. The organic mat had collapsed along the edge of the headscarp, indicating that it had greater strength than the underlying soil. Probing revealed a frost table at 104 cm beneath a fresh sliding plane, and 88-99 cm behind the headscarp. Above the headscarp, water was ponded around many tree wells. Roots were outstretched in the direction of extension (Fig. 6b) and fresh sliding plane surfaces were exposed between tension cracks above the headscarp, and along the flow path margins where intact blocks of forest floor had been torn away (Fig. 6c).

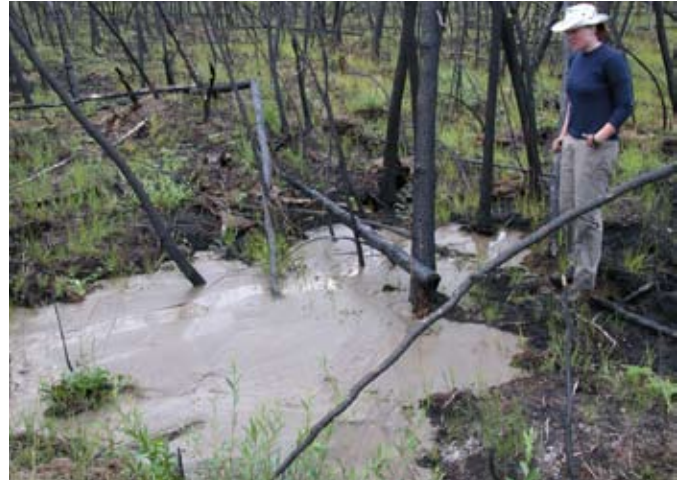
**Figure 9.** Surface sediment plume created by artesian groundwater flow. These commonly occurred on saturated slopes and near the initiation zones of recent failures.

Sediment-laden artesian springs (sediment plumes) were noted in proximity to many initiation zones (Fig. 9), indicating extremely high pore water pressures. Frost probing in mid July located the frost table between 44 cm

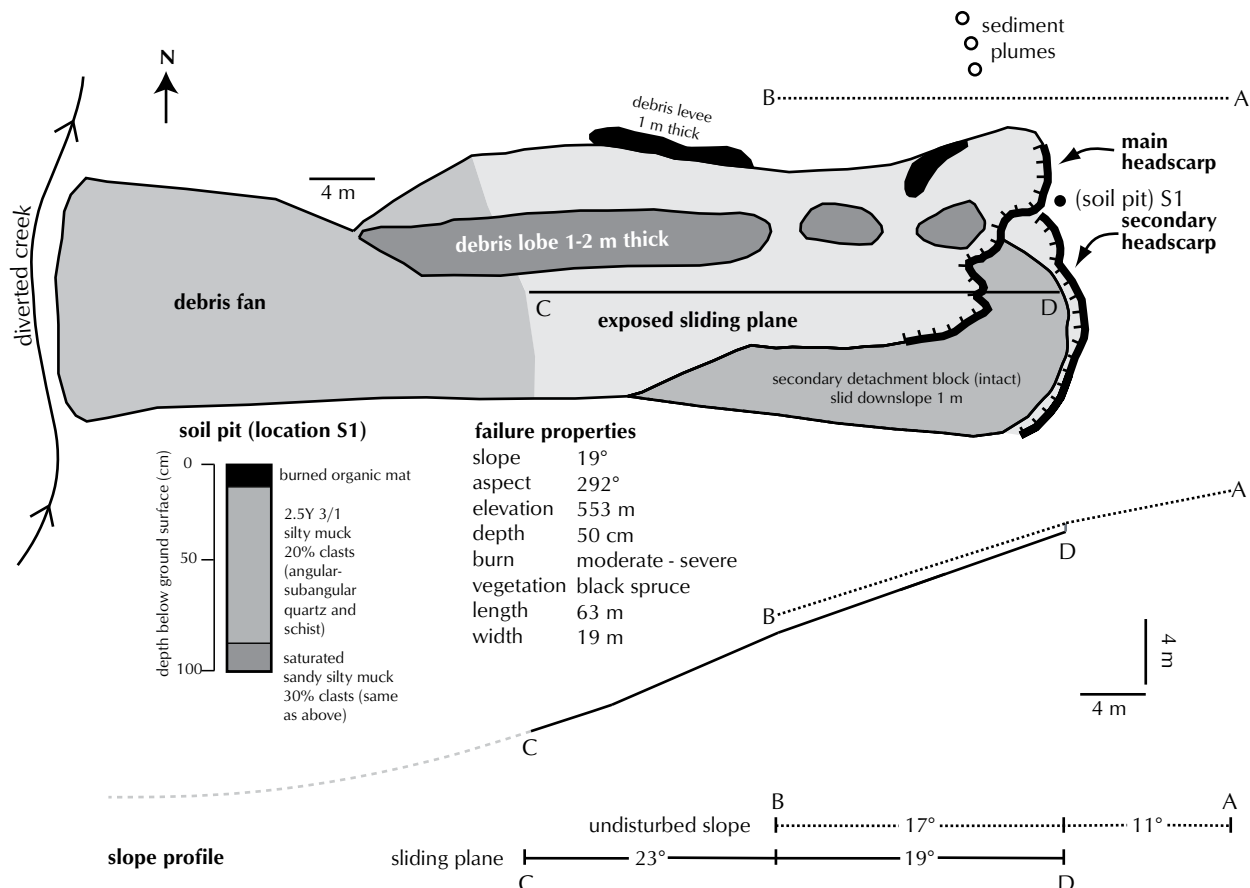
**Figure 8.** Morphology and slope profile of typical elongate detachment (05PL012) in Fifty Mile Creek watershed; drawn to scale.

Active-layer detachments occurred mainly along the upper portions of convex tributary valley slopes in the Fifty Mile Creek watershed. The morphology of a typical elongate-shaped detachment is shown in Figure 8. Slope angles in the initiation zones ranged between 11° and 25°. Failures occurred on all aspects, but were most common on north- and east-facing slopes. The highest density of failures occurred along one tributary valley, where 15 detachments have occurred within 1 km (05PL012 to 05PL027). Failures were very shallow, ranging between 15 cm and 50 cm. They were generally up to 60 m long and up to 25 m wide, although a few failures traveled several hundred metres downslope. Surficial materials in the initiation zones of the failures consisted of brown, silt-rich (up to 37-60% silt) colluvium, with 20-50% angular to sub-angular schistose clasts.

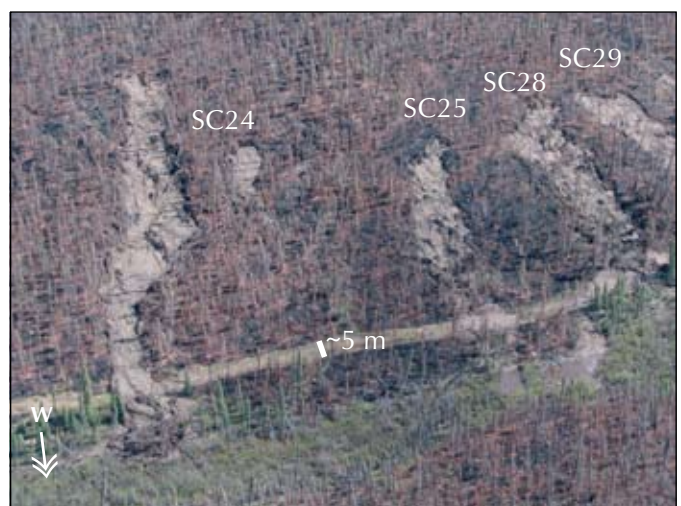
**Figure 14.** Oblique aerial photograph of multiple active-layer detachments on a west-facing slope. The failures crossed local access trails and deposited material directly into Steele Creek.

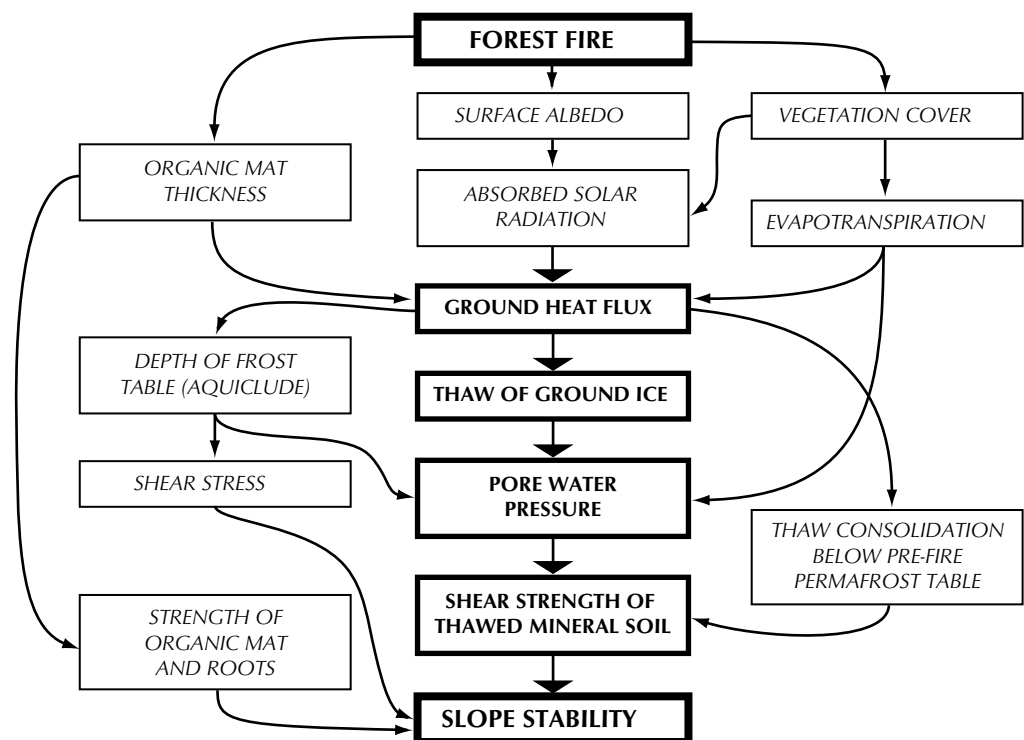
**Figure 15.** Conceptual framework for the impacts of forest fire on the stability of slopes underlain by permafrost. Note: for clarity, factors that are unaffected by fire (e.g., topography, precipitation) are not shown.

Forest fires impact numerous aspects of the thermal, hydrological and geotechnical conditions of slopes underlain by permafrost. A conceptual framework for these direct and indirect factors is shown in Figure 15. The relative significance of each of these controls on overall slope stability is difficult to assess, and merits future study.

Fire alters slope thermal conditions by burning the vegetation canopy and ground cover, thereby reducing shading. Simultaneously, charring of the surface organic mat decreases the albedo. The result of these two changes is an increase in the solar radiation absorbed at the ground surface. As a consequence, the mean July ground surface temperatures on burnt north-facing and south-facing slopes in Steele Creek were about 3°C warmer than comparable unburned slopes (see Table 1). The destruction of live vegetation may also reduce evapotranspiration so that less of the heat available at the ground surface is lost by latent heat transfer to the atmosphere. Finally, a reduction in the thickness of the insulating surface organic mat allows heat to be transmitted downwards more easily. All of these impacts cumulatively lead to enhanced summer ground heat flux

Although not shown in Figure 15, which focuses only on changes following forest fire, topography and precipitation are also very important factors for slope
