# The Dawson City landslide (Dawson map area, NTS 116B/3), central Yukon

Brideau, M.-A., Stead, D., Stevens, V., Roots, C., Lipovsky, P. and VonGaza, P., 2007. The Dawson City landslide (Dawson map area, NTS 116B/3), central Yukon. *In: Yukon Exploration and Geology 2006*, D.S. Emond, L.L. Lewis and L.H. Weston (eds.), Yukon Geological Survey, p. 123-137.

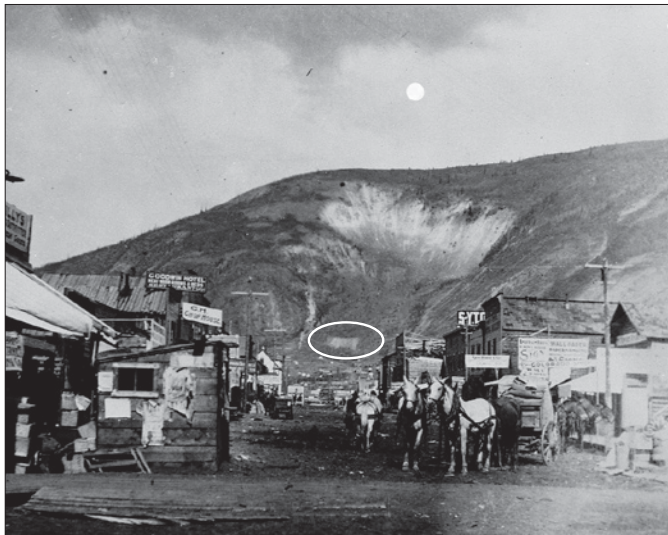
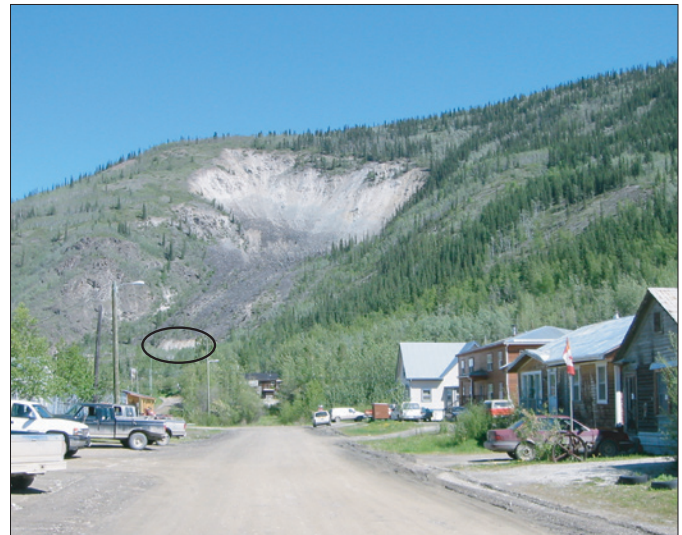
View down 2nd Avenue, ca. 1900.

**Figure 1.** Northward view of the landslide in ca. 1900 and in 2005, showing little change in the headscarp. Note that the pale snout (circled on the figure) of the middle to lower section of the debris has moved downslope. The historical photograph was obtained from the archive at the Dawson City Museum and is part of the collection of Mrs. Ellen Northrop Shannon.

The Dawson City landslide (also known as the Moosehide slide) is a dominant feature of Dawson's city-scape (Fig. 1). Due to its close proximity to the north edge of the town (Fig. 2), a variety of human land use activities have periodically taken place on the landslide debris. During the goldrush-era housing shortage (Brand, 2002), the landslide deposit and its flanks were temporarily occupied. In about 1908 (see Tyrrell, 1910), a flume was built across the upper talus to carry water to the town from Moosehide Creek; its foundation remains to this day. In the late 1970s, the lower third of the landslide deposit was quarried for coarse fill and rip-rap, and was subsequently re-contoured. During the 1990s, this area has been used as a temporary campground. High above this activity, the rock cliffs (hereafter called the headscarp) spawn occasional rockfall, which has accumulated at the base of the headscarp in a deposit (hereafter called the 'landslide debris deposit') with a furrowed character. A trail popular with summer hikers crosses the debris train below the headscarp. The surface of the landslide debris deposit slopes, steeply at intervals, down to the uppermost streets at the north edge of the town, where it terminates in a steep-sided front. Local inhabitants have wondered whether another catastrophic slide will ever occur and whether the debris will continue to encroach on their property. At the same time, earth scientists have long

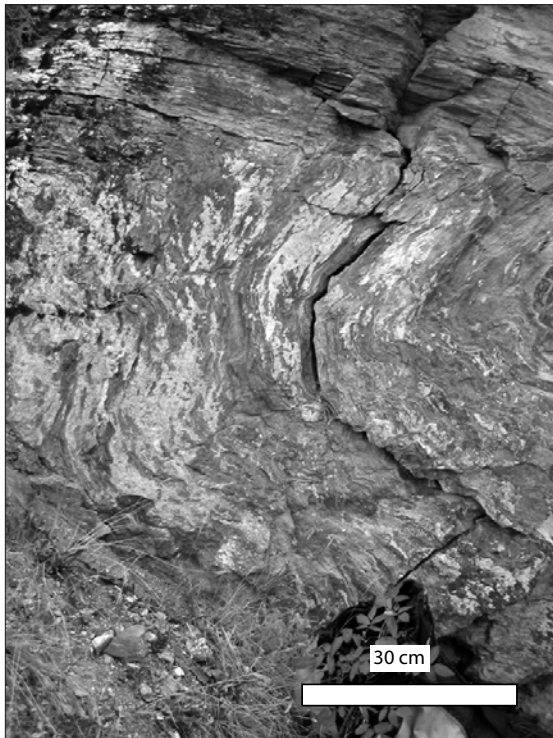
**Figure 5.** Folded metasedimentary rock on the western side of the landslide. See Figure 3 for location.

Directly beneath the headscarp, bedrock outcrop is obscured by talus and landslide debris, but a promontory on the north side and sidescarp on both sides of the landslide consists of brown to dark grey carbonaceous phyllite, amphibolite schist and minor quartzite. These rocks contain quartz (25-70%), mica (muscovite and biotite; 5-30%), chlorite (0-20%) and calcite (0-20%); thin sections also show minor amounts of opaque minerals (0-5%), epidote (1%) and zircon (1%). These rocks are more coherent than the ultramafic rock higher up and reveal discrete zones of high strain with oriented platy minerals and thin planes of mylonite. In places the strain zones have been folded (Fig. 5).

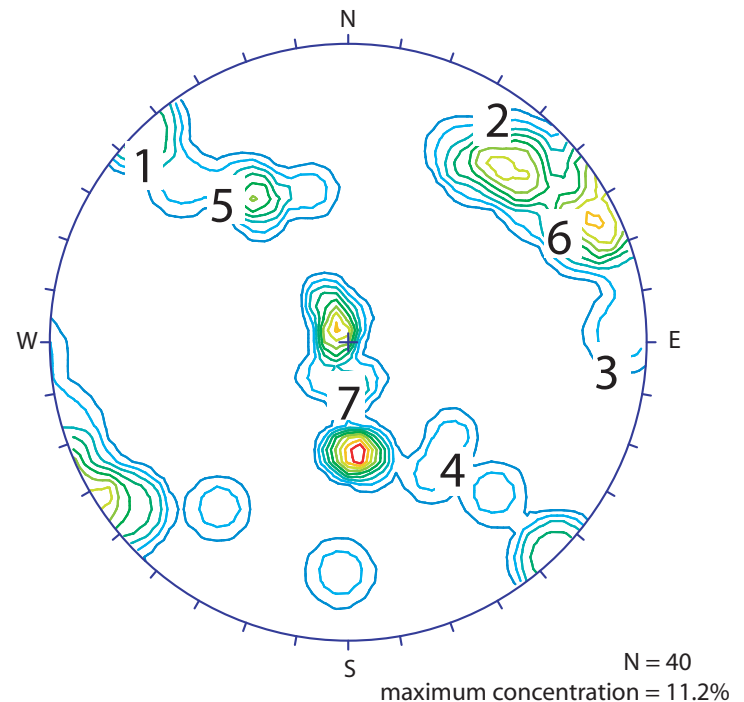
**Figure 6.** Contoured stereonet of poles to discontinuity planes in the headscarp. The numbers refer to discontinuity sets discussed in the text (and Table 1 and Fig. 4) and N refers to the number of measurements included in this figure.

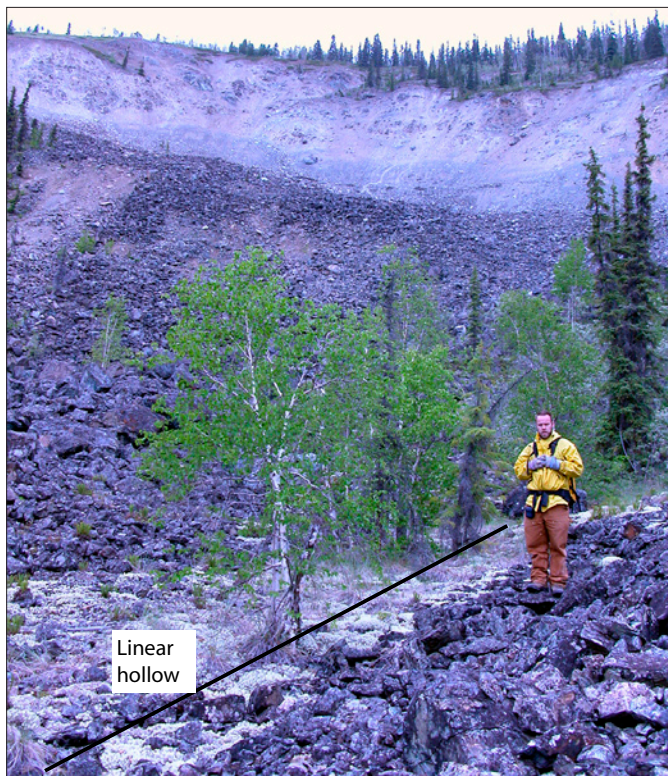
**Figure 7.** View of the eastern edge of the moving section of debris. Note that the trees are preferentially growing in a linear hollow. See location on Figure 3.

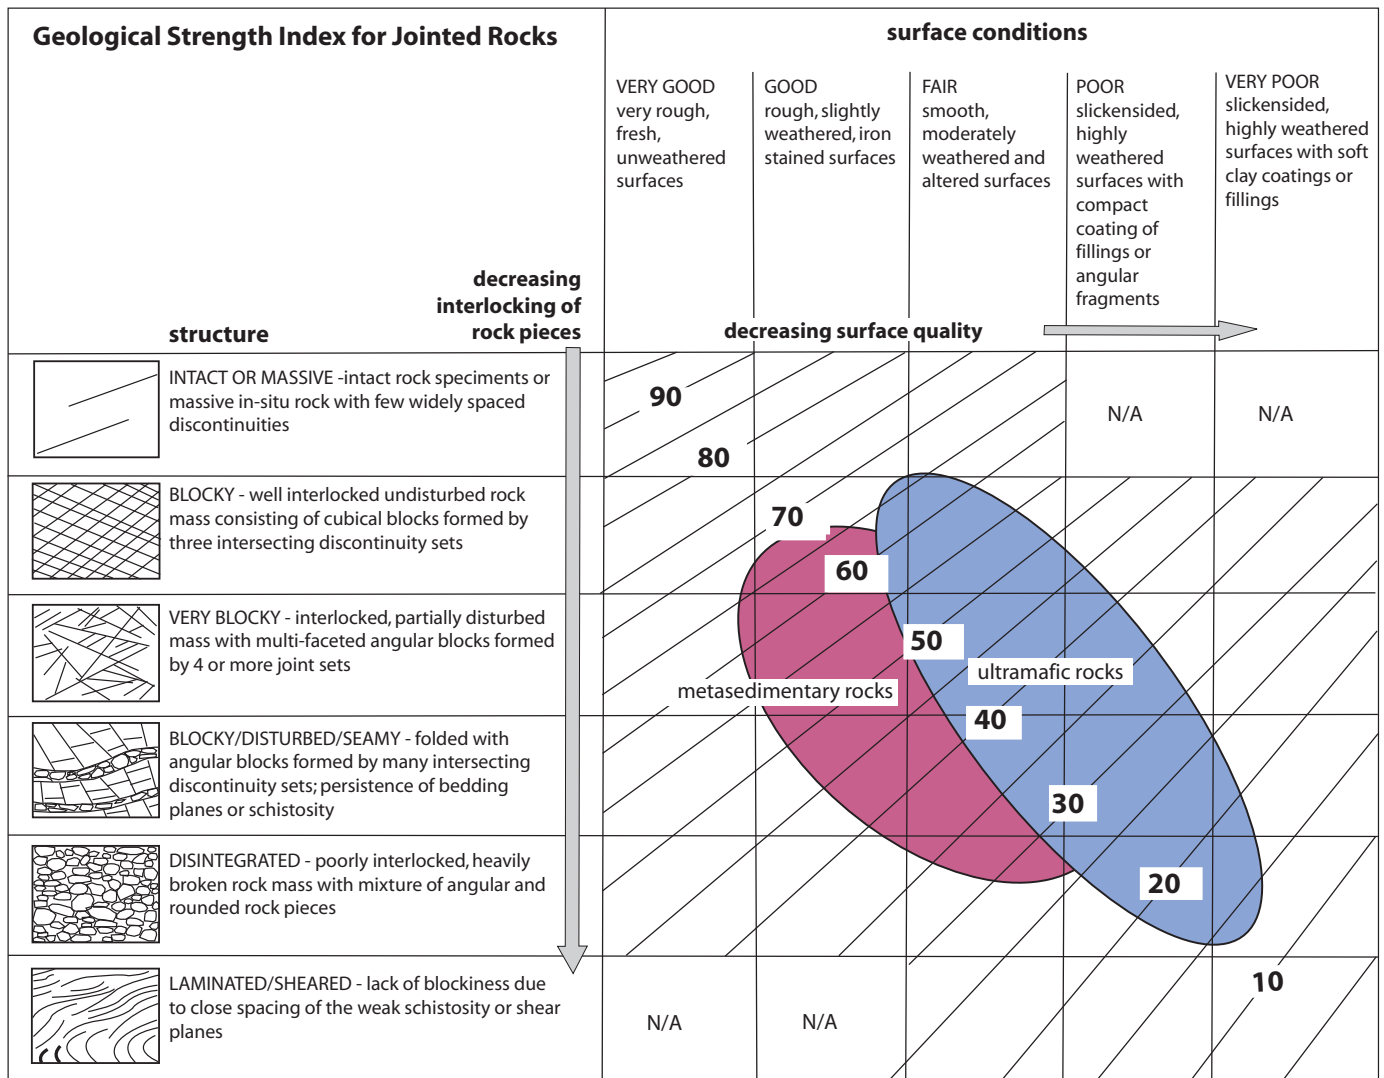
**Figure 9.** Range of Geological Strength Index values observed at the Dawson City landslide for the metasedimentary and ultramafic rocks (from Brideau et al., in press).

bedding and schistosity) and surface conditions (roughness, weathering and infillings) of a rock mass (Marinos and Hoek, 2000; Marinos *et al.*, 2005). At the Dawson City landslide, 51 GSI estimates were obtained primarily from the headscarp and sidescarp, but also from outcrops on either side of the slope failure. The range of determinations, for both metasedimentary and ultramafic rocks, are encompassed in the shaded areas on Figure 9. The ultramafic rocks exhibit a large variability in rock-mass quality from disintegrated (GSI of 10-20) to very blocky (GSI of 60-70). Recent use of the GSI chart to characterize ultramafic rocks elsewhere in the world also demonstrated large variability in rock-mass quality (Marinos *et al.*, 2006). While the discontinuity pattern for both the metasedimentary and ultramafic lithologies are similar, the higher discontinuity intensity and the poorer discontinuity surface conditions of the ultramafic rock result in the lower rock-mass quality values.

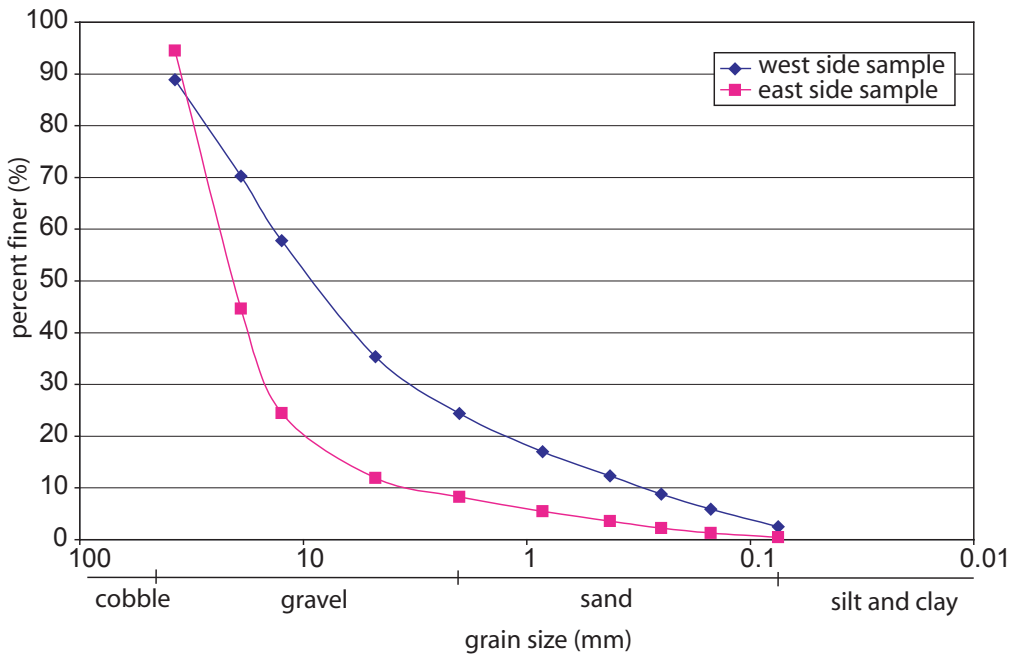
**Figure 10.** Grain-size distribution curves of two samples collected from steep snout (see Fig. 6) of the moving landslide debris.

Two samples were collected for preliminary analysis to determine the physical characteristics of the material making up the slow-moving feature. The samples were first sieved to determine the grain-size distribution (Fig. 10). The two samples consisted of 75 and 90% gravel (size range 2-4 cm), respectively, and their grain-size distribution is considered to be within the range of well graded gravel, but close to the boundary of poorly

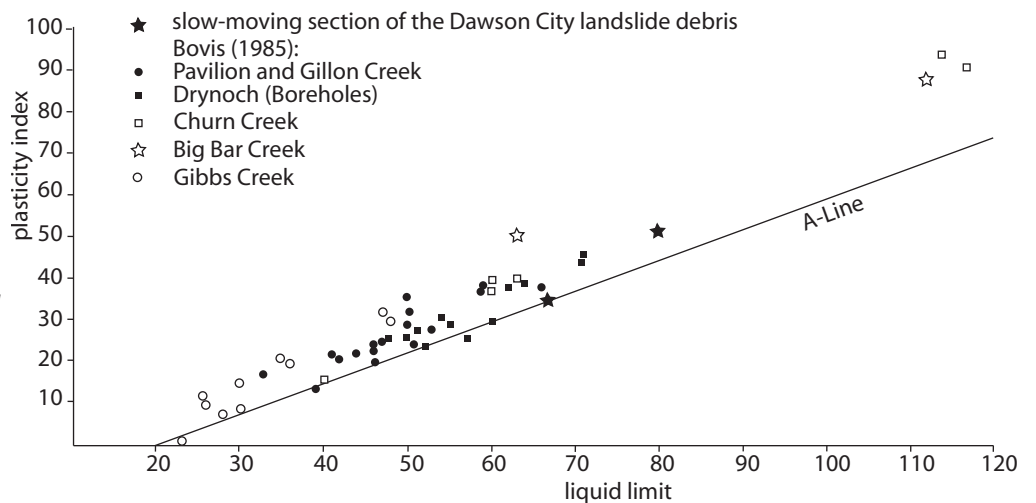
**Figure 11.** Plasticity index vs. liquid limit plot for the soil samples collected from the snout of the moving debris at the Dawson City landslide compared with previously published values from Bovis (1985). Soil samples which plot above the A-line have mechanical behaviours dominated by clay while samples that plot below it have mechanical behaviours dominated by silt (British Standard Institute, 1981).

sample) and 65.7% water (western sample) were determined using the cone penetrometer test. Figure 11 shows plasticity index (liquid limit – plastic limit) versus liquid limits for the two samples as compared to previously published values for earth flows in southern British Columbia (Bovis, 1985).

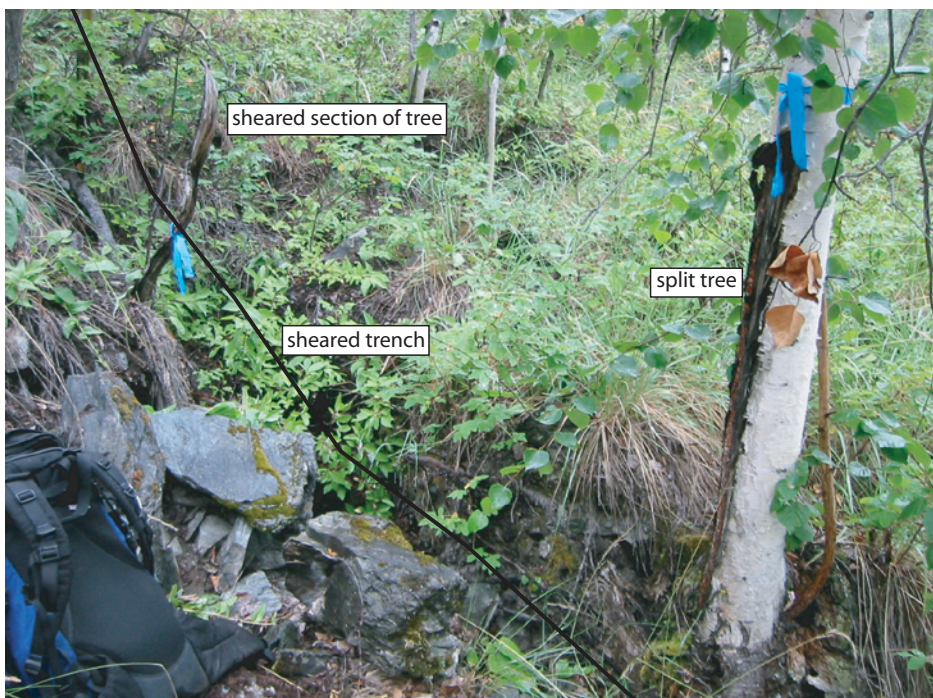
**Figure 12.** Split tree that was cored along the western edge of the moving section of the landslide debris.

Four split trees were examined to determine current movement rates of different portions of the Dawson City landslide. Split trees occur along sheared trenches, parallel to the edge of the middle to lower landslide deposit and above the active headscarp. These trees were cored in July, 2006 and are being examined as part of a larger dendrogeomorphology study on split trees. Tension cracks and trenches were also observed throughout the landslide site. In areas with thick organic soil, stretched roots spanned several tension cracks.
