A reconnaissance inventory of permafrost-related landslides in the Pelly River watershed, central Yukon

Panya Lipovsky¹
Yukon Geological Survey

Lipovsky, P. and Huscroft, C., 2007. A reconnaissance inventory of permafrost-related landslides in the Pelly River watershed, central Yukon. *In: Yukon Exploration and Geology 2006*, D.S. Emond, L.L. Lewis and L.H. Weston (eds.), Yukon Geological Survey, p. 181-195.

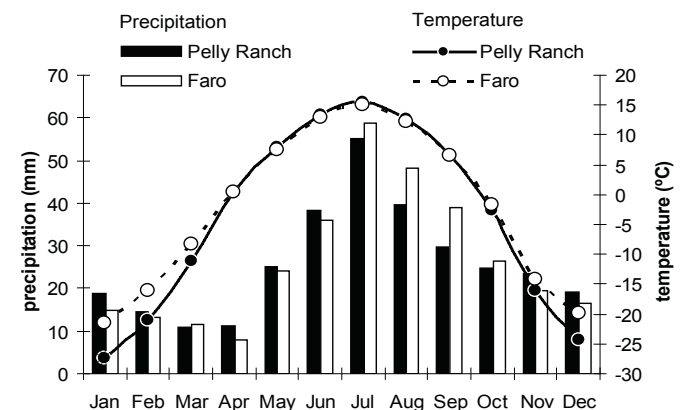
Figure 2. Monthly temperature and precipitation normals (1971-2000) for Pelly Ranch and Faro (from Environment Canada online climate data).

Monthly temperature and precipitation normals indicate very similar conditions and seasonal variations for the two climate stations (Fig. 2). Mean daily temperatures at Pelly Ranch range between -27.5°C (daily minimum -32.8°C) in January to +15.5°C in July (daily maximum 22.6°C). July is the wettest month, receiving a mean monthly precipitation of up to 59 mm in Faro and 55 mm at Pelly Ranch. Snow depths reported for the two climate stations are up to 33 cm (at the end of each month), and snow cover generally persists between October and April.

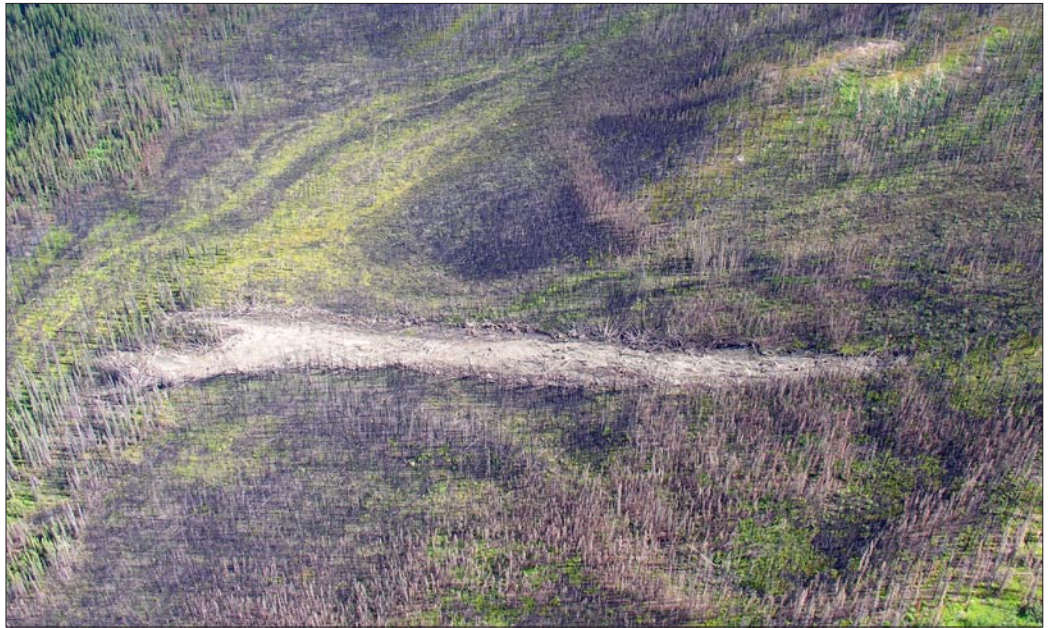
Figure 4. A large active-layer detachment was initiated on a gentle north-facing slope near the mouth of Excell Creek following forest fires in 2004. The failure is estimated to be approximately 300 m long. Photo taken in July, 2006.

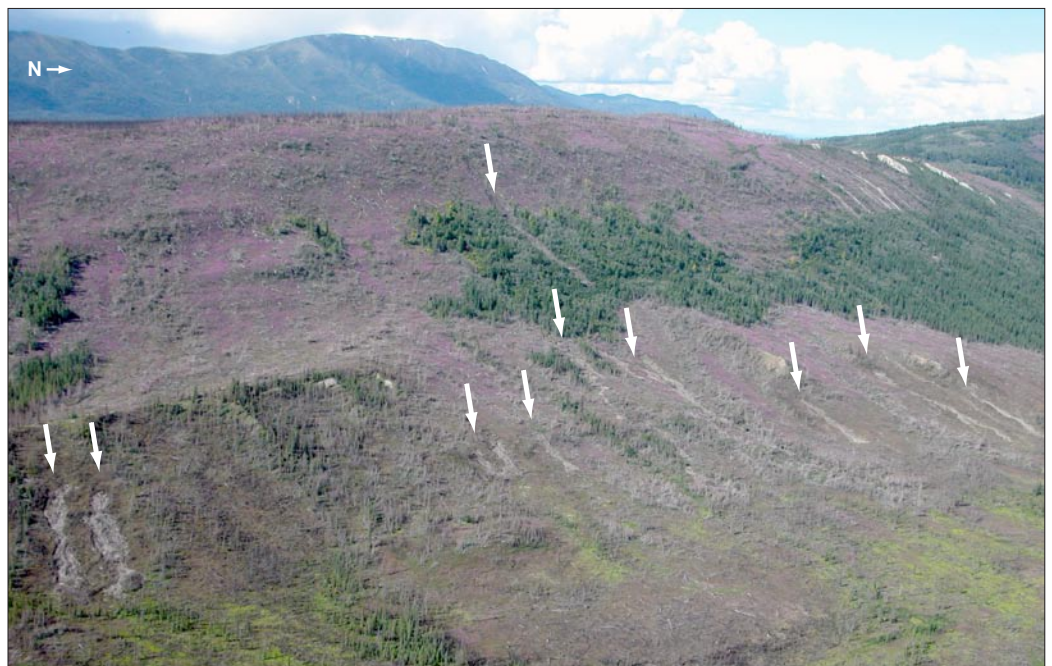
Figure 5. Multiple small active-layer detachments (highlighted by arrows) were initiated by forest fires in 2004. The slides occur in colluviated till on northeast-facing slopes having angles between 13-16°. Photo taken in July, 2006.

materials. Only 10 large active-layer detachments were identified. Two of these appeared to have occurred very recently based on the sharply defined headscarps and lack of vegetation regeneration; these were likely initiated by forest fires that burned in 2004 near Faro (Fig. 4 and #128 in Fig. 3), and in the headwaters of the Little Kalzas River near the mouth of the MacMillan River (#103 in Fig. 3). At least 10 small active-layer detachments also appear to have been triggered by the 2004 forest fires on northeast-facing slopes adjacent to the Pelly River, approximately 2 km upstream from the mouth of Earn River (Fig. 5 and #115 in Fig. 3).

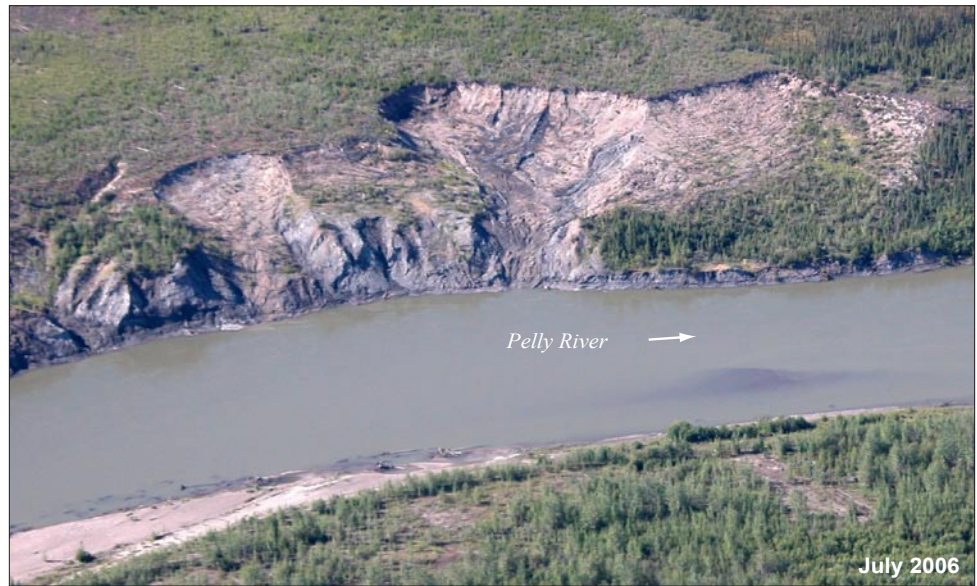
Figure 9. Oblique aerial photograph of a retrogressive thaw slump (#5 in Fig. 3) that was contributing sediment to the Pelly River in 2006. This landslide has been active and increasing in size since at least 1989. View is to the south. Estimated width of main failure is approximately 200 m.

Twenty-seven medium-sized retrogressive thaw failures were identified. Almost all of these occurred along near the South MacMillan (e.g., Fig. 8) and MacMillan rivers, while only four occurred along the Pelly River (e.g., Fig. 9). Most of the slides occurred in till-blanket or veneer materials, although at least seven occurred in glaciolacustrine deposits and four occurred in glaciofluvial complex deposits. Twenty-one of these medium-sized failures initiated in or prior to the 1980s. Six retrogressive thaw failures initiated since 1990; these are located
