Preliminary stratigraphic and geotechnical investigations of the glaciolacustrine and loess deposits around the city of Whitehorse (NTS 105D/11), Yukon

Brideau, M.-A., Stead, D., Bond, J.D., Lipovsky, P.S. and Ward, B.C., 2011. Preliminary stratigraphic and geotechnical investigations of the glaciolacustrine and loess deposits around the city of Whitehorse (NTS 105D/11), Yukon. *In: Yukon Exploration and Geology 2010*, K.E. MacFarlane, L.H. Weston and C. Relf (eds.), Yukon Geological Survey, p. 33-53.

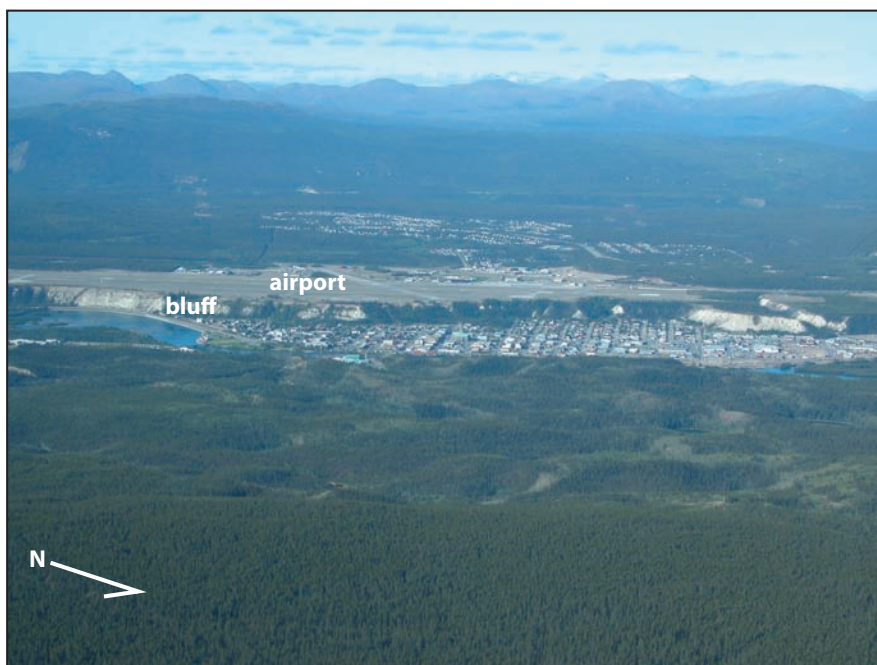
Figure 5. A view to the west over Whitehorse showing the glaciolacustrine surfaces remnant from Glacial Lake Laberge. The hummocky and kettled terrain in the foreground is glaciolacustrine sediment that was deposited over stagnant ice and moraine. This is in contrast to the glaciolacustrine plain on the west side of the Yukon River (see airport).

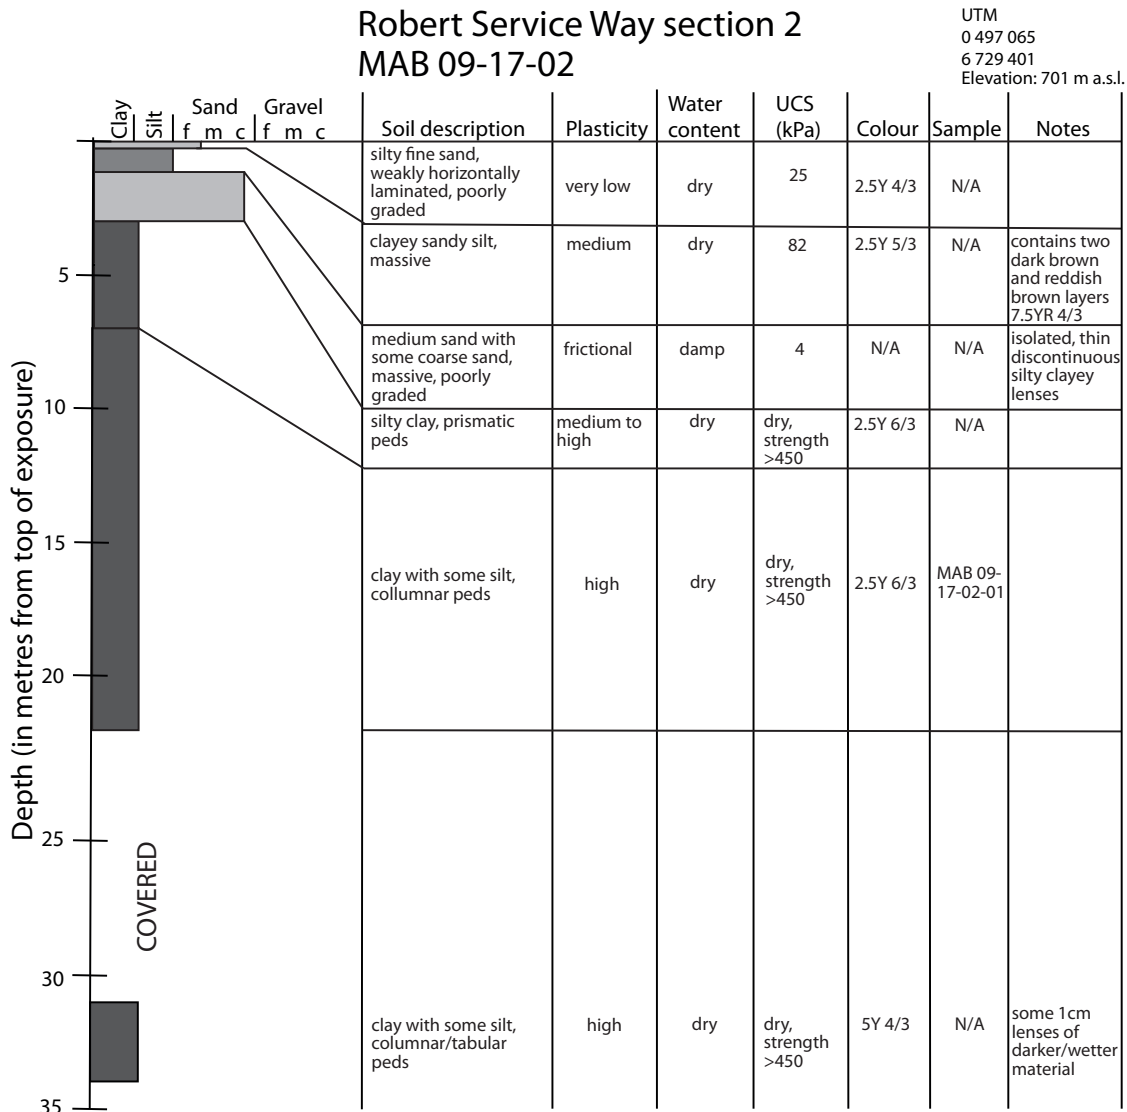
Figure 9. Geotechnical logs of stratigraphy and soil properties observed at station MAB 09-17-02 (see Fig. 1 for location).

The two main stratigraphic units observed are a horizontally laminated silt and clay (Figs. 9, 11, 12, 14, and 16a) and a fine to coarse sand that may or may not be horizontally laminated, cross-bedded or interbedded with silty-sand units (Figs. 6, 7, 8, 9, 10, 11, 13, 14, 16b and 16c). The silt and clay-rich unit exhibits rhythmic layering of light and dark lamination, which likely represents suspension settling; colour changes are due to varying silt and clay abundance (Smith and Ashley, 1985; Ashley, 2002). Convolute laminae in interbedded silt and fine sand units are observed at station MAB 09-16-01 (Figs. 6 and 16b). Convolute laminae have previously been reported in glaciolacustrine deposits and are interpreted to be the result of turbid underflow currents and subaqueous fan settings (e.g., Ashley, 2002; Bennett *et al.*, 2000) which cause soft sediment deformation loading during slumping. Crossbeds and climbing ripples have been attributed to turbidity currents in glacial lakes by Shaw and Archer (1978). Rip-up clasts of silt and clay in a medium to coarse sand bed were observed at station MAB 09-16-01 (Figs. 6 and 16c), which are also characteristic of turbidity currents. Similar features were described by Barnes (1997) at his Riverdale section (Fig. 1).

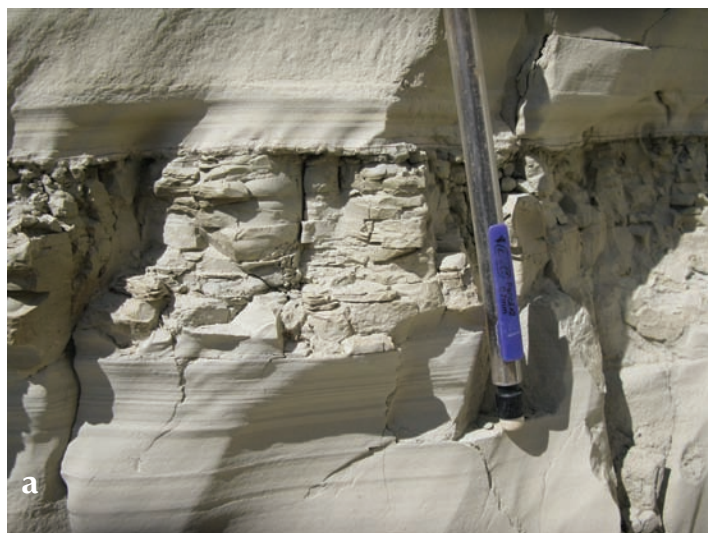
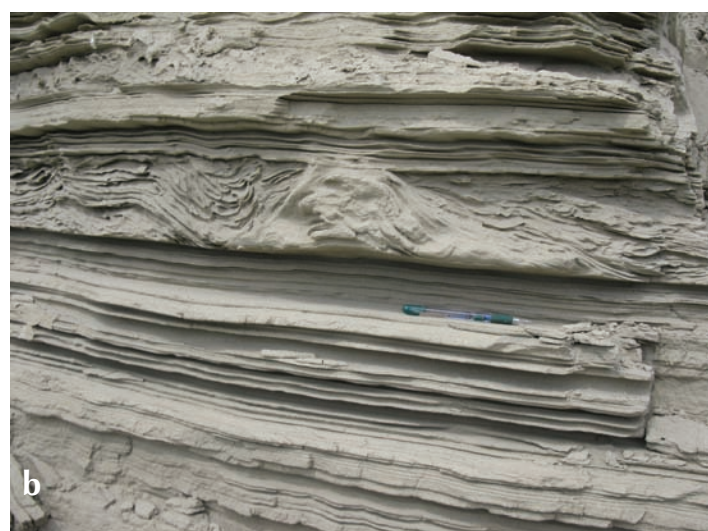
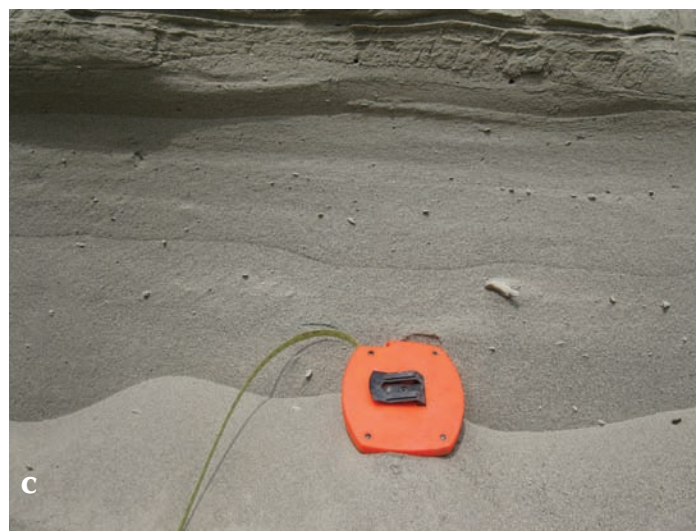
Figure 16. Photos of some of the sedimentological structures observed in the measured sections: (a) horizontally laminated rhythmite of silt and clay at section MAB 09-19-03; (b) convoluted bedding of fine sand and silt at section MAB 09-16-01; (c) silt rip-up clast in silty, fine to coarse sand at section MAB 09-16-01.

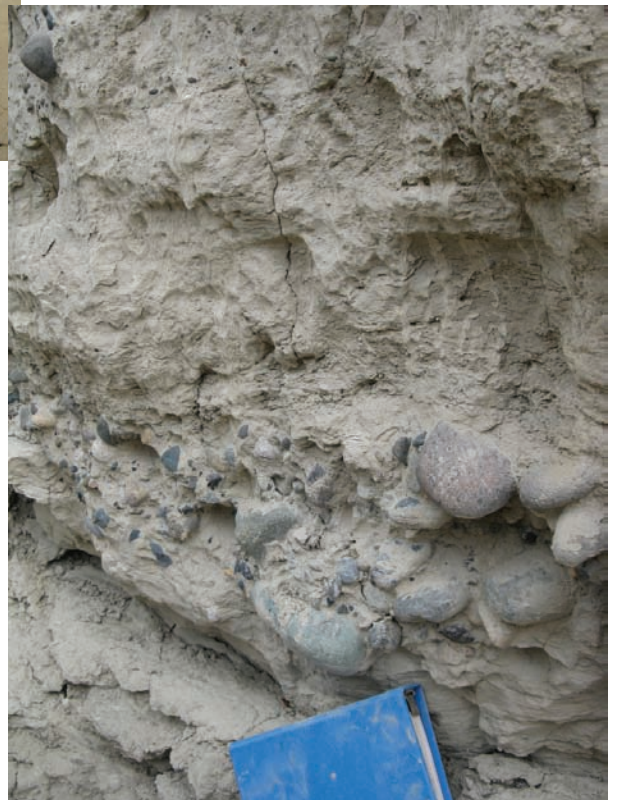
Figure 18. Gap-graded, polymictic, well rounded coarse gravel (including cobbles), in a matrix of silt and clay, at station MAB 09-20-02.

A series of stratigraphic units defined as gap-graded (bimodal), polymictic, well rounded pebble gravel with minor cobbles in a silt and clay matrix were observed only at station MAB 09-20-02 (Figs. 15 and 18). A possible depositional environment for these coarse units could be from melt-out of stranded ice in a lacustrine environment (Mougeot, 1998), resulting in the deposition of large clasts within a fine matrix, while still preserving the horizontal contacts above and below the unit. These units are bounded above and below by silt and clay-rich units that do not contain coarse fragments. These units are exposed just above the level of the Yukon River, and as such, represent the lowest topographic elevation exposure visited in this project; it is unclear however from this study if it also represents the lowest stratigraphic level.

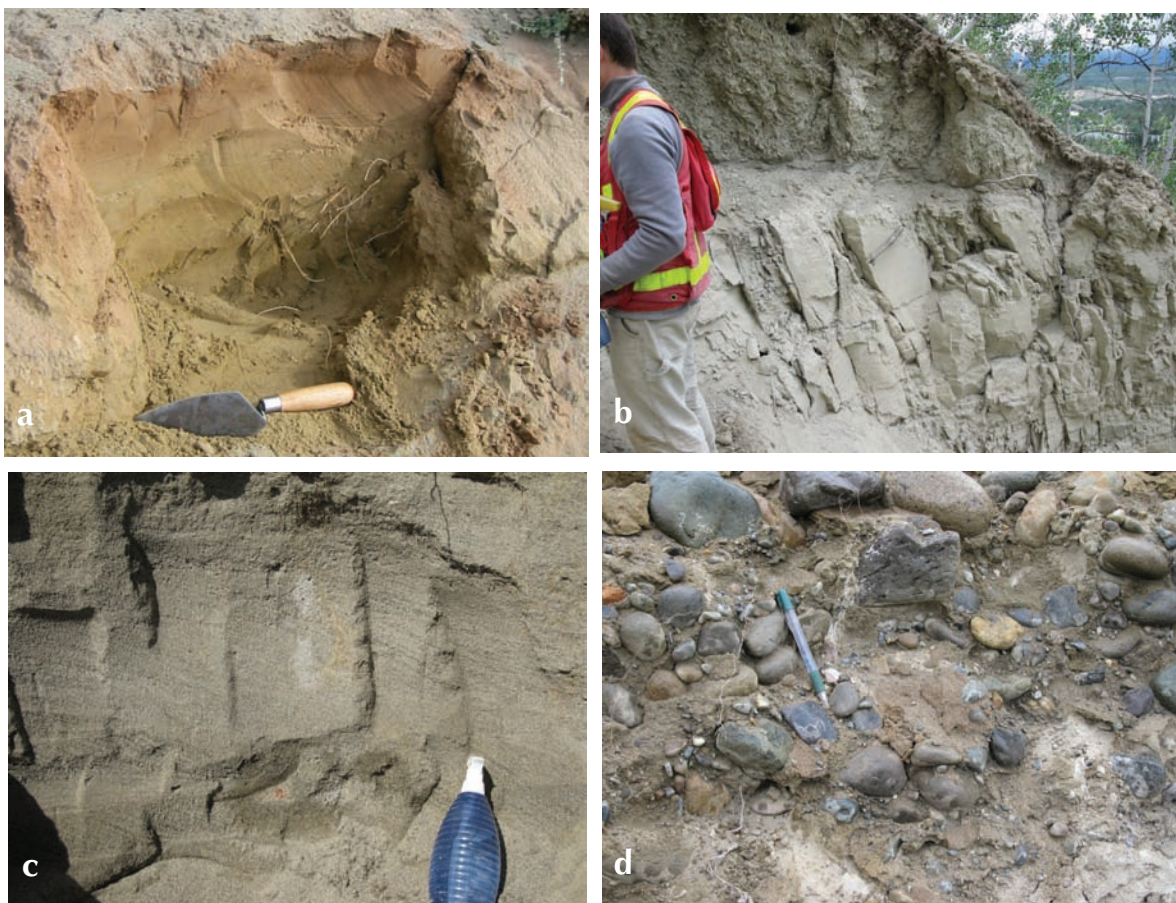
Figure 20. Field photos of selected samples analysed for grain size distribution in Figure 19: (a) loess unit of sample MAB 06-23-02-01; (b) laminated silty clay of sample MAB 09-17-02-01; (c) medium cross-bedded sand of sample MAB 09-17-01-03; and (d) sandy gravel of sample MAB 09-16-01-05.

The grain size distribution of sixteen samples was determined using a stack of ten sieves with openings varying in size from 37.5 mm (#1½) to 0.075 mm (#200). The samples were initially dried in an oven for 24 hours at 100°C after which the soil clumps were broken using a pestle and mortar before being put through the sieve stack. The grain size distribution of four samples containing more than 30% silt and clay was further analysed using a hydrometer, according to the method defined in ASTM (2007). The grain size distributions are presented in Figure 19, demonstrating a wide range of sediment grain sizes associated with the glaciolacustrine environment. The weak red (2.5YR 5/3) fine sand and silt of sample MAB 06-23-0-01 (Fig. 20a) is representative of the grain size distribution and appearance of loess from wind-reworked glaciolacustrine deposits. The clayey silt of sample MAB 09-17-02-01 (Fig. 20b) represents lacustrine deposition in calm water. The cross-bedded coarse to fine sand of sample MAB 09-17-01-03 likely represents underflow current deposition (Fig. 20c), whereas the coarse gravelly

sand of sample MAB 09-16-01-05 (Fig. 20d) is interpreted as the proximal part of a large turbidite. An overall fining-upward stratigraphic sequence is illustrated in Figure 20: coarse deposits at the bottom of the section, followed by a sandy unit, which is in turn overlain by a laminated silt and clay unit, and finally capped by a loess unit. This sediment package suggests that the glacier which dammed the valley became progressively more distal to the Whitehorse area.

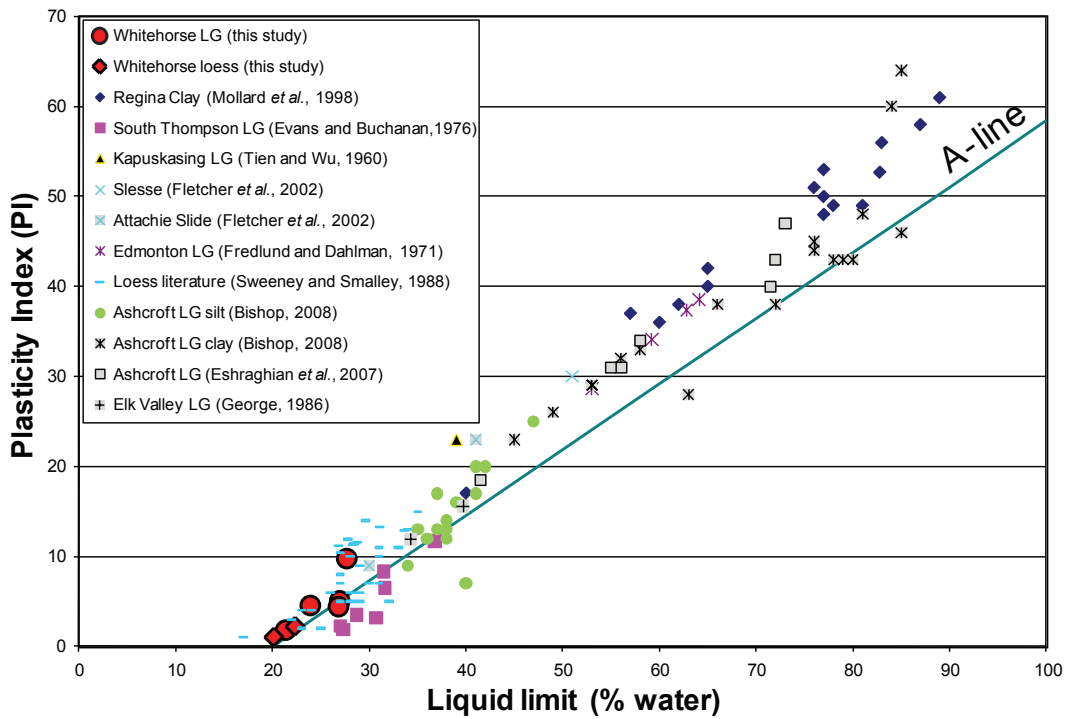
Figure 21. Plasticity chart comparing samples from this study with plasticity values for samples from other locations in Canada found in the literature. The A-line is an empirical boundary dividing soils with a mechanical behaviour dominated by the presence of clay (above) or silt (below). LG = glaciolacustrine.

The results of the seven tested Whitehorse-area samples are plotted on Figure 21 along with published test results from other glaciolacustrine and loess deposits from other areas in Canada. The Whitehorse samples exhibited a low plasticity behaviour that was similar to the range of values reported by Evans and Buchanan (1976) for samples from the Thompson River Valley, and the plasticity of Canadian loess deposits (Sweeney and Smalley, 1988). The low plasticity is attributed to the low clay content (<20% by weight) of the samples collected in this study, as well as those collected by Evans and Buchanan (1976). The high plasticity samples from Mollard *et al.* (1998), Eshraghian *et al.* (2007), and Bishop (2008), all contain 40-80% clay by weight.

Figure 21 have accompanying clay mineralogy analyses. Two exceptions are the samples from the Elk Valley region, which are kaolinite and illite-dominated (George, 1986), and the sample from Regina, which contained up to 55% montmorillonite (Mollard *et al.*, 1998). The low montmorillonite content of the Whitehorse-area samples makes them more comparable to the Elk Valley samples.

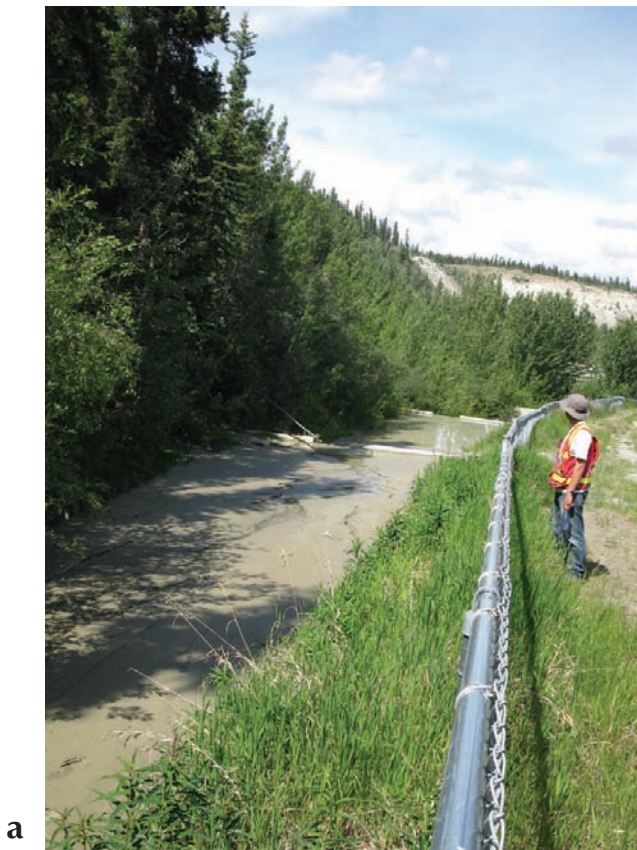
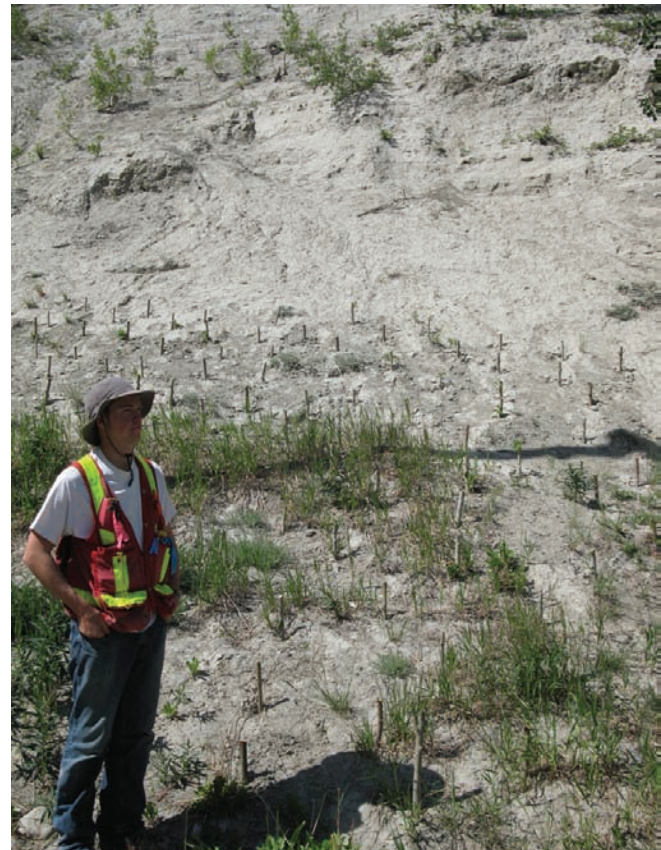
Figure 24. Examples of the remediation effort completed to reduce erosion of the bluffs in downtown Whitehorse: (a) check dam to reduce flow velocity and encourage deposition; and (b) planting of grass and tree saplings in order to reduce erosion due to overland flow, and to increase soil strength by increasing the root network.
