KENO HILL SILVER DISTRICT

CLOSURE ISSUES REPORT

DRAFT

MARCH 2009

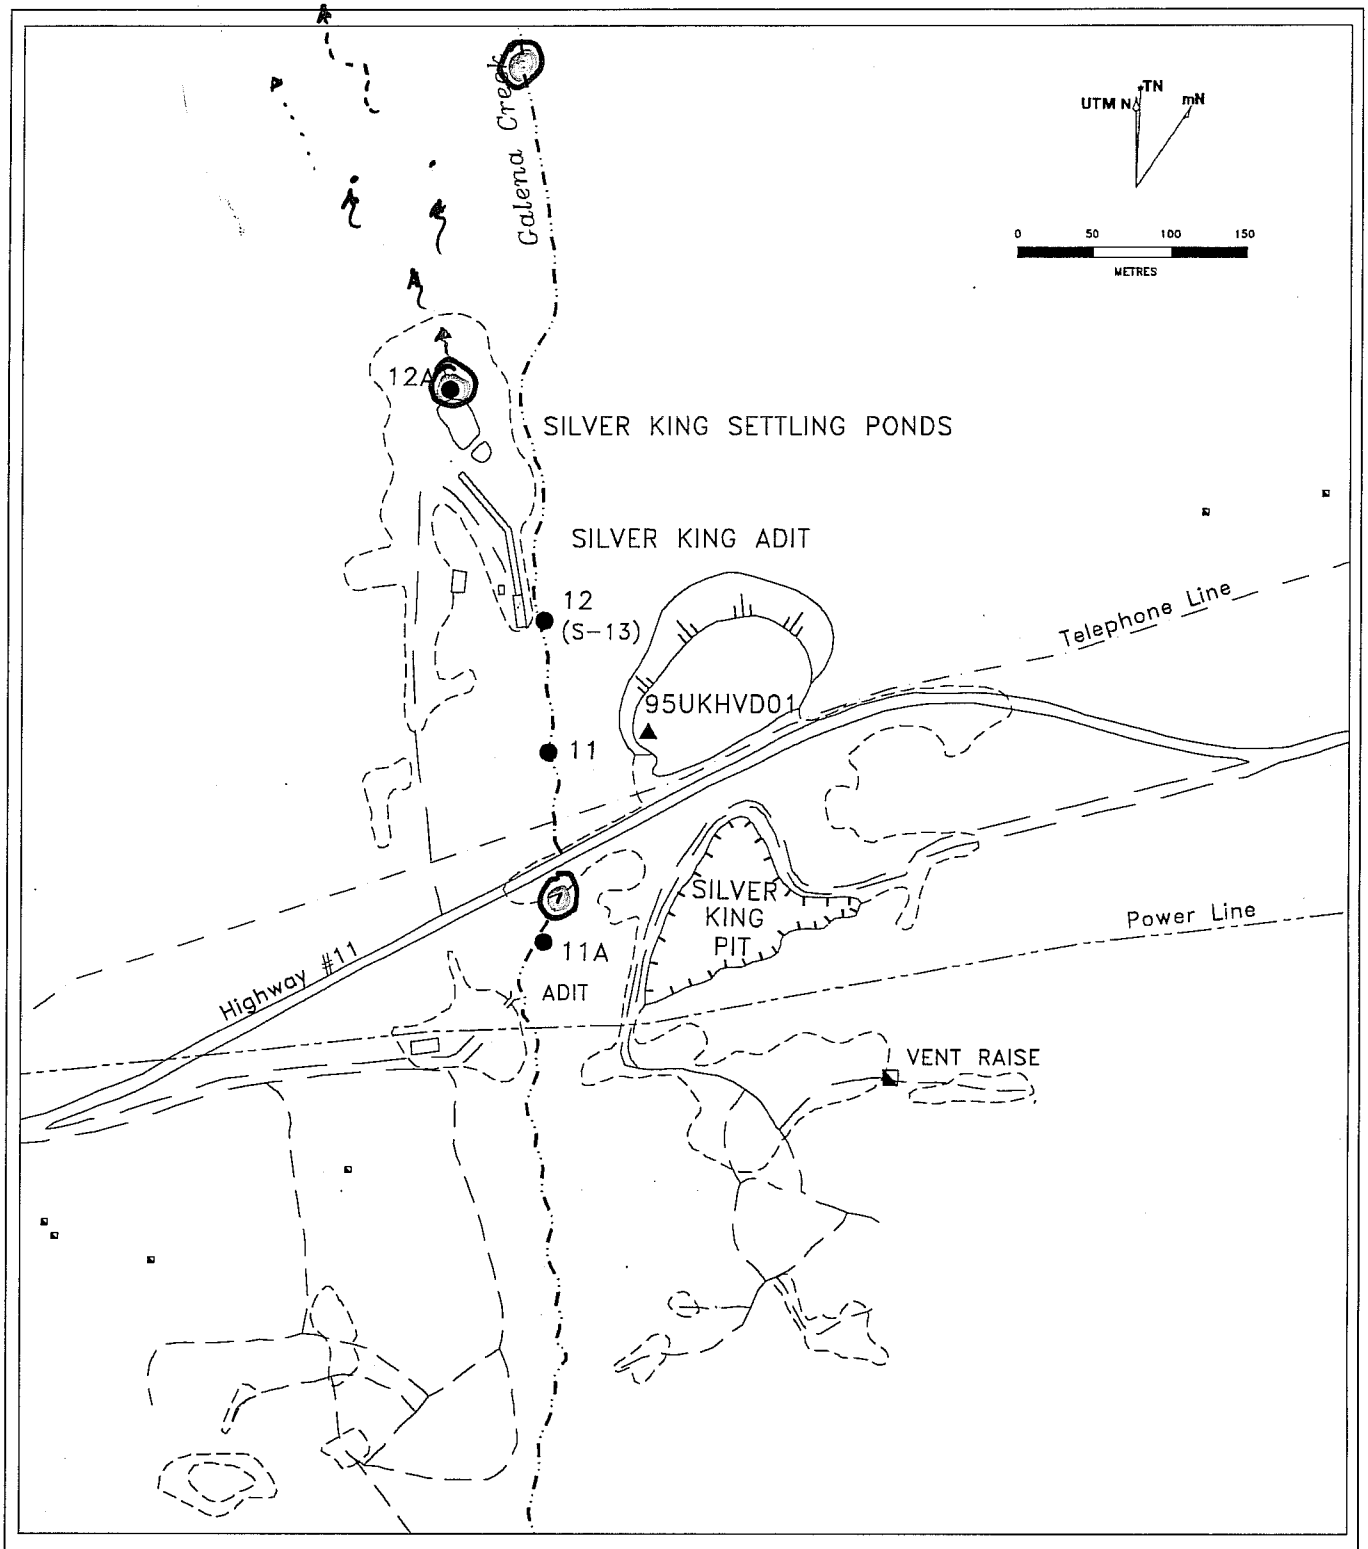
Silver King Site #1

#1 *- Drainage channel eroded into face of dump - channel does not extend up face through dump crest.*
- The dump in general is stable, with no new tension cracks – no toe heave observed.
- Subsidence on the top of the dump is an old feature.
- The dump has a protection berm around the crest.

#4 *The Open Pit is stable, with limited unravelling of the slope walls.*
- No water is noted in the pit.
- Temporary barriers that were installed to prevent access have fallen down. There are no berms around the edge of the pit to prevent access.

#20 *appears to be <400t in low grade pile: material may have been used for berms around settling ponds*

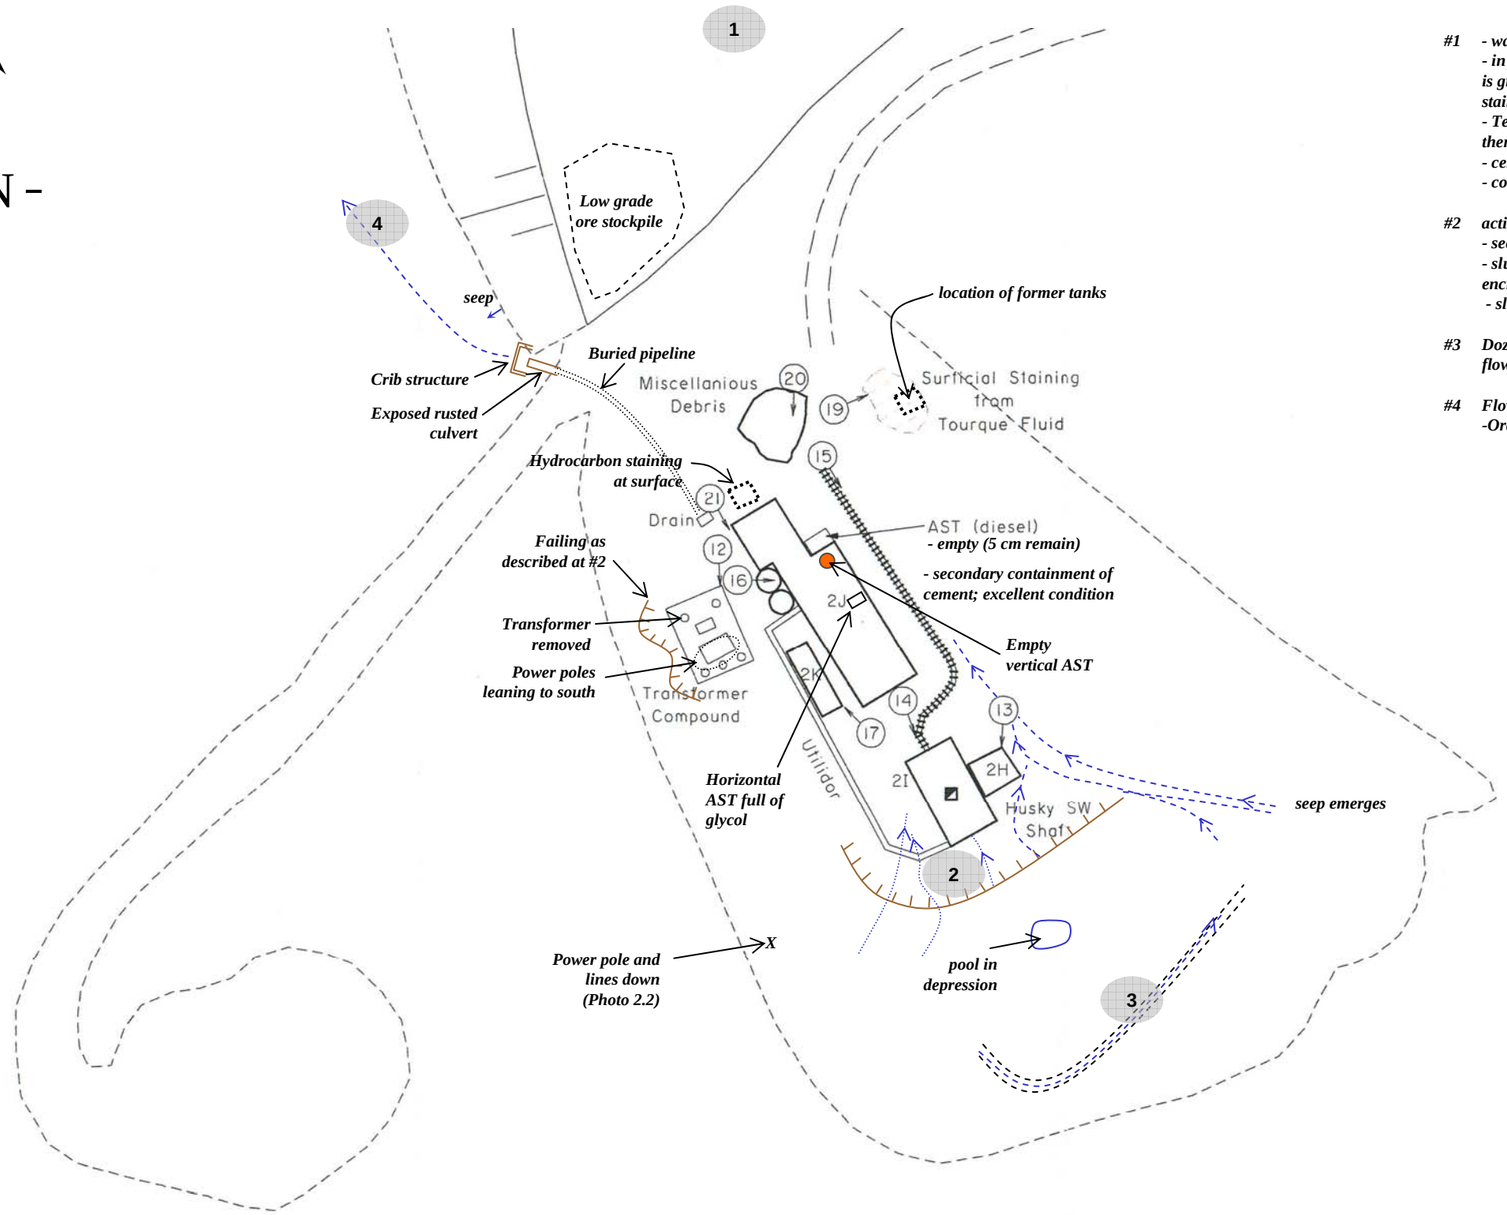
#1 - waste dump has tension cracks up to 15 cm wide
- in lowest bench, material contains rounded clasts (overburden?), but colour is greenish brown to greenish gray, with pale yellow to orange dark brown stains on clasts
- Tension cracks (12 m back from crest) parallels dump crest (Photo 2.3), then curves to intersect dump crest at NE end
- central part of zone of cracking has subsided by ~0.5 m
- could be permafrost in dump foundation

#2 actively failing till bank
- seepage forms rivulets across entire face
- slumped material is very soft, saturated; encroaching on headframe structure (Photo 2.1)
- slope is ~2V:15H

#3 Dozer trail with water seeping into it. Flow observed towards northwest, but flow diffuses into broad area of willows and grass

#4 Flow visually estimated at 1 l/s
-Orange staining and precipitation along flow path

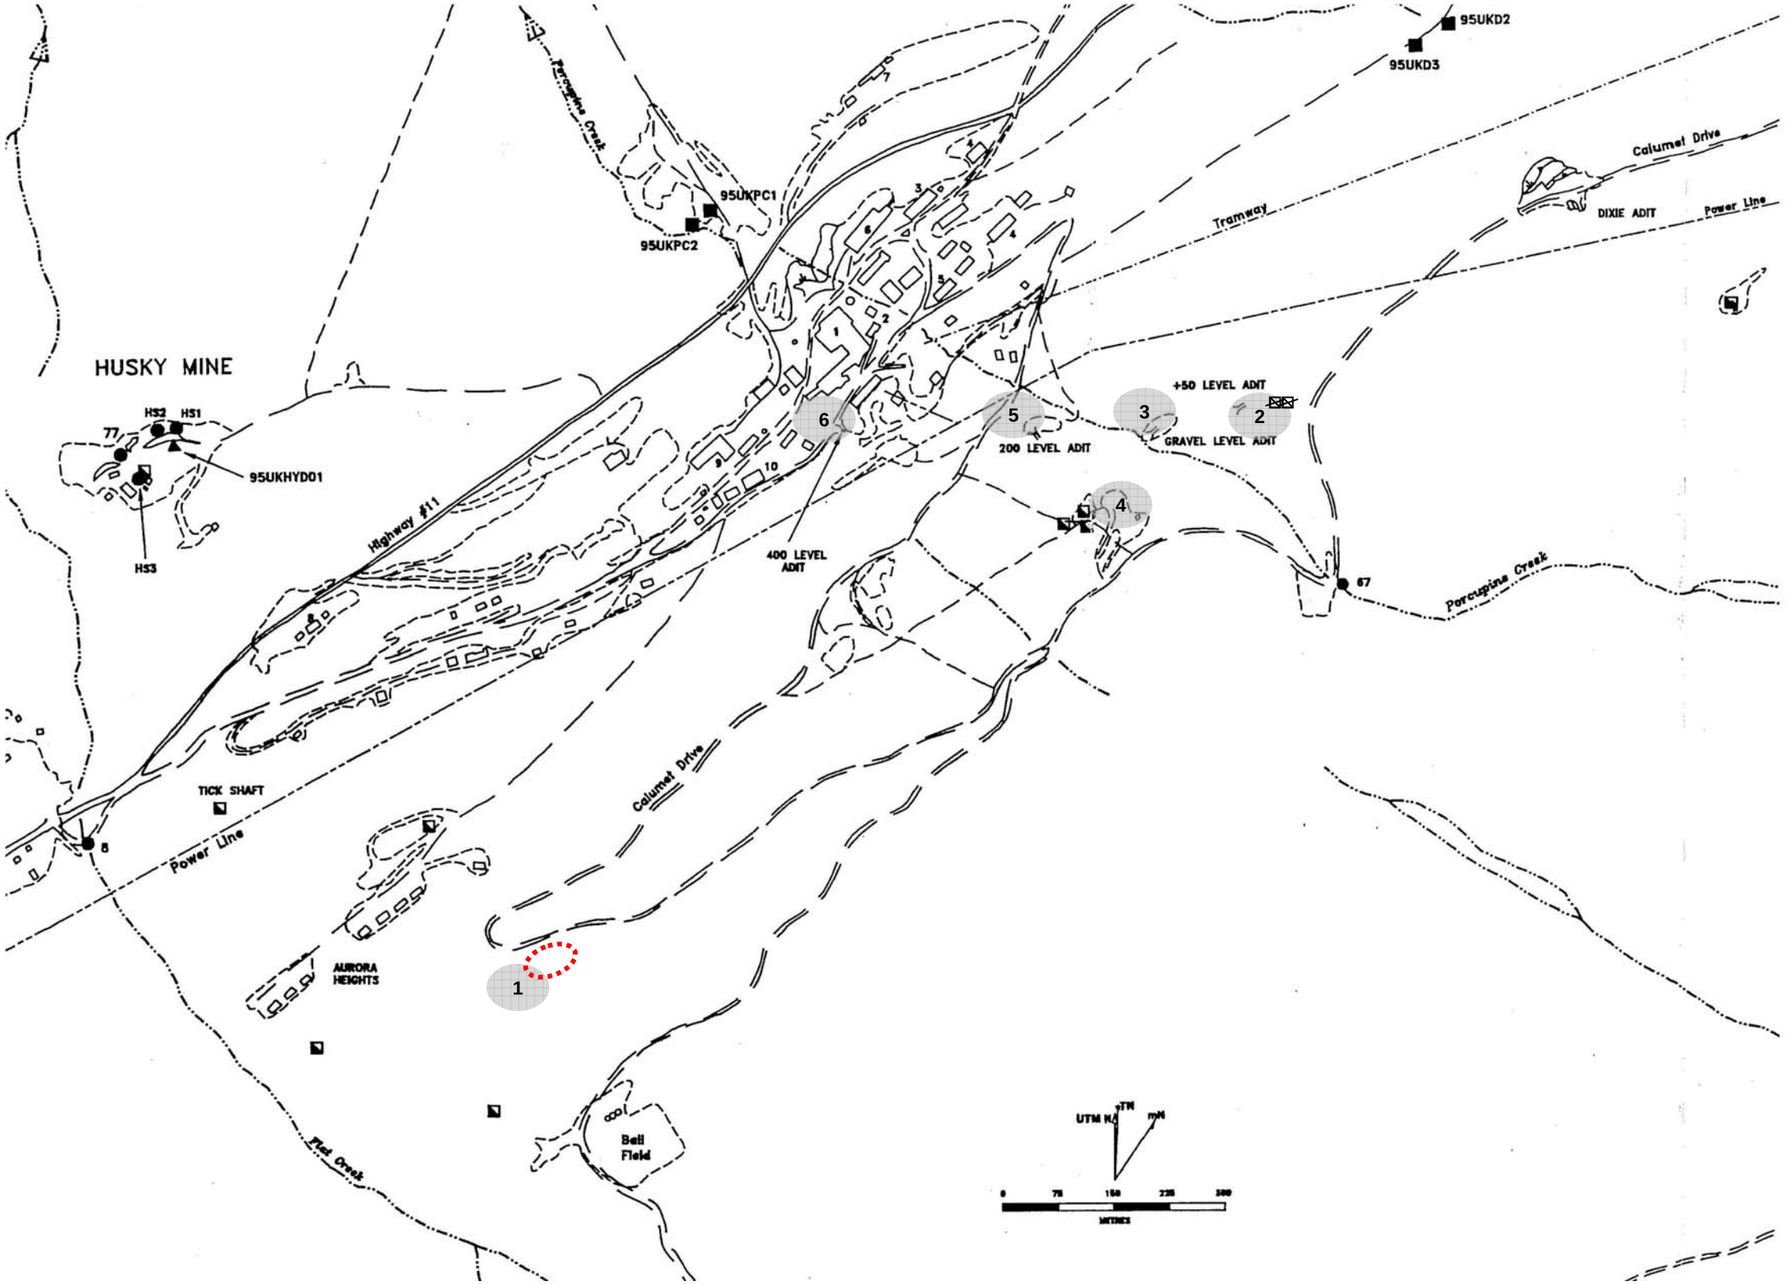
#4 - Only one shaft was located in this area. "Shed" noted in PWGSC (2000) was collapsed, and further investigation revealed that the debris was situated over an unstable shaft that appeared to be open. Ground subsidence was observed immediately adjacent to the shaft house debris on all sides. Access to the site is somewhat difficult due to dense alder growth, but the immediate vicinity is cleared and the collapsed shaft house presents an intrigue risk.

#5 - 200 level adit confirmed gated and secure; timber portal supports remained intact. Timber loadout structure beginning to deteriorate; this structure is visible from Calumet Drive, and has ore cars sitting on rails that are also visible. The loadout structure and ore cars present an intrigue risk.
- Minor rusty brown staining observed on waste rock surface of working area between adit and loadout.

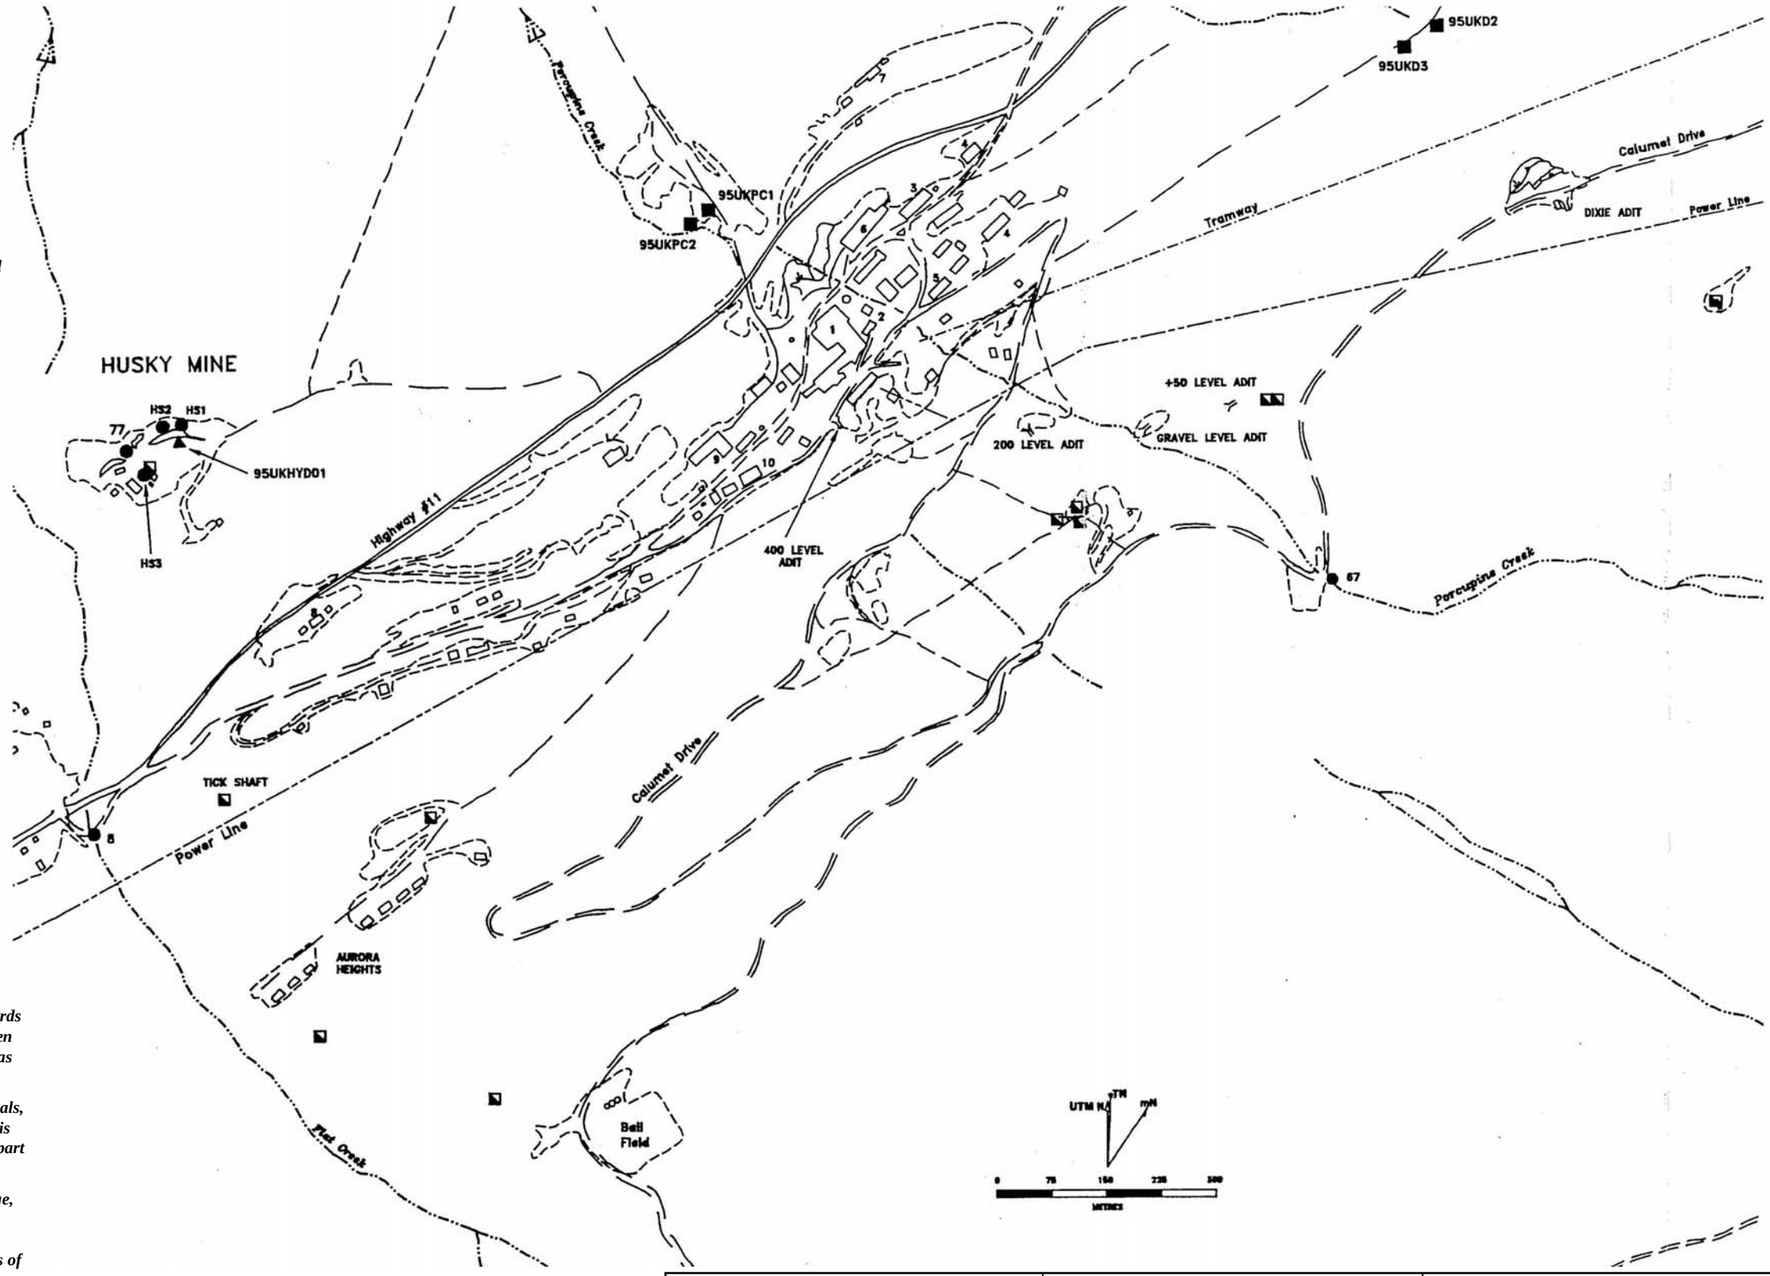
#1 - The Elsa Dump is located the position indicated. Seven other solid waste disposal sites are noted in PWGSC (2000).
- Existing contaminants of concern, and concentrations of those contaminants, at the Elsa Dump and at other solid waste dumps reported in PWGSC (2000) are poorly understood at this time. In addition to municipal solid waste, it is possible that industrial chemical wastes, derived from mine and mill operations, are disposed at this site.
- As is typical for solid waste dumps, there is no record of the types and quantities of waste disposed at this location. Although PWGSC (2000) provides an estimate of dump composition, actual dump composition may be different than reported.
- No characterization of groundwater or surface water downgradient of the Elsa Dump has been carried out, and the presence and quality of landfill leachate remains uncertain.

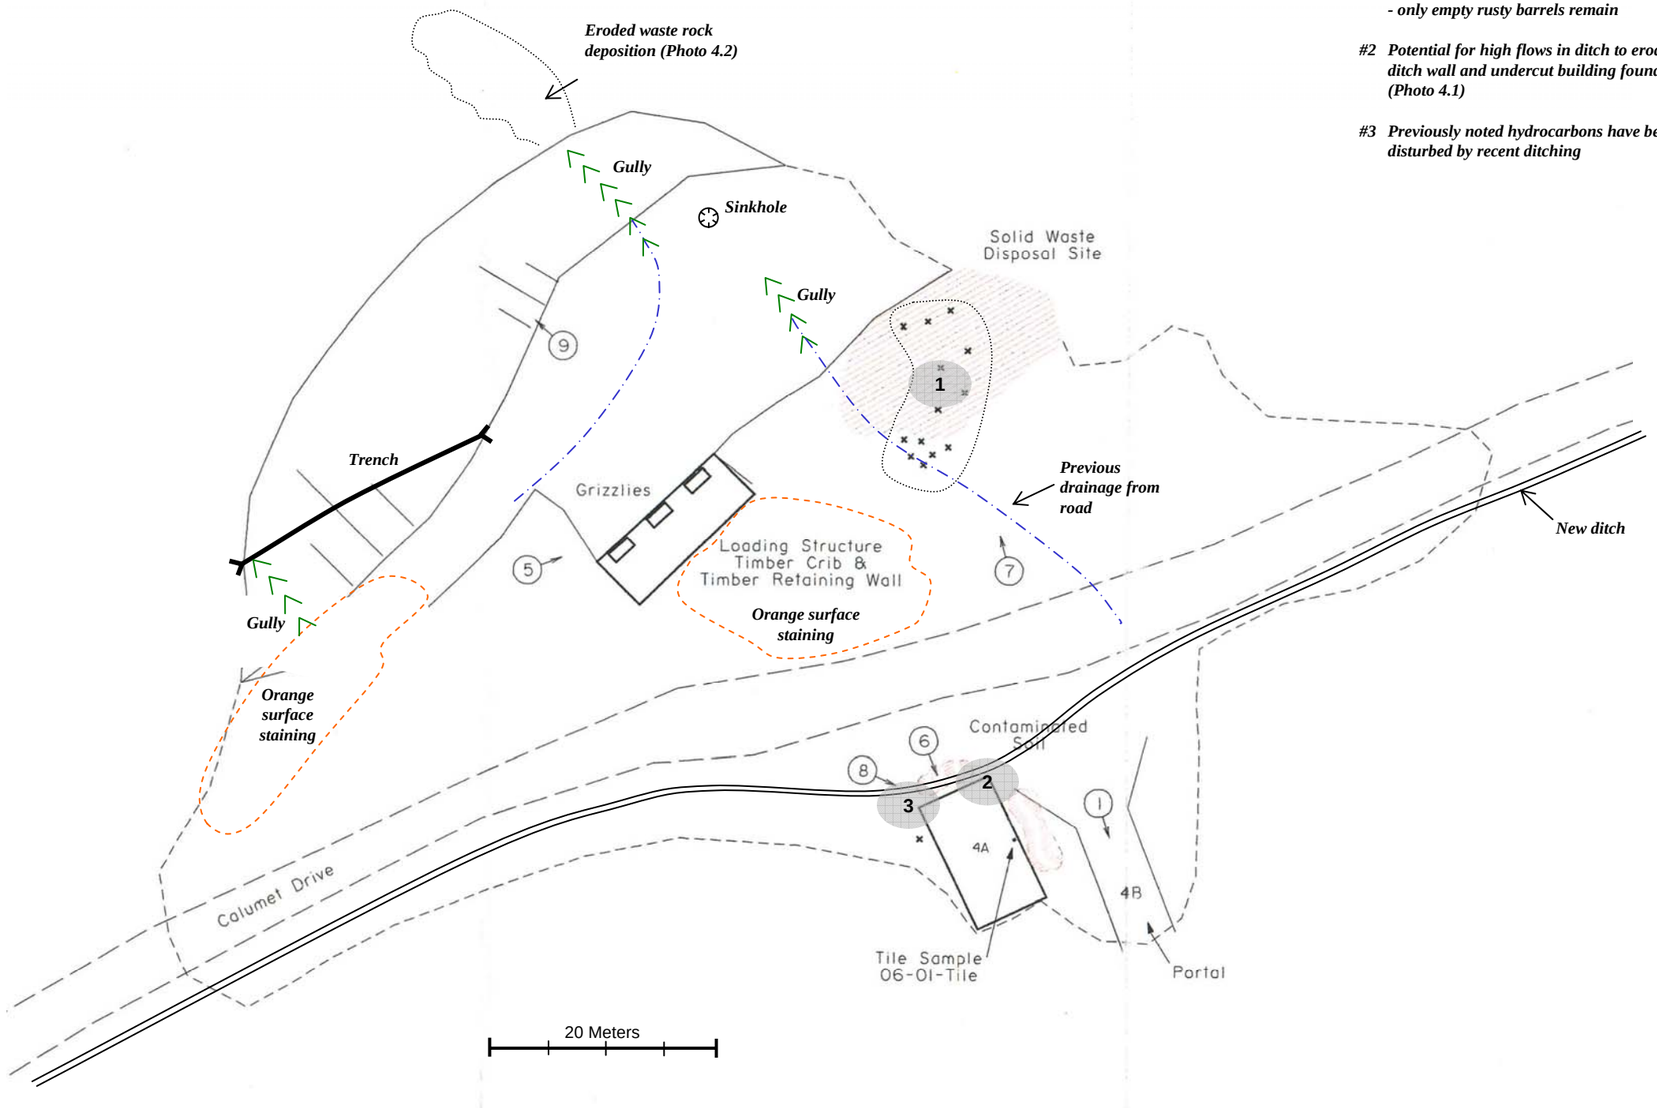
#1 -Several barrels removed - only empty rusty barrels remain

#2 Potential for high flows in ditch to erode ditch wall and undercut building foundation (Photo 4.1)

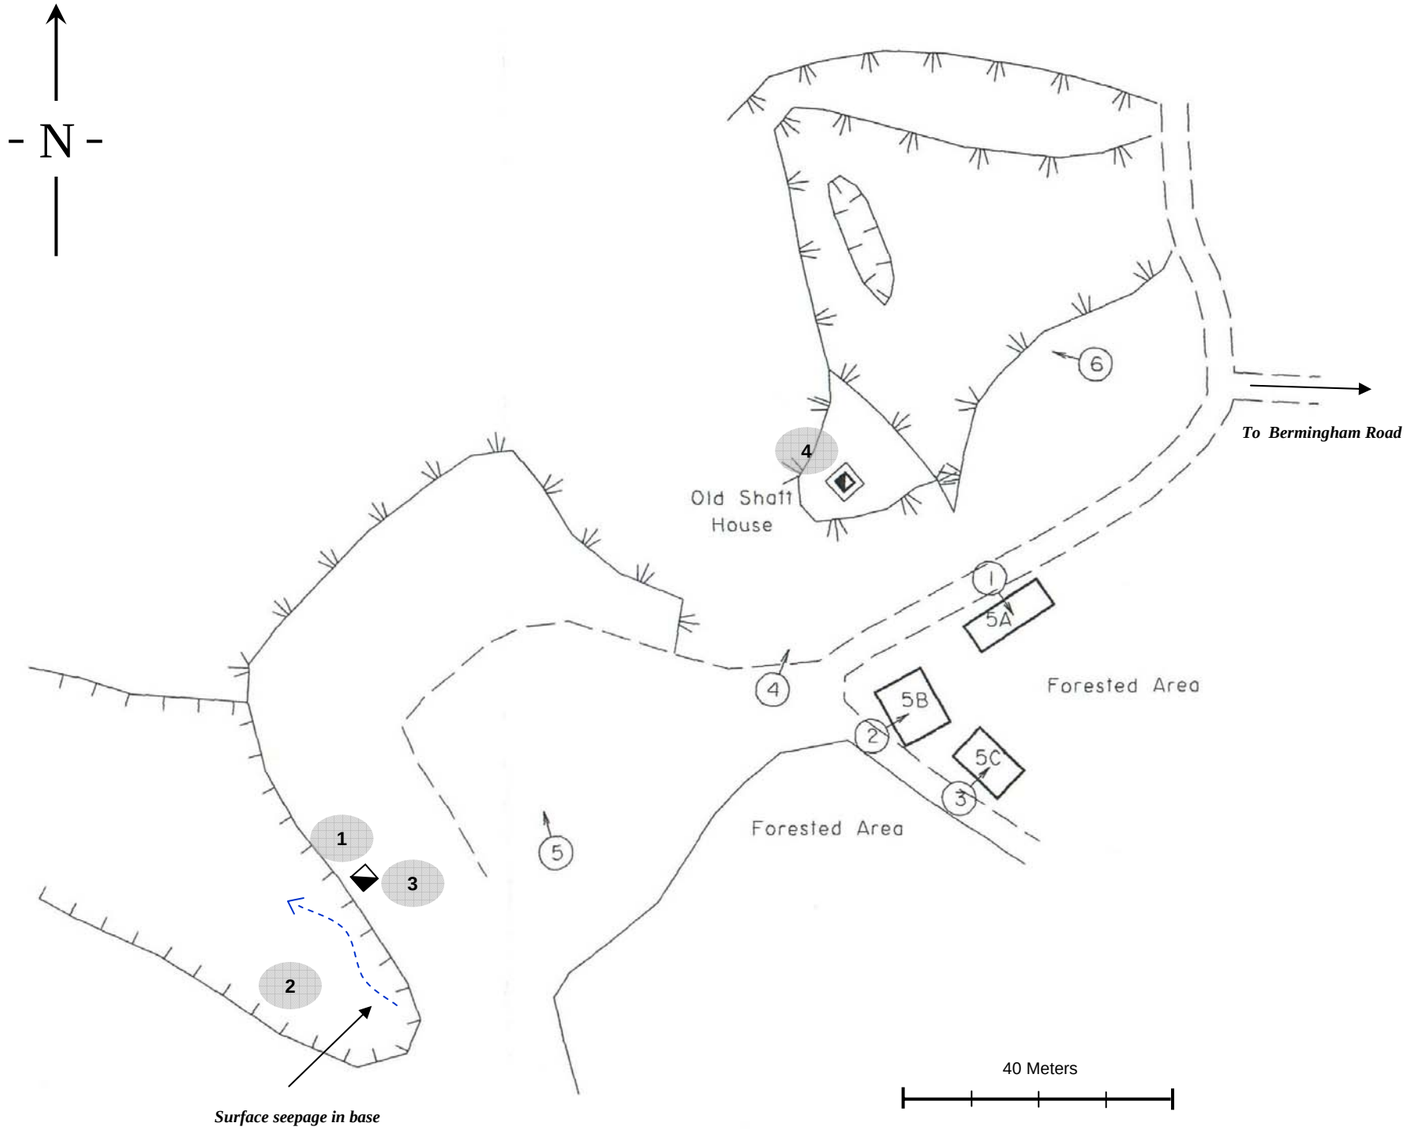
#1 ***- Shaft #1 is open at surface, with no barrier to access. Timber cribbing is in good condition, and drift to southeast is clearly visible from top of shaft (Photo 1) and appears to be open. This feature represents a high intrigue risk.***

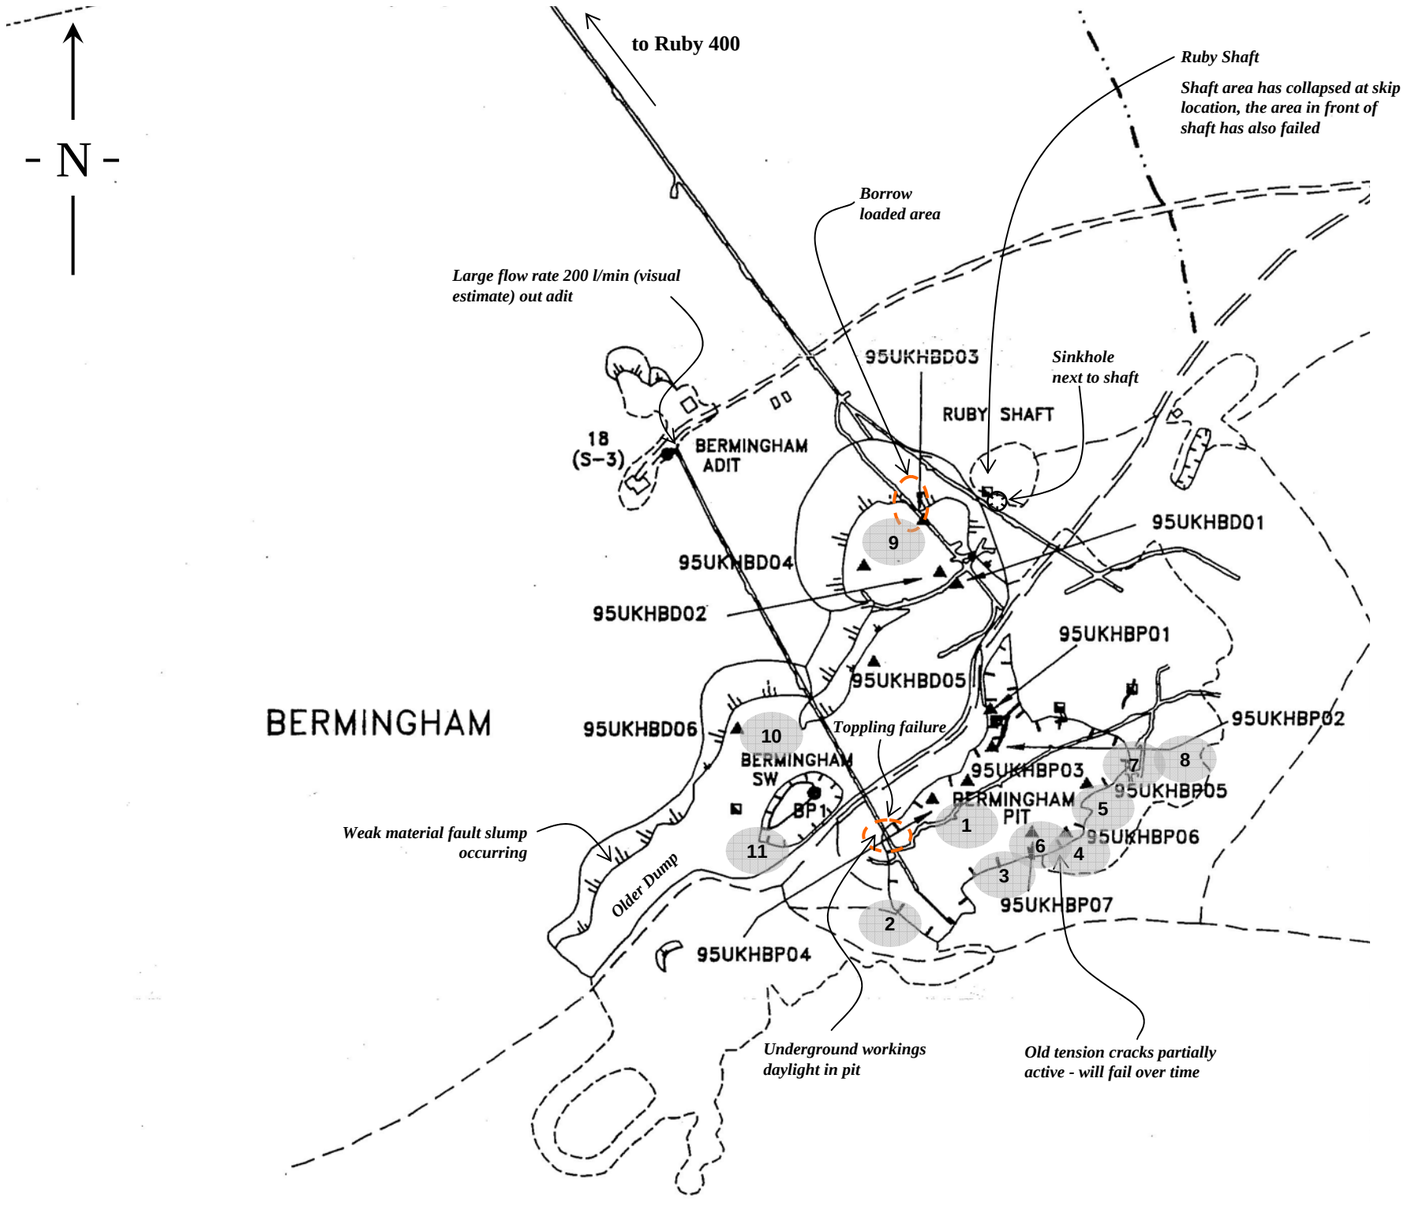
#1 *No water was noted in the bottom of the pit.*

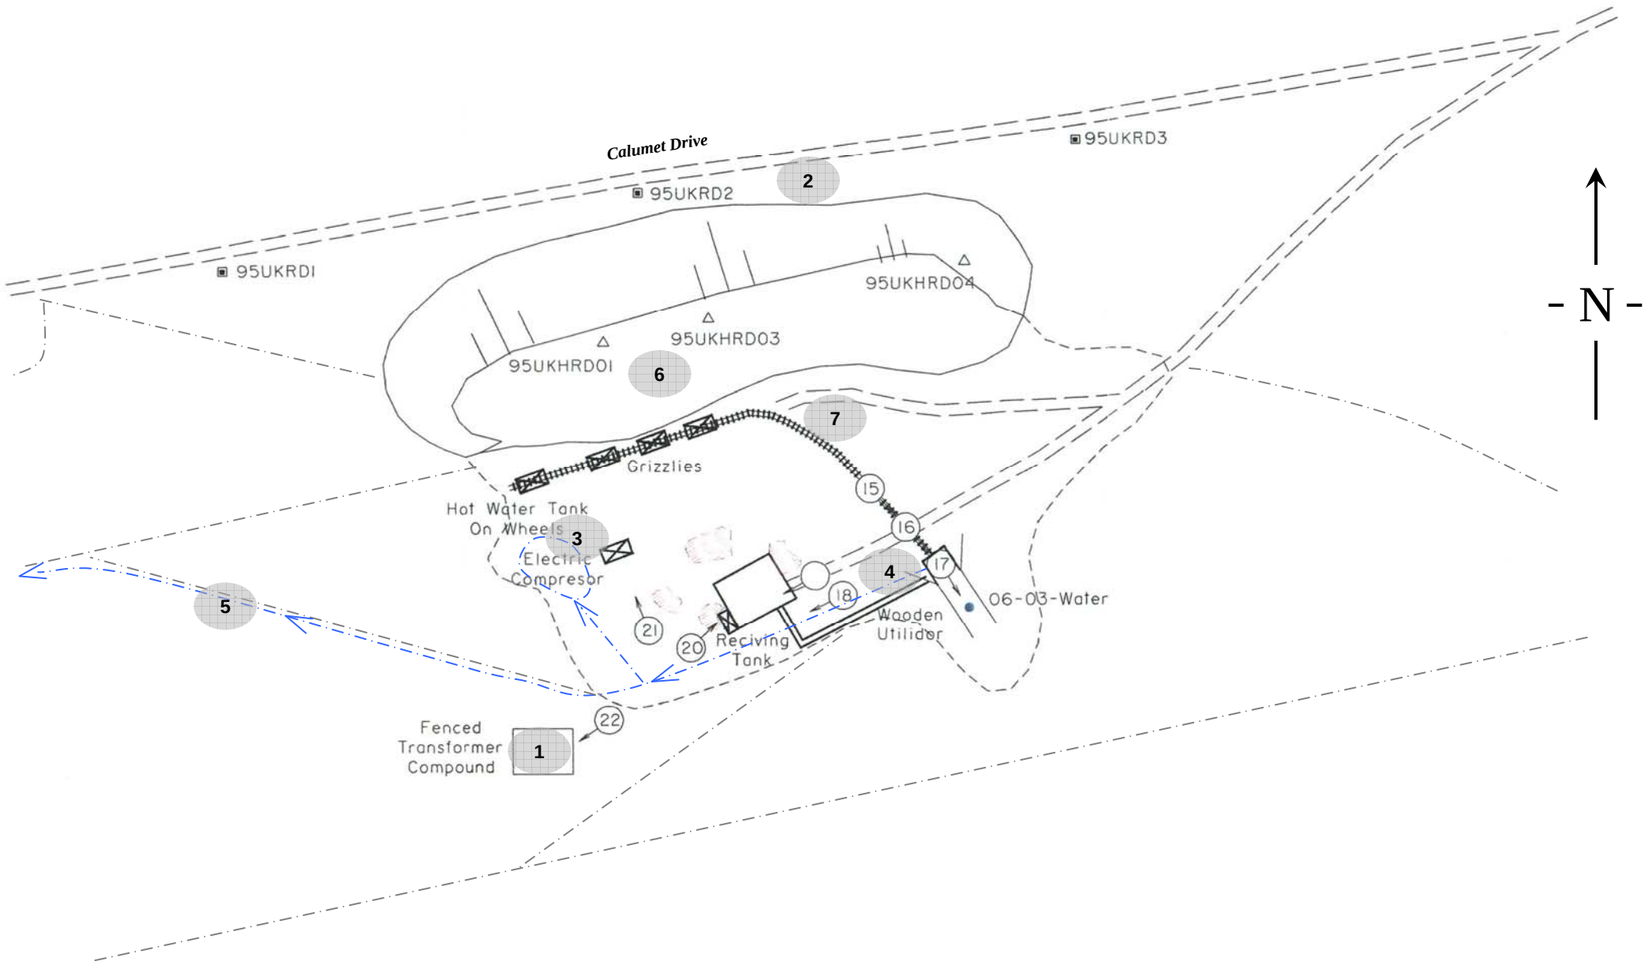
#2 - Kill zone between waste dump and roadway. No impacted vegetation observed below road.

#3 - Adit drainage pooling on surface and infiltrating into waste rock. No surface outflow from pond at time of inspection.

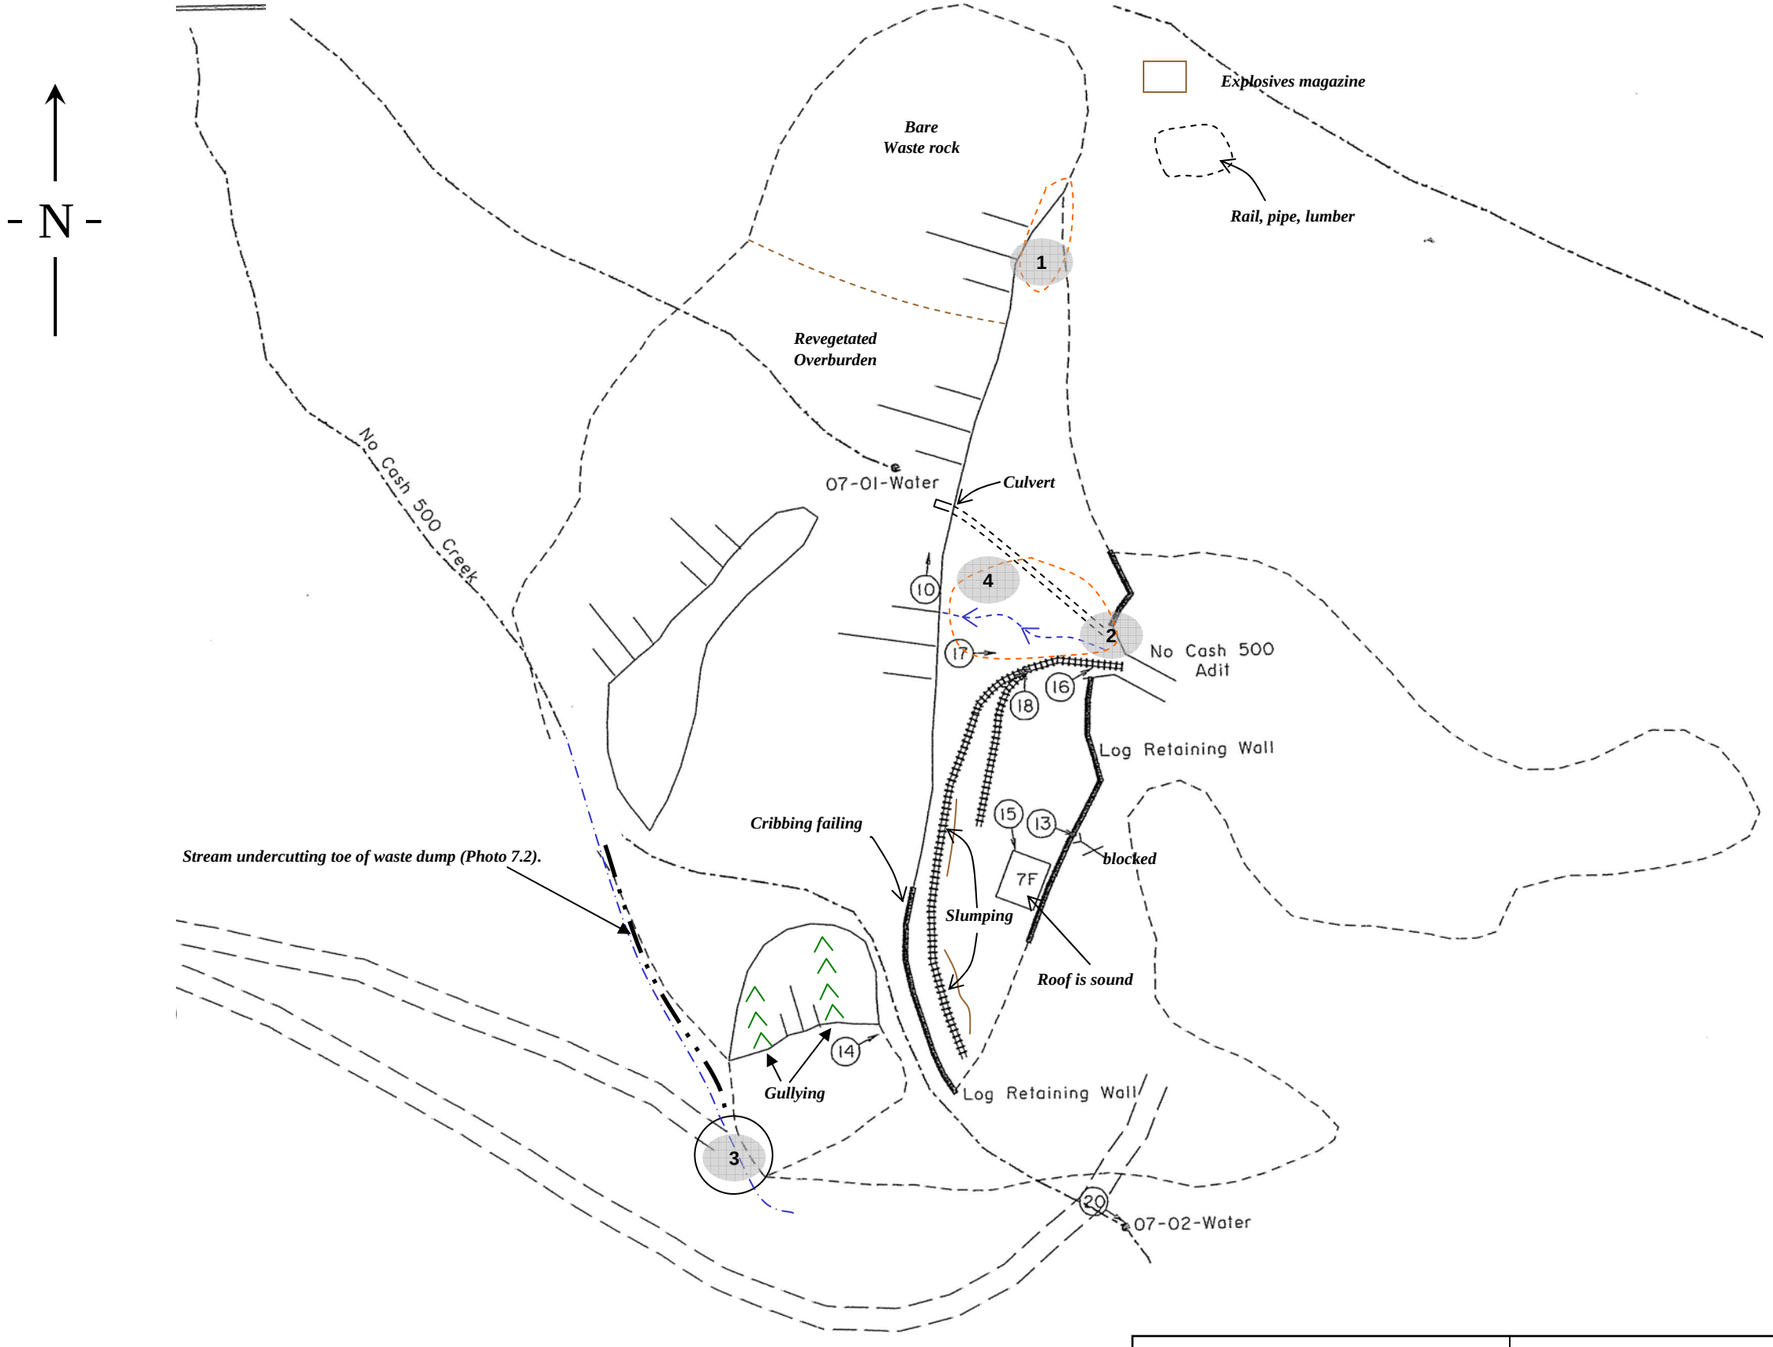
#1 - Pale yellowish and orangey dark brown staining isolated clasts
- Flow path (dry) marked by pale yellow stain

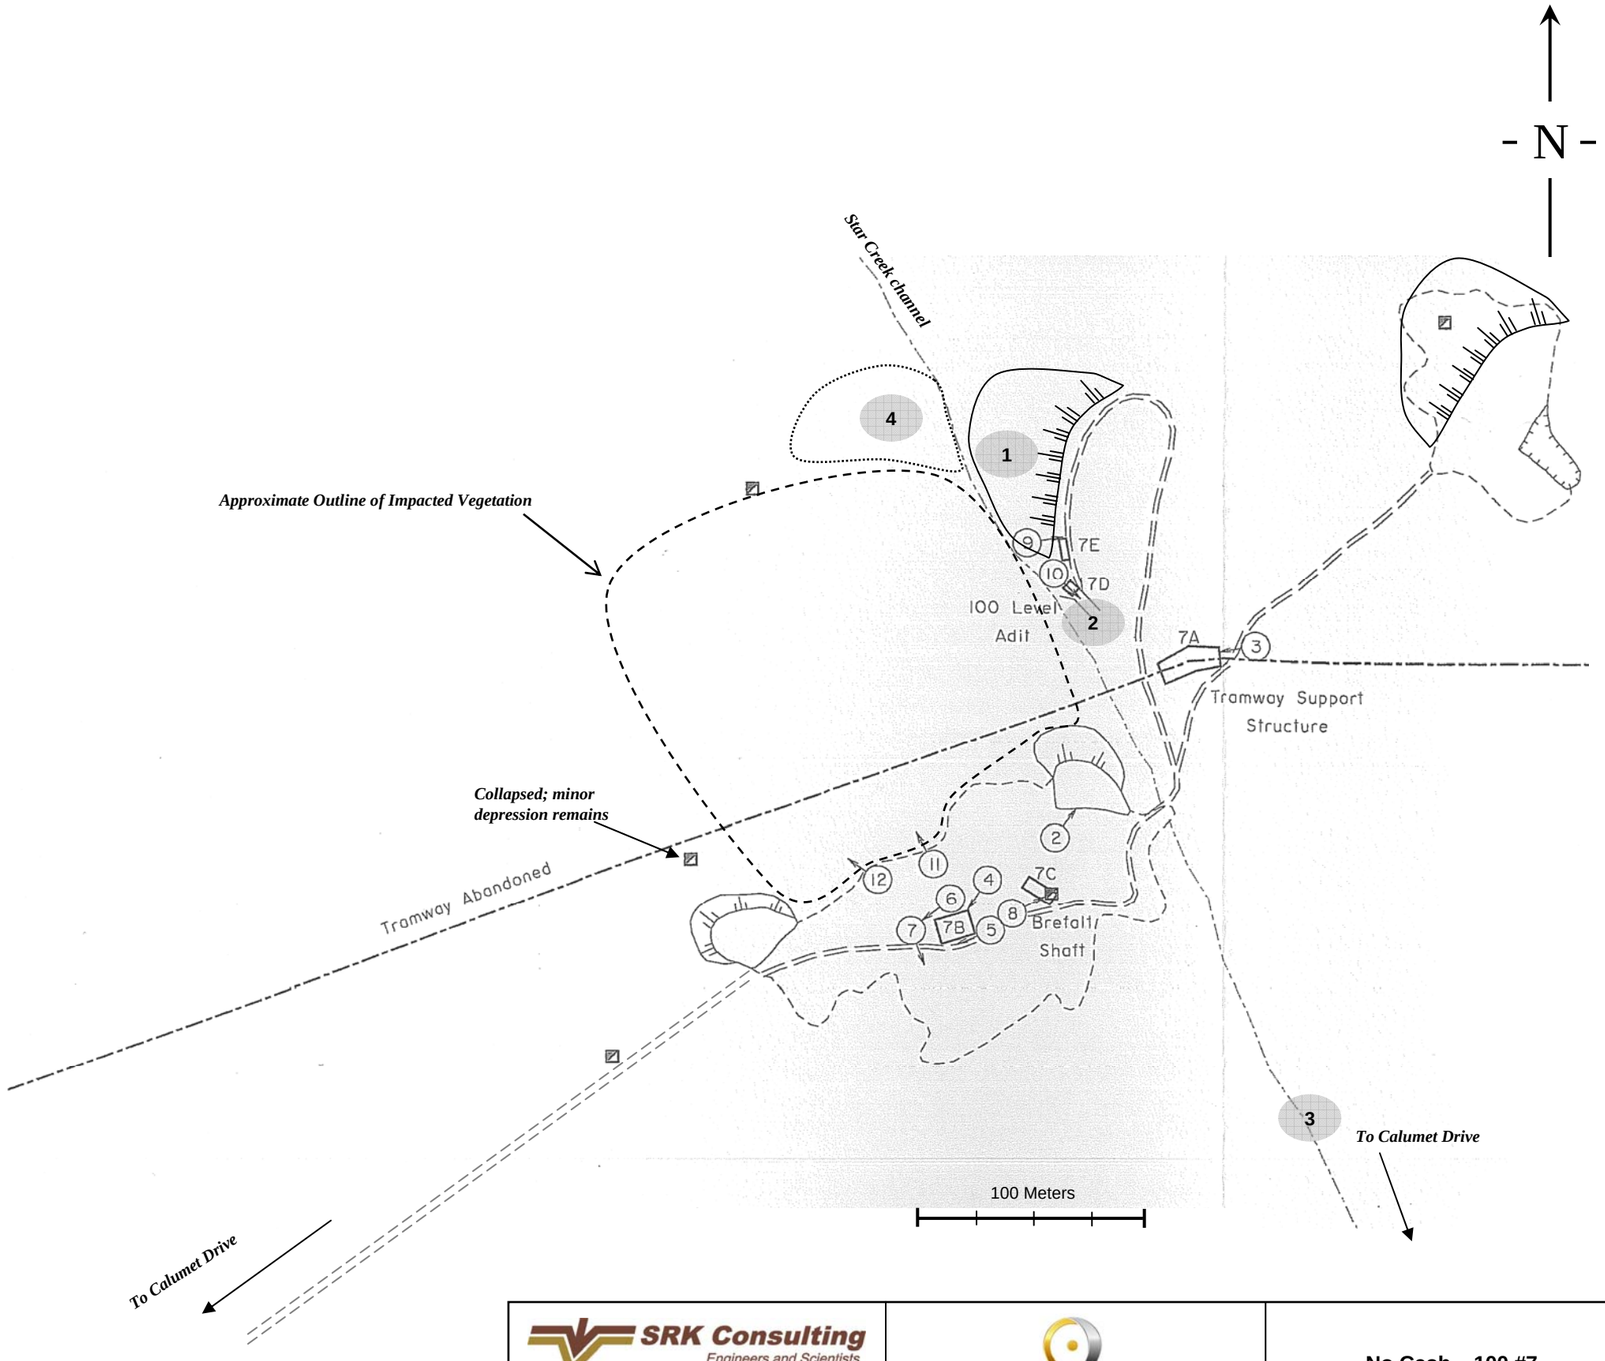
No Cash - 500 #7

#1 - Waste rock pile from No Cash 100 adit not previously noted. Contains remnants of trestle structure- no rails observed in place. Rail and other metal debris observed at toe.
- Waste rock spills into adjacent valley that forms the upper end of the Sandy Creek drainage. No surface water observed in flow path adjacent to 100 adit waste dump at time of inspection (Sept. 2005).
- Waste rock does not block flow path

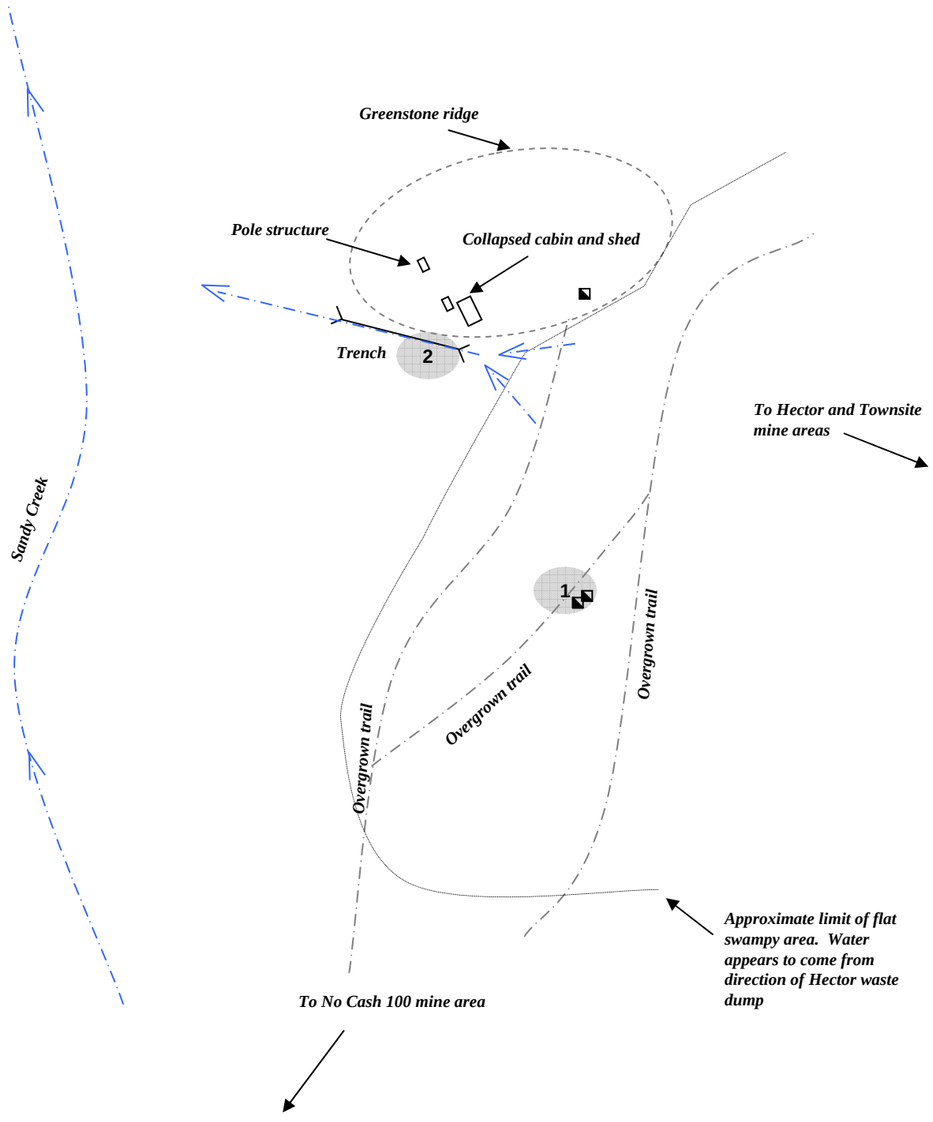
#1 - Two 3 m x 3 m openings in muskeg, 1.5 m deep, with exposed mineral soil on margins. Waste rock pile adjacent to SW shaft approximately 0.5 m high x 5 m x 8m; composed of dark grey quartzite and minor quartzite breccia with siderite veining, with minor orange to dark rusty brown staining.
- Little vegetation growing on waste pile- 10% coverage.
- Size of openings may be due to be regressive thawing of permafrost. Standing water (0.3 m) present in both holes, and bottoms felt solid when probed with a stick.

#2 - Trench contains greenstone rubble, with water flowing through the rubble. Appears to collect water from flat swampy area to southeast and channel the water towards Sandy Creek.
- Trench is overgrown with willows and is difficult to identify.
