KENO HILL SILVER DISTRICT

CLOSURE ISSUES REPORT

DRAFT

MARCH 2009

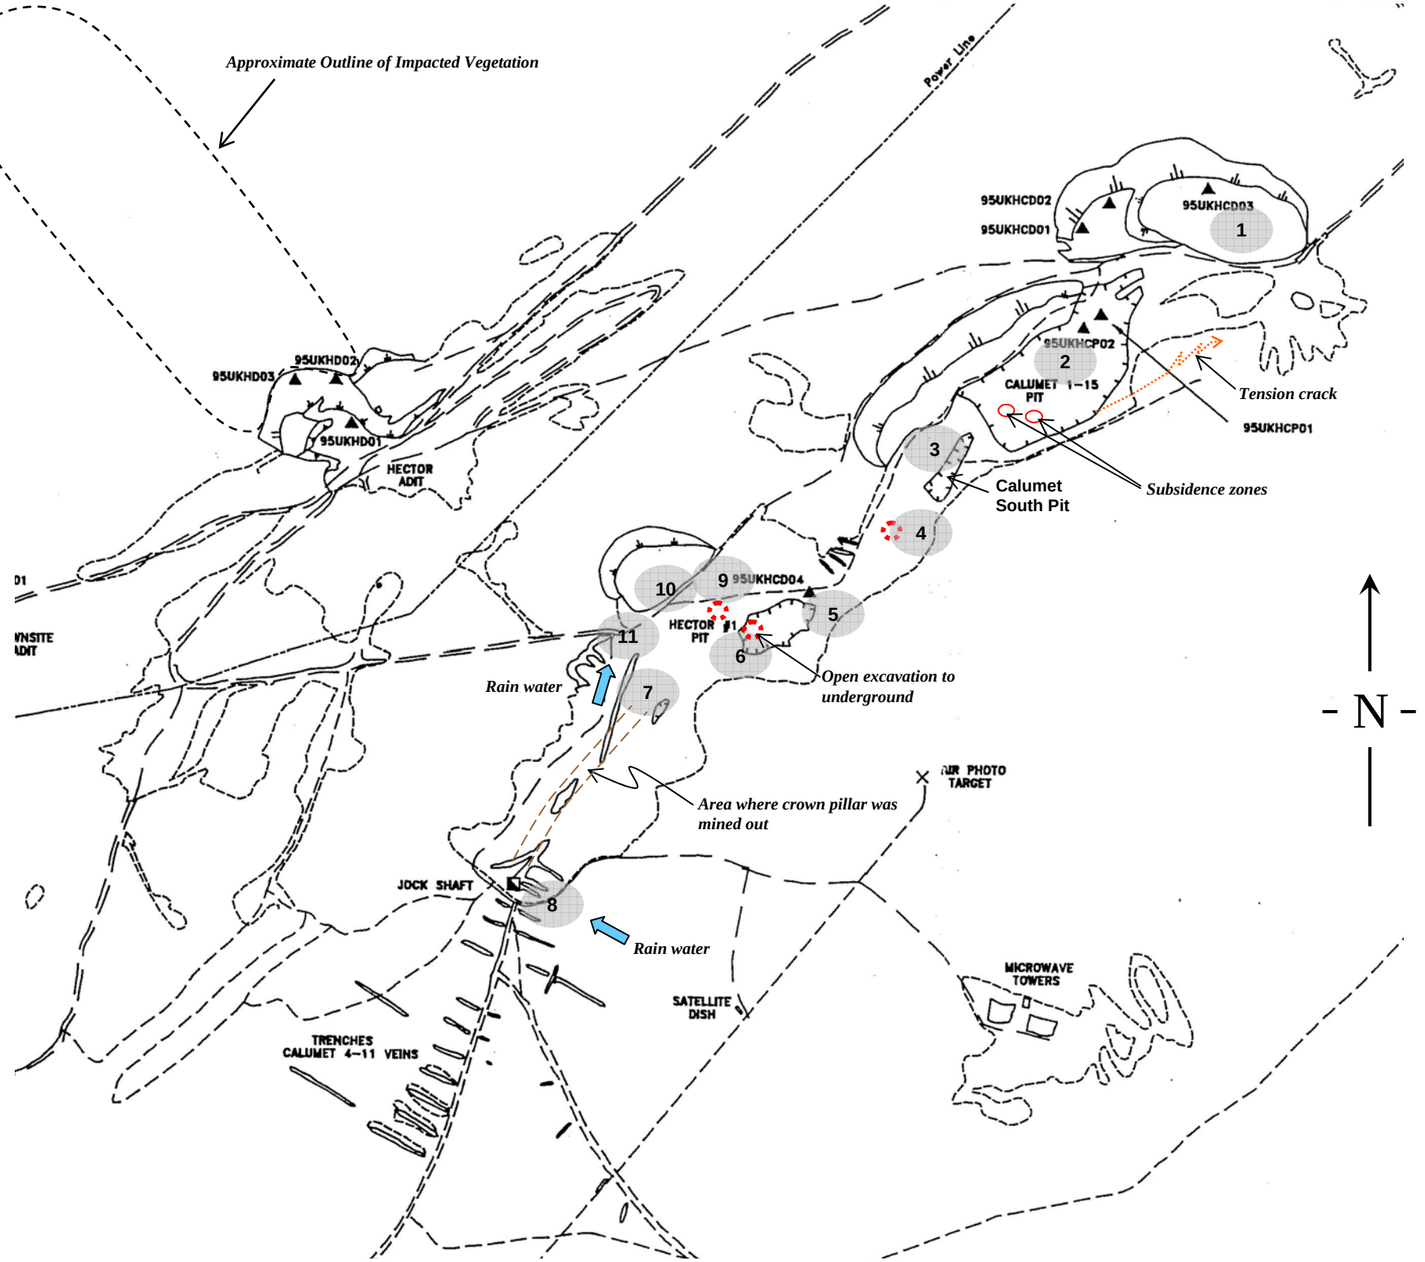
#6 *Crack 4 m back from the pit crest*
- *this is an early feature and is not currently active*
- *the bottom of the pit has an open excavation to the underground*

#7 *Trenching and ore extraction along the previous crown pillar intersected a number of raises as indicated by large quantity of timber in the trenches.*

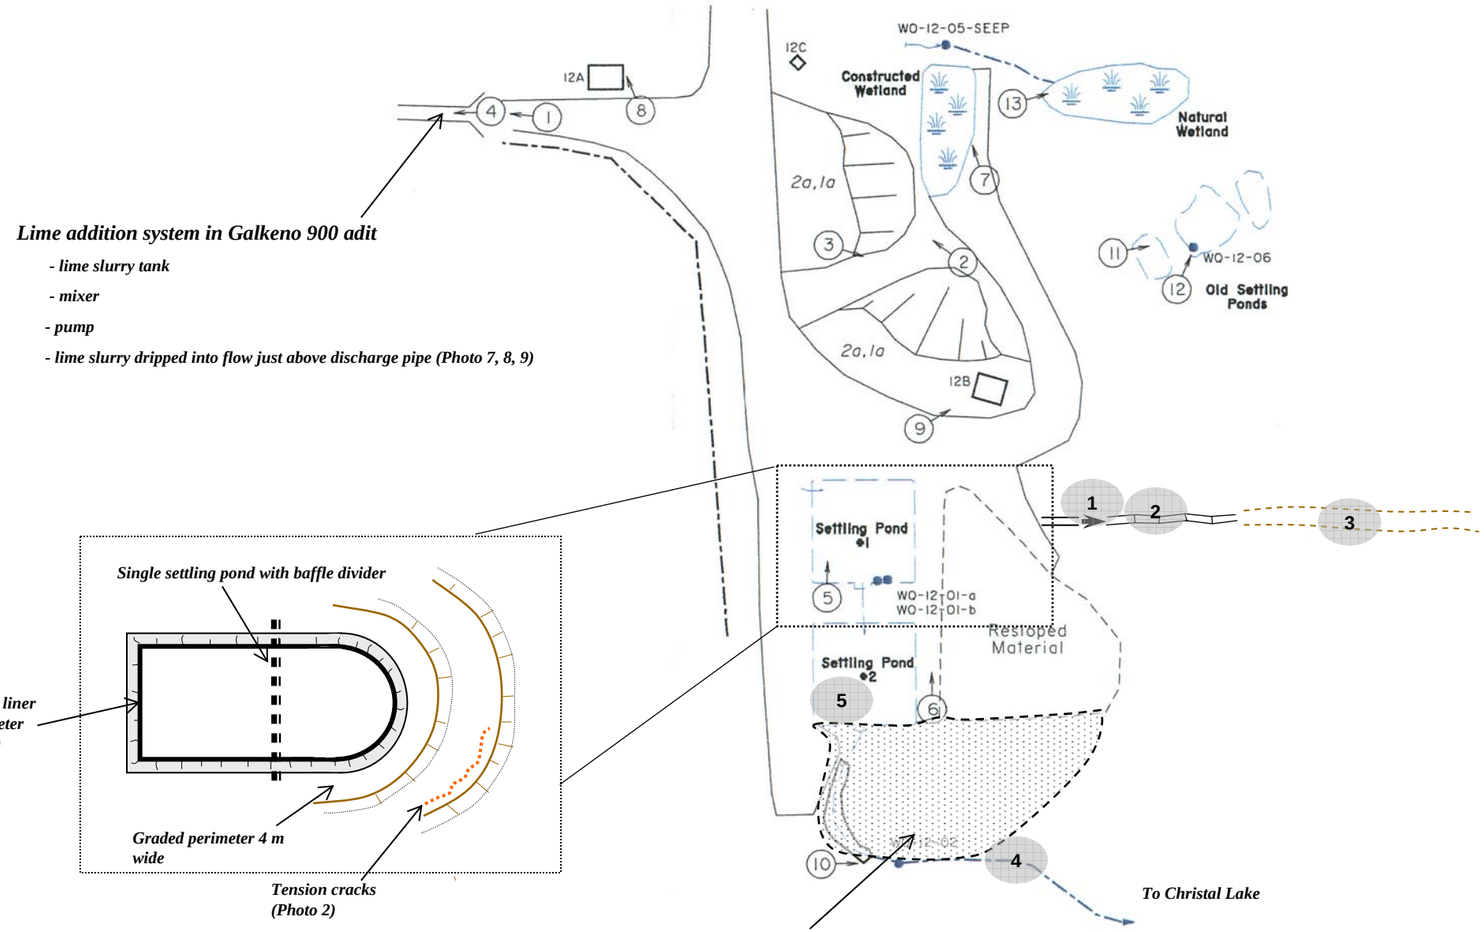
#1 Discharge from pipe into unbraced corrugated sections (Photo3)

#3 Discharge path shows whitish precipitates, heavy iron-staining and permafrost thaw features (Photo 5)

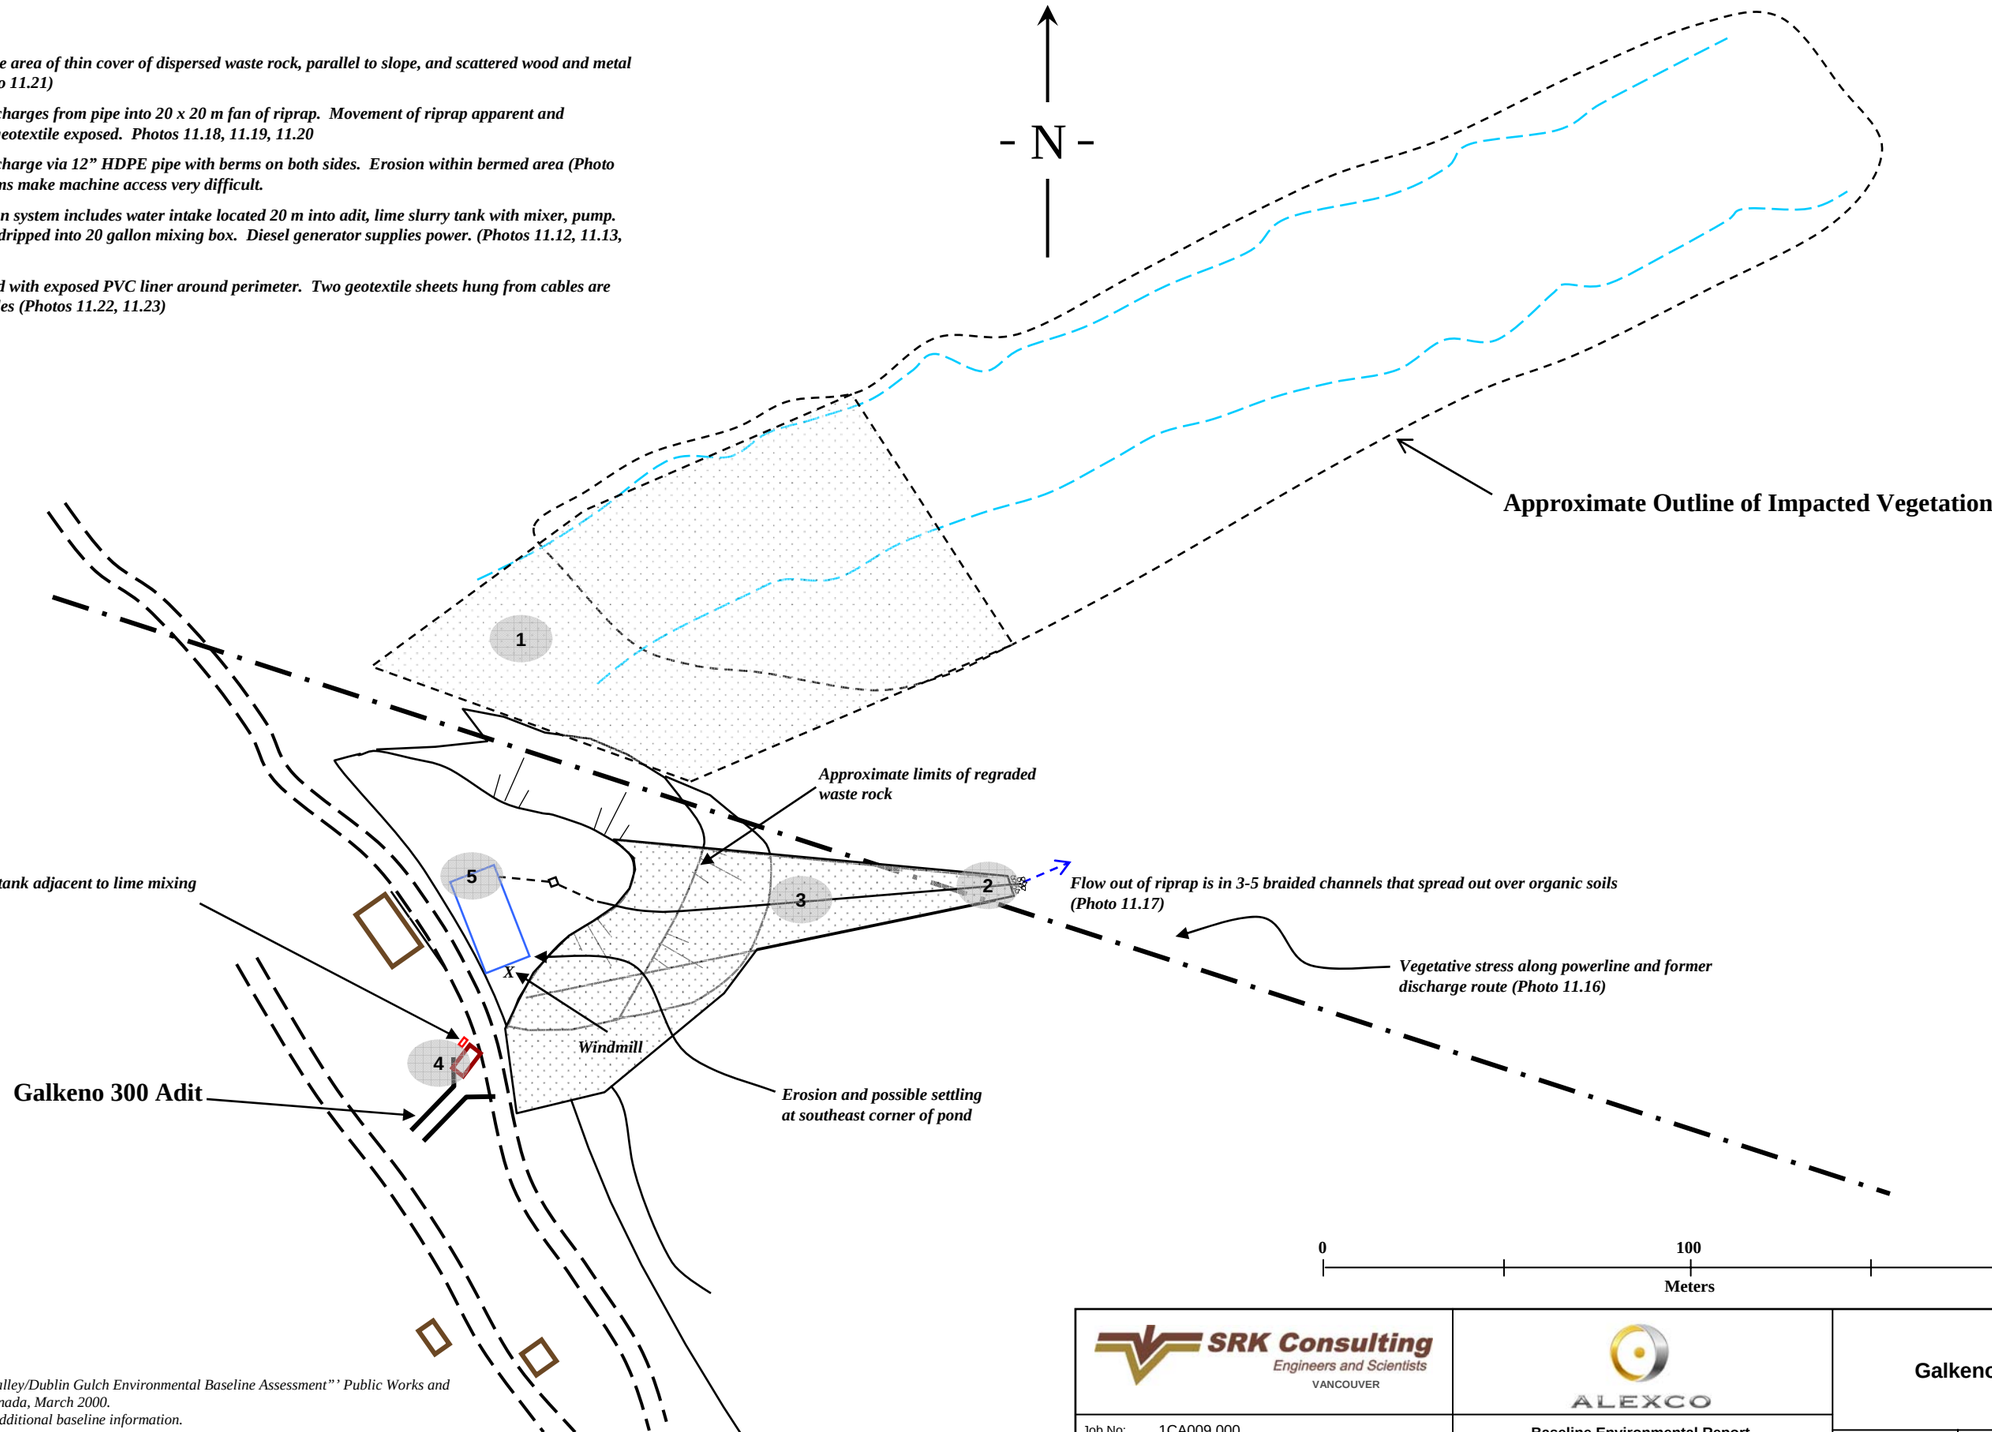
#1 Approximate area of thin cover of dispersed waste rock, parallel to slope, and scattered wood and metal debris (Photo 11.21)

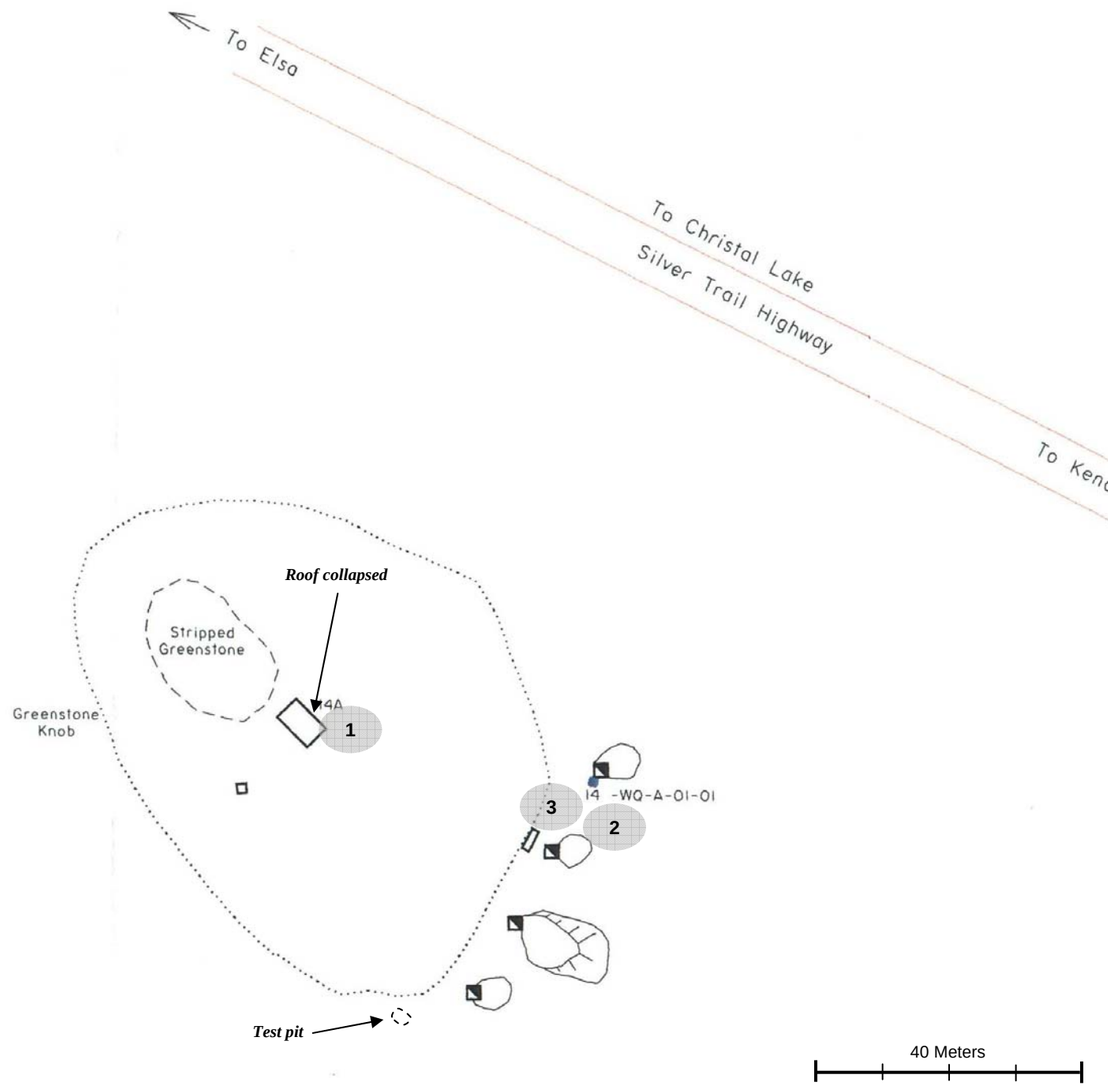
#1 - 2 sheets of approximately 1.2 m by 1.2 m asbestos fibreboard in NE corner of cabin- fixed to wall as heat shield for wood stove.

#2 - Minor unvegetated oxidized greenstone and vein material.

#3 - 3 m x 2 m x 2 m rock cut into base of outcrop with greenstone waste rock adjacent to east.

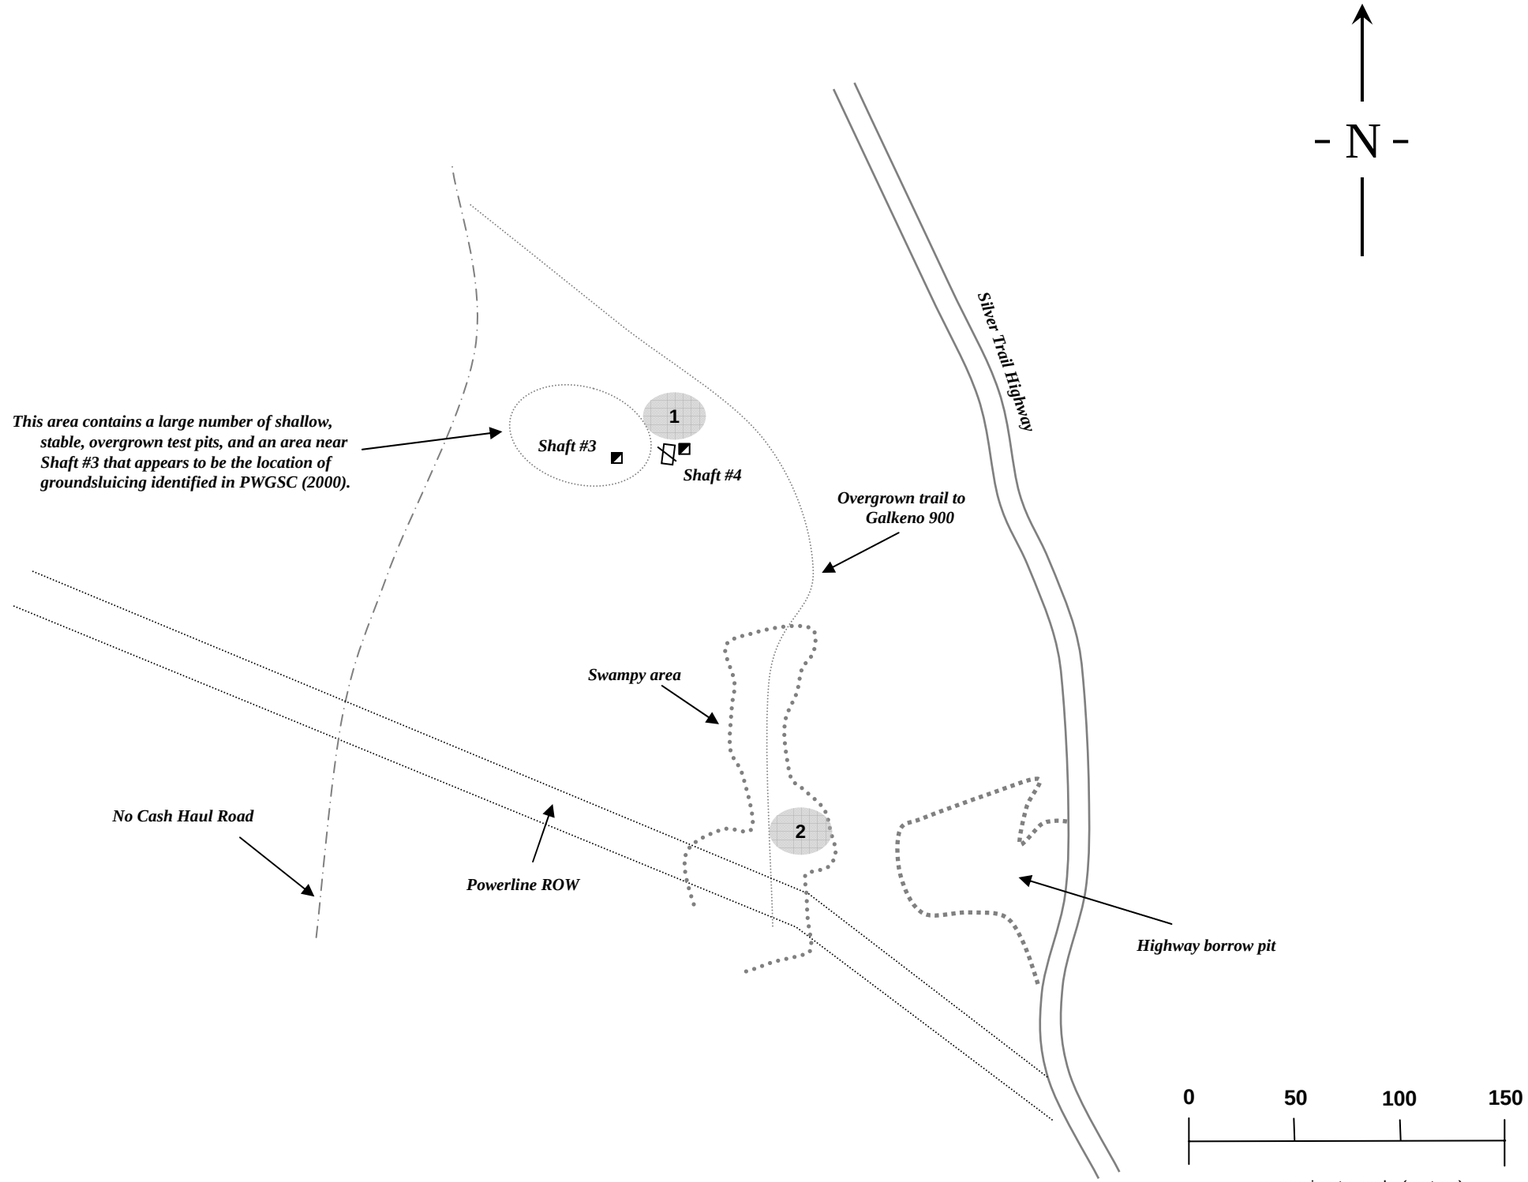
#1 - Shafts #1 and #2 described in PWGSC 2000 not located.
- Two previously-unidentified shafts were located.

- Shaft #3: NAD 83 483470 E, 7088650 N. 1.7 m x 1.7 m collapsed timber-cribbed shaft, with subsidence around the shaft opening forming a 2 to 3 m deep 3 m x 5 m depression (Photo 15.-1). Area to east and southeast appears to have been groundsluiced (4 m x 30 m x up to 1 m deep)- presently covered by dense growth of alders.

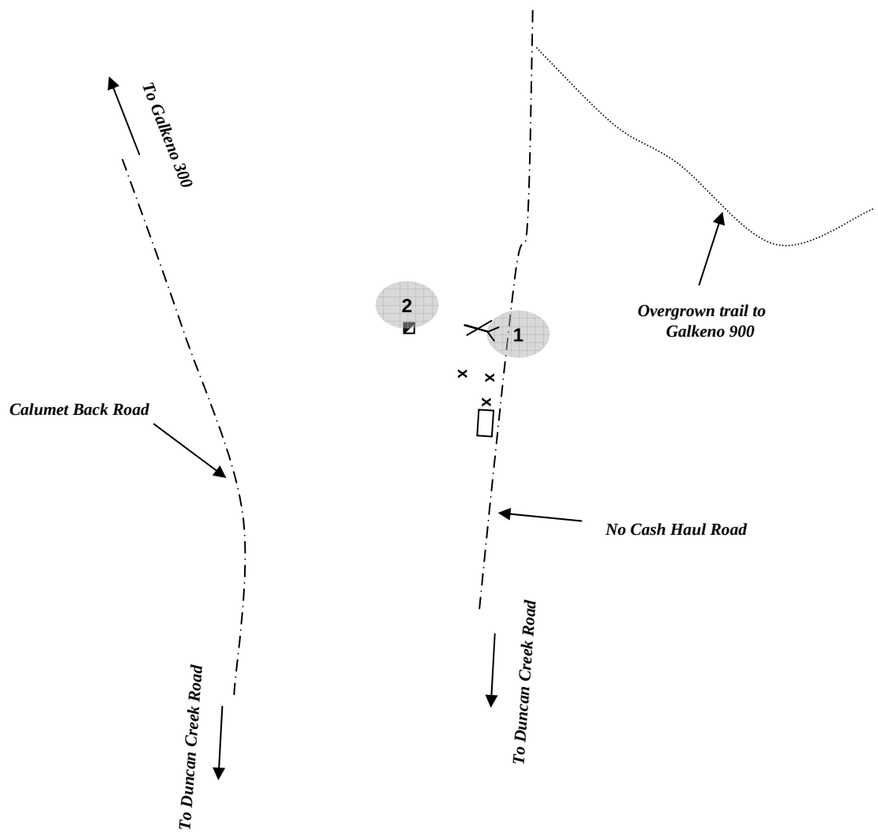
#1 - There appeared to be insufficient volume of waste rock for a 37 m adit. Waste may have been used as road material.
- Linear subsidence above adit extends for ~30 m, up to 2.5 m deep with stable sides and complete revegetation.

#2 - Shaft waste pile 70% overgrown with moss, lichen, heather, and isolated birch.
- Composed of weathered quartzite breccia, siderite vein material, minor oxidized carbonaceous phyllite.
- Abundant black manganese oxide staining observed, lesser orange to dark rusty brown staining.
- Shaft remains open; water and debris observed at 4m depth. Timber support remained intact.

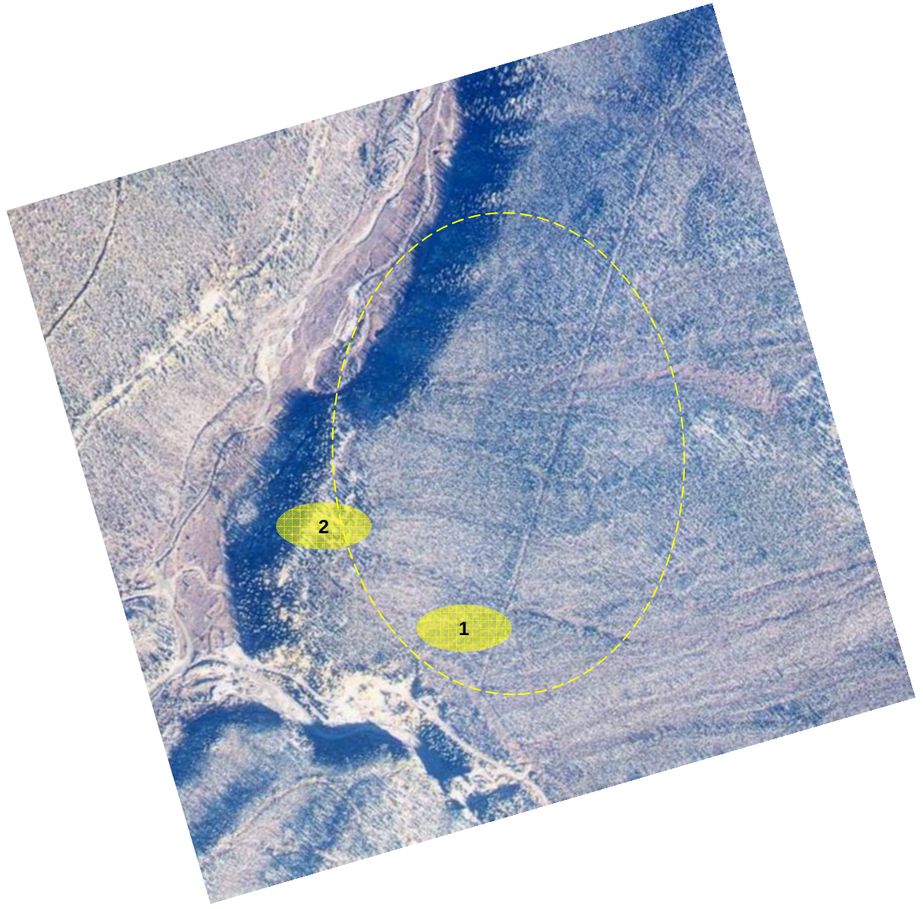
#1 - Area of trenches identified in PWGSC 2000 east of confluence of Lightning Creek and Upper Duncan Creek.

- At the time of inspection in 2006, no trenches were located. There are several cutlines in the area indicated on the aerial photograph, and there are areas where melting of permafrost along the cutlines has resulted in subsidence and the formation of linear depressions.

- Complete or nearly complete vegetative coverage was observed on all cutlines inspected in 2006.

#2 - Test pitting in gravel observed in this area. It is suspected that this disturbance is related to placer exploration.

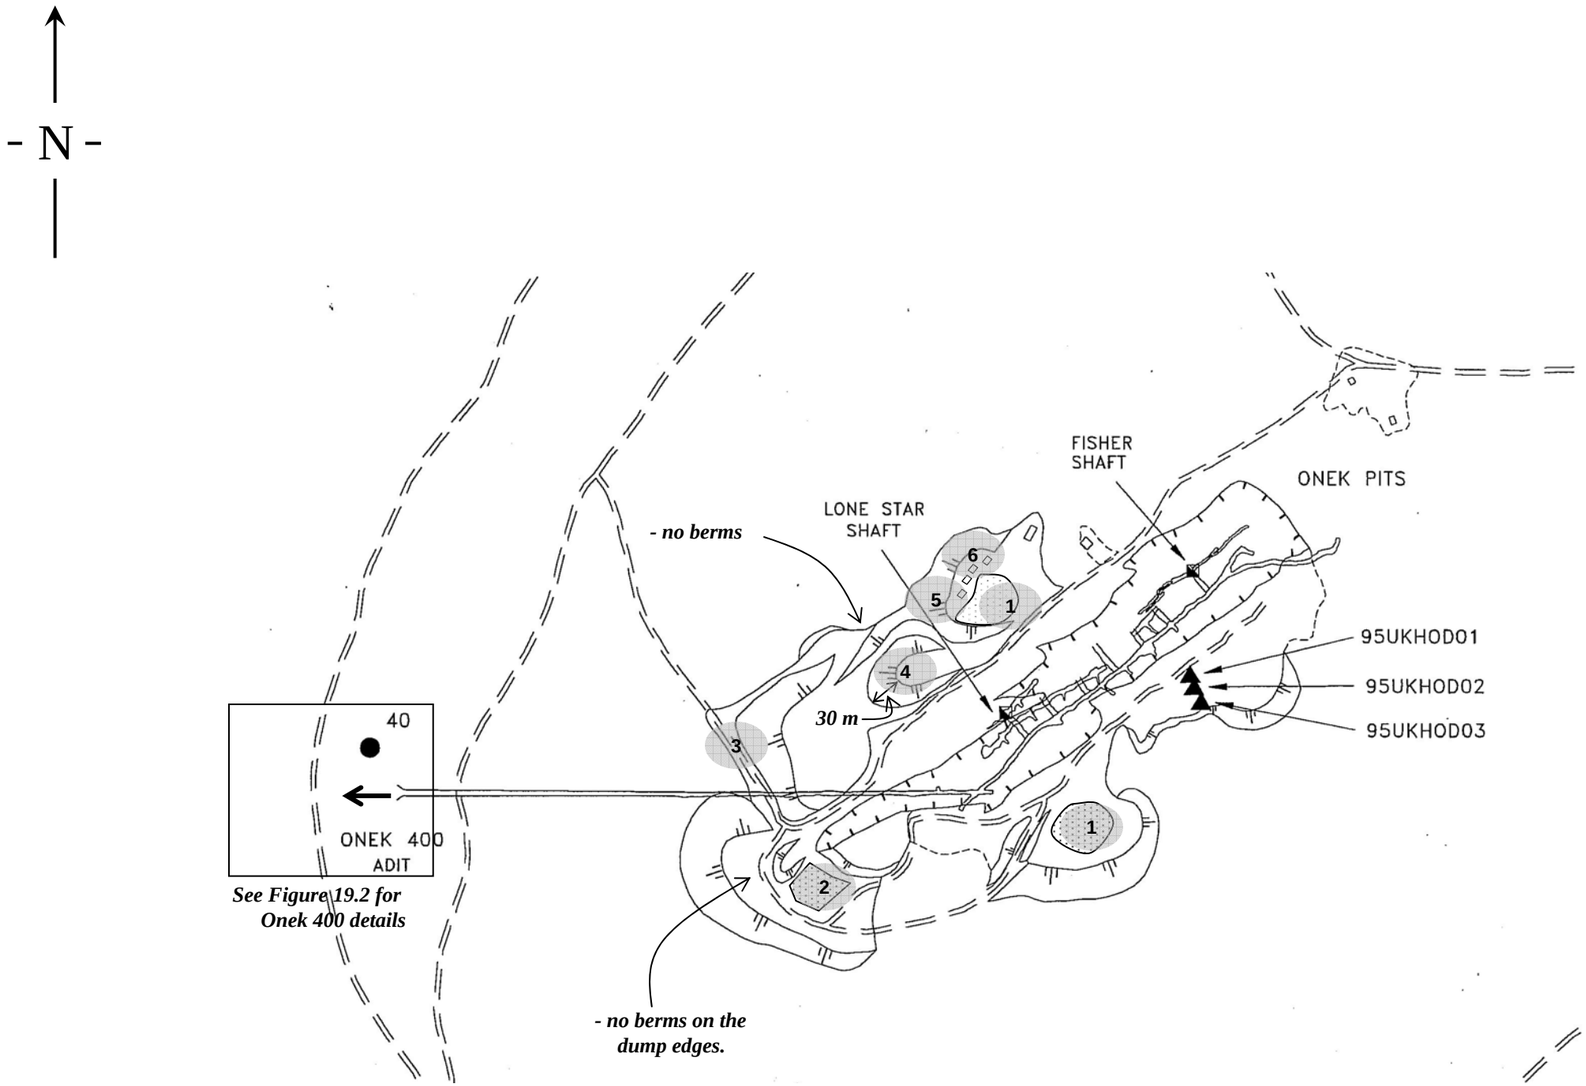
Figure: **72**

#1 - Free dumps and traffic surfaces of oxidized dark orangey brown to black ore

#2 - Free dumps of oxidized dark orangey brown to black ore
- Approximately 40 dump loads, each 2 m x 4.5 m x 4.5 m

#6 -Minor hydrocarbon staining near buildings. Buildings in poor repair. One lead/ acid battery noted.

- No large pit failures are expected

- Dumps reviewed; berms noted on some dumps

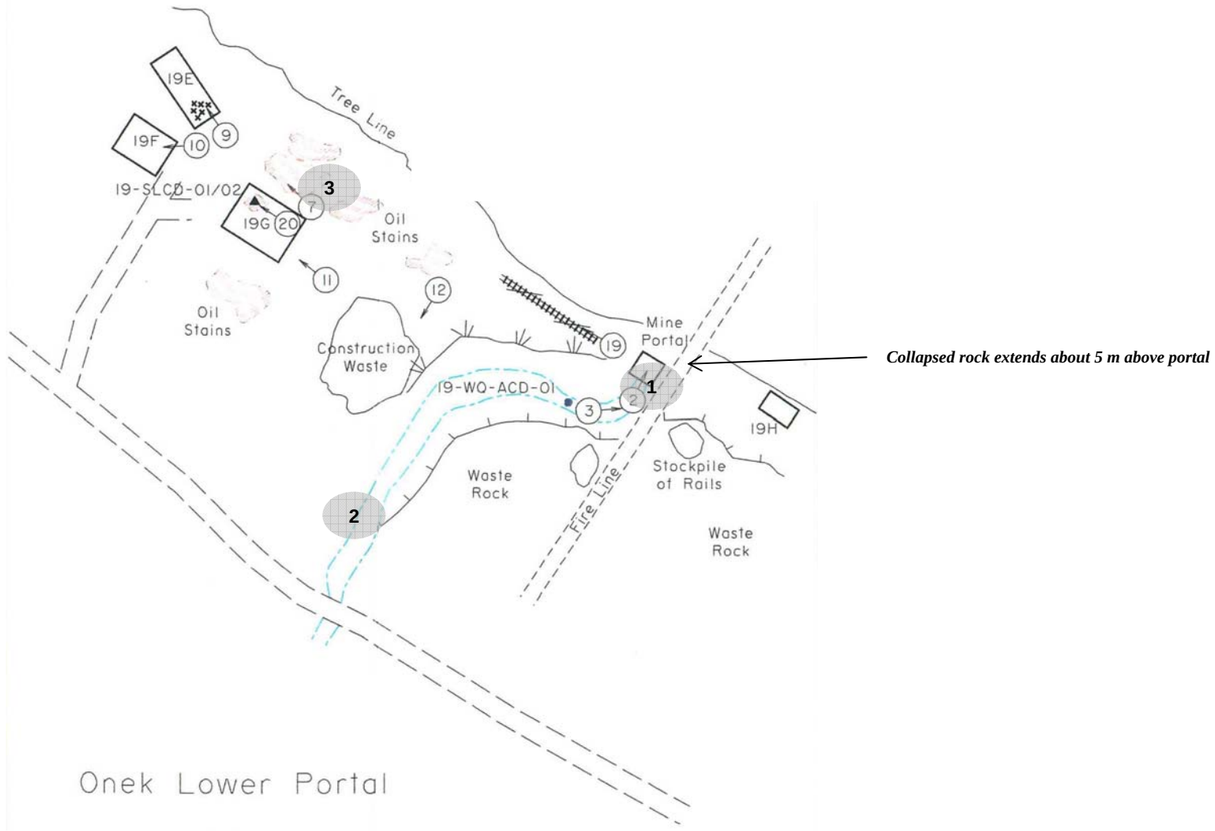
Onek Site #19
Onek 400 Portal

#1 Ice blockage in portal. Outflow is not in discharge pipe, but flows along base (Photo 19.9). Timber bracing in poor condition (Photo 19.10).

#2 Drainage from portal flows along ditch (Photos 19.7 and 19.8) and infiltrates about 10 m above culvert. Does not re-emerge downstream of road.

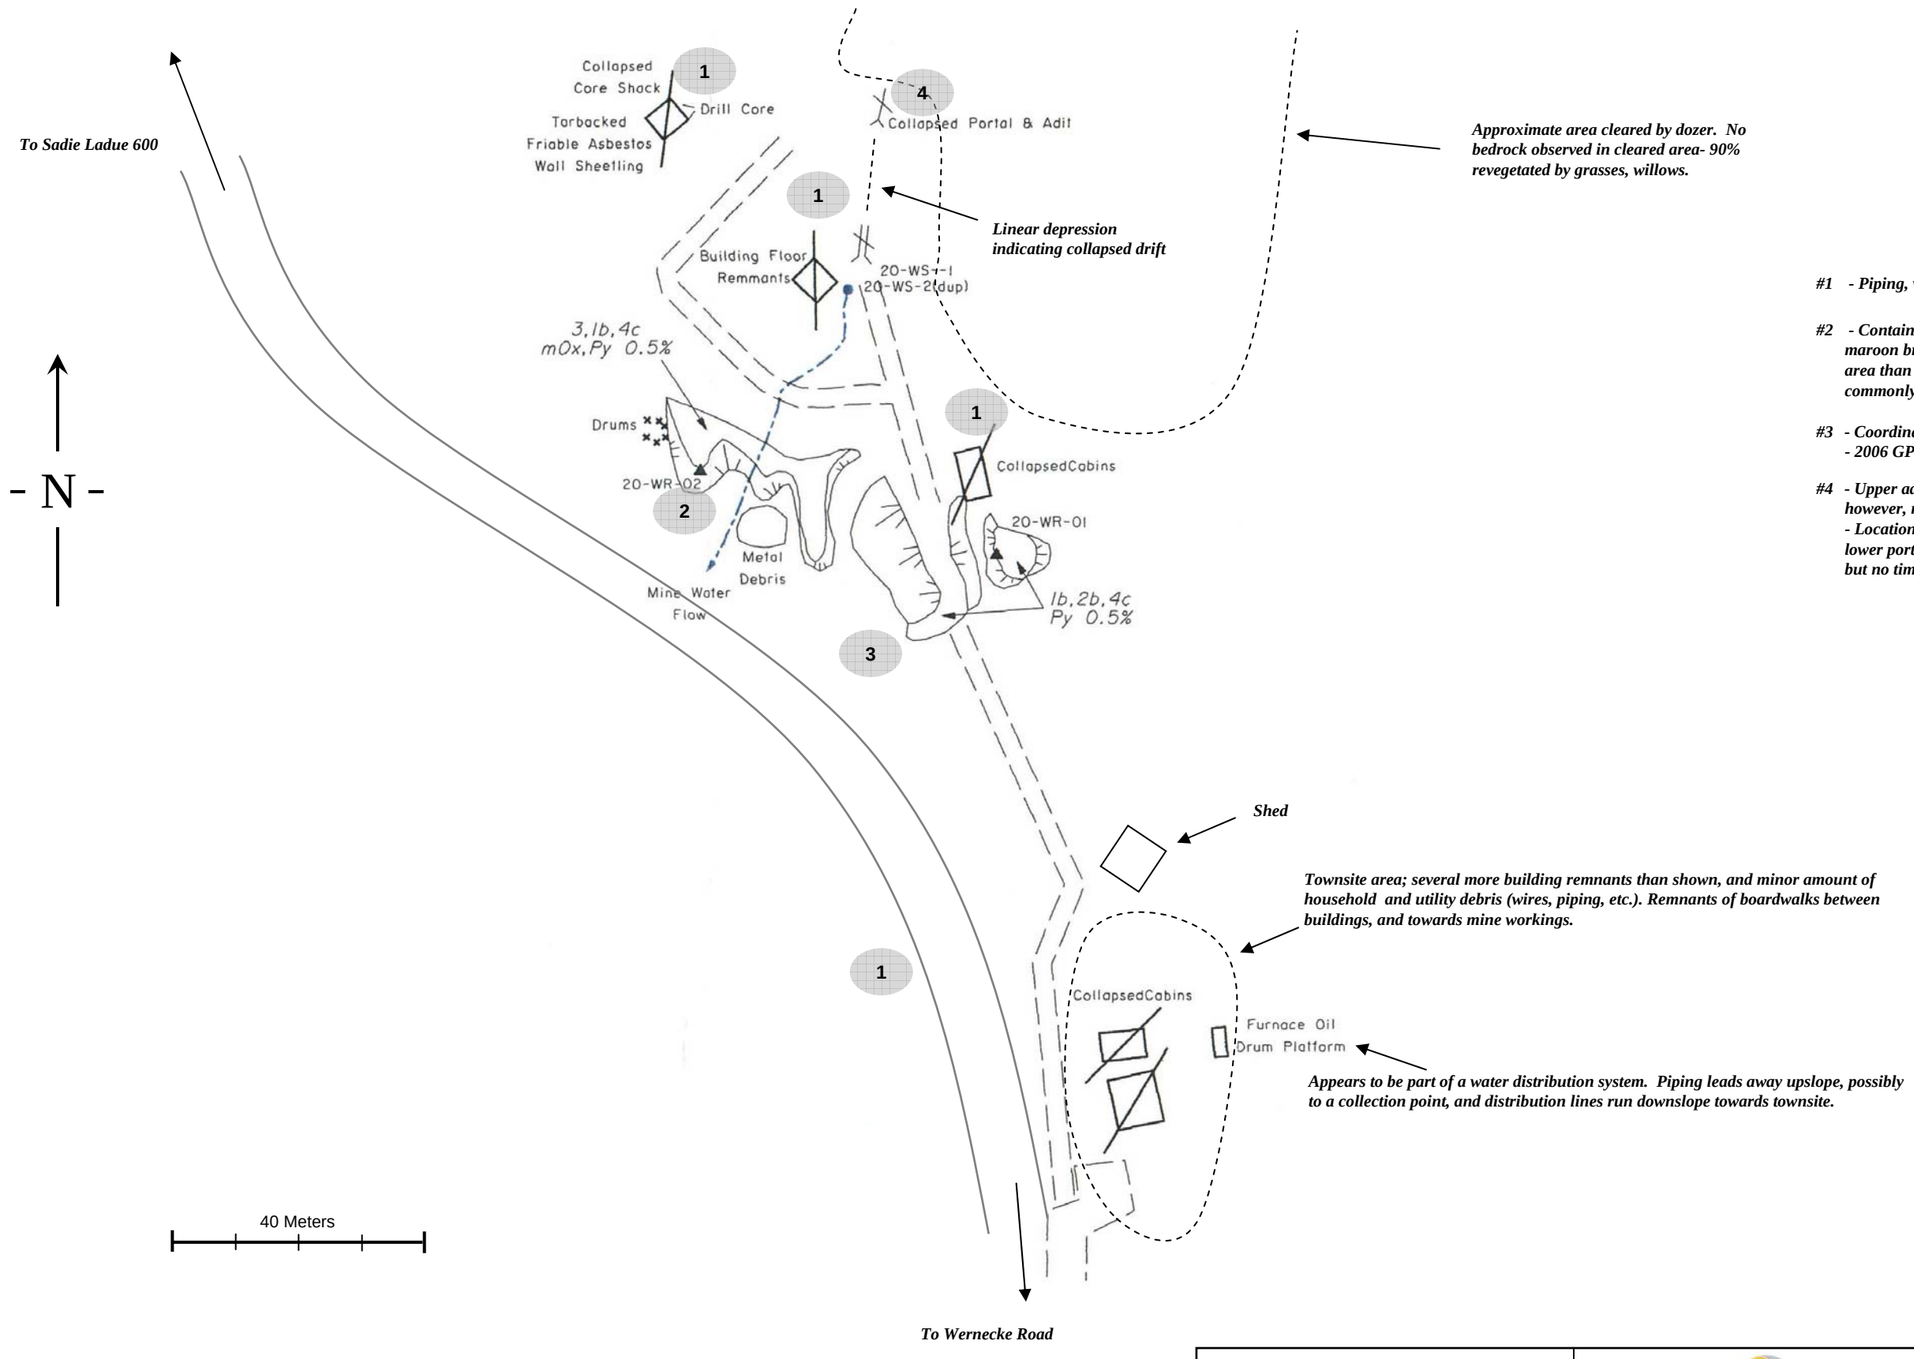
#1 - Piping, wood, and metal debris spread across site

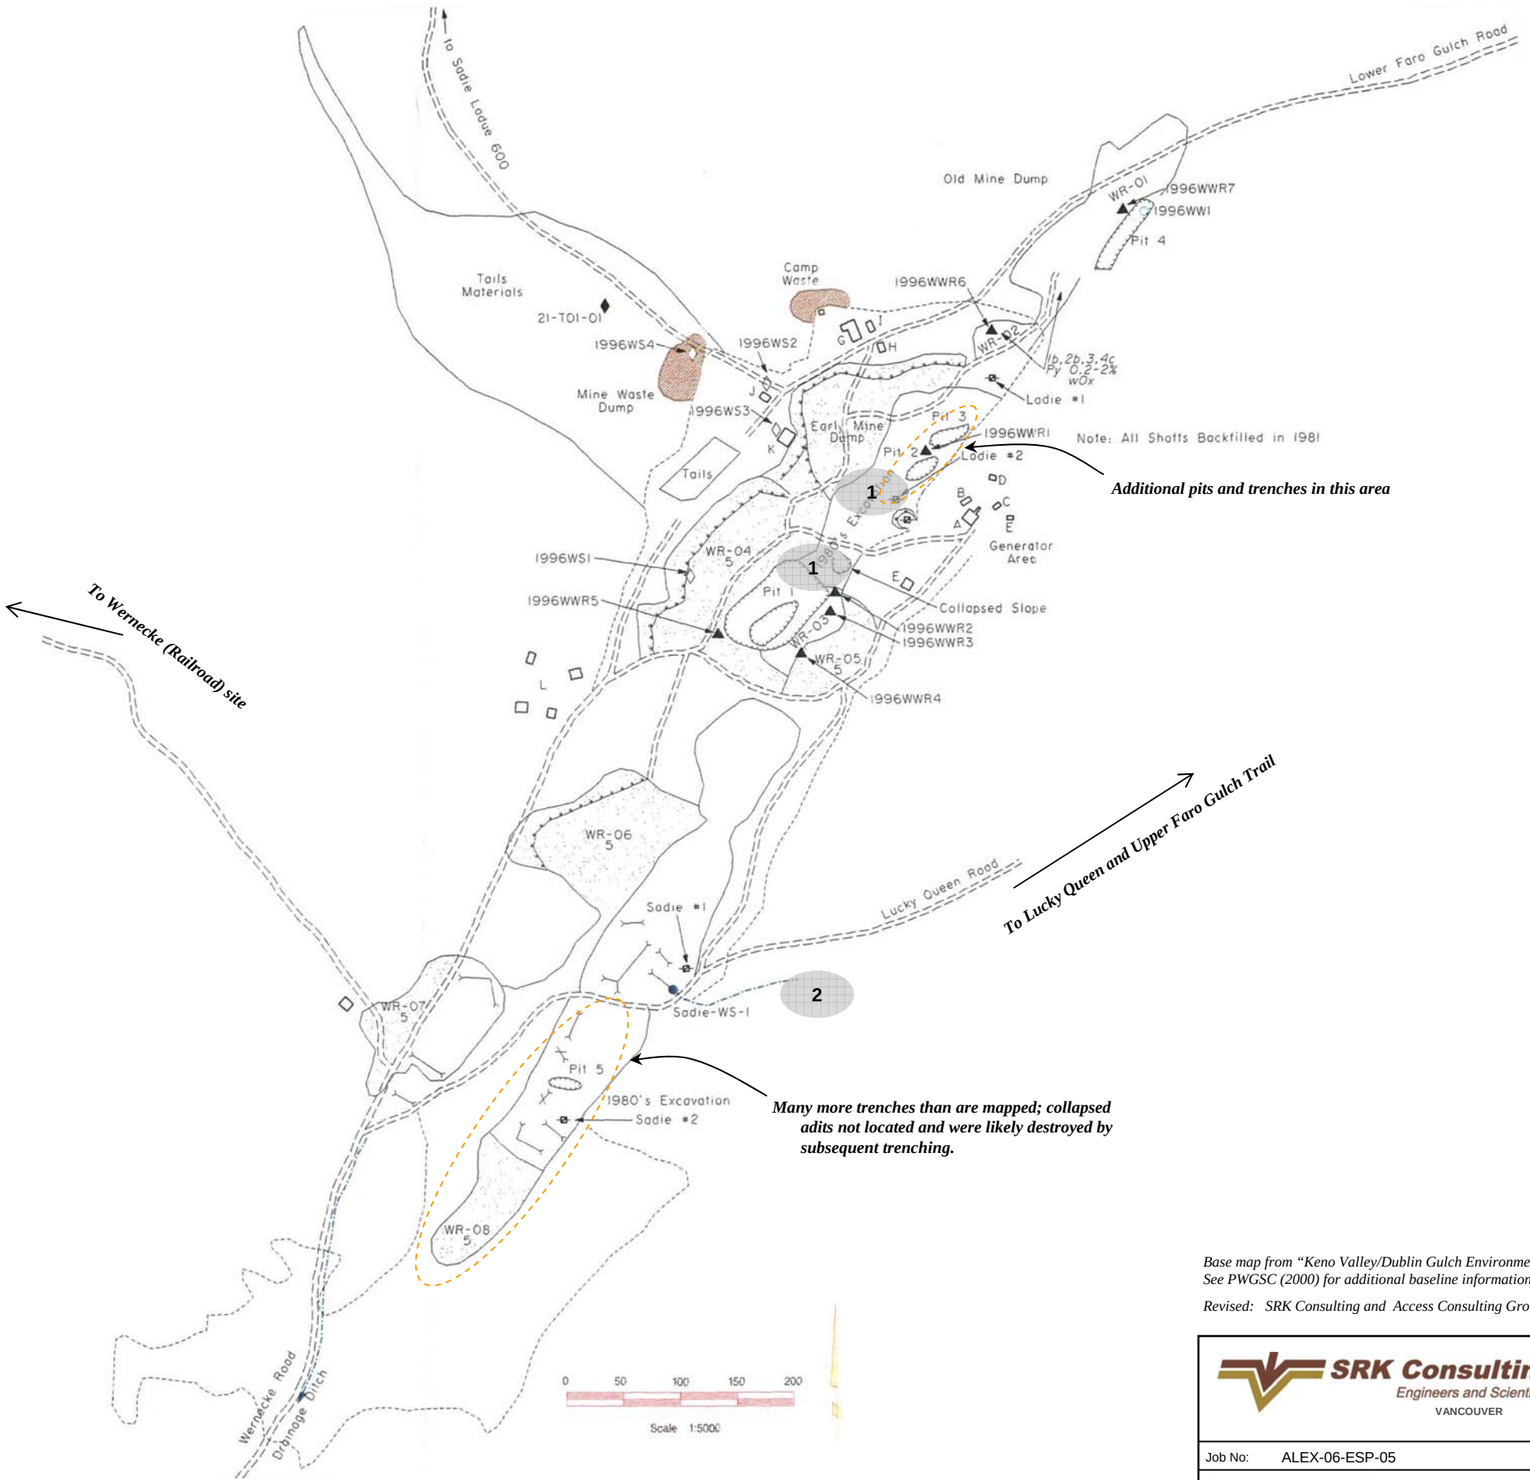
Additional pits and trenches in this area

Many more trenches than are mapped; collapsed adits not located and were likely destroyed by subsequent trenching.

#2 Water flow continues to enter pit at this location (visual estimate of 0.5 L/second in Sept. 2005). Water infiltrates into pit bottom- no evidence of surface flow out of pit was observed. May enter underground workings below pit.

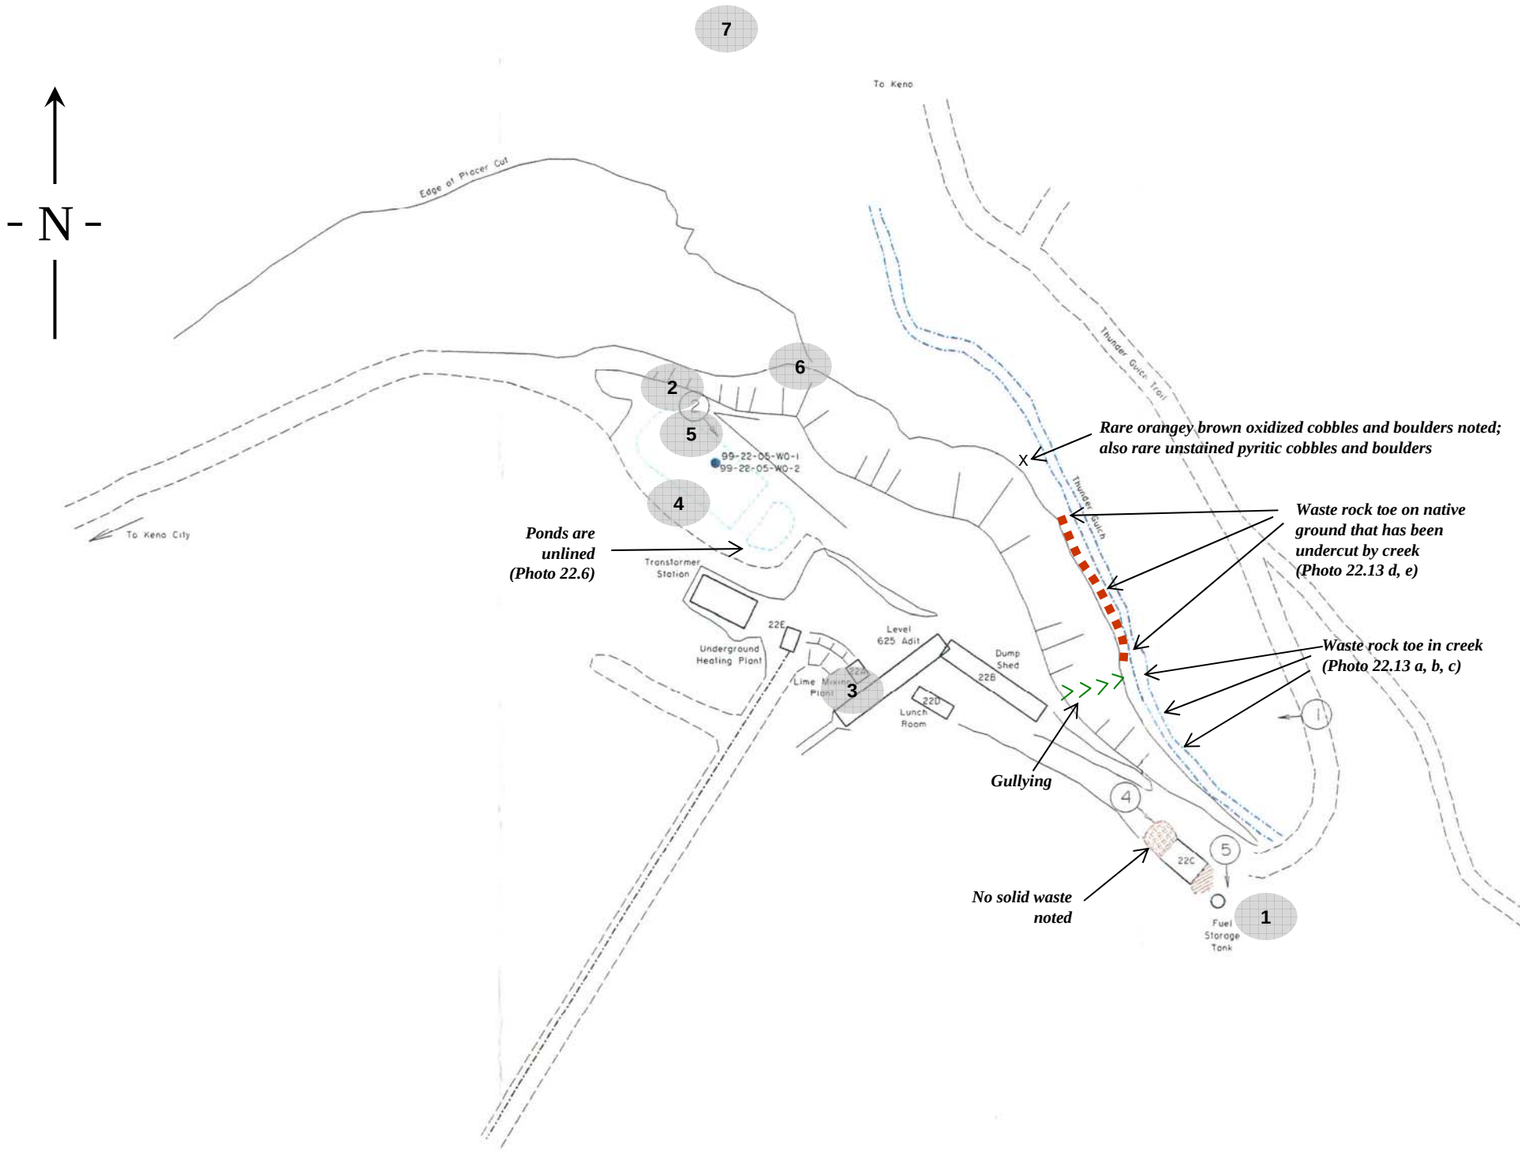
Figure: **84**

#1 Secondary Containment
- *wood lumber crib lined with black plastic*
- *plastic is compromised on west side, i.e. a spill would not be contained*
- *containment has ponded water and algae inside to depth of 5 cm*

Tank contains ~8" of product
- *appears to be drawn down to level of outlet pipe and valve*

#2 Minor tension cracks along edge of pond and along crest of waste rock slope (Photos 22.7 and 22.8)

#6 5 – 8 Seeps, no staining but some unhealthy vegetation (Photo 22.12)

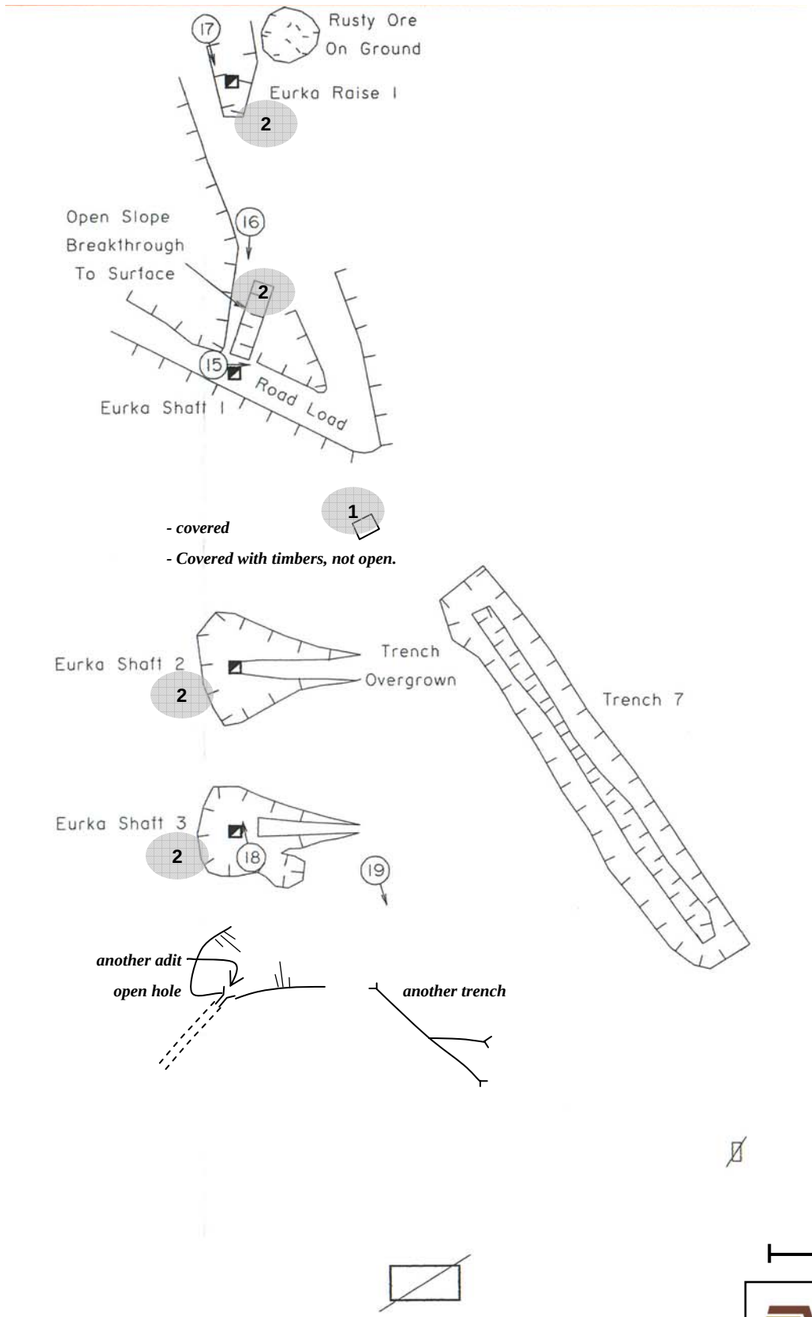
Bellekeno Site #22
Eureka area

#1 - Unmapped vertical raise identified in 2005.
- 6 – 8 ft of the raise is exposed. Lower down is closed as the sides may have collapsed.
- May have been backfilled in 2006.
