KENO HILL SILVER DISTRICT

CLOSURE ISSUES REPORT

DRAFT

MARCH 2009

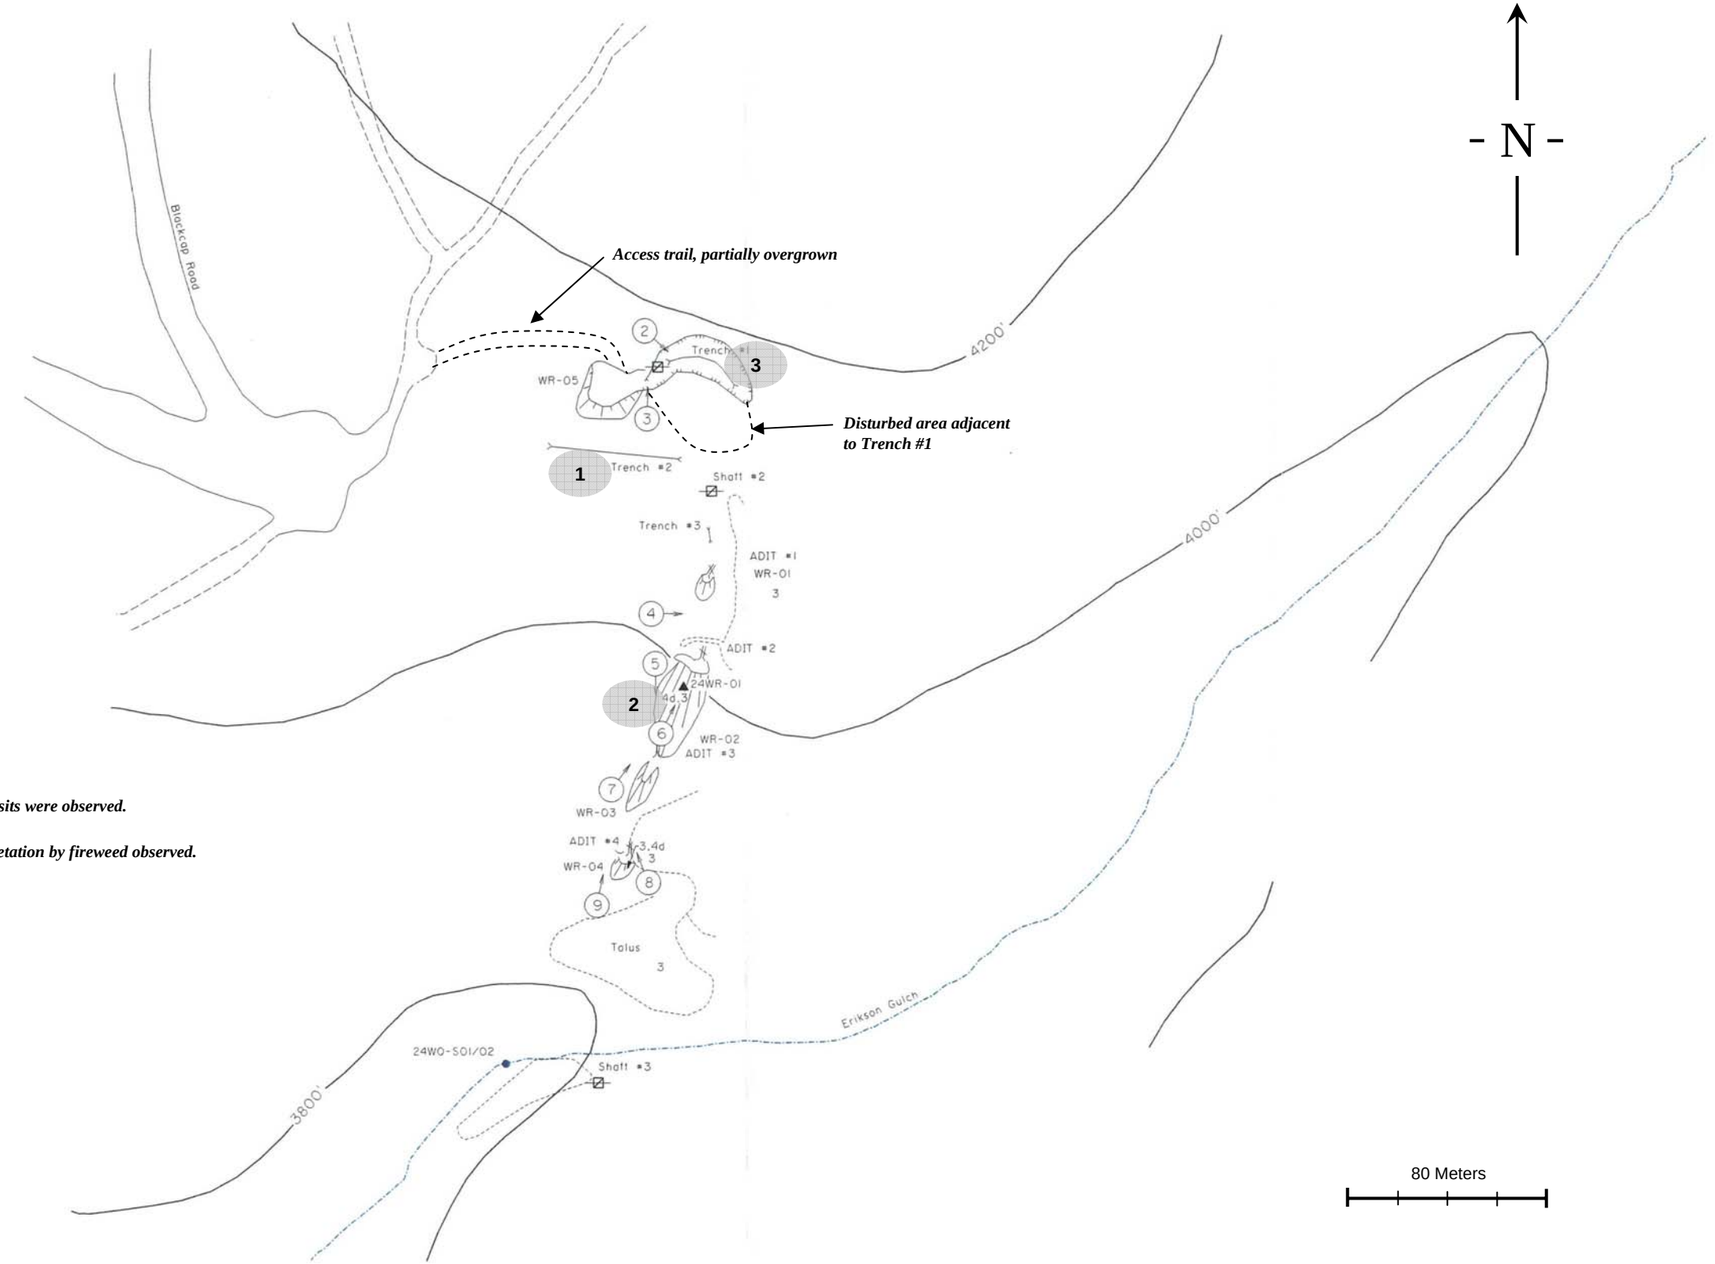
#1 - Trench #2 appears to channel surface runoff, but no erosion or sediment deposits were observed.

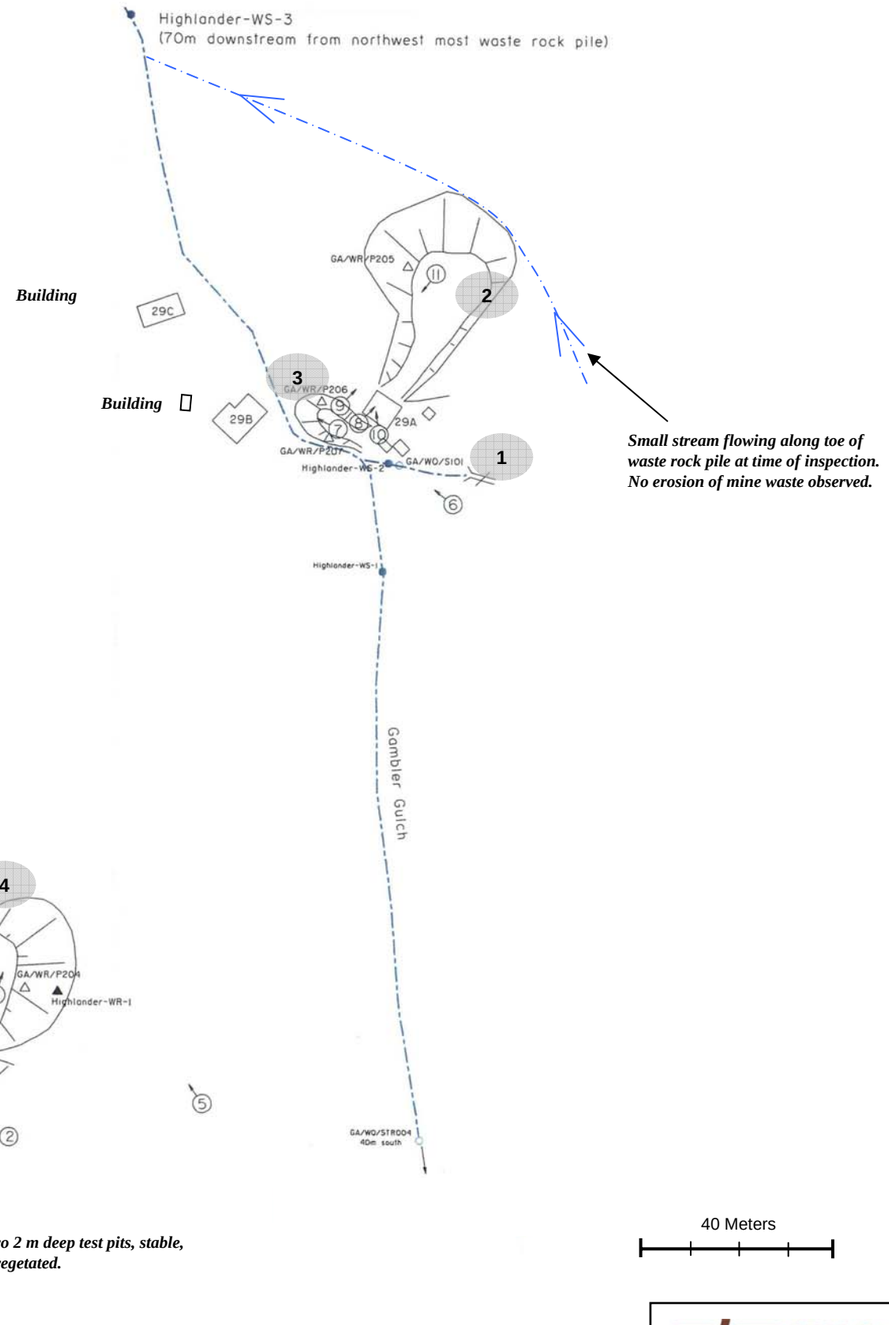
Small stream flowing along toe of waste rock pile at time of inspection. No erosion of mine waste observed.

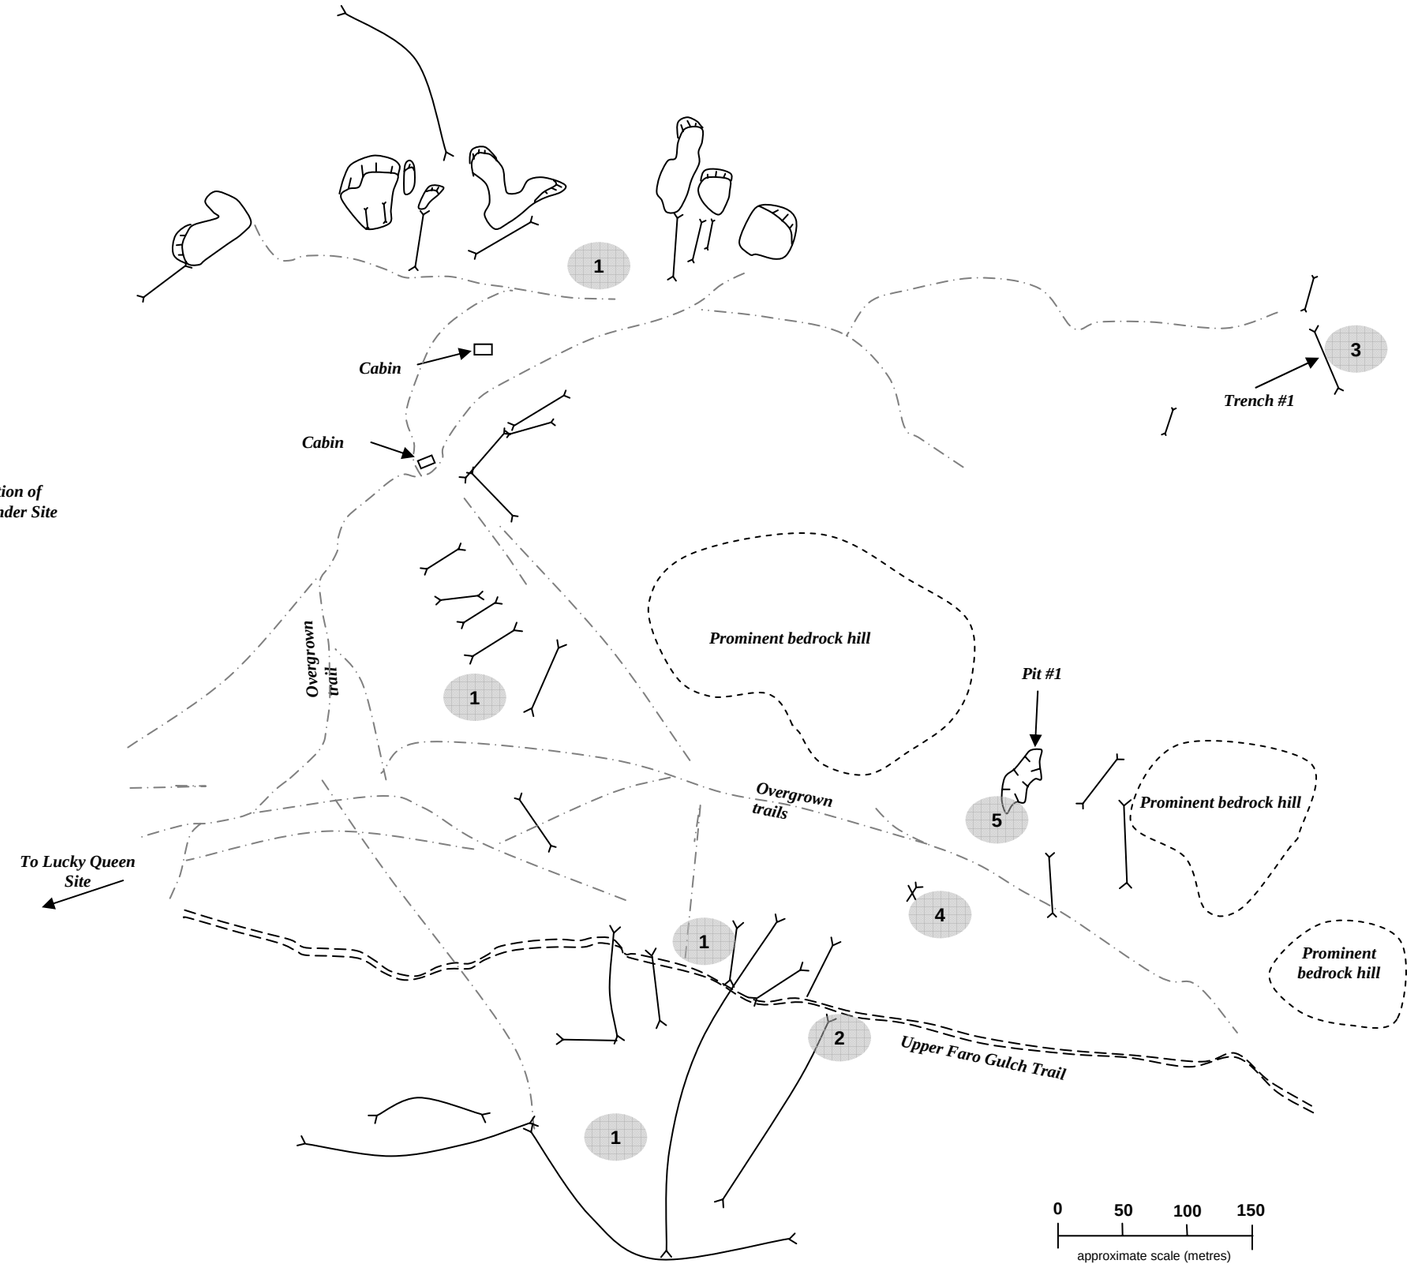
#2 - Ponded water in trench upslope of Upper Faro Gulch Trail (0.5 m deep x 2 m wide x 7 m long). Water was clear, with grasses growing around edges of pond (Photo 30-5). Trickling flow observed from spill point onto trail, then flow infiltrated into surface of trail.

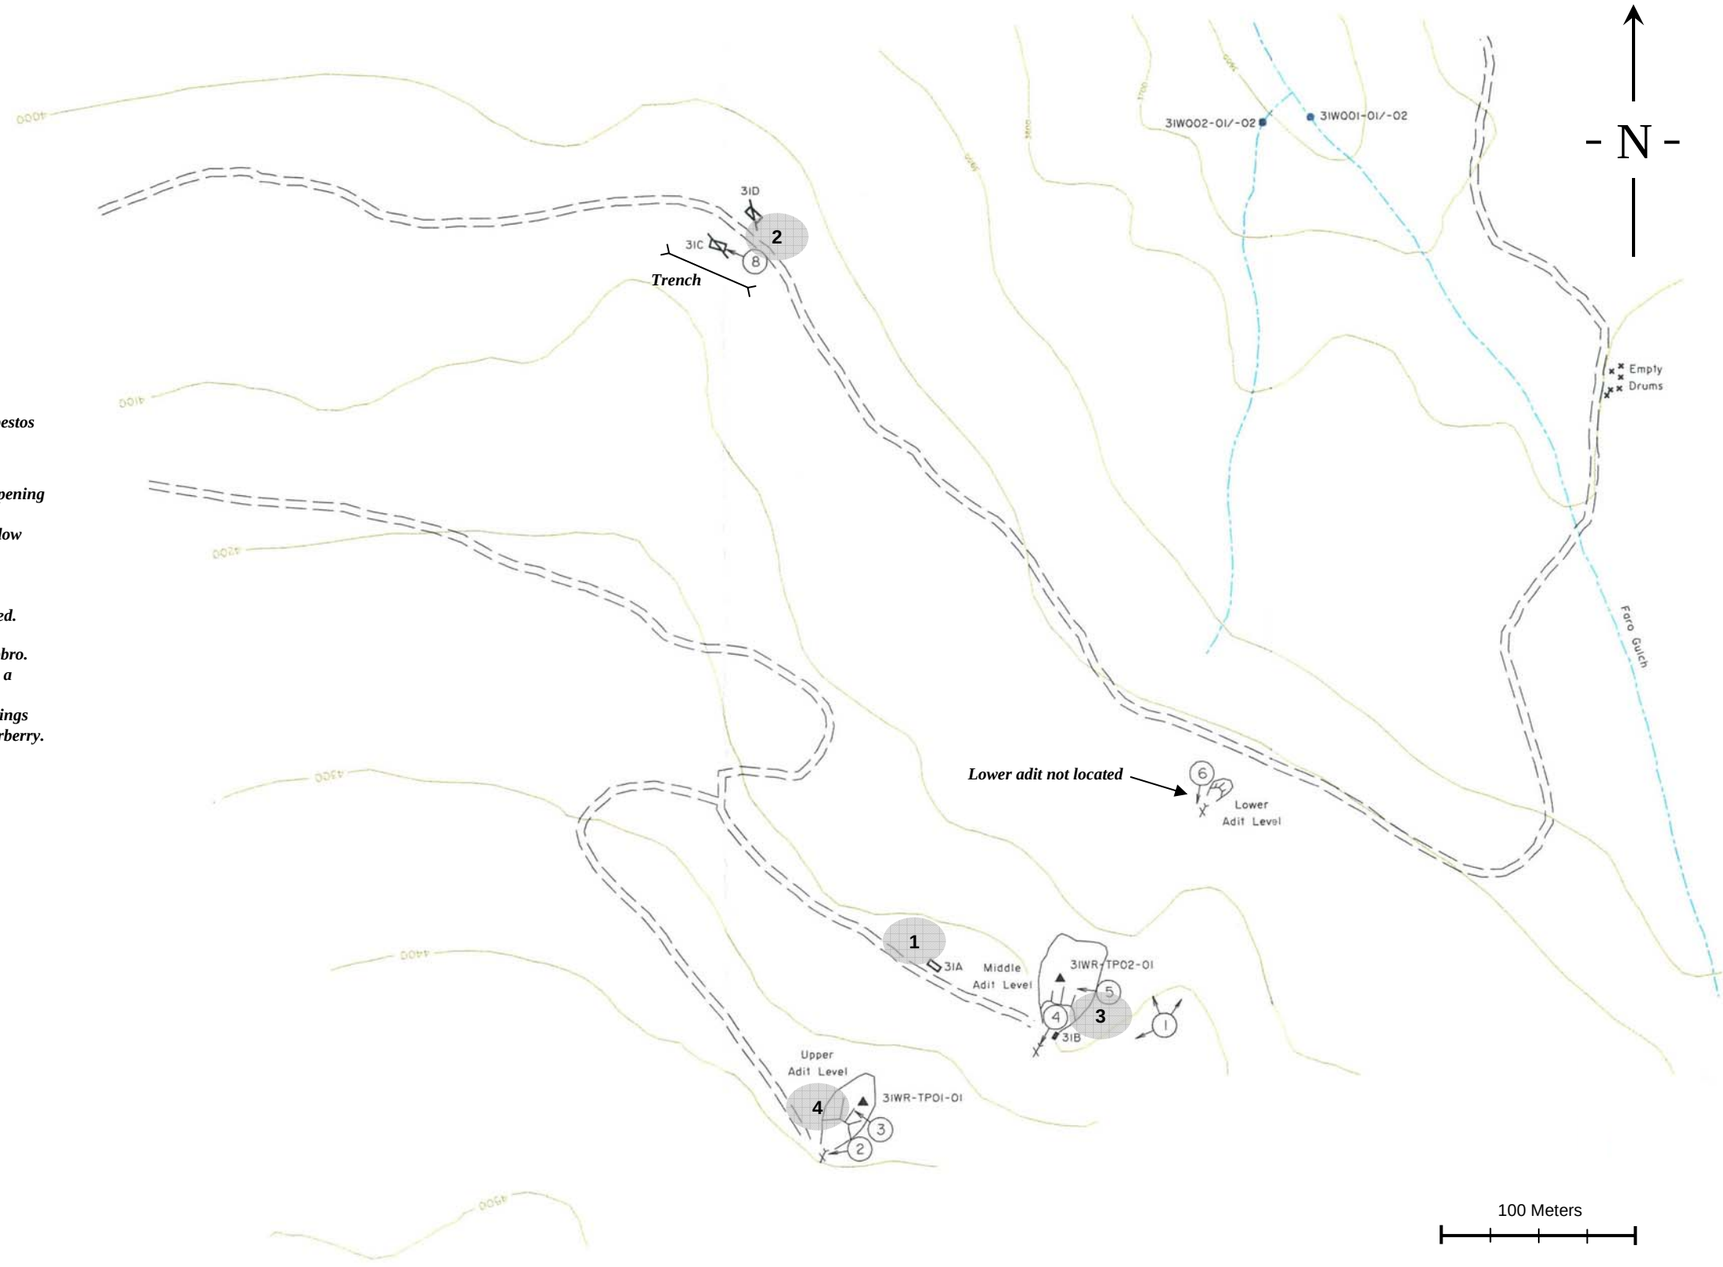
#2 - Buildings 31C and 31D area collapsed- tarpaper, particle board, lumber, asbestos shingle siding (<1 m^3), other household debris remain.

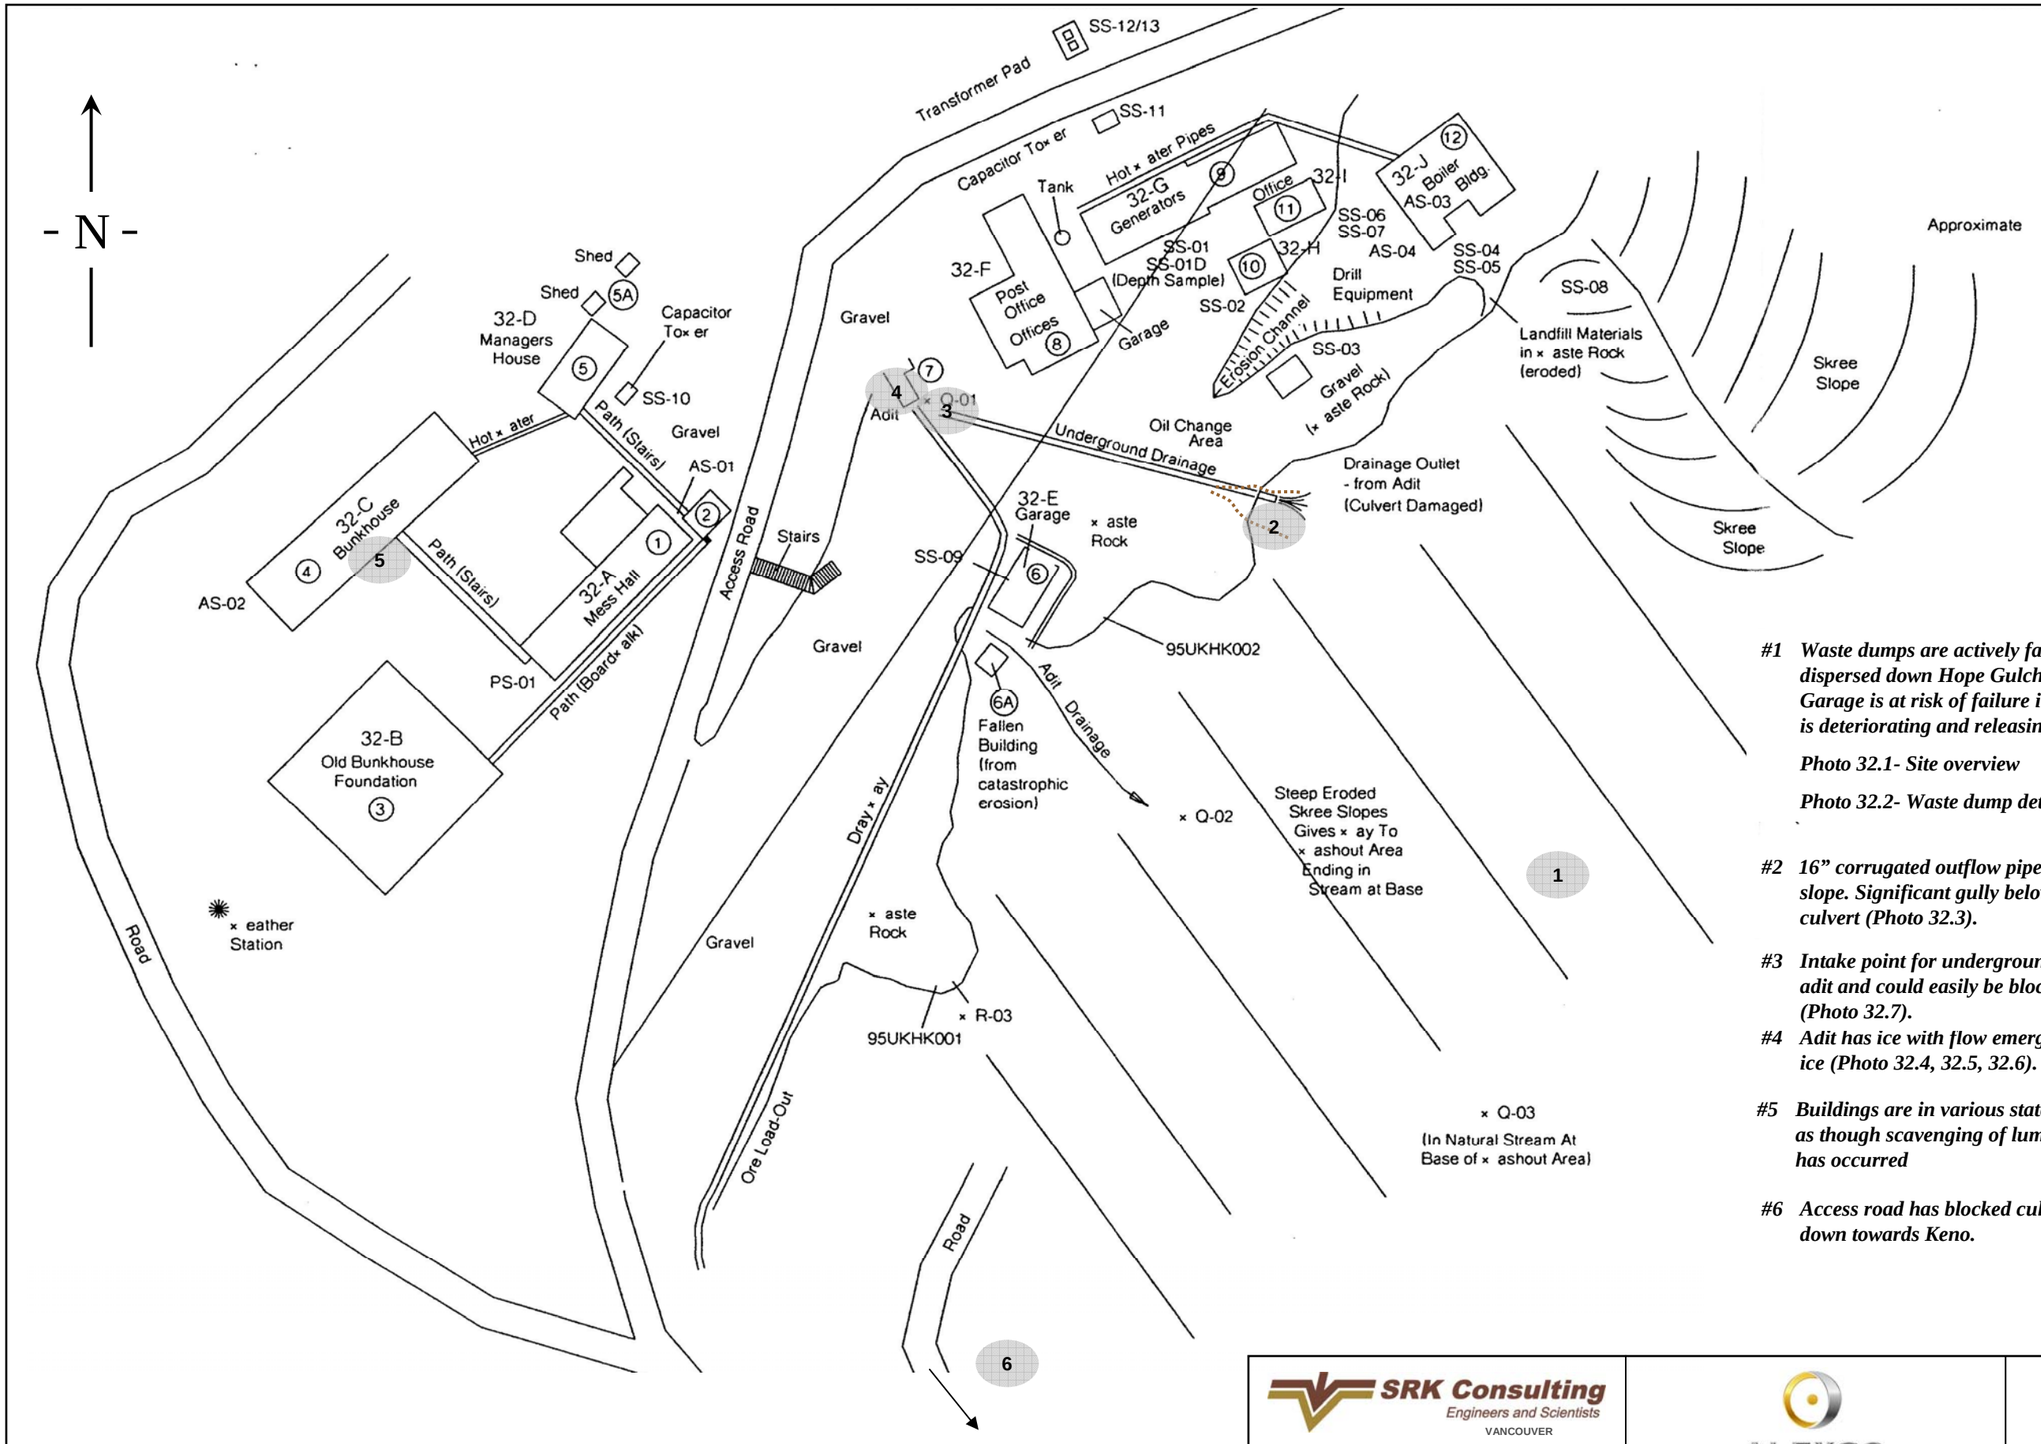
#1 Waste dumps are actively failing and waste material is being dispersed down Hope Gulch. Waste that forms foundation of Garage is at risk of failure in the short term. Timber cribbing is deteriorating and releasing retained waste material.

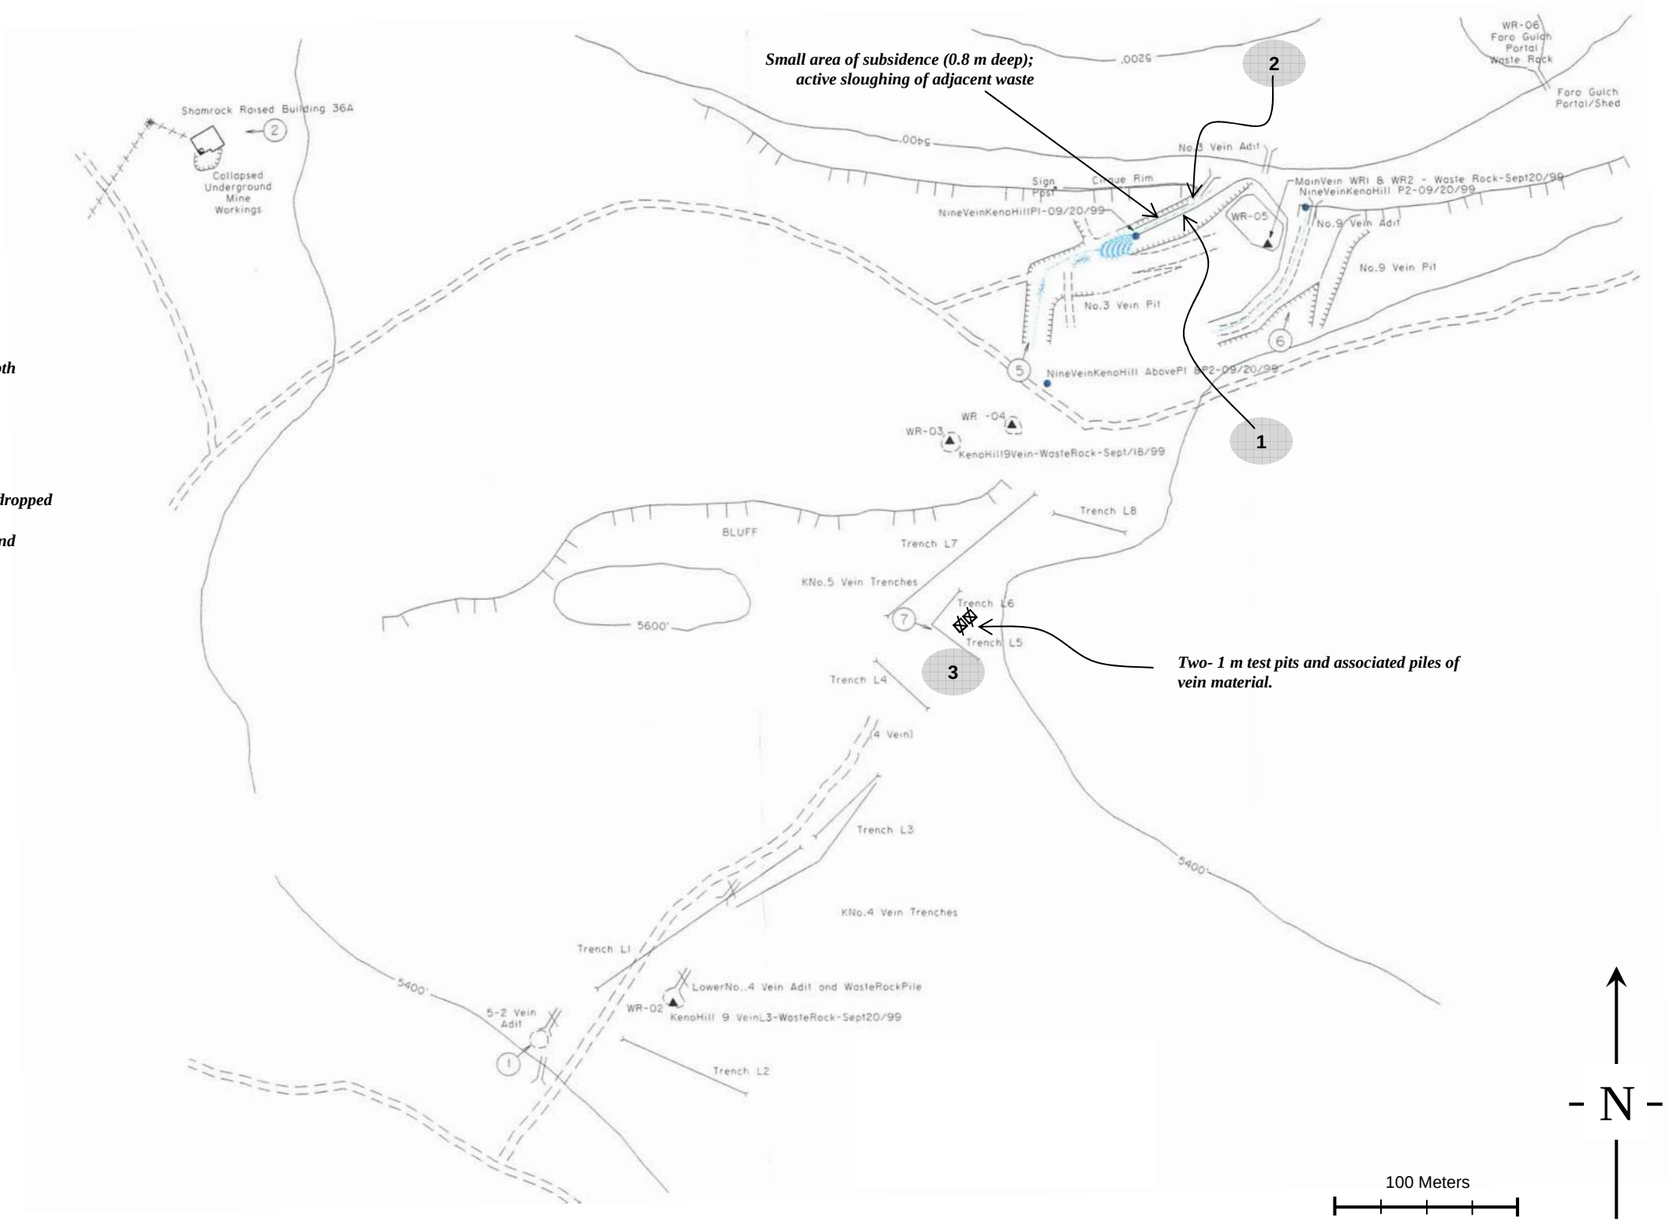
Keno No. 9 Site #36 (Map 1)

#1 - Collapse of supports for drift; open hole with high potential for access. Depth estimated to be a minimum of 4 m. High risk due to proximity to Signpost.

#2 - Open hole (opening 0.5 m x 1 m).
- Easy to crawl into; void appears to be 3 m x 2 m x 1.5 m. High risk due to proximity to Signpost.

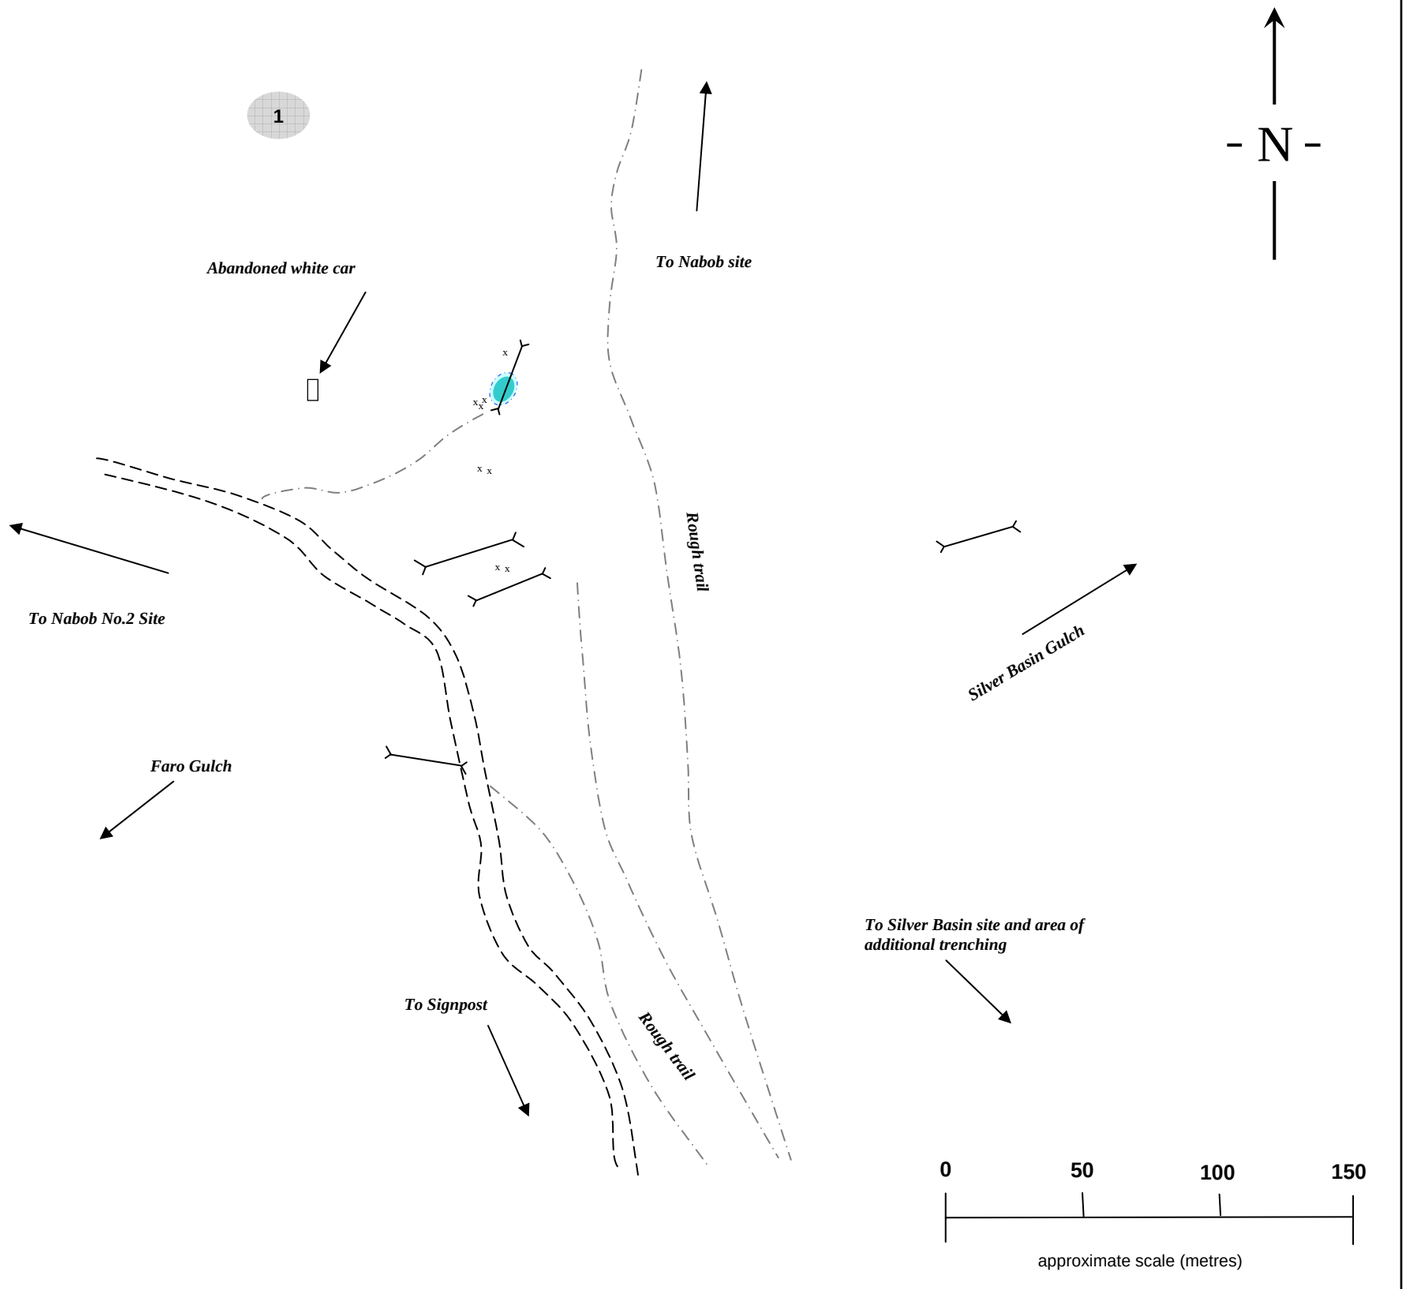
#1 - Surface topography in this area prevents surface drainage from flowing to north into McKay Gulch. All surface drainage from the Site reports east to Silver Basin Gulch or west to Faro Gulch.

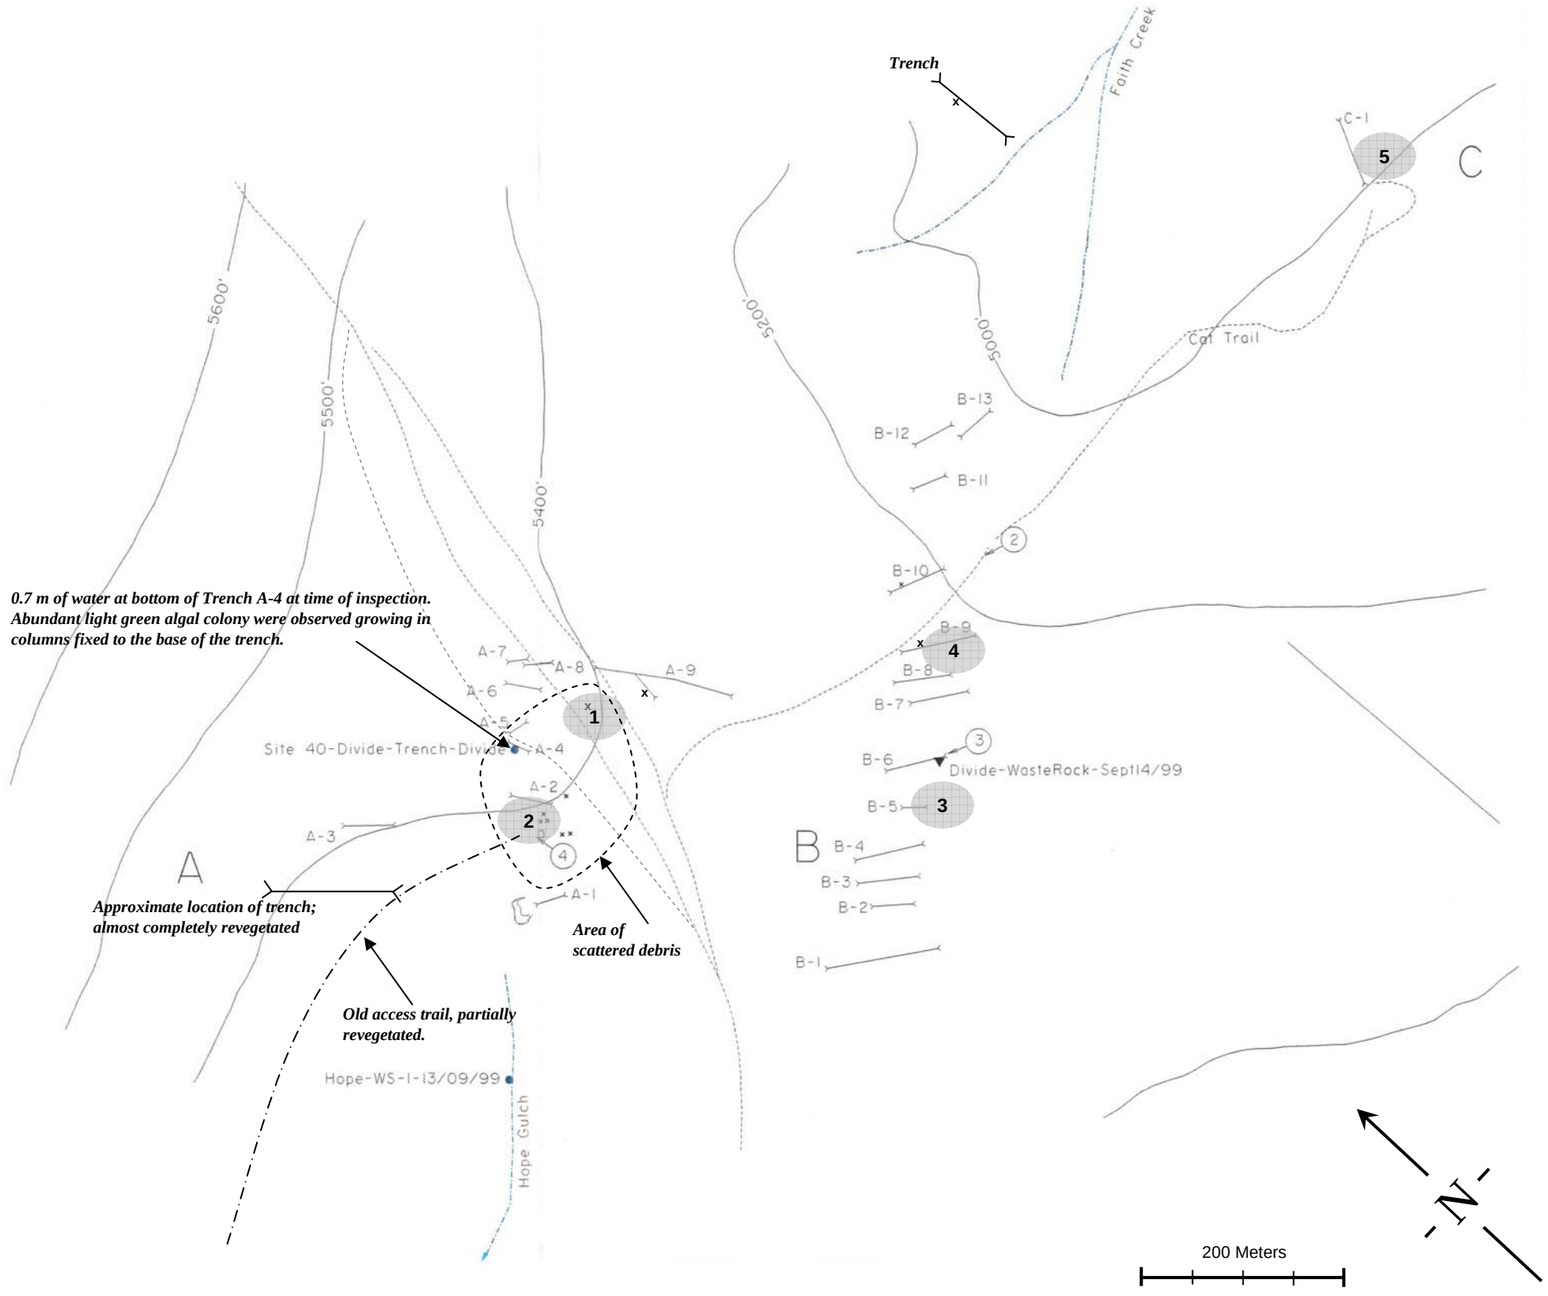
#2 - Building reported in PWGSC 2000 was observed to be laying on its side at the north end of Trench A-2.

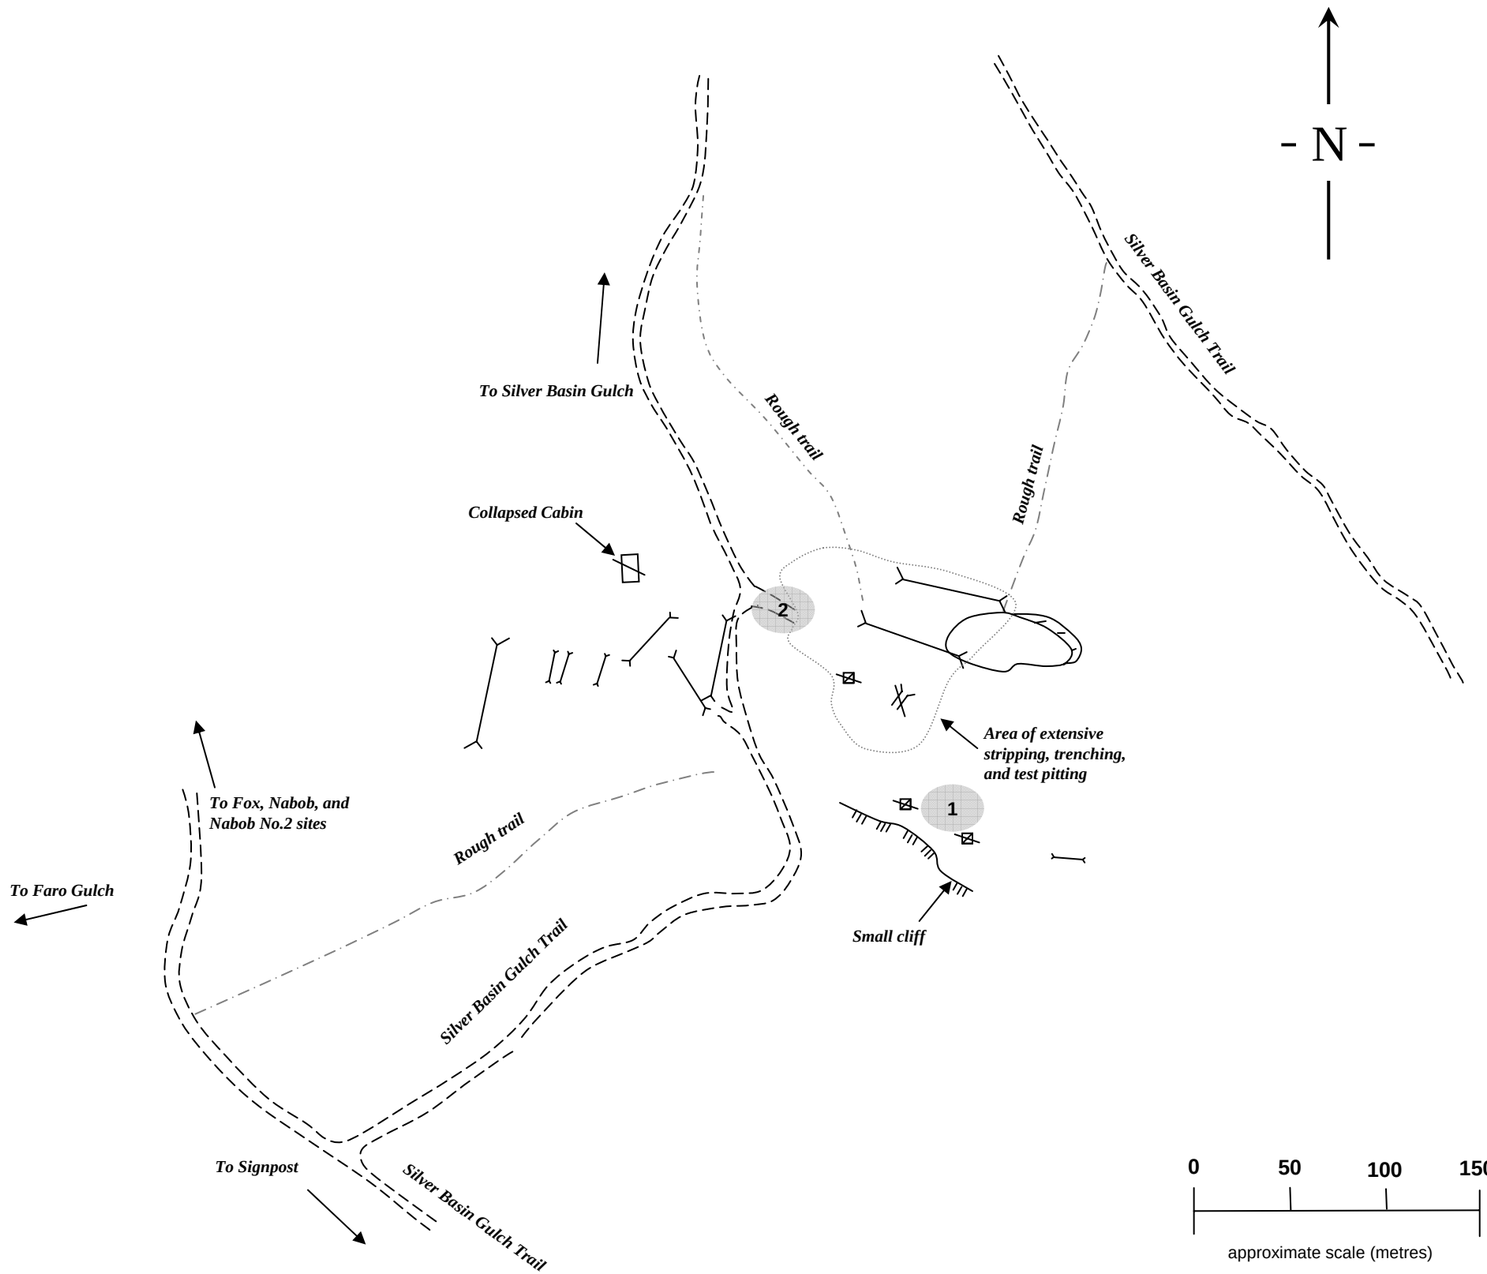
#2 *- Surface runoff from Silver Basin Gulch Trail channels down surface excavation. Oxidized vein material is exposed in the eroded channel.*

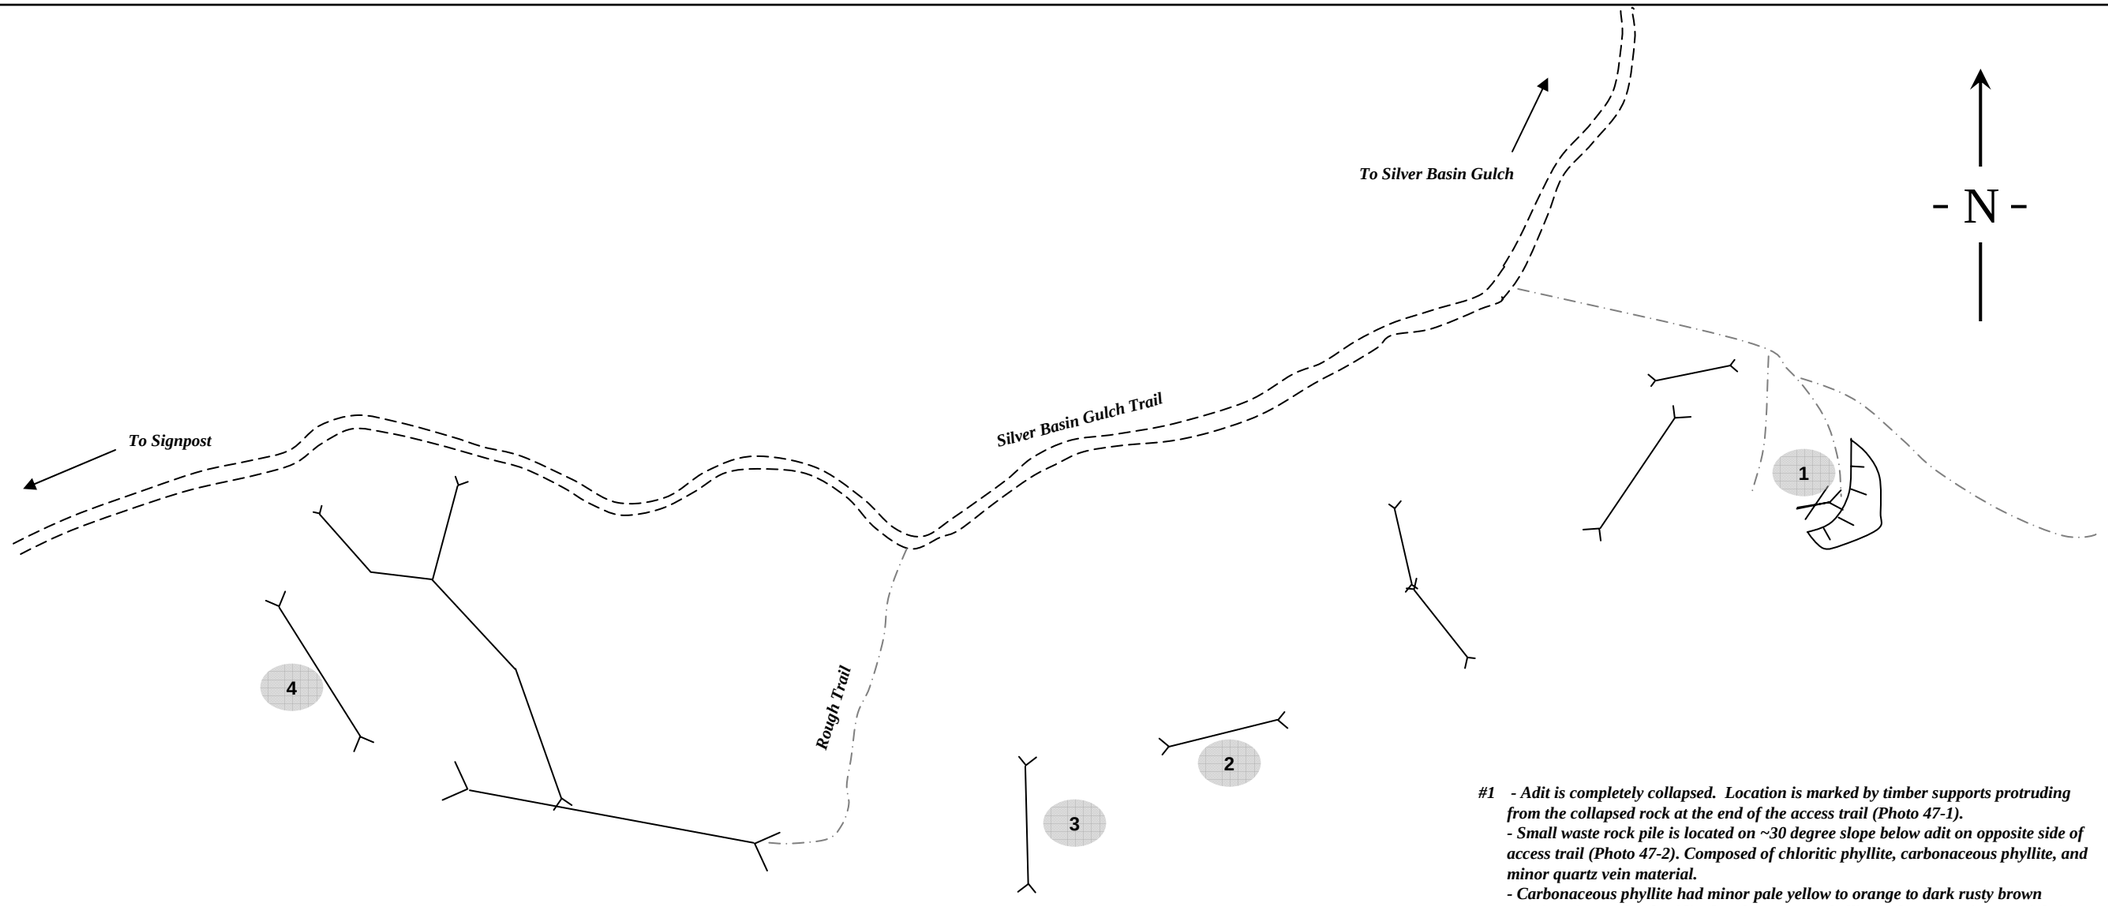
#1 - Adit is completely collapsed. Location is marked by timber supports protruding from the collapsed rock at the end of the access trail (Photo 47-1).
- Small waste rock pile is located on ~30 degree slope below adit on opposite side of access trail (Photo 47-2). Composed of chloritic phyllite, carbonaceous phyllite, and minor quartz vein material.
- Carbonaceous phyllite had minor pale yellow to orange to dark rusty brown staining. A sample of oxidized carbonaceous phyllite and quartz vein material (<2 mm fraction) returned a rinse pH of 3.43 and rinse conductivity of 0.27 mS/cm.
- Acid weathering indicated by presence of clasts weathered to quartz sand with orange staining (Photo 47-3).
- Within Silver Basin Gulch surface catchment.
