KENO HILL SILVER DISTRICT

CLOSURE ISSUES REPORT

DRAFT

MARCH 2009

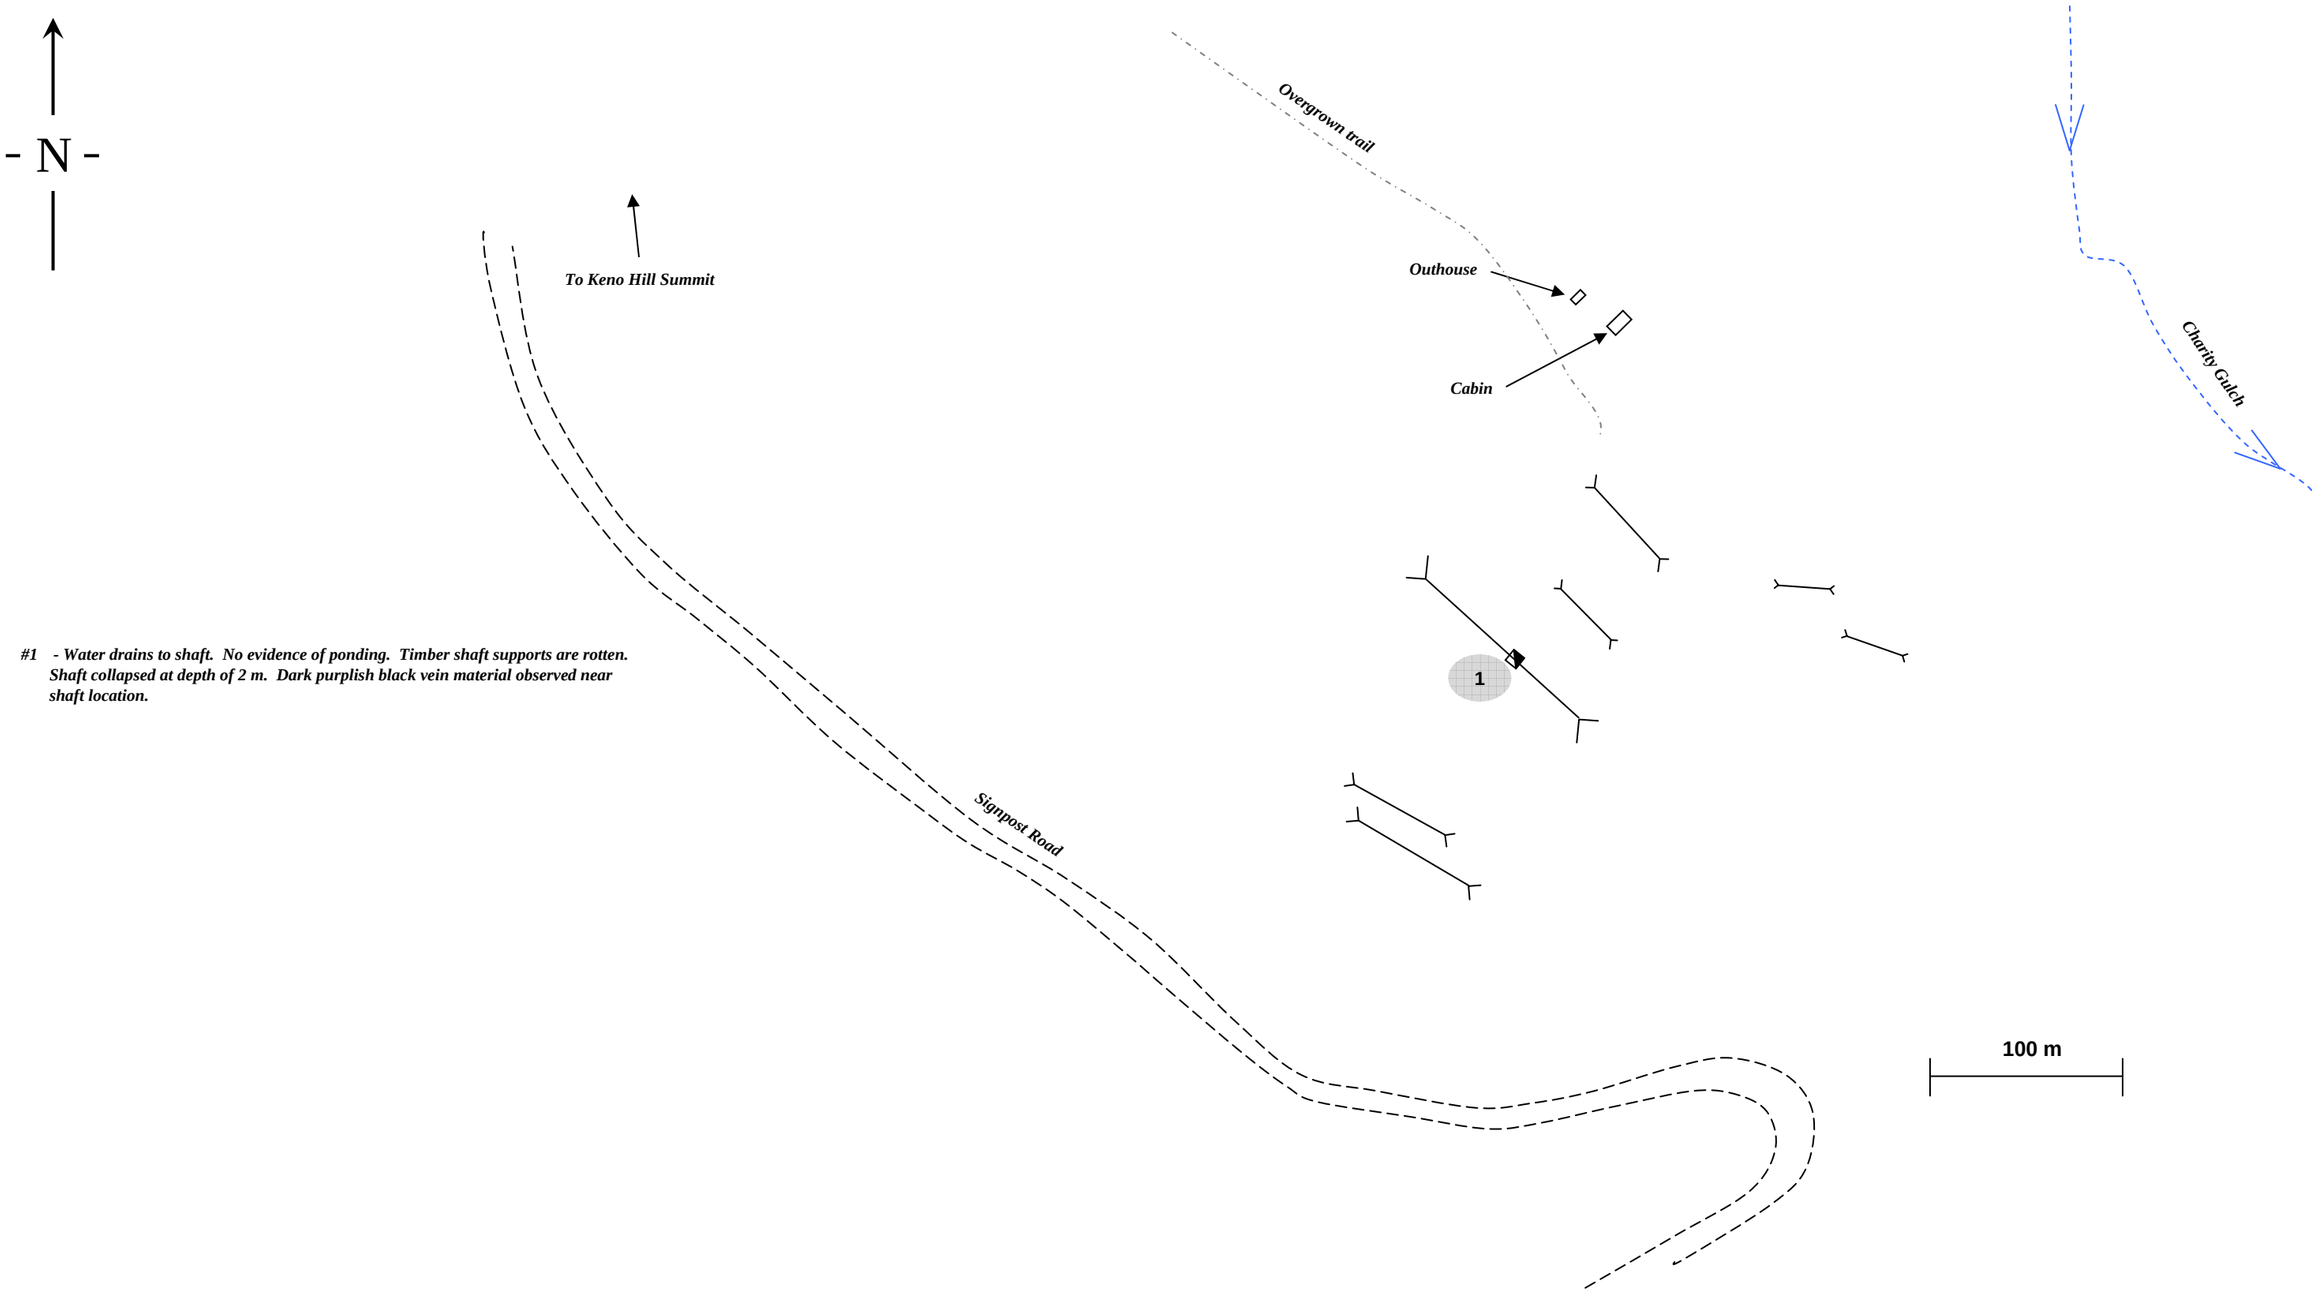
FIGURE 127 - APEX

#1 - Water drains to shaft. No evidence of ponding. Timber shaft supports are rotten. Shaft collapsed at depth of 2 m. Dark purplish black vein material observed near shaft location.

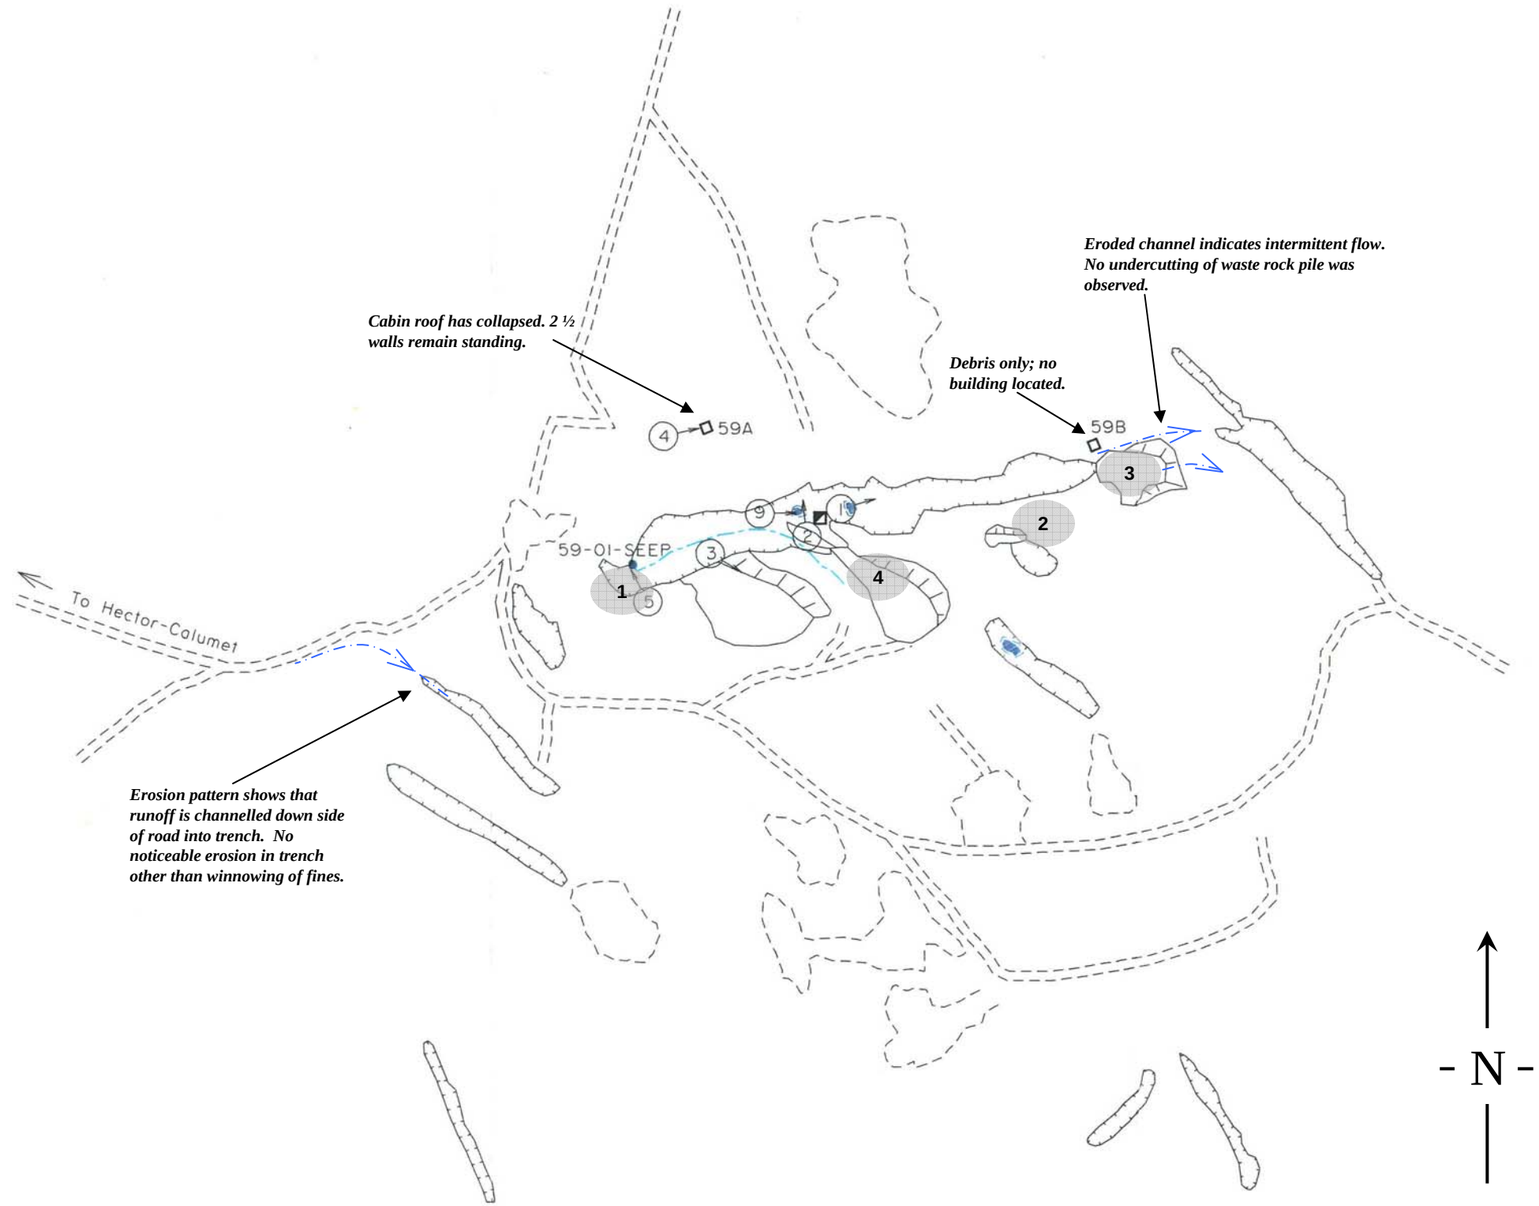
FIGURE 129 - EAGLE

#1 - Permanent pond at upper limit of trench (Photo 59-1). Water is dammed behind material pushed into trench to form roadway. Fill is low, broad, and appears stable.
- Water trickles from pond spill point into trench below. Trench bottom has well-developed mini-wetland community of horsetails, willows and algal mats; extends entire length of trench (Photos 59-2, 59-3).
- Sides of trench range from bare to partially-vegetated.

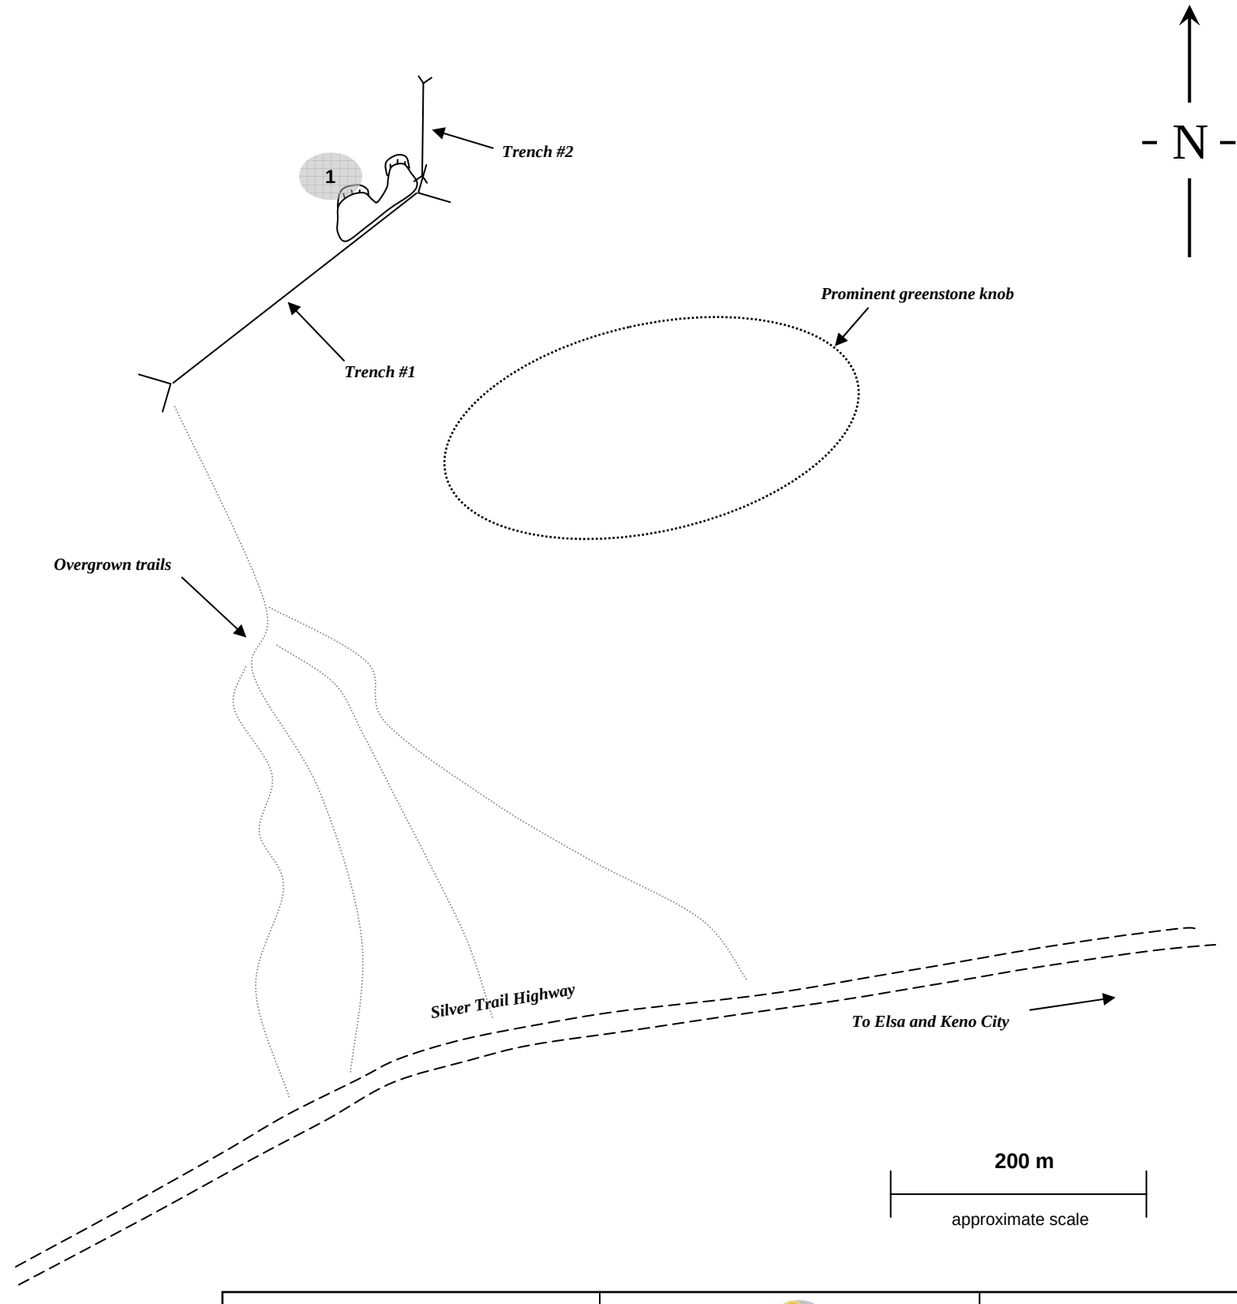
#1 - Waste rock pile at northwest end of Trench #1 has widespread staining (yellowish, yellowish-brown, and rusty orange to rusty brown), as well as areas that appear to be leached (Photos 63-1, 63-3). Abundant medium- to coarse-grained pyrite (up to 5% locally) noted as massive pods and veinlets, as well as disseminated in waste rock.
- Grain relief within clasts and fresh, untarnished appearance of pyrite suggests galvanic protection of pyrite and selective weathering of other sulphides.
- An area of heavily stressed vegetation (2 m wide) was noted north of waste rock pile toe (Photo 63-3).
- Two flow lobes were observed, and an unvegetated flow deposit of waste rock extended to north from toe of pile (Photo 63-4). Small headwall in source region indicates that instability is ongoing (Photo 63-5). Dump height approximately 2 m.

Determine necessity for additional sampling and static ABA testing and follow-up kinetic testing based on results of static testing. Geochemical specialist review of data and recommend follow up and mitigation.

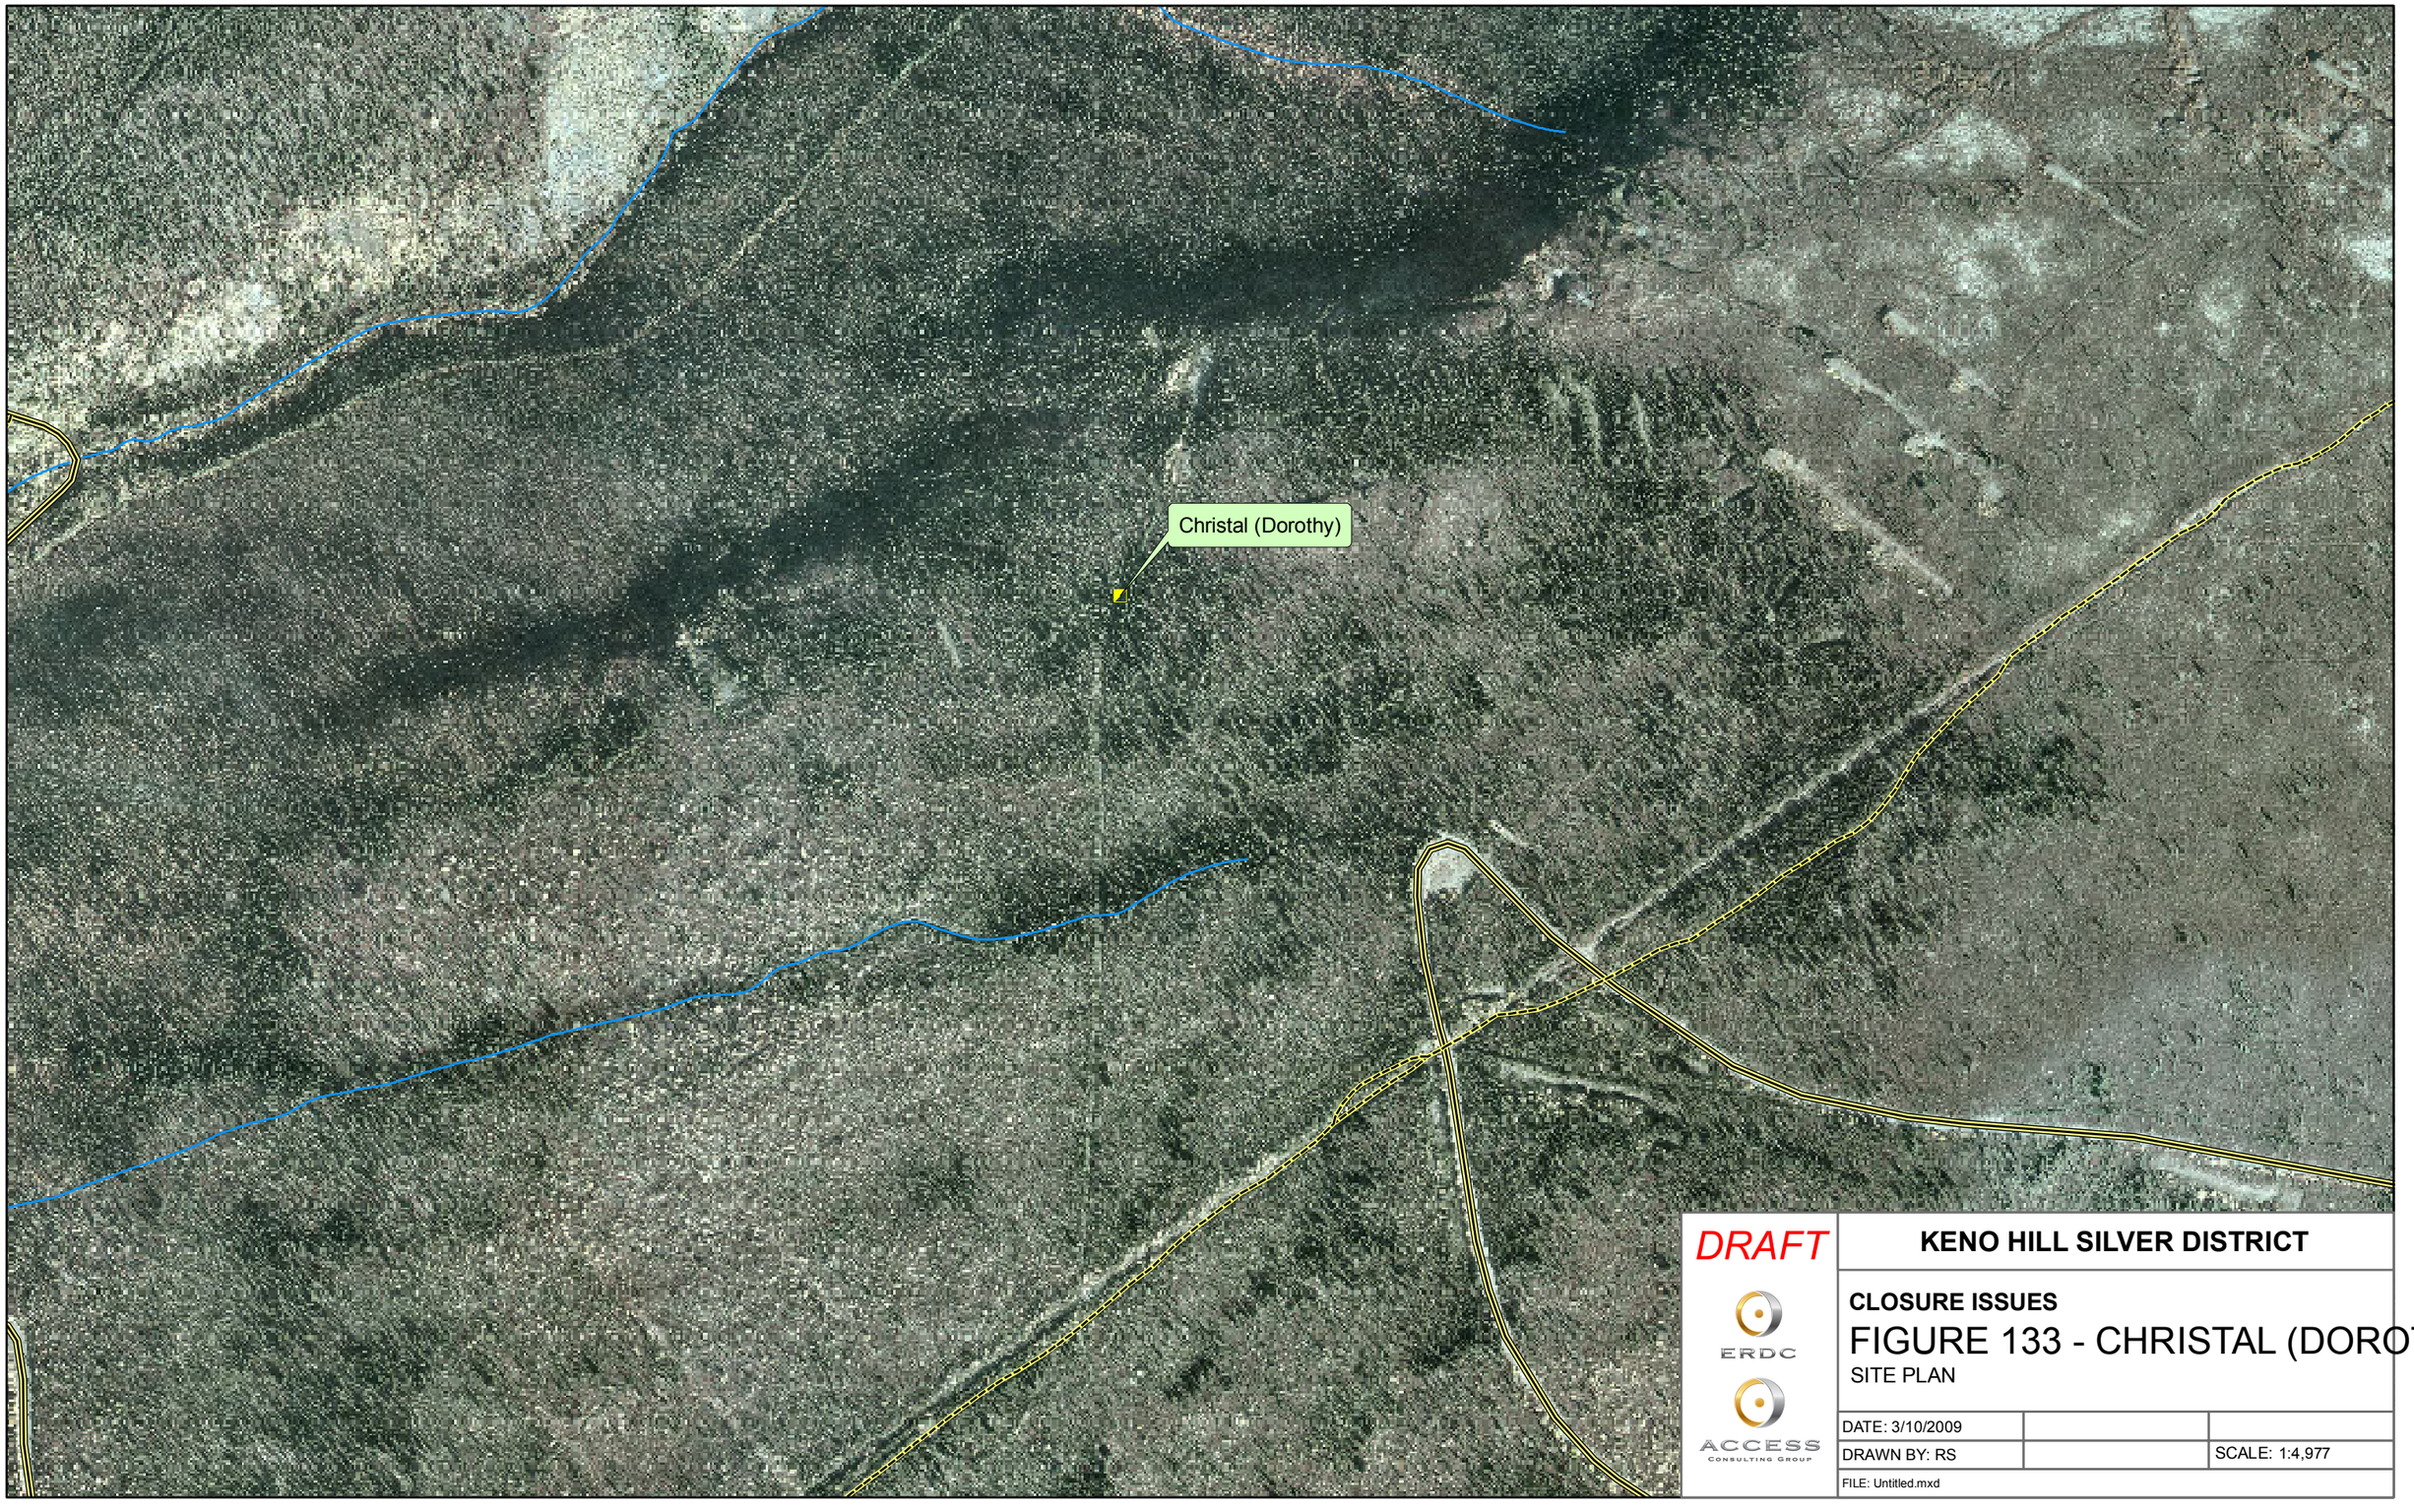
General Location Description	Closure Issue Categories					
	Human & Wildlife Health and Safety	Chemical Control	Water Management	Physical Stability	Community Concerns	Other
Shaft #3				✔		
Waste rock pile - west of Shaft #3				✔		
Second shaft - just north of Shaft #3	✔			✔

- Waste rock pile to west of shaft, 6 m x 10 m x 2 m, at angle of repose on slope below shaft. Composed of quartzite with minor black staining. Pile is 95% covered in moss and lichen, with willow and spruce colonizing the top and margins of pile.

Determine necessity for additional sampling and static ABA testing and follow-up kinetic testing based on results of static testing. Geochemical specialist review of data and recommend follow up and mitigation.

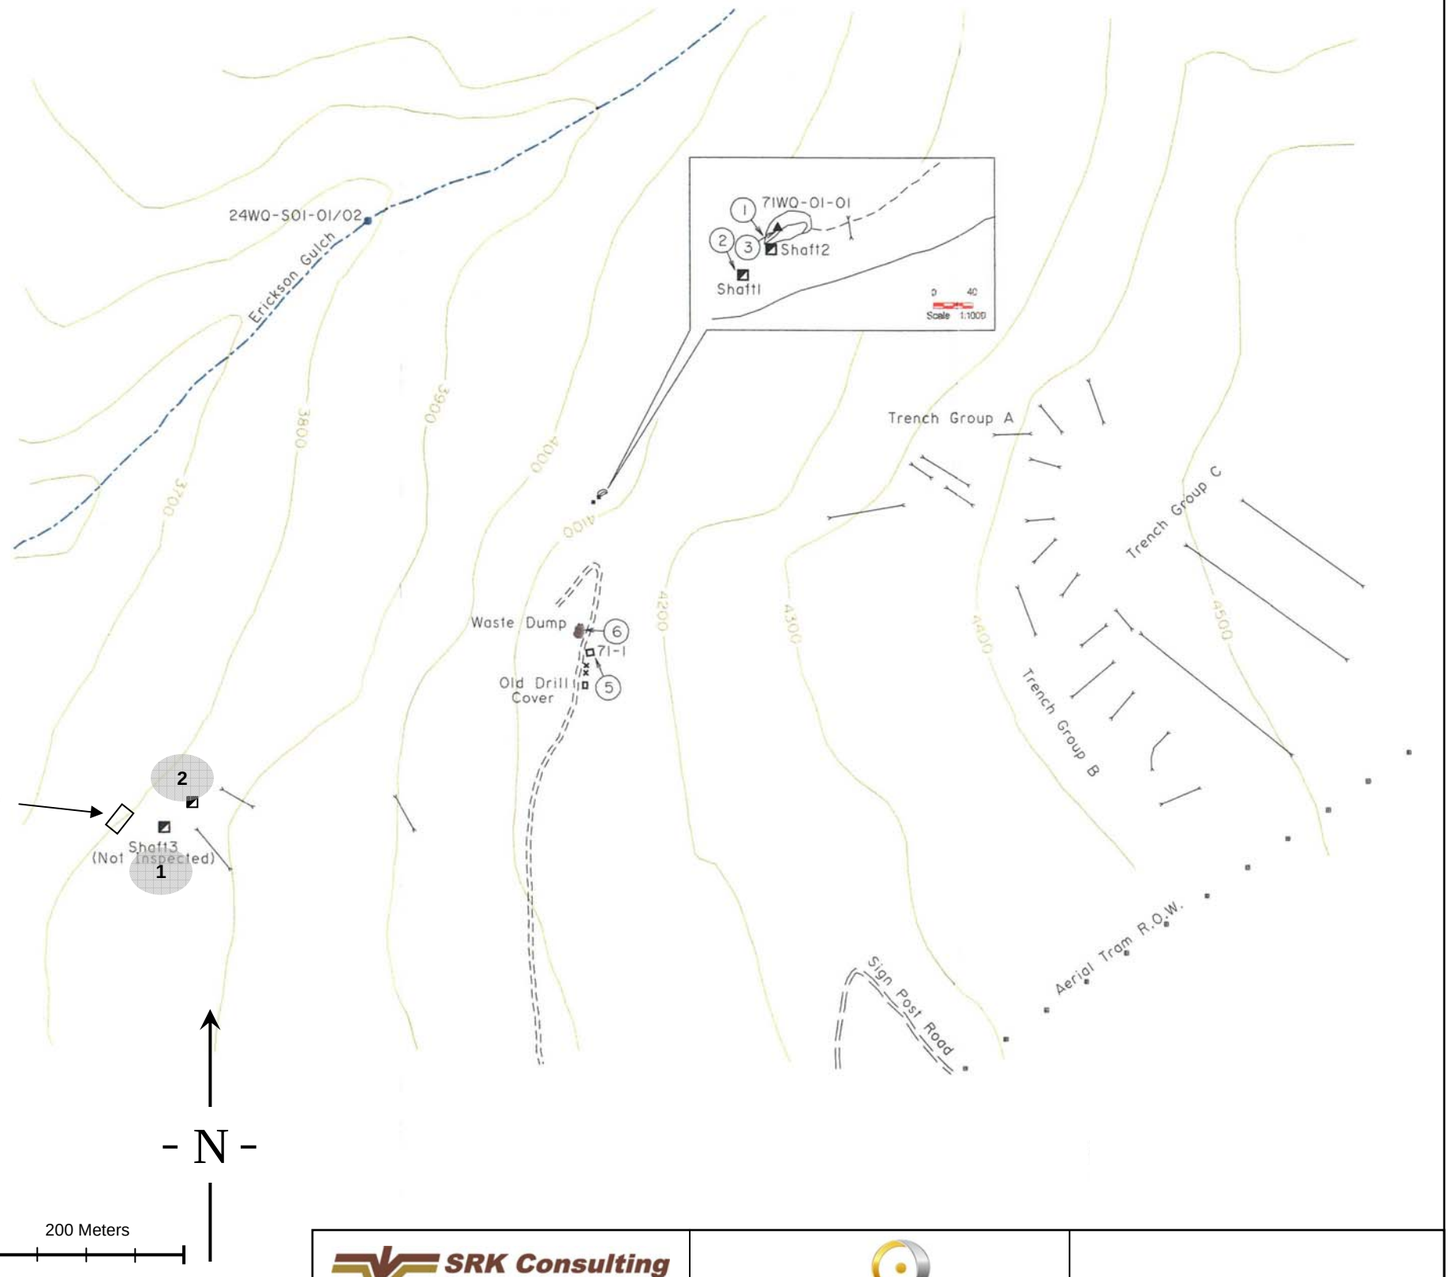
#2 - Second shaft (1 m x 1.5 m x 2.5 m deep) identified 20 m NE of Shaft 3. Excavation (4 m x 4 m x 6 m) into colluvium on moderate slope to access solid bedrock, with timber-cribbed shaft in base of excavation. Shaft is caved at 2.5 m, with clear water in bottom.

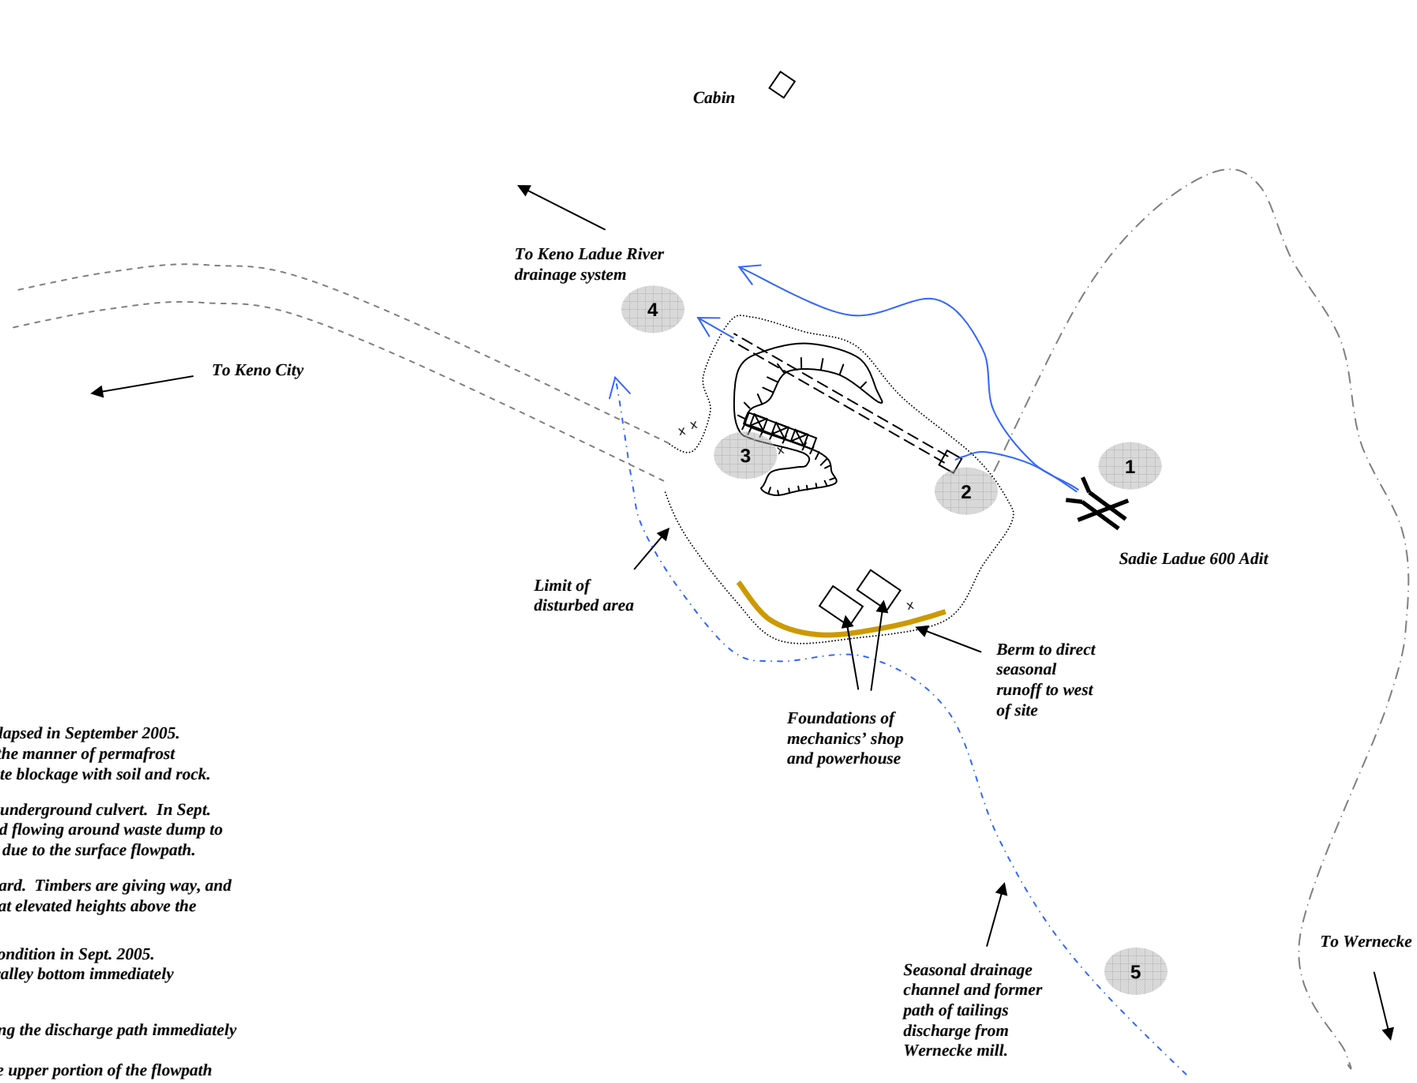
#1 - Adit and collar overburden were completely collapsed in September 2005. Overburden and vegetative mat were receding in the manner of permafrost regression. Large flow of water exiting adit despite blockage with soil and rock.

#3 - Load-out structure is deteriorating and is a hazard. Timbers are giving way, and rails and portions of the structure are suspended at elevated heights above the underlying waste rock foundation.

#4 - Culvert and discharge appeared to be in good condition in Sept. 2005.
- No surface tailings were observed in the broad valley bottom immediately downstream of the Sadie Ladue 600 site.

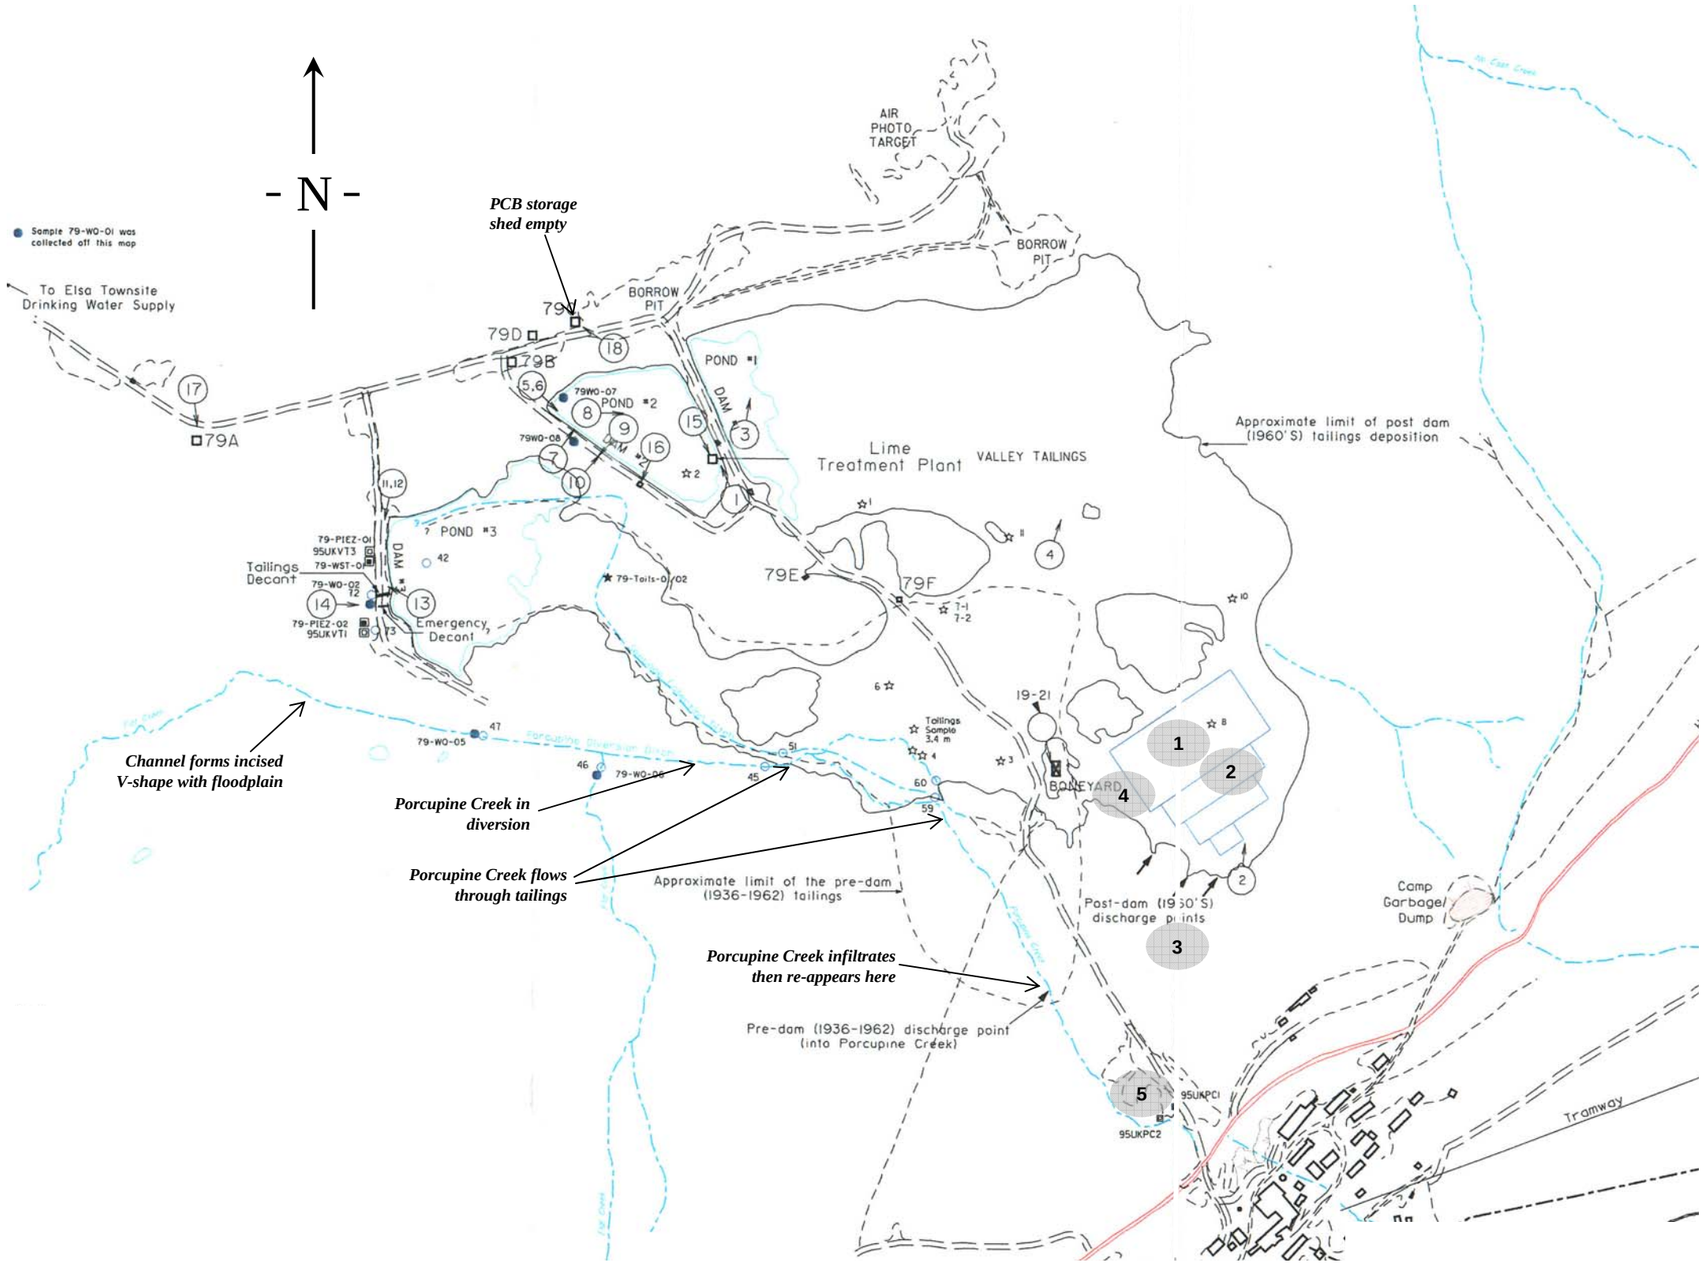
FIGURE 139 - VALLEY TAILINGS

***#1** Approx. location of sludge disposal cells (Photo 79.1) Tension cracks in berm at the NE corner.*

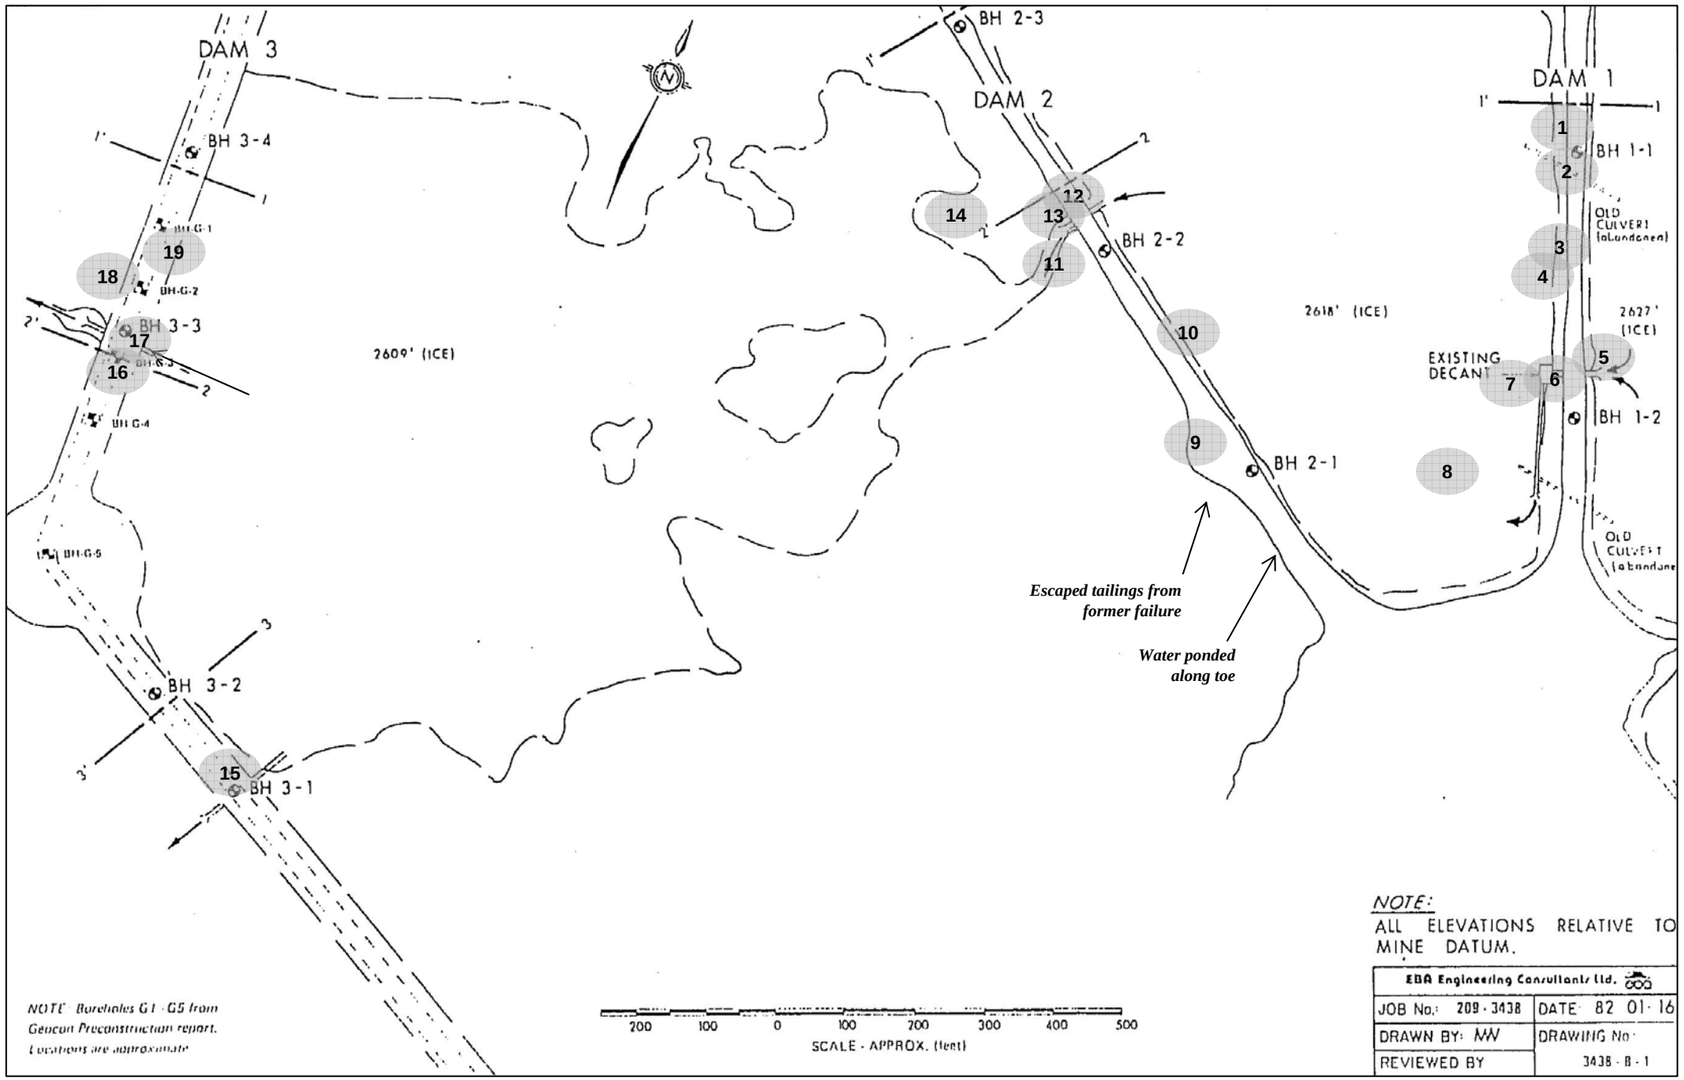
Figure: **140**

#1 Dam 1 recently re-surfaced (Photos 79.7, 79.8)

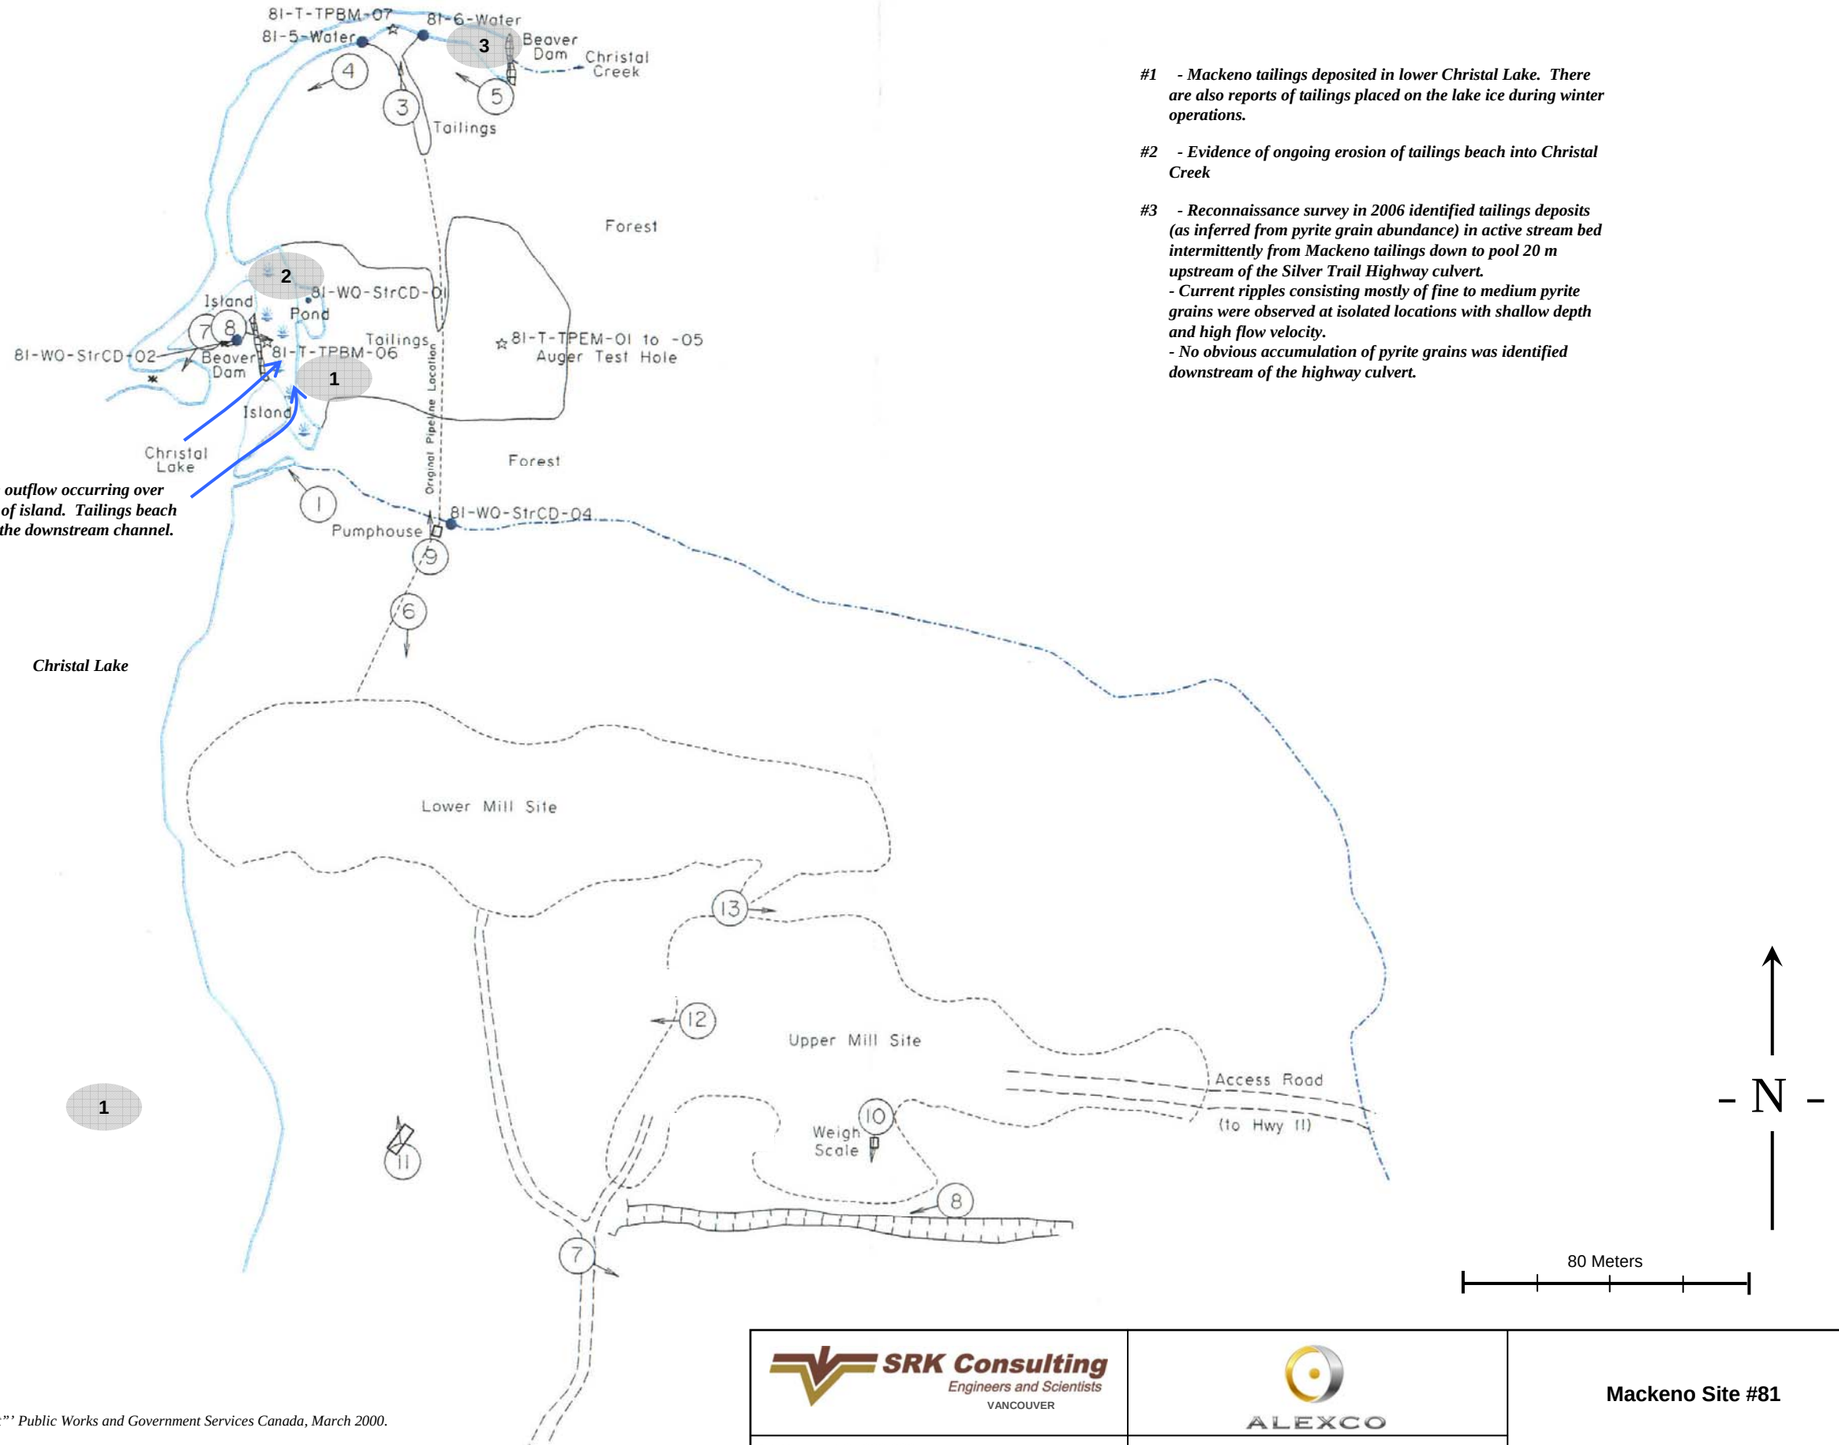
FIGURE 142 - MACKENO

Significant portion of lake outflow occurring over beaver dam and southeast of island. Tailings beach occupies the right limit of the downstream channel.
