# 2021 Annual Report
# Long-Term Performance Monitoring Program
# Clinton Creek Mine, Yukon

**Government of Yukon**
**Department of Energy, Mines and Resources**
**Assessment and Abandoned Mines Branch**

MARCH 30, 2022
ISSUED FOR USE
FILE: 704-ENG.WARC03956-03

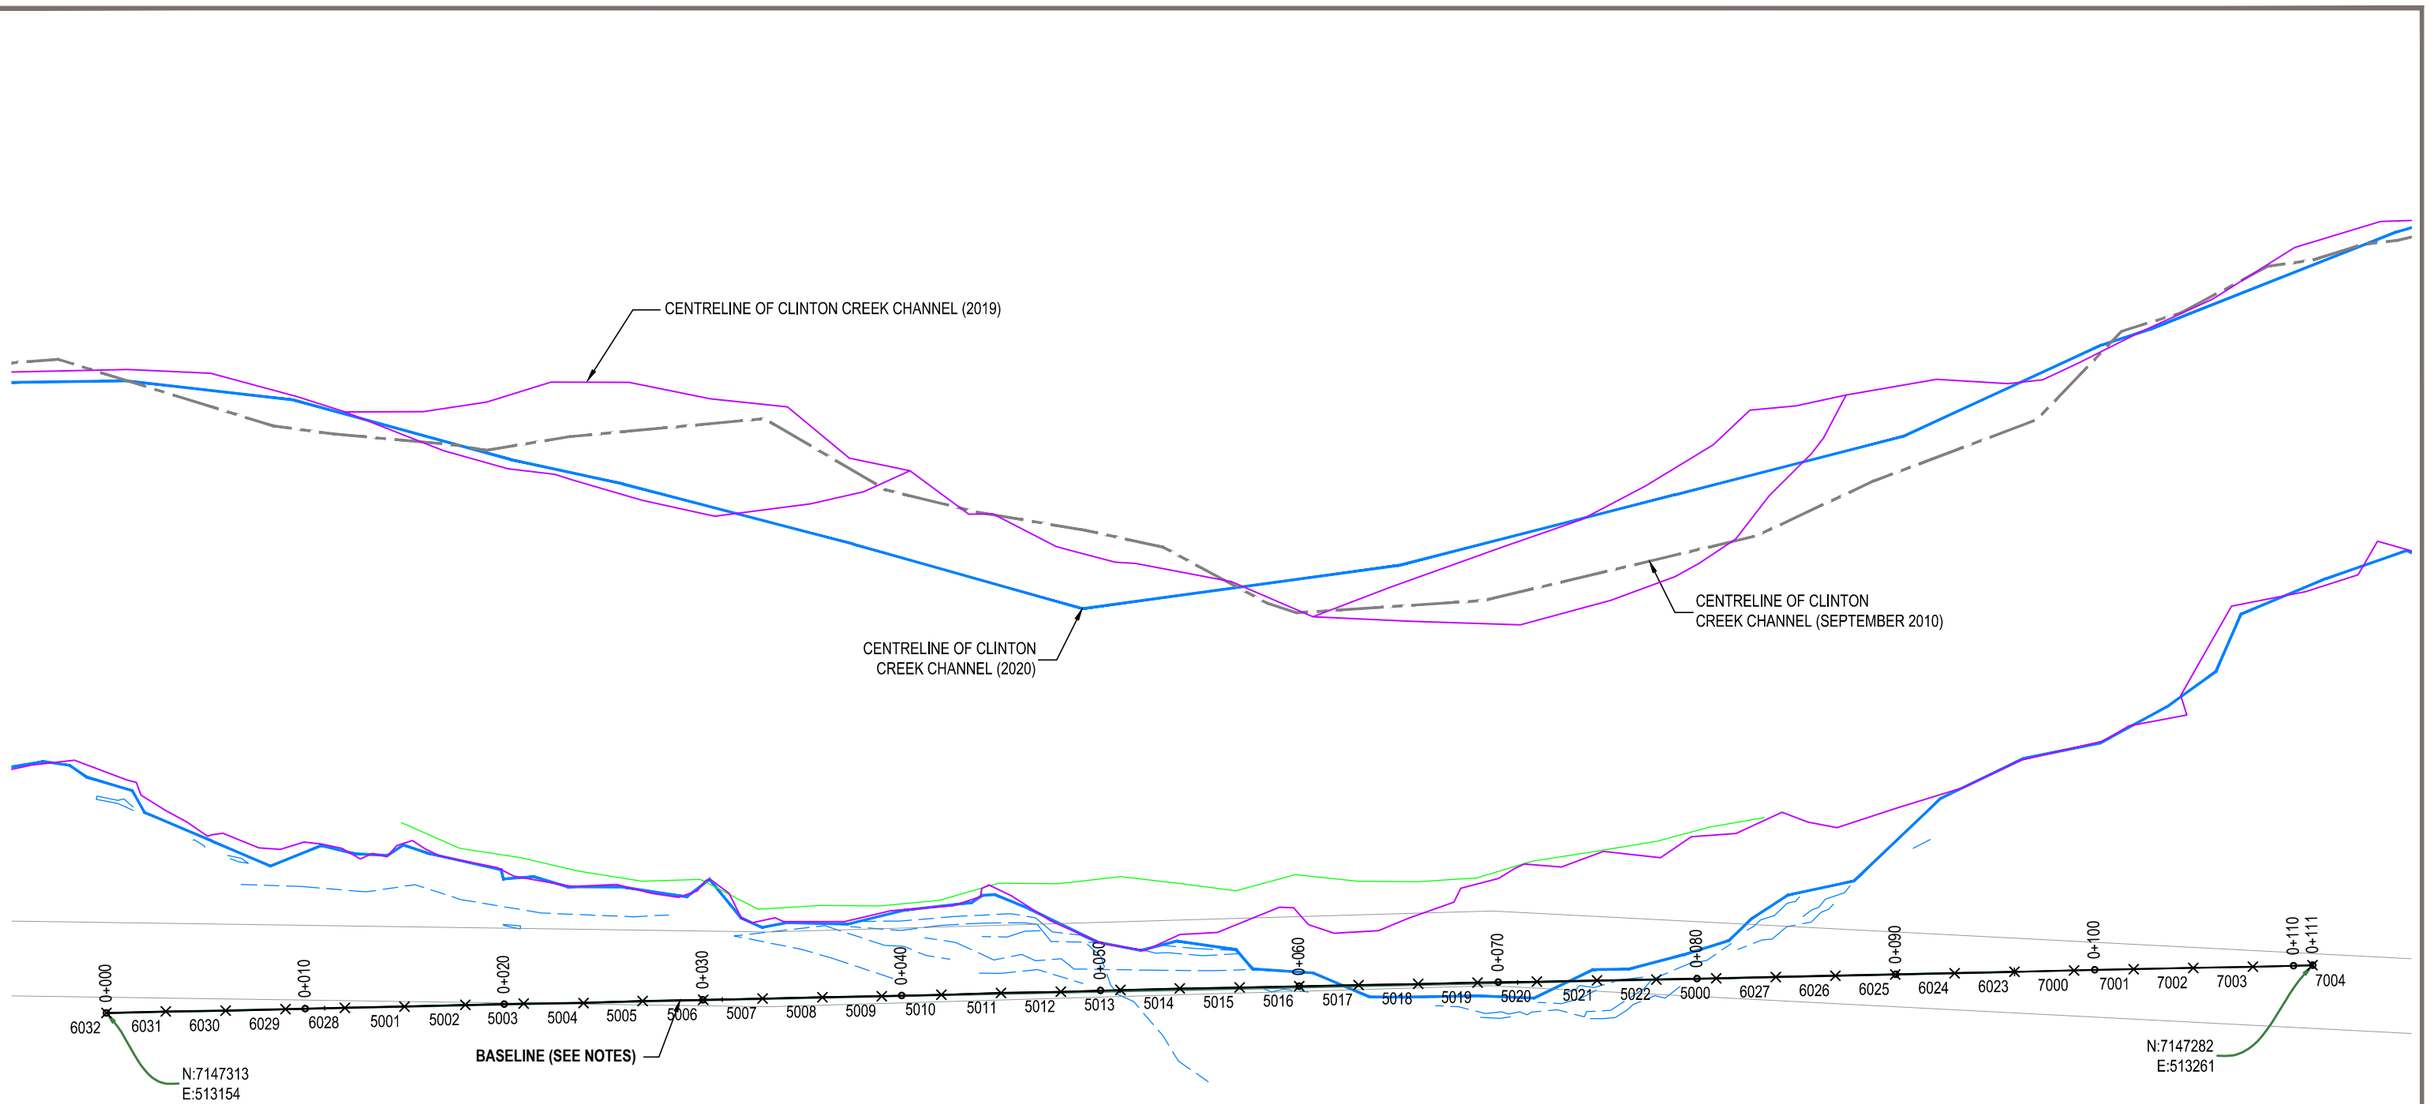
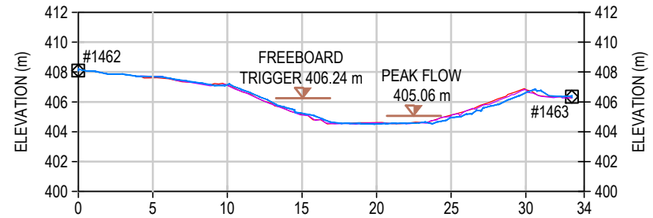
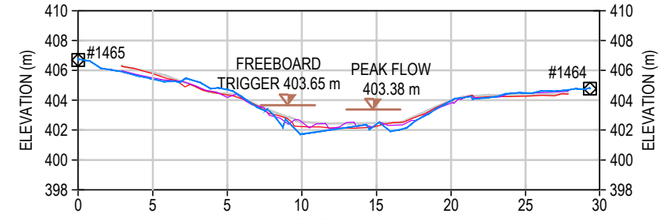
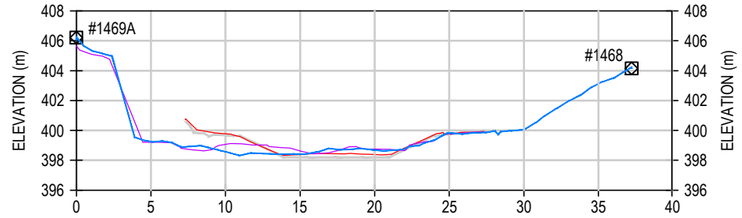
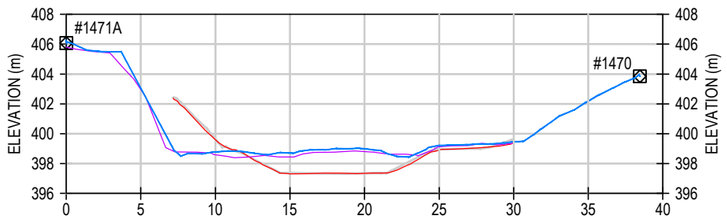
**Figure 13**

| DRAWING NO. | TITLE |
|---|---|
| FIGURE 13 | GABION DROP STRUCTURE #4 (DS4) AND ACB MATS |

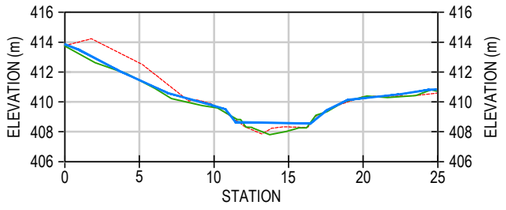
**Figure 15**

| DRAWING NO. | TITLE |
|---|---|
| FIGURE 15 | WOLVERINE CREEK ALIGNMENT AND PROFILE |

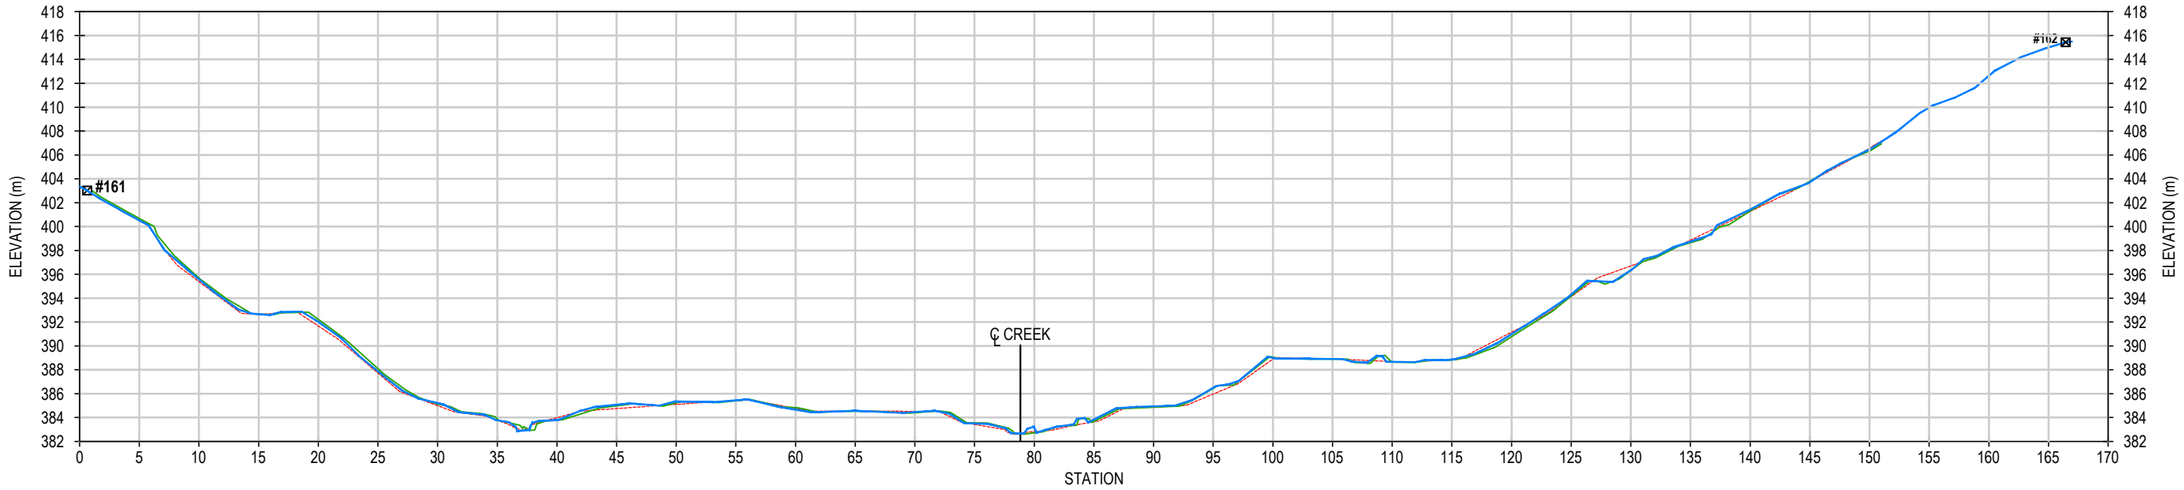
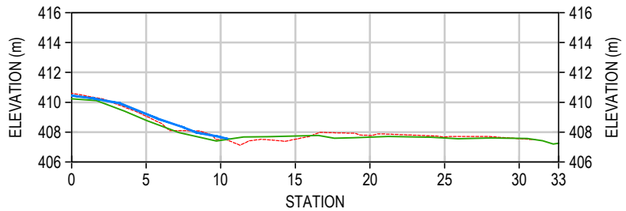
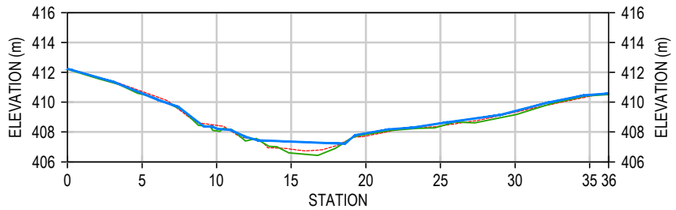
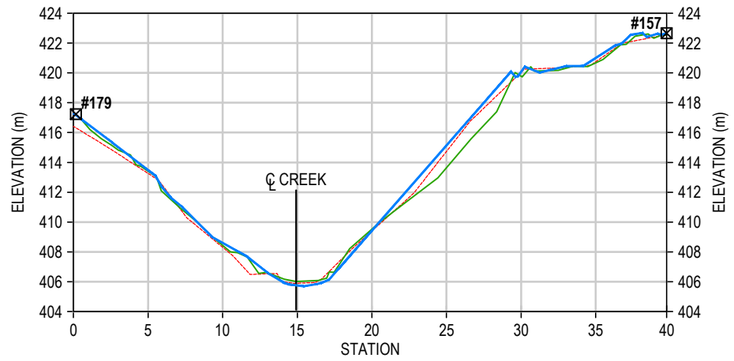
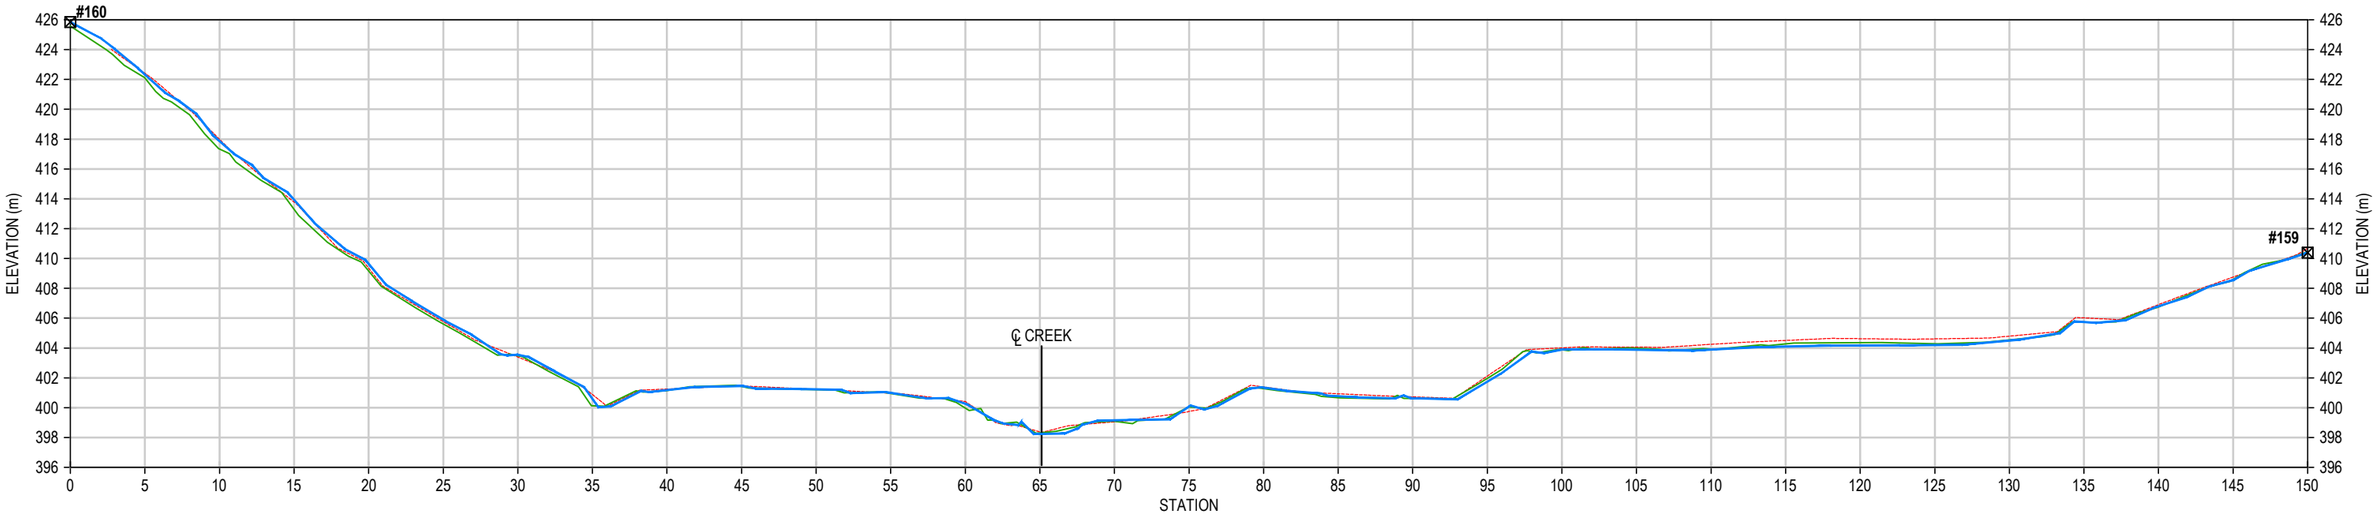
**Figure 16**

| DRAWING NO. | TITLE |
|---|---|
| FIGURE 16 | WOLVERINE CREEK PONDS AND CHANNEL CROSS-SECTIONS PS-1, PS-2, PS-3, I AND J |

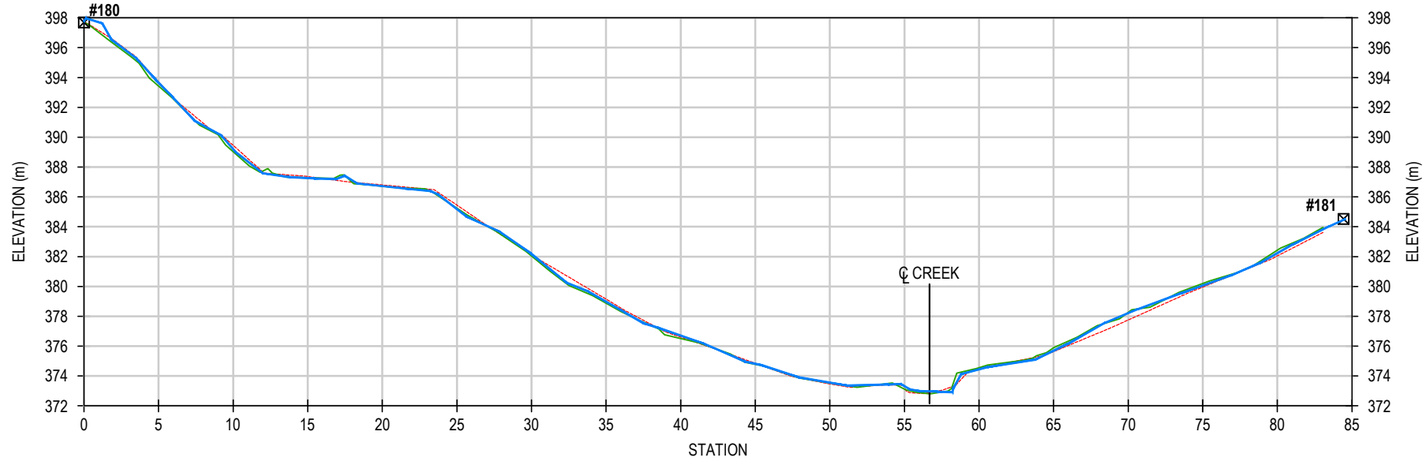
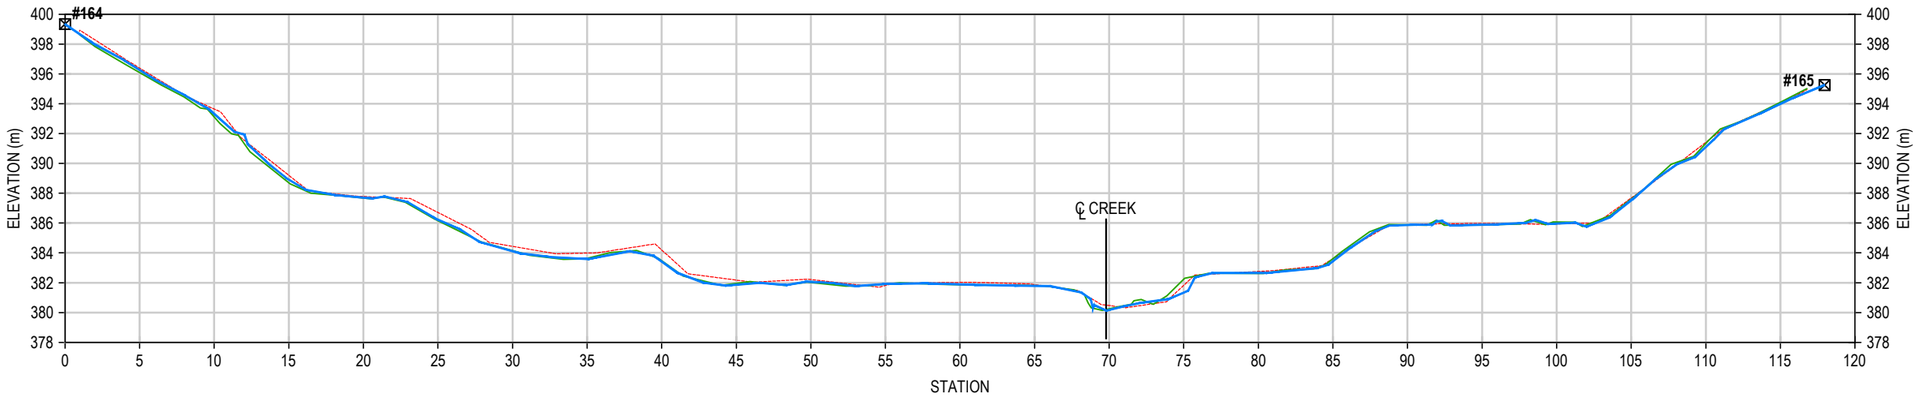
**Figure 17**

| DRAWING NO. | TITLE |
|---|---|
| FIGURE 17 | WOLVERINE CREEK PONDS AND CHANNEL CROSS-SECTIONS K AND L |

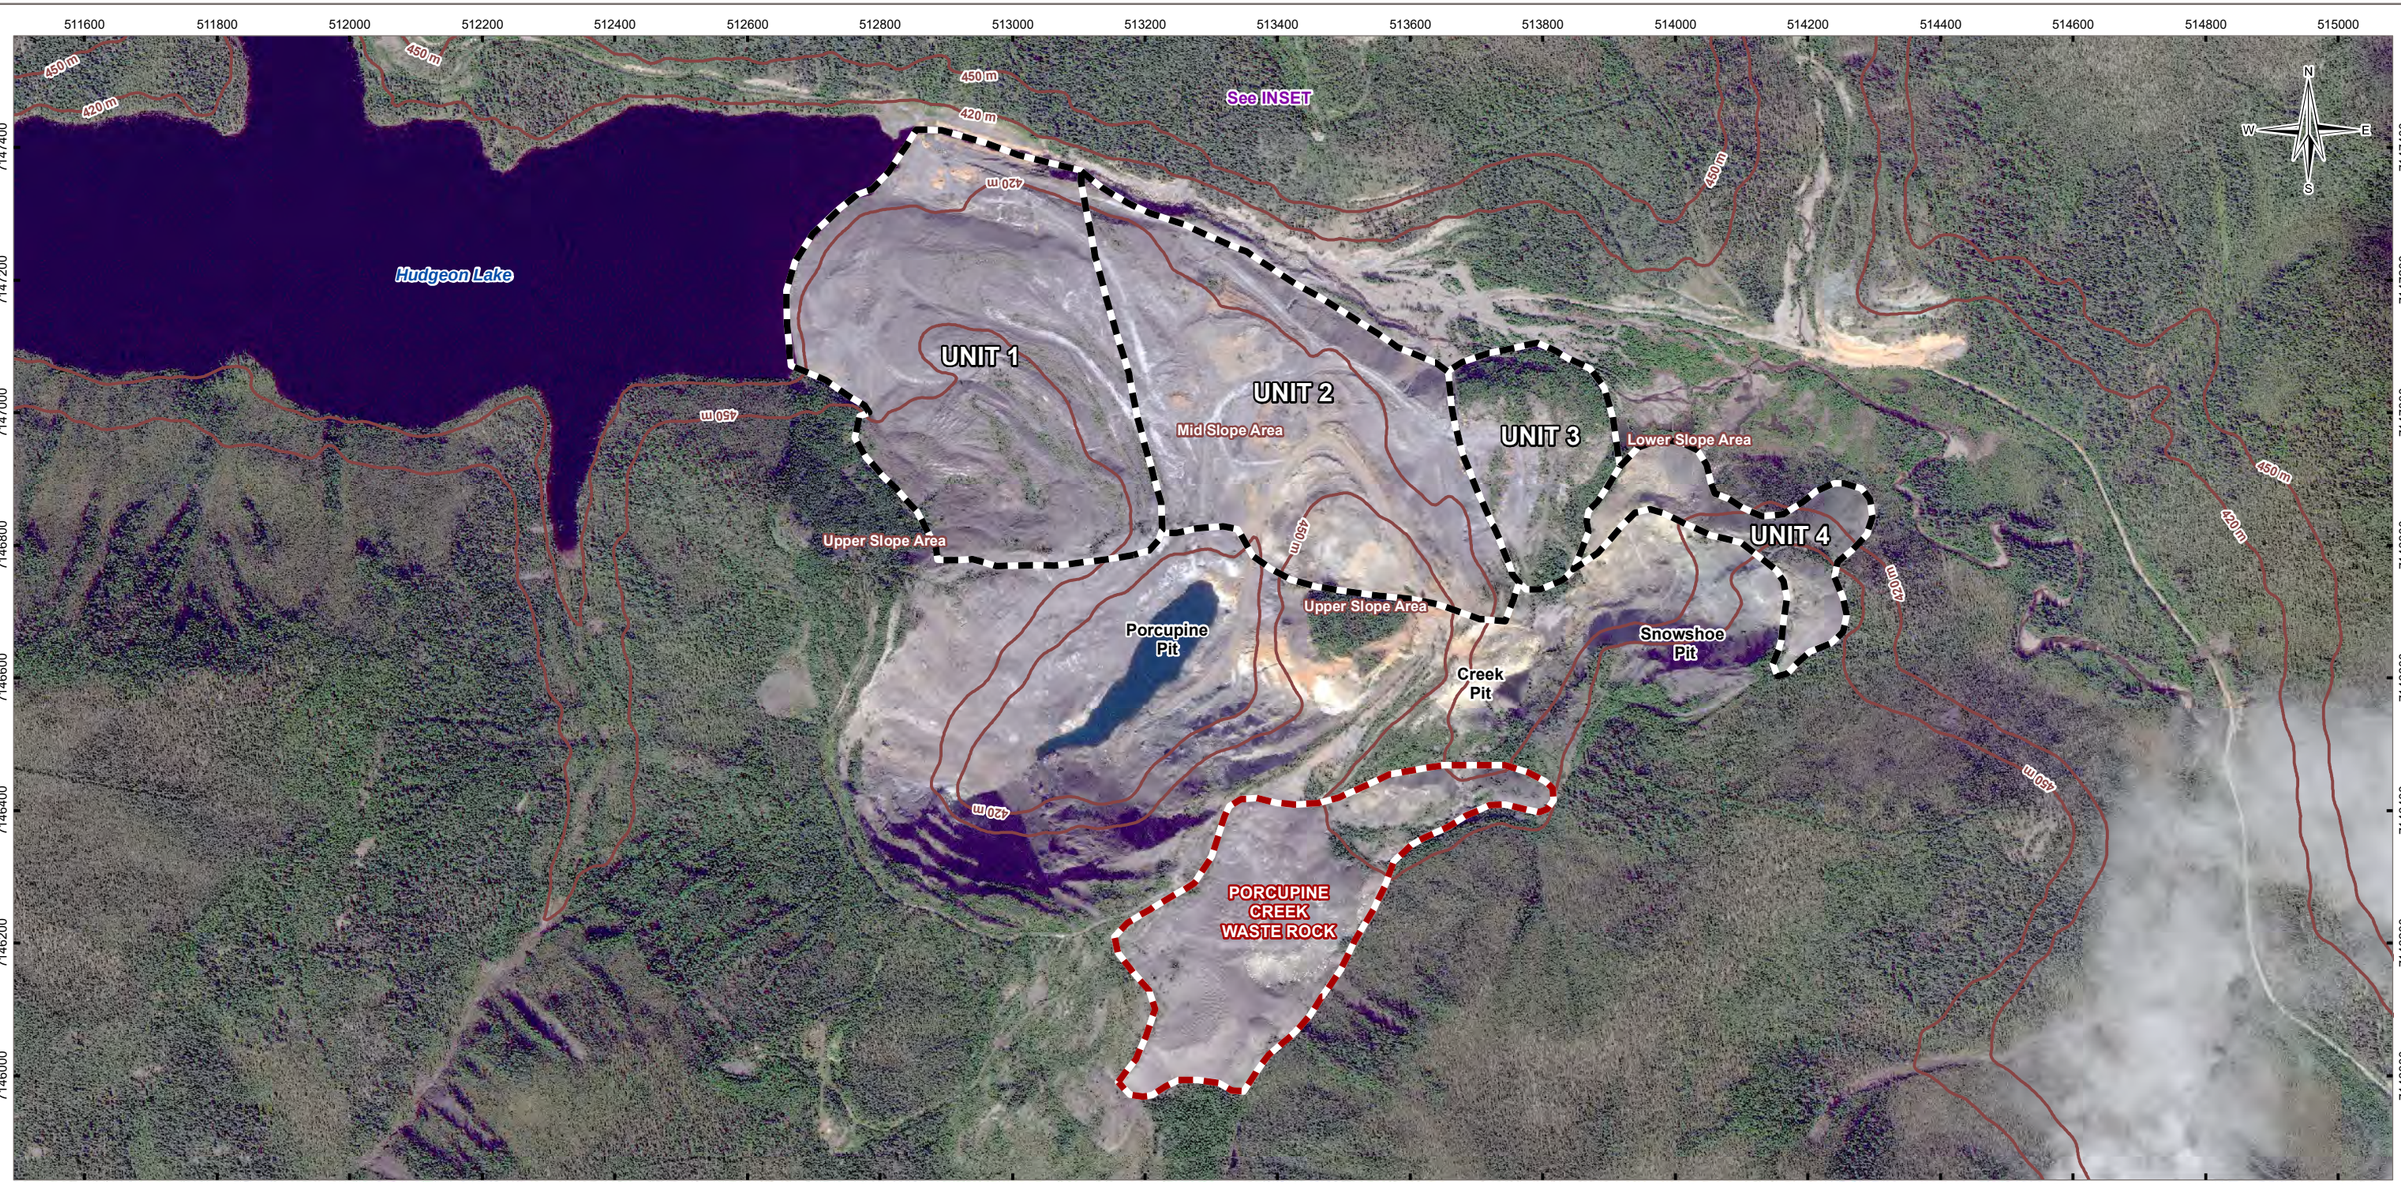
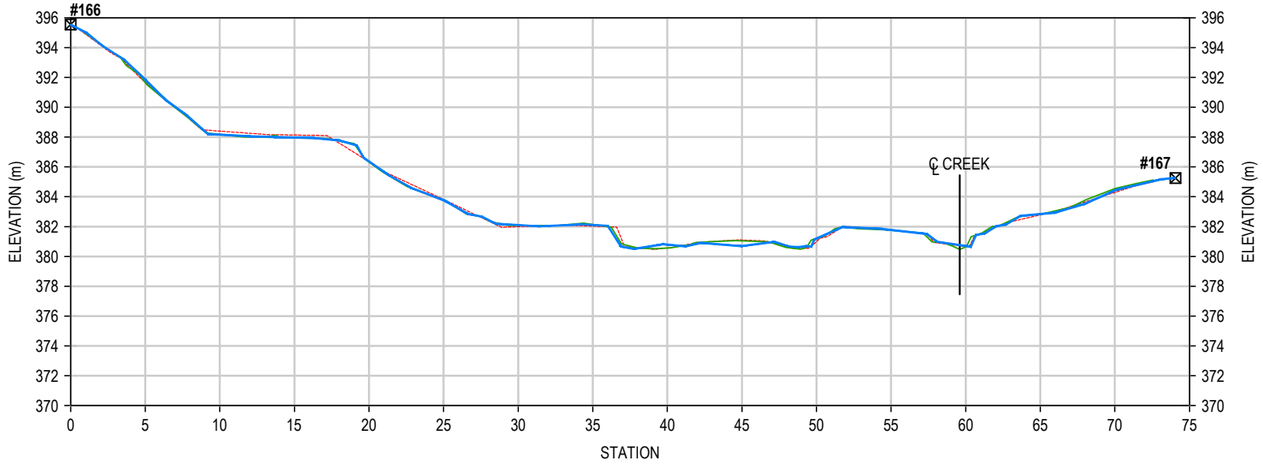
**Figure 18**

| DRAWING NO. | TITLE |
|---|---|
| FIGURE 18 | WOLVERINE CREEK PONDS AND CHANNEL CROSS-SECTIONS M AND N |

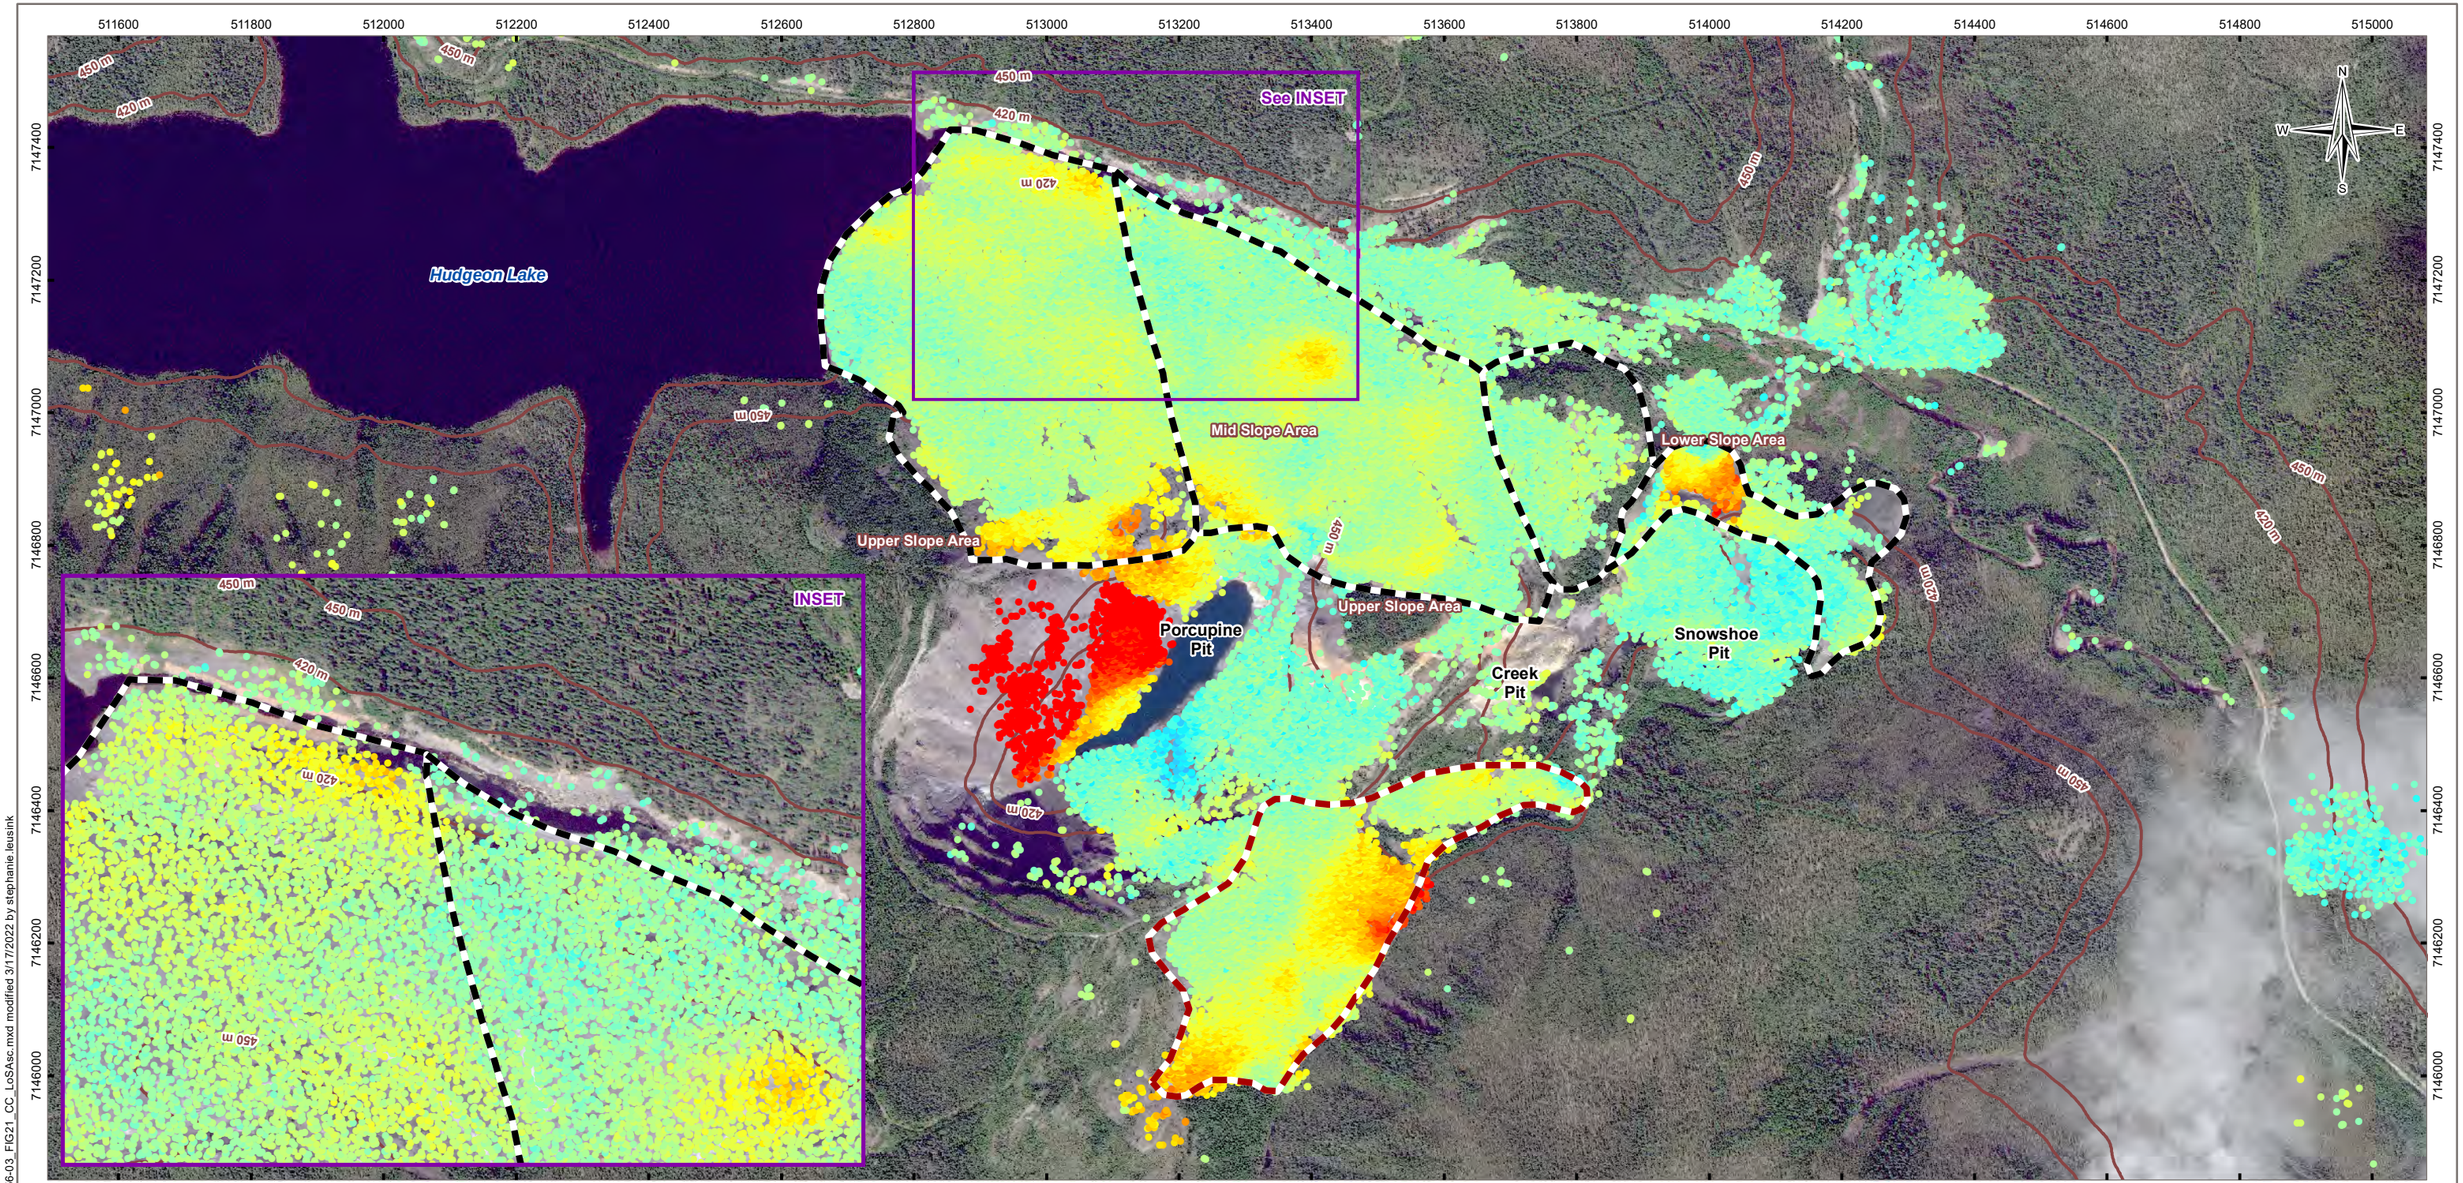
**Figure 20**

The tailings lobes and slope segments are illustrated in Figure 20.

| DRAWING NO. | TITLE |
|---|---|
| FIGURE 20 | WOLVERINE CREEK TAILINGS PILE SHOWING EXTENTS OF TAILINGS LOBES |

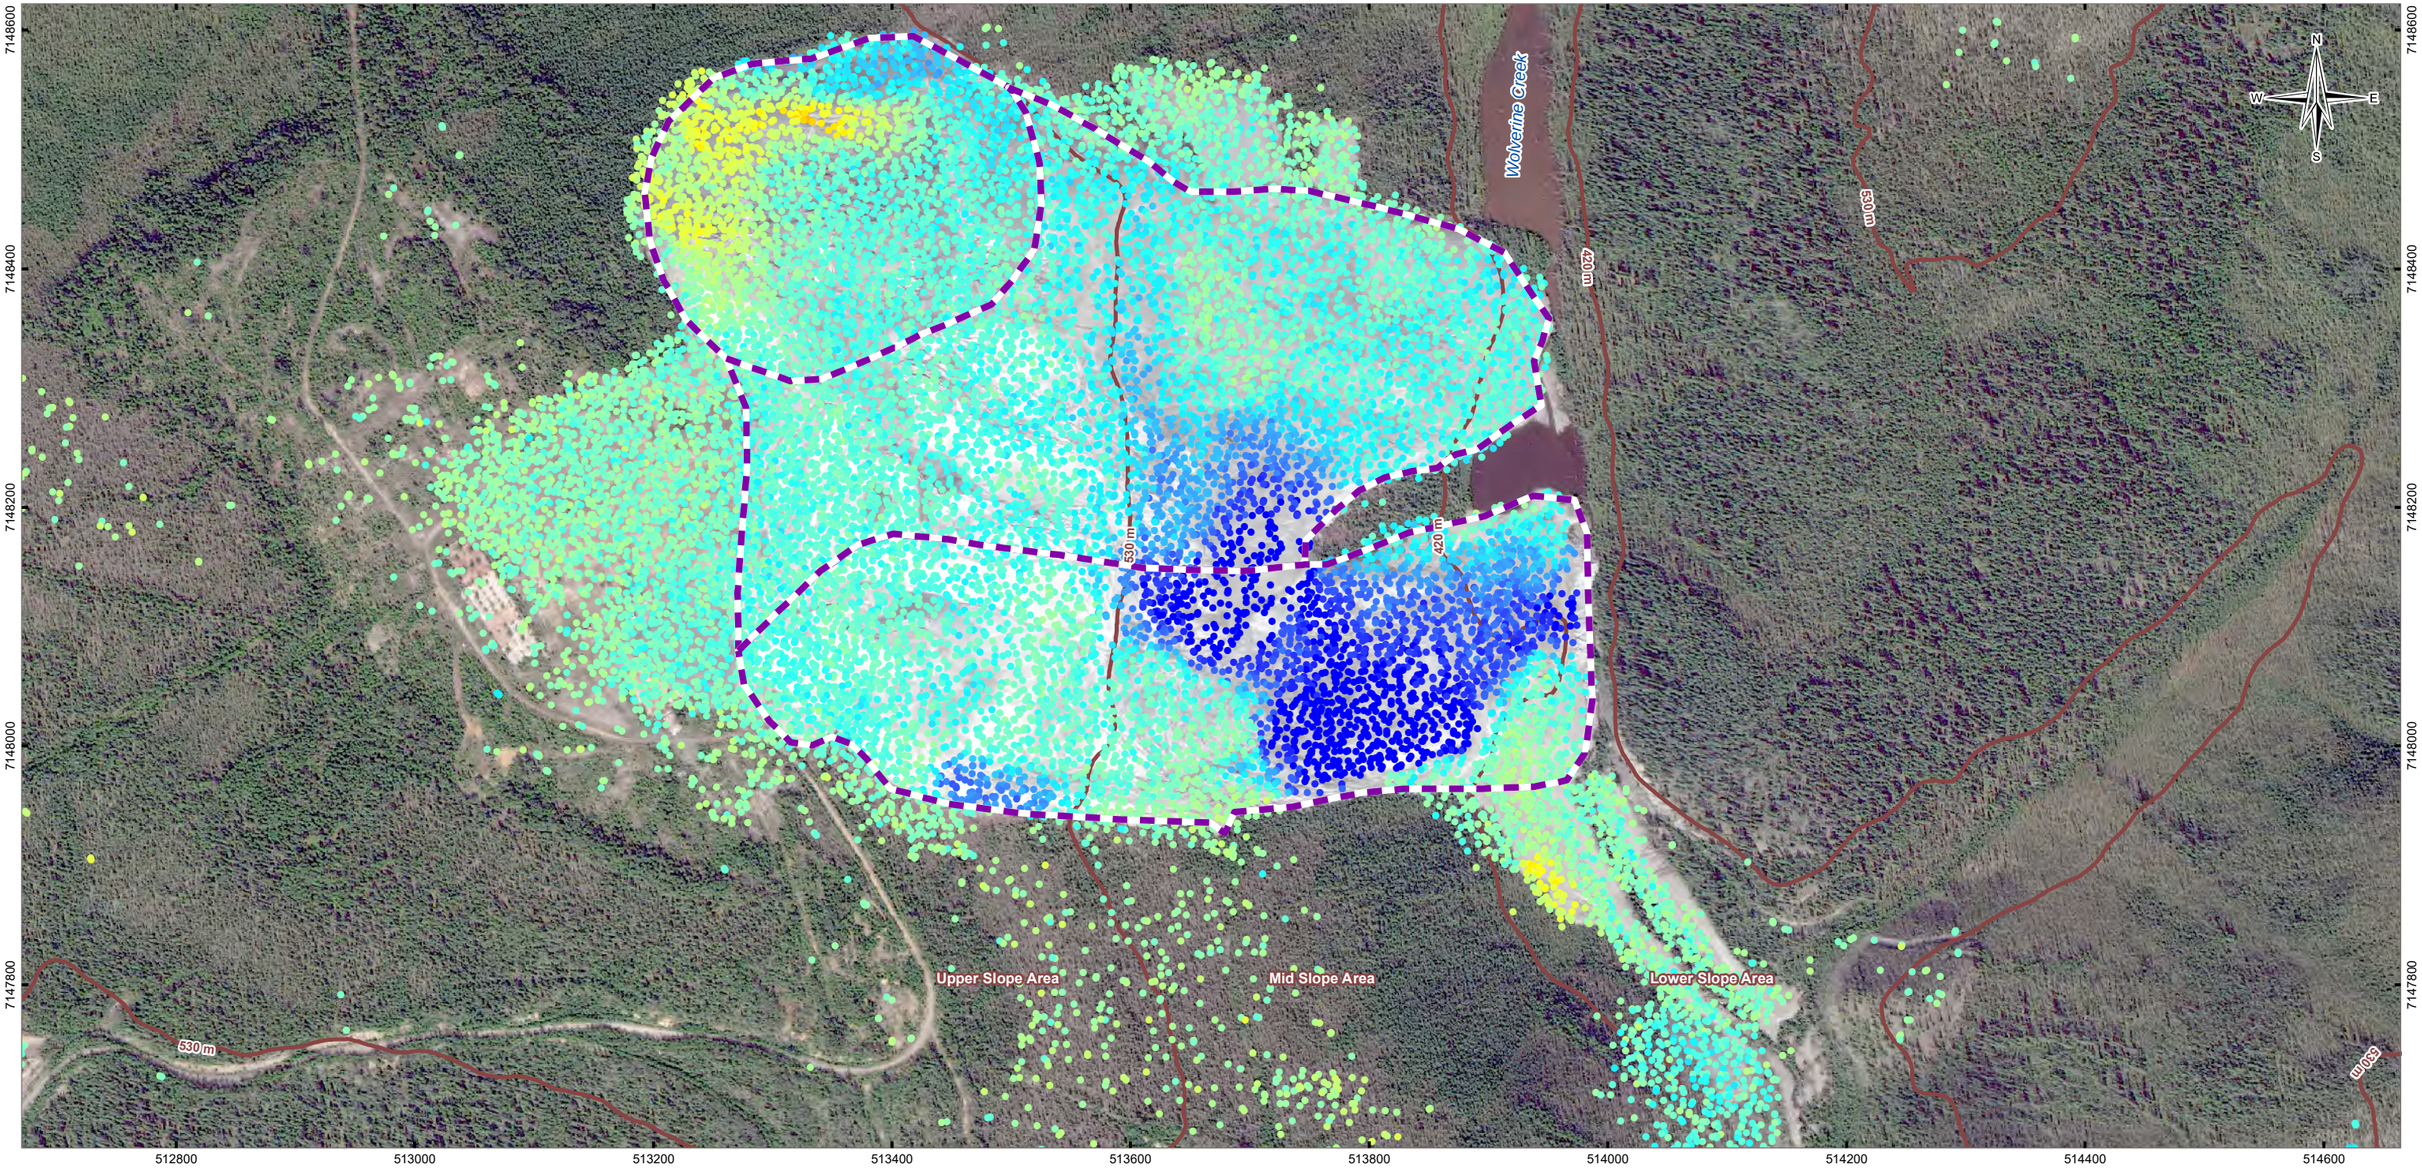
**Figure 25**

| DRAWING NO. | TITLE |
|---|---|
| FIGURE 25 | WOLVERINE CREEK WASTE ROCK PILE - LoS InSAR - ASCENDING ORBIT |

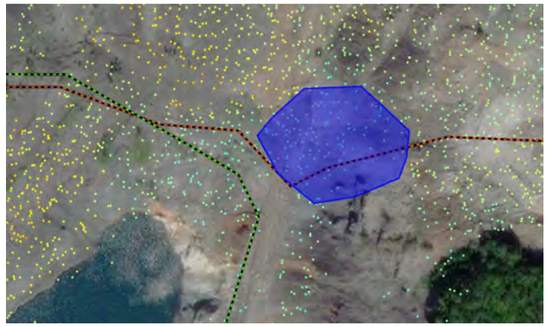
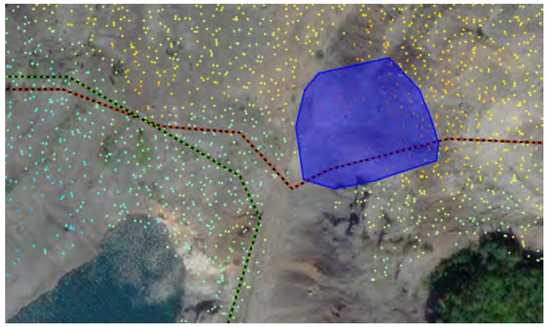
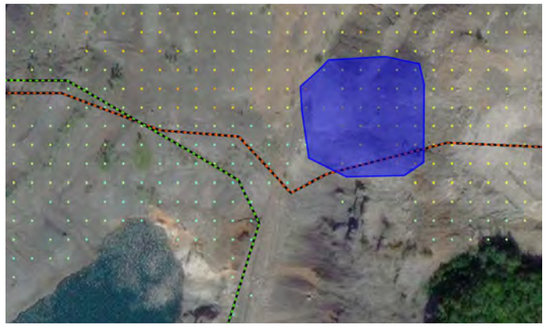
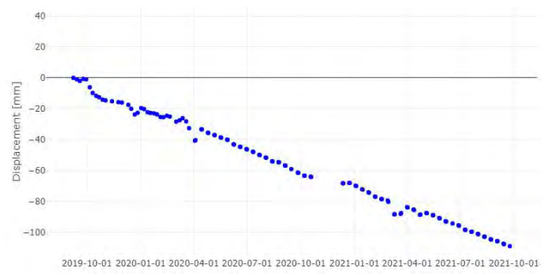
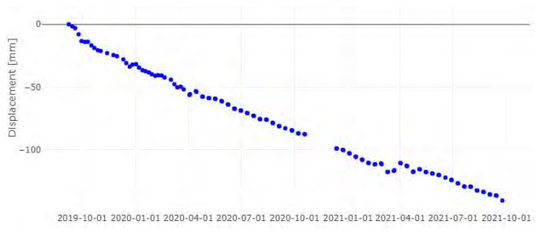
**FIGURE 30**

| DRAWING NO. | TITLE |
|---|---|
| FIGURE 30 | CLINTON CREEK WASTE ROCK DUMP UNIT 1 NORTHWEST LOCALIZED MOVEMENT 1-D AND 2-D SqueeSAR ANALYSIS |

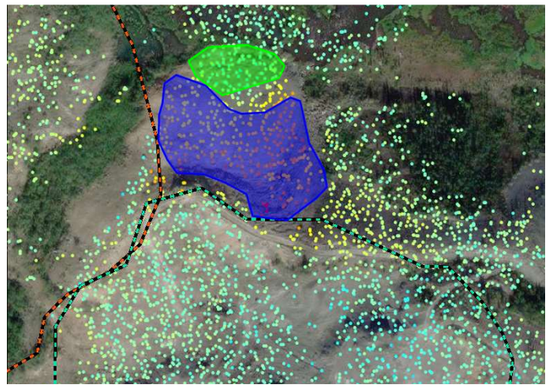
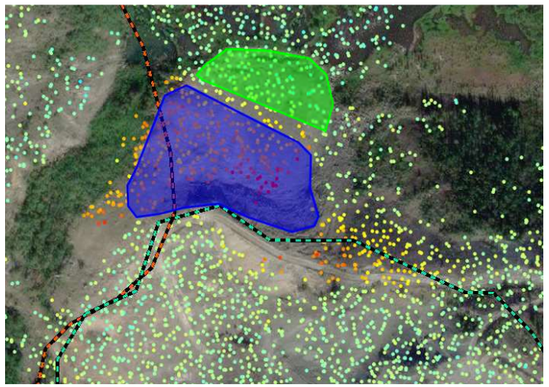
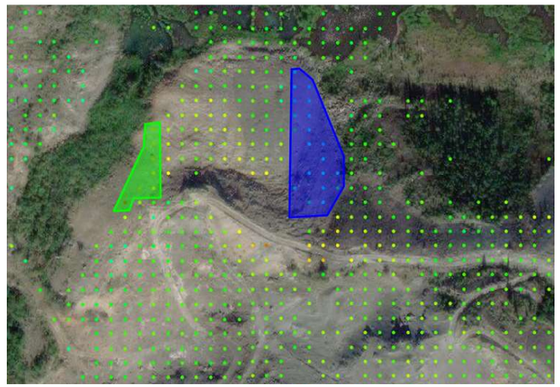
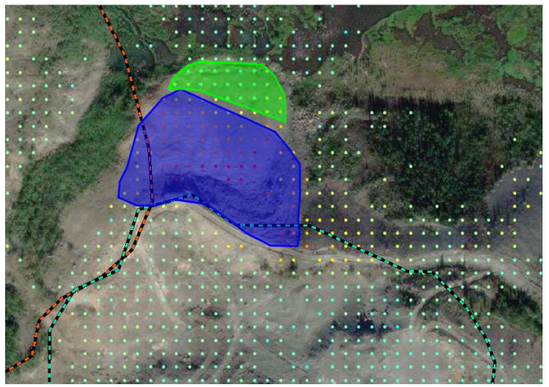
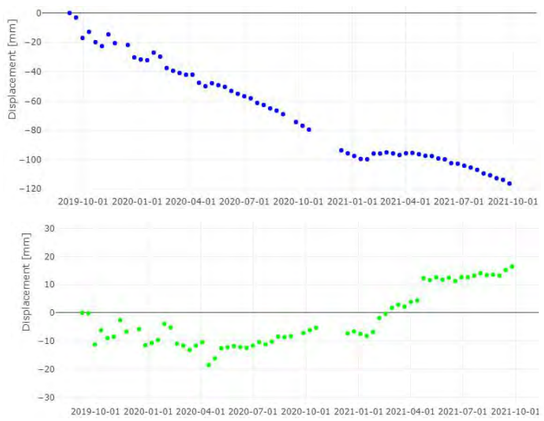
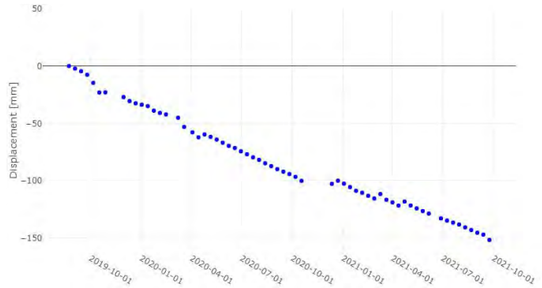
**FIGURE 31**

| DRAWING NO. | TITLE |
|---|---|
| FIGURE 31 | CLINTON CREEK WASTE ROCK DUMP UNIT 2 LOCALIZED MOVEMENT NEAR PORCUPINE PIT 1-D AND 2-D SqueeSAR ANALYSIS |

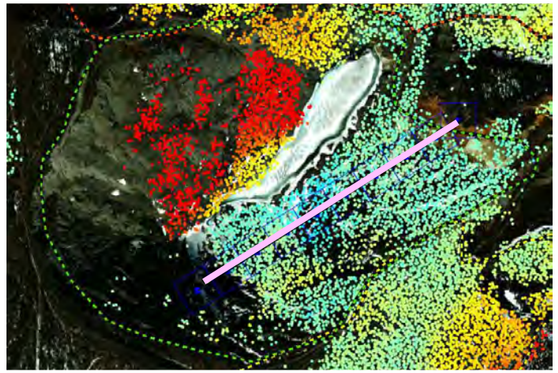
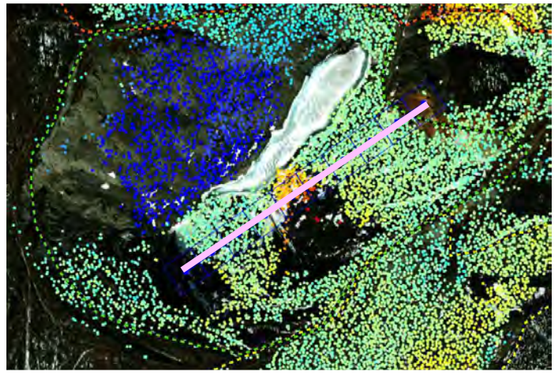
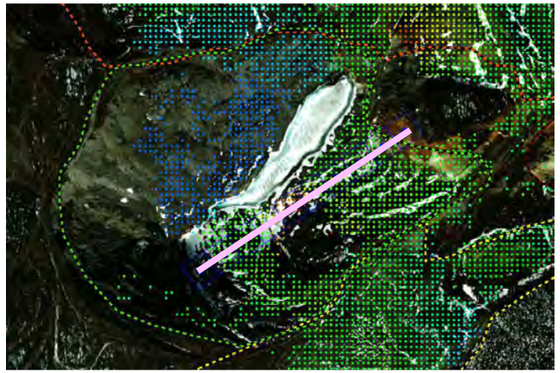
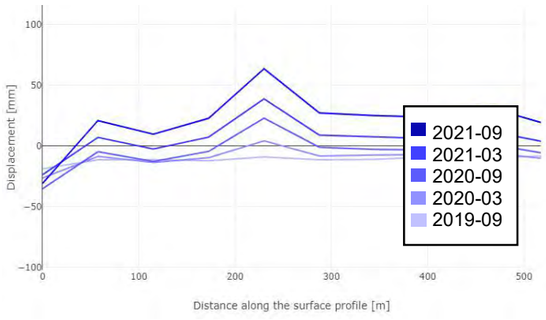
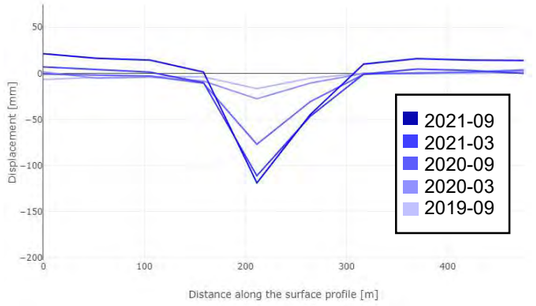
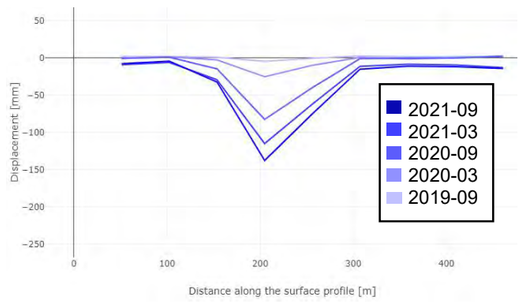
**FIGURE 34**

Movement on the northwest wall of the Porcupine Pit is shown on Figure 34. As shown on the figure, downslope movement is relatively uniform throughout the area, with little variation in displacement rates across the pit wall. Eastward movement was approximately 22 cm from September 2019 to September 2020, decelerating to about 16 cm over the remainder of the monitoring period. Downward movement was approximately 9 cm from September 2019 to September 2020, decelerating to about 6 cm over the remainder of the monitoring period.

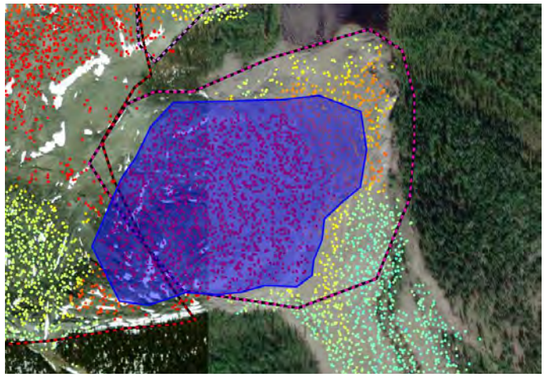
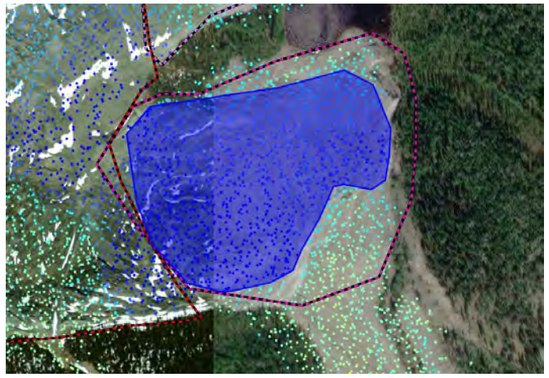
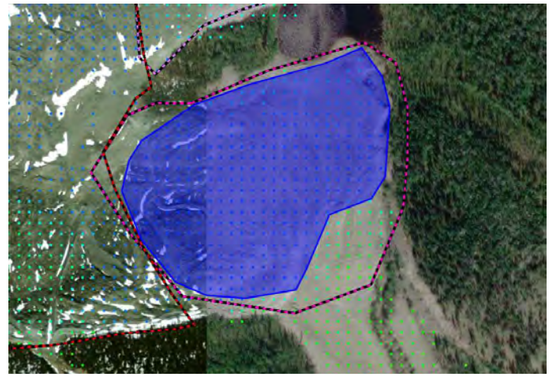
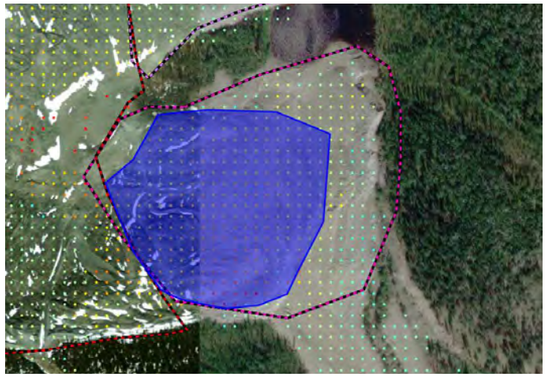
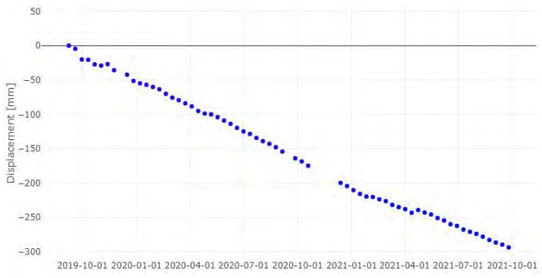
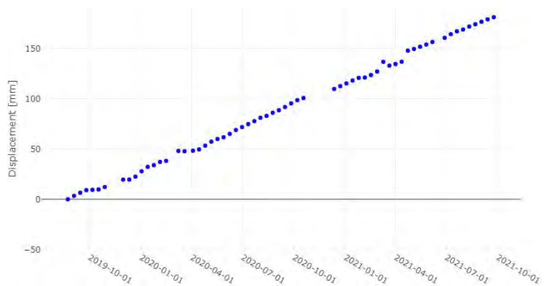
**FIGURE 35**

The southeast wall of the Porcupine Pit has a localized zone of movement in the central portion of the wall, which is shown in Figure 35. The area shown in the figure may correspond to an old, relatively large landslide that originated from near the pit rim, where a possible headscarp has been observed during site inspections. InSAR detected about 12 cm of westward movement and 4 cm of downward movement of the landslide over the monitoring period. Movement of the surrounding areas of the pit wall was less than approximately 2 cm over the same period. This is illustrated by the movement profiles shown on Figure 35, where localized movement is observed at about 200 m distance along the surface profile. InSAR coverage in the top of the landslide area near the pit rim is poor, possibly due to a lack of coherent reflectors detected from the descending orbit; however, LoS results from the ascending orbit indicates low to moderate movement away from the satellite, which would be consistent with downslope movement on the steep headscarp near the pit rim.

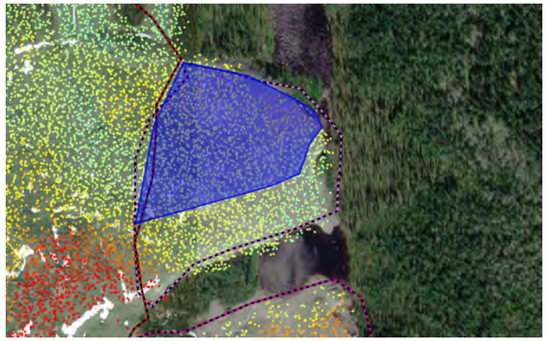
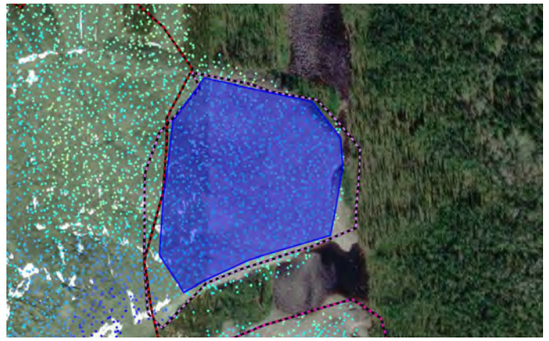
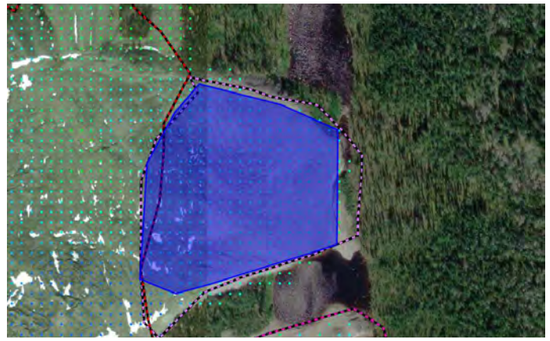
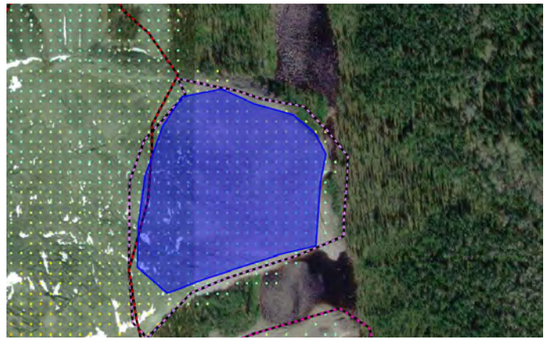
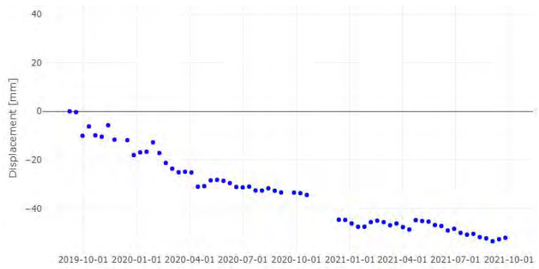
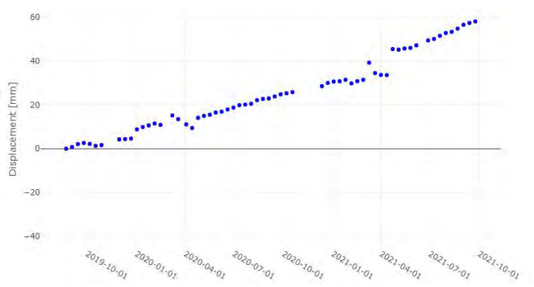
**FIGURE 36**

- The lower slope of the South Lobe, shown on Figure 36, shows approximately 15 cm/yr of eastward movement and 5 cm/yr of vertical settlement. The movement rate is nominally constant throughout the InSAR monitoring period.
- The toe of the North Lobe, shown on Figure 37, shows less than 4 cm/yr of eastward movement and negligible vertical movement. The eastward movement rate is nominally uniform, and the vertical movement rate shows a possible slight acceleration during 2021, although net movement over the two-year monitoring period is practically zero.
- The area of the tailings between the North and South Lobes, shown on Figure 38, shows approximately 15 cm/yr of eastward movement and 6 cm/yr of vertical settlement. The movement rate is nominally constant throughout the InSAR monitoring period.
