# 2021 Annual Report
# Long-Term Performance Monitoring Program
# Clinton Creek Mine, Yukon

**Government of Yukon**
**Department of Energy, Mines and Resources**
**Assessment and Abandoned Mines Branch**

MARCH 30, 2022
ISSUED FOR USE
FILE: 704-ENG.WARC03956-03

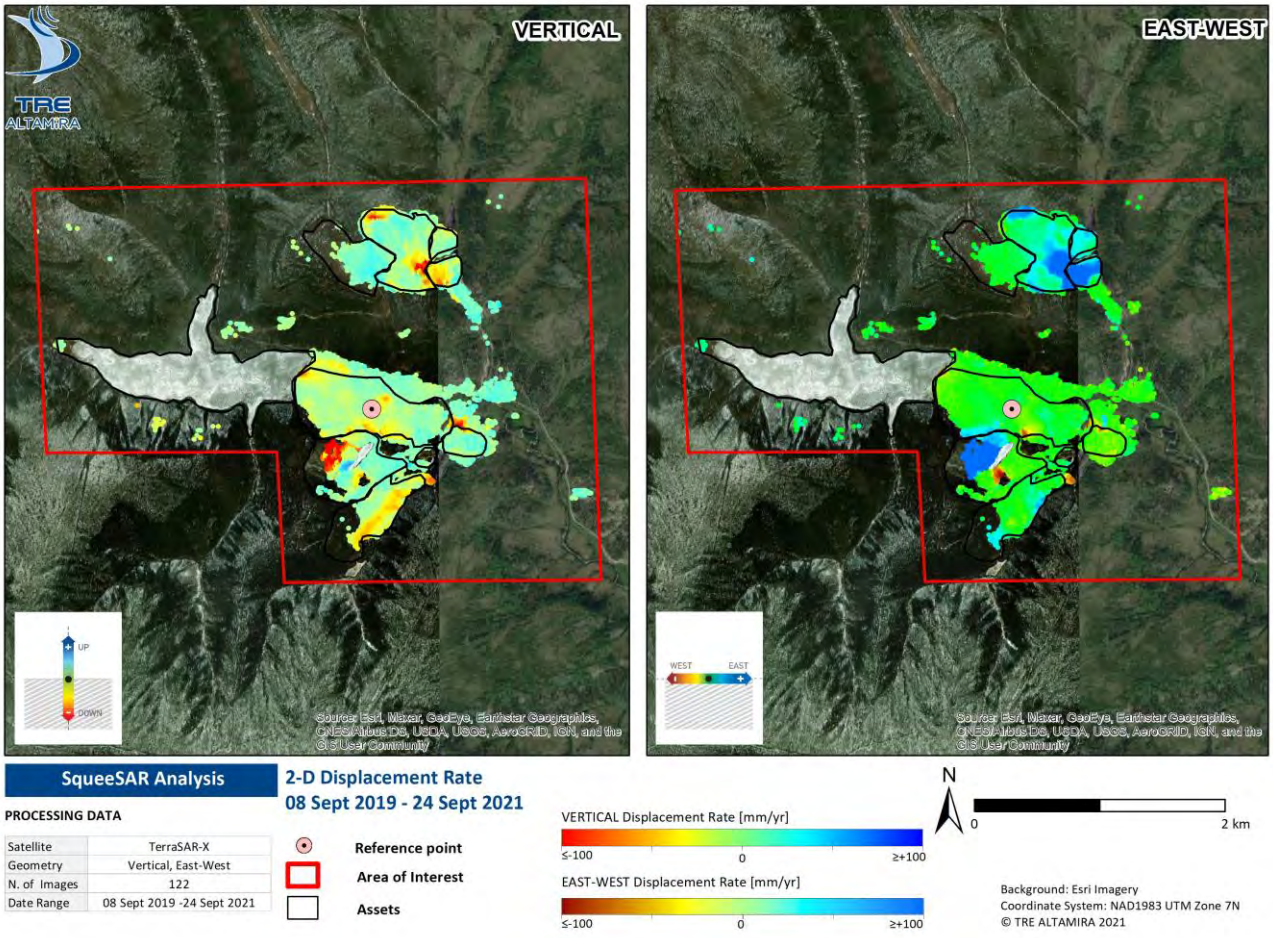
Figure 4: 2021 2-D results over Clinton Creek Mine.

The 2-D results use the overlapping (08 September 2019 to 24 September 2021) portions of the ascending and descending LOS datasets to produce true vertical and east-west displacements with millimetric precision (Figure 4). Full 2-D coverage of the site was achieved, with the exception the western end of the Former Mill Site and the west wall of the Porcupine Pit, where partial data coverage is provided. In any case, coverage at both of these sites has improved significantly compared to the previous analysis.

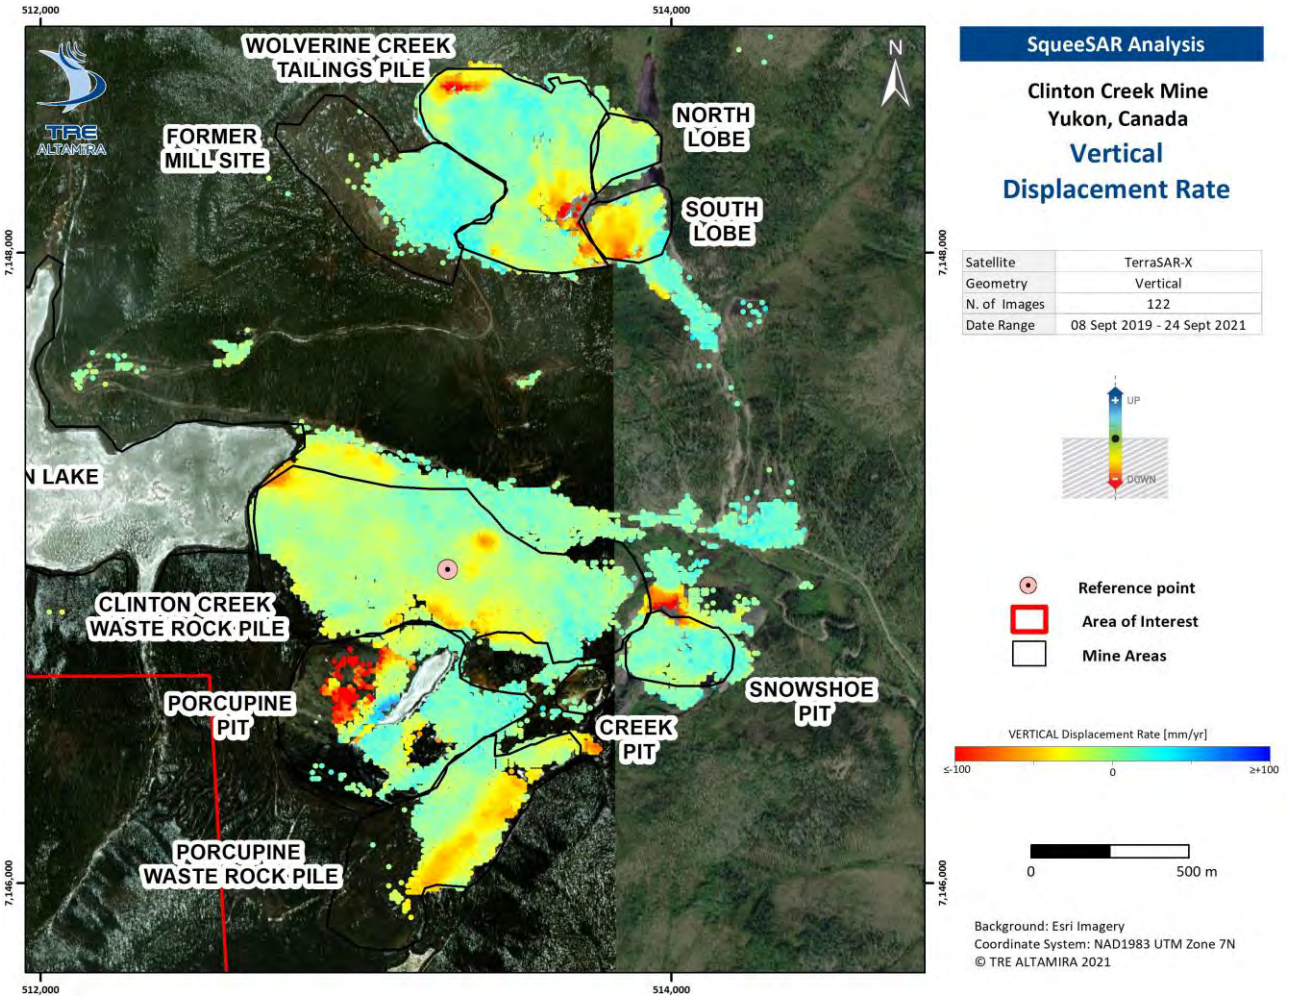
Figure 5: Vertical displacement rate for the period 08 September 2019 to 24 September 2021.

-130.7 mm/yr). Other areas identified to have subsidence were the Waste Rock Piles and the Drop Structures. Uplift reaching +67.9 mm/yr is identified within the Porcupine Pit. The average standard deviation for the vertical 2-D results was ±1.1 mm/yr.

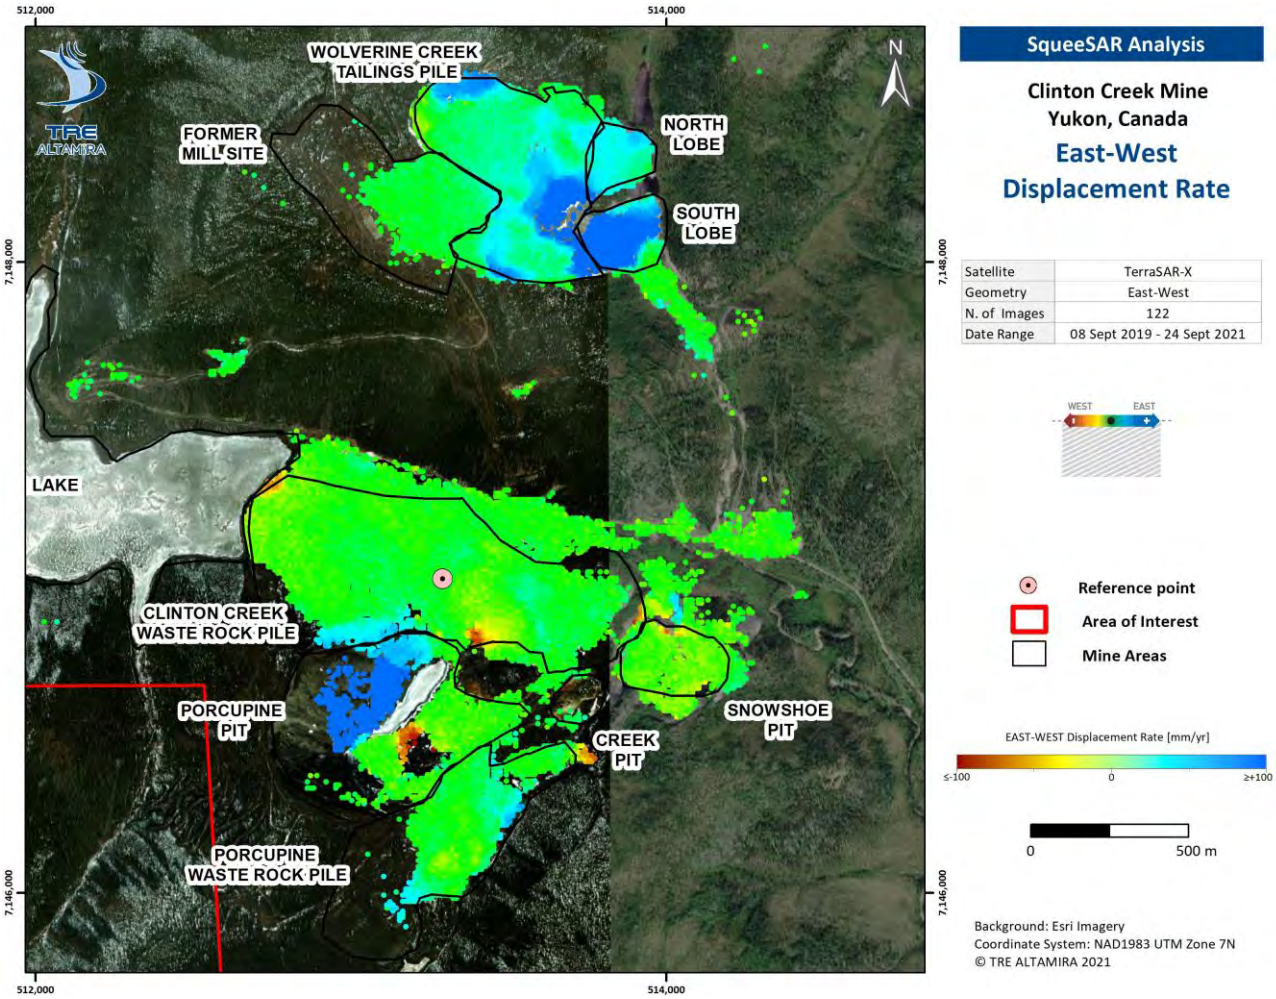
Figure 6: East-West displacement rate for the period 08 September 2019 to 24 September 2021.

Figure 6 shows the E-W horizontal movement with negative (brown) values indicating westward movement and positive values (blue) indicating eastward movement. Maximum westward movement is observed on the east wall of the Porcupine Pit, reaching a velocity of up 120.1 mm/yr, and in the eastern and south-central regions of the Clinton Creek Waste Rock Pile (up to 87.9 mm/yr and 83.9 mm/yr, respectively). Westward trends are also identified within the northern region of the Snowshoe Pit and the boundary of the Waste Pile. The highest eastward rates are observed within the Wolverine Creek Tailings Pile (up to 367.6 mm/yr) at the edge with the South Lobe, within the Porcupine Pit (up to 355.9 mm/yr) and in the South Lobe (up to 245.3 mm/yr) with eastward trends also identified within the North Lobe and the eastern boundary of the Waste Rock Piles. The average standard deviation for the E-W 2-D results was ±1.0 mm/yr.

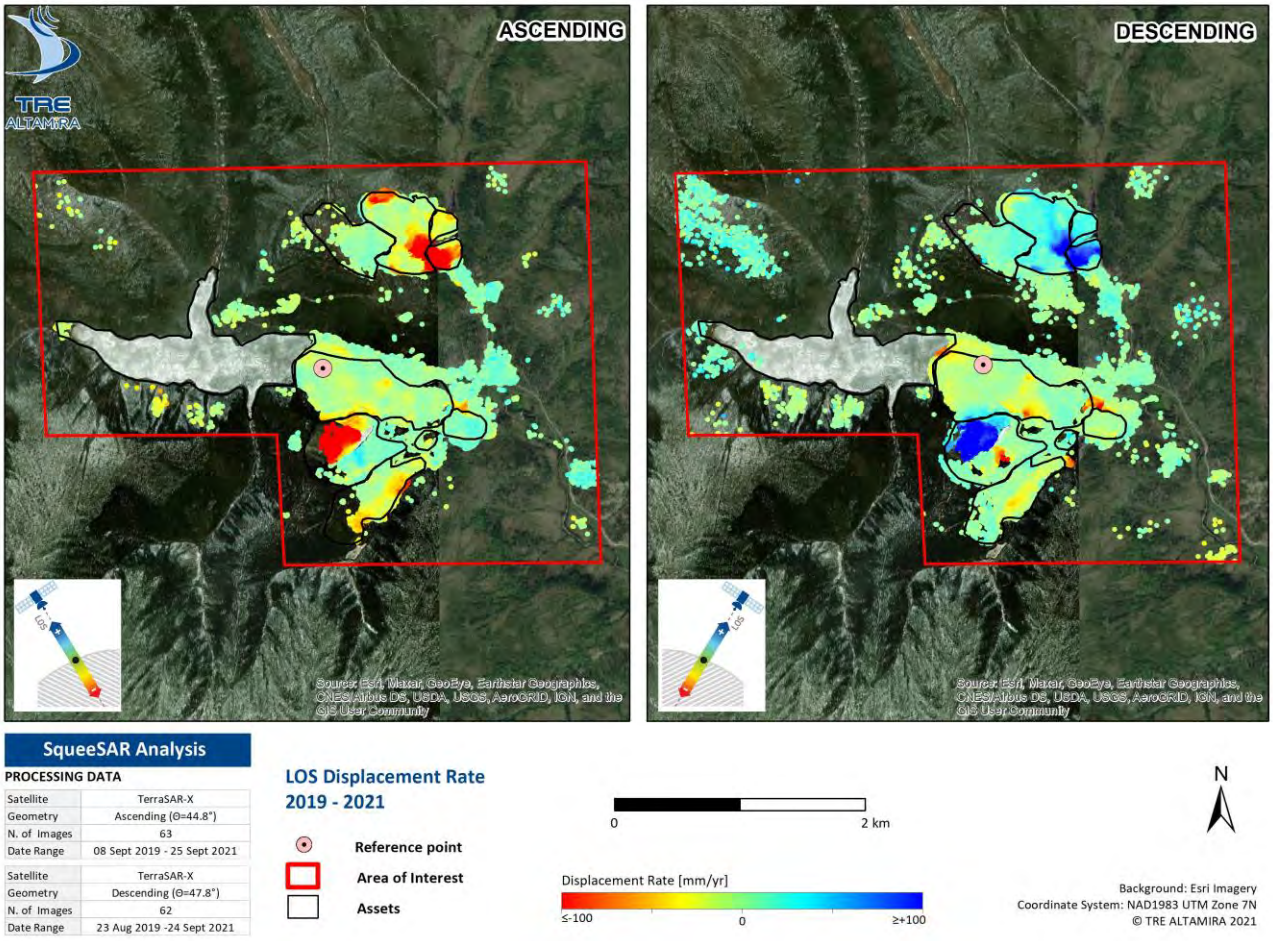
Figure 7: LOS displacement rate for ascending (left) and descending (right).

The displacement rates in the LOS data set range from -339.8 mm/yr to +54.8 mm/yr (ascending) and from -154.9 mm/yr to +230.1 mm/yr (descending). The highest displacement totals away from the satellite are located primarily within the Porcupine Pit and the South Lobe, as well as at the Wolverine Creek Tailings Pile, Waste Rock Pile, Clinton Creek Waste Pile, and north of the Snowshoe Pit. Similarly, the highest displacement totals towards the satellite are located within the Porcupine Pit and South Lobe, as well as the Wolverine Creek Tailings Pile.

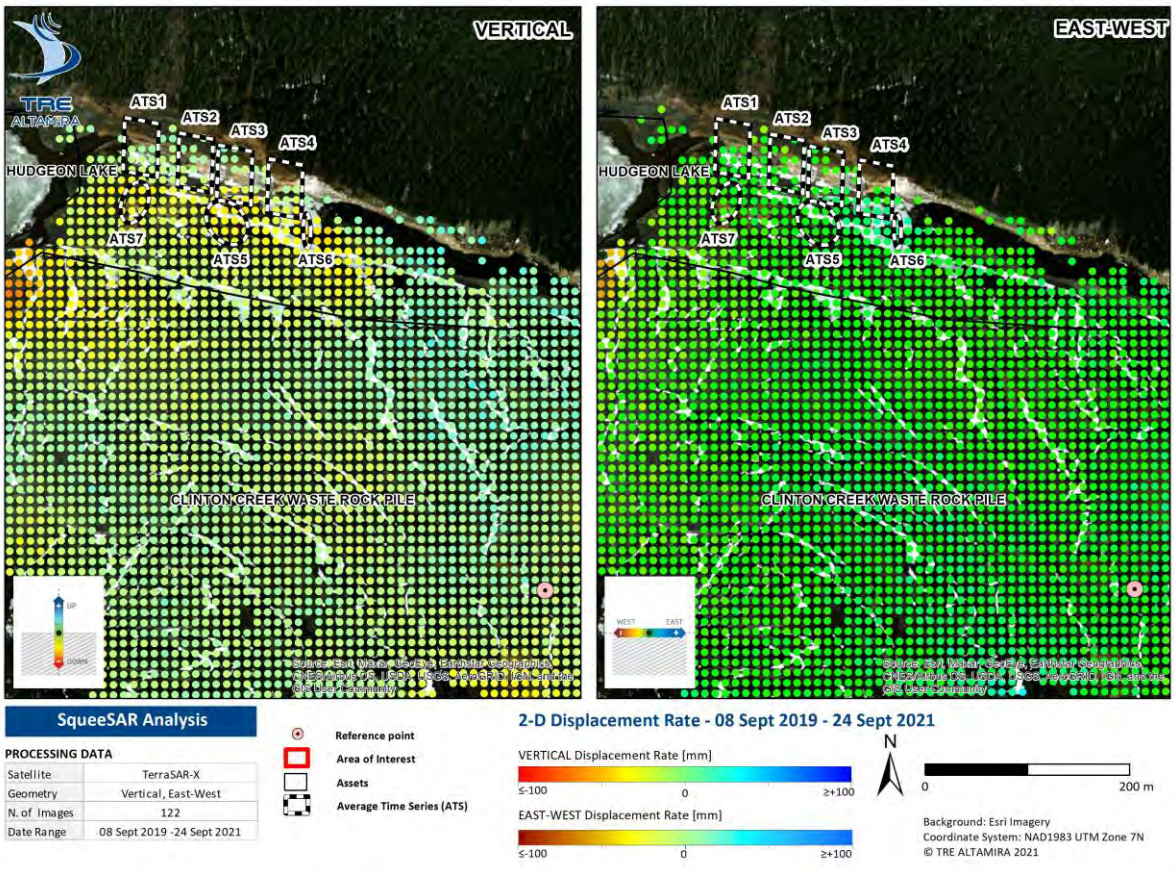
Figure 9: 2-D displacement rates over the Drop Structures from 08 September 2019 to 24 September 2021.

Both the LOS 1-D (Figure 17) and the 2-D (Figure 9) results are used to display localized displacement at the Drop Structures. ATS1 through ATS4 (Figure 10 - Figure 13) display the average displacement over Drop Structure 1 through 4, respectively, where subsidence and westward displacement are identified. ATS5 through ATS7 (Figure 14 - Figure 16) highlight movement directly south of the Drop Structures on the Clinton Creek Waste Pile.

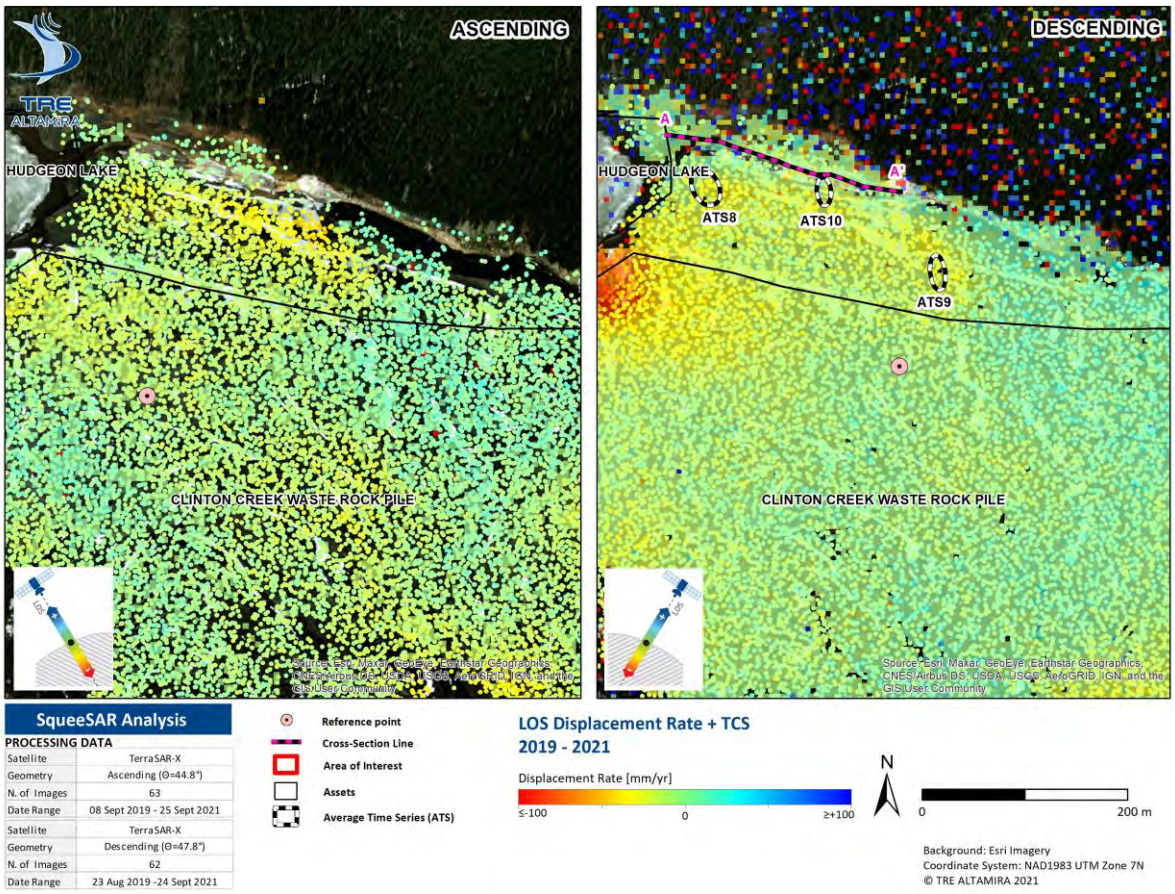
Figure 17: LOS Displacement Rate and TCS on the Drop Structures from September 2019 to September 2021.

Further analysis is highlighted below (Figure 17) and includes the TCS results. ATS8 (Figure 18) uses the descending LOS to highlight subsidence on the upper bank of the boundary between Hudgeon Lake and Drop Structure 1. ATS10 (Figure 20) highlights localized displacement away from the satellite below Drop Structure 3 within the descending results. ATS9 (Figure 19) provides the displacement average for a localized feature southeast of the Drop Structures. Cross-section A-A' (Figure 17, Figure 21) uses a buffer of 50 meters with nodes every 10 meters.

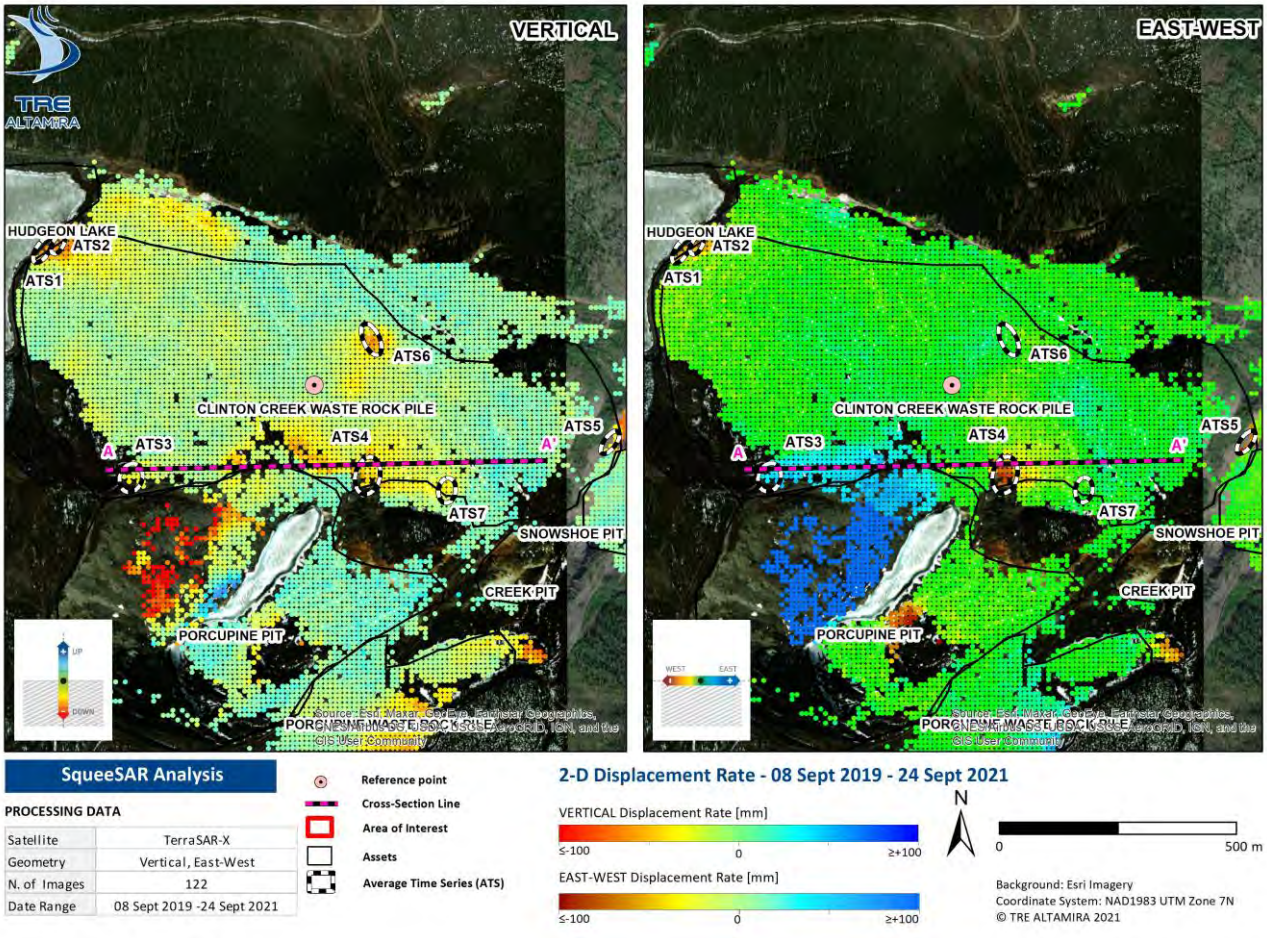
Figure 22: 2-D displacement rates over the Clinton Creek Waste Rock Pile from September 2019 to September 2021.

The Clinton Creek Waste Rock Pile area is characterized by localized areas of subsidence and horizontal displacement (Figure 22). ATS1 (Figure 23) and ATS2 (Figure 24) focus on the boundary of Hudgeon Lake, ATS3 (Figure 25), ATS4 (Figure 26), and ATS7 (Figure 29) highlight localized features along the southern extent of the Waste Rock Pile. ATS5 (Figure 27) highlights westward displacement at the eastern extent of the Clinton Creek Waste Rock Pile while ATS6 (Figure 28) highlights localized subsidence at the northeastern boundary of the asset. A cross-section runs along the base of the Waste Pile (Figure 22, Figure 30) and uses a buffer of 100 meters with nodes every 25 meters.

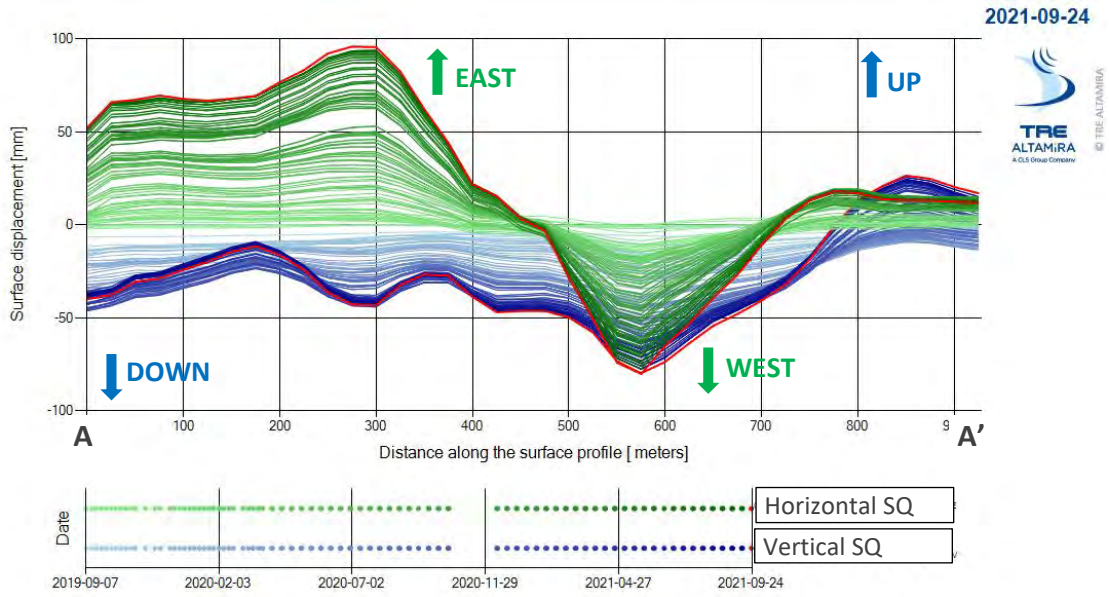
Figure 30: Cross-section along the Clinton Creek Waste Rock Pile. Green lines = horizontal displacement; blue lines = vertical displacement.

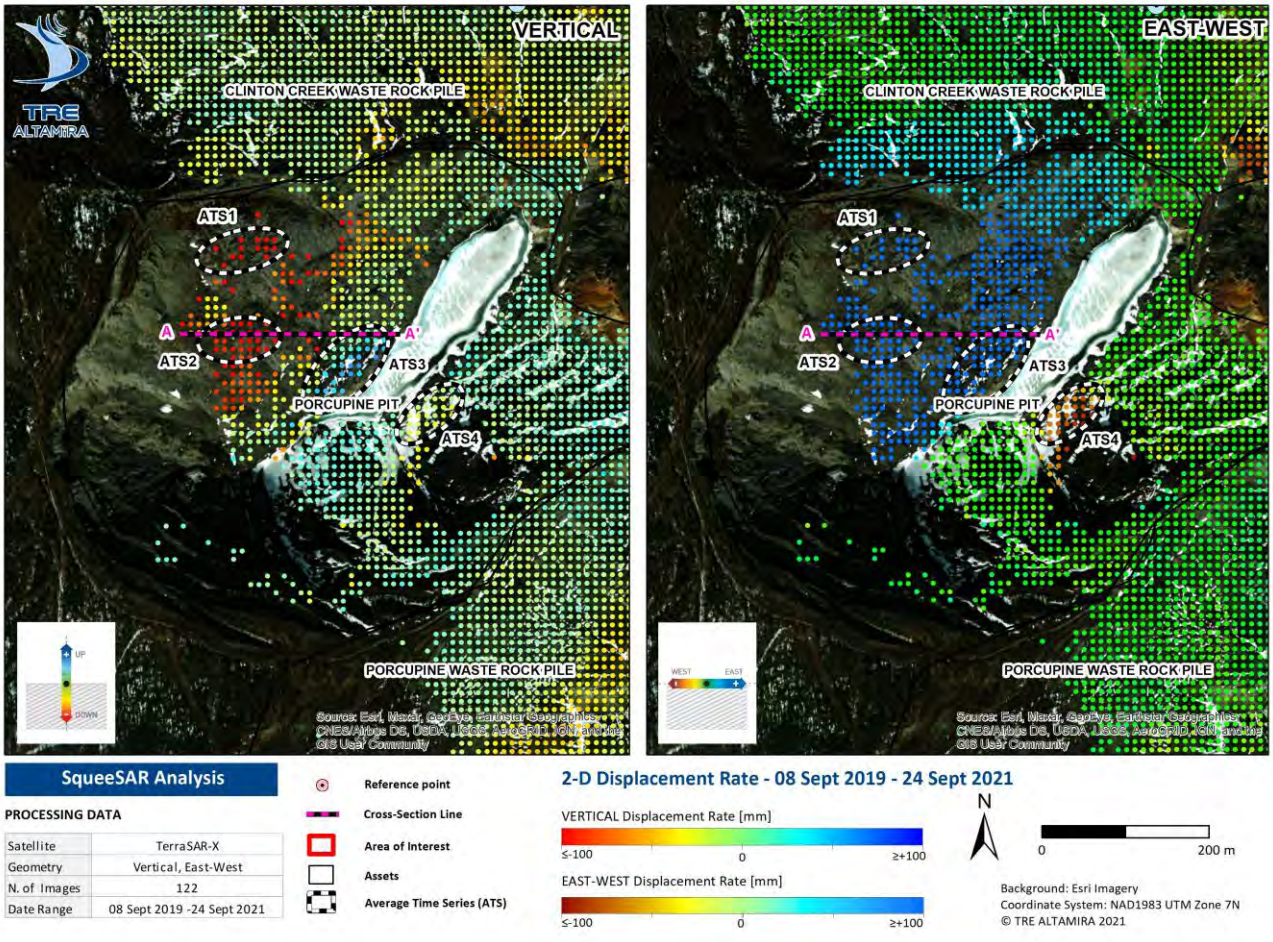
The 2-D results are used to highlight displacement over the Porcupine Pit (Figure 31). Despite the steep angle of the west wall, the 2021 SqueeSAR update provides improved MP coverage, highlighting movement downward and eastward. ATS1 through ATS4 (Figure 32 - Figure 35) illustrate local maximums within this area, indicating a general acceleration in summer/fall 2020 followed by a deceleration in 2021. A cross-section runs across the west wall (Figure 31, Figure 36: Cross-section along the west wall of the Porcupine Pit. Green lines = horizontal displacement; blue lines = vertical displacement.Figure 36) and uses a buffer of 100 meters with nodes every 25 meters.

Figure 31: 2-D SqueeSAR displacement rates over the Porcupine Pit from September 2019 to September 2021.

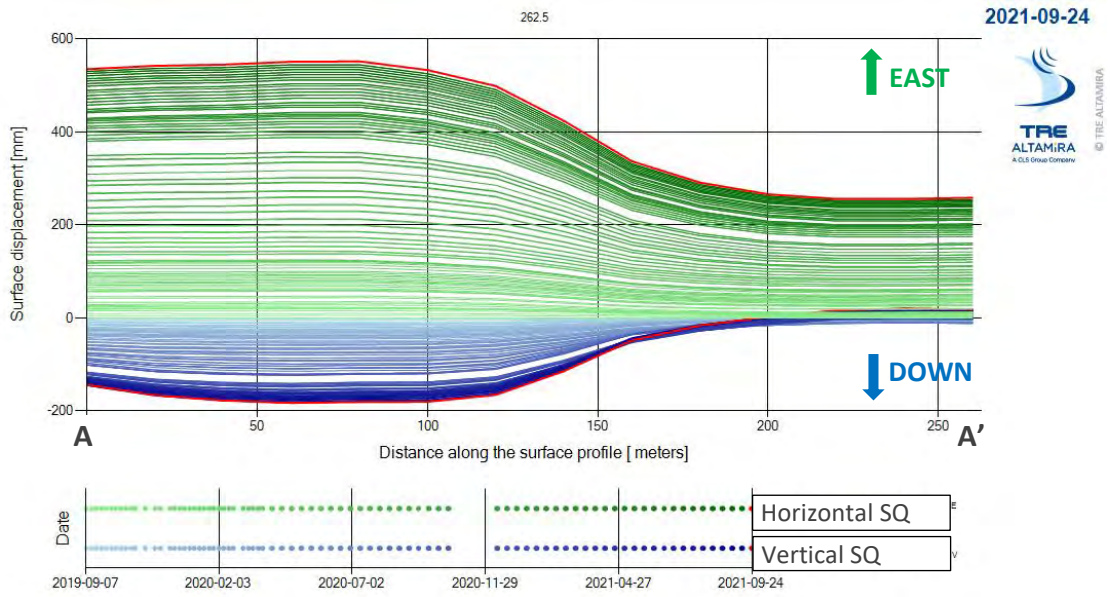
Figure 36: Cross-section along the west wall of the Porcupine Pit. Green lines = horizontal displacement; blue lines = vertical displacement.

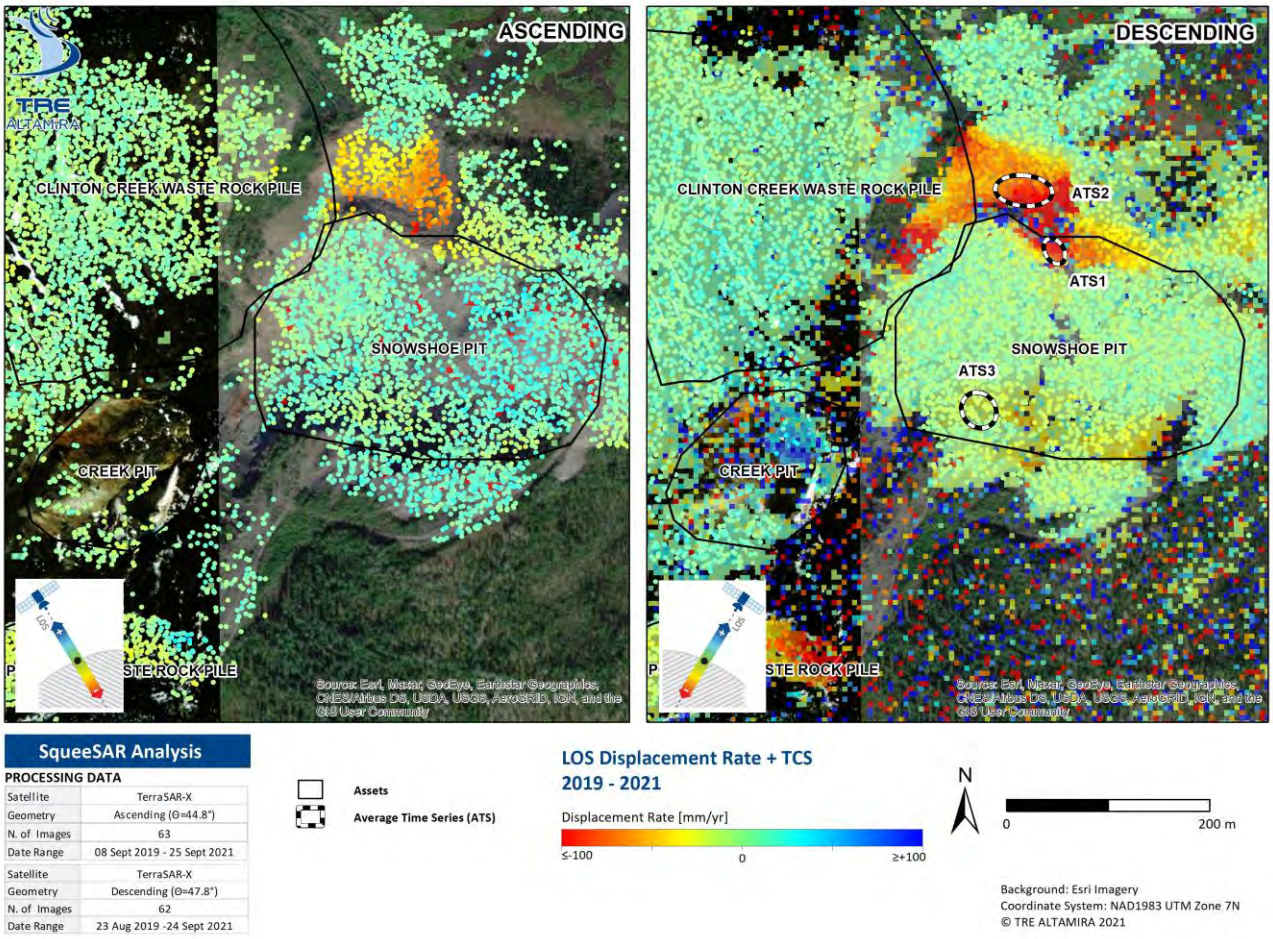
The LOS results are used to highlight displacement over the Snowshoe and Creek Pit (Figure 37). Localized displacement above the Snowshoe Pit is highlighted by ATS1 in Figure 38 and ATS2 in Figure 39. The Creek Pit has minimal coverage within the LOS results. ATS3 highlights minimal localized displacement away from the satellite in the southern portion of the Snowshoe Pit (Figure 40).

Figure 37: LOS displacement rates and TCS over the Pits from September 2019 to September 2021.

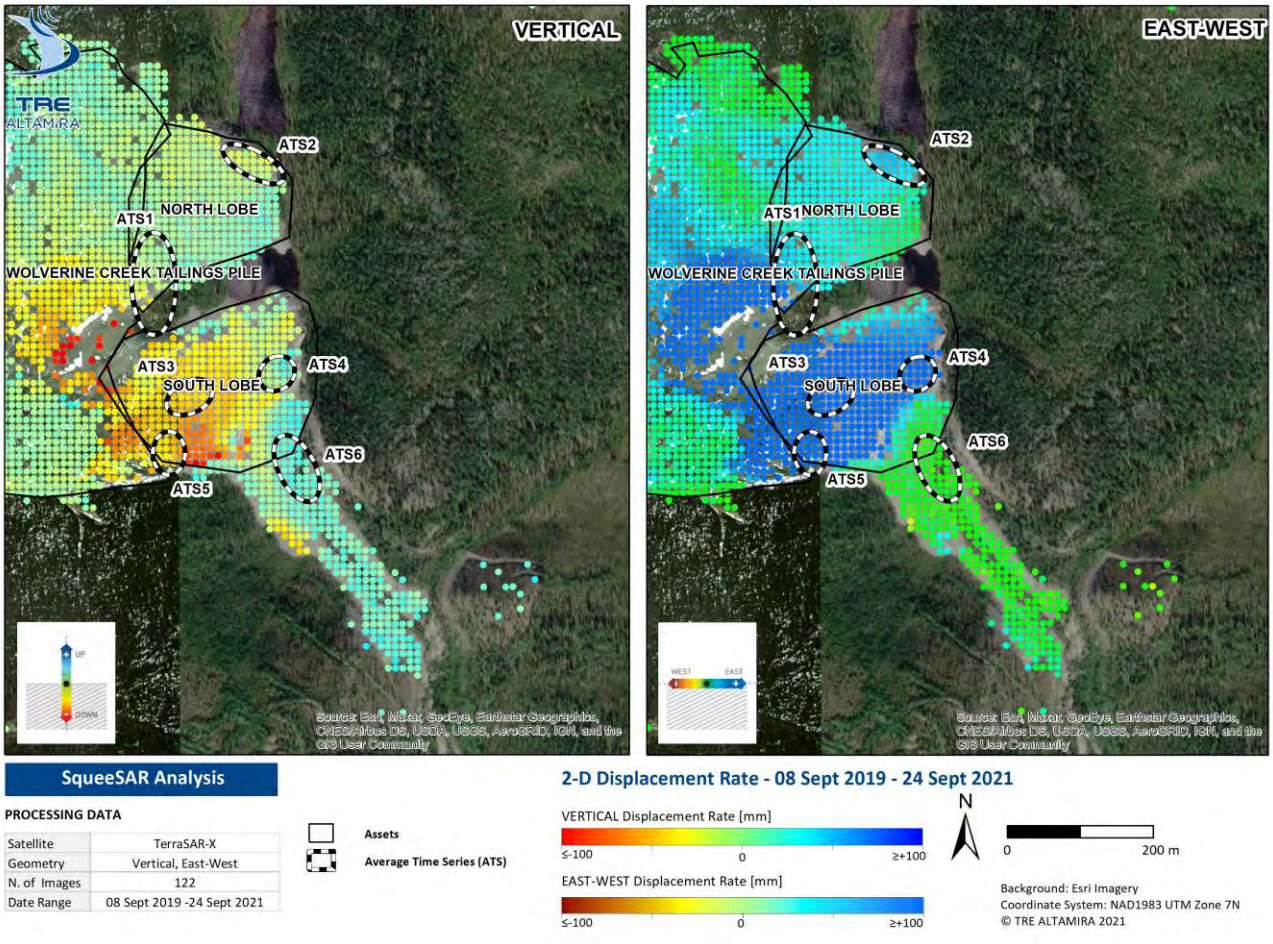
The 2-D results provide improved MP coverage over the Wolverine Creek and Lobe areas (Figure 41). Eastward movement identified within the South Lobe extends into the southwestern tip of the North Lobe and eastern edge of the Wolverine Creek Waste Pile, increasing gradually from north to south. ATS1 (Figure 42), ATS3 (Figure 44), ATS4 (Figure 45), and ATS5 (Figure 46) highlight this eastward feature and also display the vertical results. ATS2 (Figure 43) highlights displacement at the northeastern corner of the North Lobe while ATS6 (Figure 47) highlights displacement at the boundary of Wolverine Creek and South Lobe.

Figure 41: 2-D displacement rates over the Wolverine Creek and Lobe area from 08 September 2019 to 26 September 2020.

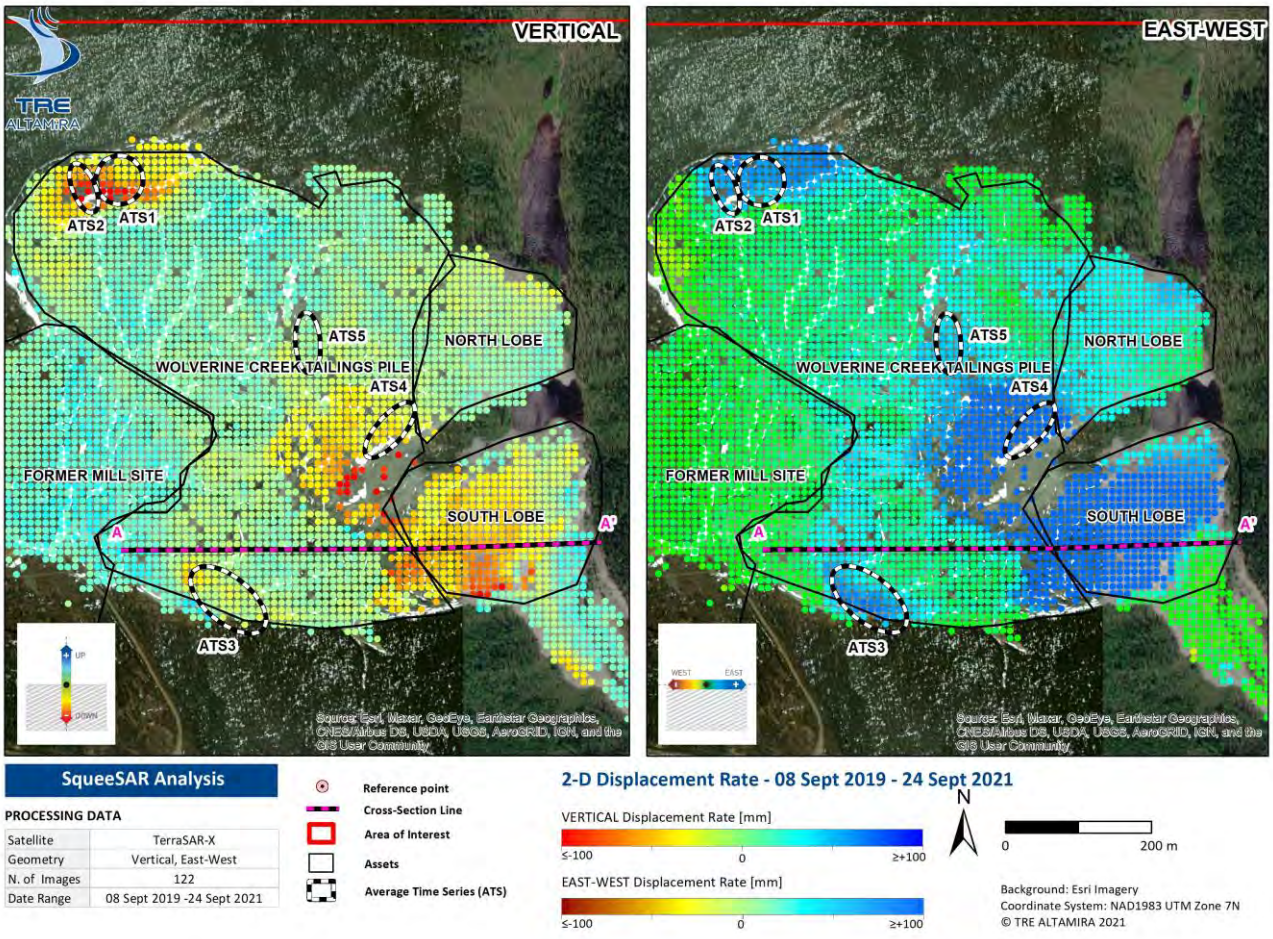
The 2-D results (Figure 48) are used to highlight displacement information within the Wolverine Creek Tailings Pile. The Wolverine Creek Tailings Pile area is characterized by localized areas of subsidence and eastward displacement. ATS1 (Figure 49) and ATS2 (Figure 50) display averages of the subsidence and eastward displacement observed within the northwestern corner of the tailings pile. ATS3 (Figure 51) highlights a localized feature of eastward displacement not identified in the 2019 monitoring study. ATS4 (Figure 52) and ATS5 (Figure 53) highlight the eastward displacement that reaches into the South Lobe. A cross-section runs along the base of the Tailings Pile and across the southern region of the South Lobe (Figure 48, Figure 54) and uses a buffer of 100 meters with nodes every 25 meters.

Figure 48: 2-D SqueeSAR displacement rates over the Wolverine Creek Tailings Pile from 08 September 2019 to 26 September 2020.

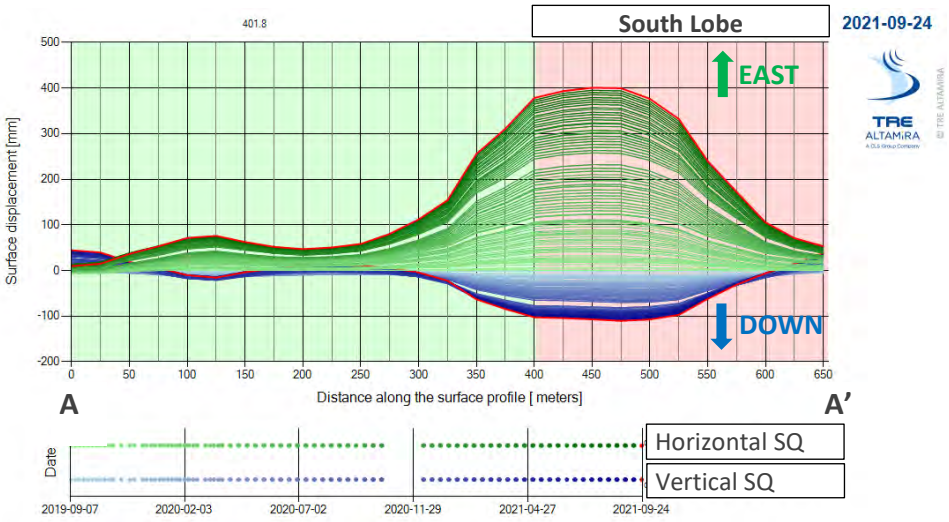
Figure 54: Cross-section along the Wolverine Creek Tailings Pile and South Lobe. Green lines = horizontal displacement; blue lines = vertical displacement.
