Phase III ENVIRONMENTAL ASSESSMENT

PESO MINE SITE

Final Report

GEOTECHNICAL SERVICES
YUKON ABANDONED MINE SITES

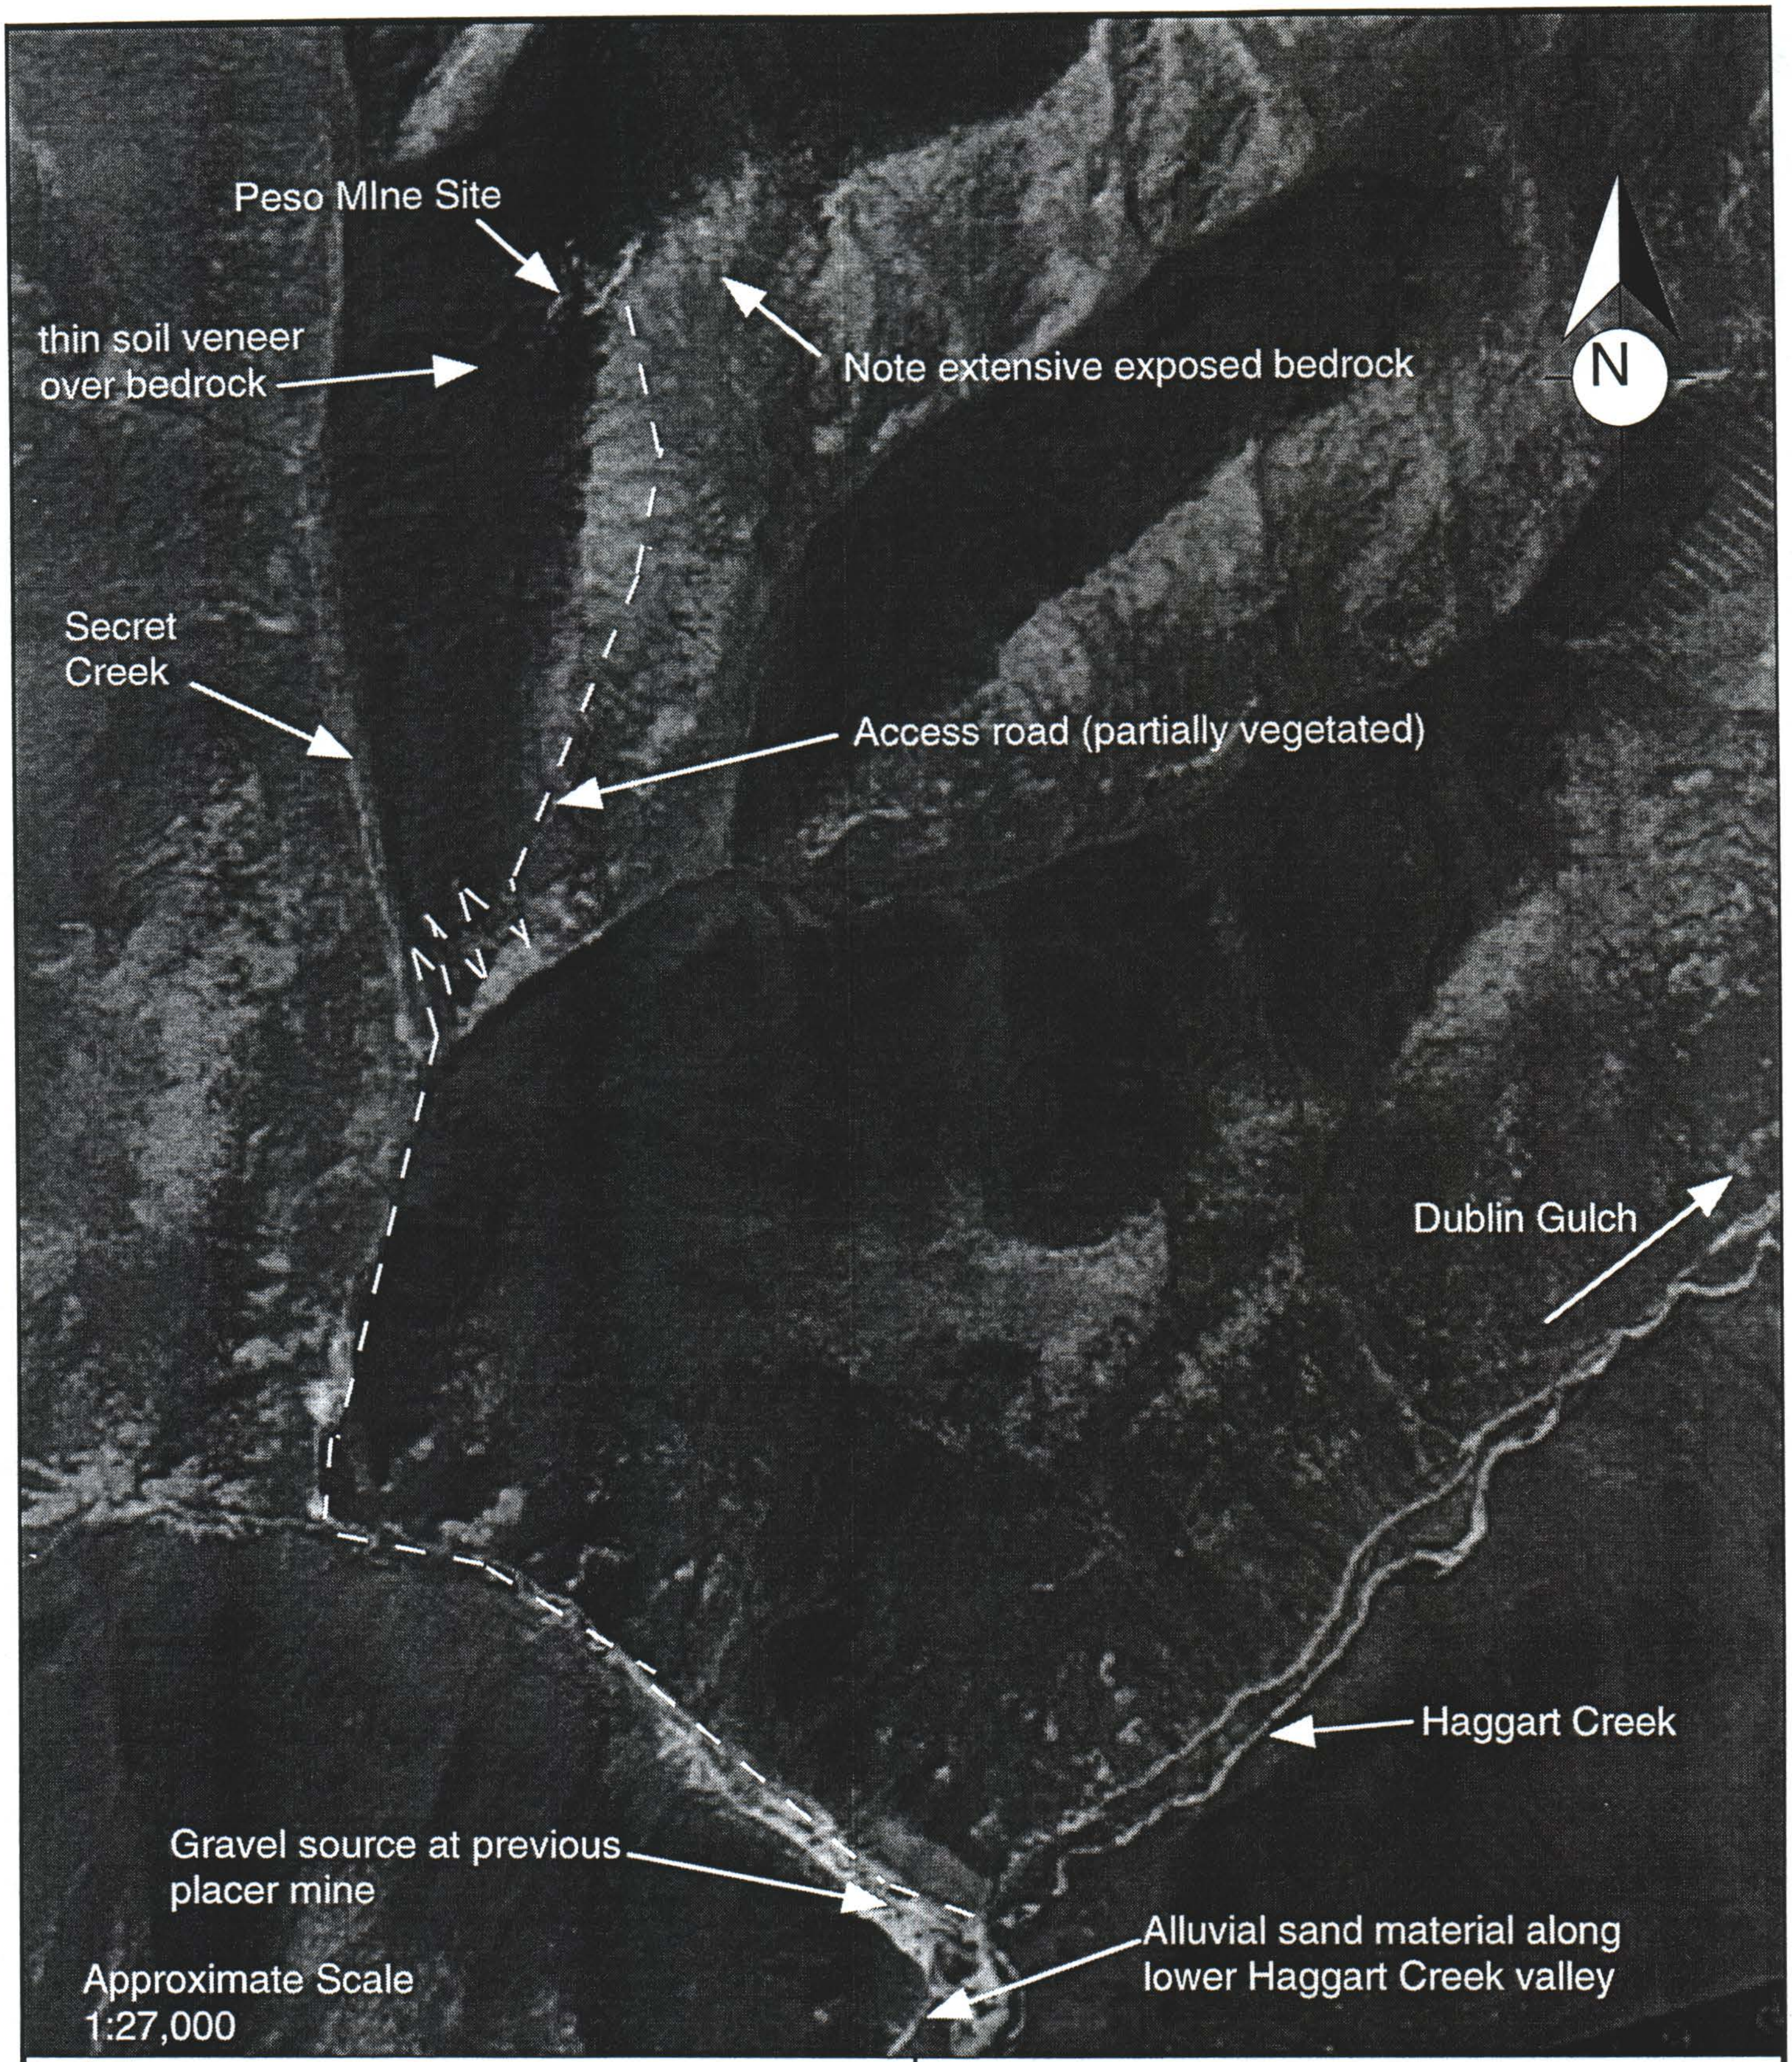
DATE	DWN.	CHKD.	FILE NO.	DWNG.	REVISION
97 10 20	MEB		0201-97-12953	12953-8	0

Aerial photography of the study area with an approximate scale of 1:40,000 was reviewed for terrain analysis considerations in order to determine the location of a fine grained borrow source. The immediate area of the Peso Mine site is characterized by extensive bedrock outcroppings as noted on Drawing 12953-8. The surficial soils consist of a thin veneer (less than 1.0 m) of colluvium or till over bedrock. The till material is a heterogeneous mixture of sand, silt, and gravel with bedrock detritus intermixed as a result of down slope movement. The topography appears to conform with the subjacent bedrock with relatively steep slopes terminating sharply at valley bottoms. The thin colluvium along the slope near the Peso Mine Site would not be suitable as fine grained borrow material. Further, there was no evidence of sizable morainic or glaciofluvial deposits within the valley of Secret Creek of sufficient quantity for borrow source development purposes.

The only potential borrow source which was identified within the study area was along the lower Haggart Creek valley where more sizable fluvial and alluvial deposits are located. As indicated on Drawing 12953-8, sand and gravel alluvial deposits are present near the confluence of Secret Creek and Haggart Creek which could be used for borrow purposes. Borehole data from a previous investigation[1] is available along the access road for the Haggart Creek and Dublin Gulch mines. The subsurface soil profile consists of a fine to medium sand, with some gravel and silt and is free of permafrost. The grainsize distribution for this sand material is enclosed in the figure section of the report. Although this could be used as borrow material, it would not be suitable as a low permeability cover for the waste rock pile due to the relatively high intrinsic permeability which could be expected from such an alluvial deposit. Further, this area is approximately a 7 km to 8 km distance along a rough trail and a difference in elevation of approximately 400 m from the Peso Mine Site. Hauling costs for this distance would be prohibitively expensive. For these reasons, it is not considered feasible to develop a fine grained borrow source for use in site restoration purposes at the Peso Mine.

3. It is not recommended to proceed with a geotechnical investigation for borrow source development as there were no fine grained sources identified in the terrain analysis within an economical distance from the Peso site.

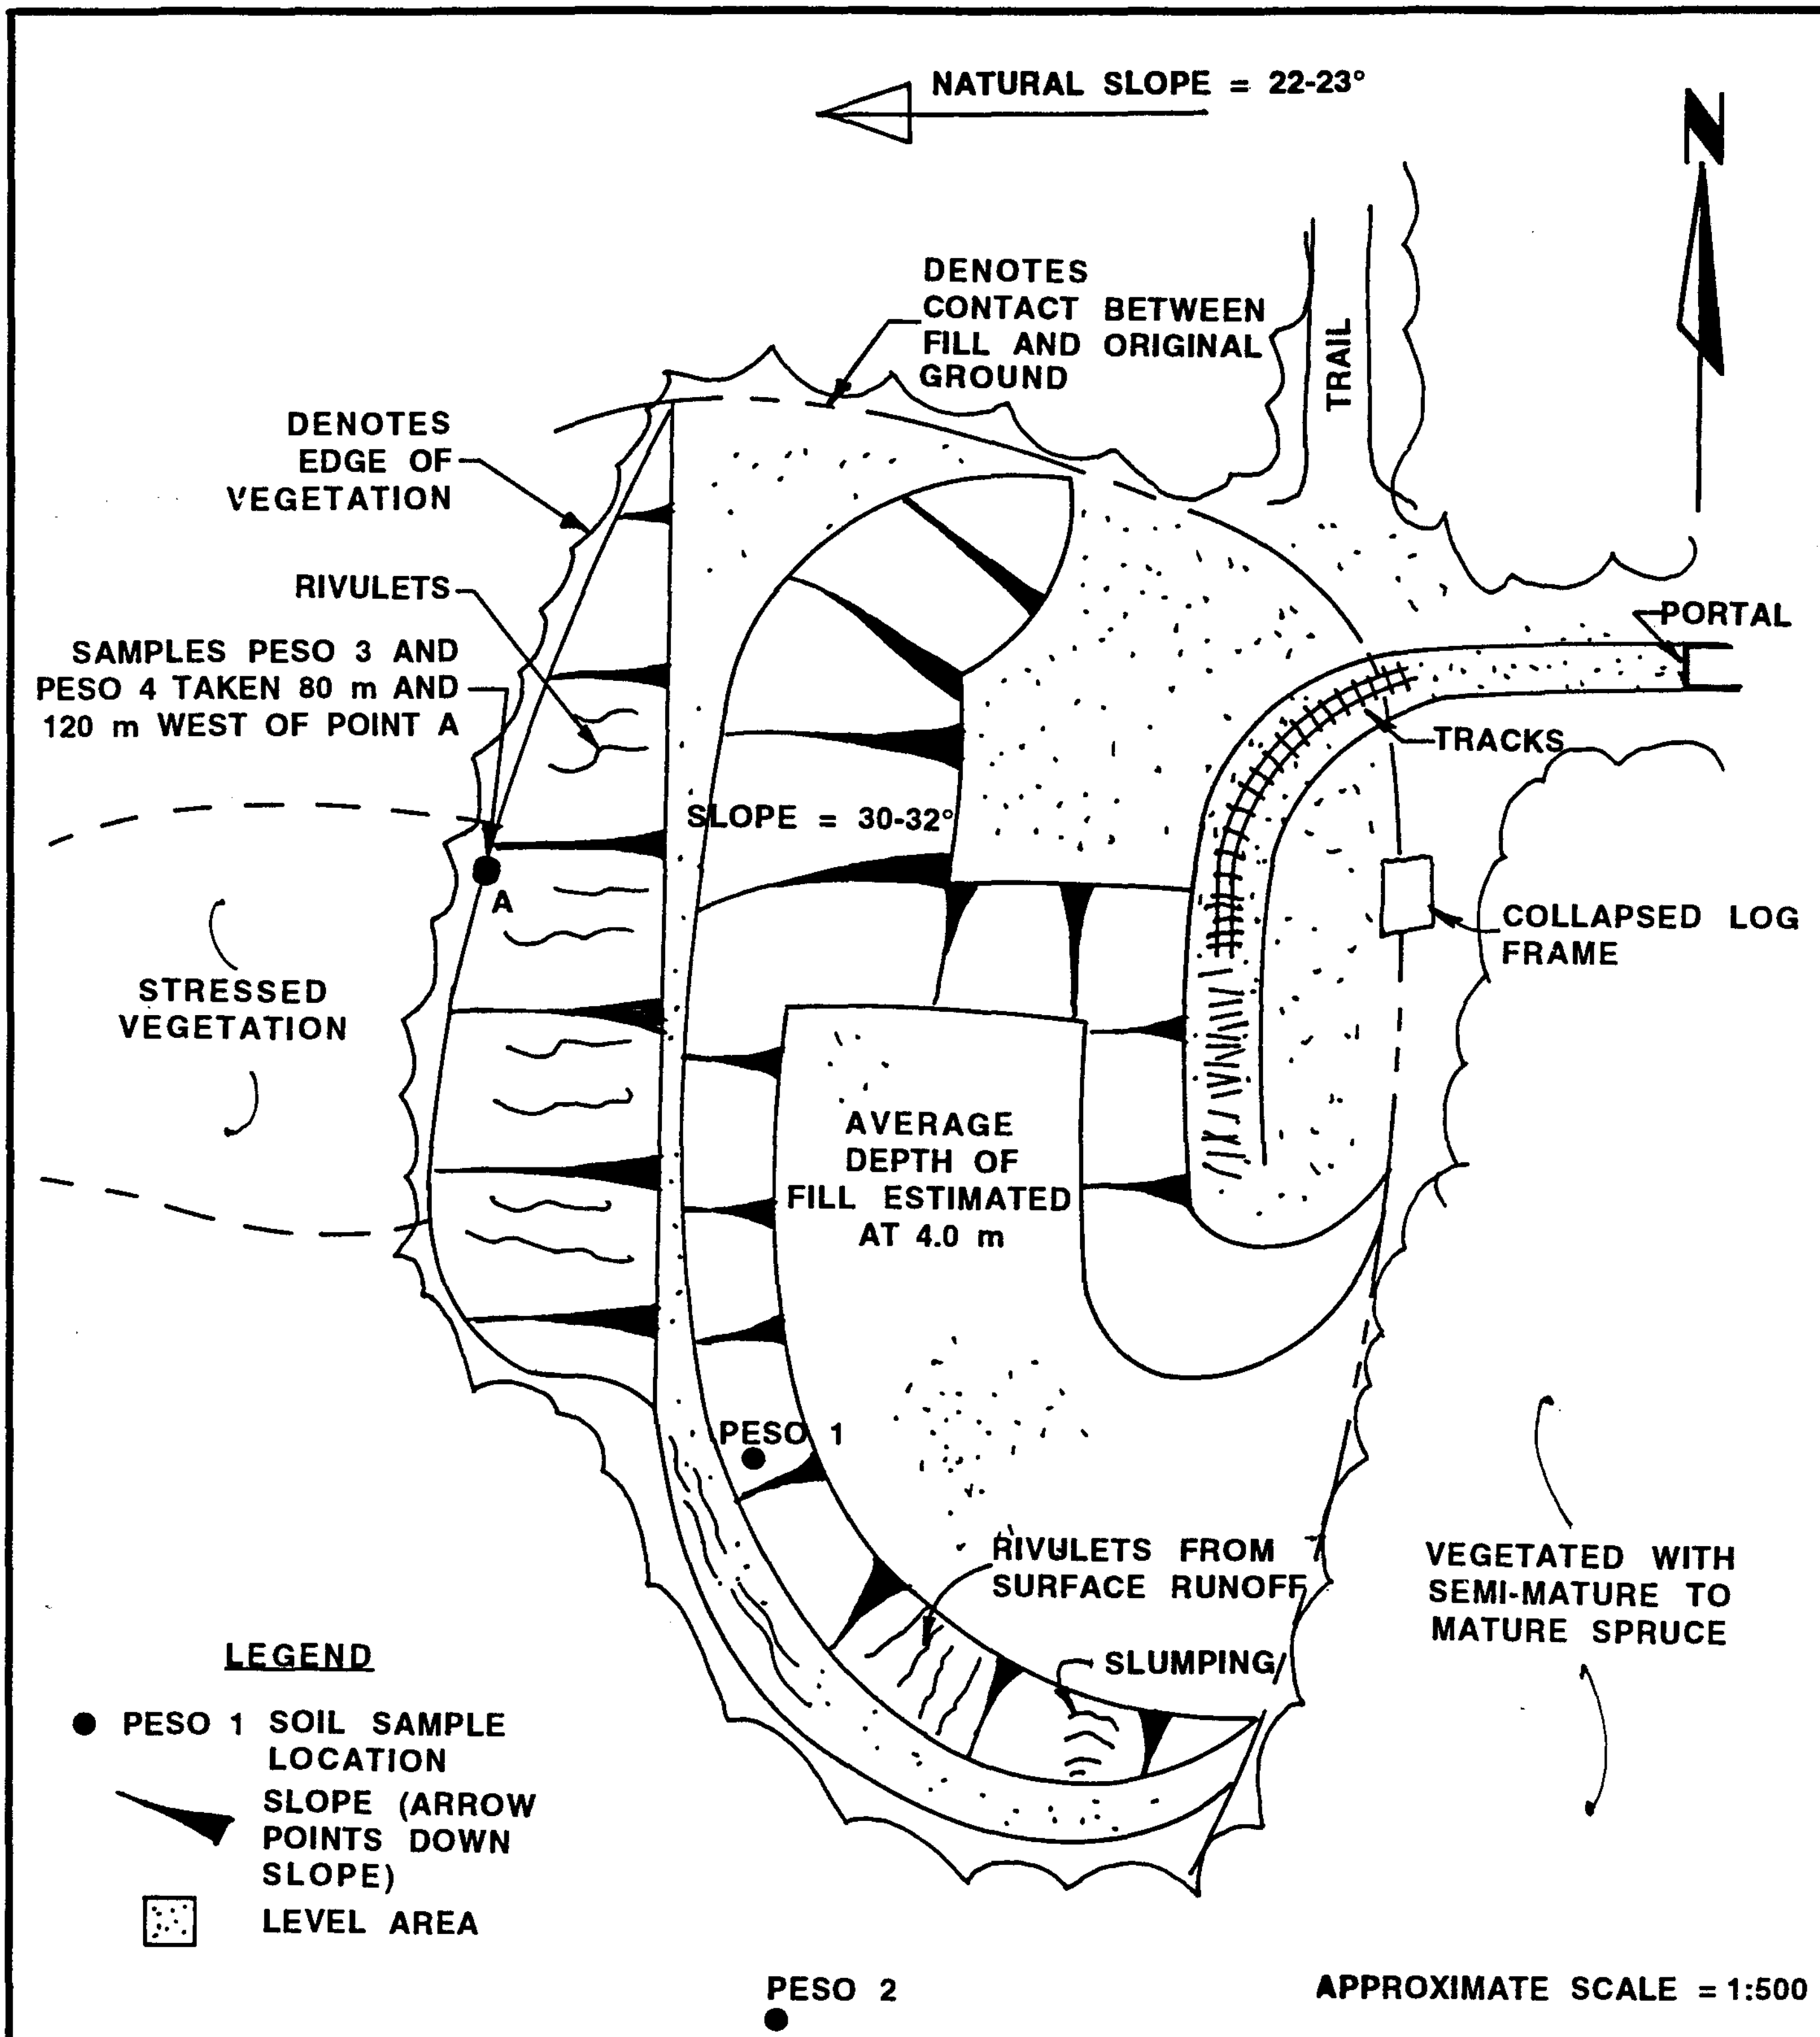
EBA Engineering Consultants Ltd.		PROJECT: GEOTECHNICAL SERVICES YUKON ABANDONED MINE SITES	
CLIENT: PUBLIC WORKS & GOVERNMENT SERVICES CANADA		TITLE: PLAN DRAWING OF PESO MINE SITE, ADIT 1 WASTE ROCK PILE	
DATE 97/10/08	DWN. MEB	CHKD. MEB	DRWG NO. 12953-9
			FILE NO. 0201-97-12953

The main development area where the adit and waste rock pile occur at the Peso Mine Site was inspected for slope stability considerations. The relevant site features noted at the time of the site visit were essentially as described on the site plan enclosed as Drawing 12953-9 and as seen in Photos PE1 and PE2. The waste rock pile encompassed a 50 m by 70 m area and occurred as 3 lifts ranging in thickness of between 2 m and 6 m. Each lift consisted of a flat bench area ranging in width between 2 m and 15 m and a side slope at an angle of approximately 30° to 32°. The waste rock consisted primarily of a platy schist material with grain sizes ranging from silt sizes (<0.08 mm) up to cobbles in size (>75 mm dia). Sample Peso 1 was retrieved from the waste rock pile at the location depicted in Drawing 12953-9 and analysed for moisture content and particle size distribution. As seen in the lab results in the Figures section of the report, the waste rock appears to resemble a silty, gravelly sand in particle size, with a moisture content of 11%. The waste material is composed primarily of sand and gravel sizes and therefore it is considered relatively stable due to the high internal angle of friction and the low pore water pressures which are common for this type of material. This is reinforced by the fact that the waste rock has been in its current state for over 30 years and that significant changes to the moisture regime which would impact the slope stability most likely would have occurred by this time.

There was no evidence of slope failures throughout the waste rock mass with the exception of some minor slumping at the south edge of the waste rock pile. It does not appear that the existing depositional structure of the waste rock pile is prone to slope failures within the waste rock mass itself. The natural ground surface surrounding the waste rock pile consisted of a west facing slope with an angle of approximately 22° to 23°. The area was well vegetated with semi-mature to mature spruce trees and the near surface soil profile consisted of a thin veneer (0.05-0.08 m) of organics underlain by dense glacial till soil, a heterogeneous mixture of silt, sand, and gravel. Sample Peso 4 was retrieved from the native soil material and analysed for grain size and moisture content. As seen in Appendix C, sample Peso 4 consisted of a silty sand, some gravel with a moisture content of 11%.

1. It is not recommended to proceed with a restoration program aimed at reconfiguring the waste rock dump strictly for slope stability considerations. This is due to the relatively stable conditions observed during the site visit and the low probability for failure in the future.

2. If it is the intention to remediate this site for ARD considerations, it is recommended to perform the necessary measures to develop a containment and isolation approach as previously discussed. This would include conducting an initial geological assessment to identify a suitable rock borrow source, performing the design and developing construction specifications for the remediation system, and engaging in the actual construction.

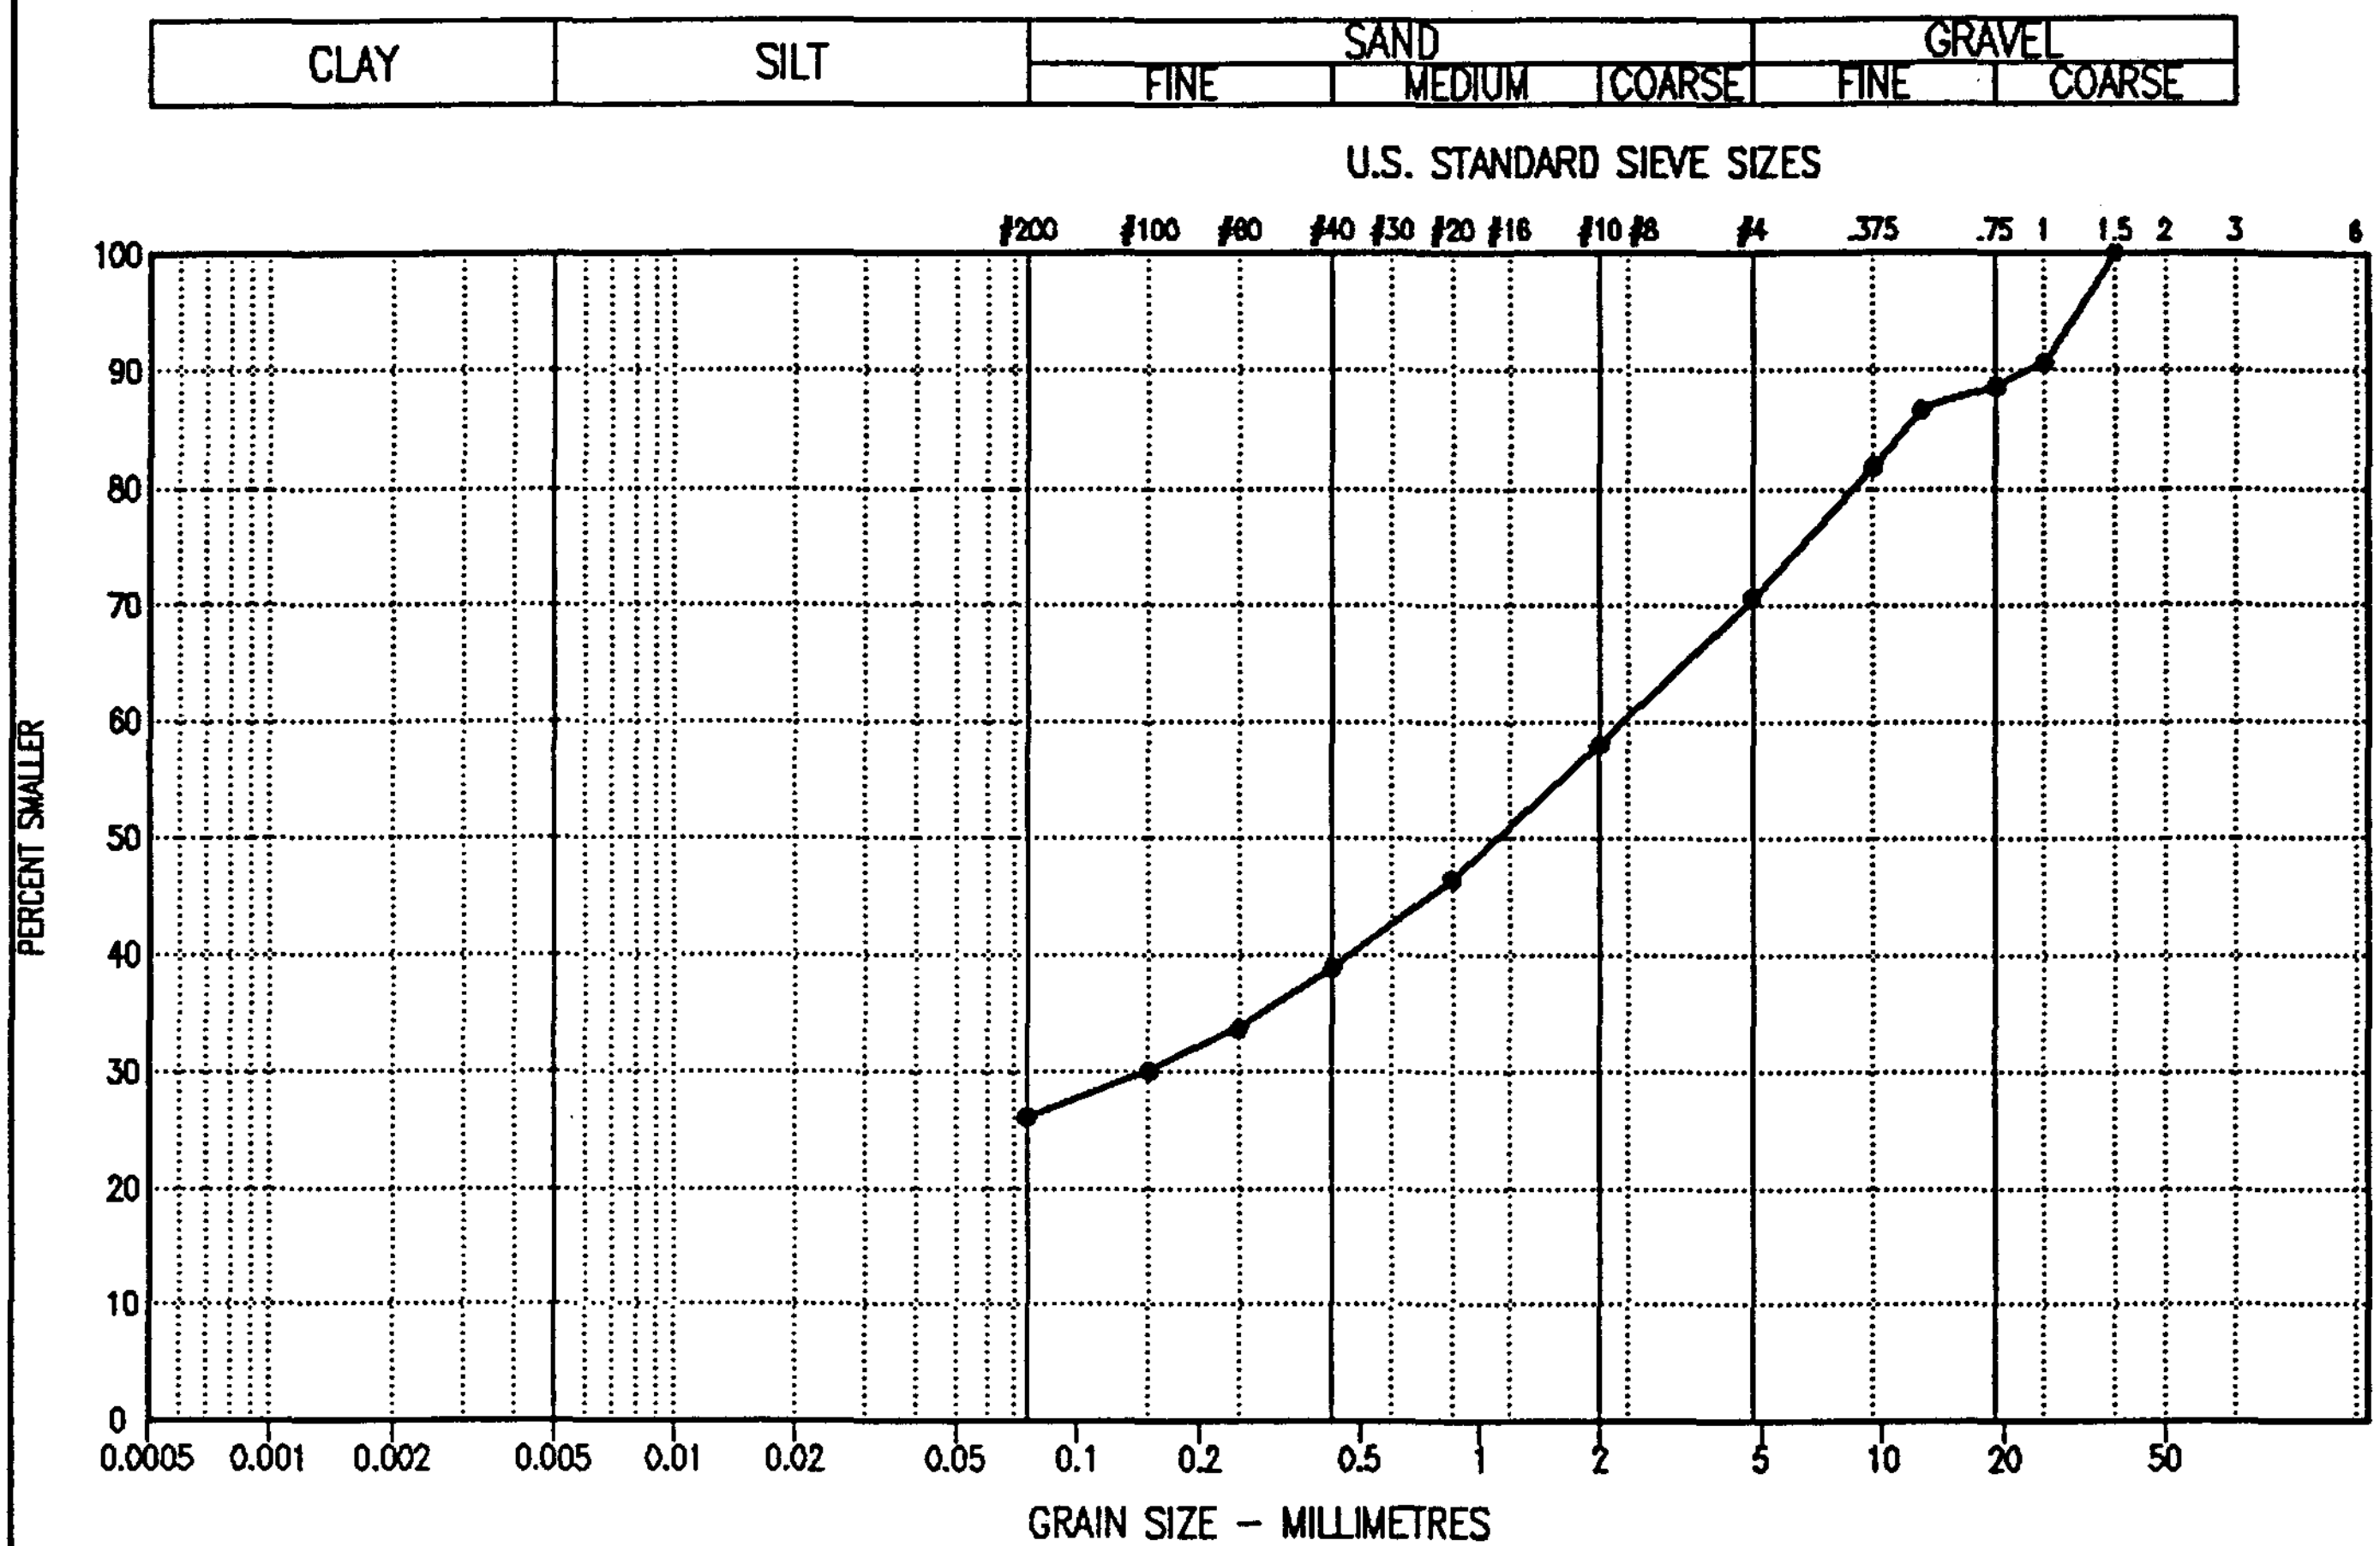
PARTICLE SIZE – ANALYSIS OF SOILS

SYMBOL	BOREHOLE NUMBER	DEPTH (ft)	DESCRIPTION CLAY & SILT %	SAND %	GRAVEL %	Cu	Cc	U.S.C
•——•	PES01	0.00	26.2	44.4	29.4	84.7	0.3	SM

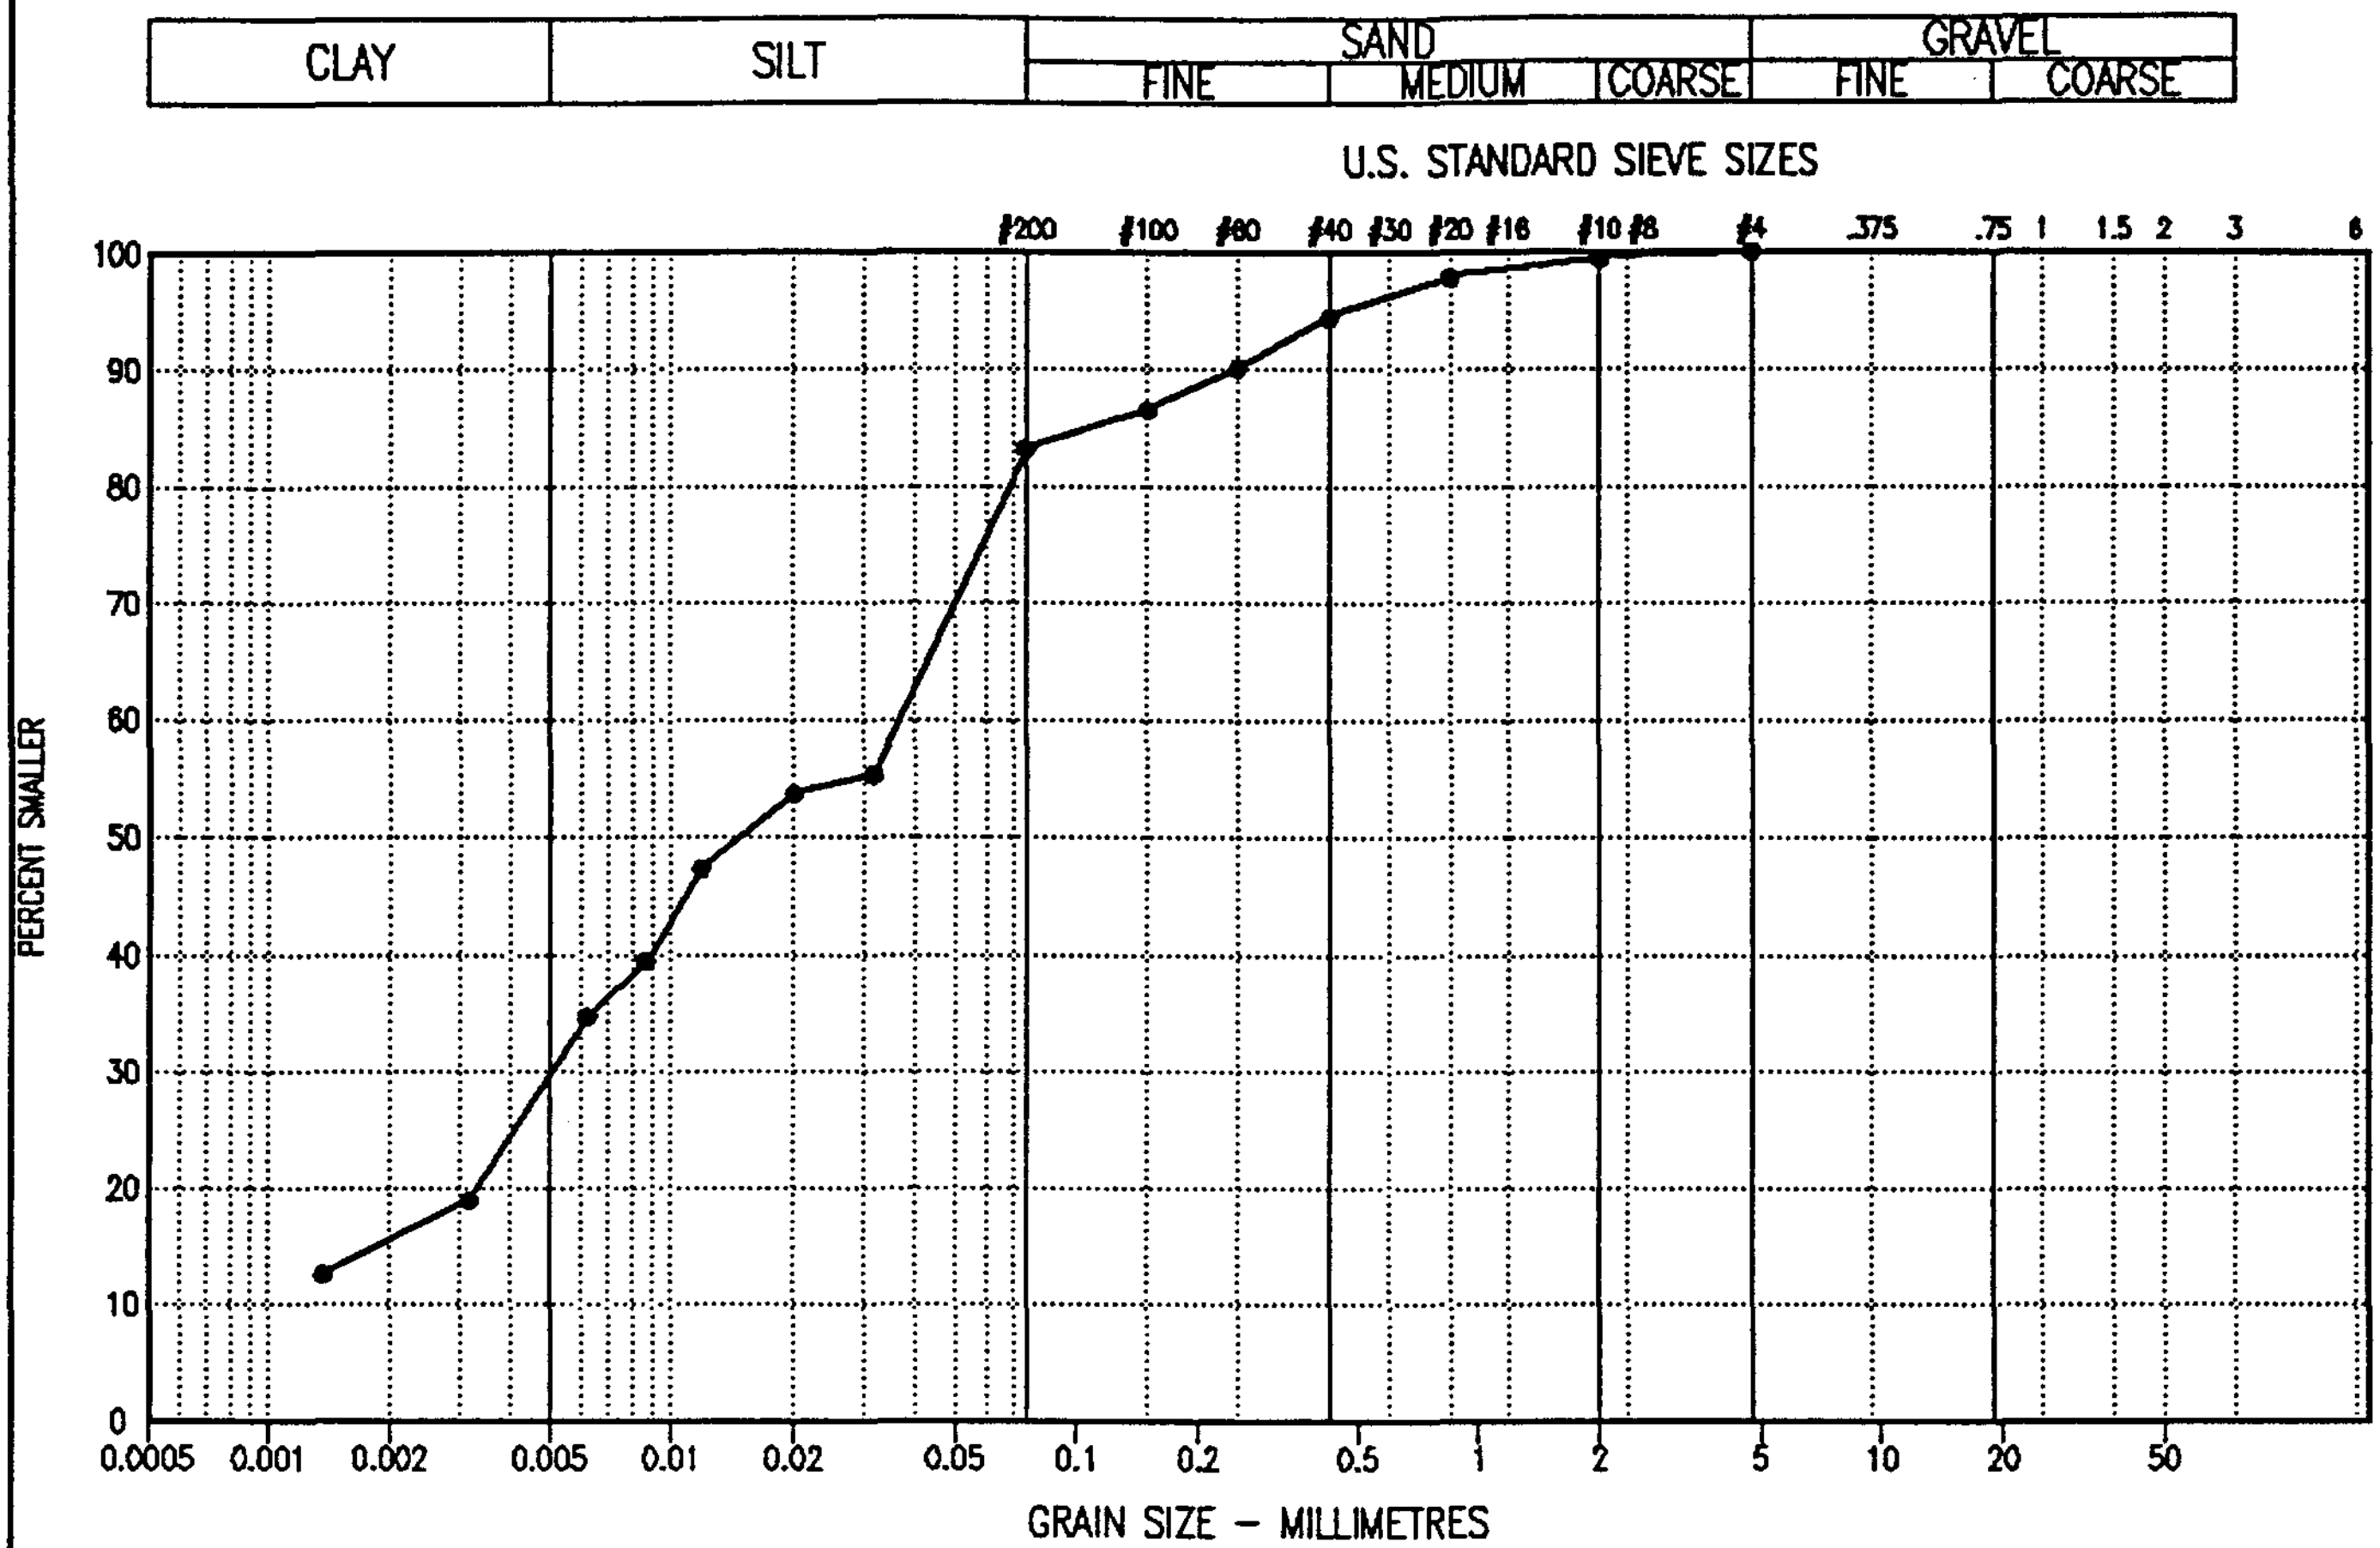
PARTICLE SIZE – ANALYSIS OF SOILS

SYMBOL	BOREHOLE NUMBER	DEPTH (ft)	DESCRIPTION CLAY %	SILT %	SAND %	GRAVEL %	Cu	Cc	U.S.C
•——•	PES02	0.00	28.4	54.6	17.0	0.0	–	–

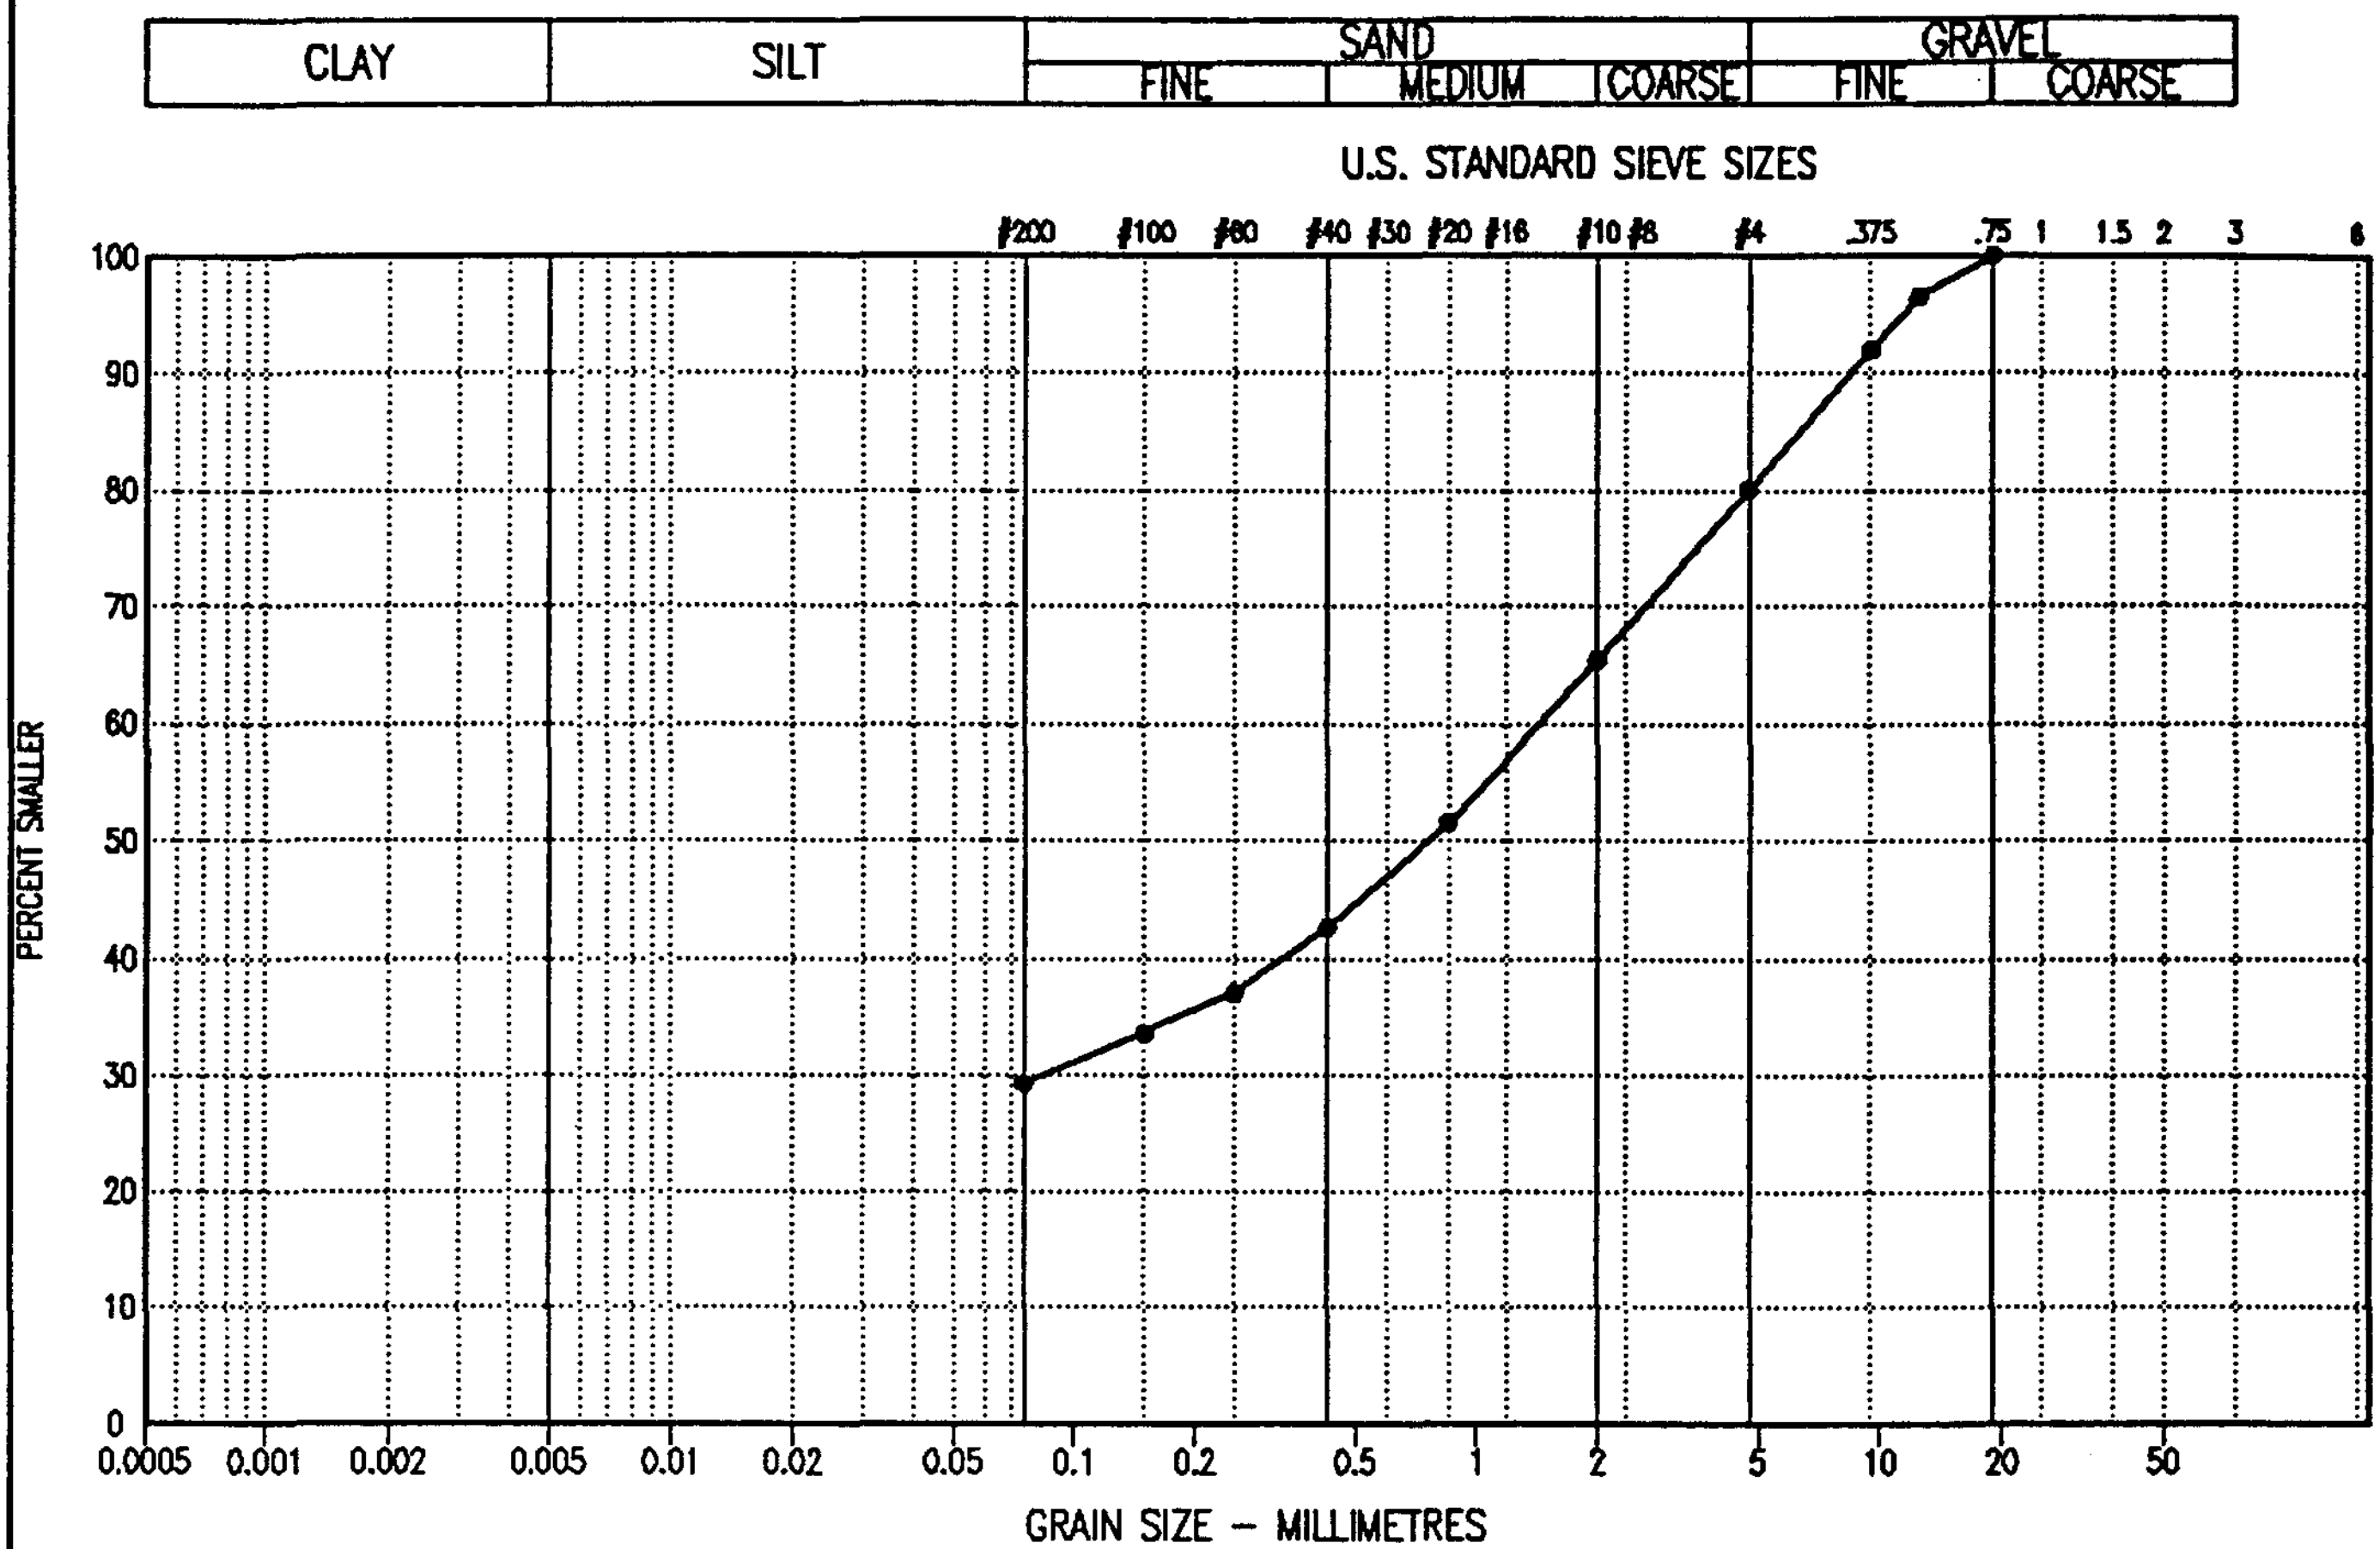
PARTICLE SIZE – ANALYSIS OF SOILS

SYMBOL	BOREHOLE NUMBER	DEPTH (ft)	DESCRIPTION			Cu	Cc	U.S.C
			CLAY & SILT %	SAND %	GRAVEL %			
•——•	PES04	0.00	29.3	50.8	19.9	60.5	0.2	SM
