Phase III ENVIRONMENTAL ASSESSMENT

PESO MINE SITE

Final Report

GEOTECHNICAL SERVICES
YUKON ABANDONED MINE SITES

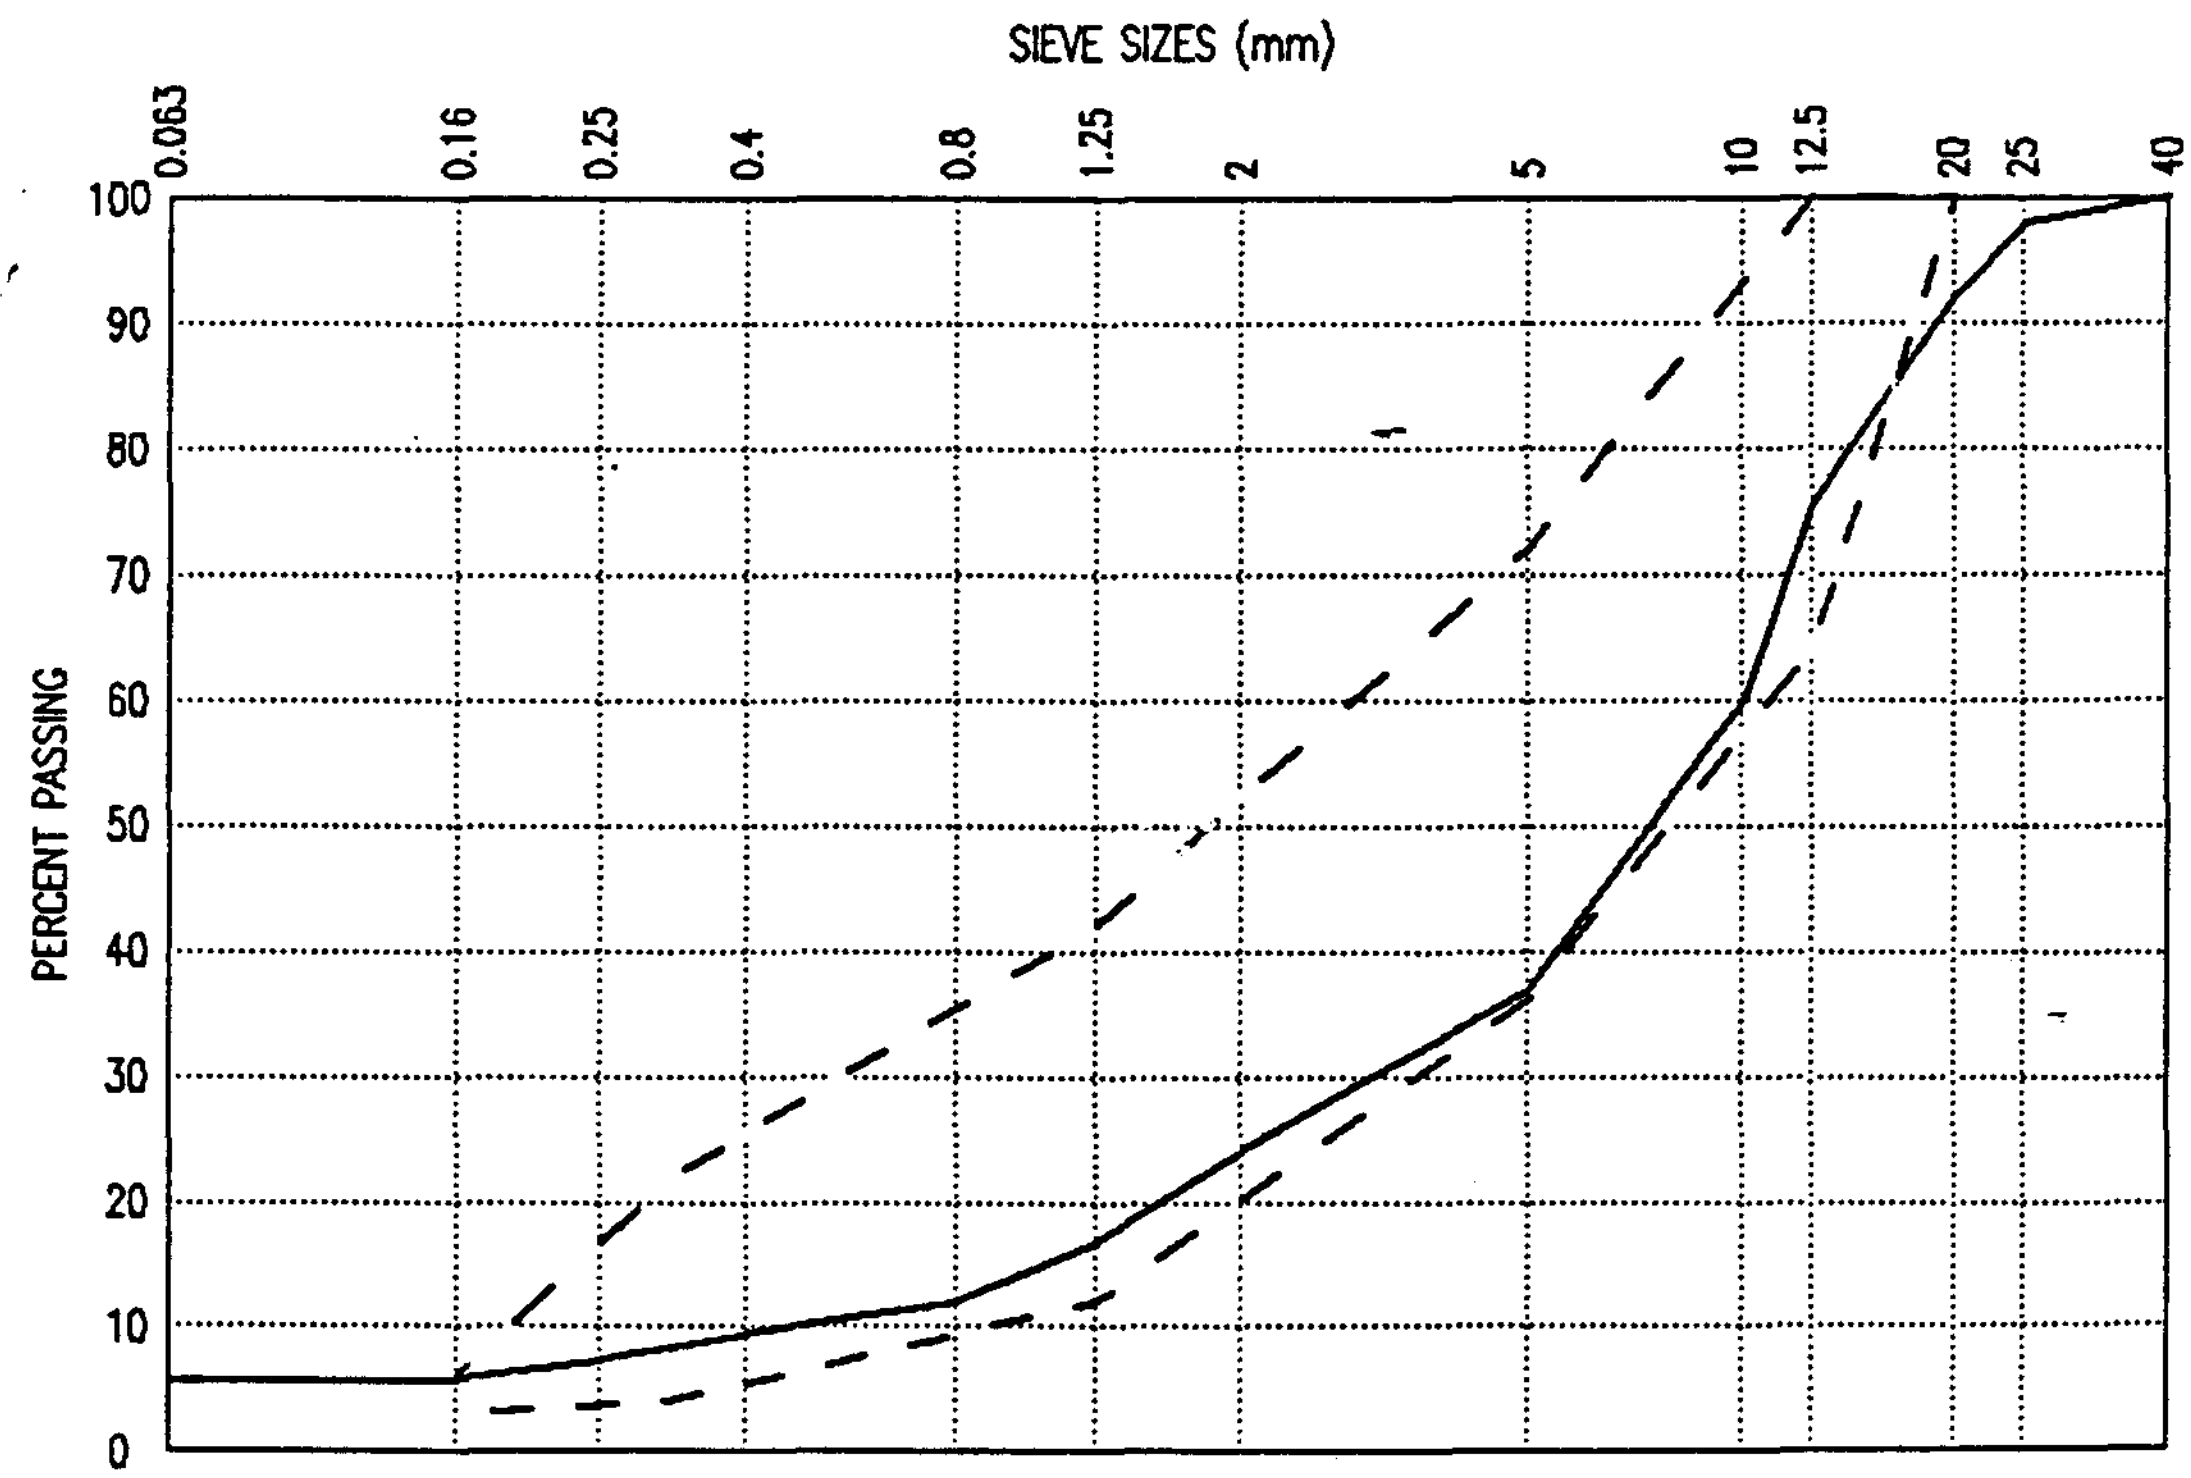
Remarks: LOS ANGELES ABRASION RESULT FOR TRIAL CRUSH MATERIALS IS 34.9% LOSS.
(ASTM C131 - GRADING "B") - YTG GRANULAR A SPEC. BAND ALSO SHOWN

Sieve	% Passing
40	100.0
25	97.8
20	92.0
12.5	75.5
10	59.7
5	36.9
2	24.0
1.25	15.6
0.8	12.0
0.4	9.2
0.25	7.2
0.16	5.5
0.063	5.5
