2004 Leakage Assessment of P01 Series Wells, Faro Mine

**Deloitte and Touche Inc.
Interim Receiver, Faro Mine**

Gartner Lee Limited

June 1, 2004

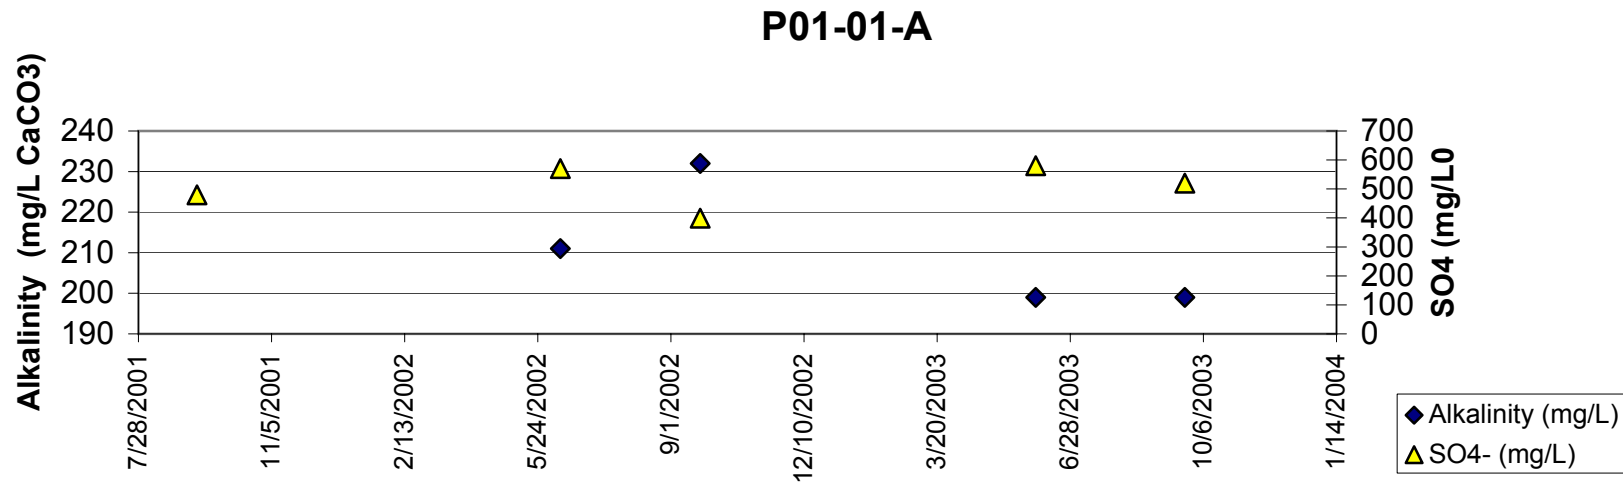
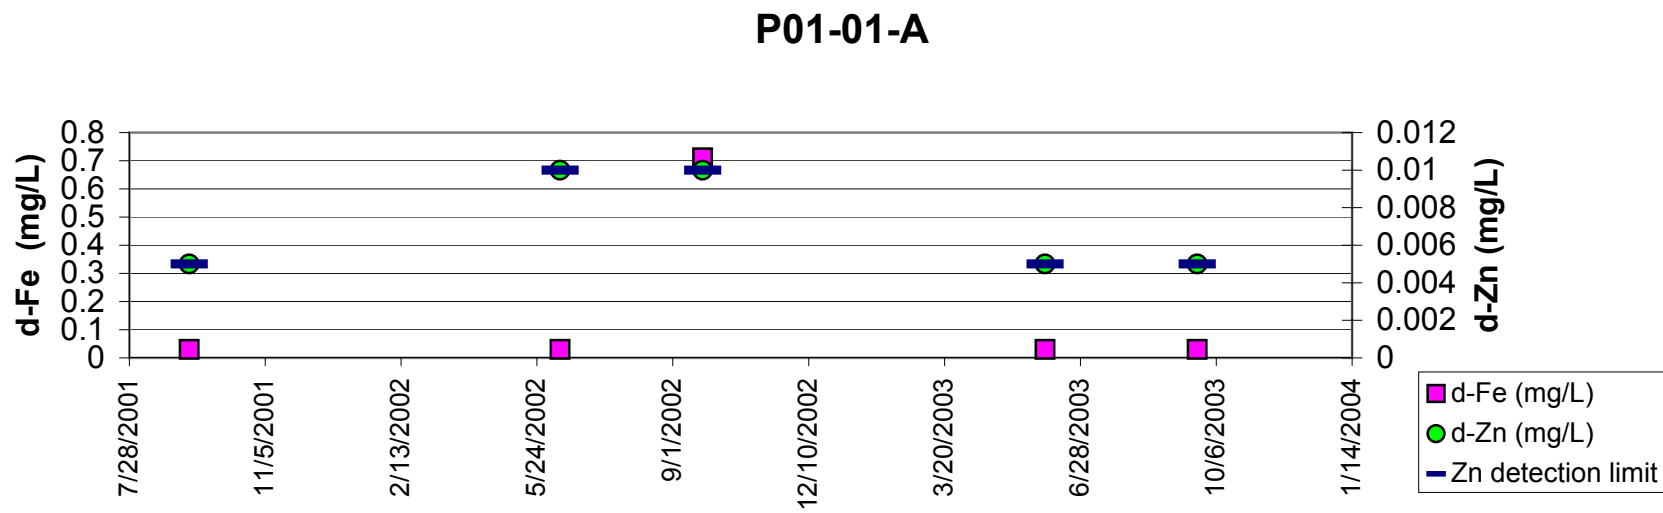
As indicated in Table 1, well P01-01-A was not sampled in 2004 because the surface casing was broken by snow removal equipment and the tubing is sand-locked in the well. Well P01-01-B was rehabilitated in June 2004 and included in the September 2004 sampling. Relevant data is presented in the following figures (Figure 1, Figure 2, Figure 3).

Figure 1. Time series of dissolved Iron (Fe) Zinc (Zn) Sulphate (SO₄) and Alkalinity for well P01-01-A

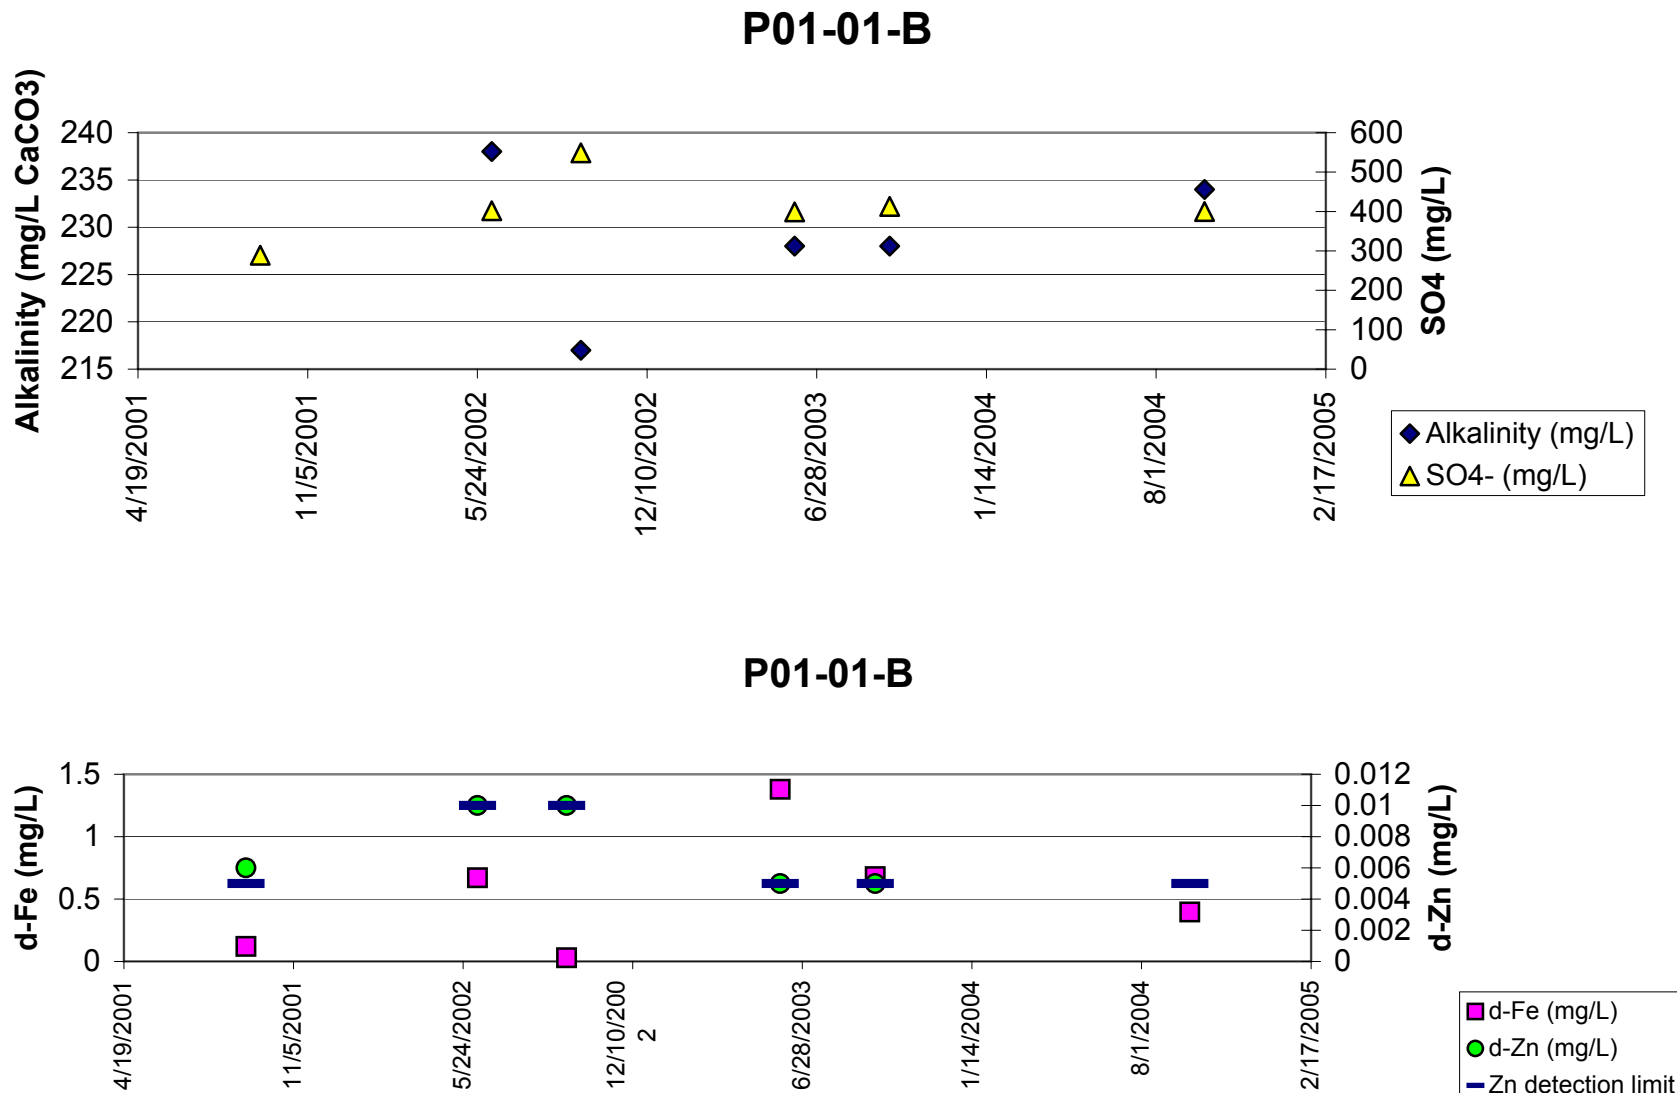
- Dissolved zinc has only been detected once (Sept/01)
- Concentrations of dissolved zinc and sulfate for the depth discrete sample (Sept/04) are within the same range as previous data
- The profile of field parameters does not suggest any evident leakage effects
- This well does not penetrate through tailings and therefore does not represent an immediate threat to water quality in the Rose Creek aquifer.
- This well should be sampled using conventional purging and sampling methods.
- Data collected thus far are likely representative of in-situ conditions at this location

Figure 2. Time series of dissolved Iron (Fe) Zinc (Zn) Sulphate (SO₄) and Alkalinity for well P01-01-B
 (note: Sept 2004 data collected using a discrete depth sampler)

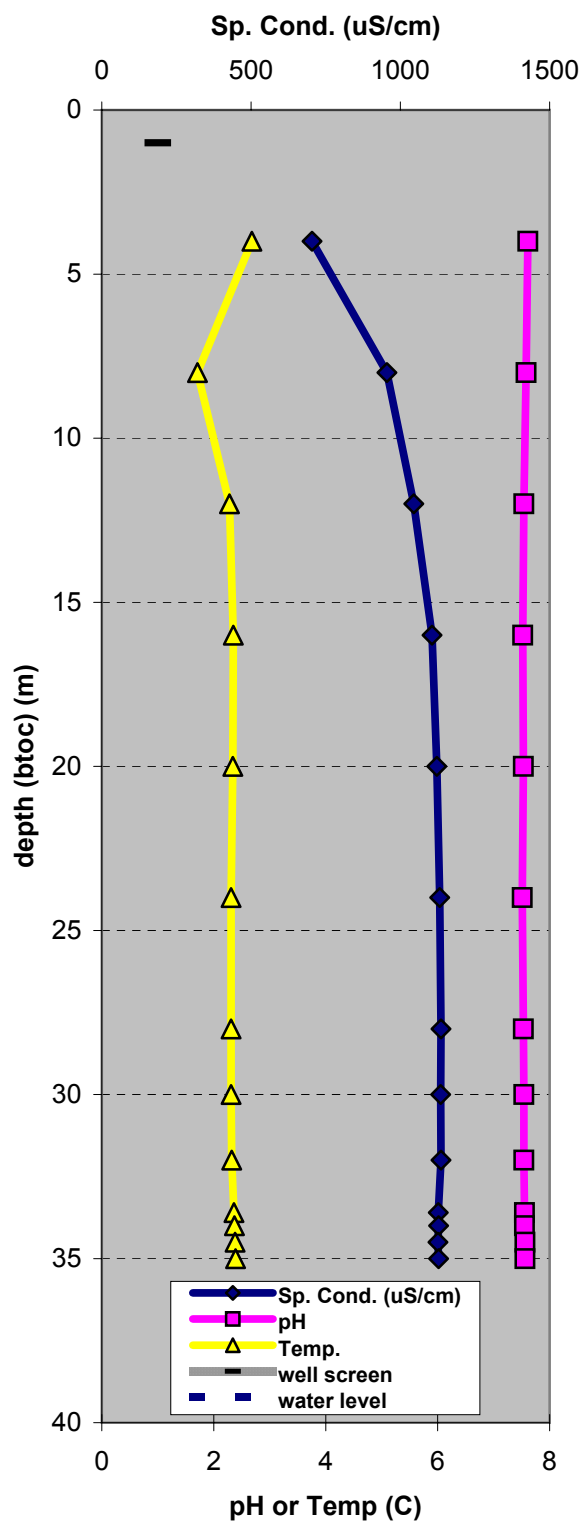
Figure 3. Geochemical (Field Parameter) profile of static water in well P01-01B

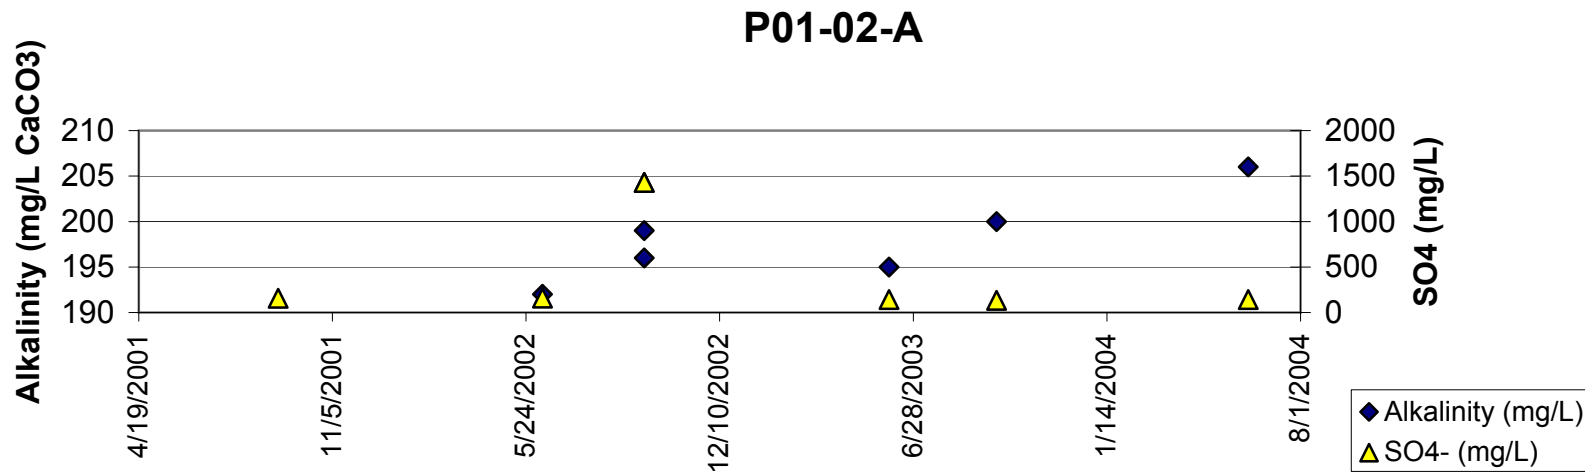
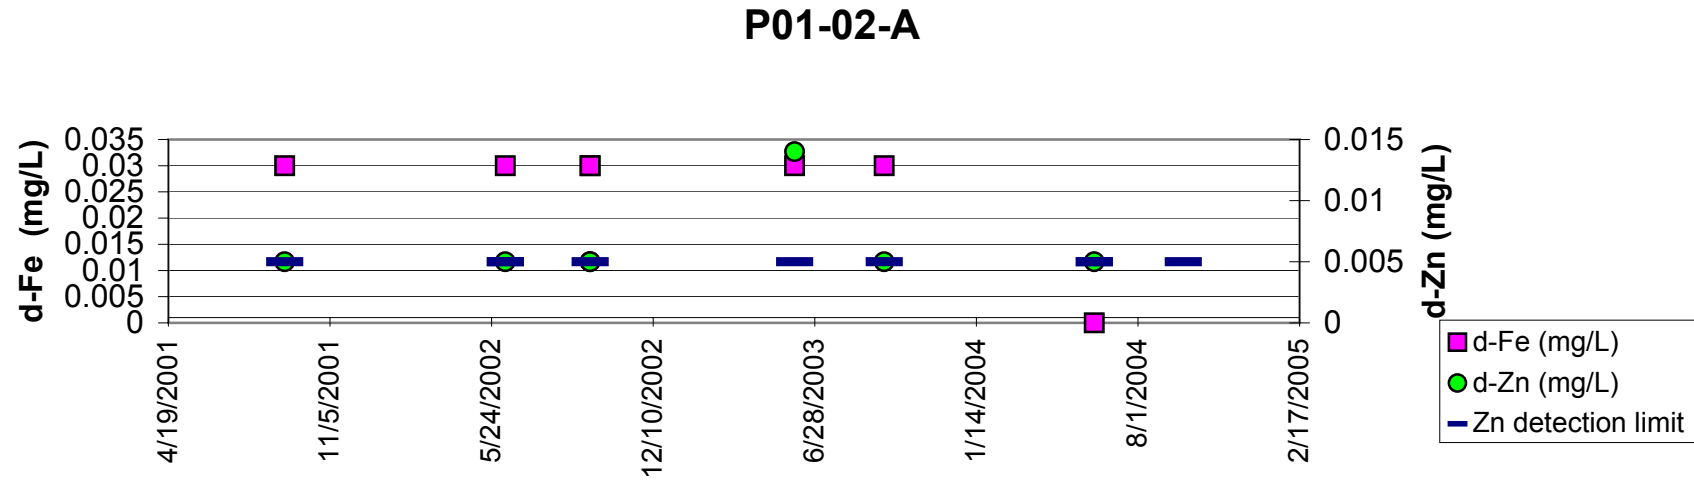
- Dissolved zinc has been detected only once (June/03)
- This well does not penetrate through tailings and therefore does not represent an immediate threat to water quality in the Rose Creek aquifer should it be susceptible to leakage.

- This well is often frozen
- The well currently has a bulge in the casing caused by freeze-thaw action acting on a well cap within the steel casing. This bulge has pinched the sampling tubing and therefore, until this well is rehabilitated, it is only possible to obtain samples through this tubing using small diameter tubing. Rehabilitation would consist of removing the protective steel casing which is cemented in the ground and subsequently replacing the PVC well casing.

- Data collected thus far are likely representative of in-situ conditions at this location
- One elevated value of sulfate (approx. 1200 mg/L) in 2002 was detected in this well. According to field records and chain of custody forms, this value is real and was replicated. The value seems higher than other historical values.

Figure 4. Time series of dissolved Iron (Fe) Zinc (Zn) Sulphate (SO₄) and Alkalinity for well P01-02-A

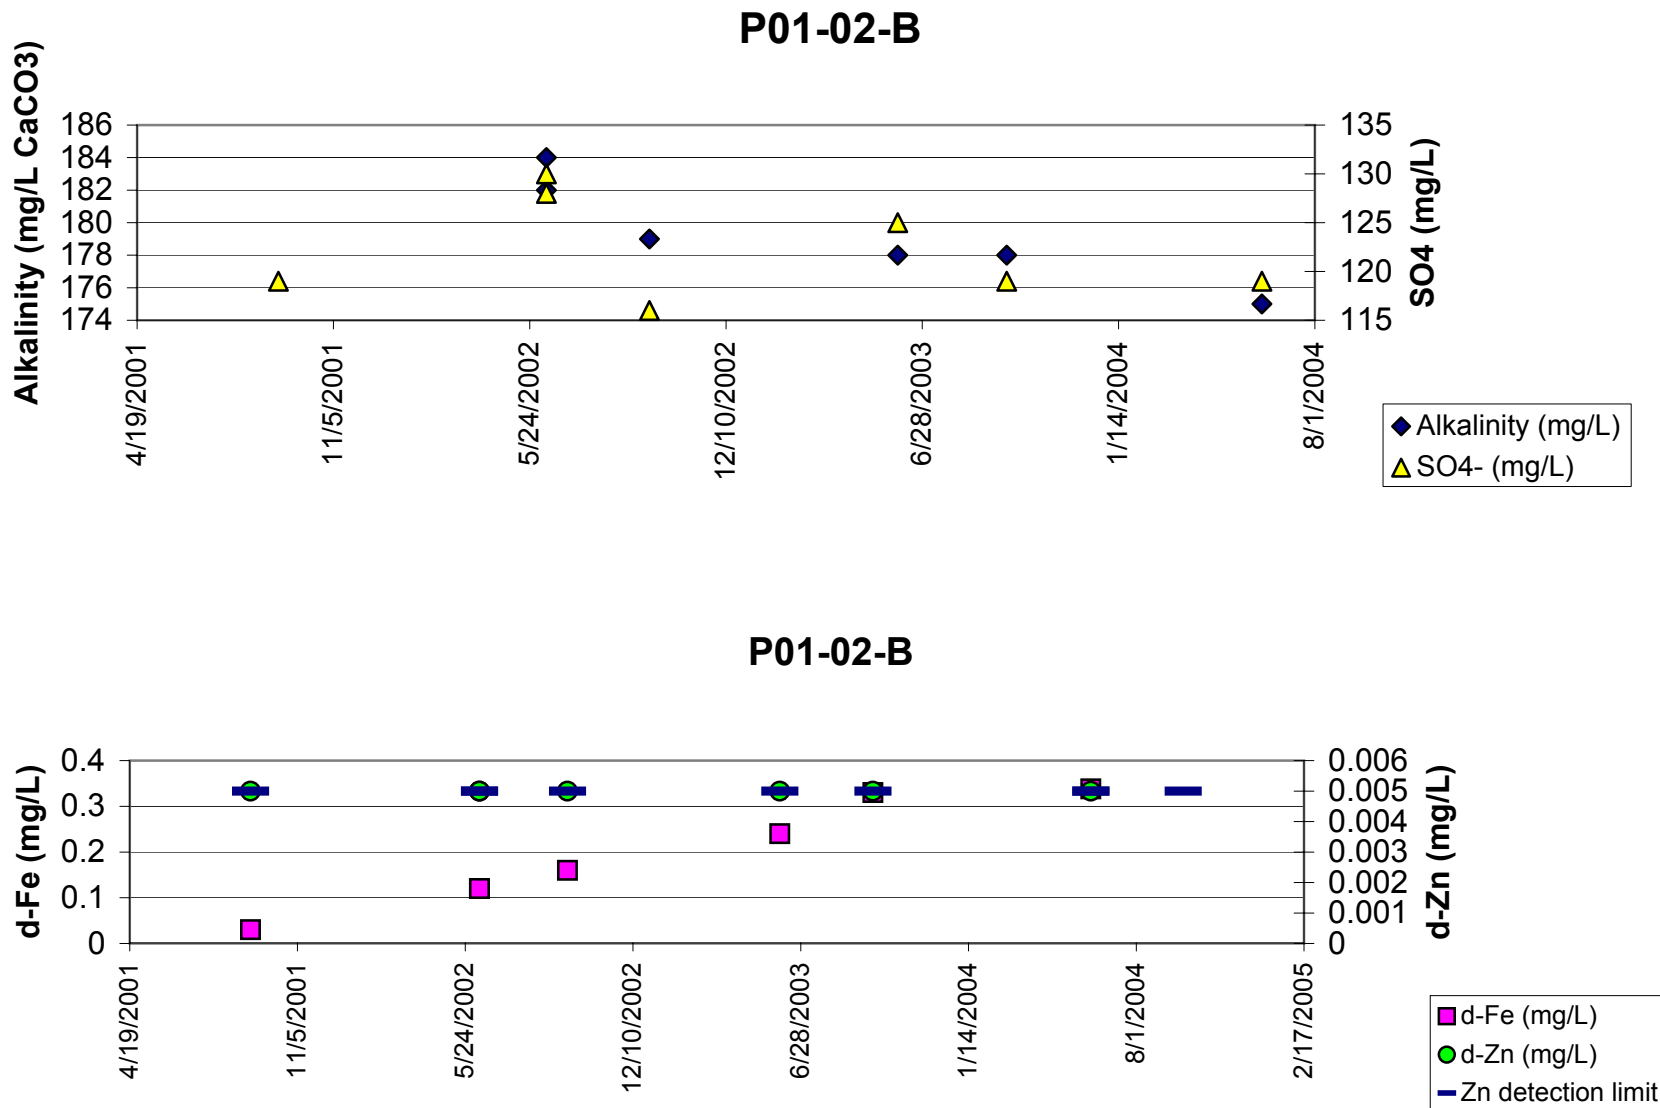
- This well is sometimes artesian and flowing (depending on water levels in the Cross Valley pond).
- Groundwater concentrations at this location are expected to be relatively uniform like they are at multi-level P03-09 also located downgradient of the dam.
- Data collected thus far are likely representative of in-situ conditions at this location
- This well is often frozen and therefore no depth-discrete sample was obtained from this well because it was frozen.

Figure 5. Time series of dissolved Iron (Fe) Zinc (Zn) Sulphate (SO₄) and Alkalinity for well P01-02-B

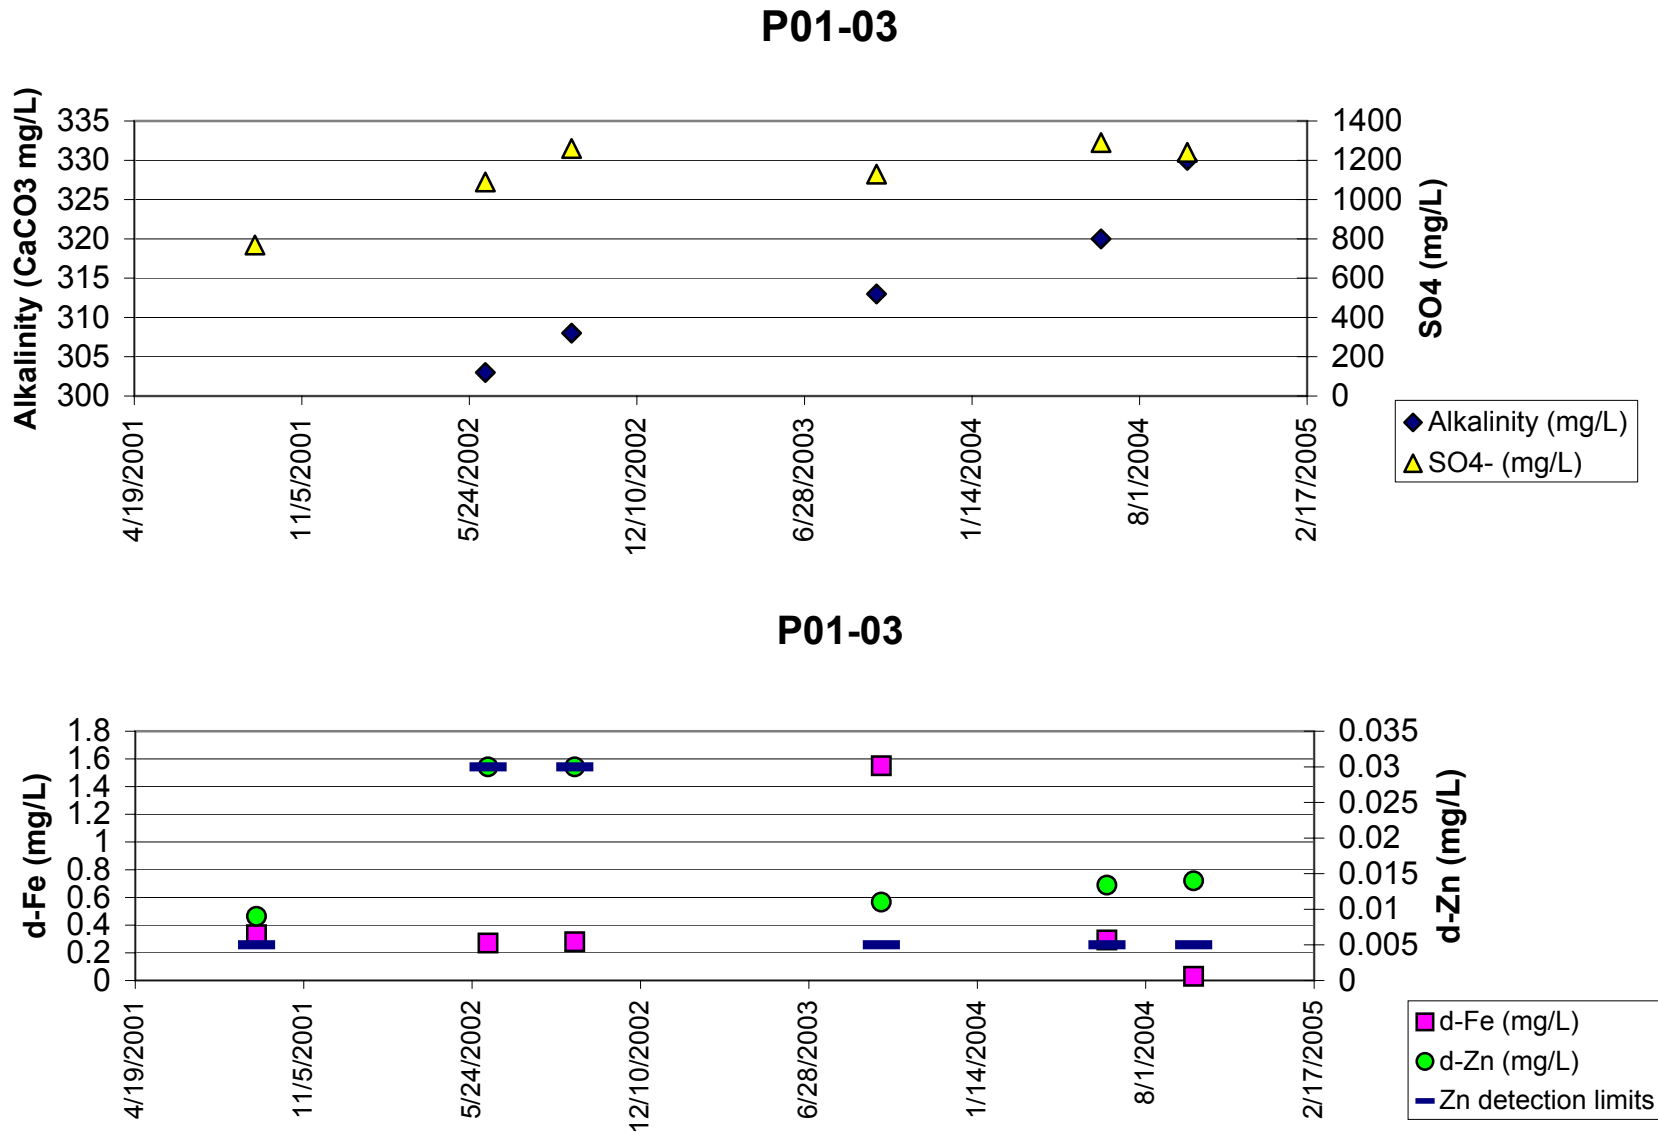
- Well is not completed through tailings
- The profiles for temperature, pH and specific conductance do not suggest any anomalies attributable to leakage
- The depth discrete sample taken at the screen has similar water quality to the conventional sample collected in June 2004
- The time series data suggests an increasing trend in sulfate but no distinguishable trend for dissolved zinc.
- This well does not penetrate through tailings and therefore does not represent an immediate threat to water quality in the Rose Creek aquifer.
- This well should be sampled using conventional purging and sampling techniques.
- Data collected thus far are likely representative of in-situ conditions at this location

Figure 7. Time series of dissolved Iron (Fe) Zinc (Zn) Sulphate (SO4) and Alkalinity for well P01-03

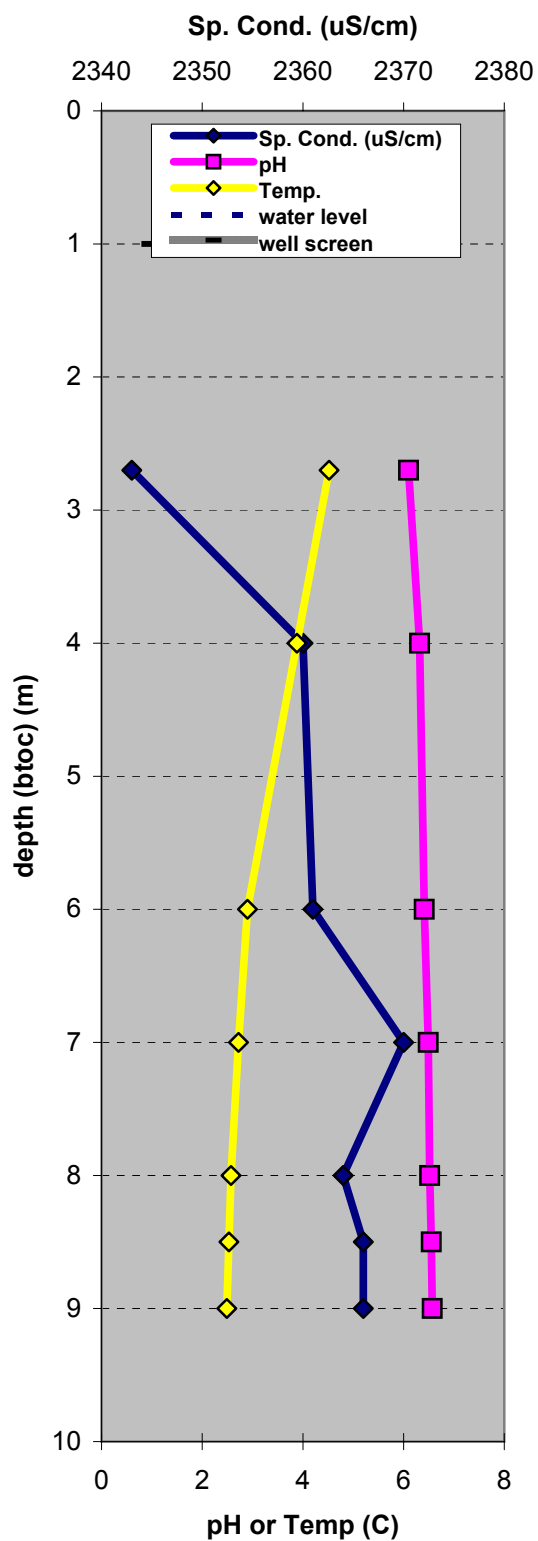
Figure 8. Geochemical (Field Parameter) profile of static water in well P01-03

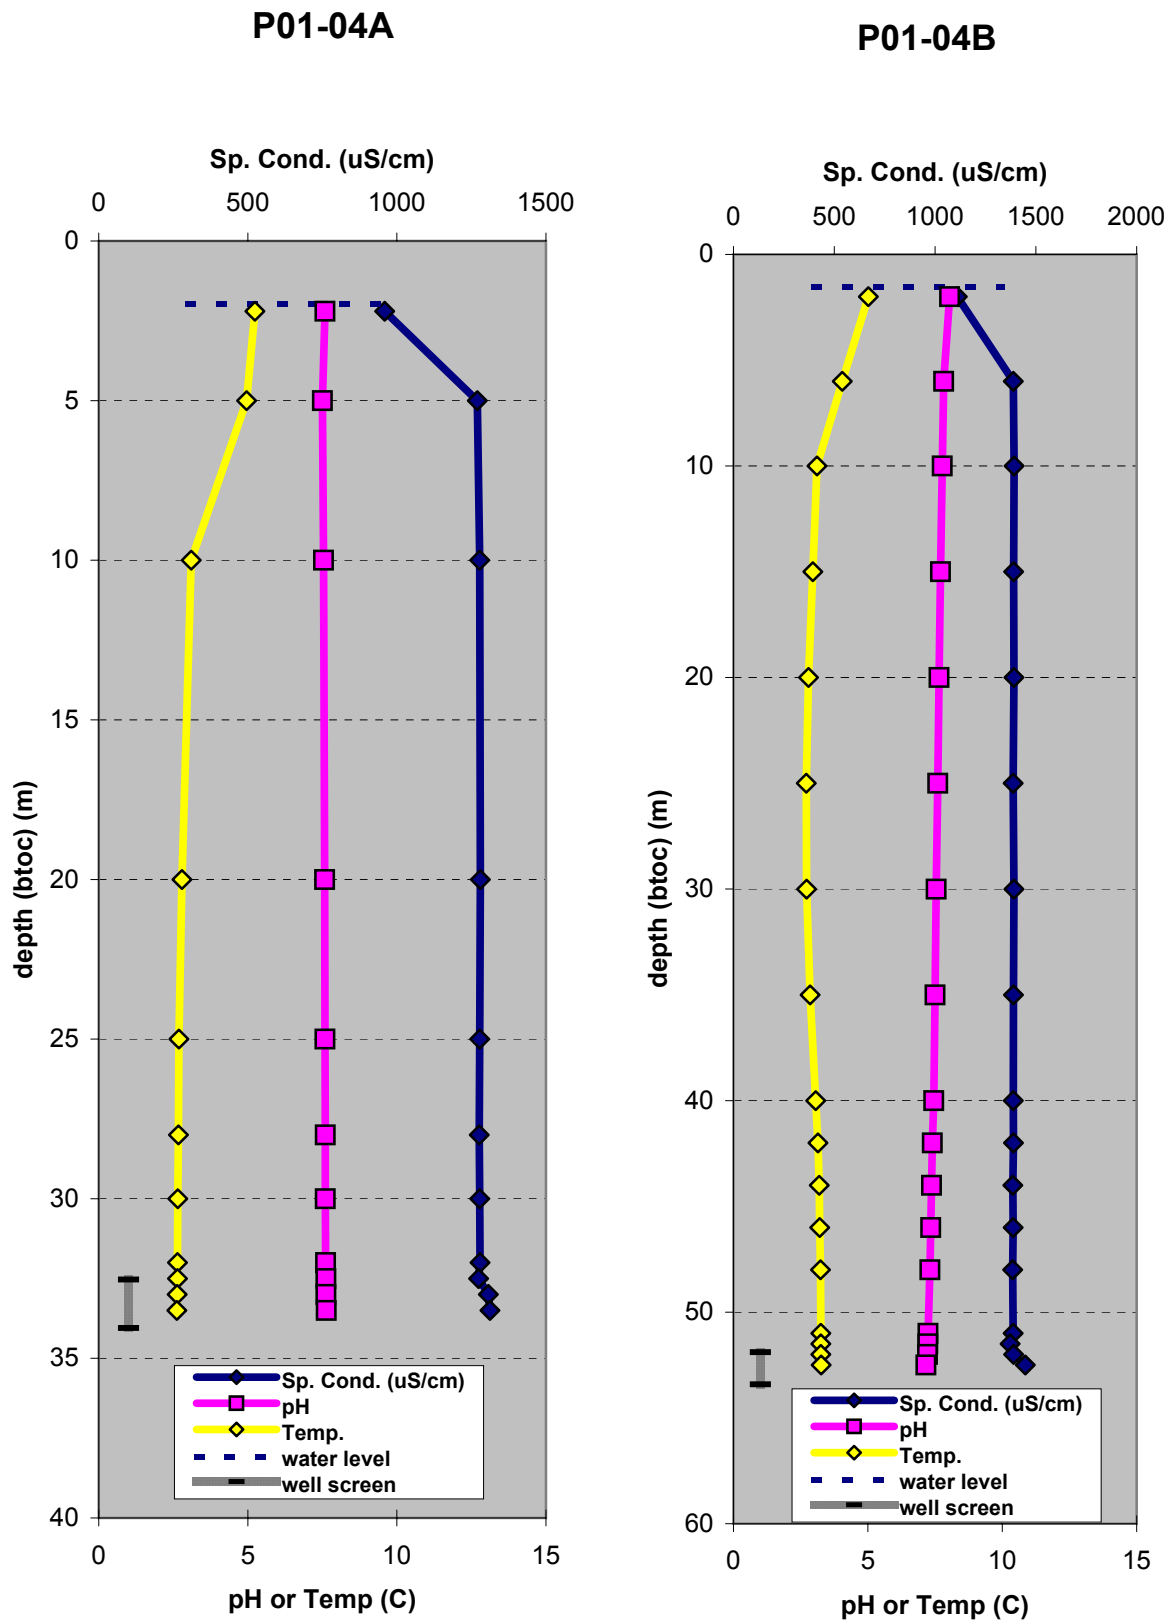
- The field parameter profile does not provide any evidence of leakage
- Specific conductance, pH and temperature are relatively constant from top to bottom
- This well shows elevated zinc (0.25 mg/L) deep in the aquifer
- The depth discrete sample concentrations of dissolved zinc and sulfate are within the same range as previous sampling
- This well does not penetrate through tailings and therefore does not represent an immediate threat to water quality in the Rose Creek aquifer.
- This well should be sufficiently purged prior to sampling to overcome any possible leakage sample bias.
- Data collected thus far are likely representative of in-situ conditions at this location

- The field parameter profile does not provide any evidence of leakage
- Specific conductance, pH and temperature are relatively constant from top to bottom
- The field parameter profile is similar for both P01-04A and P01-04B
- Sulfate values in this deeper monitor (>50m bgs) are low (< 50mg/L)
- No detectable zinc concentrations have been observed in this monitor
- This well does not penetrate through tailings and therefore does not represent an immediate threat to water quality in the Rose Creek aquifer.
- This well should be sufficiently purged prior to sampling to overcome any possible leakage sample bias.
- Data collected thus far are likely representative of in-situ conditions at this location

Figure 11. Geochemical (Field Parameter) profile of static water in wells P01-04A and P01-04B

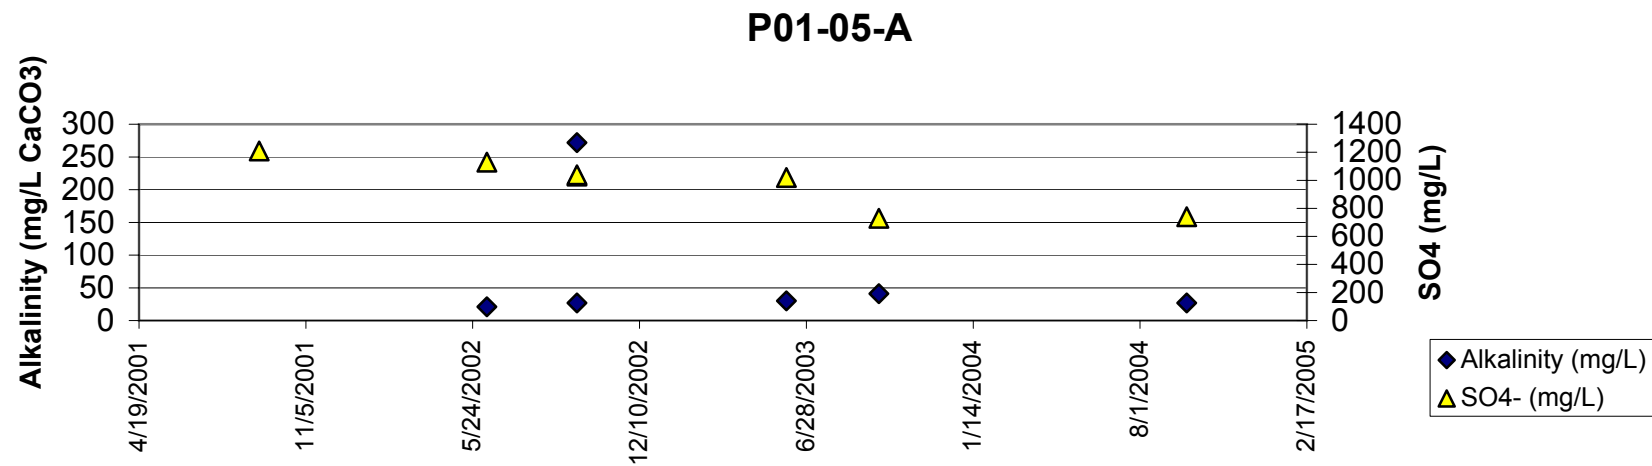
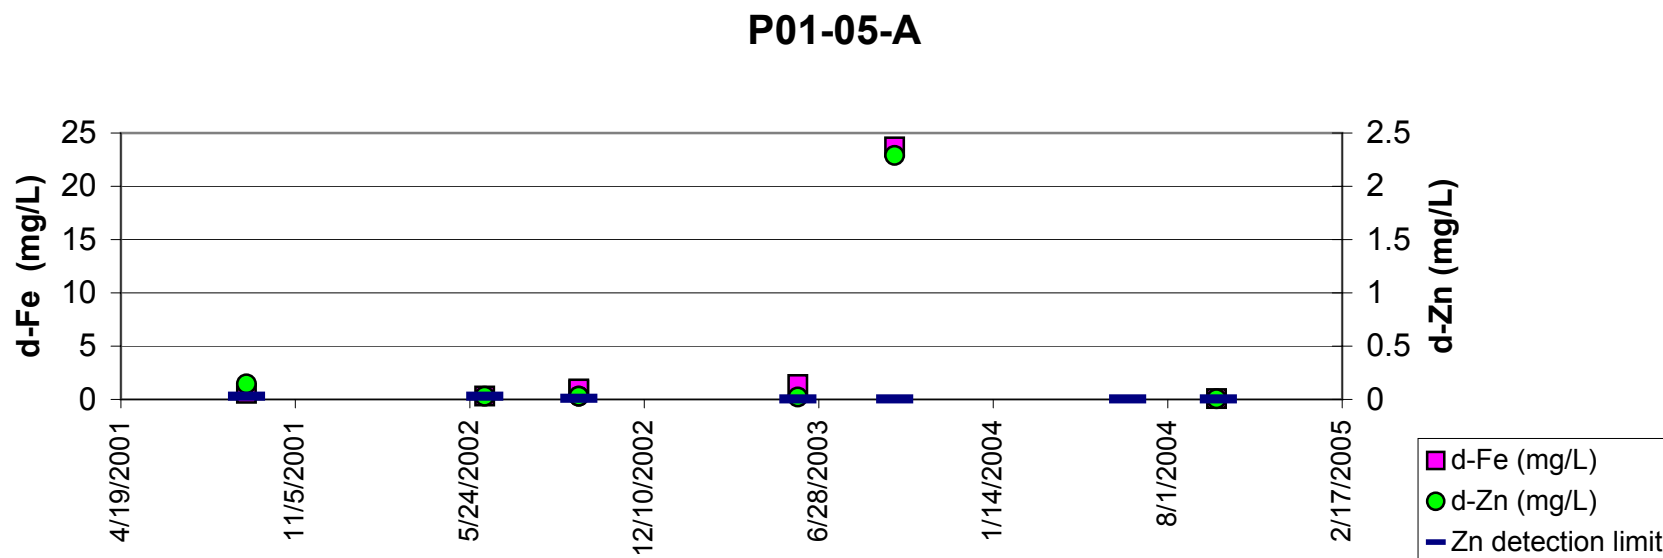
- It is not possible to determine if any leakage is occurring at this location
- If recharge rates to the well are low, this implies that any leakage rates / flow out of the well would also be low, and therefore, any impact to the local groundwater system at this point, which is in the tailings, would only be very localized.

- Samples collected after purging the well dry may have more of an impact from leakage as contaminated water may leak through joints in the casing and accumulate in the well as it slowly recharges.

Figure 12. Time series of dissolved Iron (Fe) Zinc (Zn) Sulphate (SO₄) and Alkalinity for well P01-05-A

- This well should be monitored using a protocol (not yet developed) to ensure constant review of the data and allow for determination of leakage effects should it become problematic

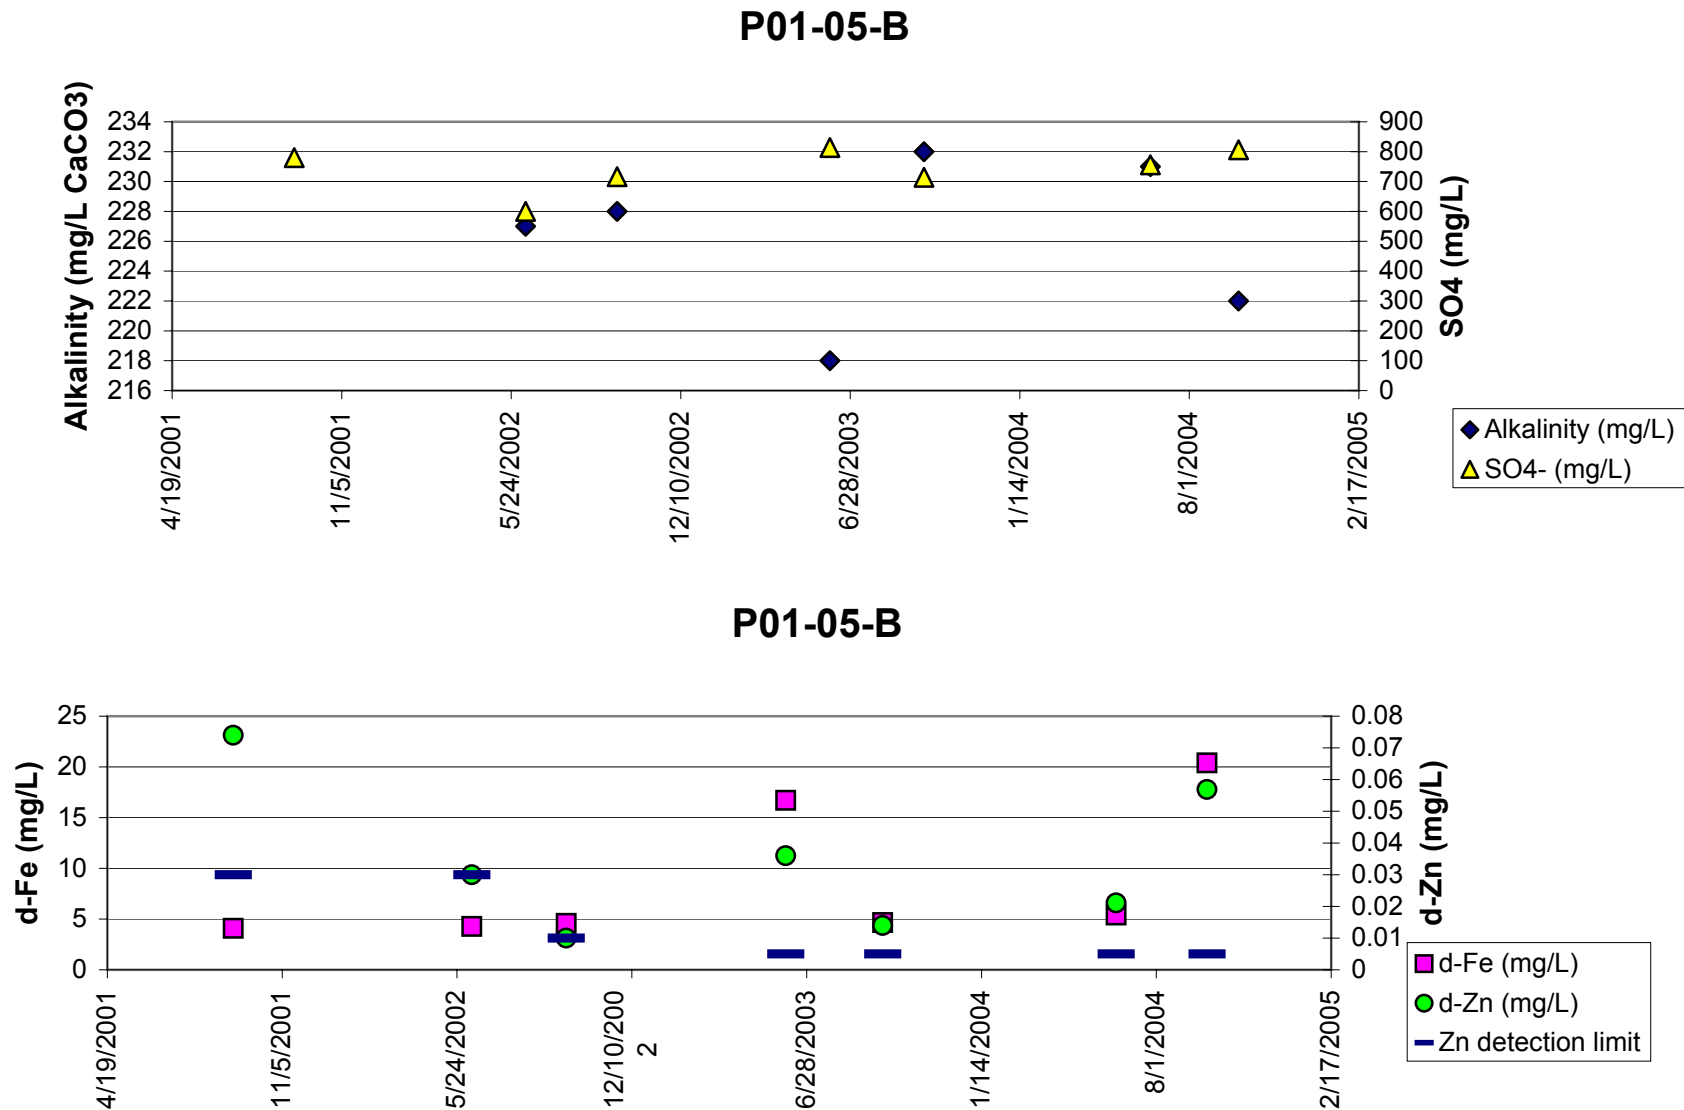
- Water accumulating on top of the packer (presumably from leakage) had elevated sulfate and zinc compared to conventional samples and samples from below the packer suggesting leakage. However, there are uncertainties with interpretation of the leakage water chemistry (above packer) (Figure 16) as geochemical reactions occur as leakage water is exposed to oxygen as it flows into the evacuated well, down the casing and to the top of the packer

- Some dilution effect of leakage water mixing with the remaining water on top of the packer once most of it has been pumped should also be considered
- The depth discrete sample (Sept. '04) had elevated zinc (> 5mg/L)

Figure 13. Time series of dissolved Iron (Fe) Zinc (Zn) Sulphate (SO₄) and Alkalinity for well P01-05-B

- It is likely that possible leakage effects are significant at this location when sampling and therefore sampling should not be continued at this location and the well should be properly decommissioned
- This well should be monitored using a protocol (not yet developed) to ensure constant review of the data and allow for determination of leakage effects should it become problematic

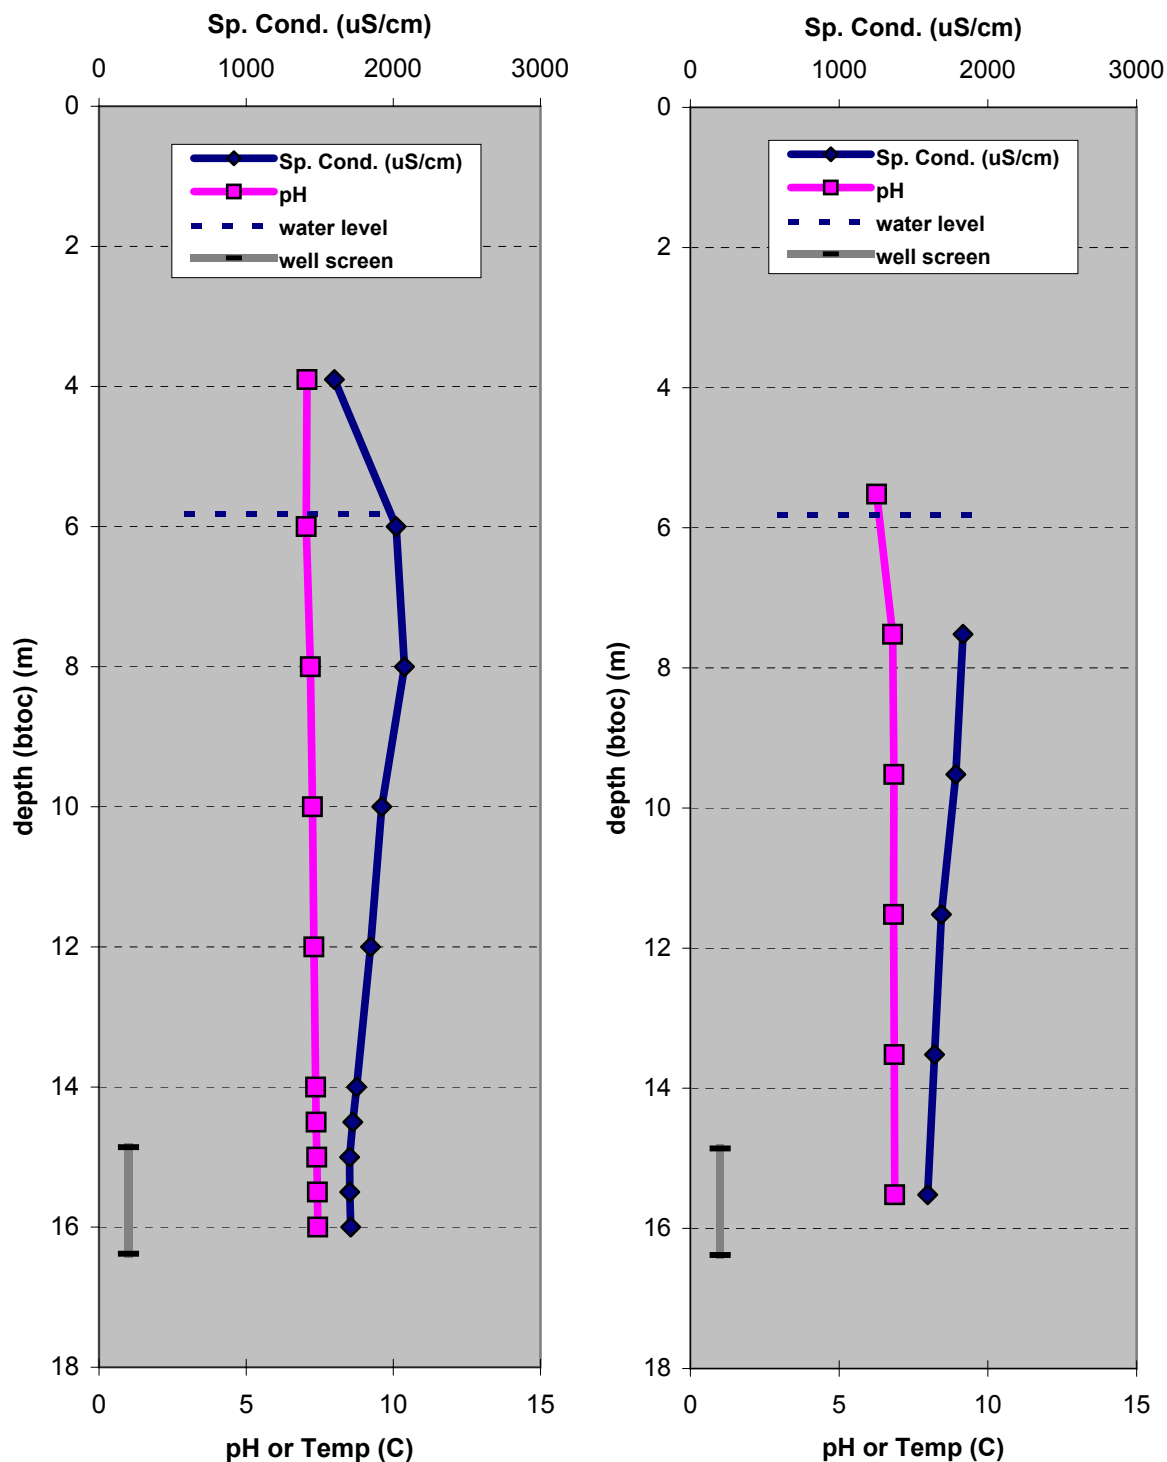
- Both the Environment Canada and Gartner Lee field profiles show the same decreasing with depth trend for specific conductance.
- The shape of the September 2004 profile (diffusion type) suggests that leakage may be occurring

- The decreasing profile suggests that conditions at the well screen are different than higher in the well casing
- Leakage testing in May/June 2004 showed the possibility for leakage to accumulate above the packer through one exposed joint below the water table

Figure 15. Geochemical (Field Parameter) profile of static water in well P01-05 by Gartner Lee Limited (GLL) and Environment Canada

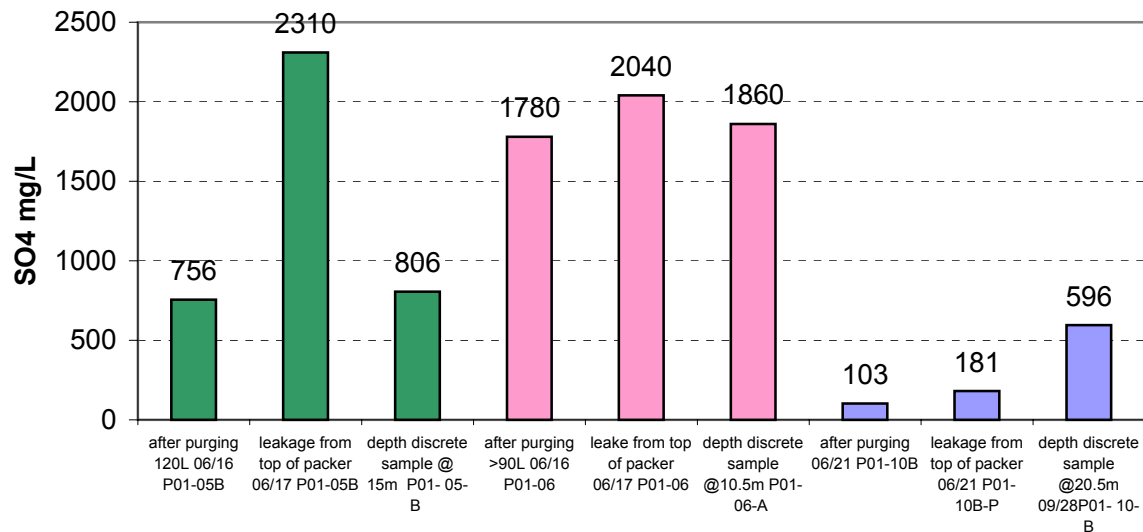
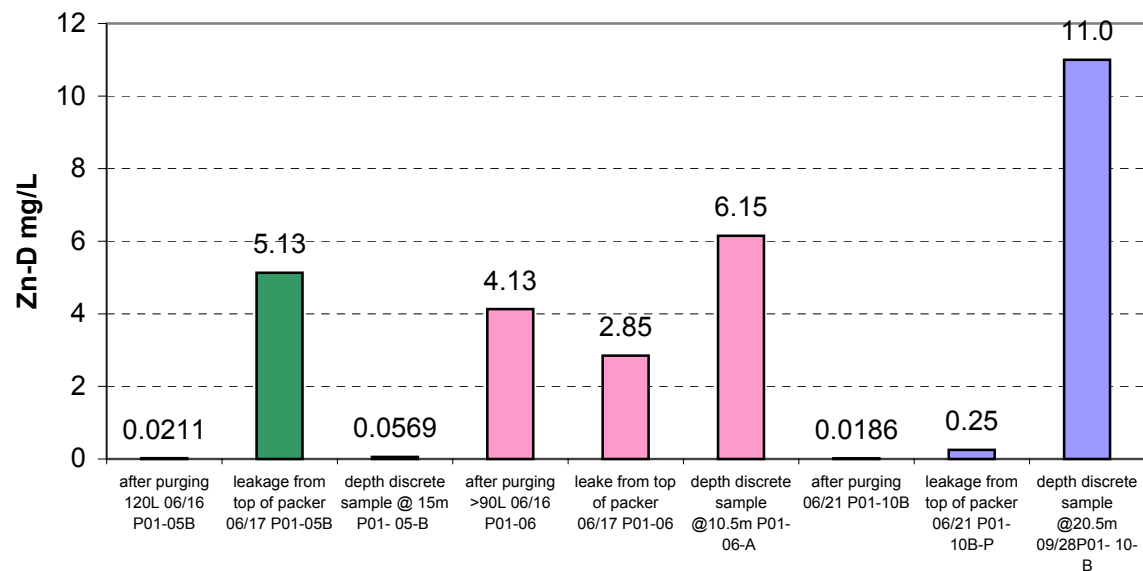
Figure 16. Summary of Leakage Assessment Sampling Results for Wells P01-05-B, P01-06 and P01-10-B
