2004 Leakage Assessment of P01 Series Wells, Faro Mine

**Deloitte and Touche Inc.
Interim Receiver, Faro Mine**

Gartner Lee Limited

June 1, 2004

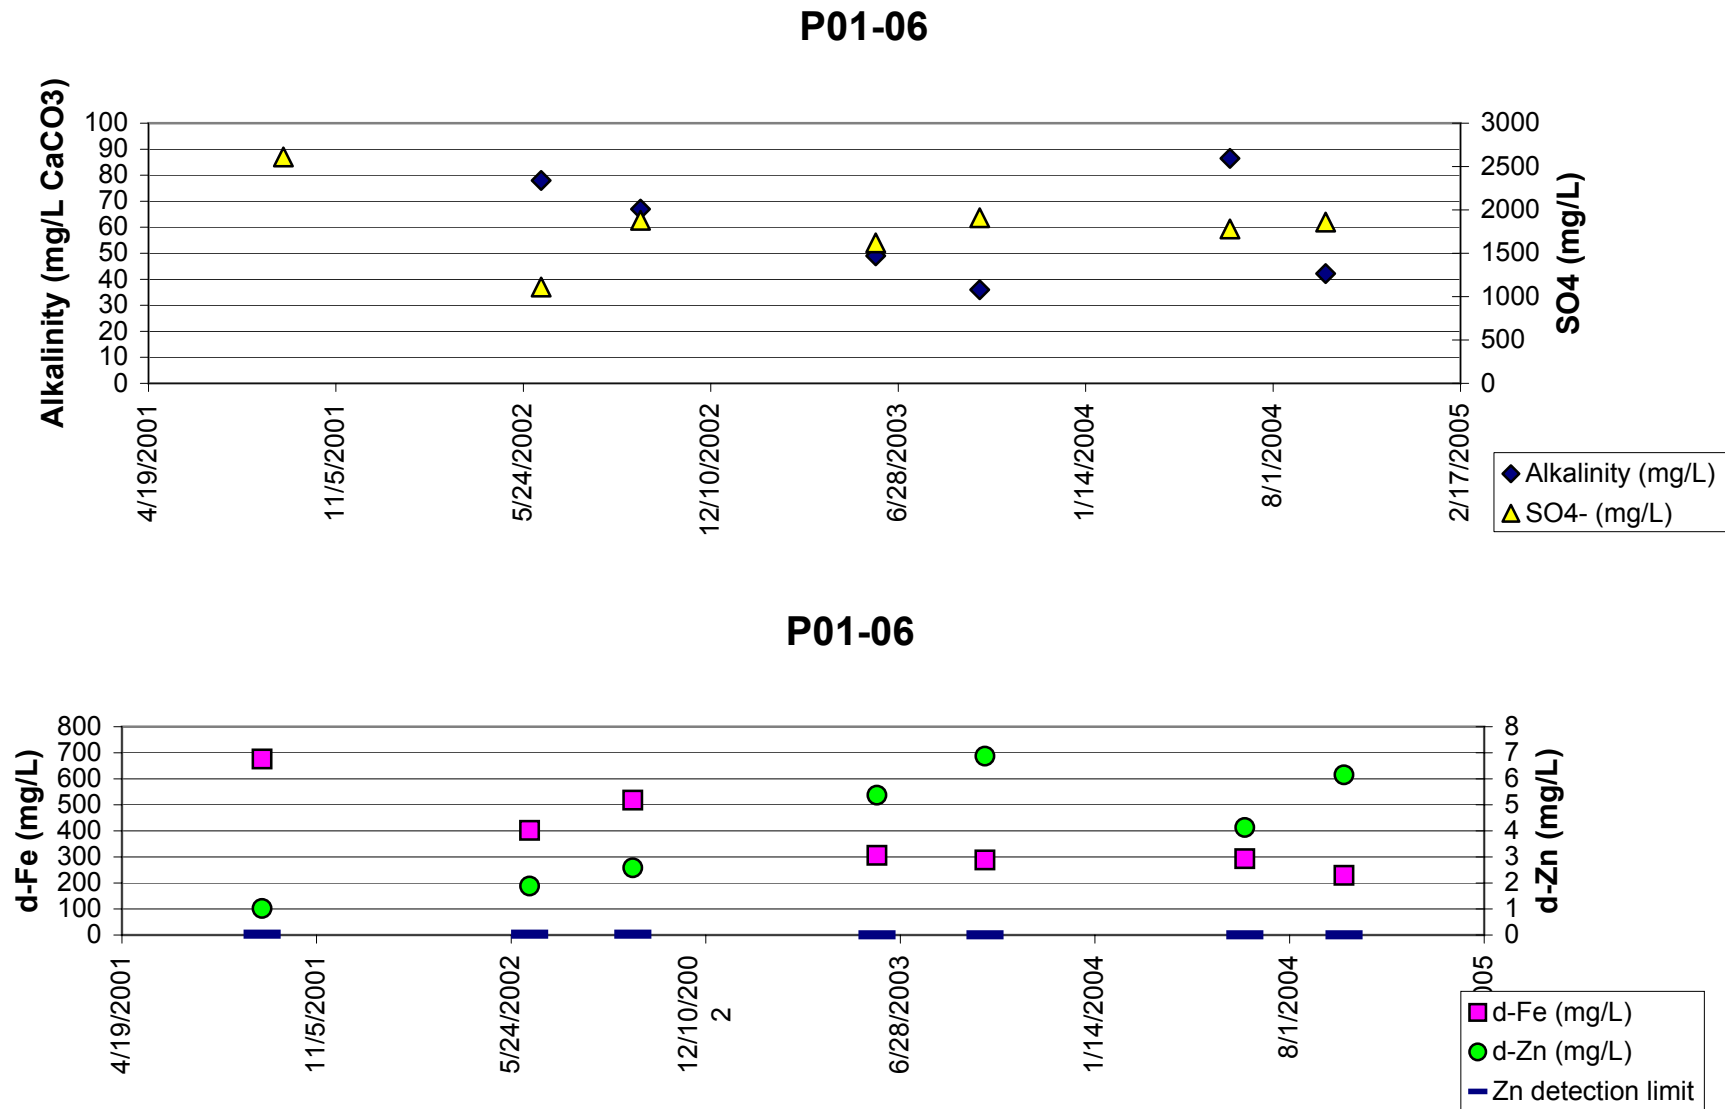
- There is an observed increasing trend in dissolved zinc concentrations in the well
- The increase is likely due to loading from upgradient of the well (either infiltration from tailings or infiltration of surface water or groundwater from X-24 (Faro Creek)) which is contaminated by rock dump seepage

- The iron concentrations are significantly more elevated (300-600 mg/L) at this location than most locations. Similar concentrations of dissolved iron (~300 mg/L) are observed at P03-06-05 located upgradient in the secondary impoundment

Figure 17. Time series of dissolved Iron (Fe) Zinc (Zn) Sulphate (SO₄) and Alkalinity for well P01-06

- The data collected so far seems representative of in-situ conditions, however, due to the transient nature of the leakage problem, future monitoring at this location should be stopped and the well should be properly decommissioned

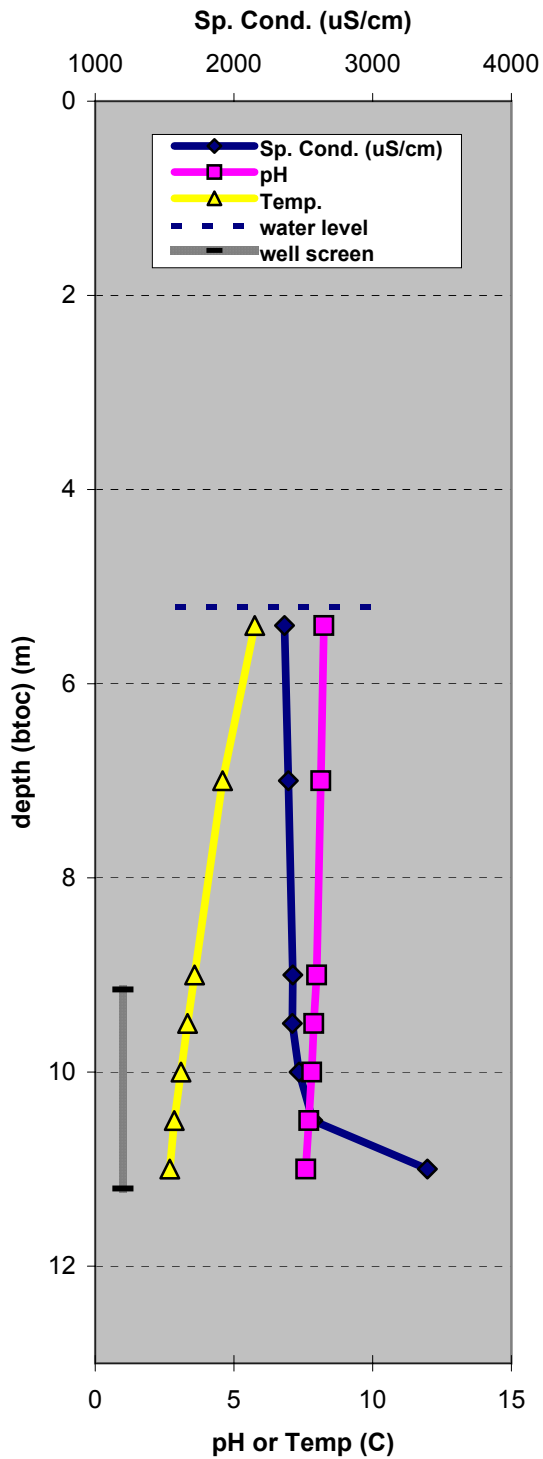
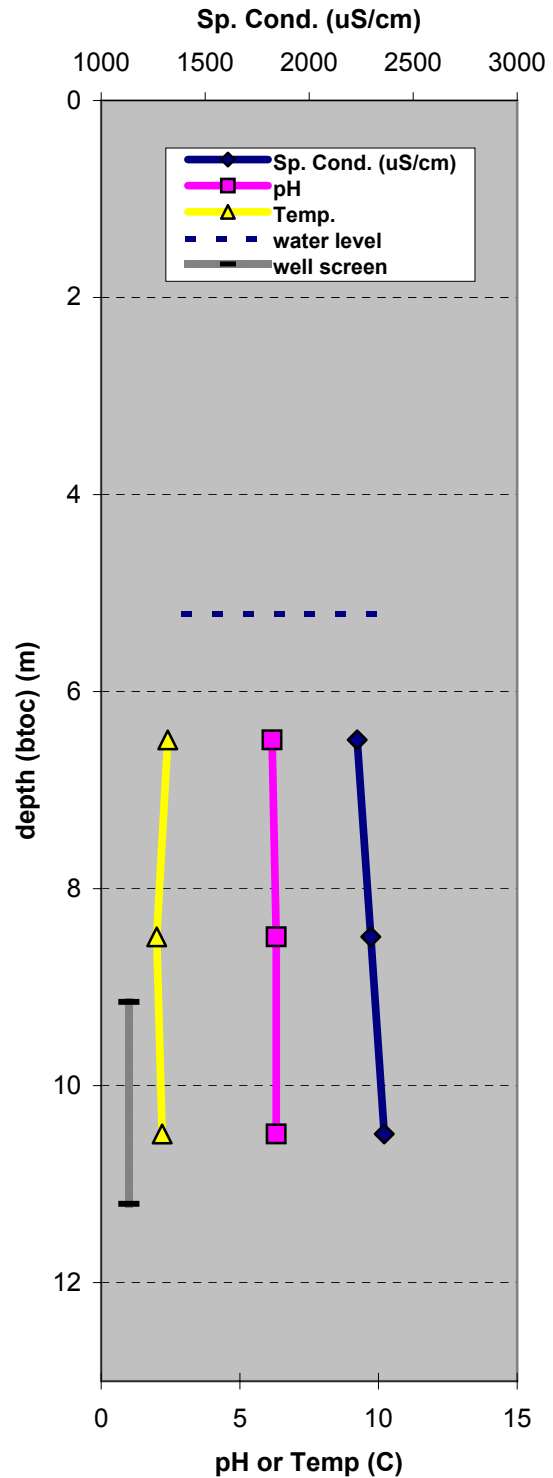
- The slope of the field parameter profiles (EC and GLL) are similar for specific conductance
- The profiles do not show clear evidence of leakage effects

Figure 18. Geochemical (Field Parameter) profile of static water in well P01-06 by Gartner Lee Limited (GLL) and Environment Canada

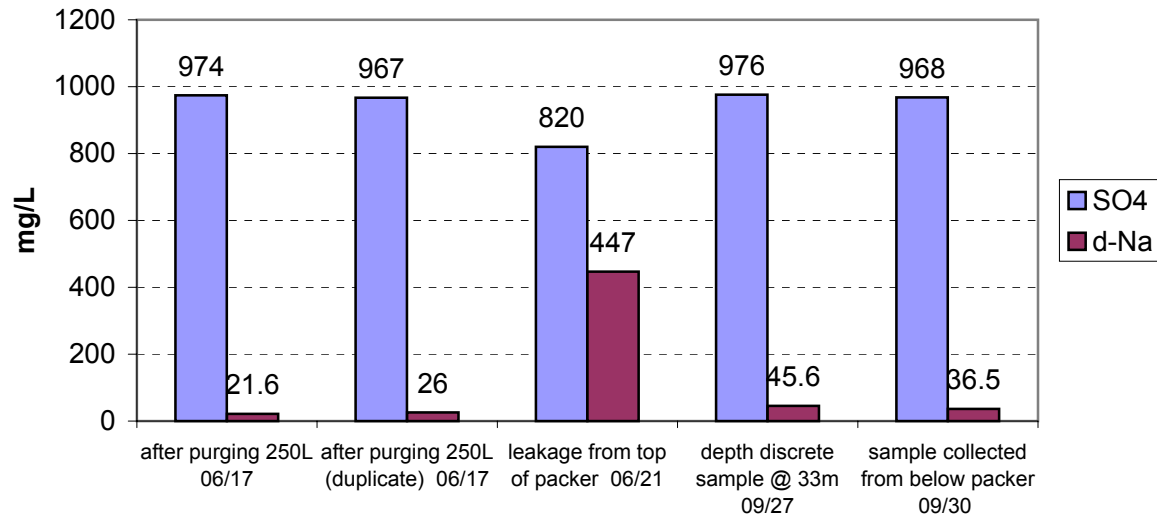
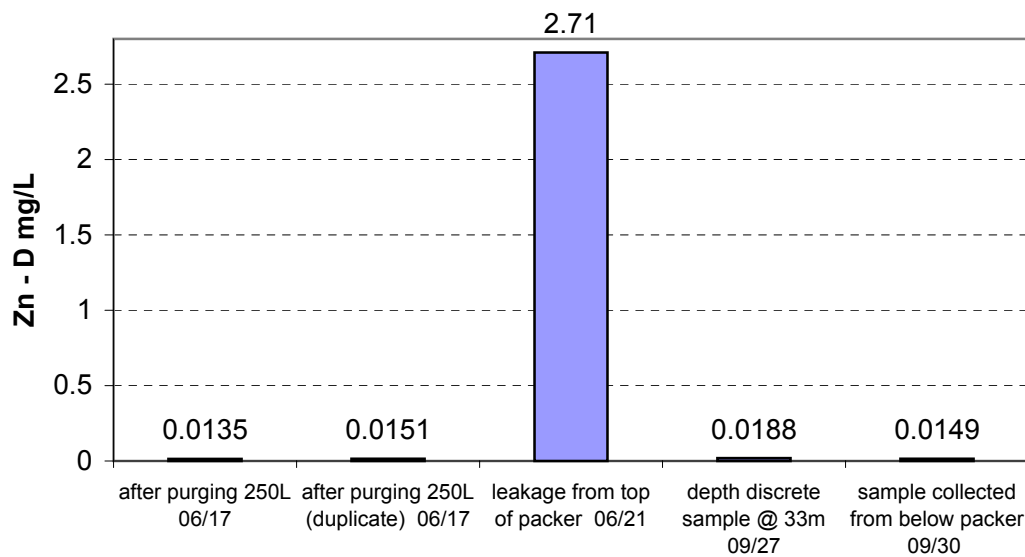
Figure 31. Summary of Leakage Assessment Sampling Results for Wells P01-07-D

purged well for 3 well volumes (250L) and collected sample.
Placed packer down well and removed any water above packer
Left packer in well 98 hrs total vol of leakage = 0.8L
Collected sample from leakage water that collected on top of packer

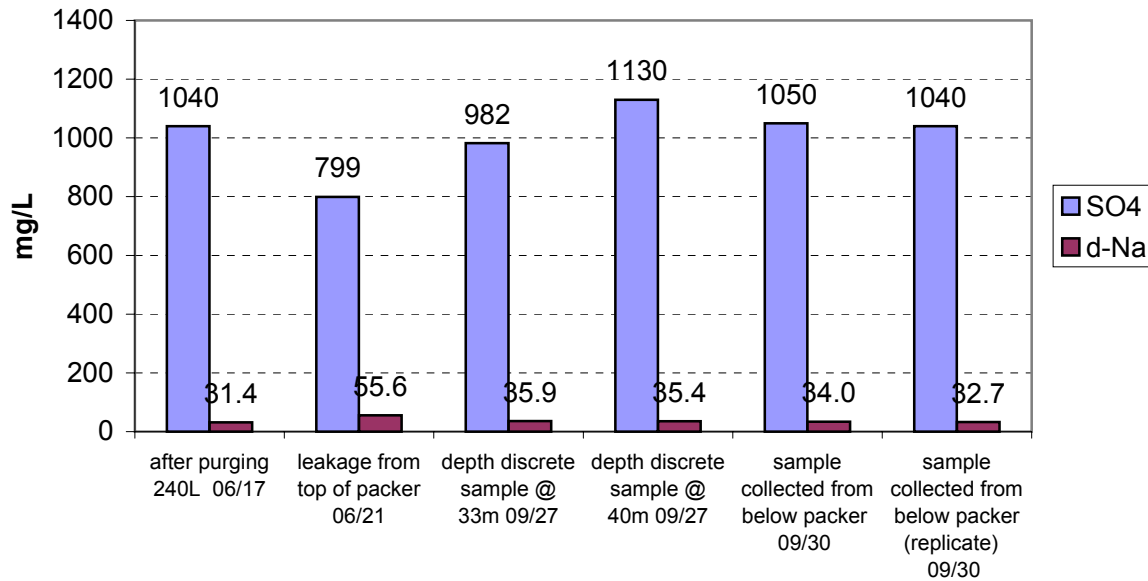
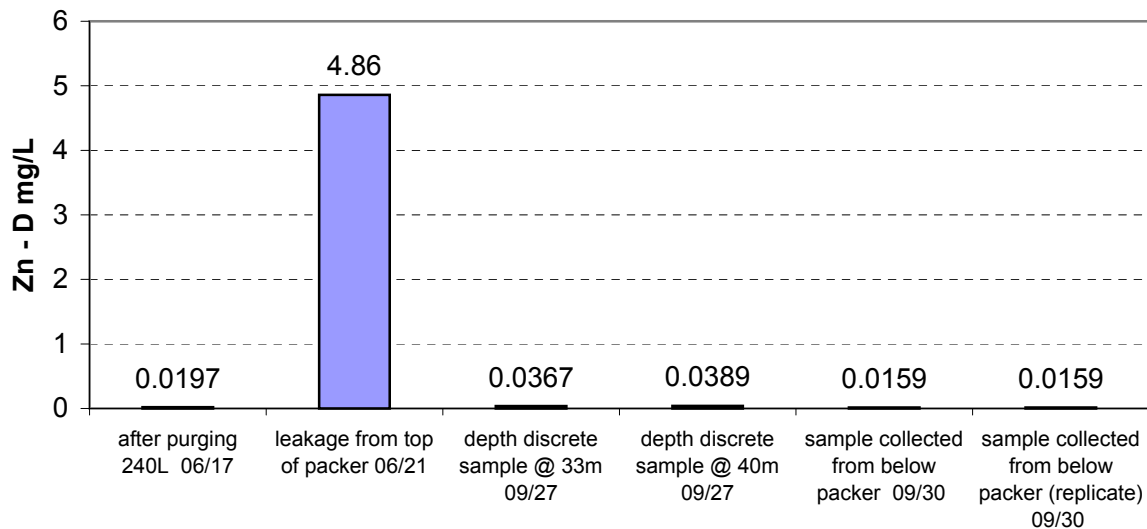
Figure 32. Summary of Leakage Assessment Sampling Results for Wells P01-07-E

purged well for 3 well volumes and collected sample.
Placed packer down well and removed any water above packer
Left packer in well 16hrs30mins total vol of leakage = 0.4L
Collected sample from leakage water that collected on top of packer

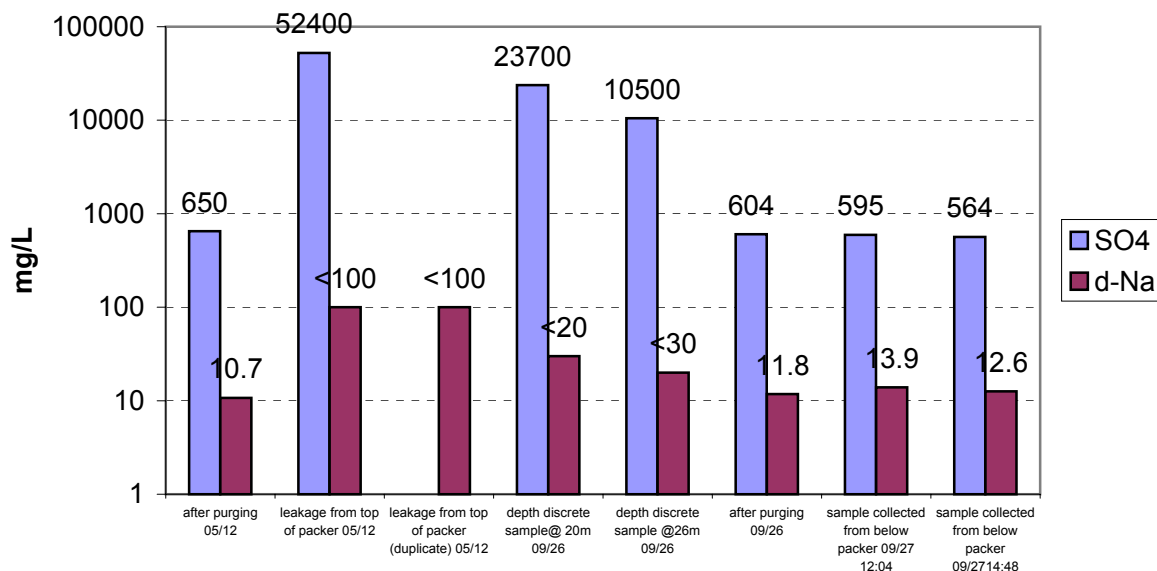
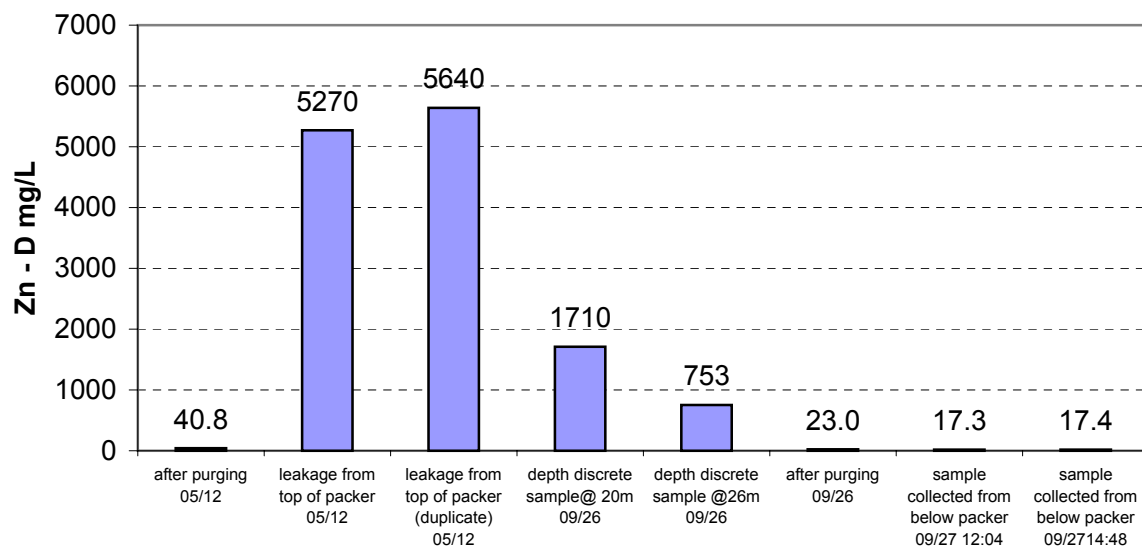
Figure 48. Summary of Leakage Assessment Sampling Results for Wells P01-09-D

purged well for 3 well volumes(150L) and collected sample.
Placed packer down well and removed any water above packer
Left packer in well >12 hrs. (depending on well)
Collected sample from leakage water that collected on top of packer

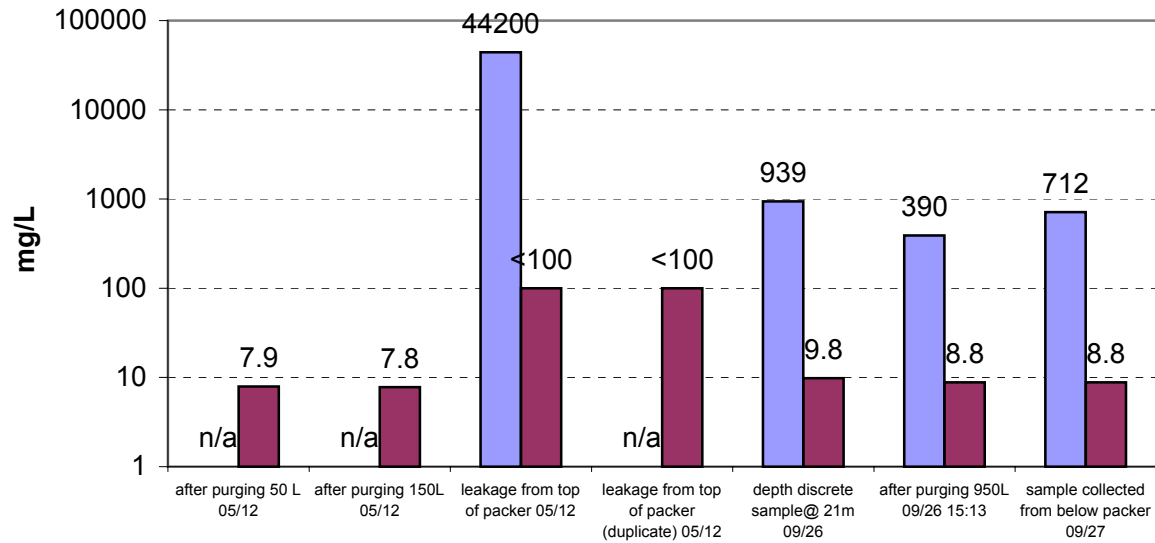
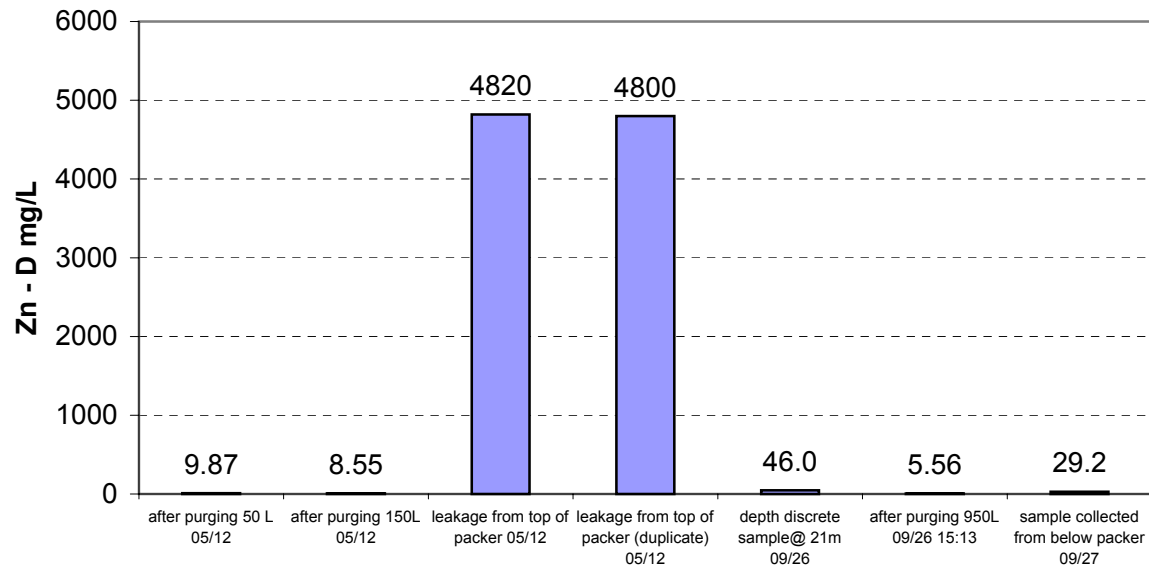
Figure 49. Summary of Leakage Assessment Sampling Results for Wells P01-09-C

purged well for 3 well volumes and collected sample.
Placed packer down well and removed any water above packer
Left packer in well >12 hrs. (depending on well)
Collected sample from leakage water that collected on top of packer

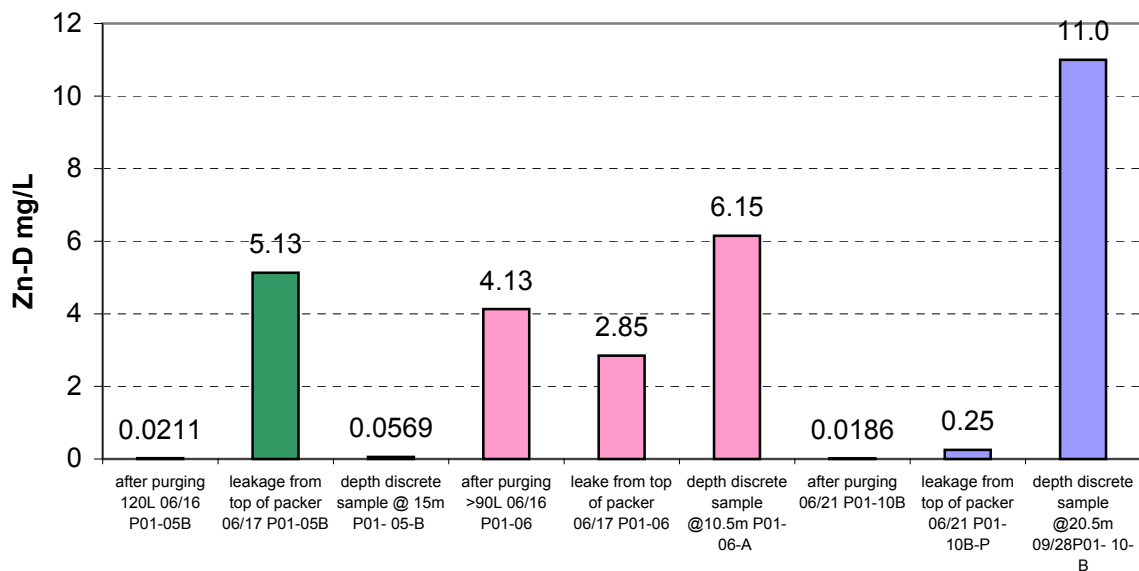
Figure 16. Summary of Leakage Assessment Sampling Results for Wells P01-05-B, P01-06 and P01-10-B

- Water accumulating on top of the packer (presumably from leakage) had elevated sulfate and zinc compared to conventional samples and samples from below the packer suggesting leakage. However, there are uncertainties with interpretation of the leakage water chemistry (above packer) (Figure 16) as geochemical reactions occur as leakage water is exposed to oxygen as it flows into the evacuated well, down the casing and to the top of the packer

purged well for 3 well volumes and collected sample.
Placed packer down well and removed any water above packer
Left packer in well ~12 hrs (depending on well)
Collected sample from leakage water that collected on top of packer

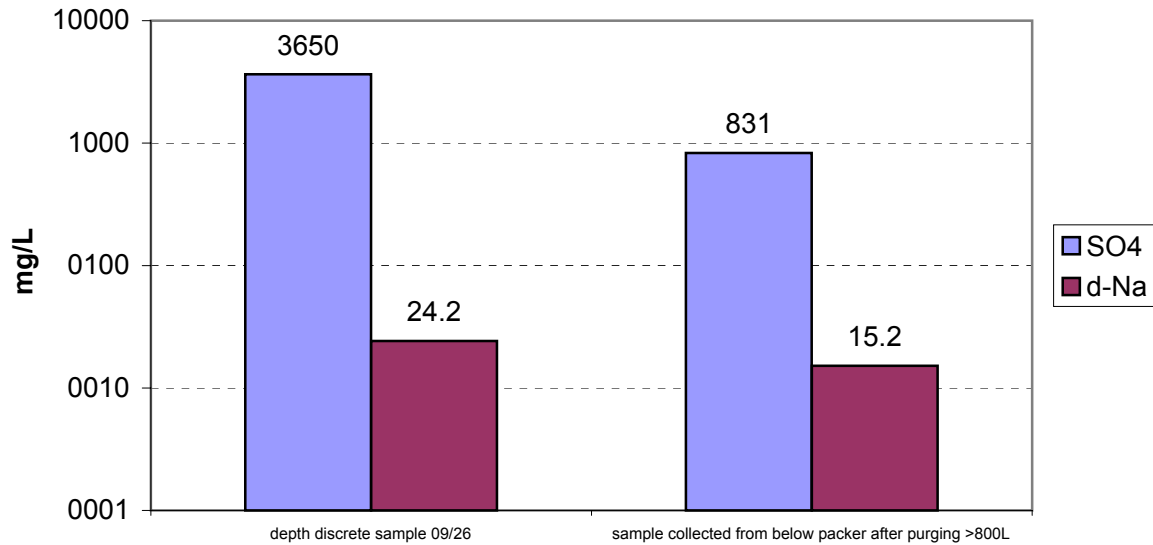
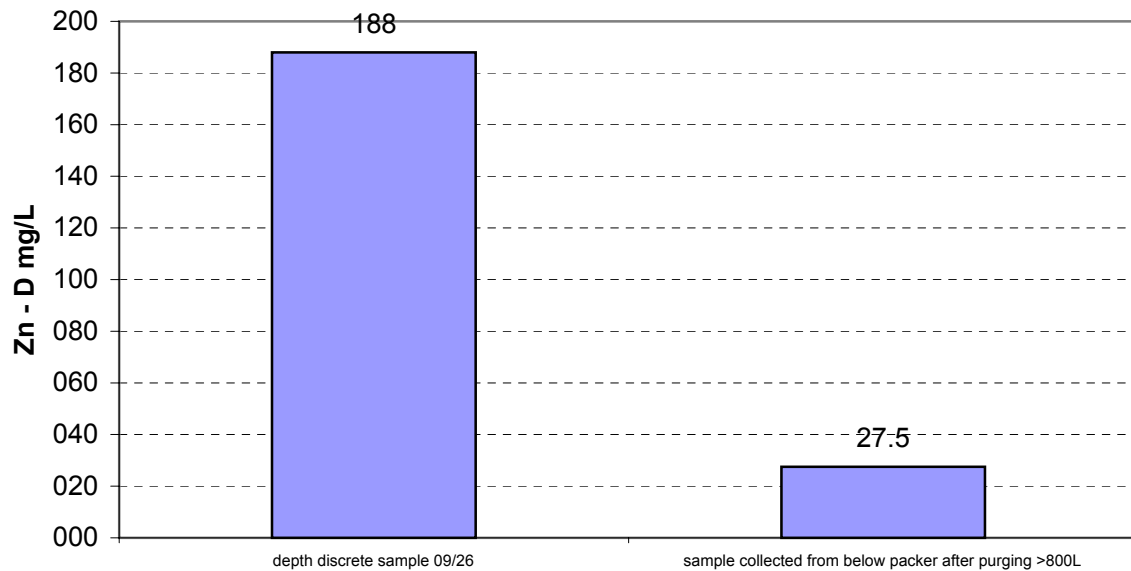
Figure 47. Summary of Leakage Assessment Sampling Results for Wells P01-09-B

took a depth discrete sample at well screen

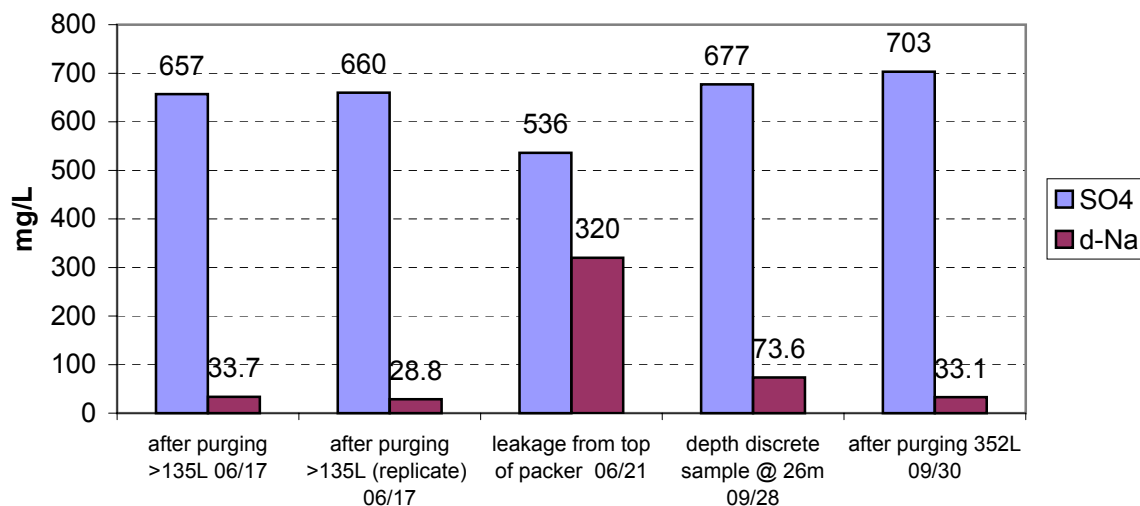
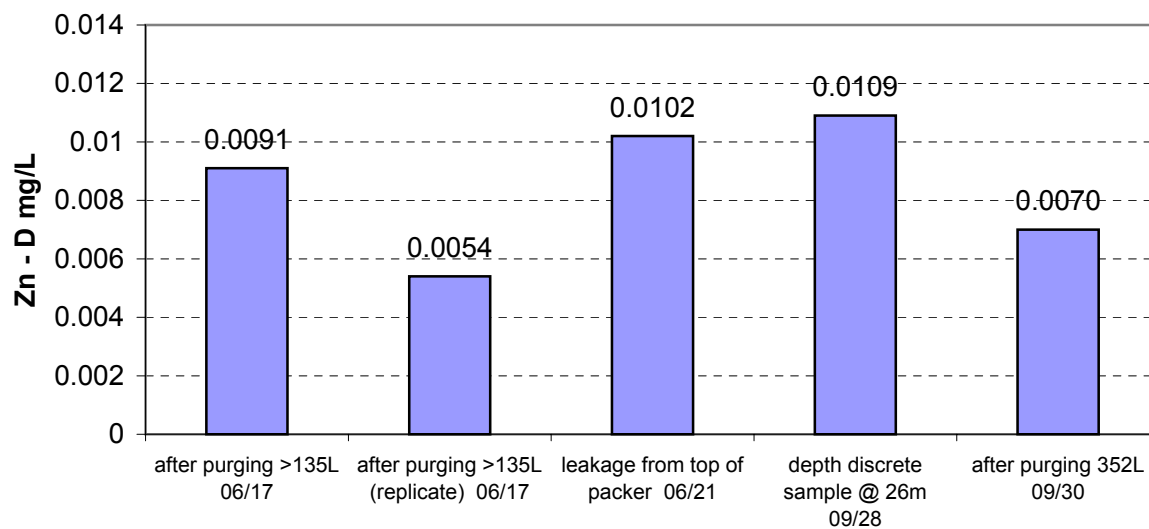
Figure 30. Summary of Leakage Assessment Sampling Results for Wells P01-07-C

purged well for 3 well volumes and collected sample.
Placed packer down well and removed any water above packer
Left packer in well 101 hrs total vol of leakage =9.9L
Collected sample from leakage water that collected on top of packer

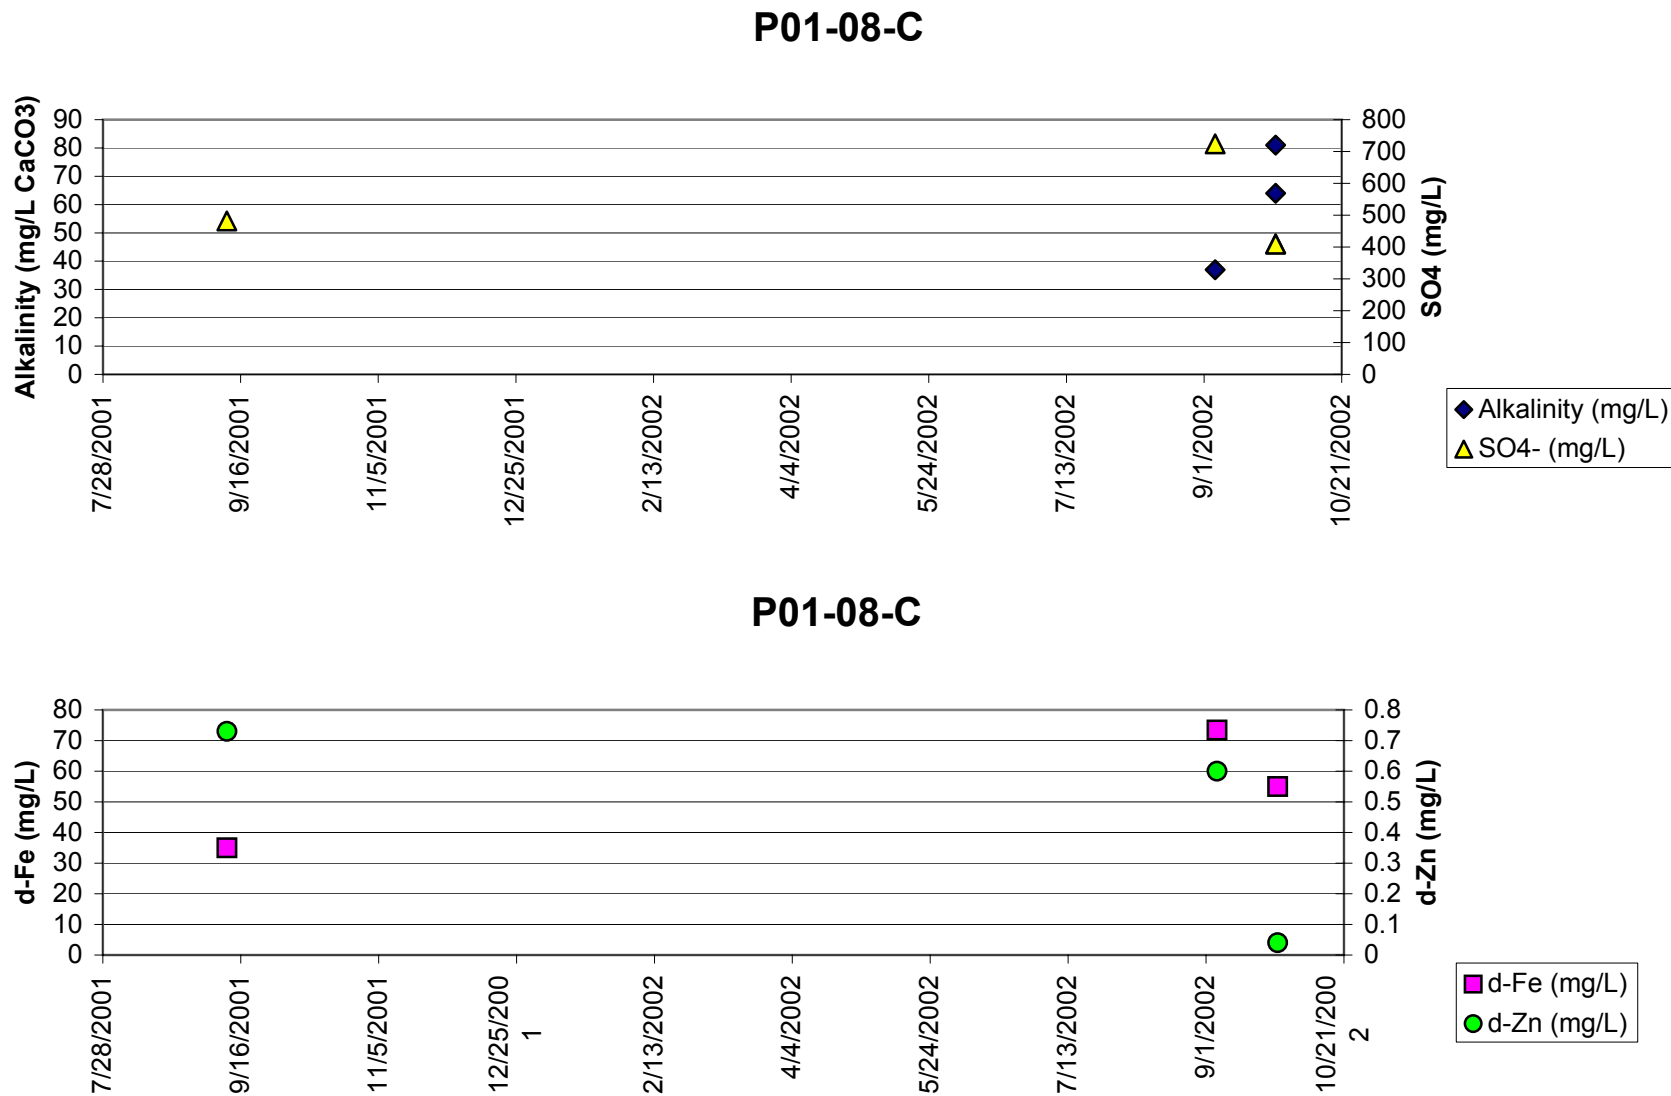
Figure 35. Time series of dissolved Iron (Fe) Zinc (Zn) Sulphate (SO₄) and Alkalinity for well P01-08-C

- Sampling tubing is stuck or frozen in this well in May 2005.
- This well has always been problematic to sample as it is often frozen and has tubing stuck in it.
- This well is not located in an area of great interest and has been problematic and therefore could be decommissioned

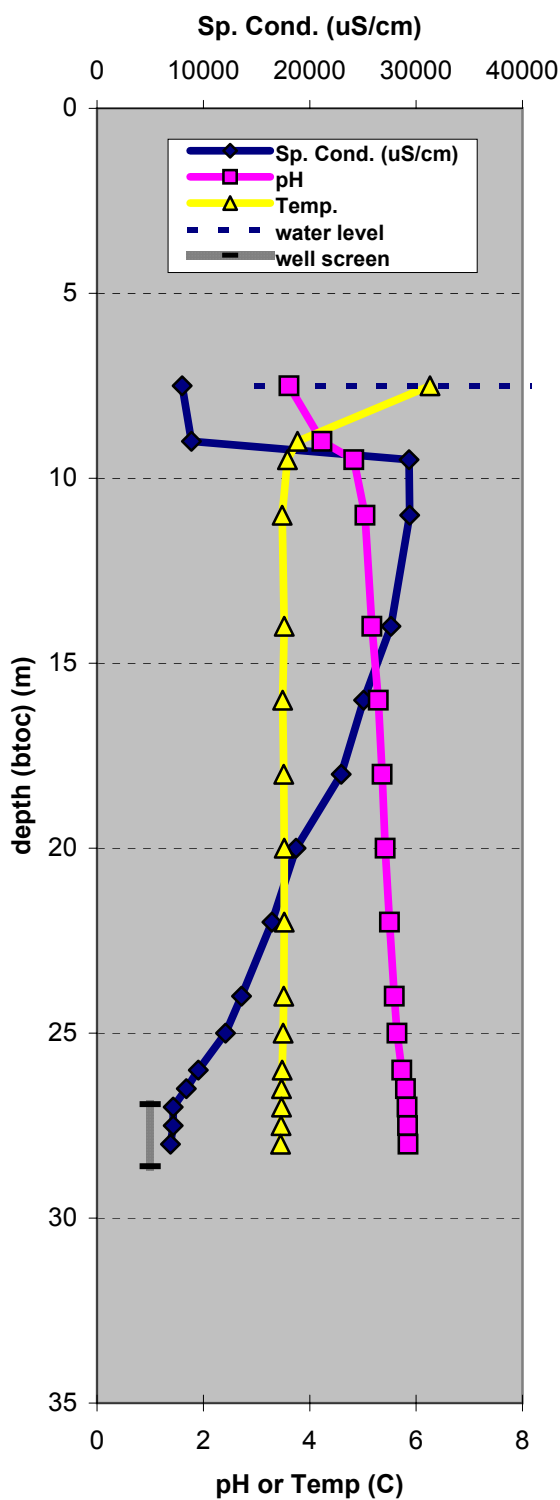
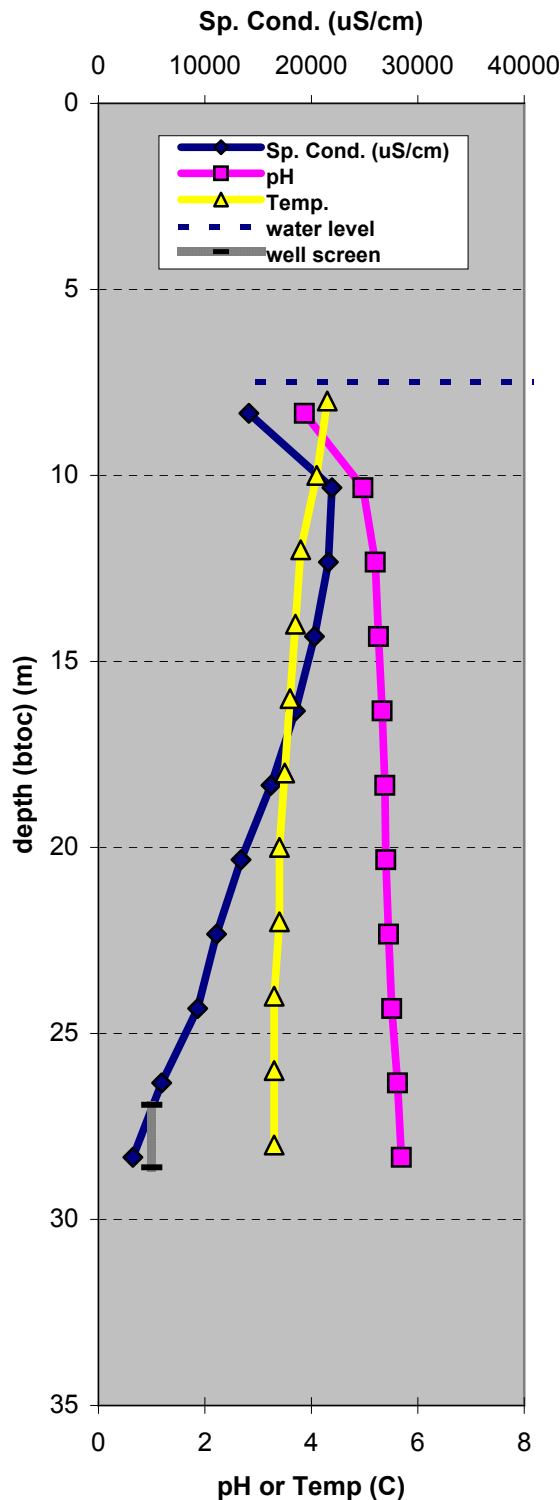
Figure 43. Geochemical (Field Parameter) profile of static water in wells P01-09D

- Both the 2004 (GLL) and 2003 (EC) geochemical field parameter profiles provide clear evidence of impact from leakage at this location
- The depth discrete samples collected in this well show clear evidence of leakage, with elevated dissolved metals and sulfate concentration within the well casing and slightly lower concentrations within the well screen where flushing and mixing with aquifer water is occurring.
- The decrease in specific conductance during purging both prior to and after packer installation indicates some flushing of contaminated water from the formation around the well screen
- The sample obtained below the packer after purging have significantly reduced concentrations of sulfate and dissolved zinc relative to all other samples collected previously
- No further sampling or testing of the well should be done and the well should be properly decommissioned

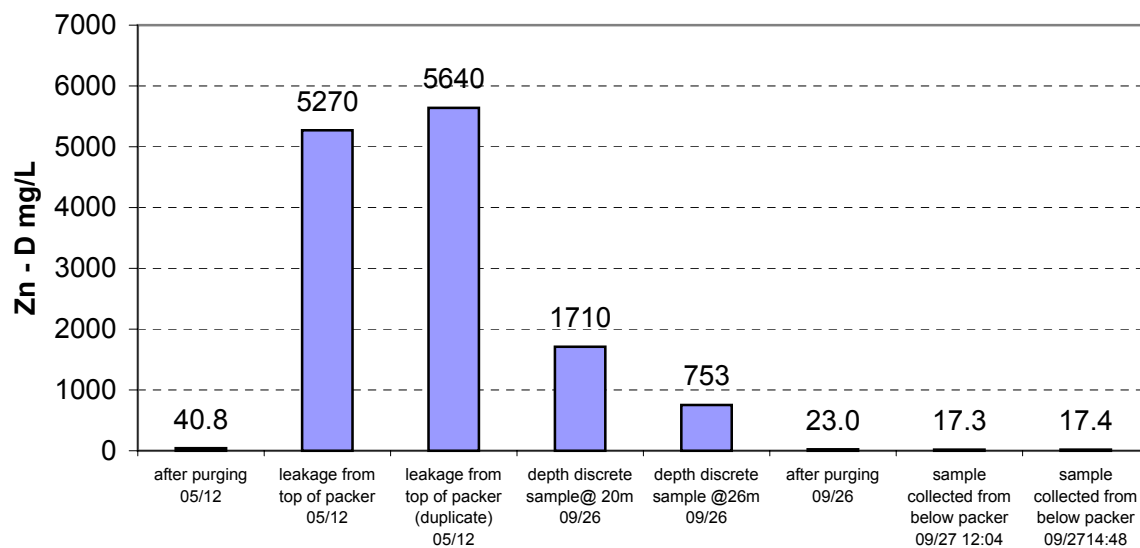
Figure 48. Summary of Leakage Assessment Sampling Results for Wells P01-09-D

purged well for 3 well volumes(150L) and collected sample.
Placed packer down well and removed any water above packer
Left packer in well >12 hrs. (depending on well)
Collected sample from leakage water that collected on top of packer

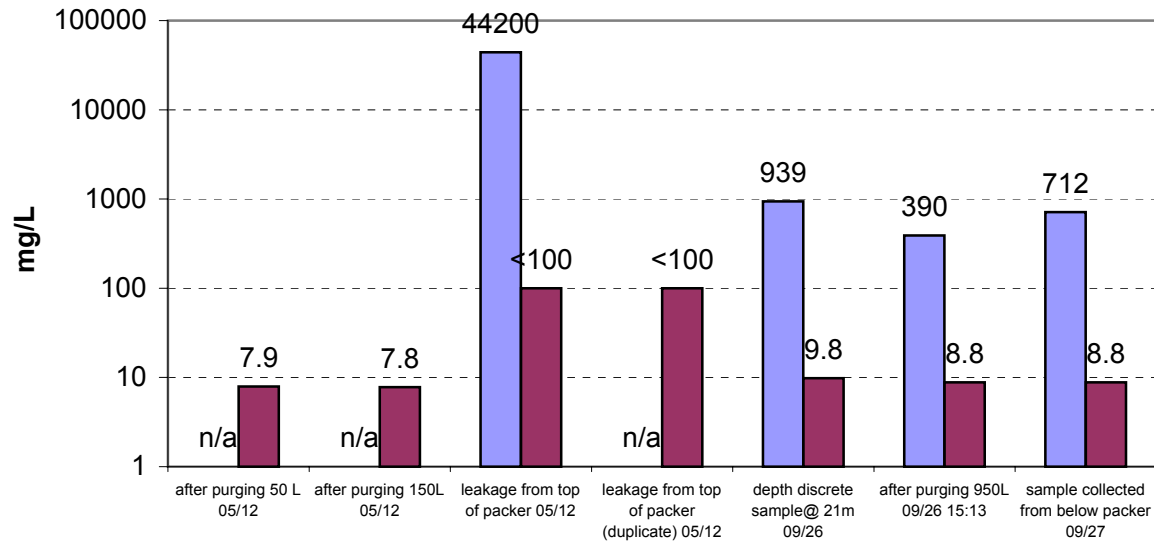
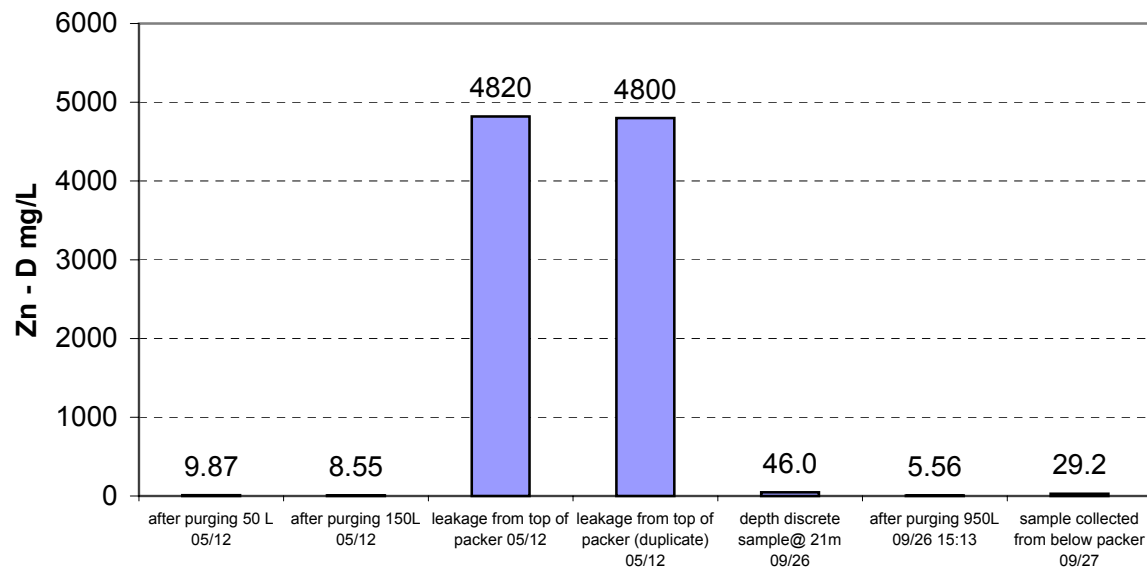
Figure 49. Summary of Leakage Assessment Sampling Results for Wells P01-09-C

purged well for 3 well volumes and collected sample.
Placed packer down well and removed any water above packer
Left packer in well >12 hrs. (depending on well)
Collected sample from leakage water that collected on top of packer

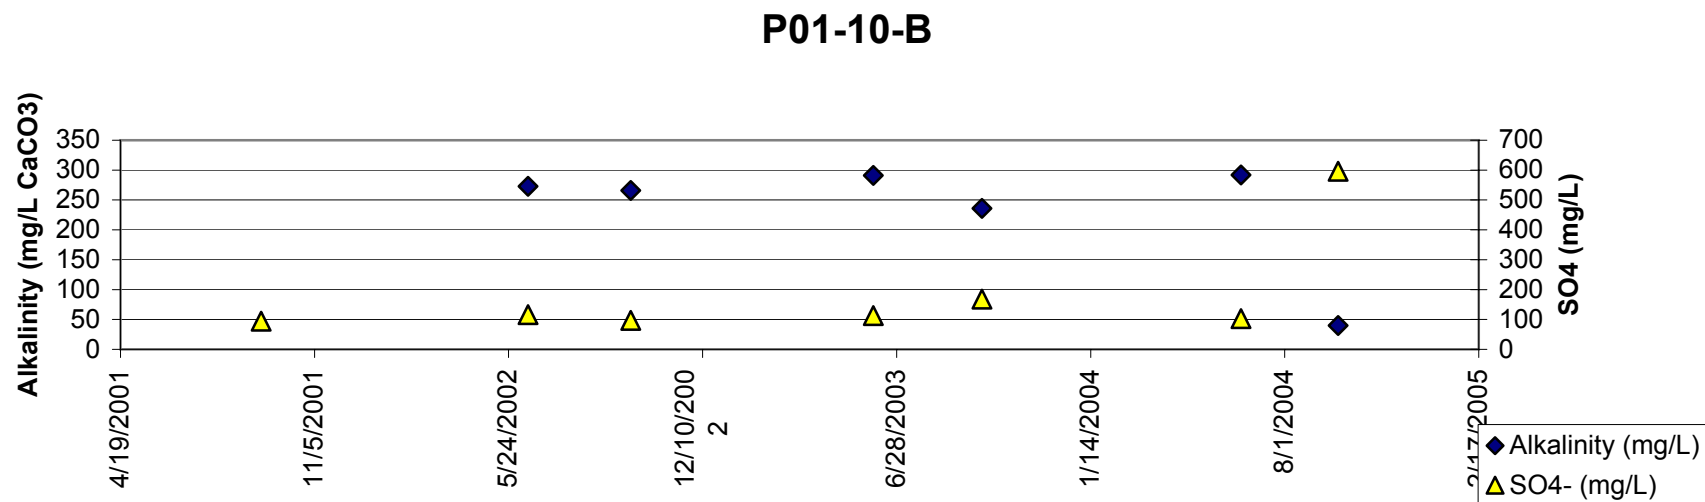
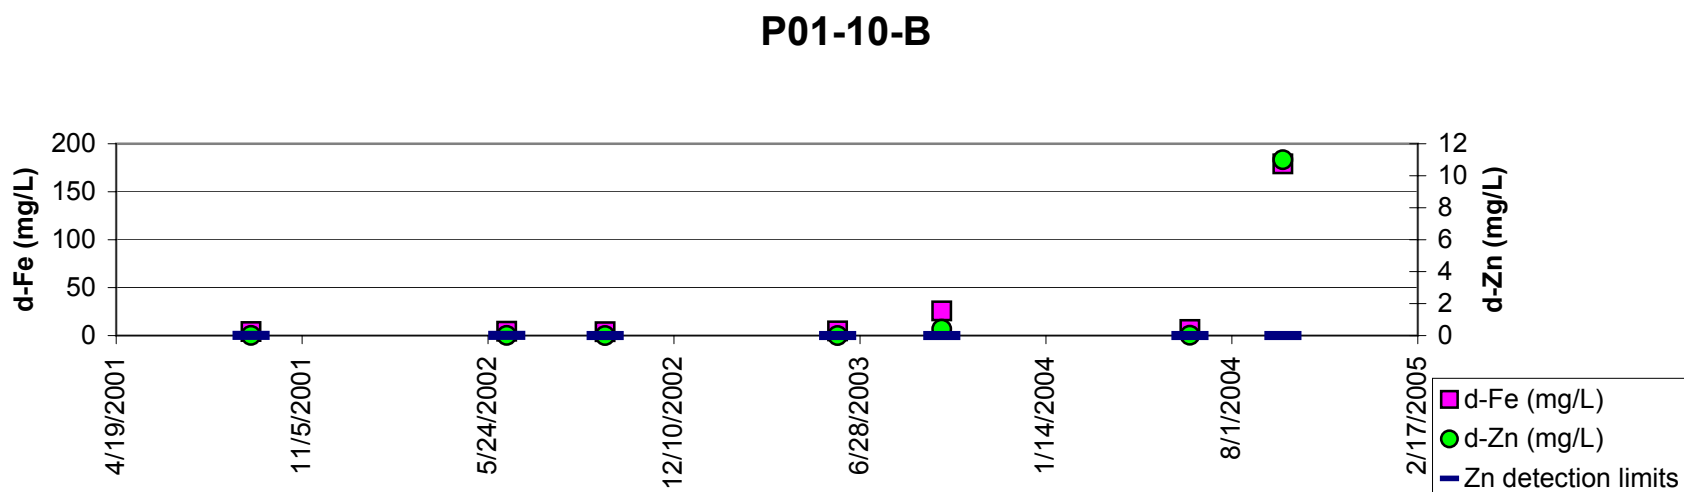
Figure 51 . Time series of dissolved Iron (Fe) Zinc (Zn) Sulphate (SO₄) and Alkalinity for well P01-10-B

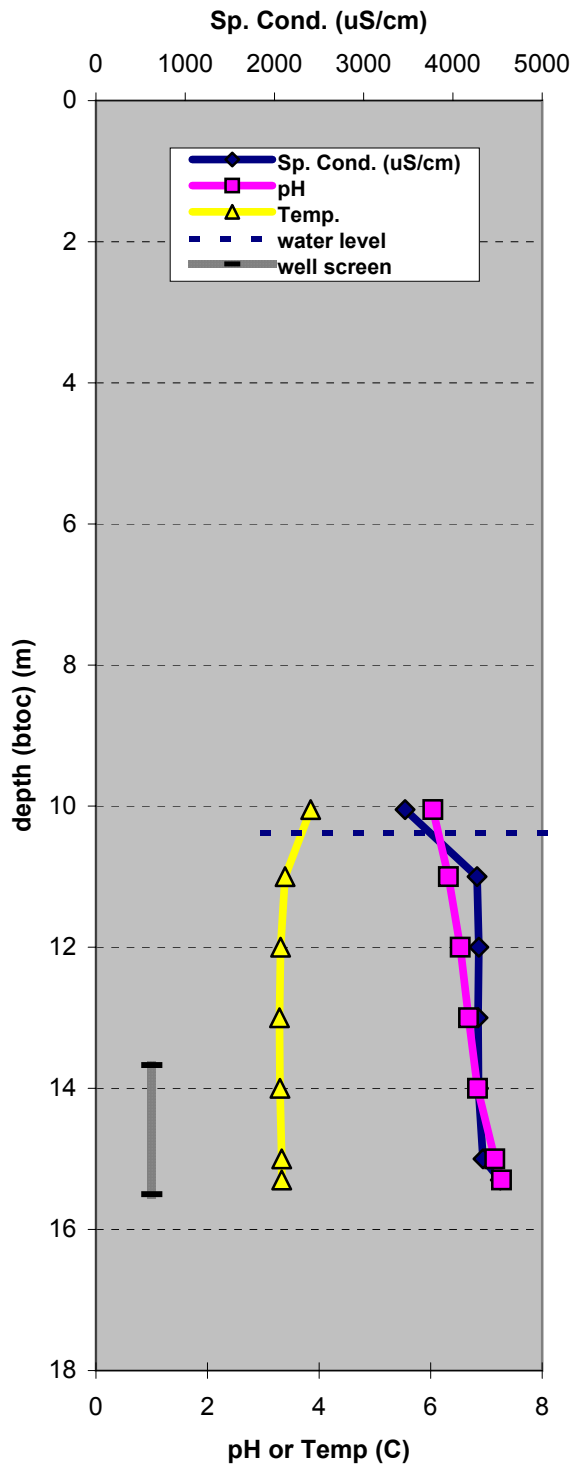
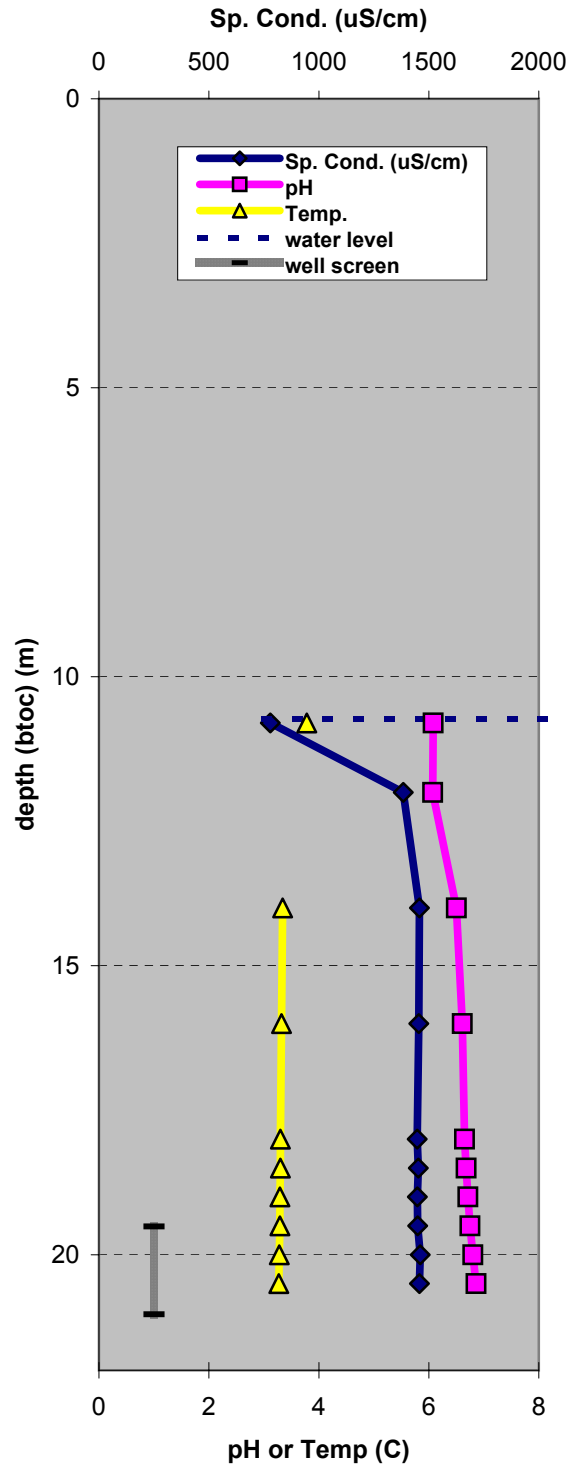
Figure 52 & 53. Geochemical (Field Parameter) profile of static water in wells P01-10A and P01-10B
