2004 Leakage Assessment of P01 Series Wells, Faro Mine

**Deloitte and Touche Inc.
Interim Receiver, Faro Mine**

Gartner Lee Limited

June 1, 2004

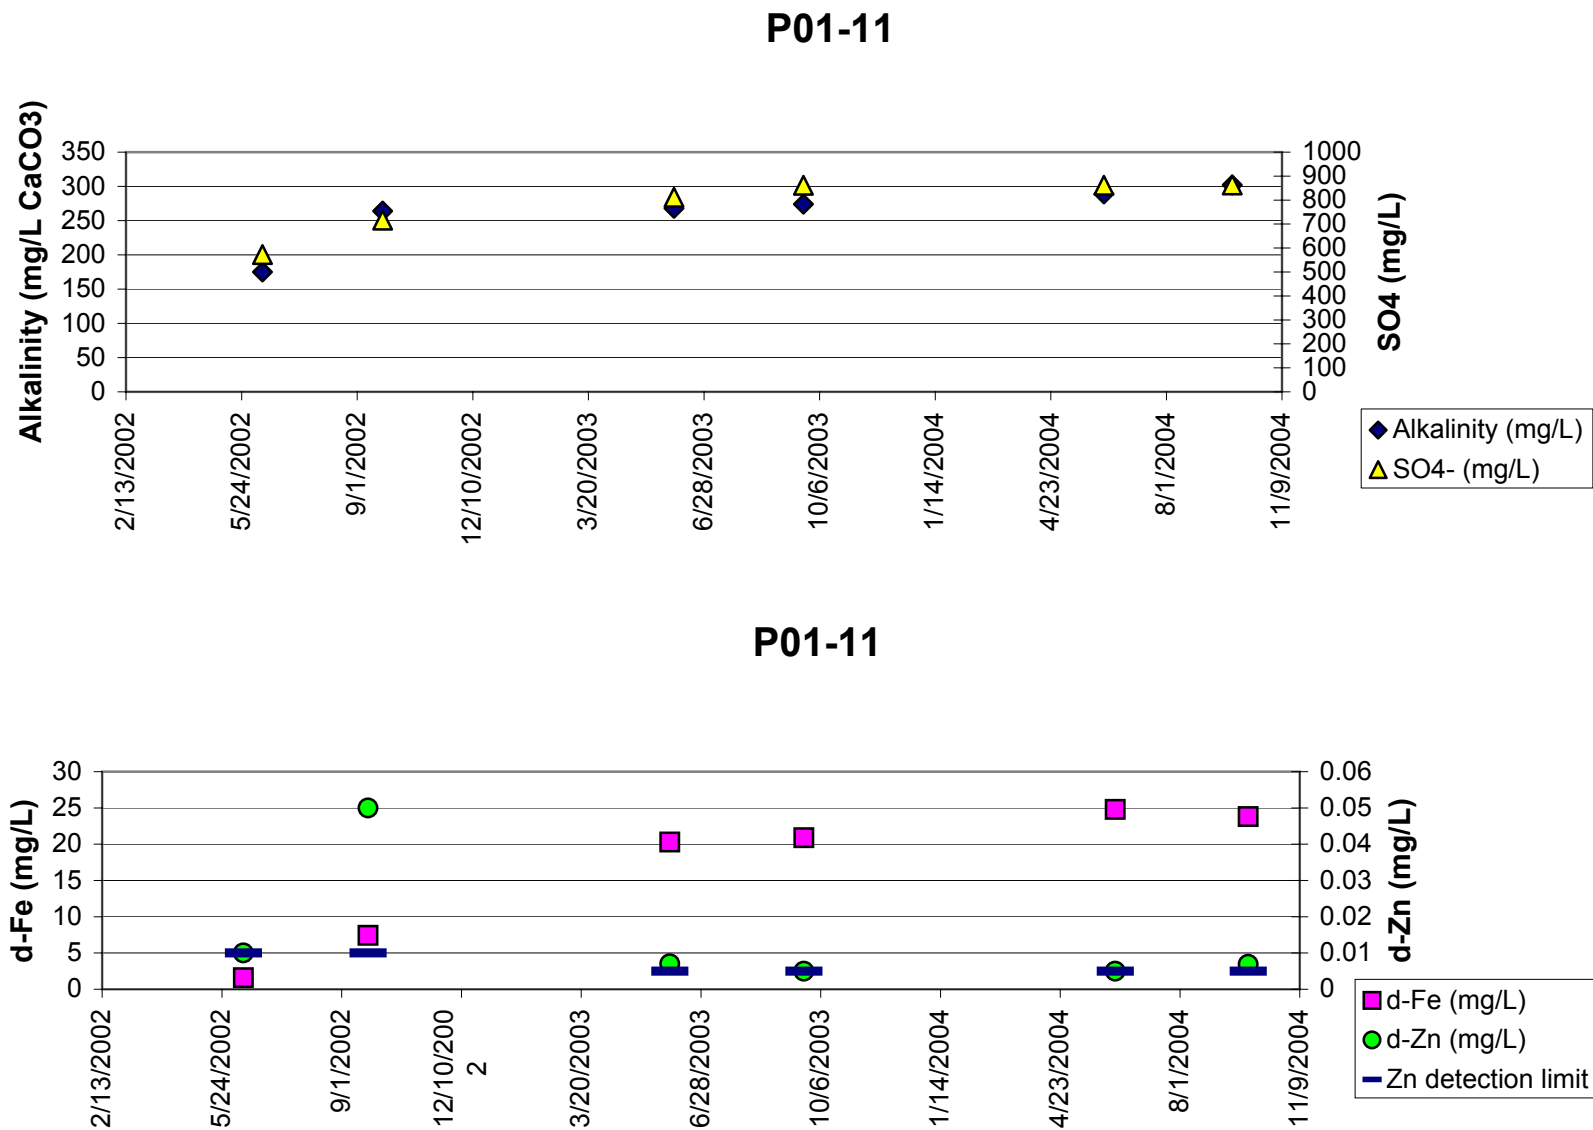
- The temperature profile from this well suggests that leakage may be occurring
- This well is not screened through tailings and therefore does not constitute an immediate risk to groundwater quality in the deeper aquifer
- The depth discrete sample showed similar chemistry to samples collected using conventional methods

Figure 54 . Time series of dissolved Iron (Fe) Zinc (Zn) Sulphate (SO₄) and Alkalinity for well P01-11

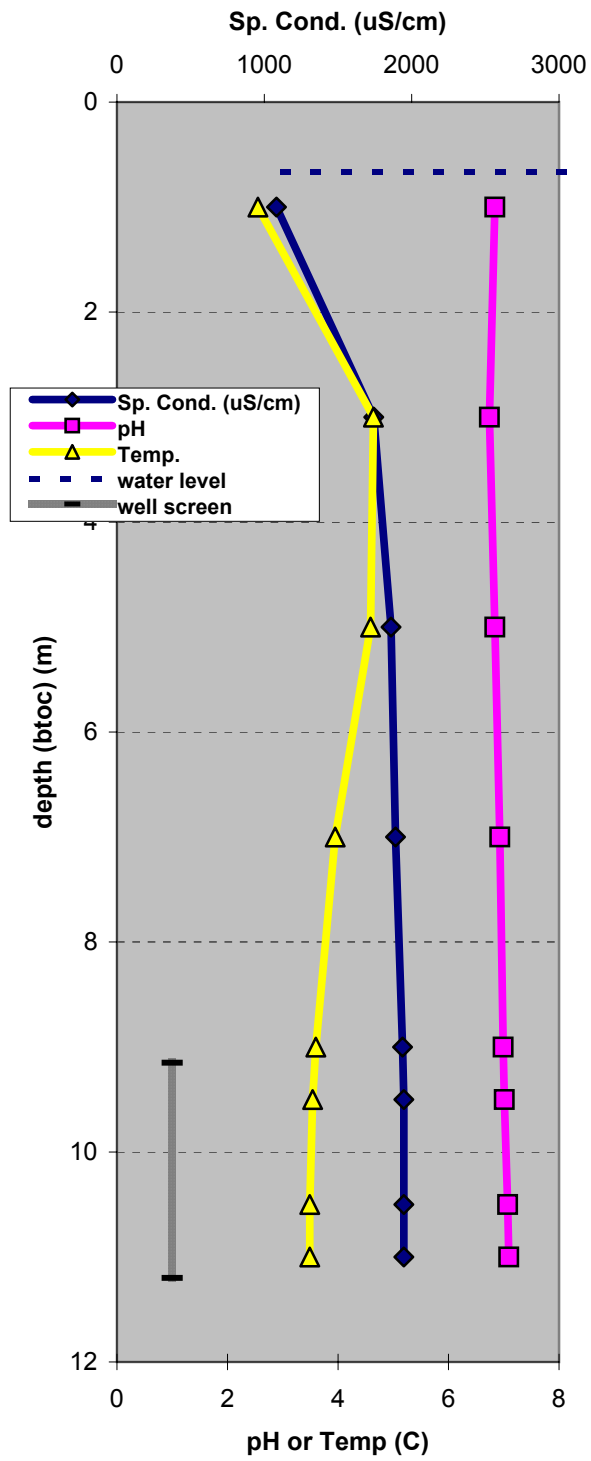
Figure 55. Geochemical (Field Parameter) profile of static water in well P01-11A

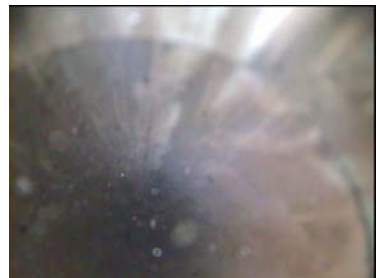
Not as black as other joints

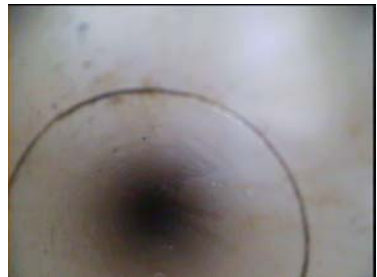
Well Location and Casing Joint Depth: P01-07D @ 2.9m

Field Observations:
Clean joint

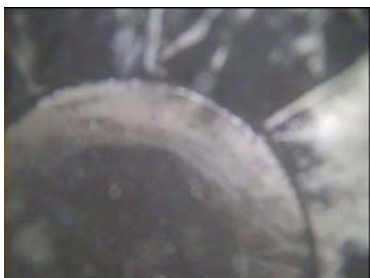
Well Location and Casing Joint Depth: P01-07D @ 15m

Field Observations:
Resembles something
like a double joint,

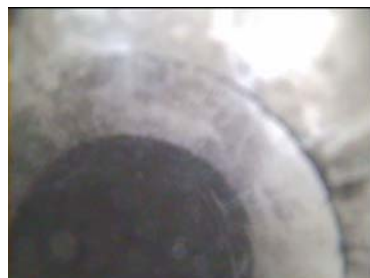
Well Location and Casing Joint Depth: P01-07D @ 17.8m

Field Observations:
Zebra-like black and
white striping on walls,
another "double joint"

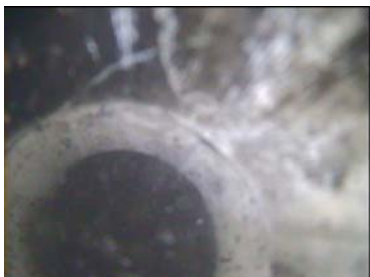
Well Location and Casing Joint Depth: P01-07D @ 20.6m

Field Observations:
Black walls with white
stripes

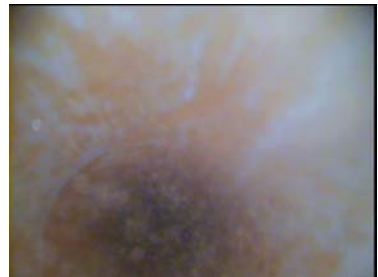
Well Location and Casing Joint Depth: X21B-96 @ 6.3m

Field Observations:
Some brown/iron
colouring on sides

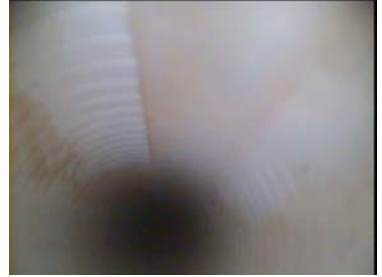
Well Location and Casing Joint Depth: X21B-96 @ 13.9m

Field Observations;
well screen

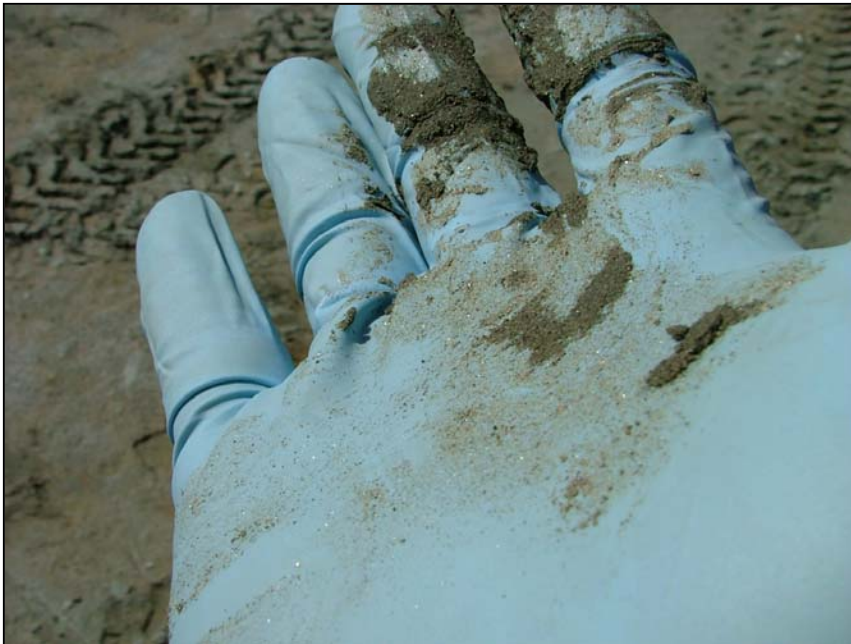
Tailings from well P01-10B

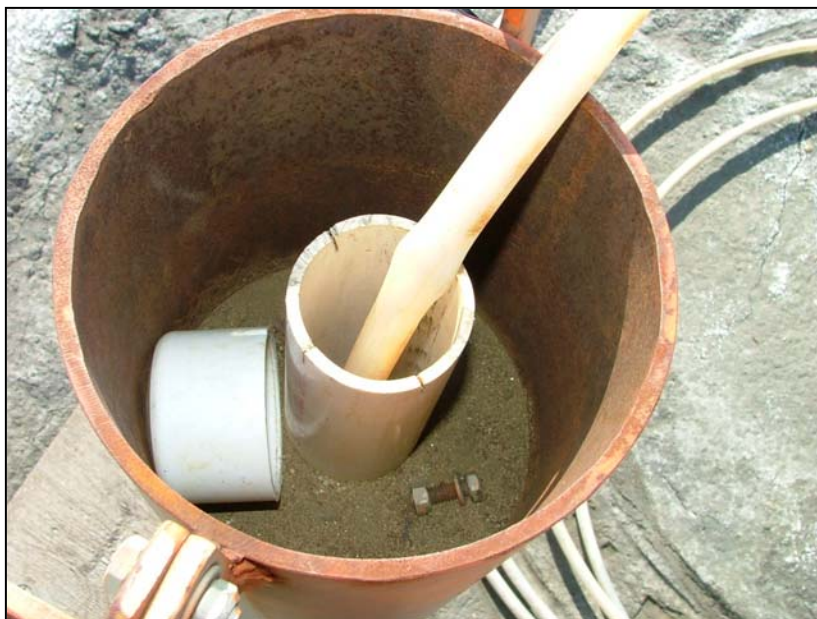
Well P01-08B (annular space filled with sand and sampling tubing stuck in well.)

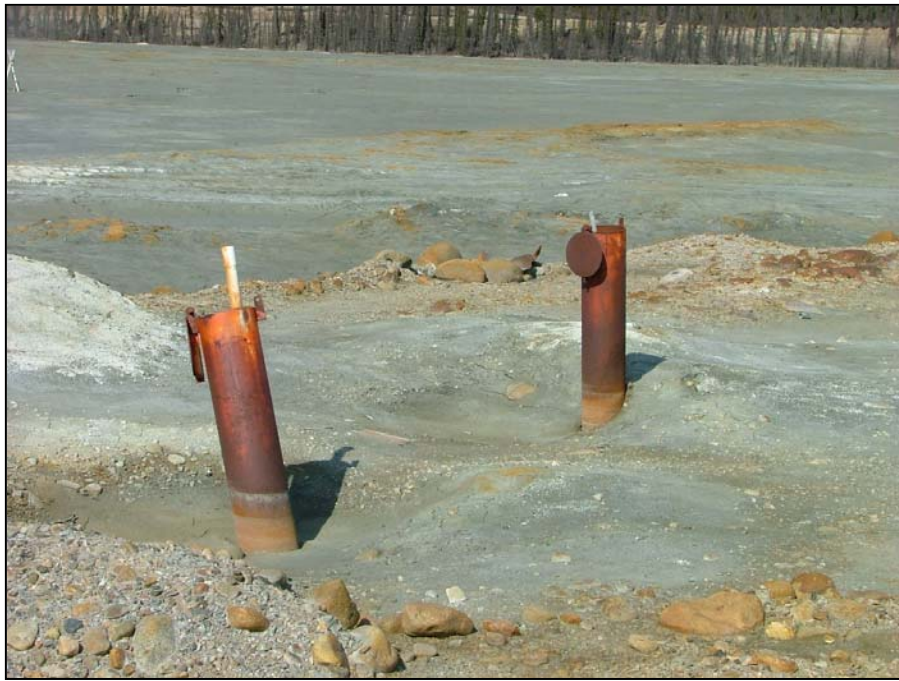
Old wells near P01-07. Casing and/or well appear to have heaved.

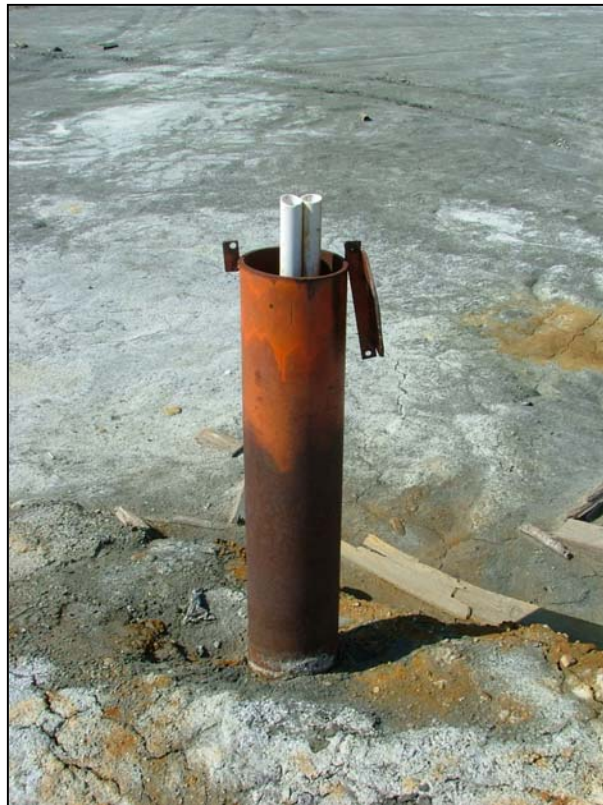
Well Cluster X21. Annular space is filled with sand
