Government of Yukon

# Former Clinton Creek Asbestos Mine 2010 Site Inspection

**Project Number:** 60160515 (402.3.1)

Date: March, 2011

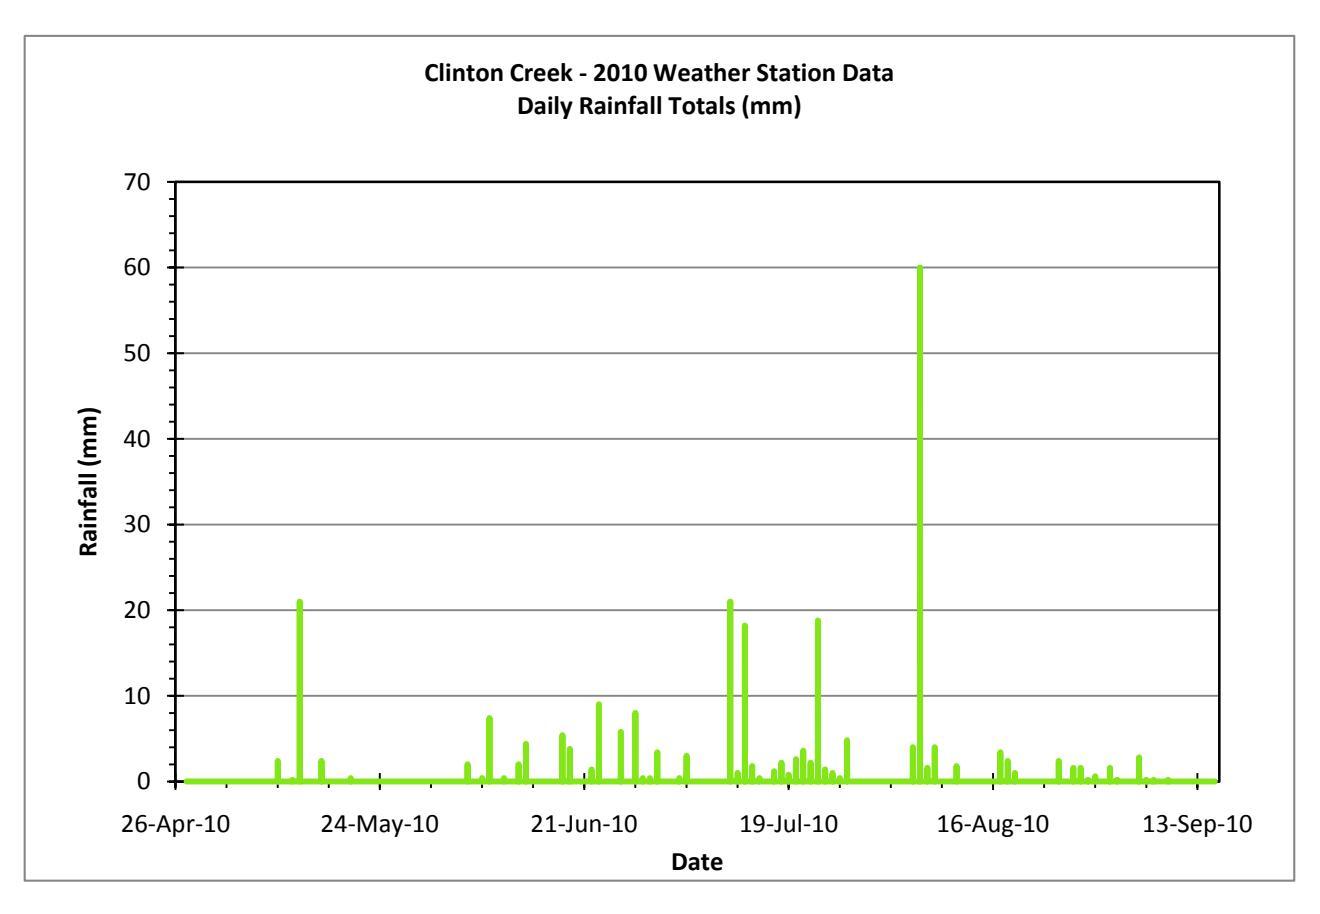
Figure 40 Daily Rainfall Amounts

A weather station located on the Clinton Creek waste rock dump near Hudgeon Lake recorded precipitation at the site. The data is illustrated on Figure 40 below and shows that a total of 255 mm of rain fell from April 27 to September 13, 2010 of which 82 mm of rain fell over a 17 day period from July 11 to 27 and 70 mm of rain fell over a 4 day period beginning August 5. Sixty millimetres (60 mm) fell on August 6 over a period of about 20 hours.

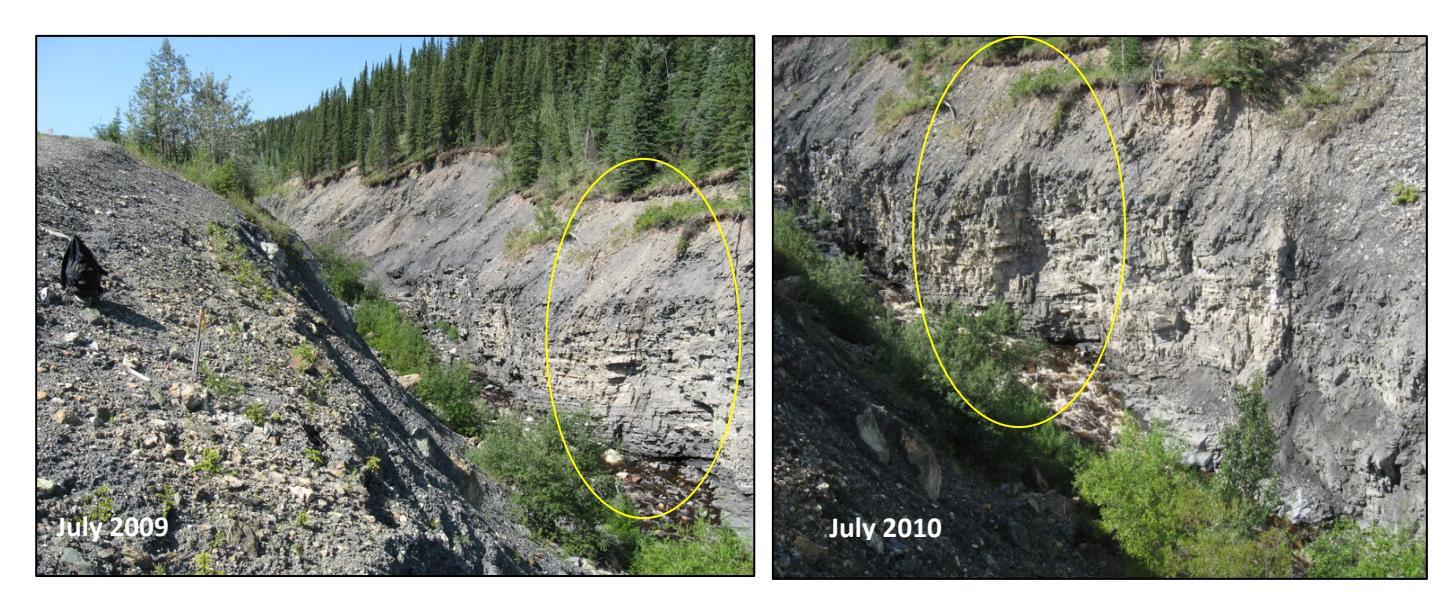
Figure 08 Station 0+470 at WP 342 in 2009 and 2010, U/S view

Farther upstream, at approximately Station 0+560, the physical features and vegetation along the LHS and RHS of the channel, as well as the channel bottom do not appear to have significantly changed from 2009 as seen on Figures 05, 06 and 07 taken from WP 341. A similar set of photos were taken at WP 342, located at approximately Station 0+470 in an upstream direction (Figure 08), cross-channel (Figure 09) and downstream (Figure 10); No significant changes in the condition of the channel over the one year period from July 2009 to July 2010 were noted.

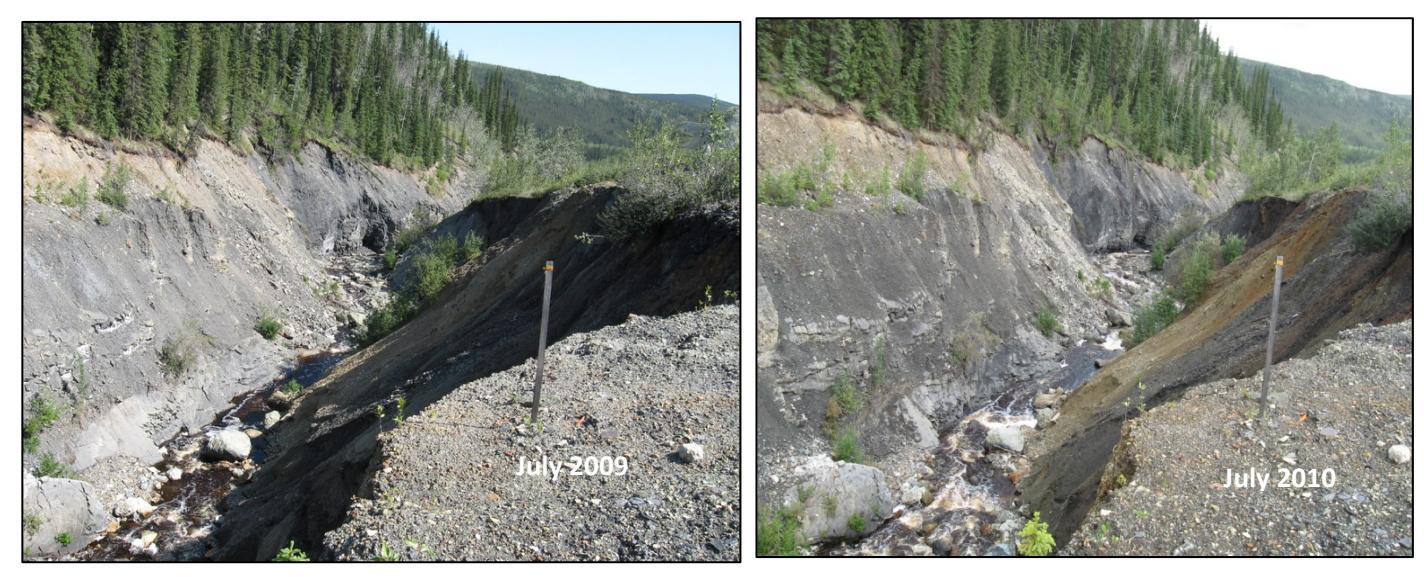
Figure 13 Clinton Creek Channel at WP 345 in 2009 and 2010, D/S view

The final vantage point to observe the channel is located near Station 0+290 m (WP 345) which provides a good view of the waste rock and bedrock contact located about 50 m downstream of the drop structures. Figure 13 illustrates these features and also signs of recent slide activity of the waste rock, likely initiated by erosion along the toe of the waste rock.

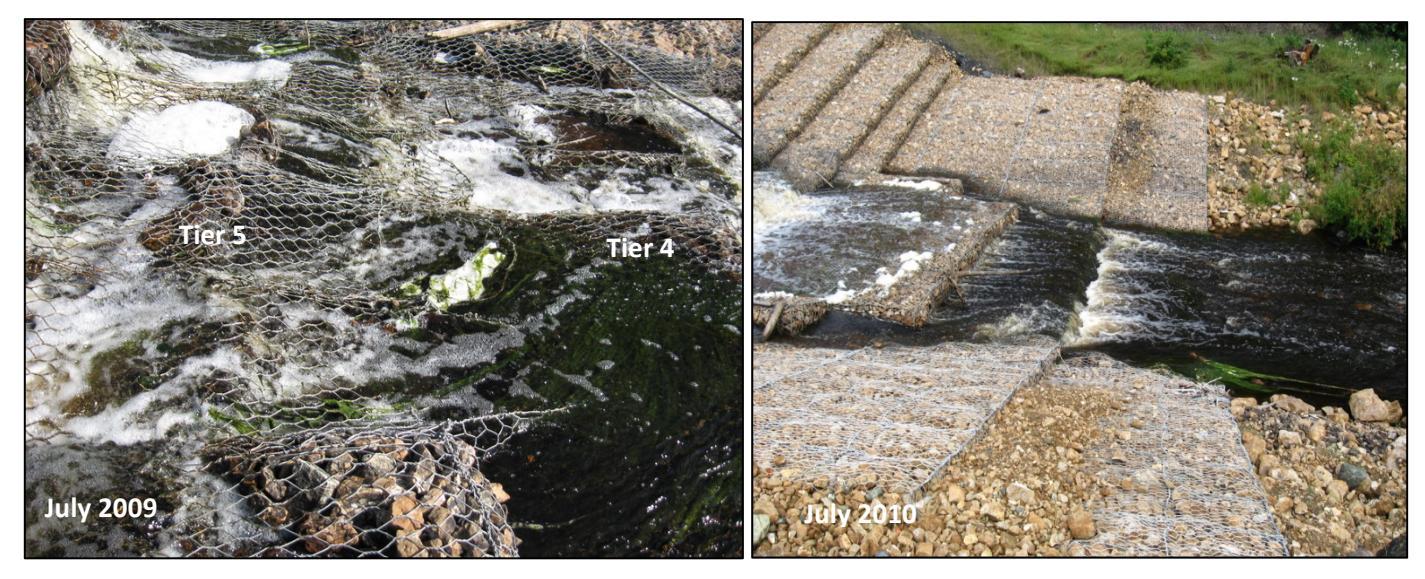
Figure 18 DS #4 Tier 4 and Tier 5 in 2009 and 2010, view North

Overall, the damage to the gabion drop structures that occurred in 2009 was more severe on the north side of the structures with the most significant damage occurring at Drop Structure #4 (DS #4). Less damage occurred at DS #2 and relatively minor damage occurred at DS #1 and DS #3.

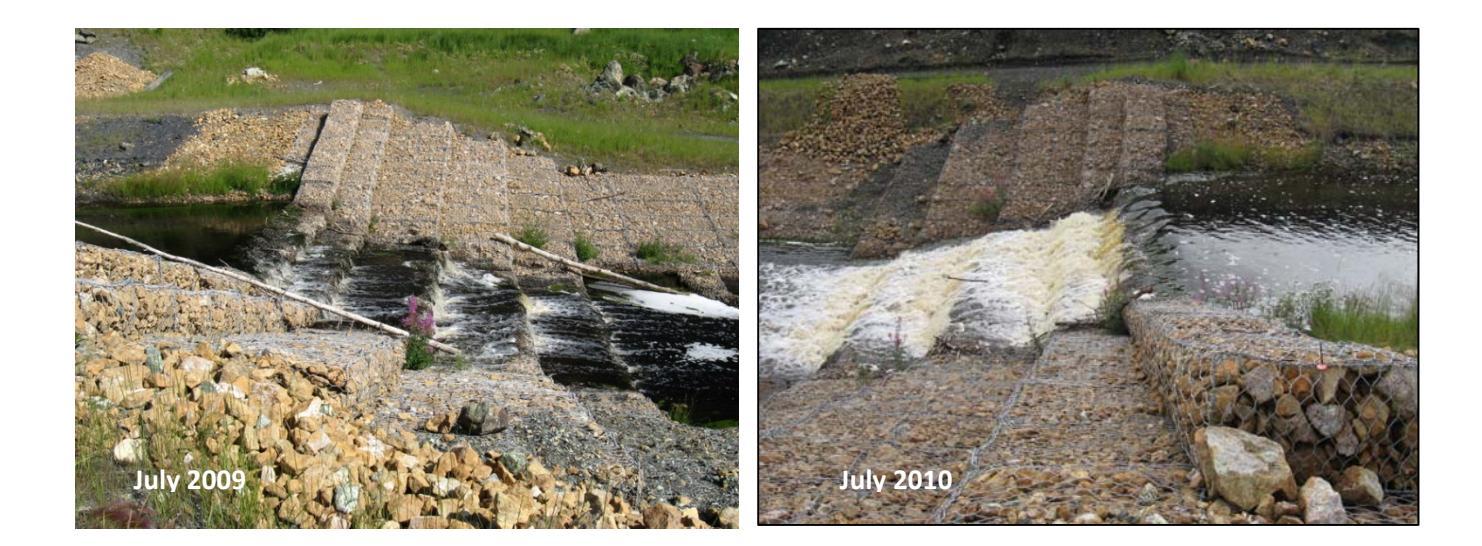
Figure 20 DS #3 in 2009 and 2010, cross channel views

Drop Structure #3 consists of a drawdown weir with 5 tiers that provide a 2 m drop in channel grade and an end sill on the bottom tier. Figure 19 illustrates the overall condition of the structure in 2009 and 2010. Cross-channel views of the structure are shown on Figure 20. The damage to Drop Structure #3 observed in 2009 included deformation of baskets, some small holes in the tops or downstream sides of individual baskets and the end sill was badly deformed but intact.

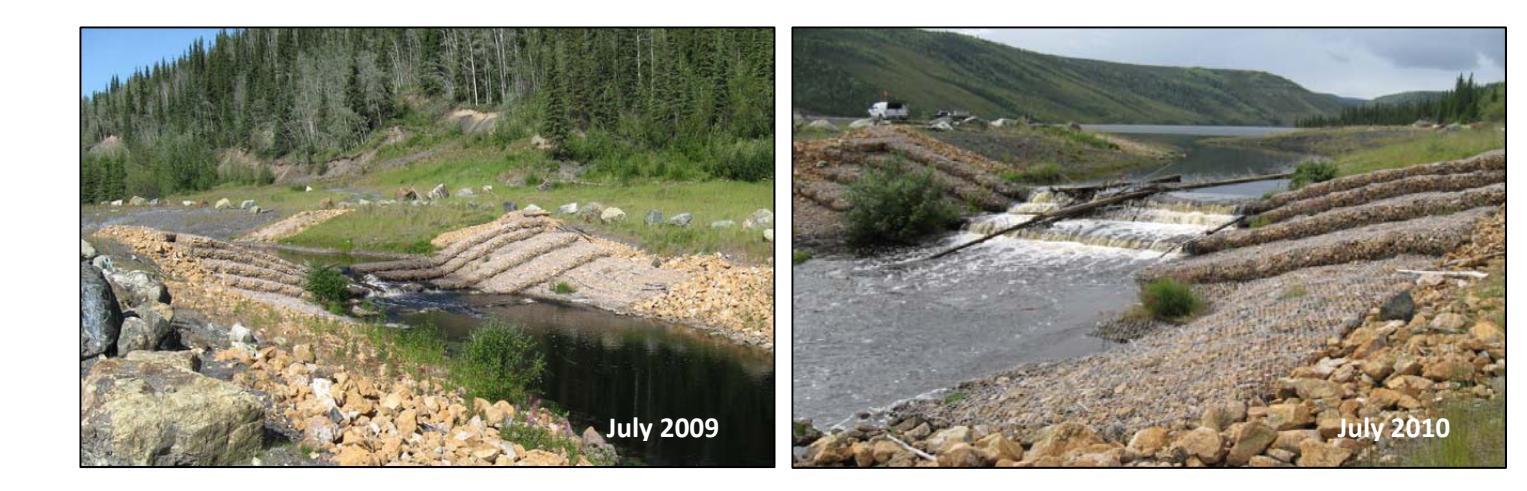
Figure 24 DS #1 in 2009 and 2010 view U/S

Drop Structure #1 consists of a drawdown weir with 4 tiers that provide a 1.5 m drop in channel grade and an end sill on the bottom tier. An upstream view of the structure in 2009 and 2010 is illustrated on Figure 24. Cross-channel view of the structure from 2007 and from 2009 and 2010 are shown on Figures 25 and 25a, respectively. The

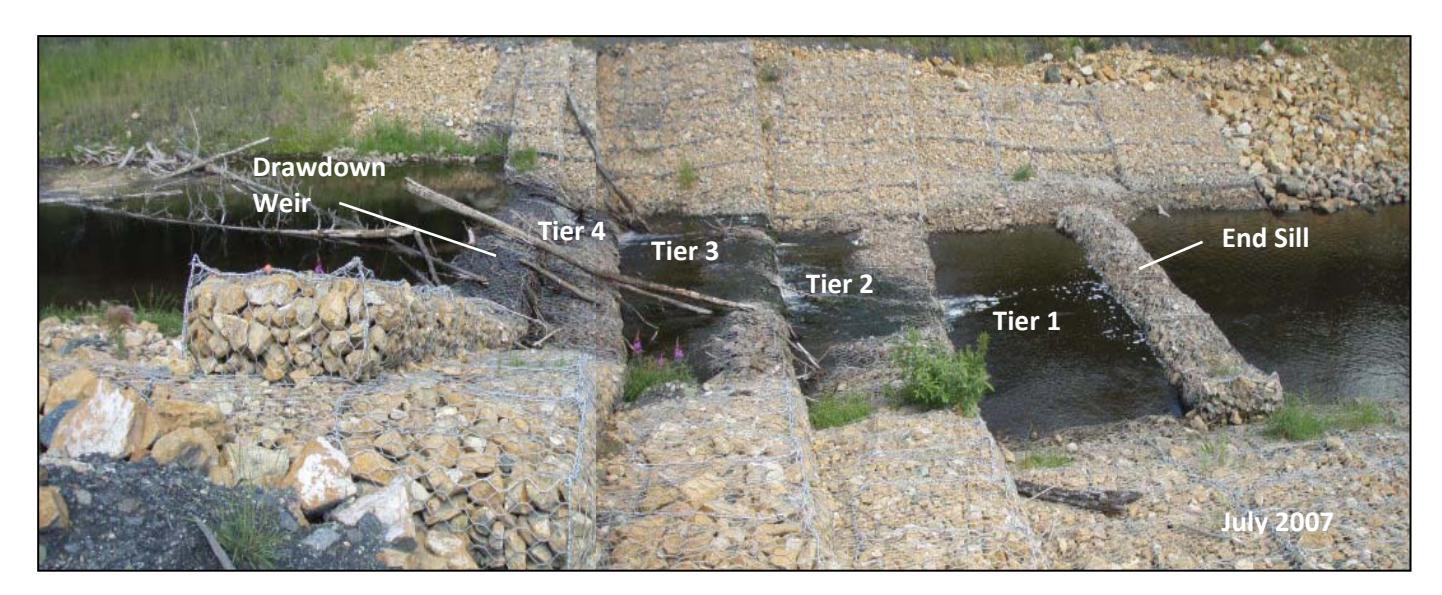
Figure 25 DS #1 in 2007, view Cross-channel to North

damage observed in 2009 included the drawdown weir leaning downstream, loss of gabion fill from several of the baskets in the end sill and Tiers 2, 3 and 4 (Figure 25a) and deformation of the end sill. The 0.5m wide opening in the drawdown weir was completed in 2007 to allow the elevation in Hudgeon Lake to drop during low flow periods and prior to freeze-up. This drop structure has undergone some settlement since construction in the fall of 2002.

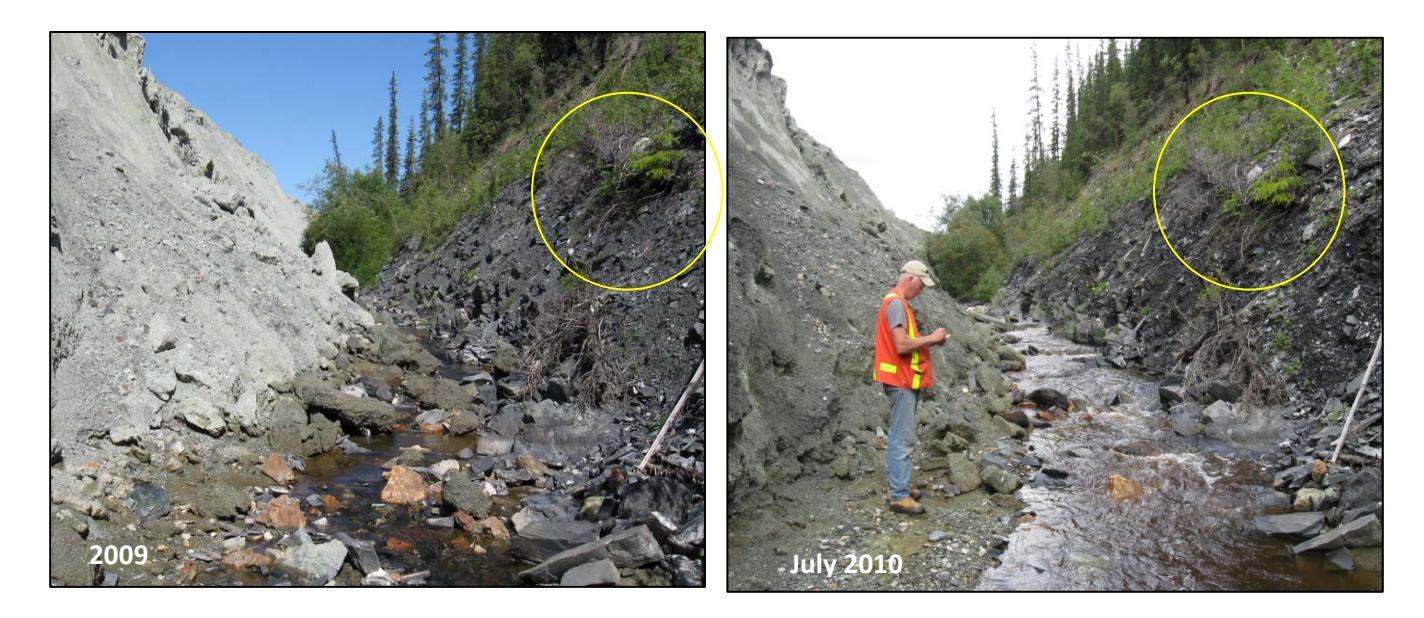
Figure 29 View U/S Along Wolverine Creek Across S Lobe at WP 337 in 2009 and 2010

The creek channel alignment across the tailings can be seen Drawing 1. A view of the creek channel near the down stream limit of the South Lobe (i.e. WP 337) is shown on Figure 29. It does not appear that there has been any significant change in the channel bottom or valley slope side of the channel. Not unexpectedly, there are noticeable differences in the tailings side of the channel due to the on-going sloughing and erosion of the over steepened tailings. At the upstream end of the channel across the South Lobe (WP 338), Figure 30 illustrates that there have been no significant changes in the creek channel at this location since 2009. The leading edge of the tailings lobe which forms the RHS of the channel consists of freshly exposed tailings with numerous slumps confirming that there is ongoing erosion of the tailings and deposition of this material downstream.

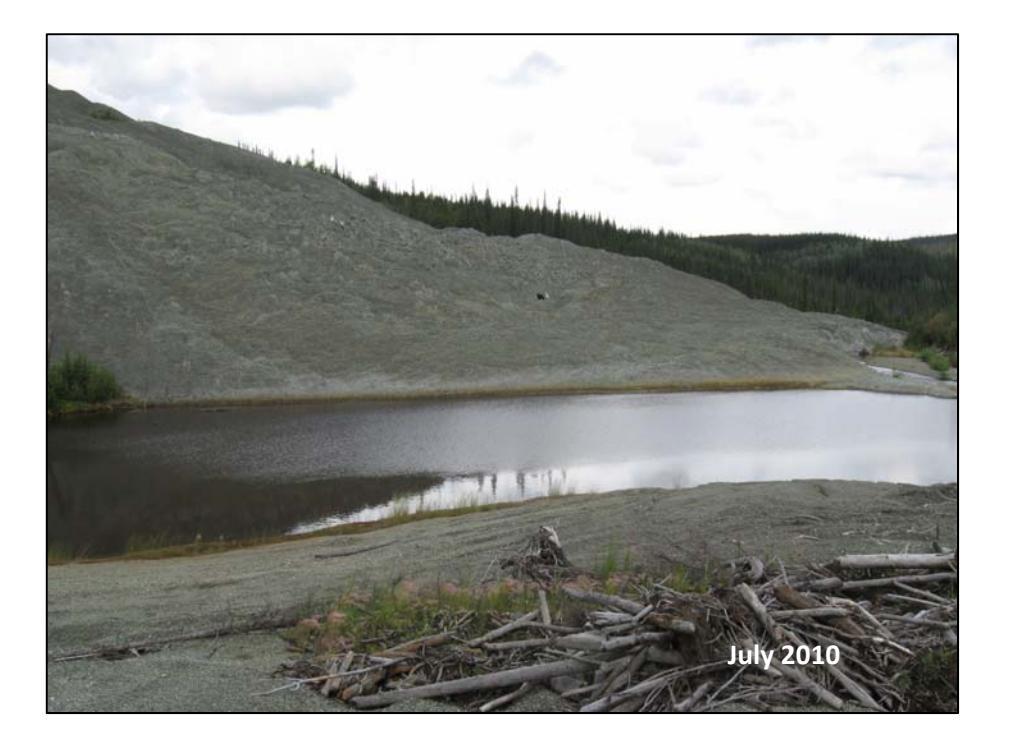
Figure 31 View of North Lobe, Lower Slope Area and creek channel, view north from South Lobe in 2010

Figure 31 illustrates the general location of the channel across the North Lobe as viewed from the South Lobe. The leading edge of this tailings lobe forms the RHS of the channel and consists of freshly exposed tailings with numerous slumps confirming that there is ongoing erosion of the tailings and deposition of this material downstream.

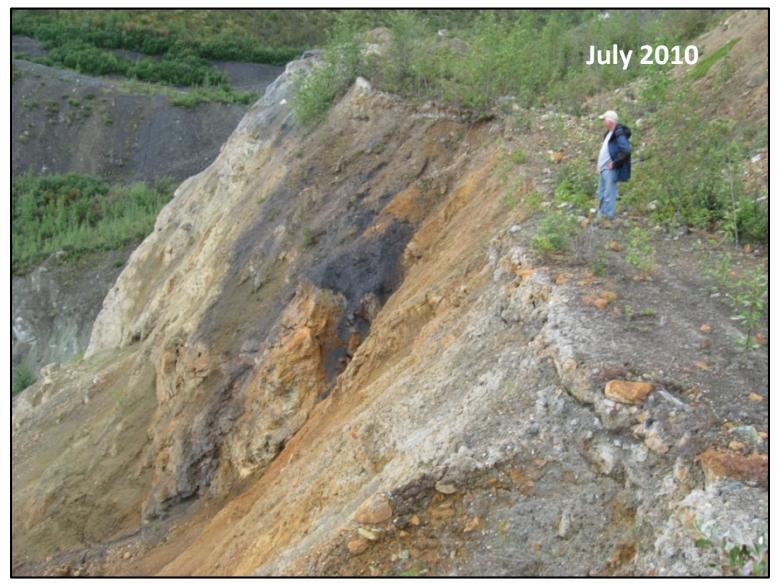
Figure 39 View of Creek Pit from WP 90 in July 2010, view South East

Figure 38, taken from WP 89, illustrates the general condition of this open pit in 2010. Note the level of water in the pond and the flow from the Porcupine Waste Rock Dump, which is located directly upstream of the pit. Some sloughing of the west wall of the Creek Pit was observed in 2010 as shown on Figure 39 taken from Waypoint 90. Photos should be taken from this Waypoint in future inspections.
