**INDIAN AND NORTHERN AFFAIRS CANADA
ABANDONED CLINTON CREEK
ASBESTOS MINE
*CONDITION ASSESSMENT REPORT***

APRIL, 2000

PREPARED BY
UMA ENGINEERING LTD.
ENGINEERS AND PLANNERS
1479 BUFFALO PLACE
WINNIPEG, MANITOBA
R3T 1L7

**Reference: Abandoned Clinton Creek Asbestos Mine
Condition Assessment Report**

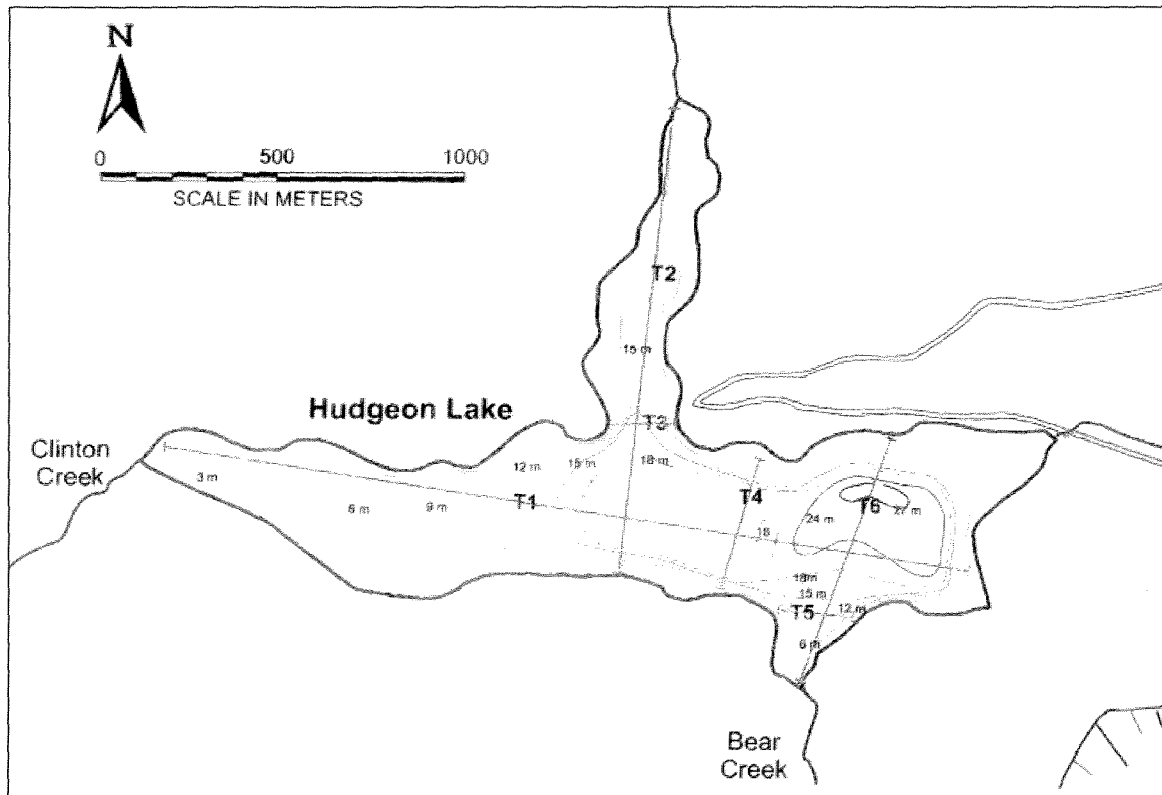
Figure 3-1
Bathymetry of Hudgeon Lake (Royal Roads University, 1998)

The deepest point of the lake (approximately 27 metres) occurs at the east end near the confluence of Bear Creek. The surface area and volume of Hudgeon Lake are estimated to be approximately 115 ha and 12 million cubic metres respectively. The results of a bathymetric survey carried out by Royal Roads University are summarized in Figure 3-1.

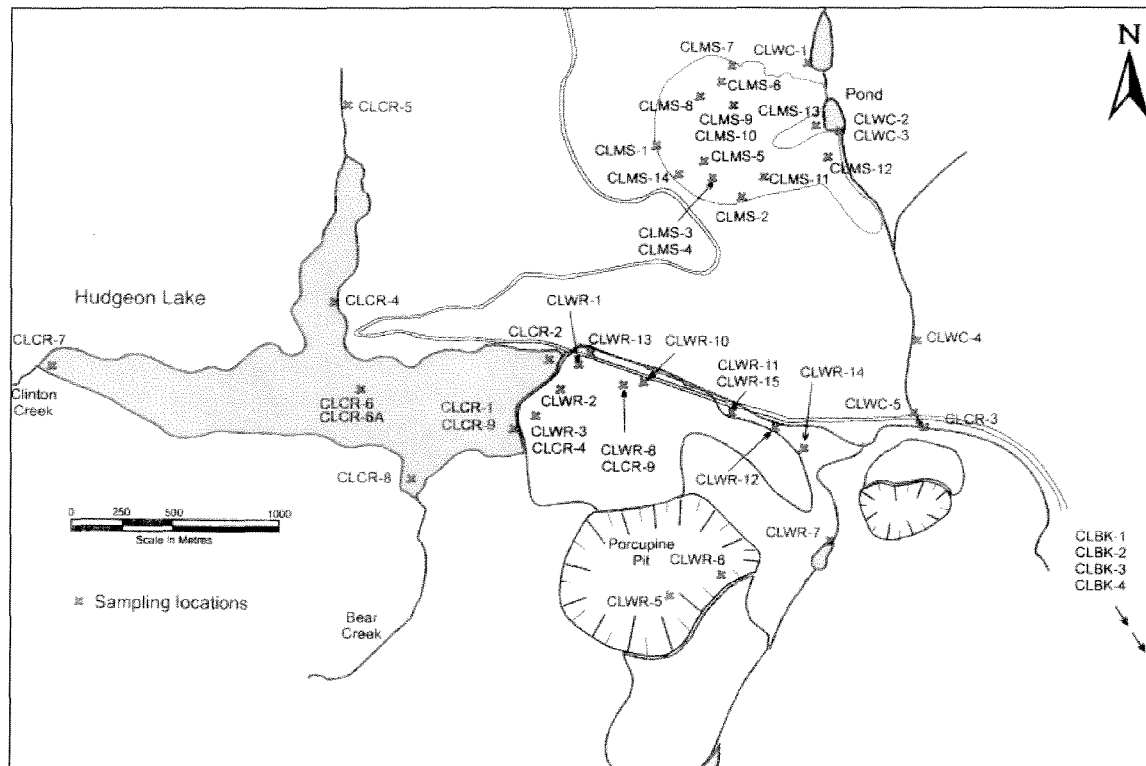
A total of 32 soil samples were collected from the site for Royal Roads University's geochemical assessment of the waste rock and tailings materials. In addition, 27 water and 23 sediment samples were taken from Hudgeon Lake and Wolverine Creek, Forty Mile River and three reference locations. Sampling locations are shown in Figure 4-1 and laboratory analyses of select soil and water samples is provided as Appendix B.

Geochemical Sample Location (Royal Roads University, 1998)
