INDIAN AND NORTHERN AFFAIRS CANADA

ABANDONED CLINTON CREEK ASBESTOS MINE ENVIRONMENTAL LIABILITY REPORT

**Prepared by
UMA Engineering Ltd.
1479 Buffalo Place
Winnipeg, Manitoba, R3T 1L7**

June 2003

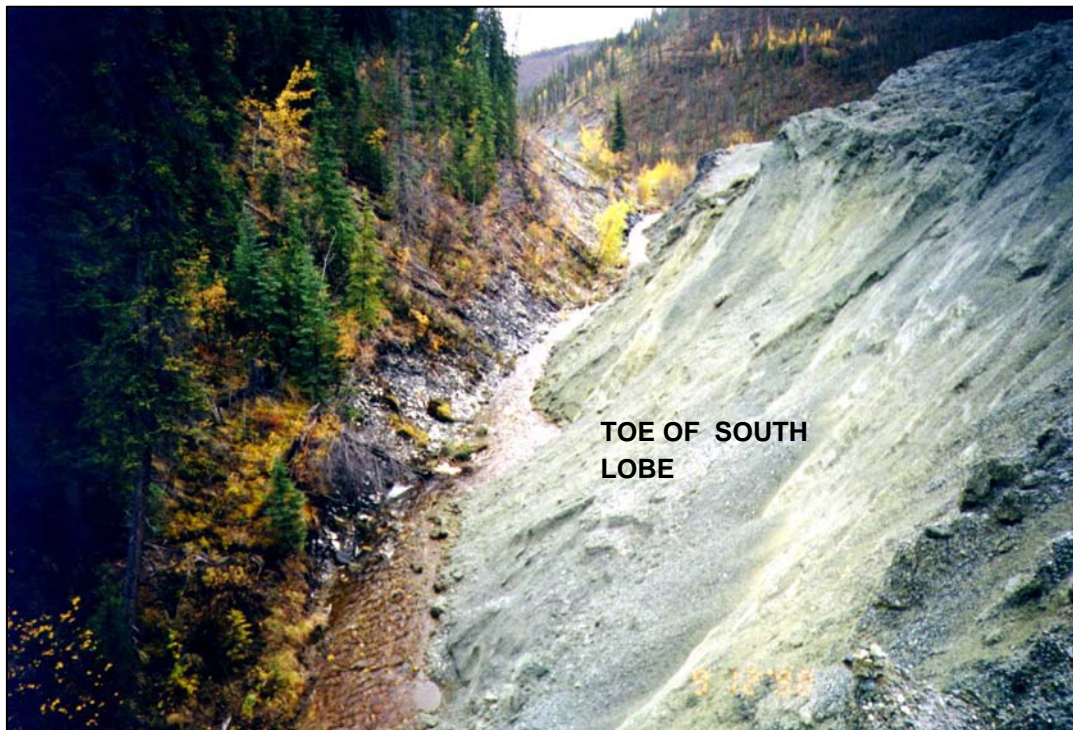
A plan view of the existing tailings piles and Wolverine Creek profile are shown on Drawing 09. Representative creek channel cross-sections are illustrated on Drawing 10. As a result of the channel blockages, the alignment and elevation of Wolverine Creek is now about 25m further to the east and about 13m higher than it was naturally. This new alignment has resulted in erosion of the east valley slope and the tailings that form the west bank of the creek (Figure 4-3).

Figure 4-3) Erosion at Toe of South Lobe, View Downstream (1998)

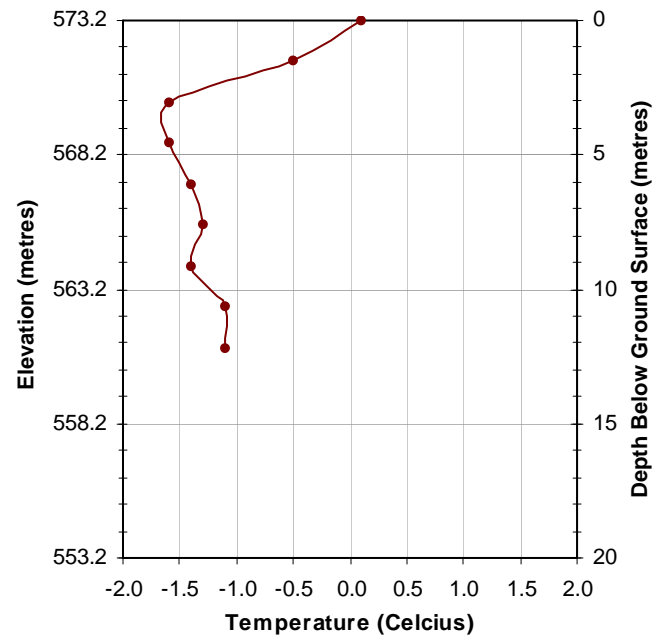
Figure 4-4) Temperature Profile for T6

Thermistor string T6 is located about 60m northwest of the tailings pile. The monitoring results on Figure 4-4 indicate that the overburden soils are frozen to depths of at least 12m. The relatively warm temperatures below ground surface indicate that the active layer could extend to 1.5m in this area although additional monitoring would have been necessary to measure the active layer thickness. In general, the ground temperatures decrease with depth to about -1.6 degrees C at 3m below ground surface and then increase slightly to about -1.3 degrees C below the 3m depth. This data supports the observation that permafrost exists in the area of the mine site.

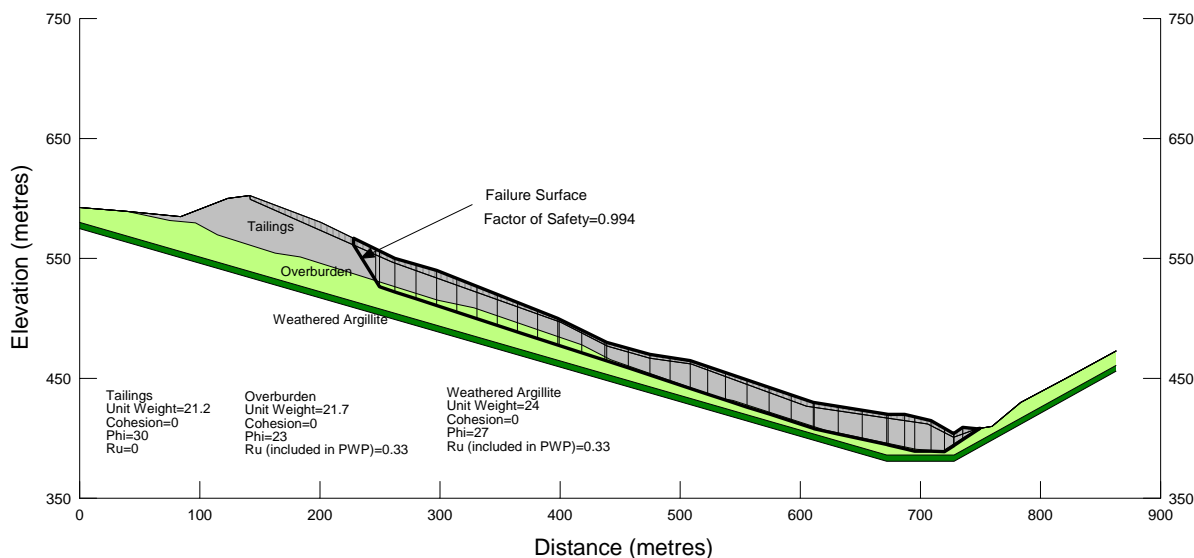
Figure 4-9) South Lobe – Existing Geometry

The movement trends presented in Table 4-1 for the monitoring points located on the upper slope indicate that relatively little movement of the tailings behind the main head scarps is occurring. Hence, it was assumed that the failure surfaces do not extend any farther back into the tailings than the obvious head scarps that have developed. The existing failure surface was assumed to be approximately parallel with the original ground surface and within a weak layer at a shallow depth in the foundation soil. Residual friction angles of shearing resistance were used for the tailings, overburden and weathered argillite, based on the direct shearing results (Section 4.4). The piezometric level within the overburden and weathered argillite bedrock was modeled using the pore water coefficient R_u , which is the ratio of pore water pressure to overburden pressure. A 3m deep, water filled tension crack located on the surface of the tailings was assumed in the model. Sensitivity analyses were subsequently carried out to determine the R_u value necessary to provide a factor of safety of 1.0. The resulting R_u values for the north and south lobes are 0.22 and 0.33, respectively. The resulting failure surface geometry and associated modeling parameters for the north and south lobes are shown in Figures 4-8 and 4-9, respectively.

The analysis indicates that a combination of residual shear strengths and high pore-water pressures in the overburden material are required to achieve a FS of unity. This observation provides further evidence that unique geological conditions, in particular a shallow weak layer within the overburden, are responsible for continued movement of the tailings pile. Almost certainly, disturbance of the thermal regime, in particular thawing of the permafrost resulting from the placement of tailings over the valley slope has been a contributing factor. Although detailed knowledge of the changes to the thermal regime that occurred during and following active placement of tailings is not known, it is possible that the thermal regime has still not reached a state of equilibrium.
