ABANDONED CLINTON CREEK ASBESTOS MINE

RISK ASSESSMENT REPORT

UMA Engineering Ltd. Engineers and Planners

APRIL, 2000

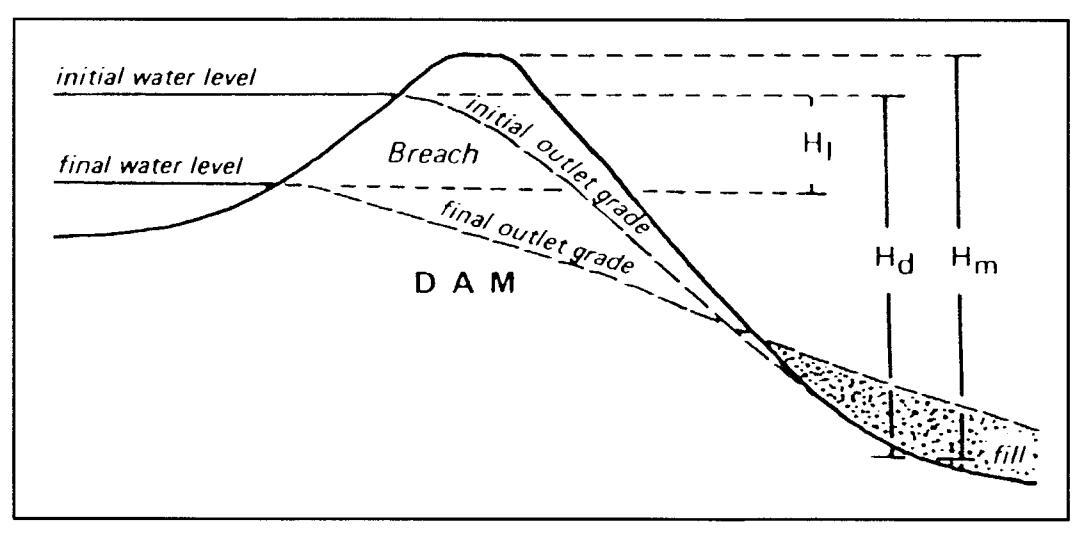
Figure 7-3 Dam Geometry Before and After Breach (Blown, 1985)

Floodwave modeling (FLDWAV) assumes the breach geometry has a trapezoidal cross-section that reaches a final size over a finite time interval. The final breach bottom width, breach side slope and breach bottom elevation are user-specified parameters that are dependent on the dam material. Earthen dams do not tend to completely fail nor do they fail instantaneously. Fully formed breaches tend to have an average breach width (*b*) in the range of $0.5h \le b \le 8h$, where *h* is the height of the dam. The breach widths are therefore usually much less than the total length of the dam crest. The time of failure of an earthen dam may be in the range of a few minutes to usually less than half an hour. In FLDWAV, this is the duration from the time between the first breaching of the upstream dam face until the breach is fully formed. For over-topped dams, the breaching of the upstream dam face occurs after the downstream face of the dam (Figure 7-3).

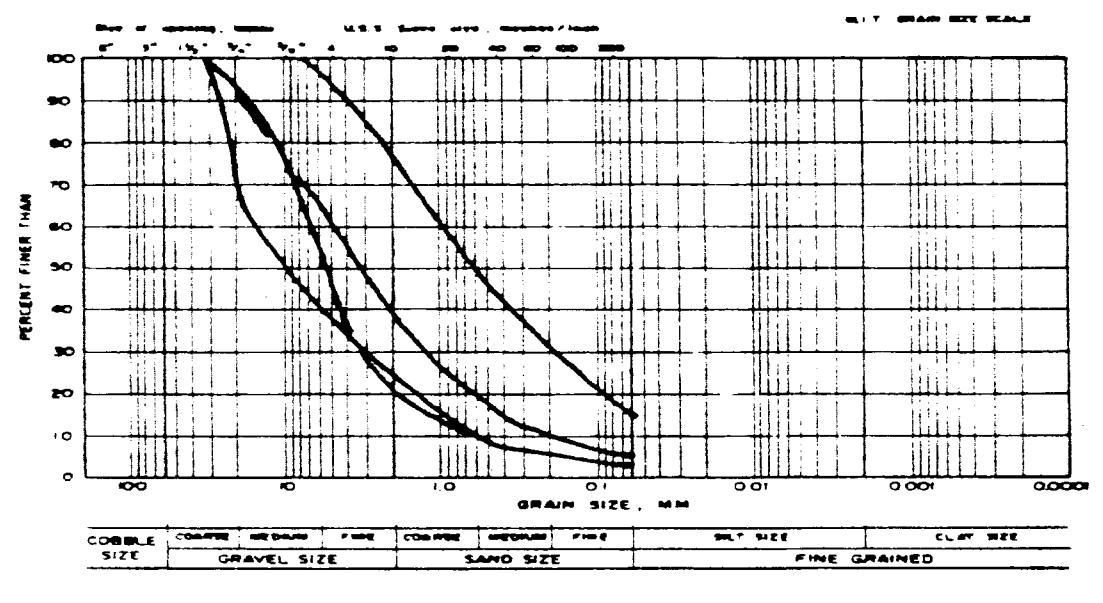
Figure 7-3 Waste Rock Gradations

The waste rock dump consists of stripped overburden material (likely colluvial soils) and argillite waste rock consisting of sand, gravel and cobble sizes containing occasional boulder size material (Figure 7-3). Given the sequence of open pit development, it is likely that the excavated overburden material is buried deep beneath the waste rock, likely some distance back from (south of) the existing creek channel. The dump material is believed to overlie ice rich alluvial material in the bottom of the original valley (Golder, 1978). Durable boulder size material from the waste rock has accumulated over time along the bottom of the Clinton Creek channel, providing resistance to erosion under normal flow conditions. Boulders from the remnants of the rock weir and channel repairs just downstream of the Hudgeon Lake outlet also help armour the creek channel at this location. Bedrock on the north flank of the downstream portion of the stream also offers resistance to erosion although over the long term, significant incising through the bedrock is evident, in particular through the weathered surface. The freshly exposed waste rock material comprising the south creek bank within the waste dump is considered to be highly susceptible to erosion, even under normal flow conditions.

The impact from waste rock erosion and sediment outwash into the downstream channel is most significant immediately downstream of the toe of the waste rock dump. From Figure 7-3, D_{50} for this material can be taken to be approximately 5 mm placing it within the size range of fine gravel. The D_{100} is shown to be less than 35 mm but the material visible in Photo 14-11A tends to indicate that the largest material size is significantly larger. The critical flow velocities for these sizes of material are approximately 0.6 and 2 m/s during laminar flow conditions. During turbulent flow conditions, such as along Clinton Creek, the direct force of the water will move these materials. Movement of boulder size material is possible under turbulent flow from micro-erosion, which undermines the stability of the boulders causing them to tumble in the direction of the flow.

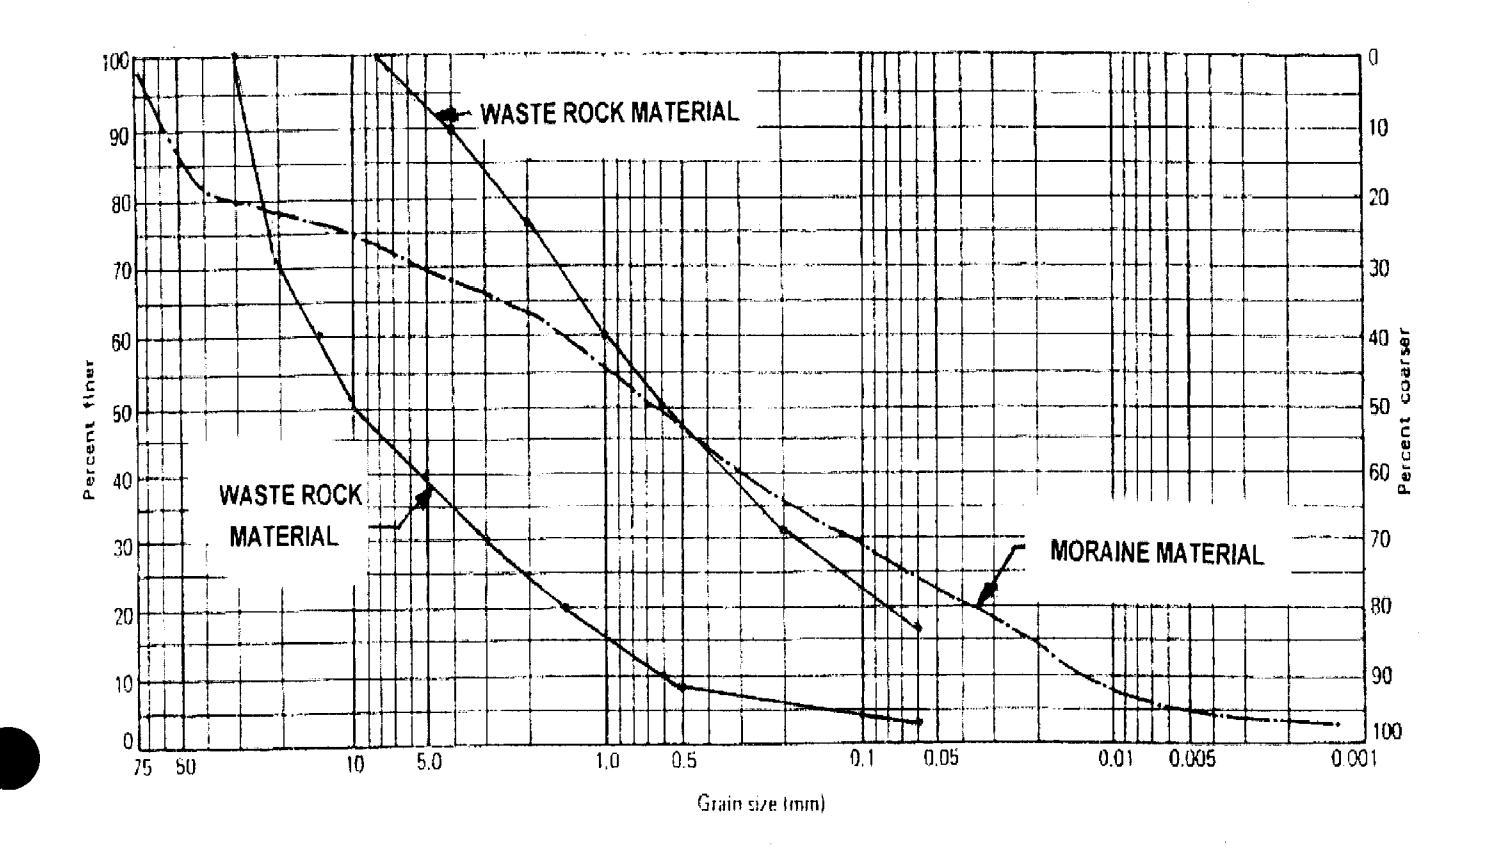
Figure 7-6 Waste Rock and Moraine Gradation Curves

Observed breach failures of natural moraine dammed lakes in British Columbia offer a reasonable indication of potential breach scenarios at the Clinton Creek waste rock dump (Evans, 1986). Similarities between the Nostetuko Lake moraine dam and the Clinton Creek dam (Blown and Church, 1985) were previously reported by Stepanek and McAlpine in 1992, in particular the width of the dams (Figure 7-5). Material properties of the waste rock and moraine are also somewhat similar; both consist of bouldery non plastic sand and gravel size particles. Gradations of the two materials are compared in Figure 7-6. Both materials are relatively stable against internal erosion but would experience rapid surface erosion due to lack of plasticity (cohesion).

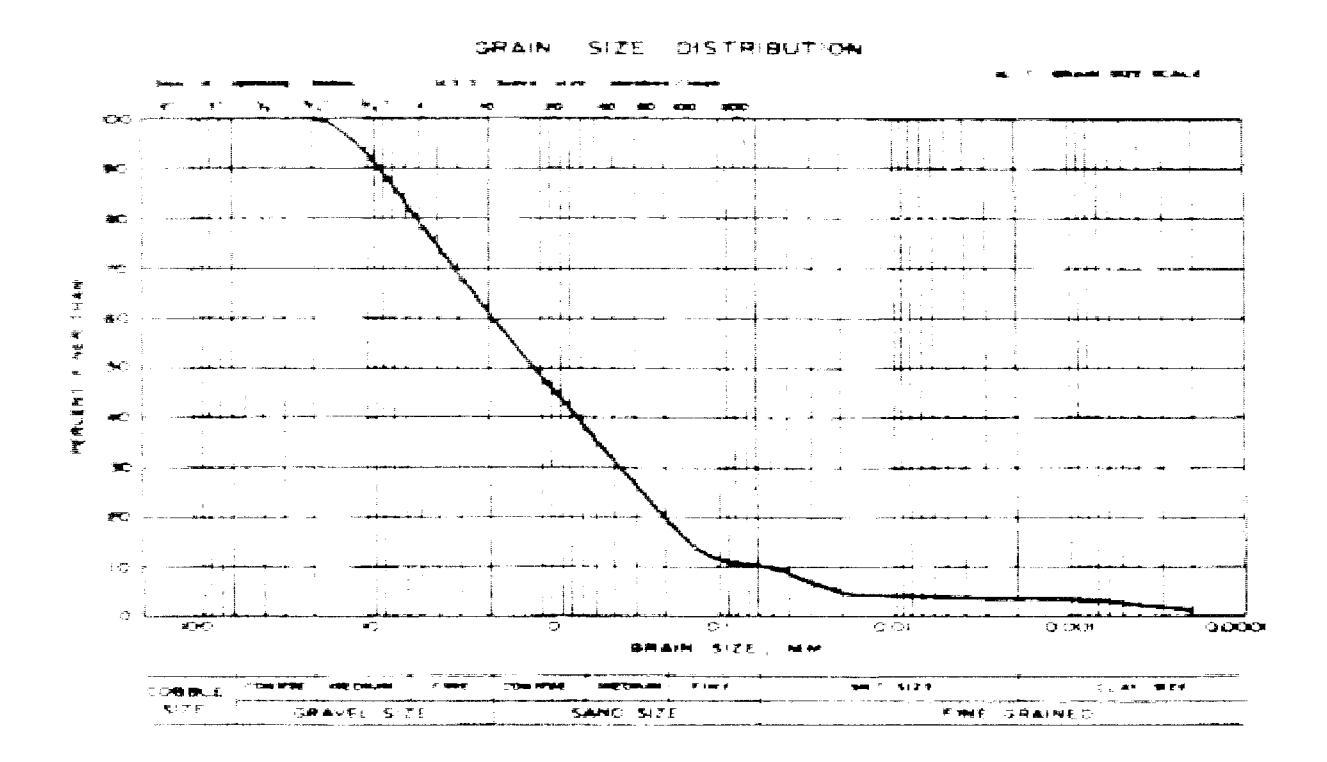
Figure 7-7 Mill Tailings Gradation

Asbestos tailings from the mill were deposited over the west slope of the Wolverine Creek valley with a stacker conveyor. The original valley slopes at about 17 degrees, dropping in elevation approximately 200 m. The natural soil profile consists of an organic layer overlying silty sandy gravel (colluvial) and weathered argillite bedrock (Golder, 1978). The Colluvium layer taper from15m near the top of the valley to almost absent at the bottom of the valley. The mill tailings generally consist of well graded crushed serpentine rock with some asbestos fibre not removed during milling (Figure 7-7).

From Figure 7-7, it can be see that the mill tailings have a D_{50} of 1 mm and a D_{100} of 20 mm. The D_{50} material has a very low resistance to flowing water with critical flow velocities of approximately 0.3 m/s while the D_{100} material has a critical flow velocity of approximately 1.8 m/s. Based on this

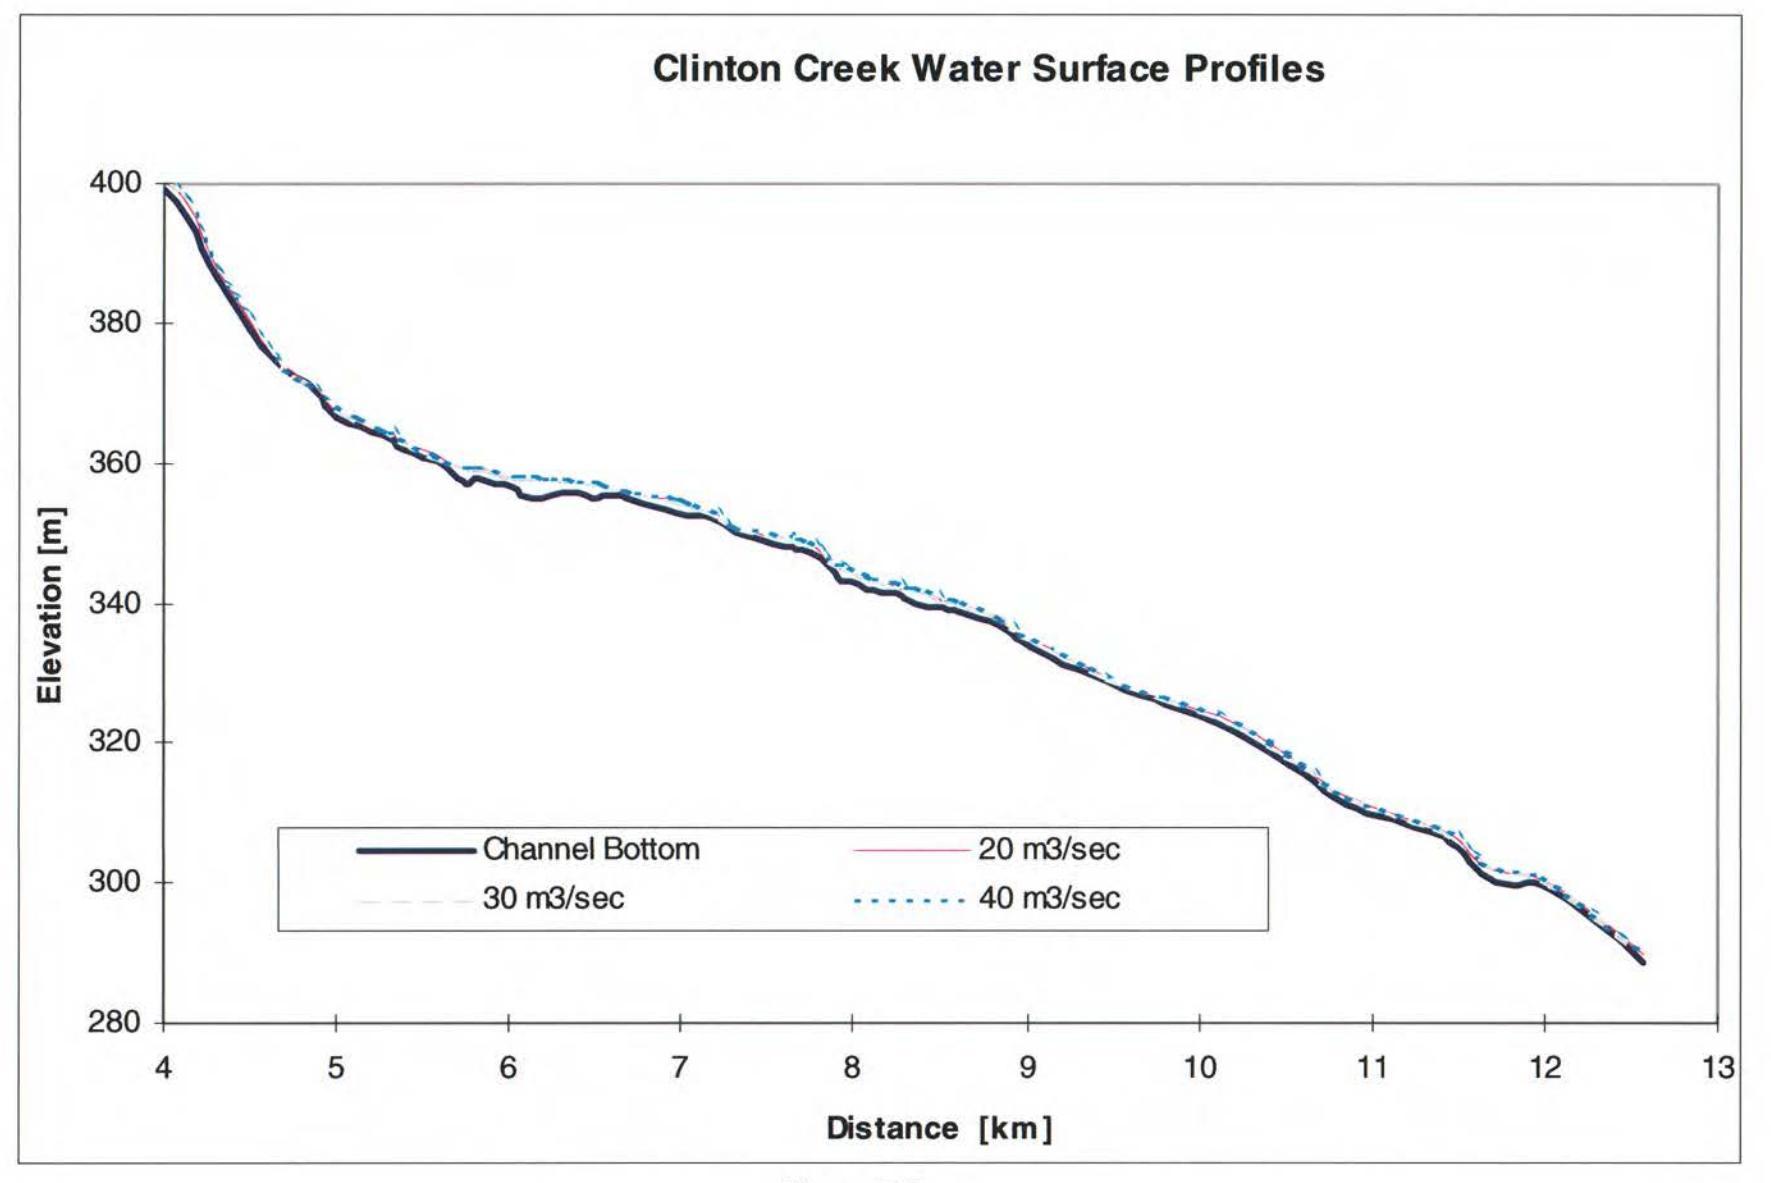
Figure 7-9 Computed Steady-State Clinton Creek Water Surface Profiles

The HEC-2 modelling confirmed that Clinton Creek does behave very much like a mountainous stream. The flow expands and contracts and the slope changes between steep and flat over short distances causing the flow to pass through critical depth at numerous locations. The computed water surface profiles for 20, 30 and 40 m³/s are shown in Figure 7-9. As seen in Figure 7-9, there is very little difference in water surface profiles within this range of flows. Numerous transition sections where the creek flow passes through critical flow are also evident. From the HEC-2 analyses it was concluded that:

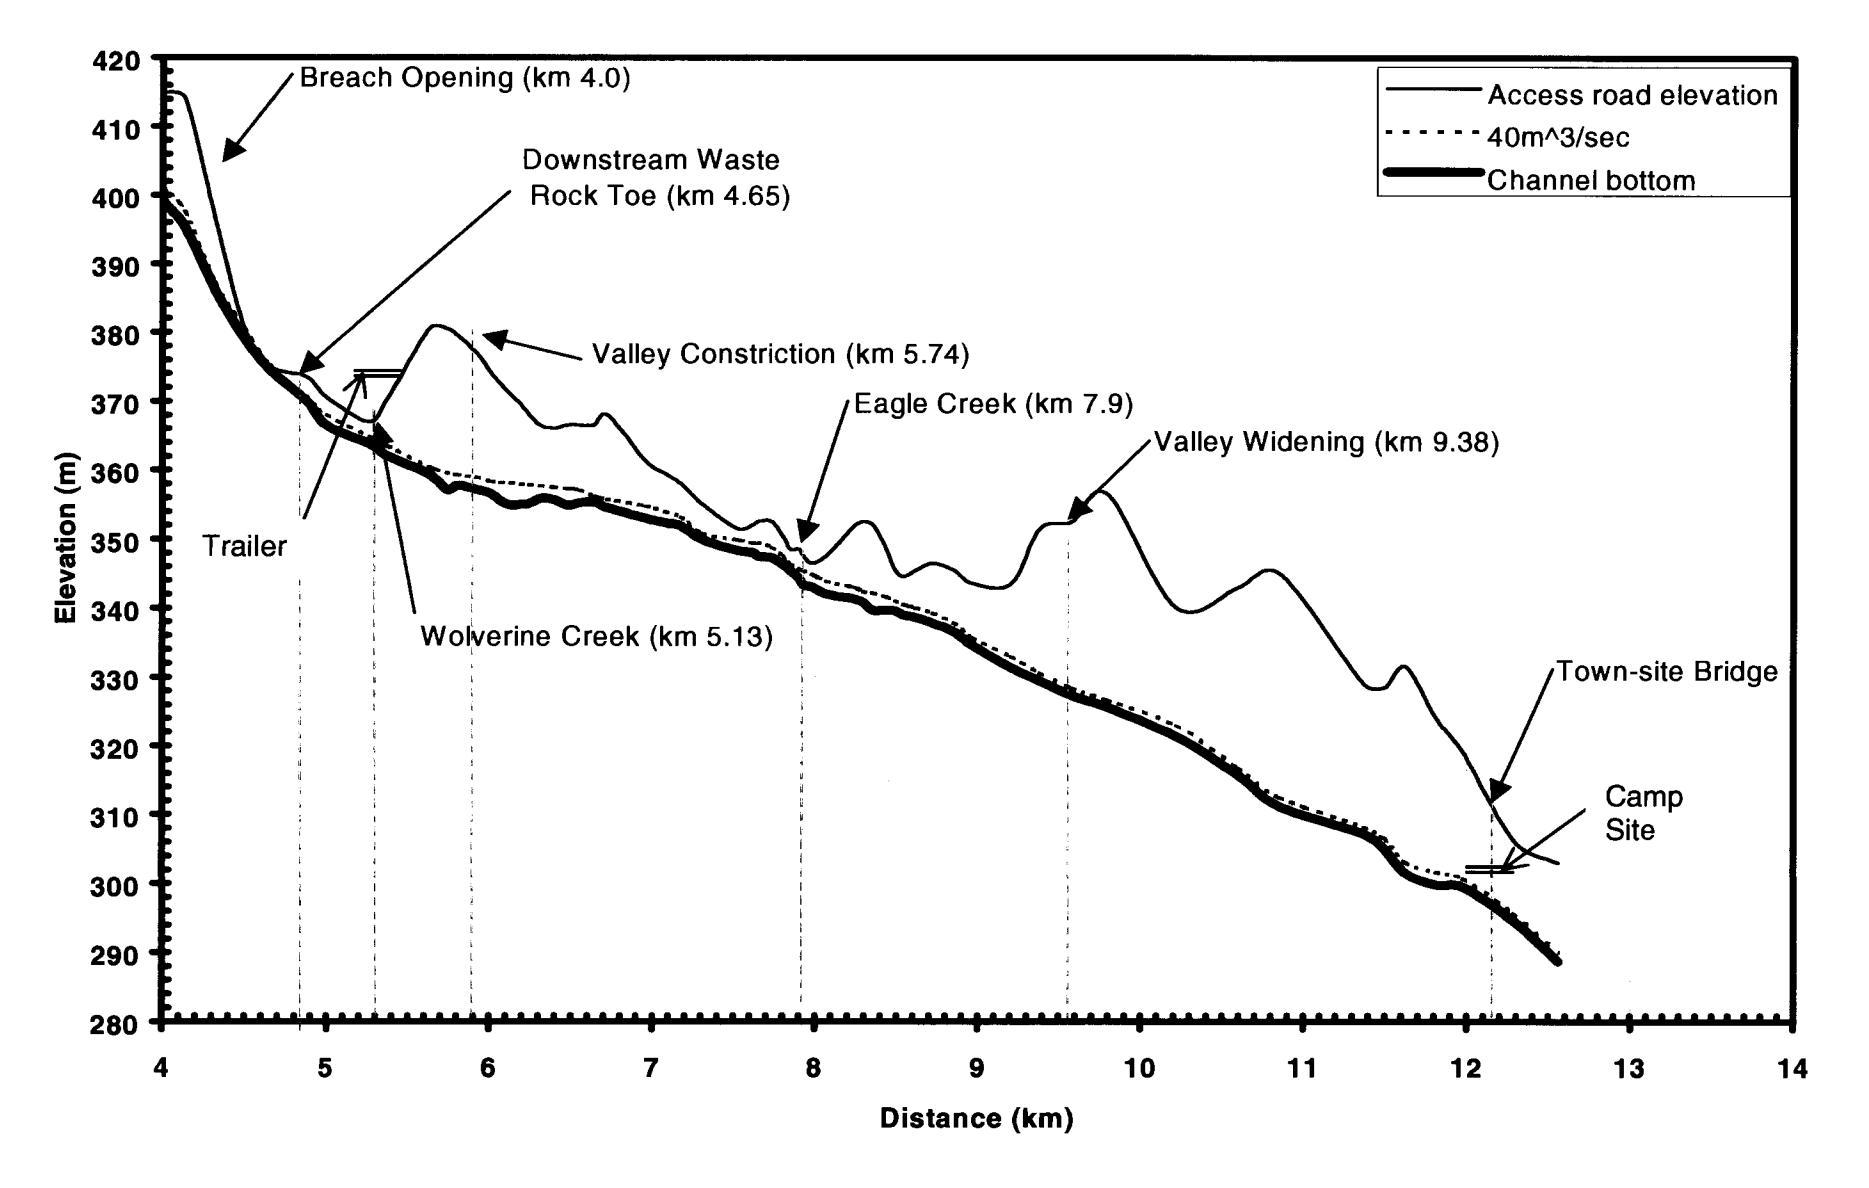
Figure 8-1 Creek, Water Surface and Road Profiles

The level of risk downstream of the mine site has been categorised as high, medium or low based on the severity of flooding within each zone. The transition between the high and medium hazard zones is based on the relative elevation of the water surface profile in the creek and the road through the narrow stretch of the Clinton Creek valley. In this regard, the most vulnerable location for human occupancy would be within the creek channel itself or along the road at an elevation lower than the predicted flood peak. To determine the vulnerability along the road under a worst case scenario, its centreline has been plotted against the creek channel and water surface profiles for a base flow of 40 m3/s, a flow exceeding the maximum flood discharge (Figure 8-1). The most
