As-Built Construction Report Fresh Water Supply Dam, Faro Mine

Project Reference Number:
SRK 1CD003.22

February 2004

**AS-BUILT CONSTRUCTION REPORT
FRESH WATER SUPPLY DAM BREACH, FARO MINE**

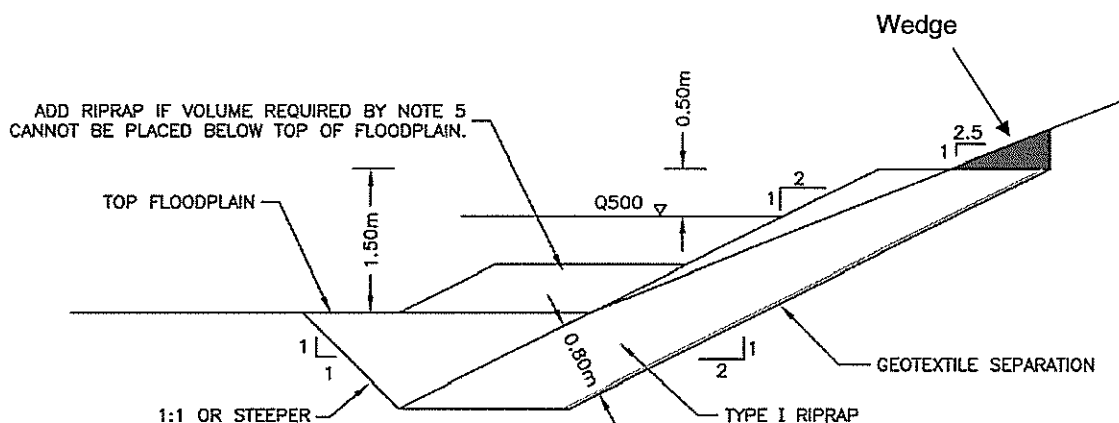
1. The "wedge" shall be backfilled using rip rap.
2. The downstream length of the erosion protection on the edge of the floodplain will be reduced. The length of the reduction will match, in volume terms, the amount of rip rap to be used to backfill the wedge.

The volume of rip rap placement is expected to remain the same, and the rip rap to be placed in the wedge will be measured and paid according to rip rap placement.

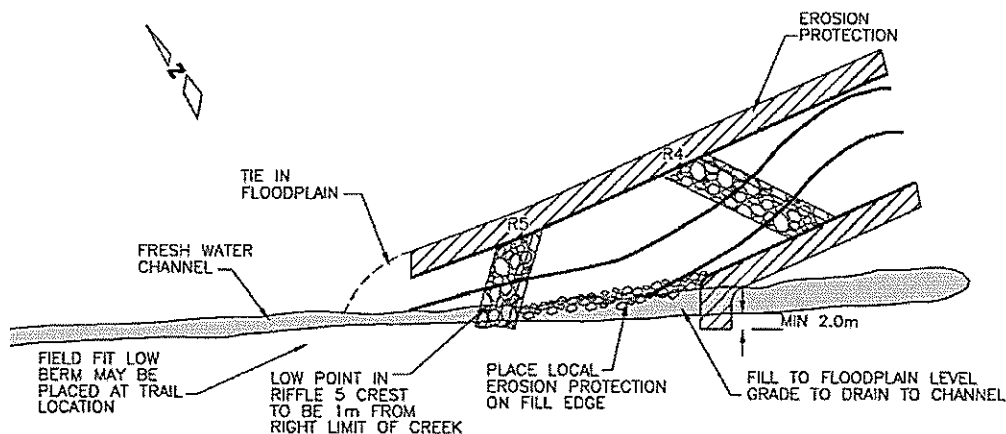
The following design change is required at the downstream section of the breach. The change essentially consists of tying in the breach channel alignment with the existing fresh water channel alignment. This will allow the use of the existing left bank of the fresh water channel as part of the breach channel. The sketch, below, provides a plan view of the required change. Further details are provided below:

1. Realign the channel as indicated in the sketch.
2. The position of the erosion protection on the left edge of channel shall be constructed in the location shown. This erosion protection will be subcut into the existing fresh water channel edge by 2 m.
3. Riffle 5 is to be modified as indicated, with the central portion of the riffle to be subcut into the existing bank by 2 m. The low point on the riffle crest shall be sloped as indicated, so that the low point is about 1 m from the right bank.
4. Rip rap is to be placed along the edge of the newly formed channel, adjacent to the fill within the fresh water channel.
5. A small berm is to be constructed on the left bank of the existing floodplain near the lower limit of the construction site.
