**To:** Distribution- - see below  
**From:** H. F. McAlpine  
**Date:** October 22 1999  
**Subject:** Dam Safety Assessment of the Mt. Nansen Tailings Dam

**BYG Tailings Dam, Mount Nansen, YT - Site Visit Report**

INDIAN AND NORTHERN AFFAIRS  
WATER RESOURCES DIVISION  
BYG Tailings Dam, Mount Nansen, YT - Site Visit Report

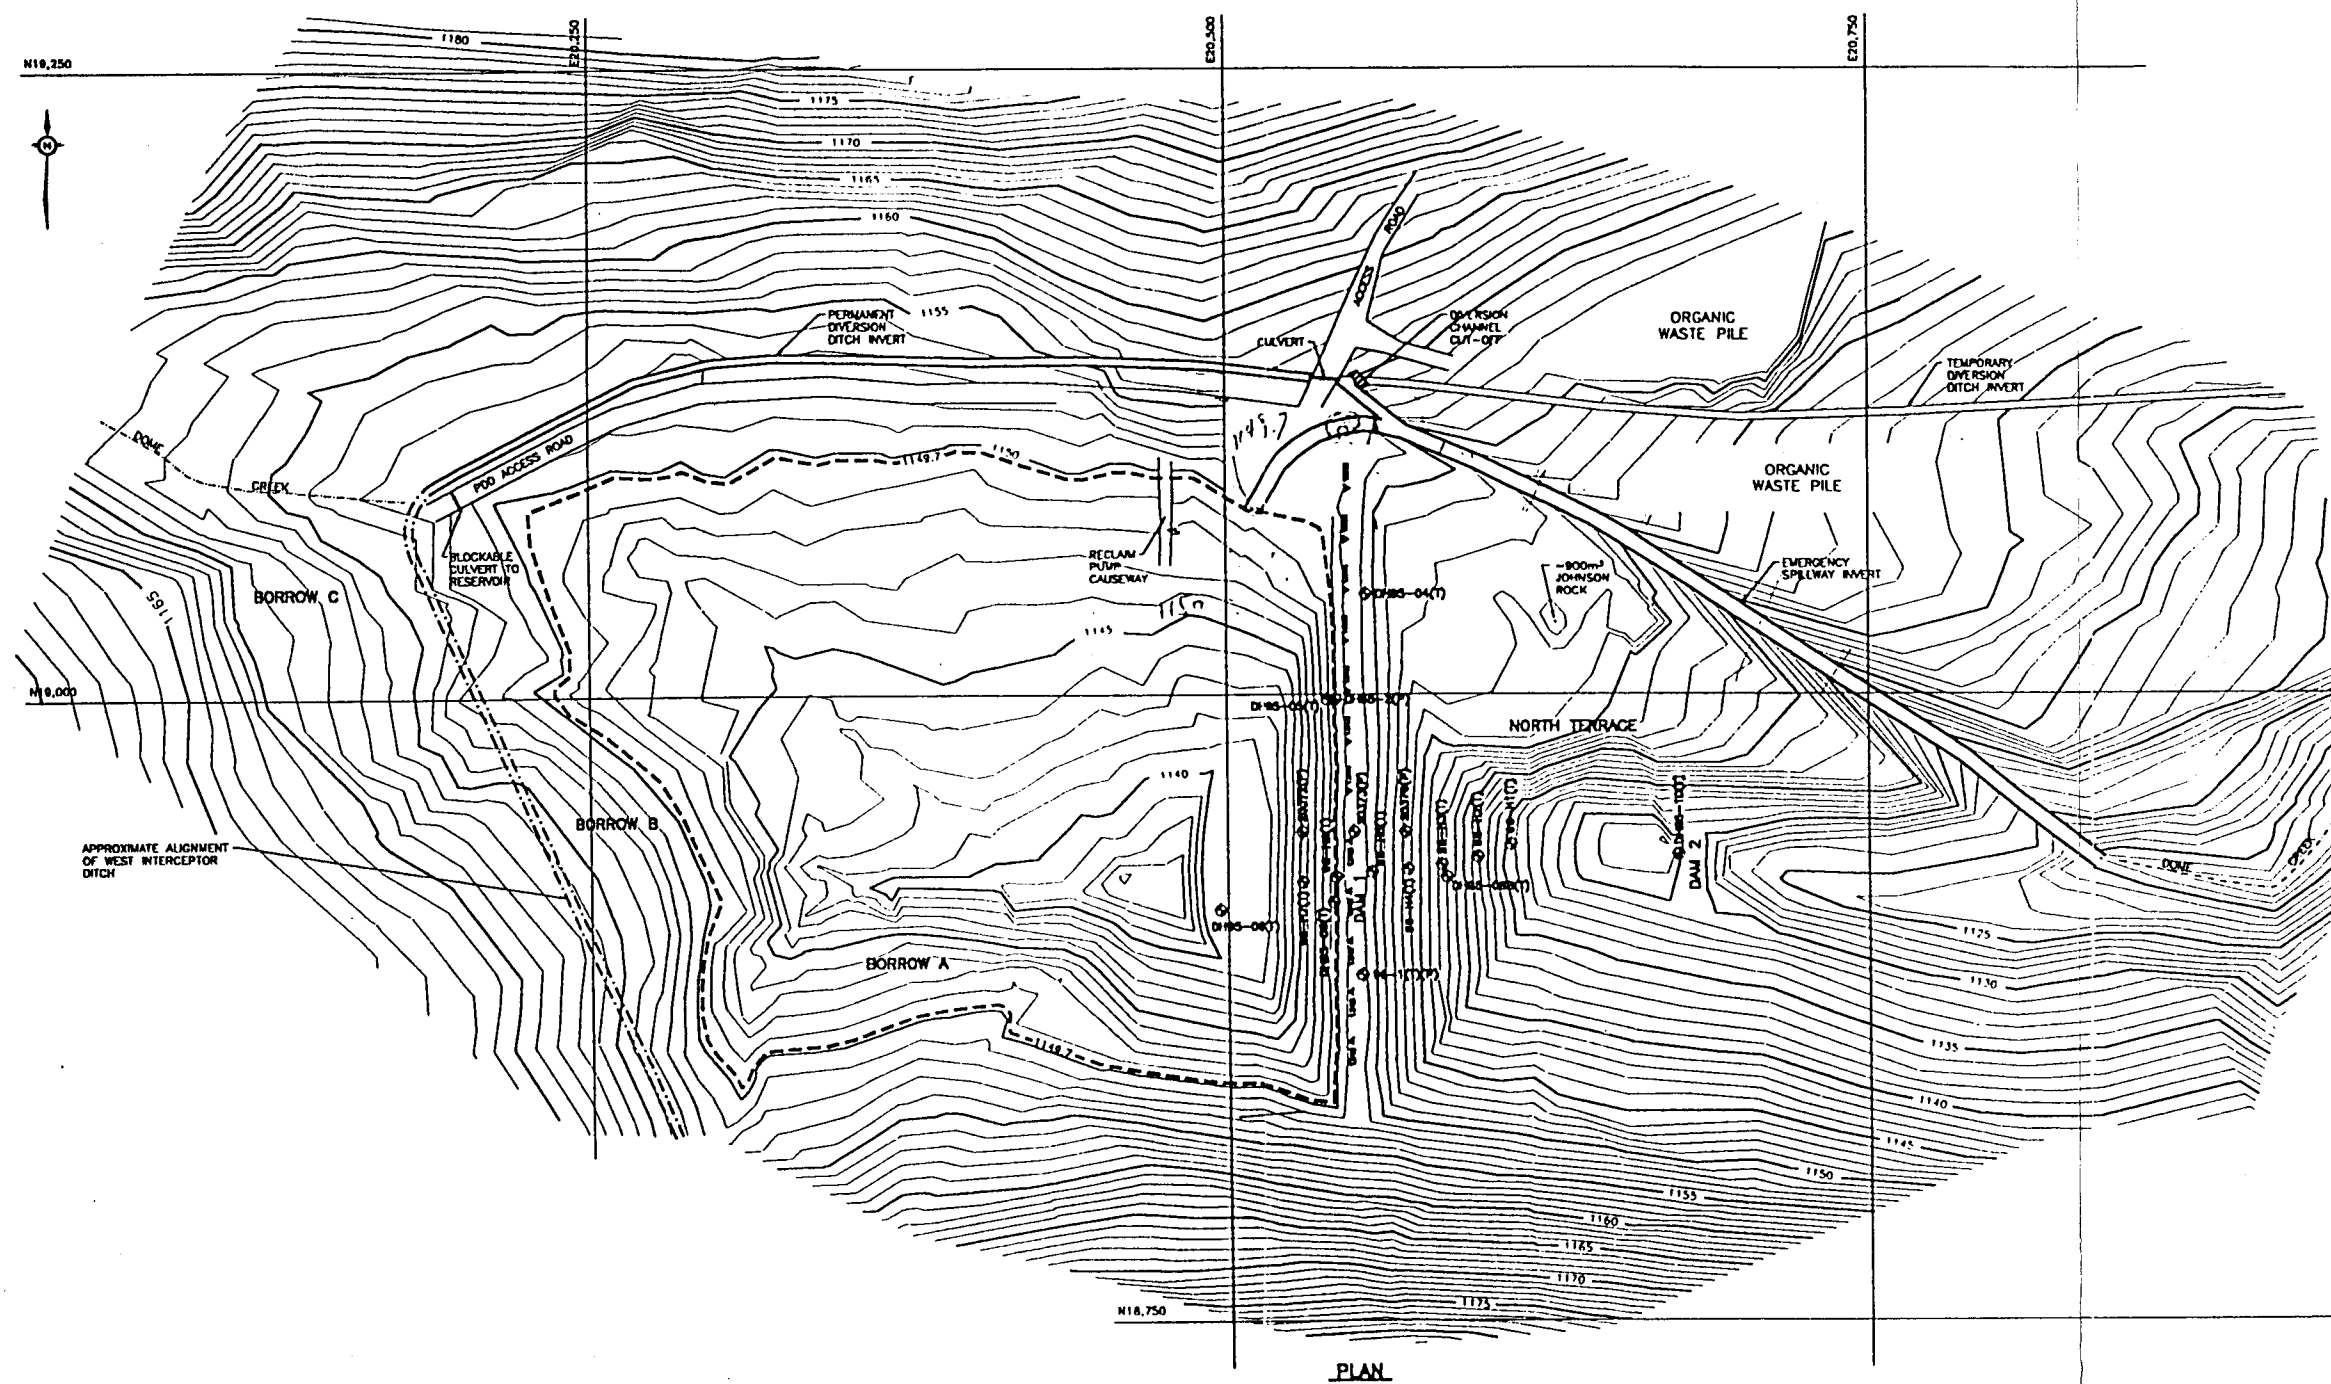
The purpose of this letter is to provide a general impression of the current condition of the BYG Tailings Impoundment (see Photo 1 and Figure 1 for site plan) as well as to identify some issues related to the safety and integrity of the dam that require immediate attention. On September 16, 1999 our Robert Lo visited the site together with yourself, Mr. Cord Hamilton of EBA and Mr. Milos Stepanek of Geo-engineering. This report is based mainly on our observations and discussions on site together with a preliminary review of some recent site monitoring data provided to us through EBA. The letter was prepared in consultation with Mr. Cord Hamilton of EBA. We will carry out a more thorough review as stipulated earlier, but this must not delay initiation of improvement measures given in this letter.
