**CLINTON CREEK**

**INDEPENDENT ENGINEER'S CHANNEL  
ASSESSMENT**

PROJECT NO.: 0533-019

DATE: October 31, 2016

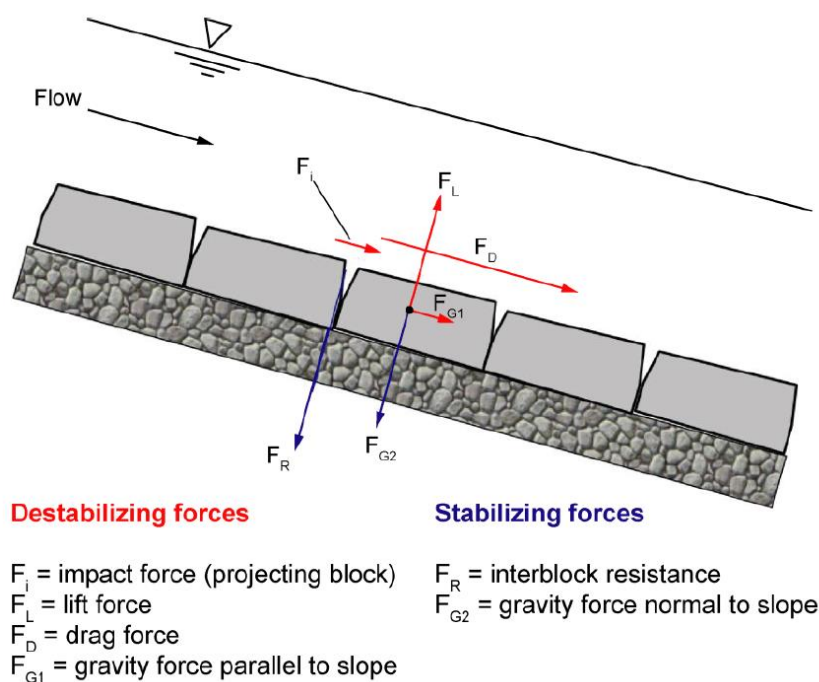
**Figure 2-3. Typical force-balance on a single unit in a typical cable-tied ACB mat (FEMA 2014).**

The blocks weigh down the subgrade and geotextile, and resist the hydraulic forces of the flowing water as shown in Figure 2-3. Blocks or mats of blocks that do not abut, have a lower inter-block resistance and therefore, a lower stabilizing force. A block that projects into the flow will receive a greater impact force and therefore, a larger destabilizing force. Therefore, the way in which blocks and mats are installed at a site can impact the long term stability of the structure. Complex flow hydraulics (i.e., not smooth, uniform flow) can introduce larger destabilizing forces at angles not parallel to the block surface.

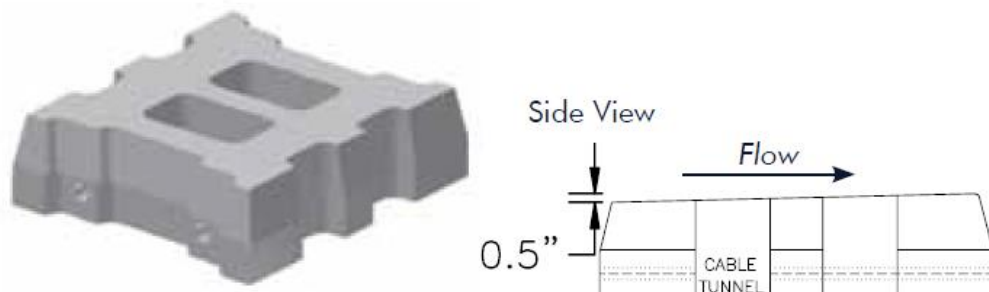
**Figure 4-5. Armorflex Tapered Series Block. (Contech 2012).**

The supplier stresses that the tapering of the blocks is important to the stability of the blocks in high velocity flows. For the benefit of block tapering to be realized, the blocks must be placed in the correct orientation to flow direction and on a perfectly smooth drain rock/subgrade layer so that the blocks align with a 0.5" (1.3 cm) offset, as shown in Figure 4-5.

This last statement is incorrect – as shown in Figure 4-5, the blocks are to be installed with the taper on the upstream side. A spot check of YG AAM construction monitoring photos show the marker lines on the downstream side. The supplier was contacted by BGC to confirm whether the
