## **KENO HILL SILVER DISTRICT**

## **CLOSURE ISSUES REPORT**

MARCH 2009

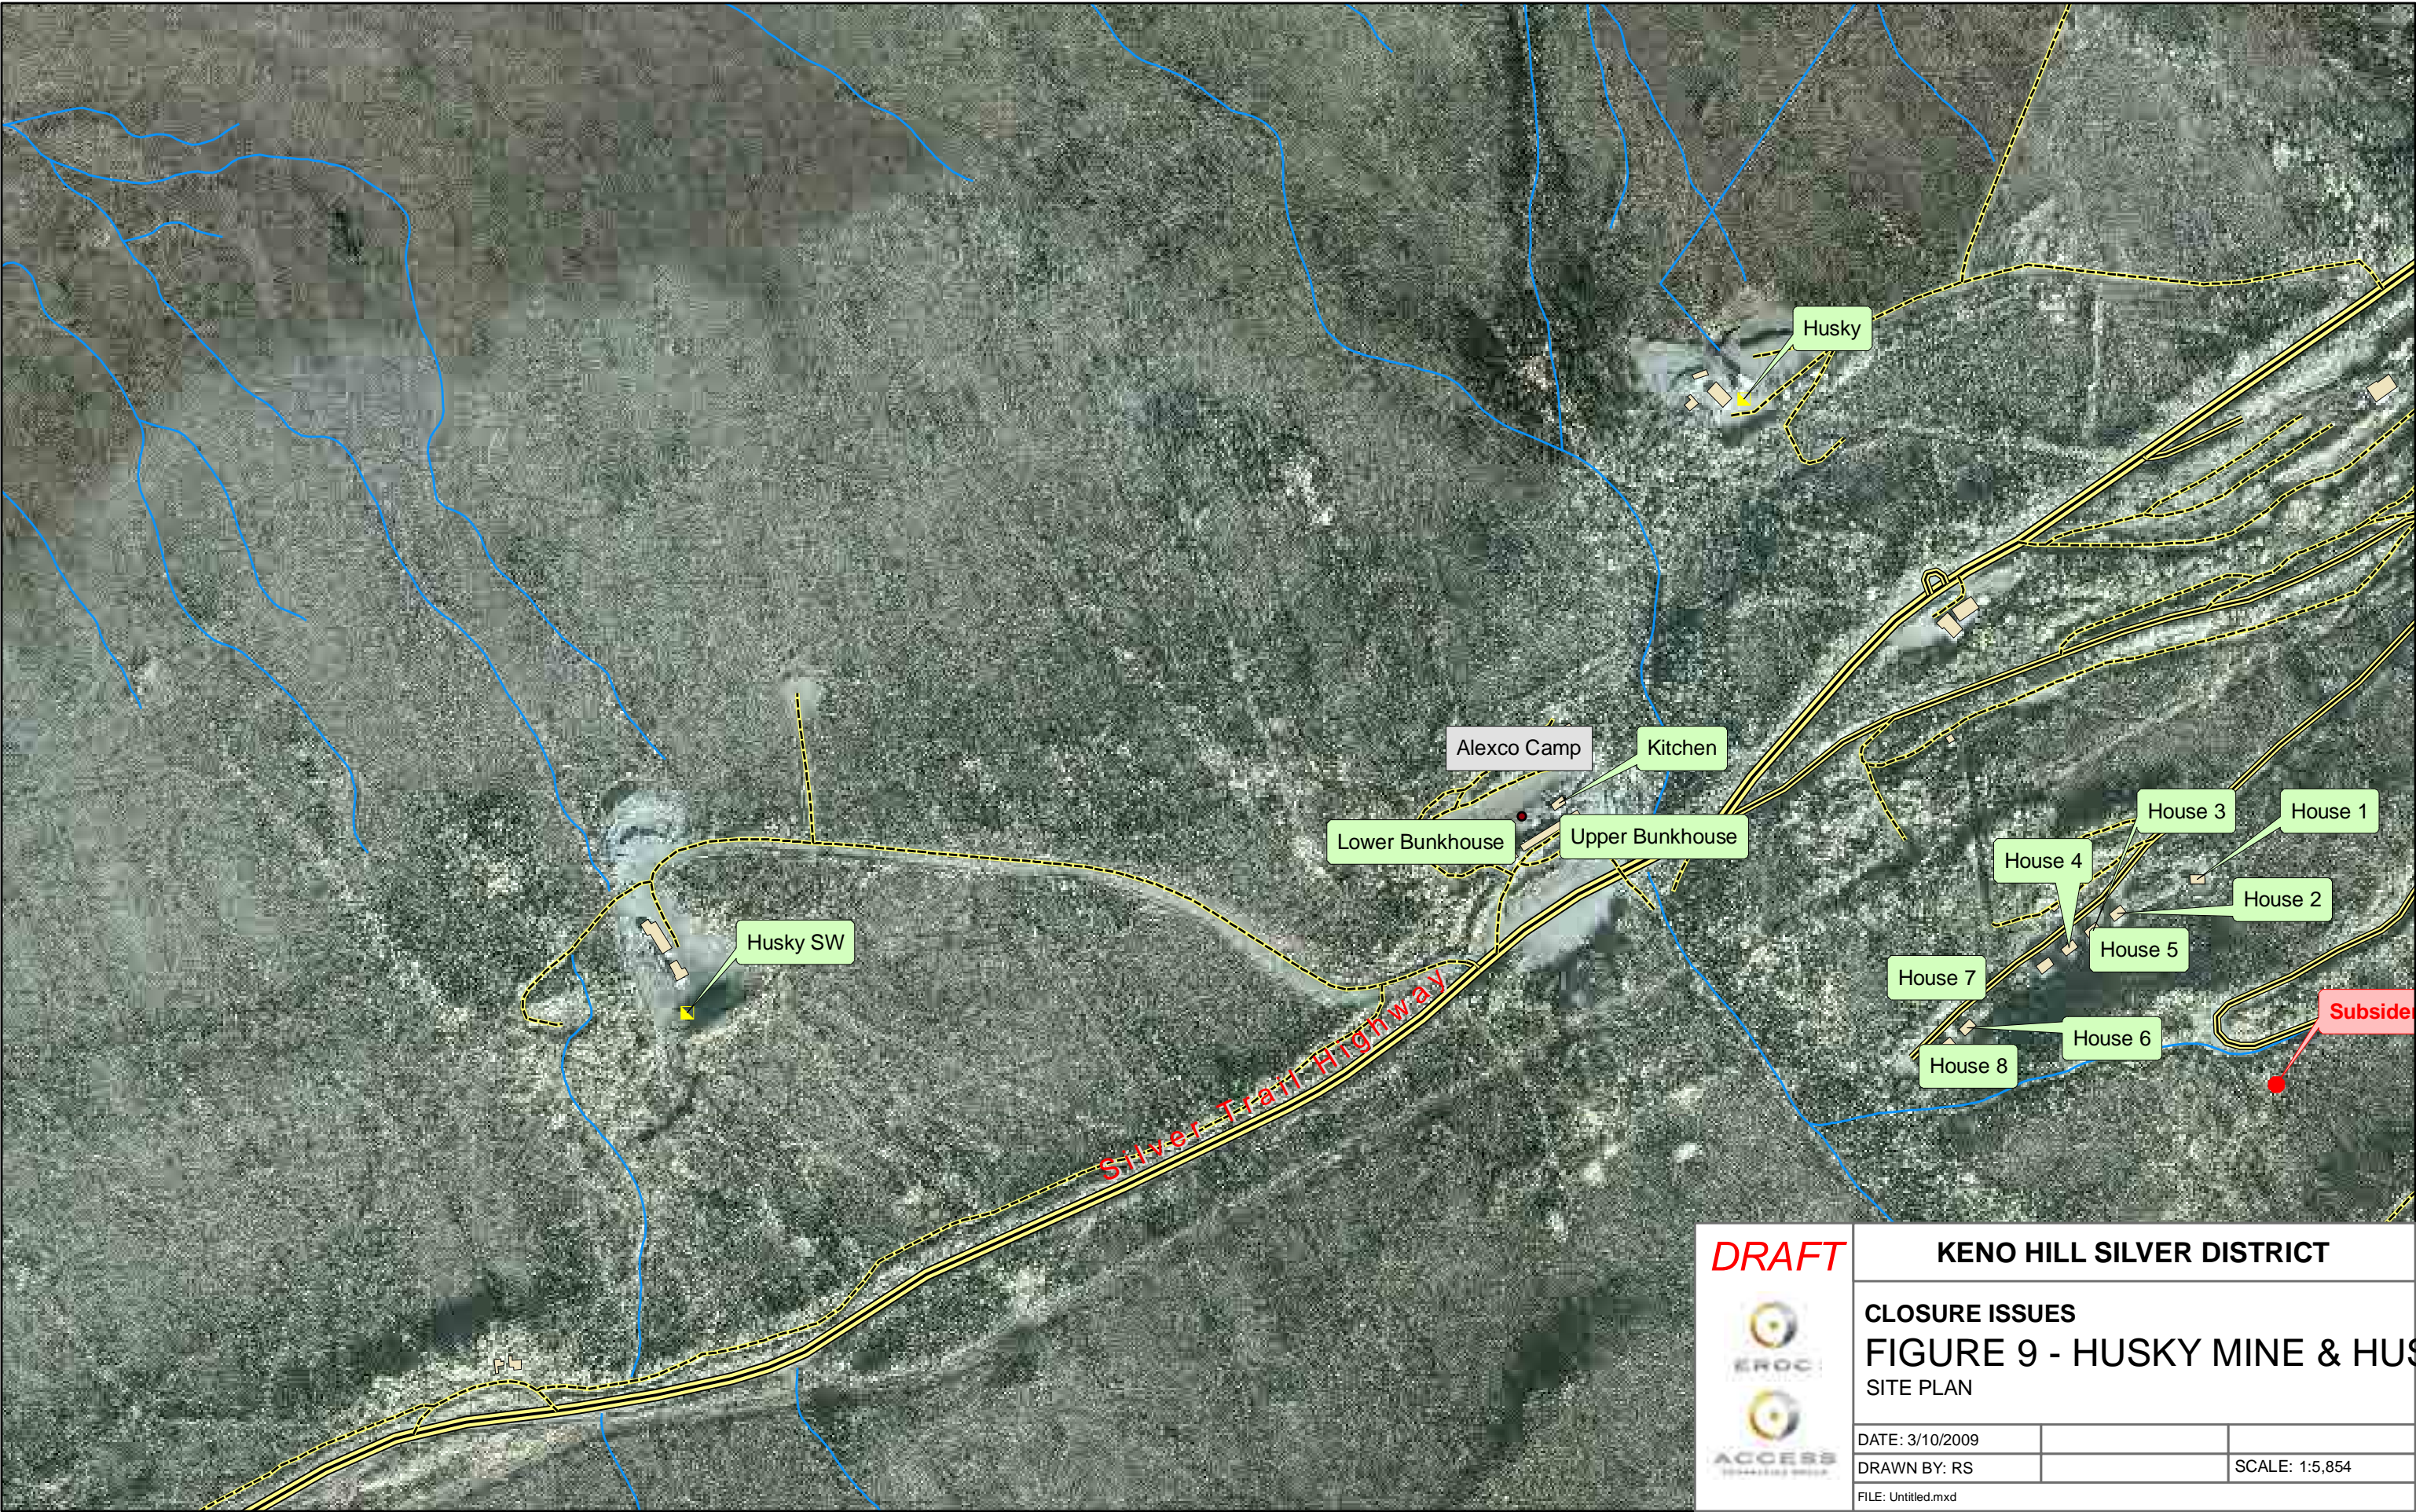
VANCOUVER		 		Husky SW Site #2		
Job No:	1CA009.000	Baseline Environmental Report, United Keno Hill Mines Property		Date:	Approved:	Figure:
Filename:	Site2_Husky+Husky_20070131.ppt			Jan. 2007		10

- #1 - waste dump has tension cracks up to 15 cm wide  
- in lowest bench, material contains rounded clasts (overburden?), but colour is greenish brown to greenish gray, with pale yellow to orange dark brown stains on clasts  
- Tension cracks (12 m back from crest) parallels dump crest (Photo 2.3), then curves to intersect dump crest at NE end  
- central part of zone of cracking has subsided by ~0.5 m  
- could be permafrost in dump foundation
- #2 actively failing till bank  
- seepage forms rivulets across entire face  
- slumped material is very soft, saturated; encroaching on headframe structure (Photo 2.1)  
- slope is ~2V:15H
- #3 Dozer trail with water seeping into it. Flow observed towards northwest, but flow diffuses into broad area of willows and grass
- #4 Flow visually estimated at 1 l/s  
-Orange staining and precipitation along flow path

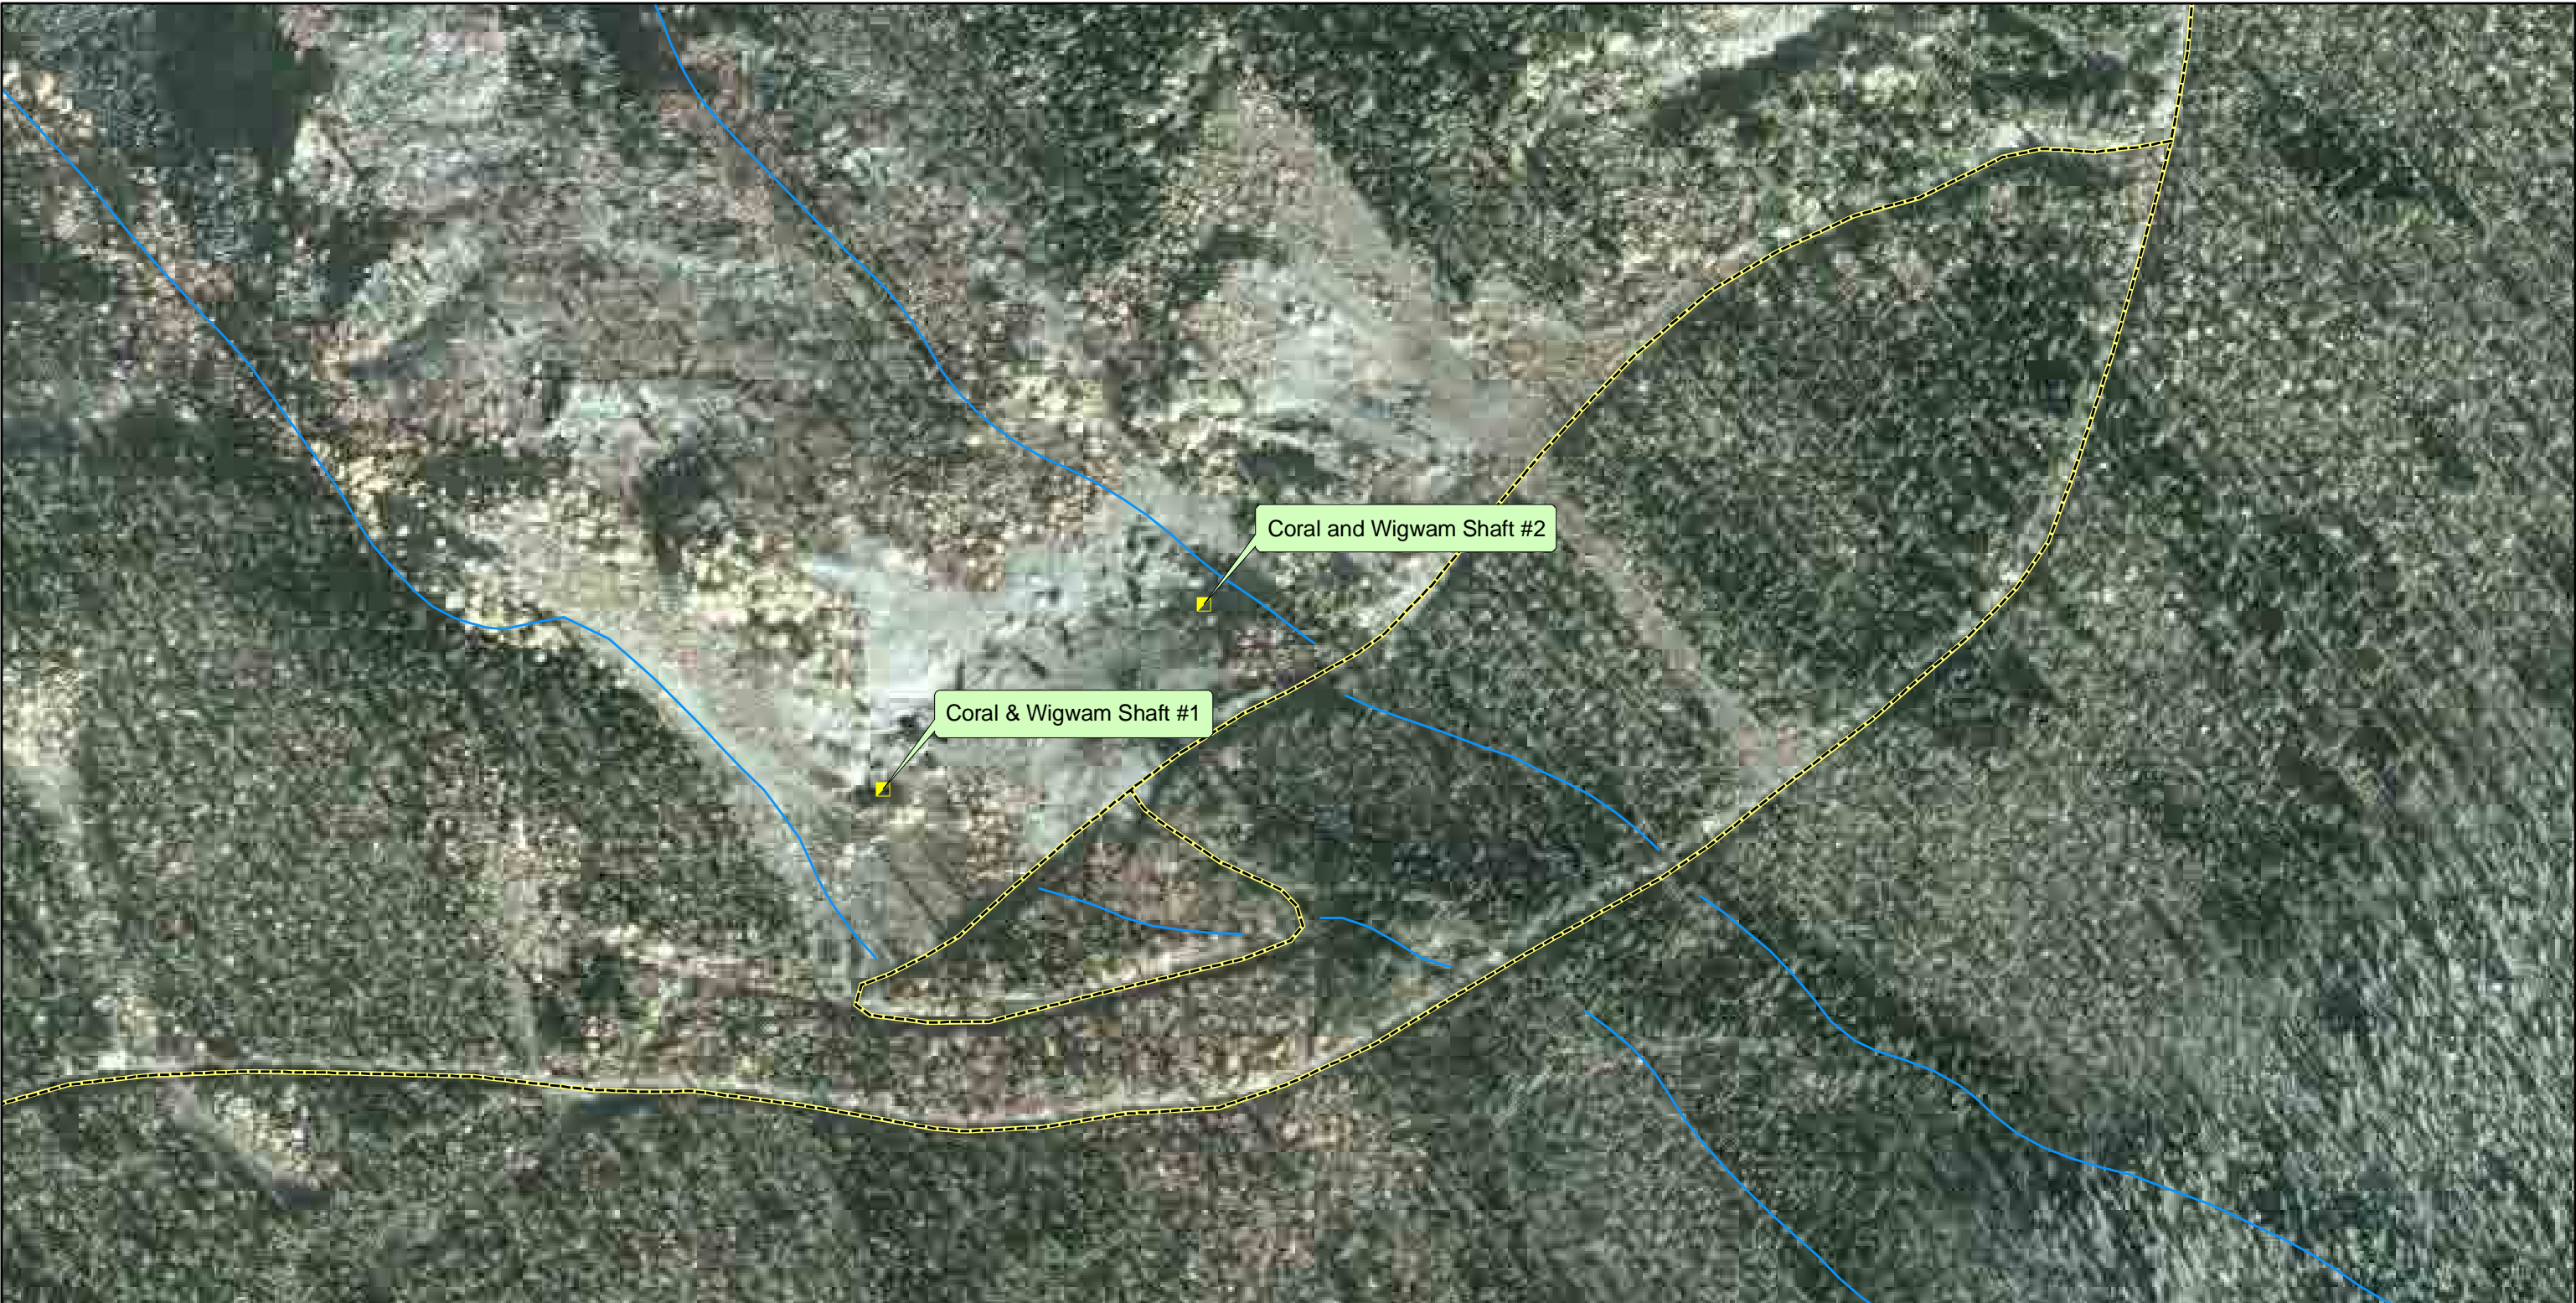
- #1** - Shaft #1 is open at surface, with no barrier to access. Timber cribbing is in good condition, and drift to southeast is clearly visible from top of shaft (Photo 1) and appears to be open. This feature represents a high intrigue risk.

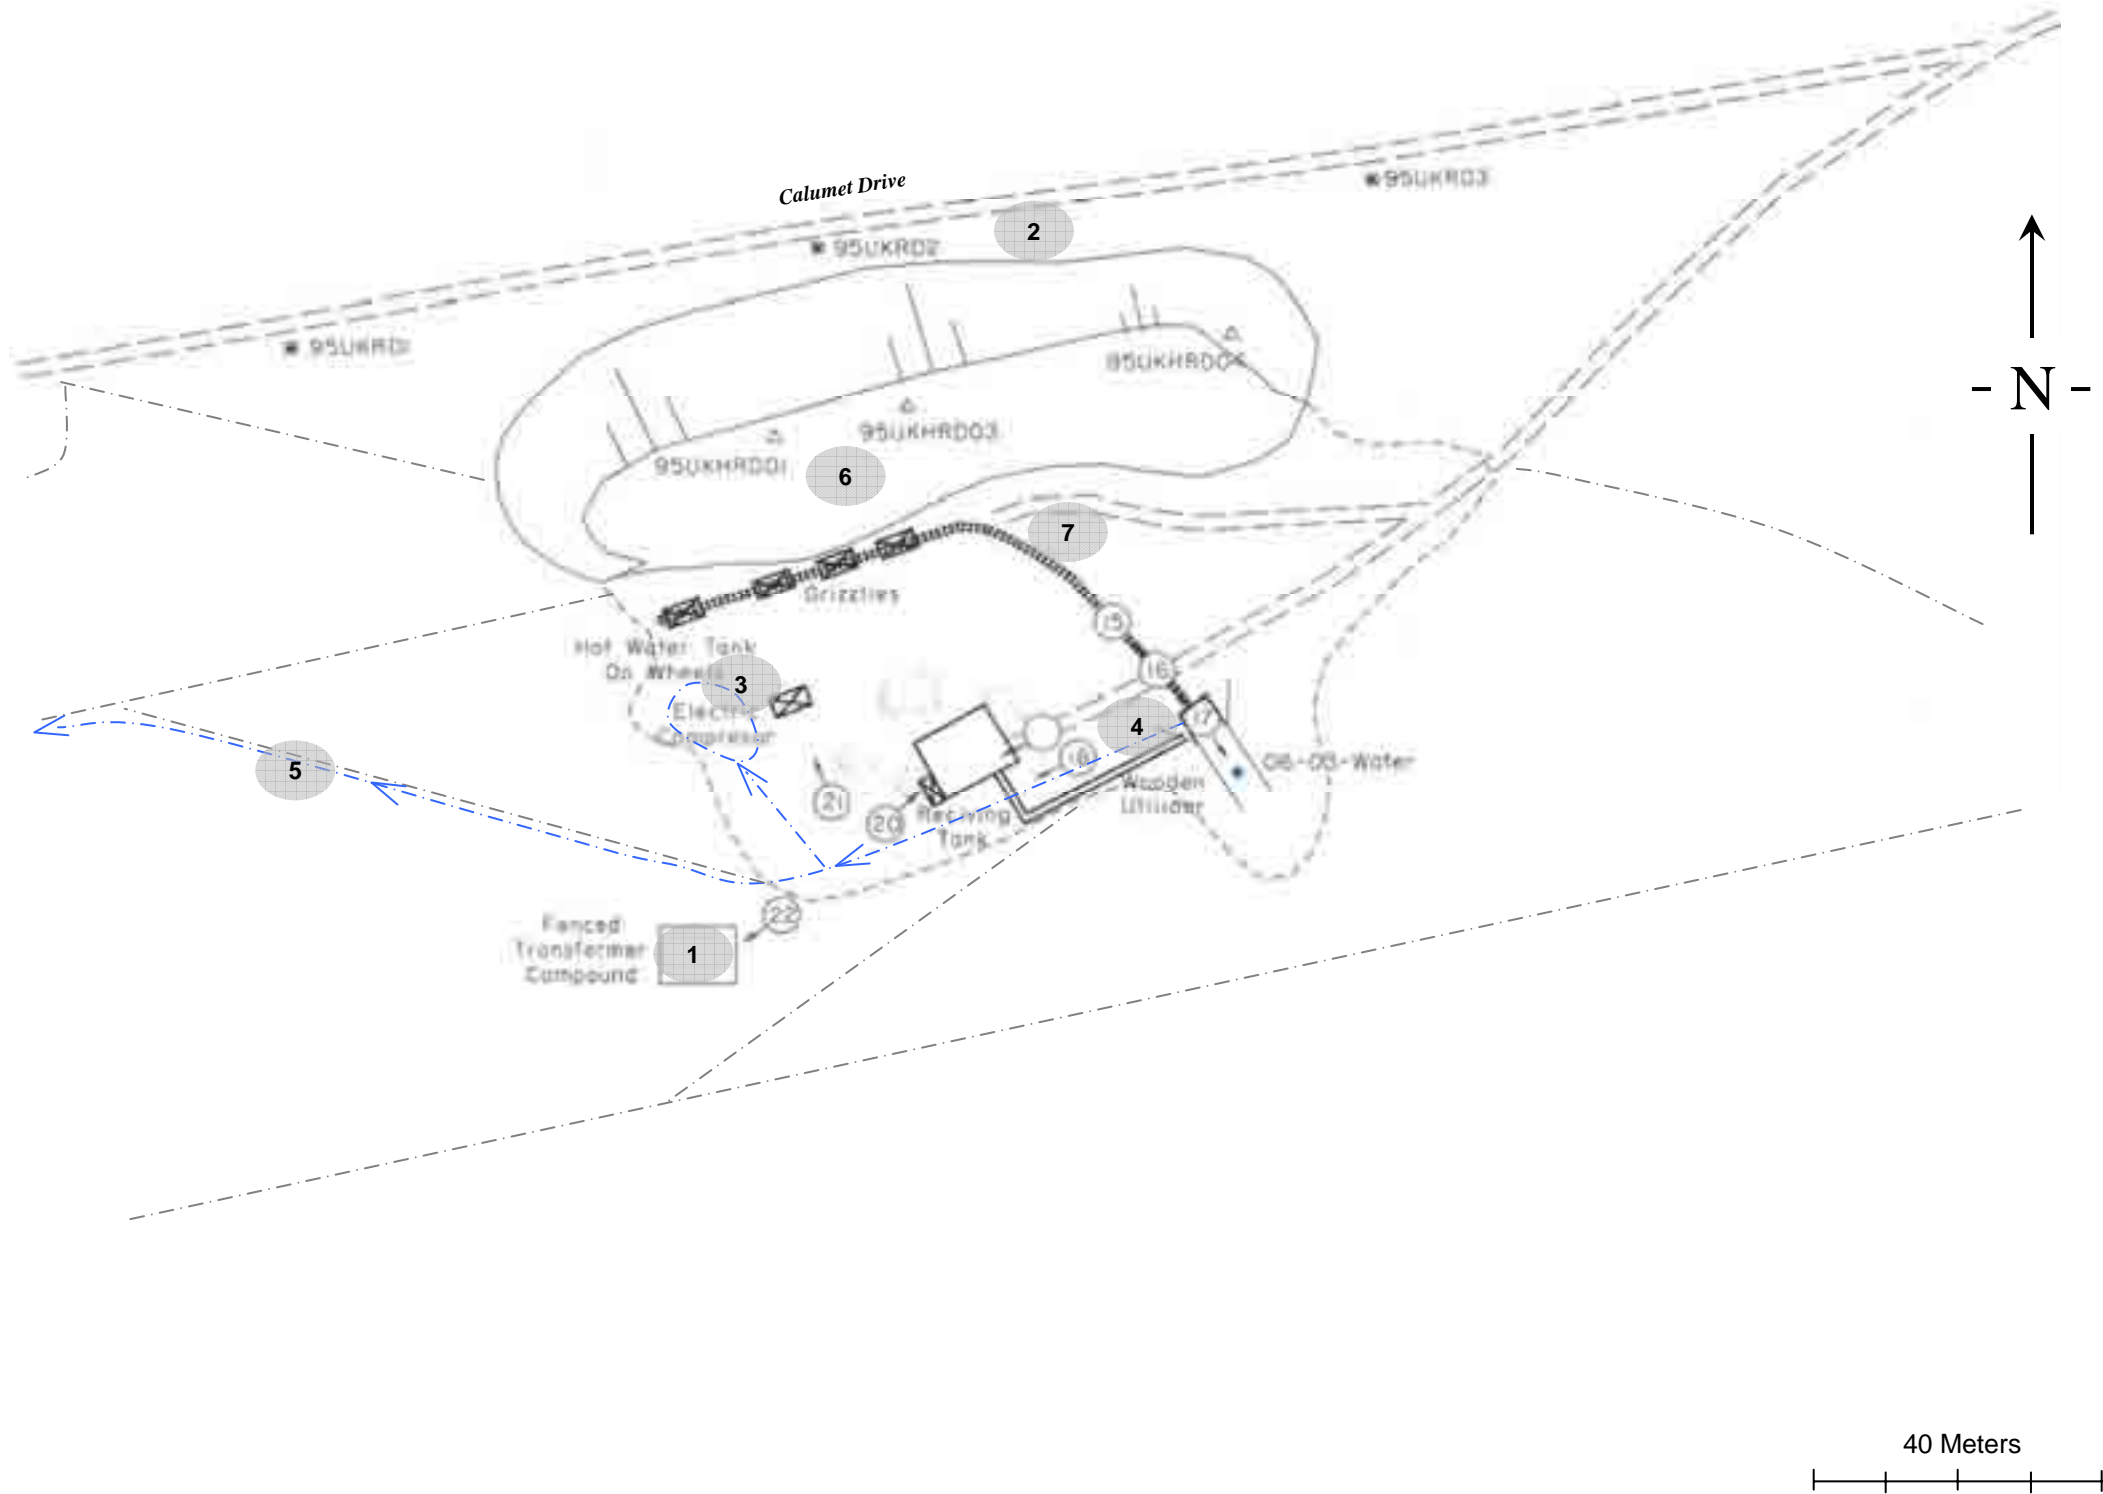
Bermingham & Ruby Site #6  
Ruby 400 Adit

- #5- Adit drainage channelled along old overgrown trail. Reports to culvert crossing Calumet Drive; tracing flow downgradient indicated that this water probably ultimately reports to No Cash Creek. Flow infiltrates on slope below culvert, and does not report to No Cash Creek as surface flow.

- #6- Minor light orange to yellow to rusty brown staining observed along runoff pathways on traffic surfaces
- #7- Wooden structures beginning to deteriorate

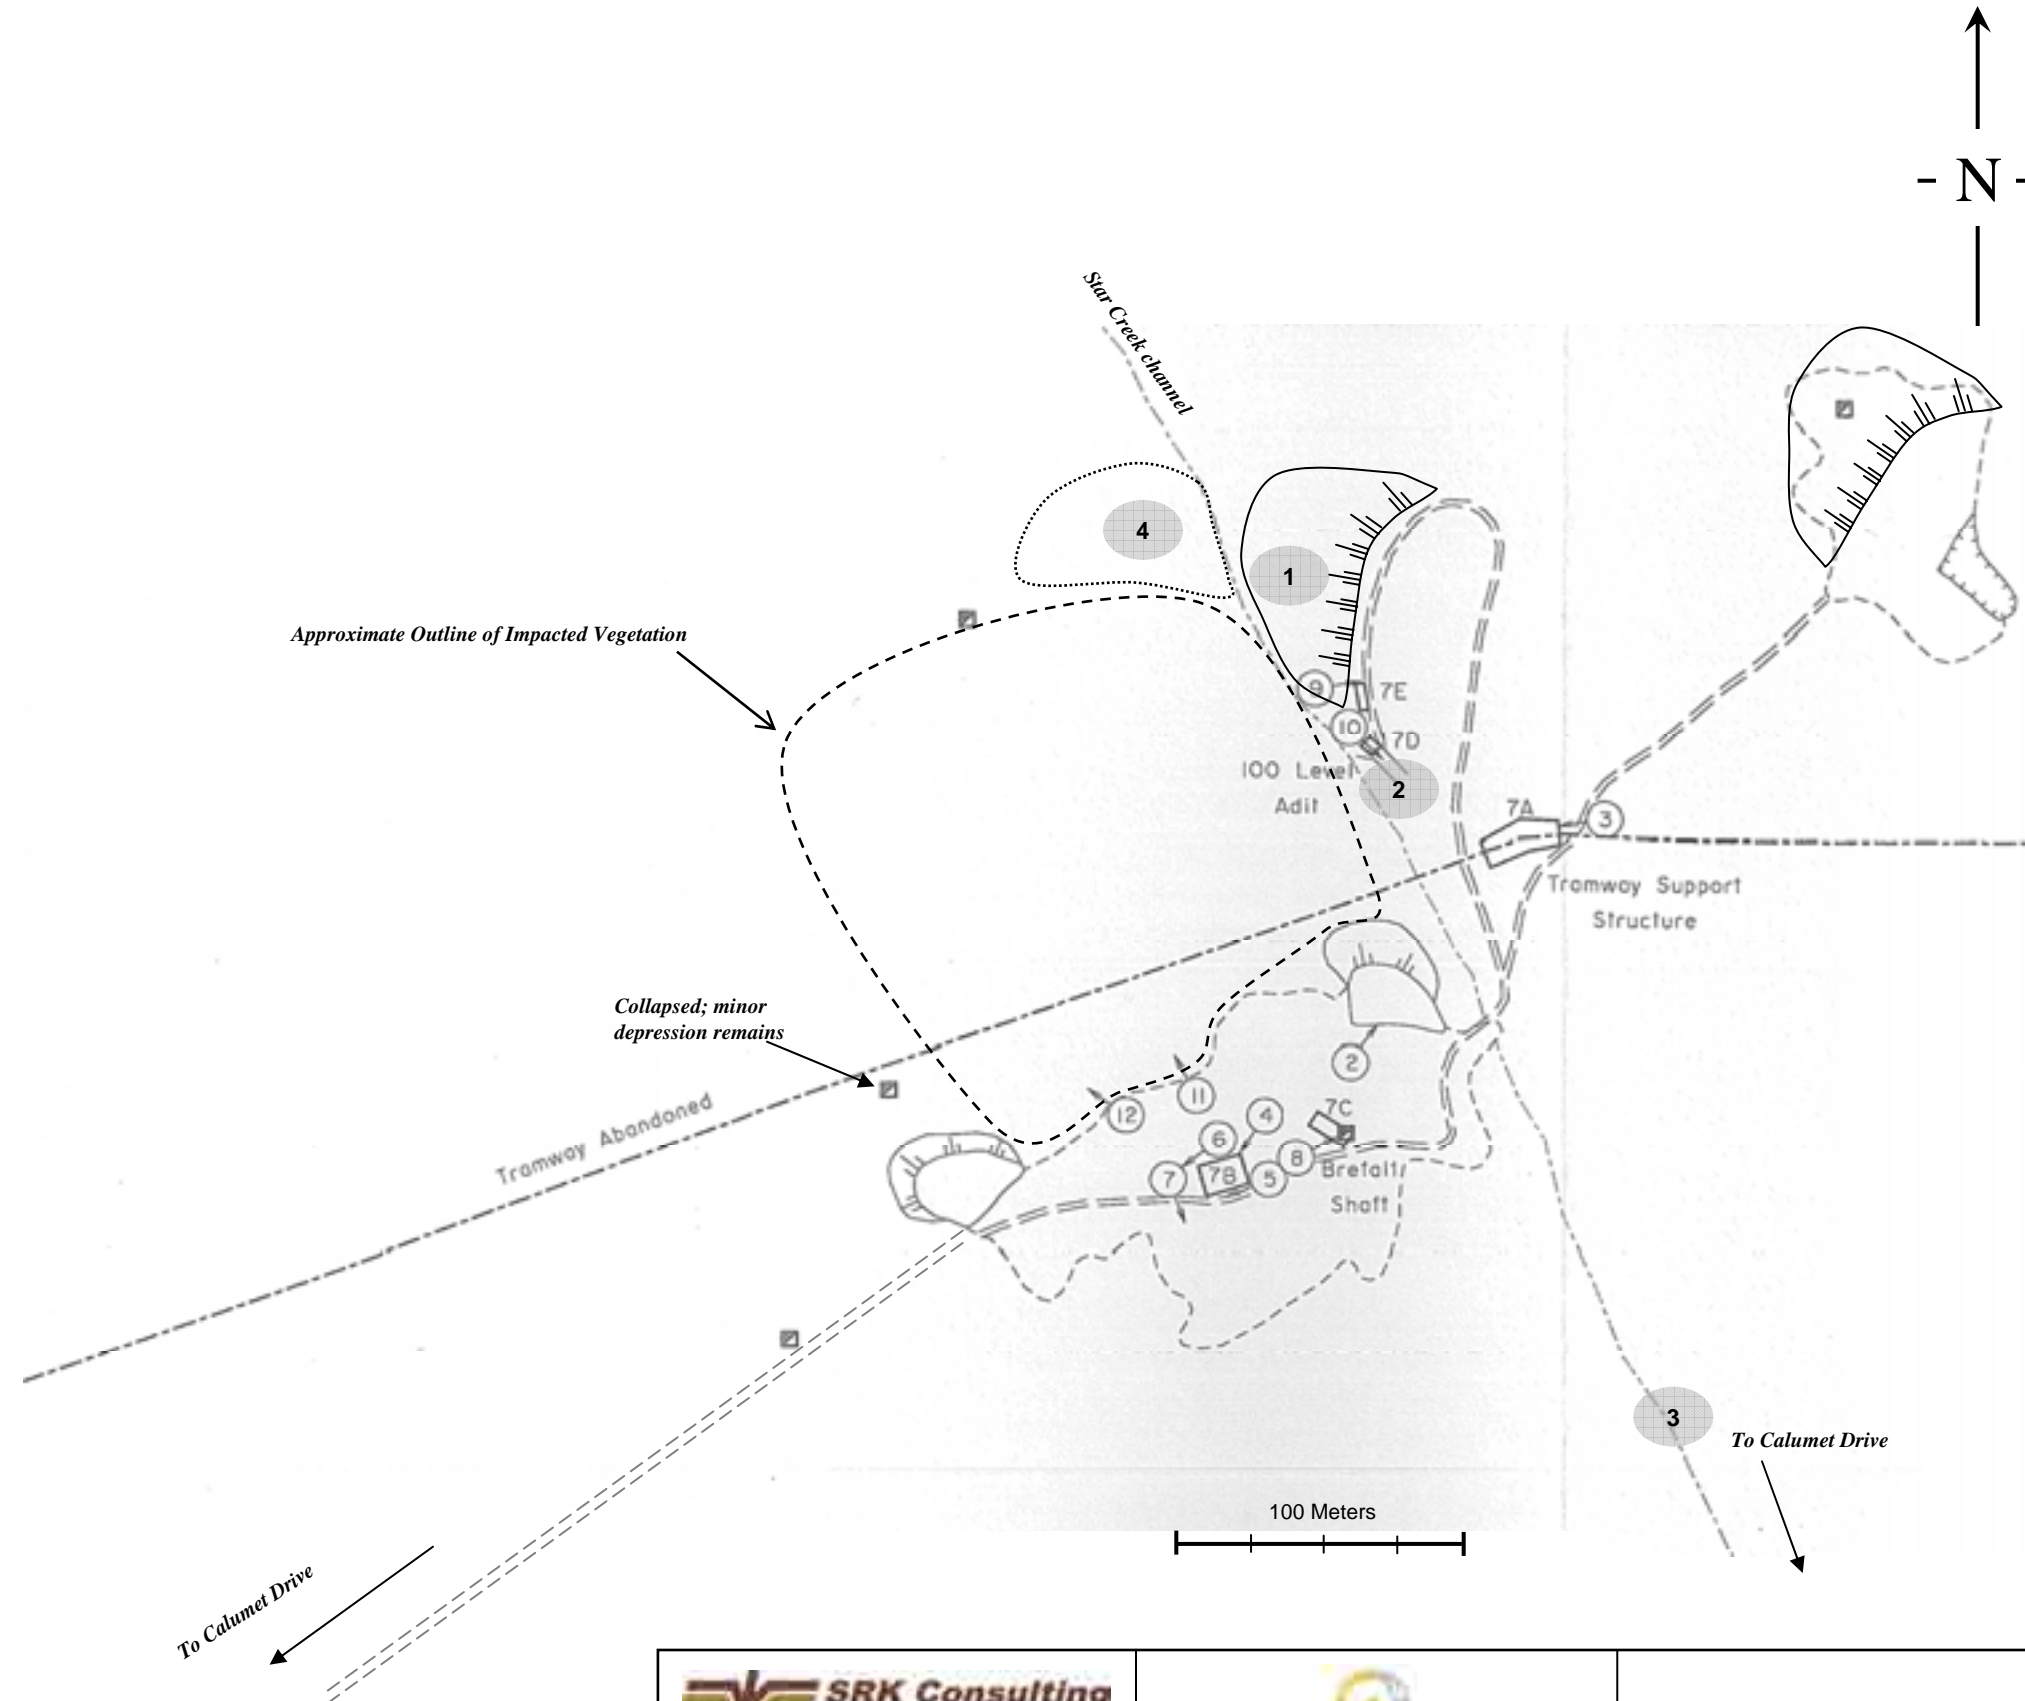
SRK Consulting Engineers and Scientists VANCOUVER		  ALEXCO		No Cash – 100 #7		
Job No:	1CA009.000	Baseline Environmental Report, United Keno Hill Mines Property		Date:	Approved:	Figure:
Filename:	Site 7-No Cash 500_20070131.ppt			Jan. 2007		34

- #3 - Drainage observed along Star Creek channel at Calumet Drive visually estimated at 2 L/second. No surface flow in Star Creek channel was observed upstream of channel crossing at No Cash 100 site or at any location within the site. It is likely that this water enters the workings and reports to No Cash 500 adit.

- #3 - Area of additional stripping, minor test pitting/ trenching observed

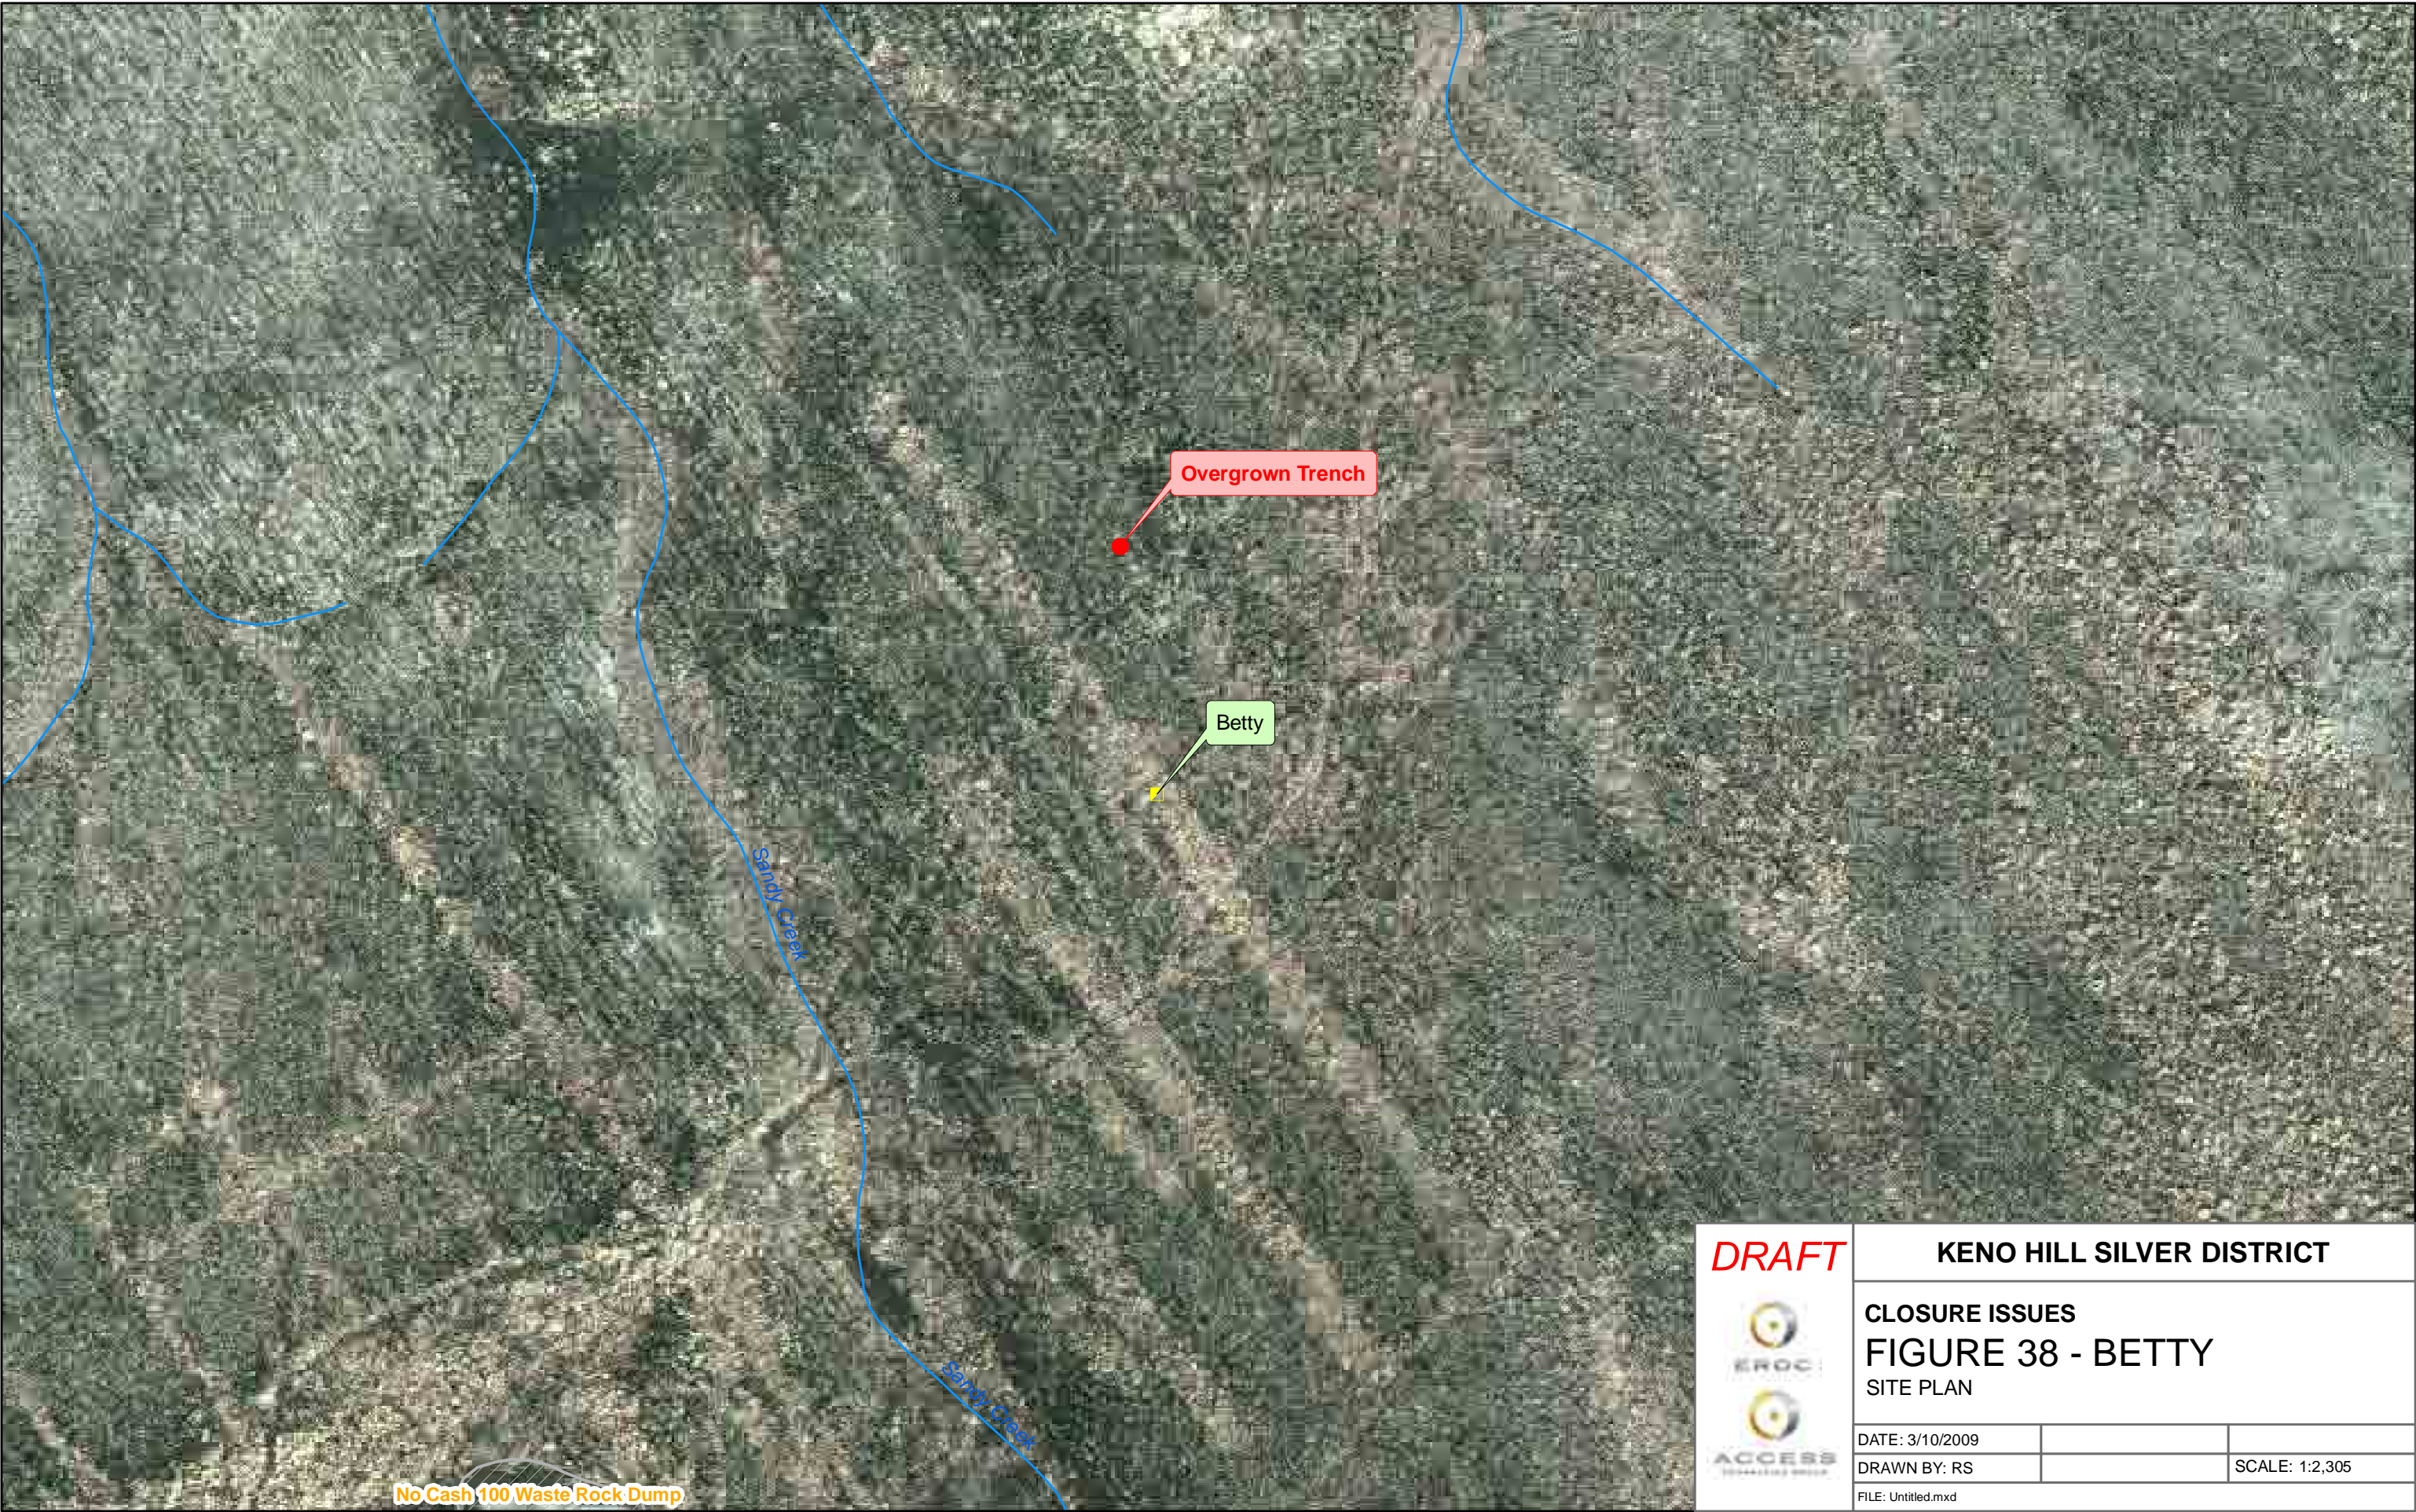
- #1 - Two 3 m x 3 m openings in muskeg, 1.5 m deep, with exposed mineral soil on margins. Waste rock pile adjacent to SW shaft approximately 0.5 m high x 5 m x 8m; composed of dark grey quartzite and minor quartzite breccia with siderite veining, with minor orange to dark rusty brown staining.
- Little vegetation growing on waste pile- 10% coverage.
  - Size of openings may be due to be regressive thawing of permafrost. Standing water (0.3 m) present in both holes, and bottoms felt solid when probed with a stick.
- #2 - Trench contains greenstone rubble, with water flowing through the rubble. Appears to collect water from flat swampy area to southeast and channel the water towards Sandy Creek.
- Trench is overgrown with willows and is difficult to identify.

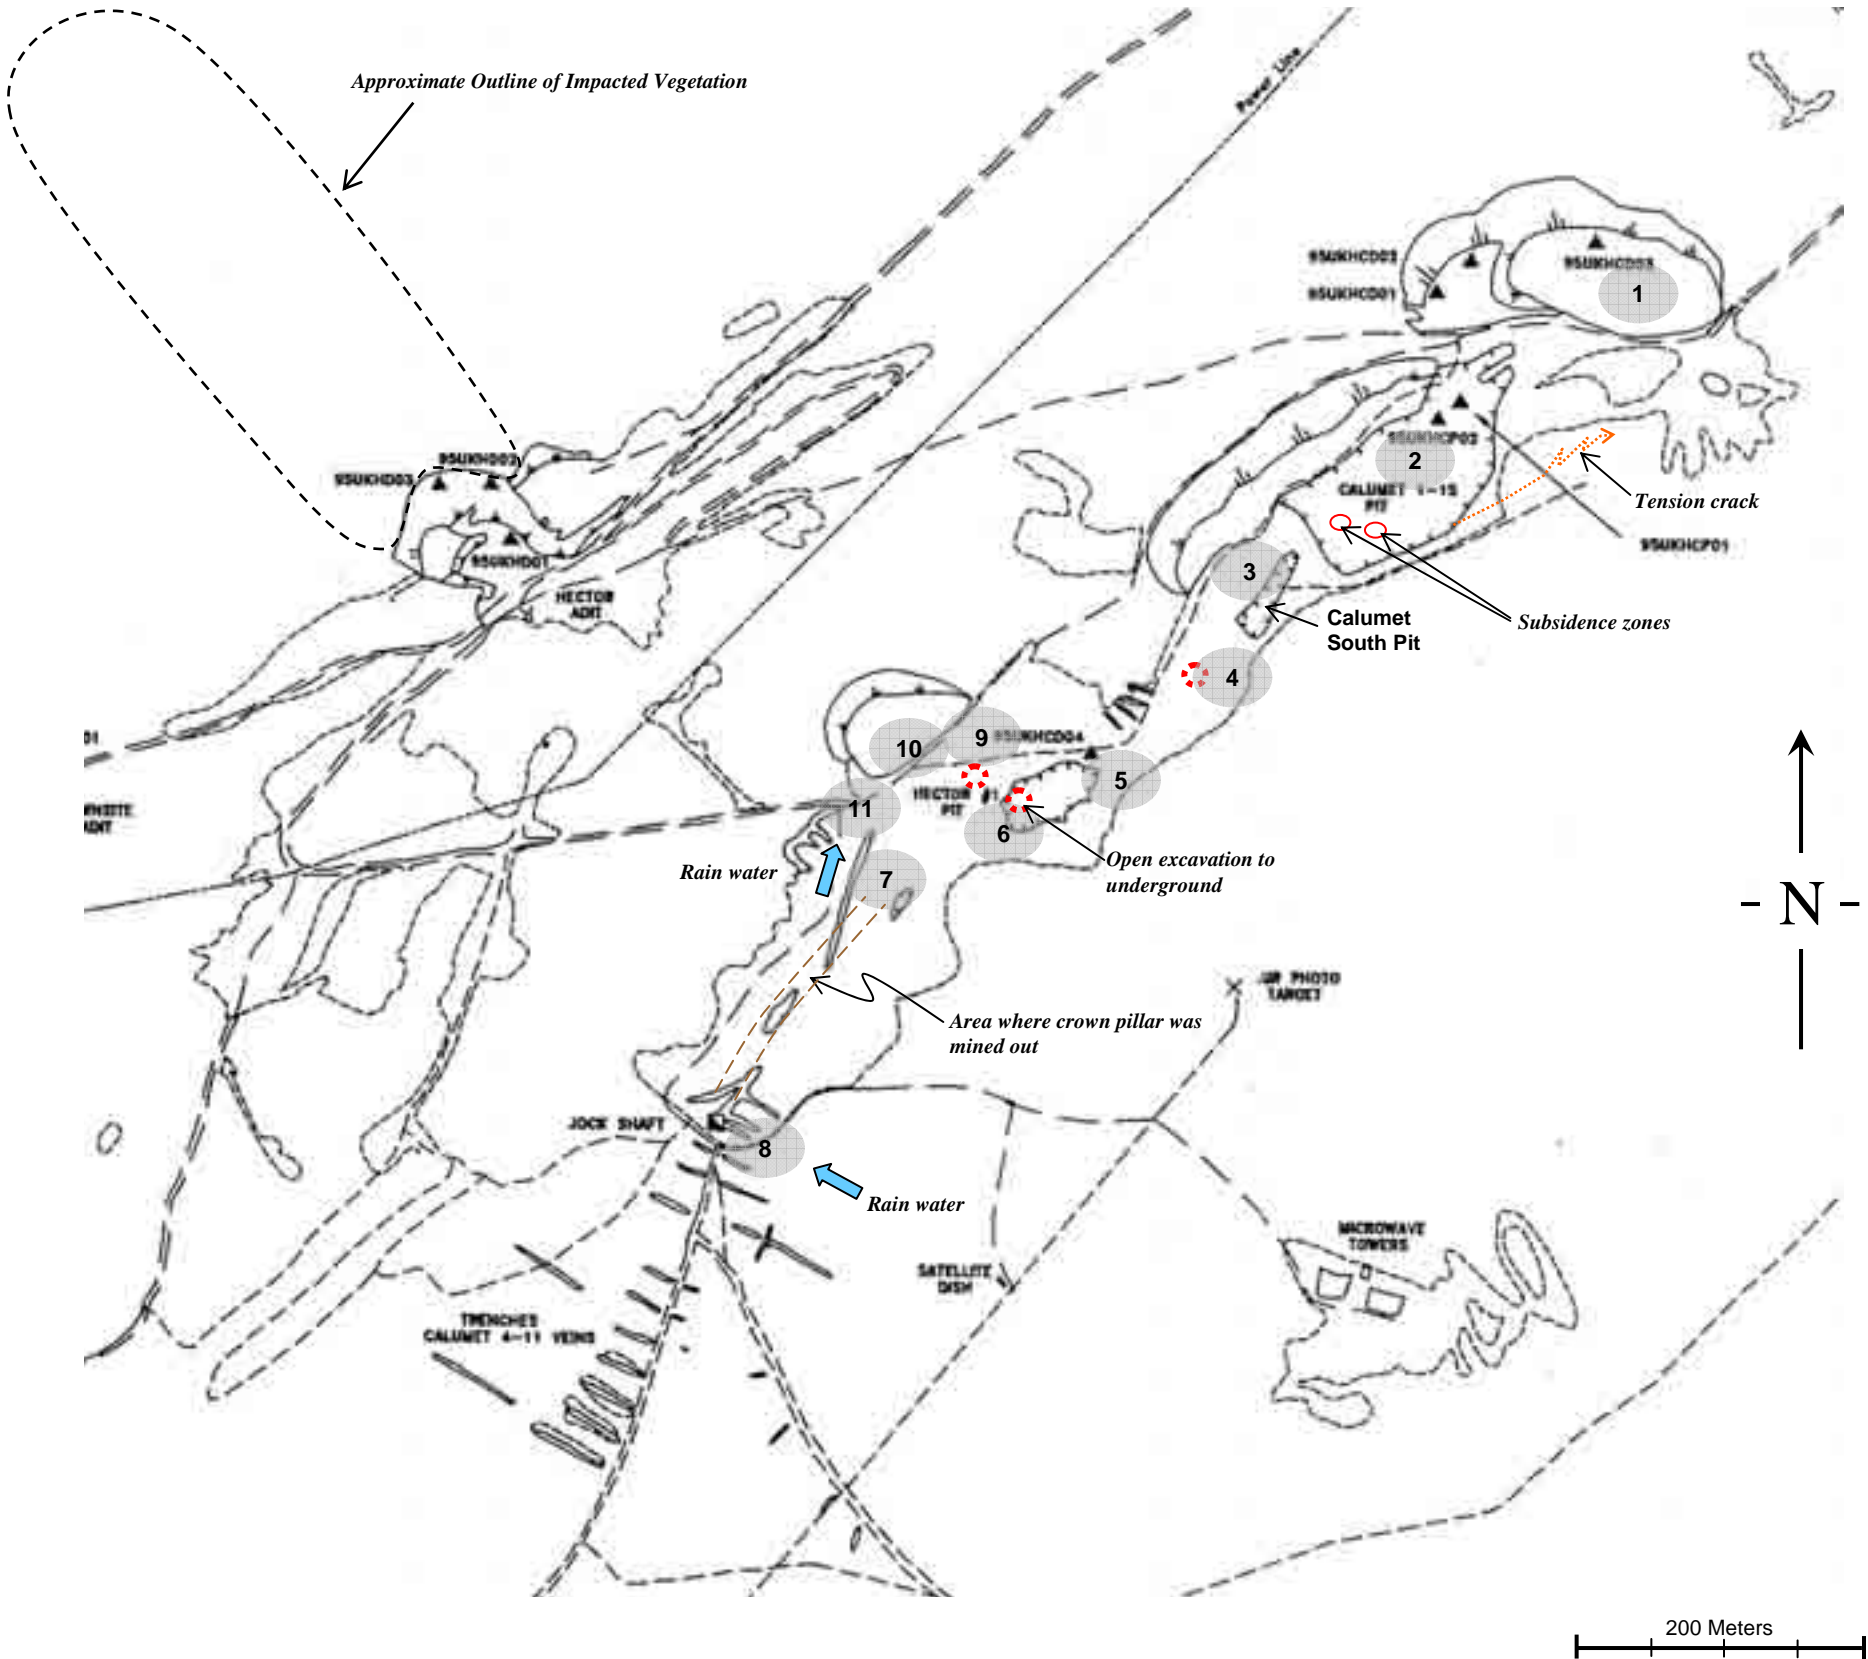
Date: Jan. 2007  
Approved:  
Figure: 41

- #1** This dump appears to be stable
- No tension cracks observed
  - This is a high dump but the topography below the dump face is fairly flat
- #2** Pit has intersected old workings

- Subsidence is occurring in the material in the bottom of the pit
  - There are a number of tension cracks around this pit, these do not fully delineate failures. These are not currently active but these areas are expected to continue unravelling.

- Large slabs coming off the bench faces
- #3** This is a small excavation
- No water was noted in the bottom of the pit.
  - The western slope of the pit is unravelling substantially.

- no water was noted at the bottom of the pit
  - no large failures are anticipated
- #6** Crack 4 m back from the pit crest
- this is an early feature and is not currently active

- #9** Possible raise to surface.
- #10** Old tension-cracks back from face
- on dump crest new some fairly recent tension cracks were observed, this dump appears to consist of a combination of fine and coarse material, which makes this dump less stable.

- the face is eroding and steepening up – this is a higher risk dump
  - the dump has a poor upper profile and pools of water are occurring on the top of the dump

- #11** All the water from the hill drains down and is channelled over the dump. Erosion is cutting a wide v-trench in the fine material on the dump face. This dump will become unstable over the longer term.
