## **KENO HILL SILVER DISTRICT**

## **CLOSURE ISSUES REPORT**

MARCH 2009

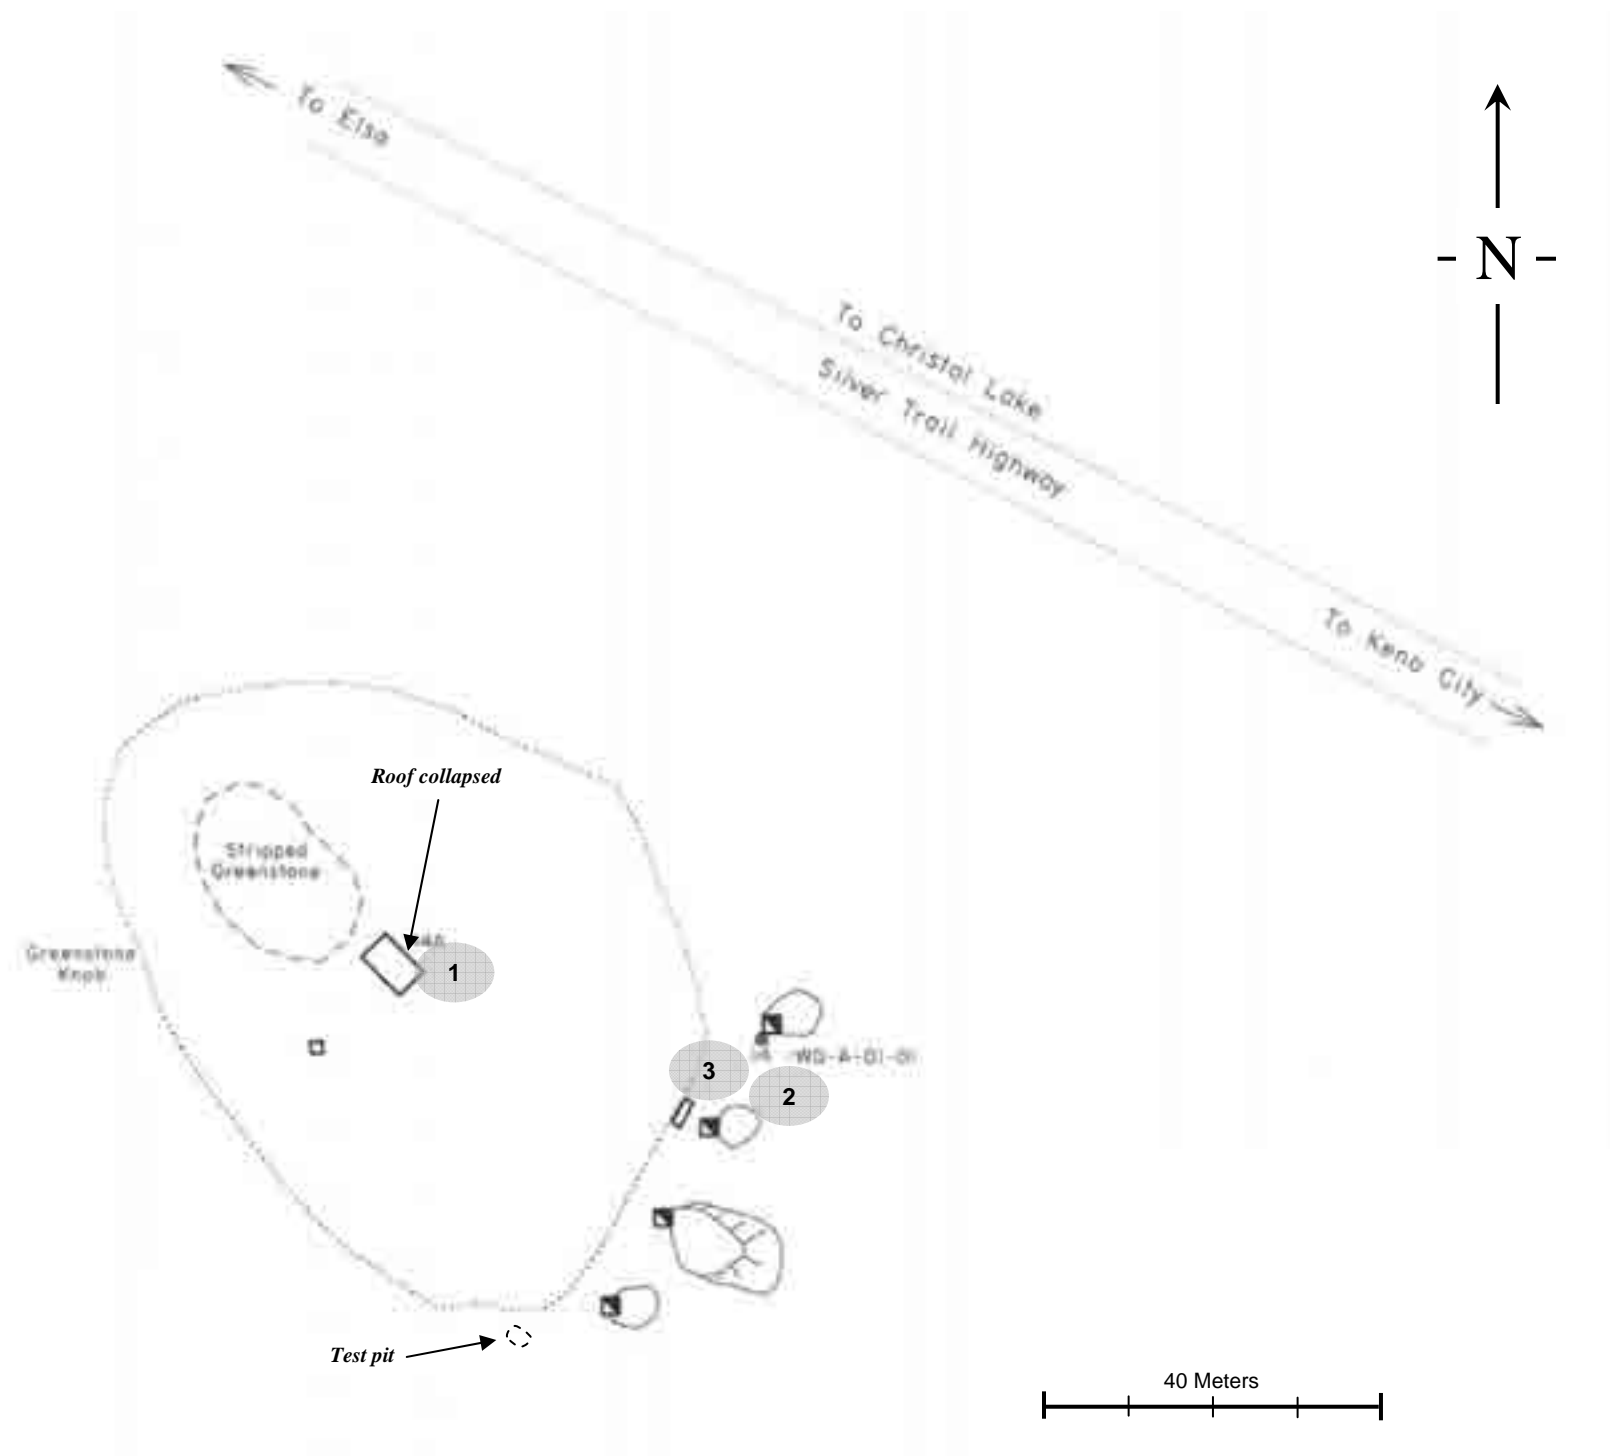
VANCOUVER		 		Bluebird Site #14		
Job No: ALEX-06-ESP-05		Baseline Environmental Report, United Keno Hill Mines Property				
Filename: Site14_Bluebird_20070131.ppt				Date: Jan. 2007	Approved:	Figure: <b>61</b>

- #1 - 2 sheets of approximately 1.2 m by 1.2 m asbestos fibreboard in NE corner of cabin- fixed to wall as heat shield for wood stove.
- #2 - Minor unvegetated oxidized greenstone and vein material.
- #3 - 3 m x 2 m x 2 m rock cut into base of outcrop with greenstone waste rock adjacent to east.

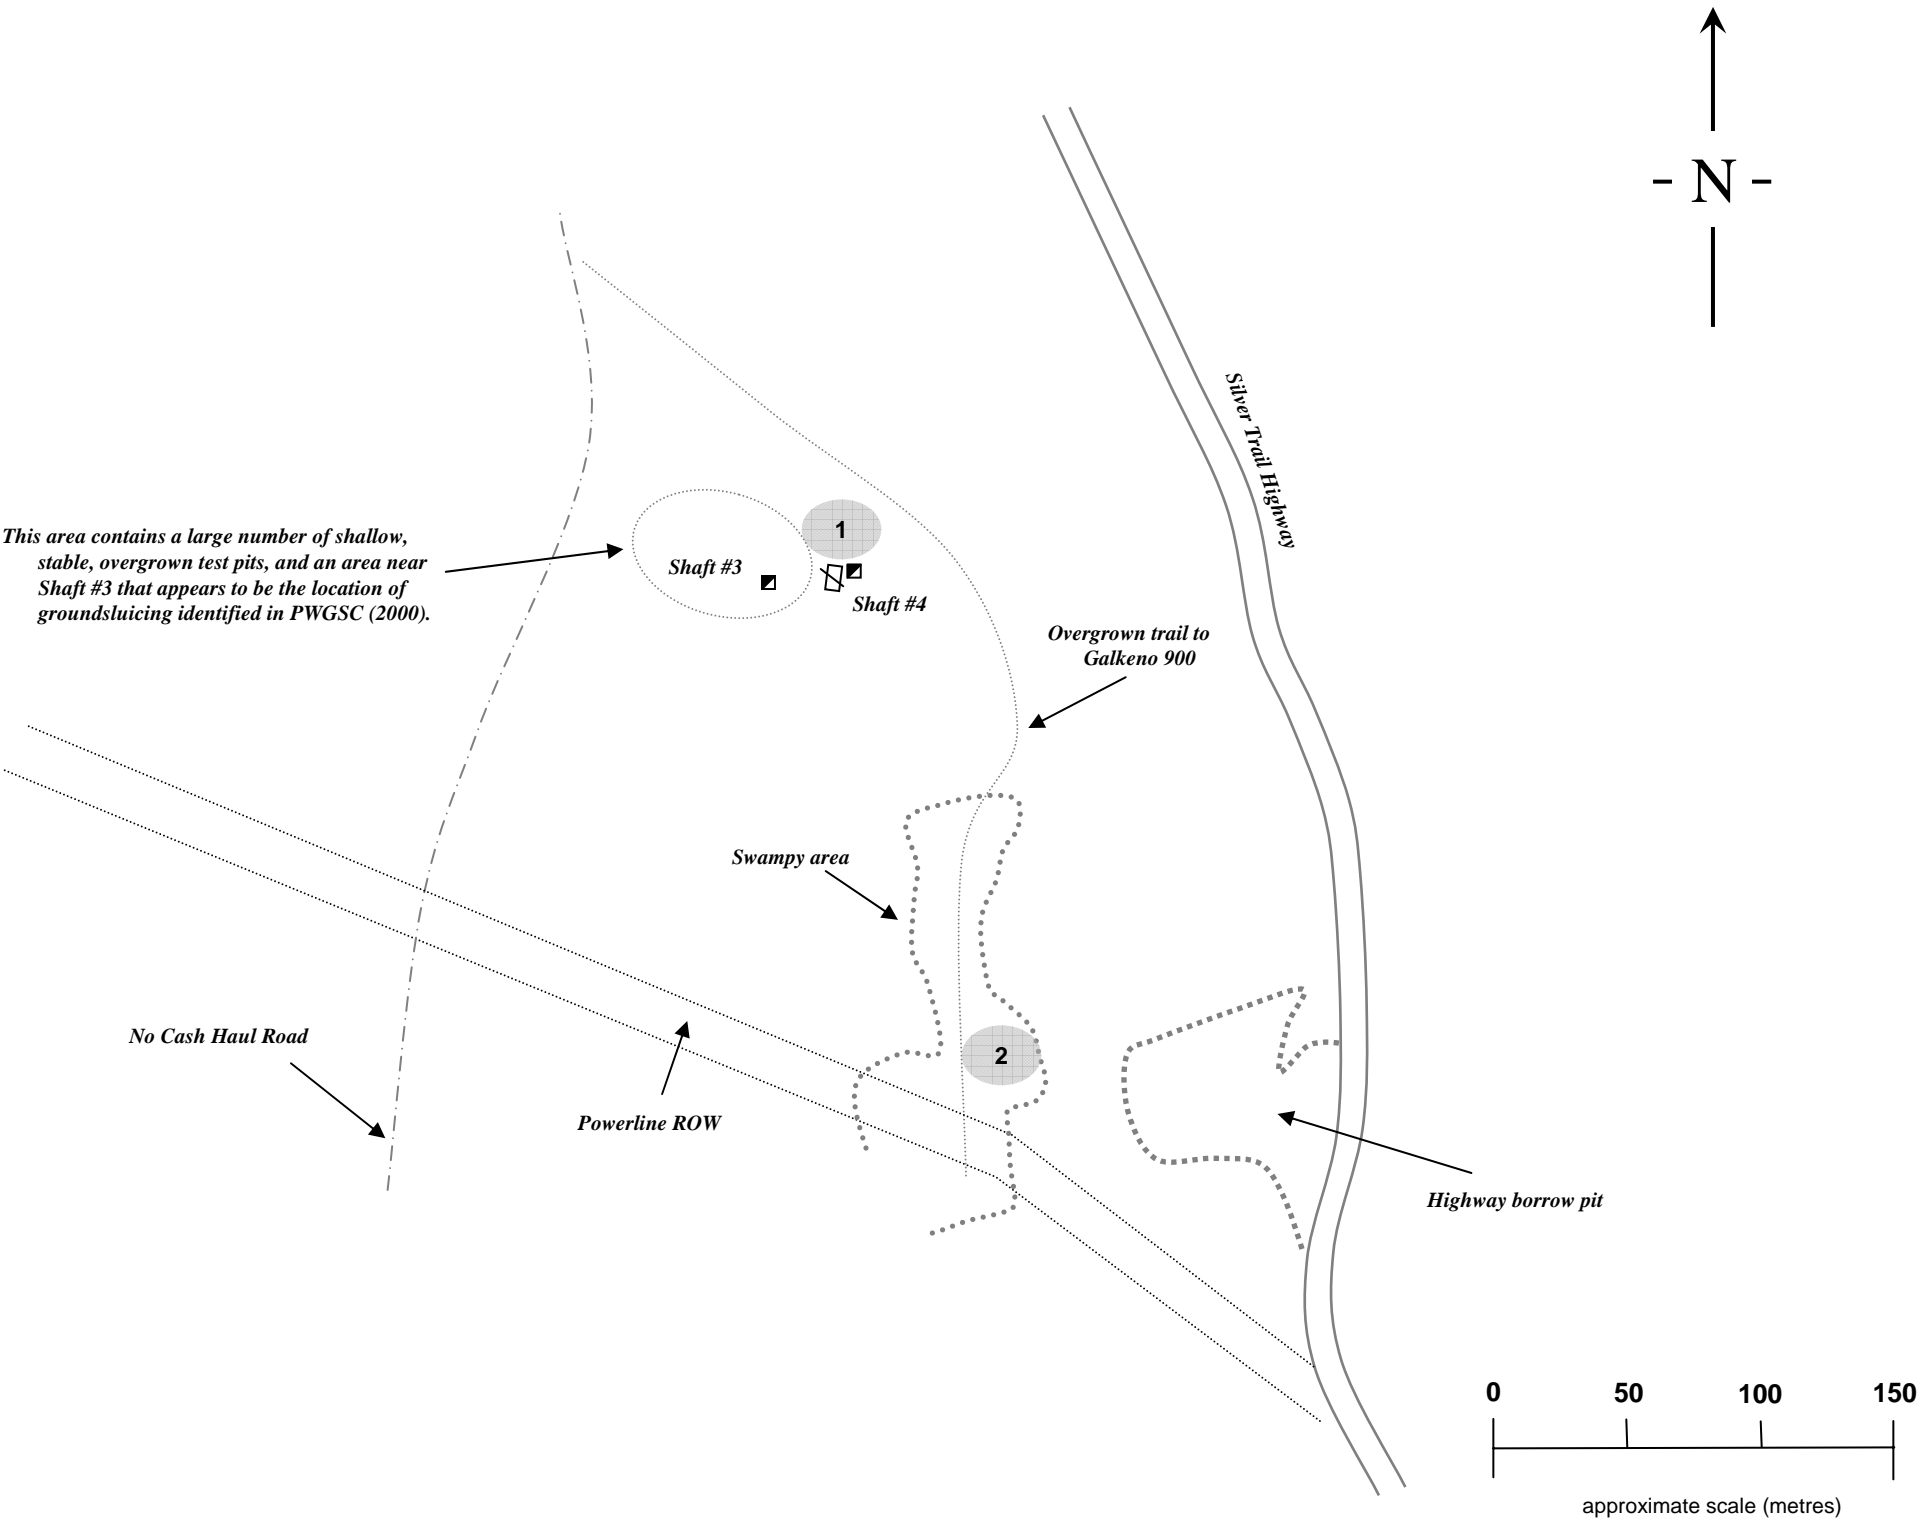
- Orange staining extends to depth of 0.3 m. Rinse pH of sample of near-surface fines was 6.2, with a rinse conductivity of 0.9 mS/cm.
- Unoxidized greenstone observed below veneer of oxidized waste in shallow test pit.

- #1 - Swampy area to southeast of shafts #3 and #4 is location of Shaft #1 and Shaft #2 described in PWGSC (2000). Vegetation consists of saturated moss and small shrubs, along with isolated black spruce and willows.

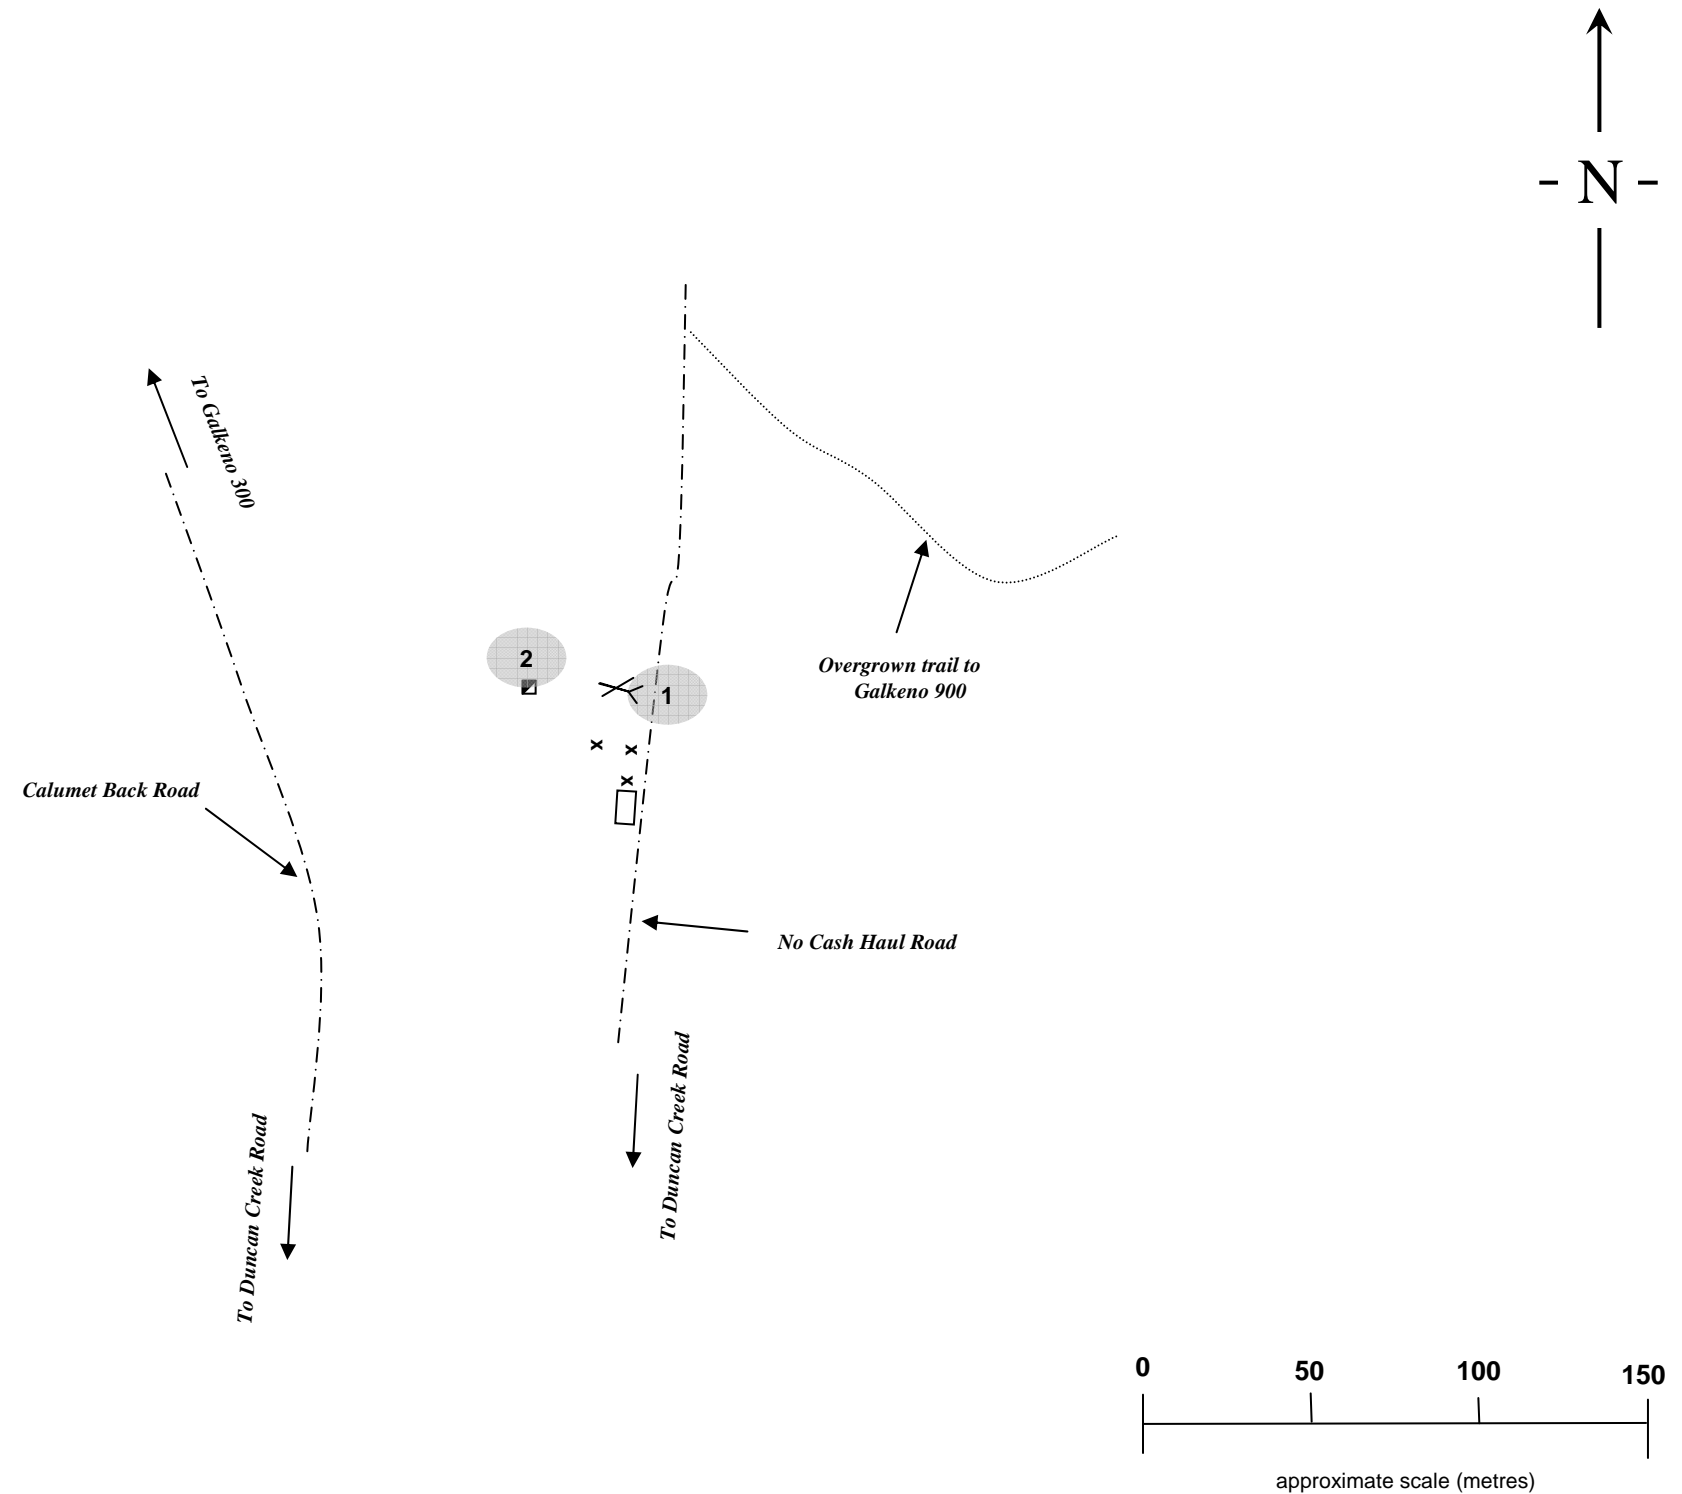
SRK Consulting Engineers and Scientists VANCOUVER		  ALEXCO		Rico Site #16		
Job No:	ALEX-06-ESP-05	Baseline Environmental Report, United Keno Hill Mines Property		Date:	Approved:	Figure:
Filename:	Site16_Rico_20070131.ppt			Jan. 2007		65

- #1 - There appeared to be insufficient volume of waste rock for a 37 m adit. Waste may have been used as road material.  
- Linear subsidence above adit extends for ~30 m, up to 2.5 m deep with stable sides and complete revegetation.
- #2 - Shaft waste pile 70% overgrown with moss, lichen, heather, and isolated birch.  
- Composed of weathered quartzite breccia, siderite vein material, minor oxidized carbonaceous phyllite.  
- Abundant black manganese oxide staining observed, lesser orange to dark rusty brown staining.  
- Shaft remains open; water and debris observed at 4m depth. Timber support remained intact.

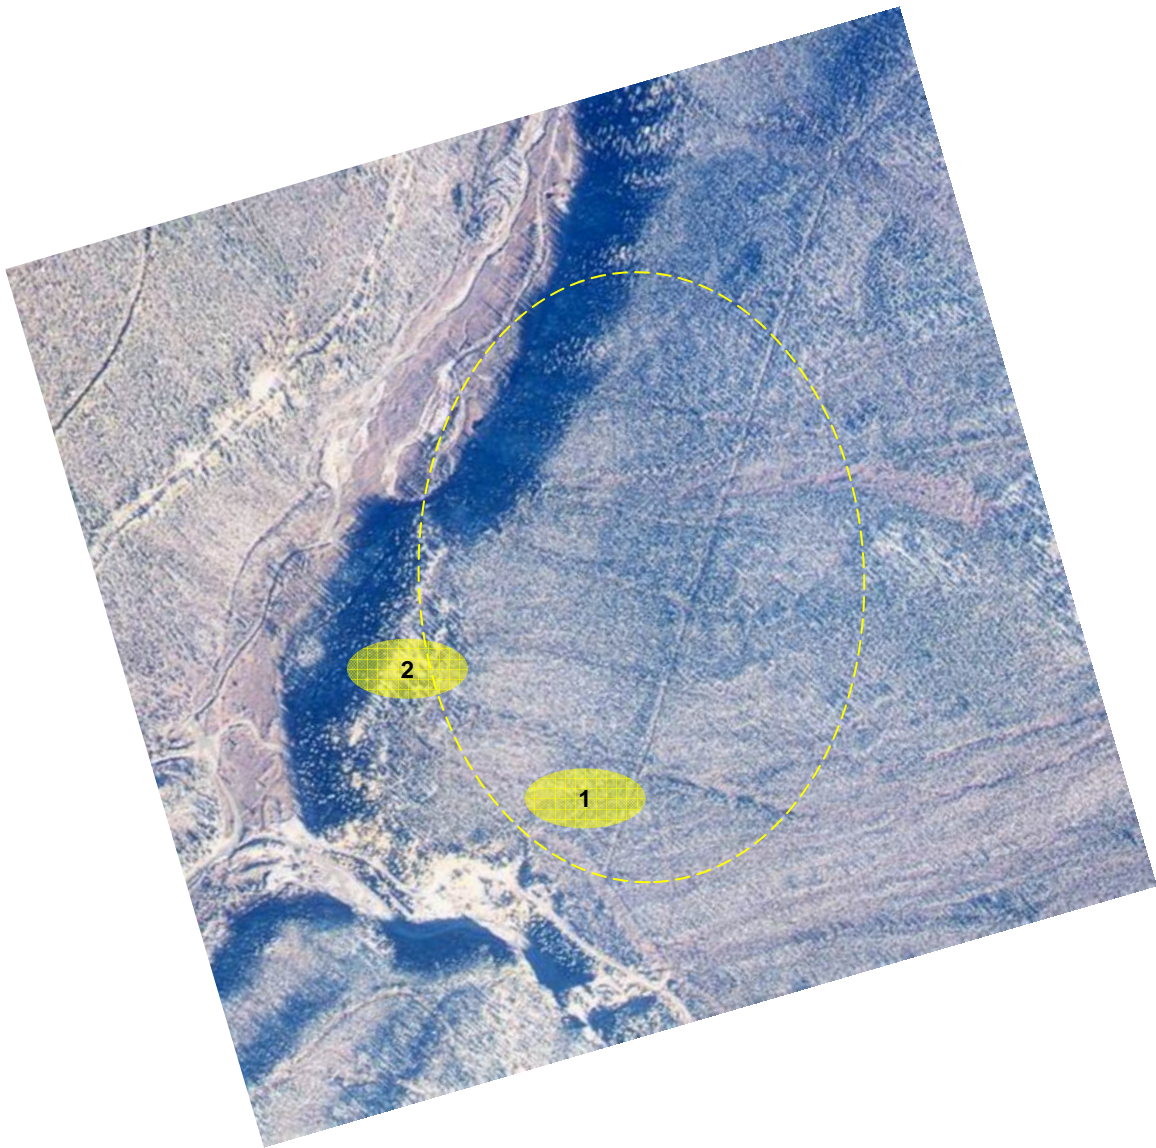
- #1** - Area of trenches identified in PWGSC 2000 east of confluence of Lightning Creek and Upper Duncan Creek.
- At the time of inspection in 2006, no trenches were located. There are several cutlines in the area indicated on the aerial photograph, and there are areas where melting of permafrost along the cutlines has resulted in subsidence and the formation of linear depressions.
  - Complete or nearly complete vegetative coverage was observed on all cutlines inspected in 2006.
- #2** - Test pitting in gravel observed in this area. It is suspected that this disturbance is related to placer exploration.

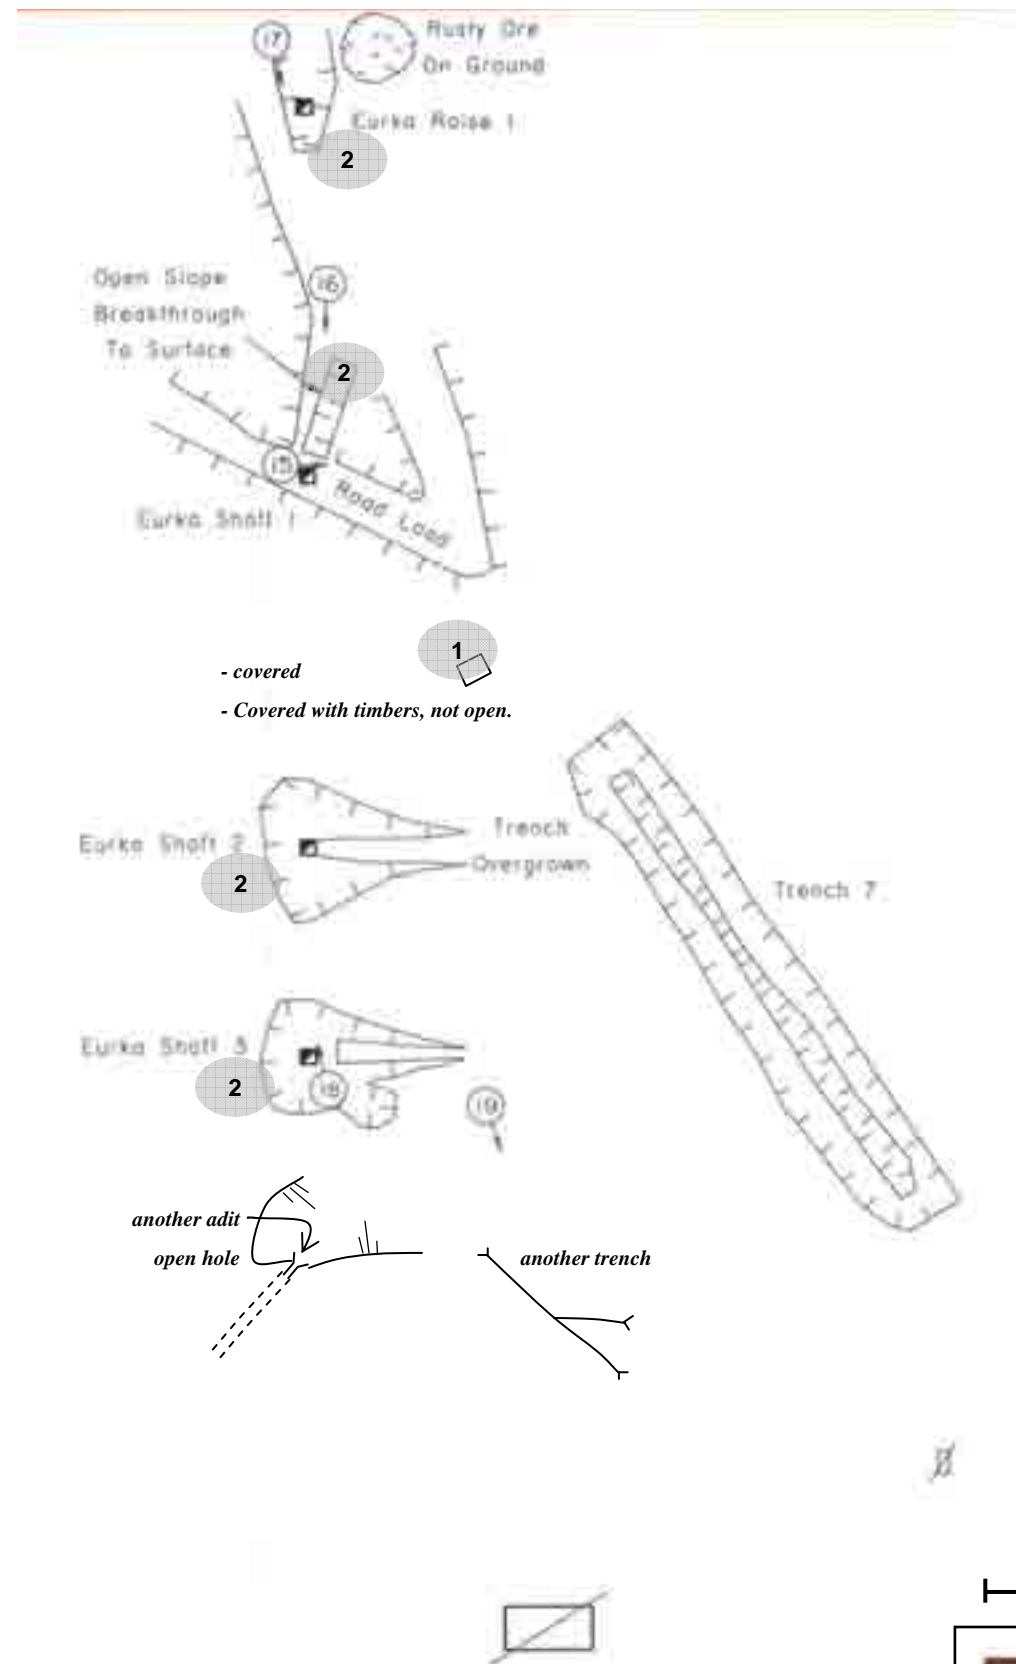
Date: Jan. 2007	Approved:	Figure: <b>84</b>
--------------------	-----------	----------------------

- #1 - Unmapped vertical raise identified in 2005.  
- 6 - 8 ft of the raise is exposed. Lower down is closed as the sides may have collapsed.  
- May have been backfilled in 2006.
- #2 - Eureka Raise 1, Eureka Shaft 1 and adjacent collapsed stope, Eureka Shaft 2, Eureka Shaft 3 all backfilled in 2006

- covered  
- Covered with timbers, not open.

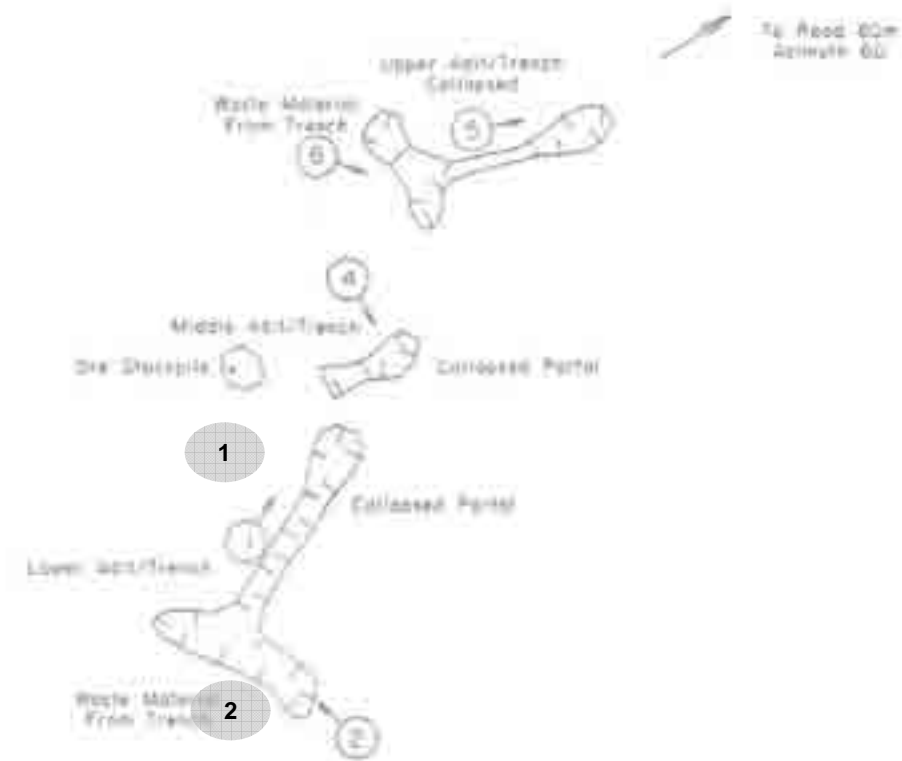
#1 - Coordinates in PWGSC (2000) are not correct.  
NAD 83 UTM position 486195 E 7089814 N.

#2 - Minor (10%) orange, black, and dark rusty brown clasts exposed on lower  
margin of pile- remainder is revegetated. Fines are light greyish brown.

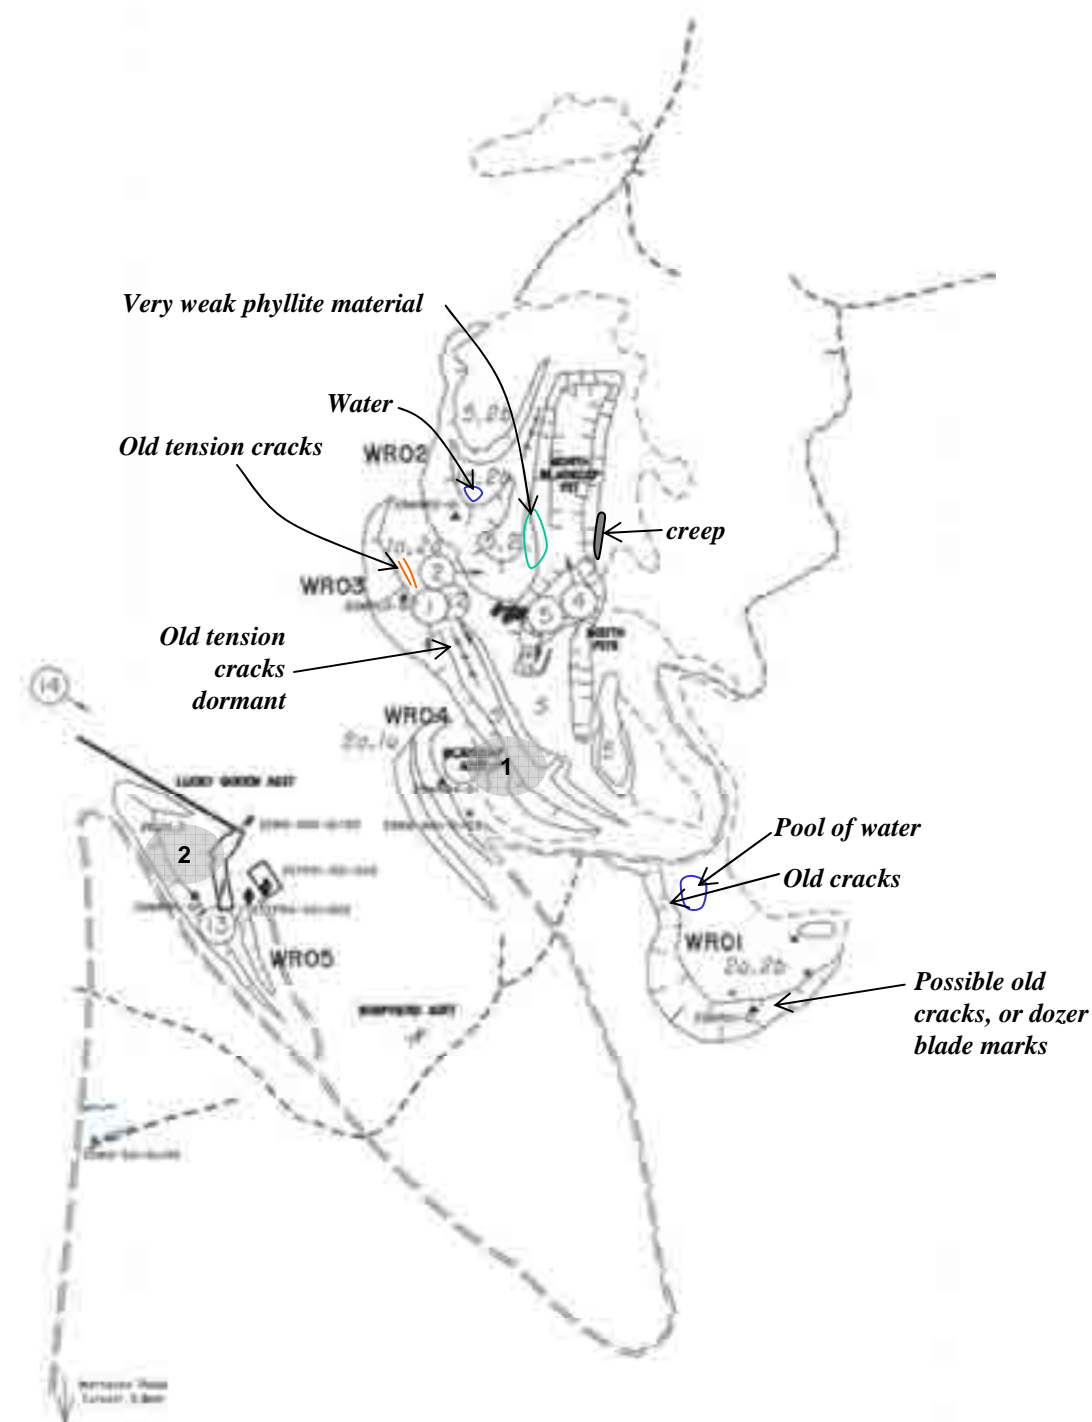
**Pit Notes:**

- Small operation with some poor blasting practices
- East wall is benched on a 10 ft lifts; slope angle is low
- The west wall was mined with no benches, very ragged appearance
- The dip of ore body is at a low angle to the east.
- The faces are unravelling substantially on the western entrance
- Water pooling on the dump on the west side
- Some tension cracks exist on the west dump; these appear dormant
- Berms are placed on approximately 50% of the waste dumps

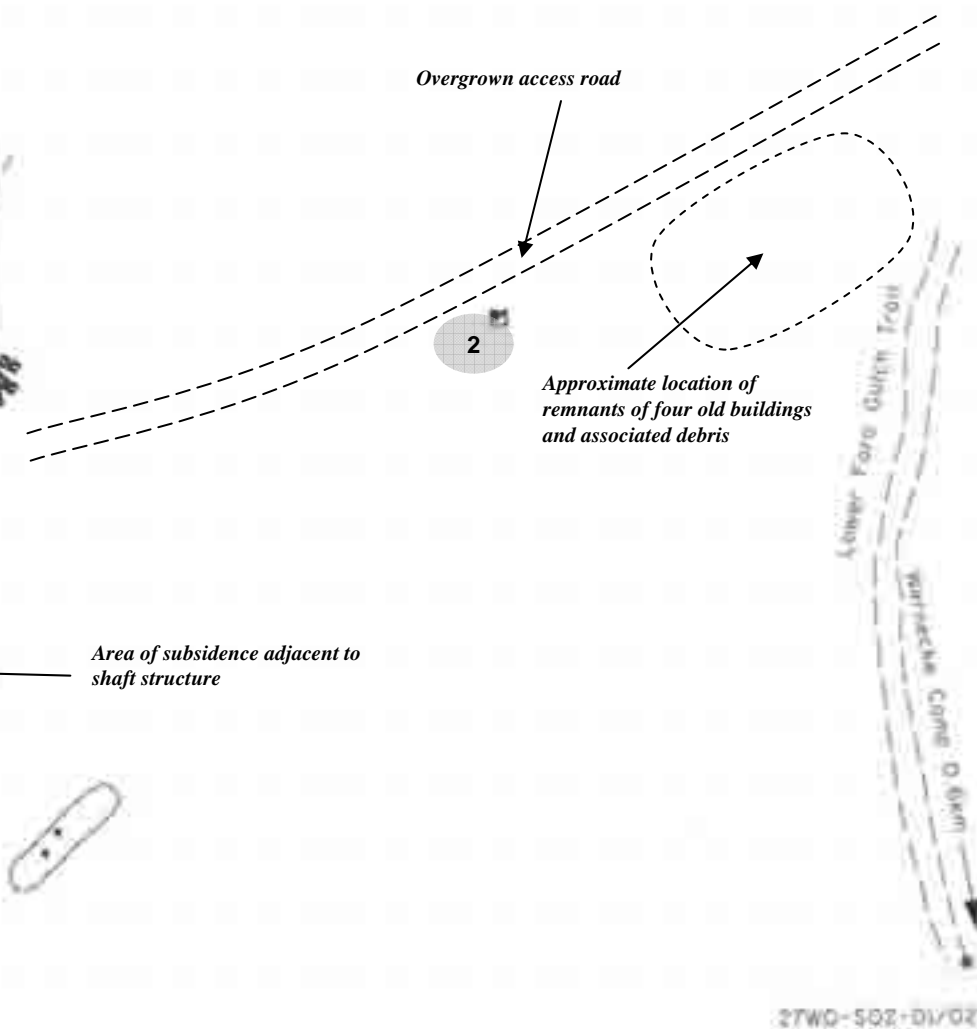
- #1 - Hanging wall to shaft has collapsed, and there appears to be an open void. Risk of inadvertent access was low at the time of inspection; however, wood structure that formed a roof over the opening was observed to be actively deteriorating, and may lead to the development of an open hole in the future. May be exacerbated by continued failure of hanging wall. Intrigue risk is high and access could be gained with intent. (Photos 1 and 2).
- Area of subsidence immediately west of shaft structure is overgrown with willows (Photo 3).
  - Manway was secured at time of inspection by planking nailed over entry, as noted in PWGSC (2000).

- #2 - Upper shaft forms stable open hole, with water at a depth of 3m. Warning flagging strung by PWGSC remained in place.
- Minor subsidence observed adjacent to shaft on north side, over an area of 2m x 3m x 1m deep.

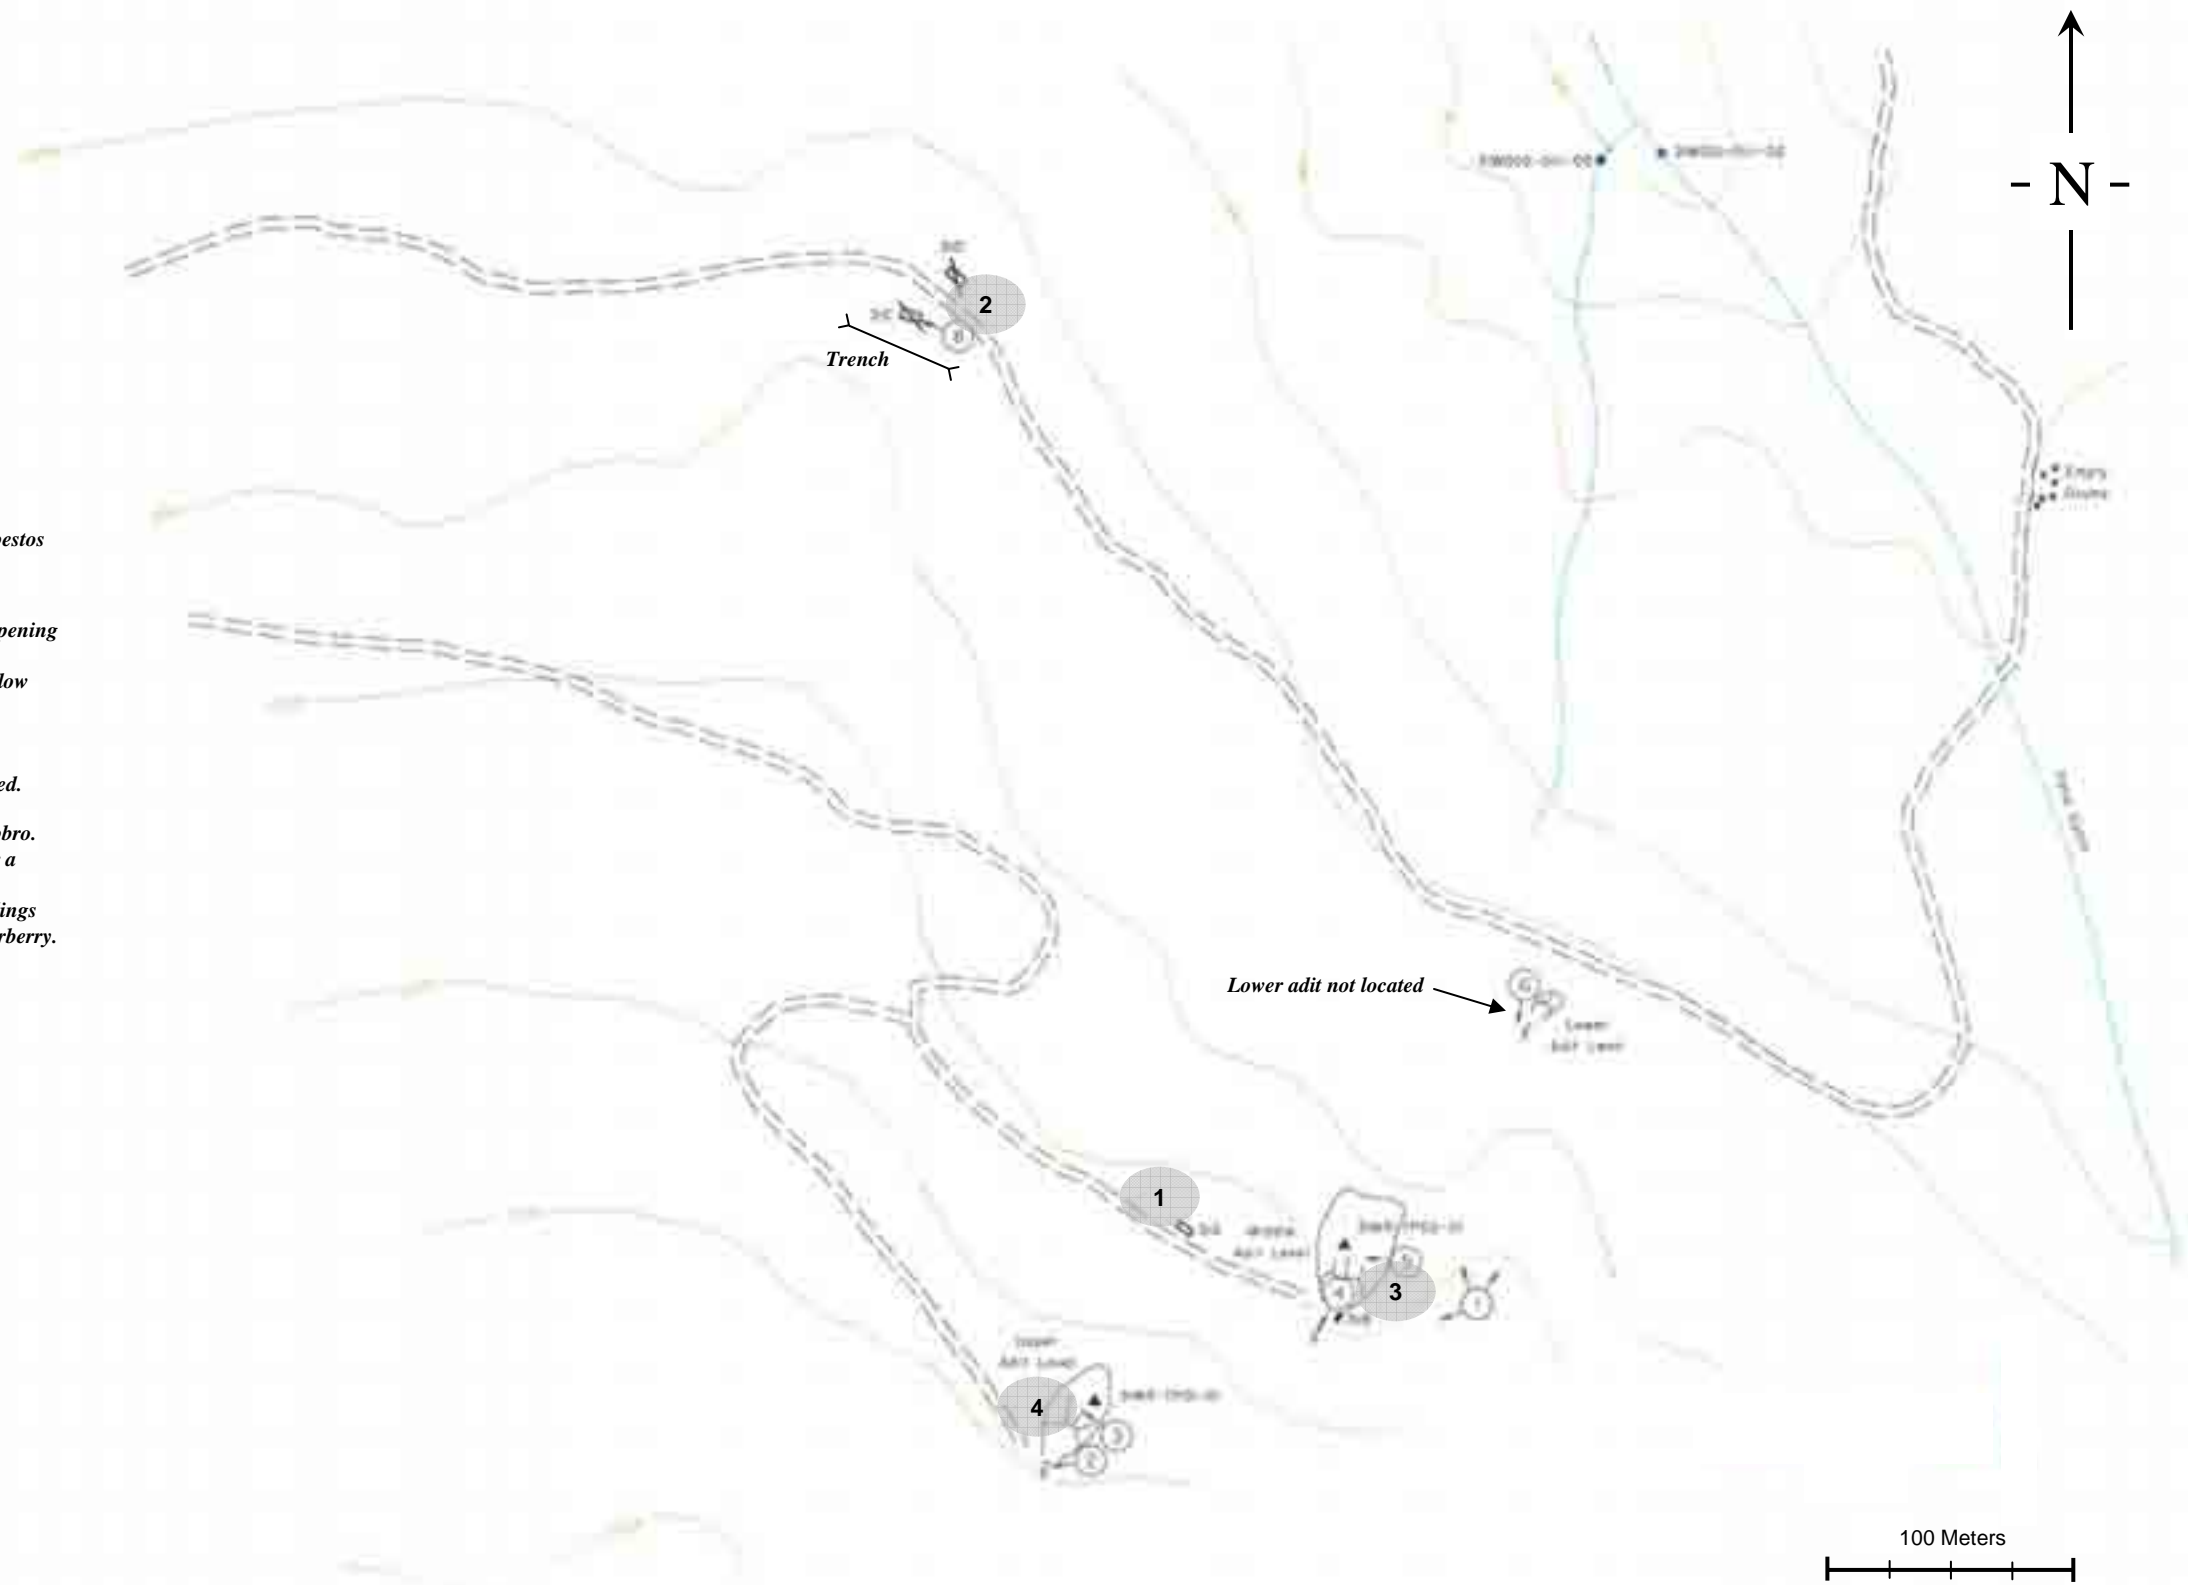
- #4 - Waste rock is mostly graphitic phyllite with minor greenstone or foliated gabbro. East side of waste rock pile has oxidized siderite waste over length of dump for a width of 3 m.

- Test pit, likely excavated during PWGSC investigations, has ~25 willow seedlings growing in it. Dump otherwise has minor revegetation- willows, fireweed, bearberry.

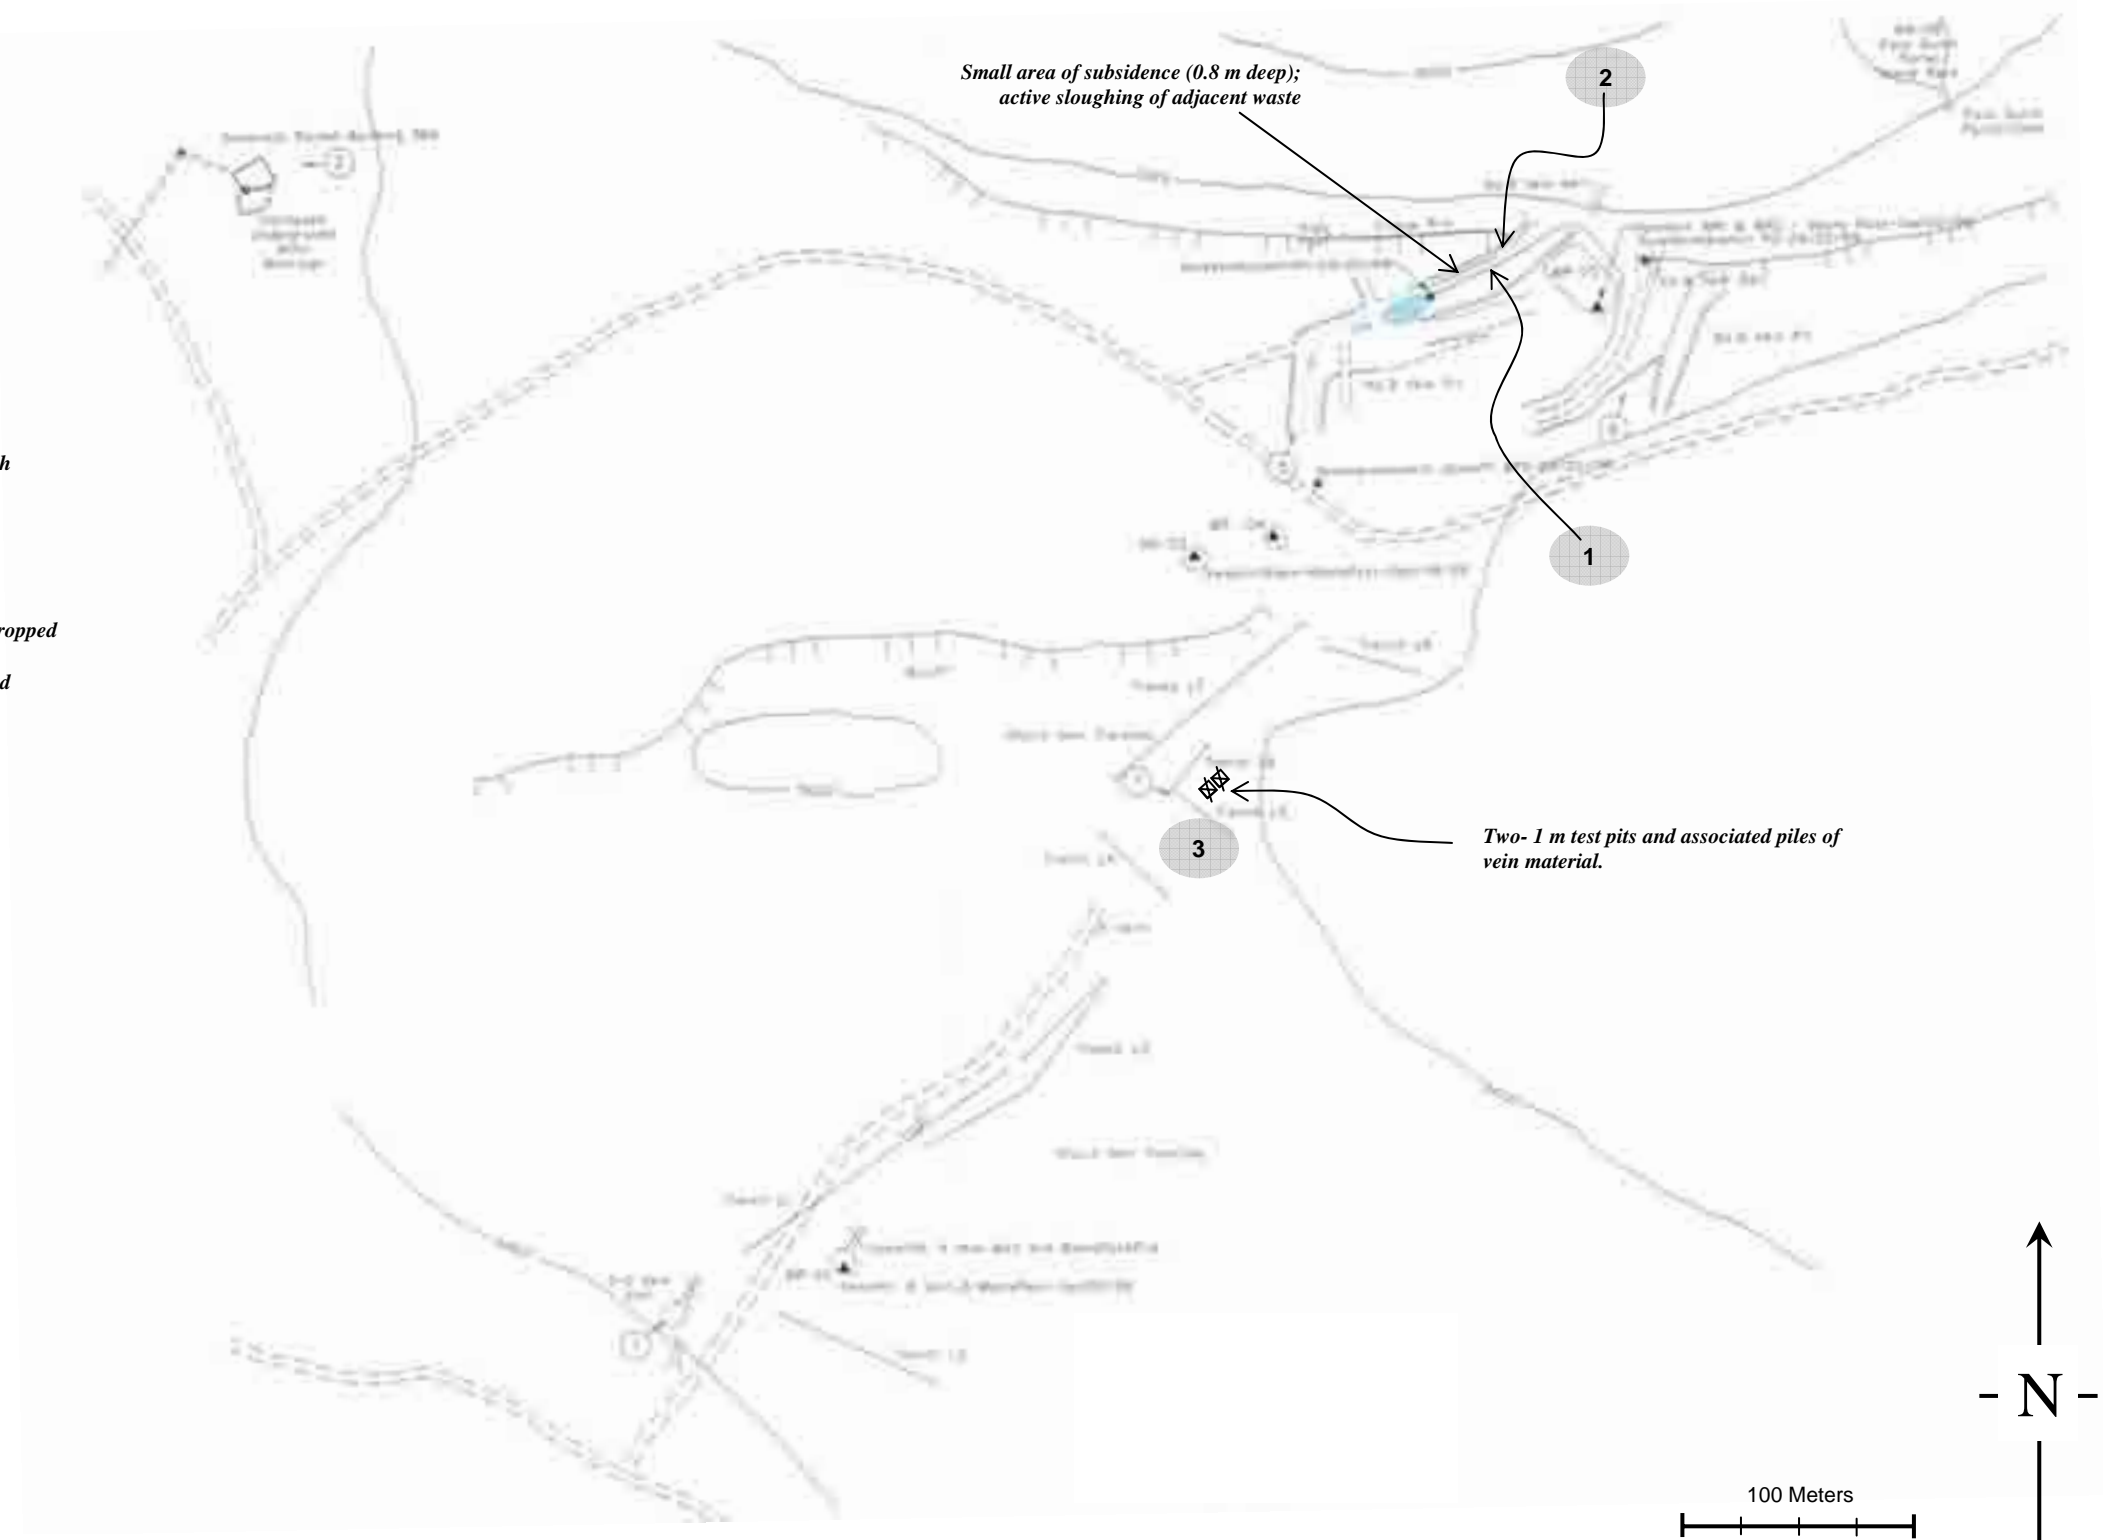
- #1** - Collapse of supports for drift; open hole with high potential for access. Depth estimated to be a minimum of 4 m. High risk due to proximity to Signpost.
- #2** - Open hole (opening 0.5 m x 1 m).  
- Easy to crawl into; void appears to be 3 m x 2 m x 1.5 m. High risk due to proximity to Signpost.
- #3** - Timber-lined shaft, 3 m x 1.5 m, partially collapsed. Water at 2 m depth- a dropped rock suggested water depth was about 0.3 m.  
- Associated waste rock pile (1.5 m x 15 m x 10 m) composed of rusty brown and black vein material and blocky greenstone.
