## **KENO HILL SILVER DISTRICT**

## **CLOSURE ISSUES REPORT**

MARCH 2009

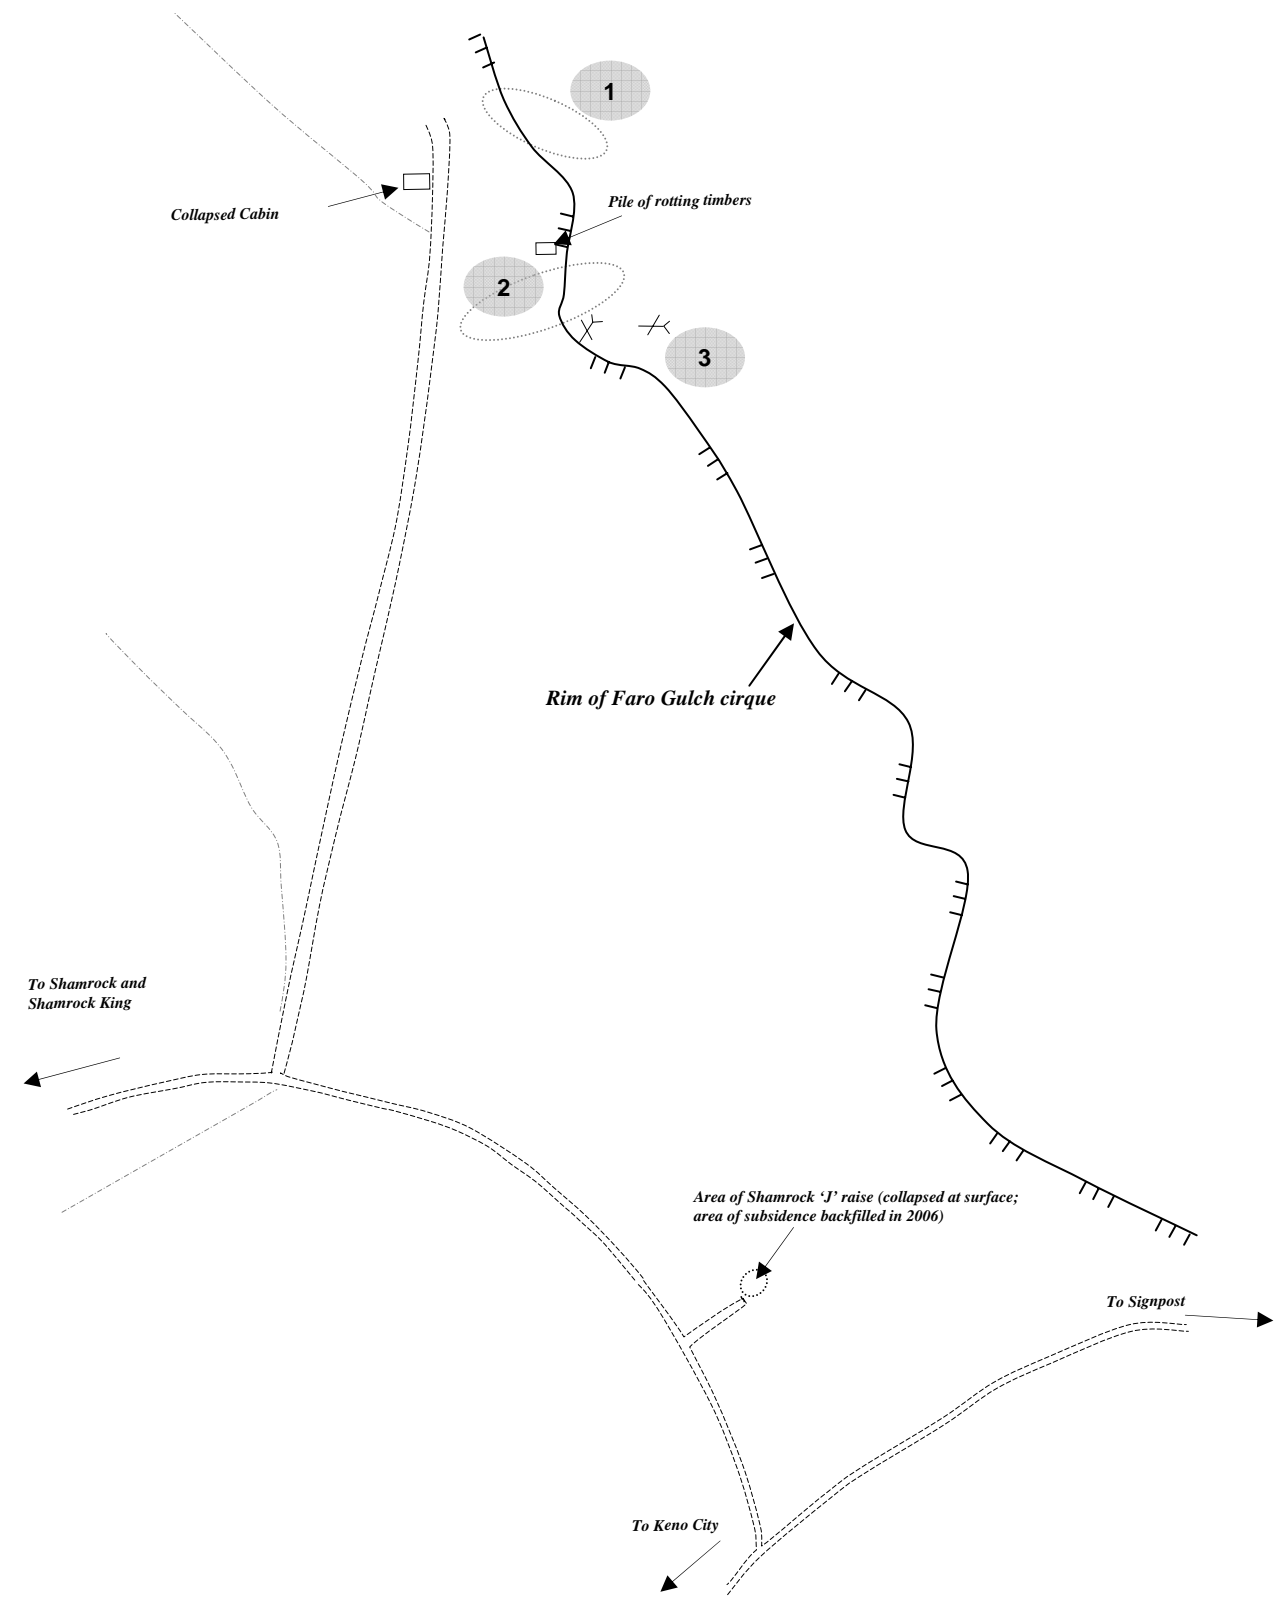
Date: Jan. 2007  
Approved:  
Figure: 115

- #1** - Areas of trenching and test-pitting near rim of Faro Gulch.
- #2** - Area of several shallow hand shafts and hand trenches.
- #3** - Two collapsed adits had small waste piles on slope below adit mouth. Waste rock is blocky light grey quartzite, greenstone, and carbonaceous phyllite.
- Support timbers protruding from the collapsed rock at both adits; no accessibility to underground.
  - Audible trickling noise of water coming from collapsed rock at upper adit; no surface flow observed.

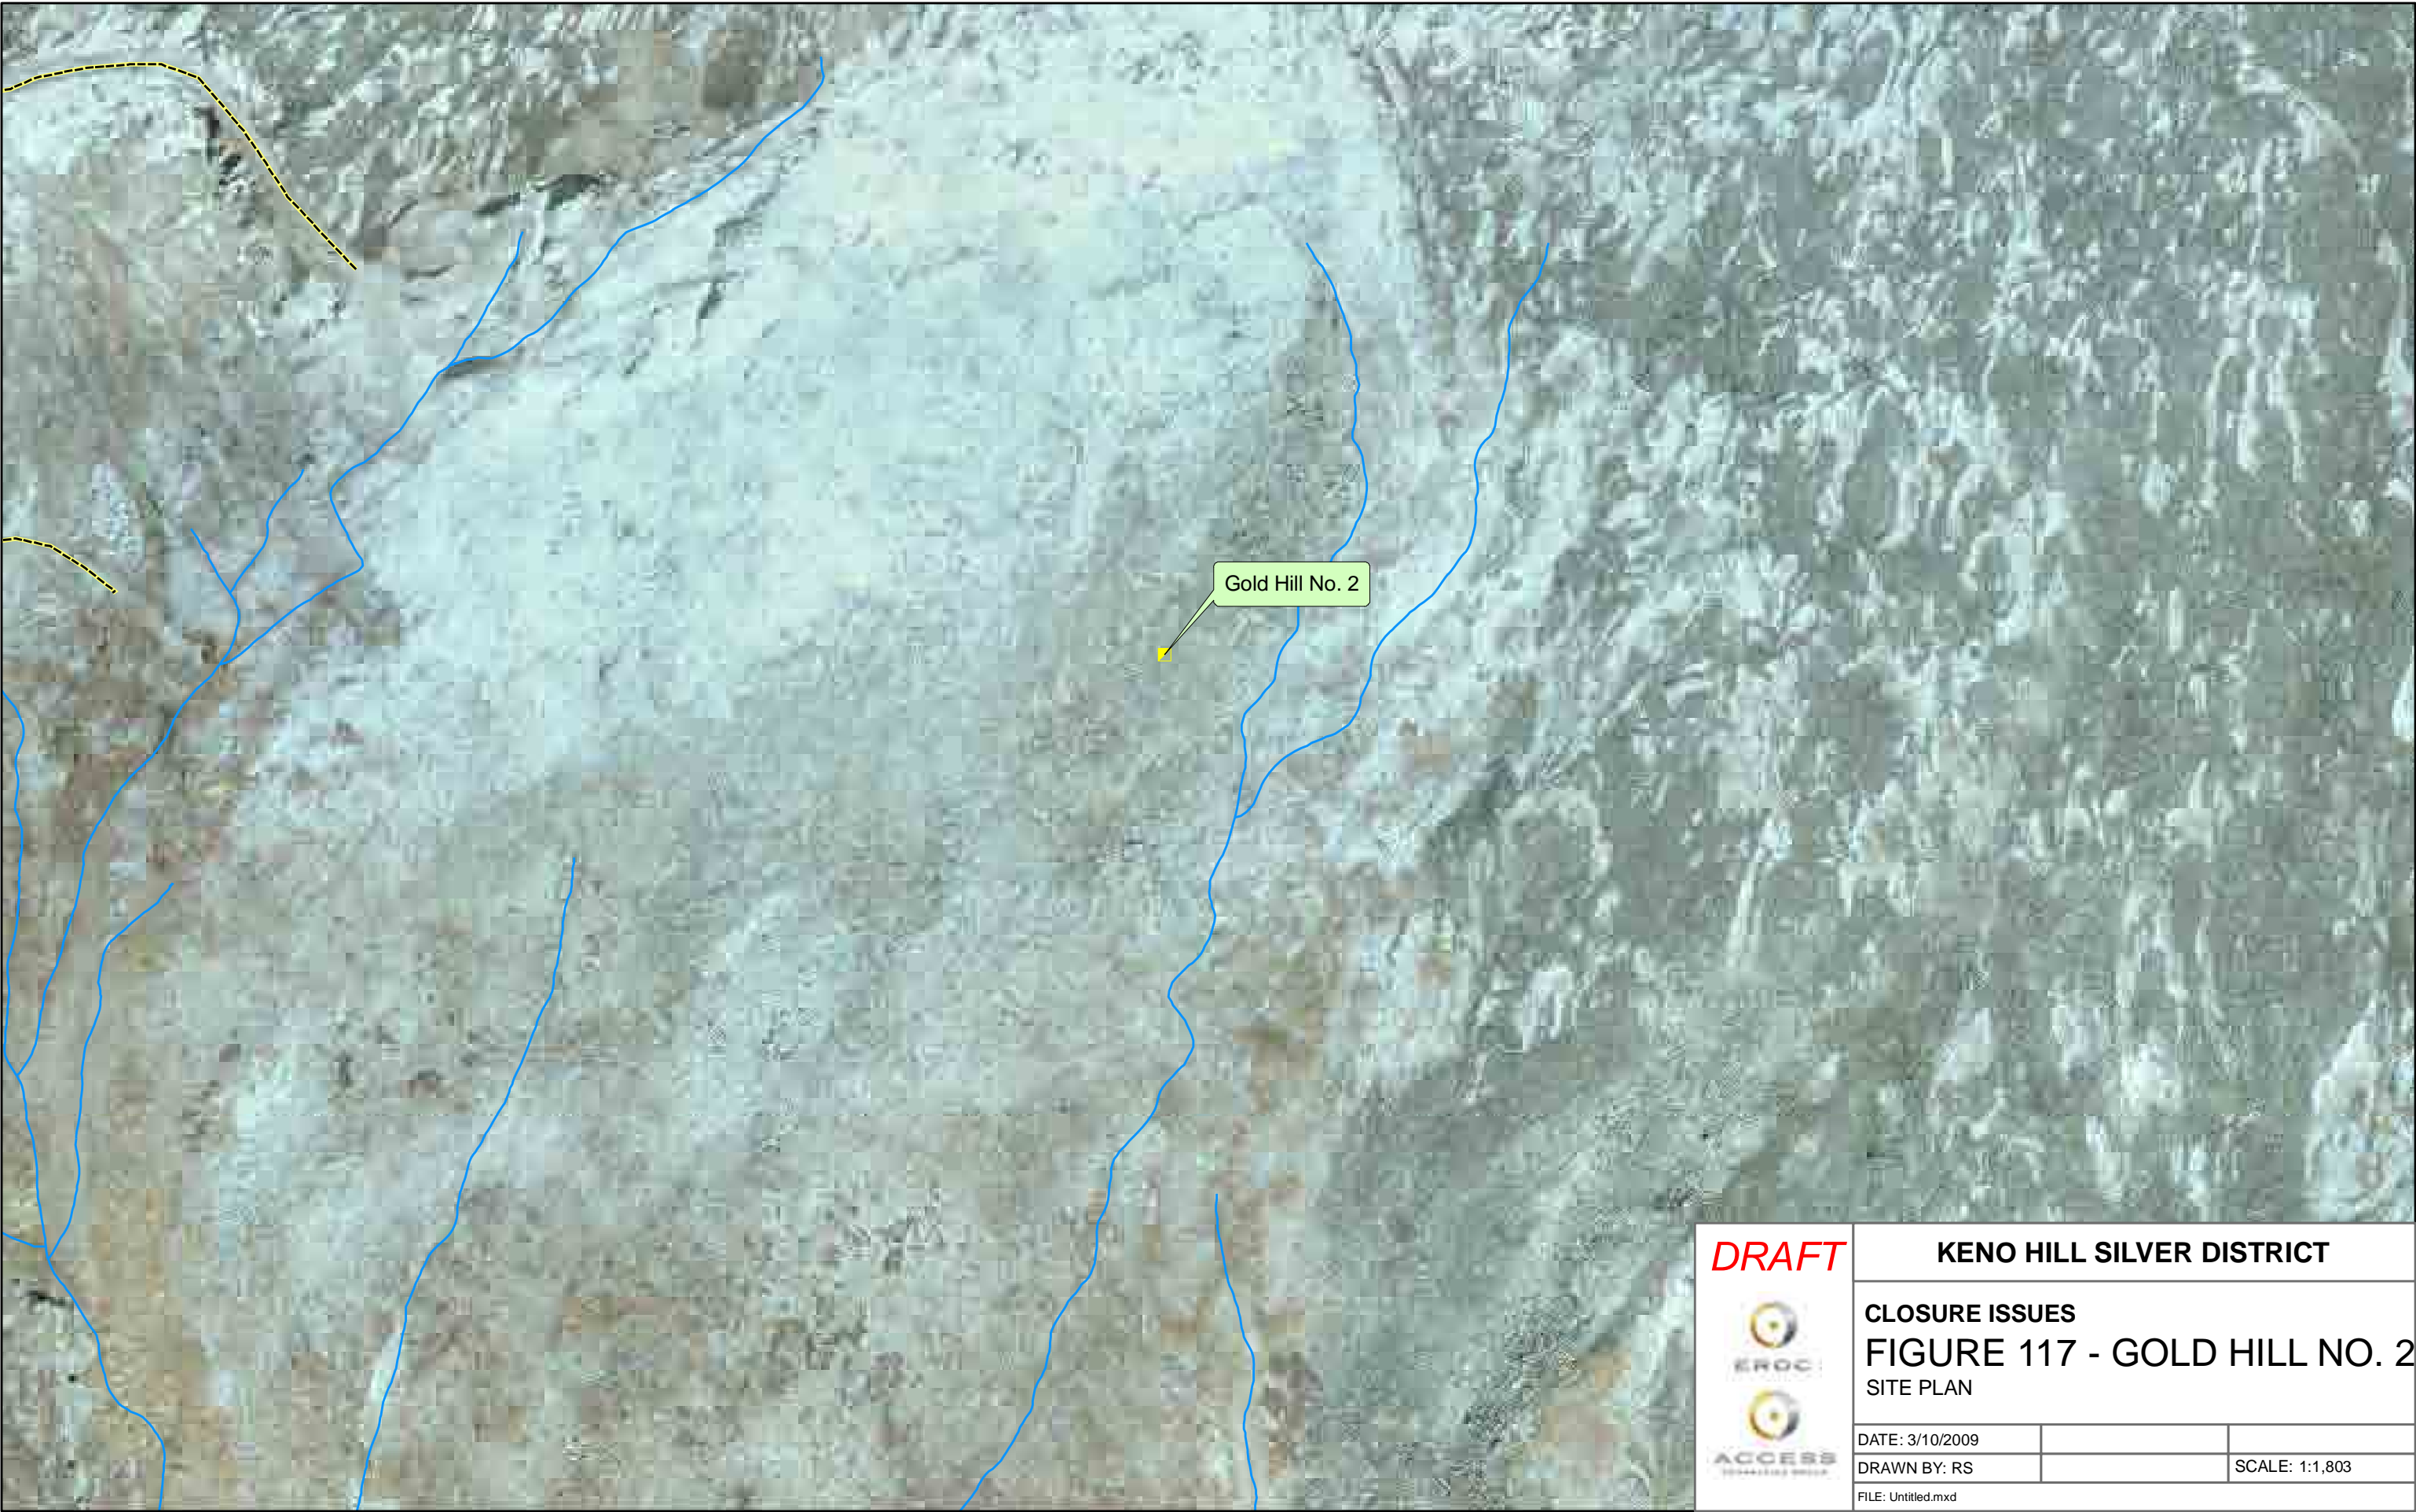
**Table 35 Gold Hill No.2 Closure Issues Matrix**

Common Site Name: <b>Gold Hill No. 2</b> PWGSC site #: 37 Site coordinates: <u>easting</u> <u>northing</u> 490740.00      7090400.00      *coordinates are projected to UTM zone 8 N, Nad 1983						
General Location Description	Closure Issue Categories					
	Human & Wildlife Health and Safety	Chemical Control	Water Management	Physical Stability	Community Concerns	Other
Trench T8			✓			
General site debirs	✓

- #1 - Orange staining at upper end of trench along ephemeral drainage path. Dry at time of inspection (Aug. 2006).  
- Small pond at lower end of trench (1 m x 2 m x 0.3 m). No staining observed.
- #2 - Waste rock from trenches has uniformly-stained fracture surfaces- orange to brownish orange, occasionally rusty brown.
- #3 - Debris scattered throughout site- drill rods, lumber, pipe, metal.

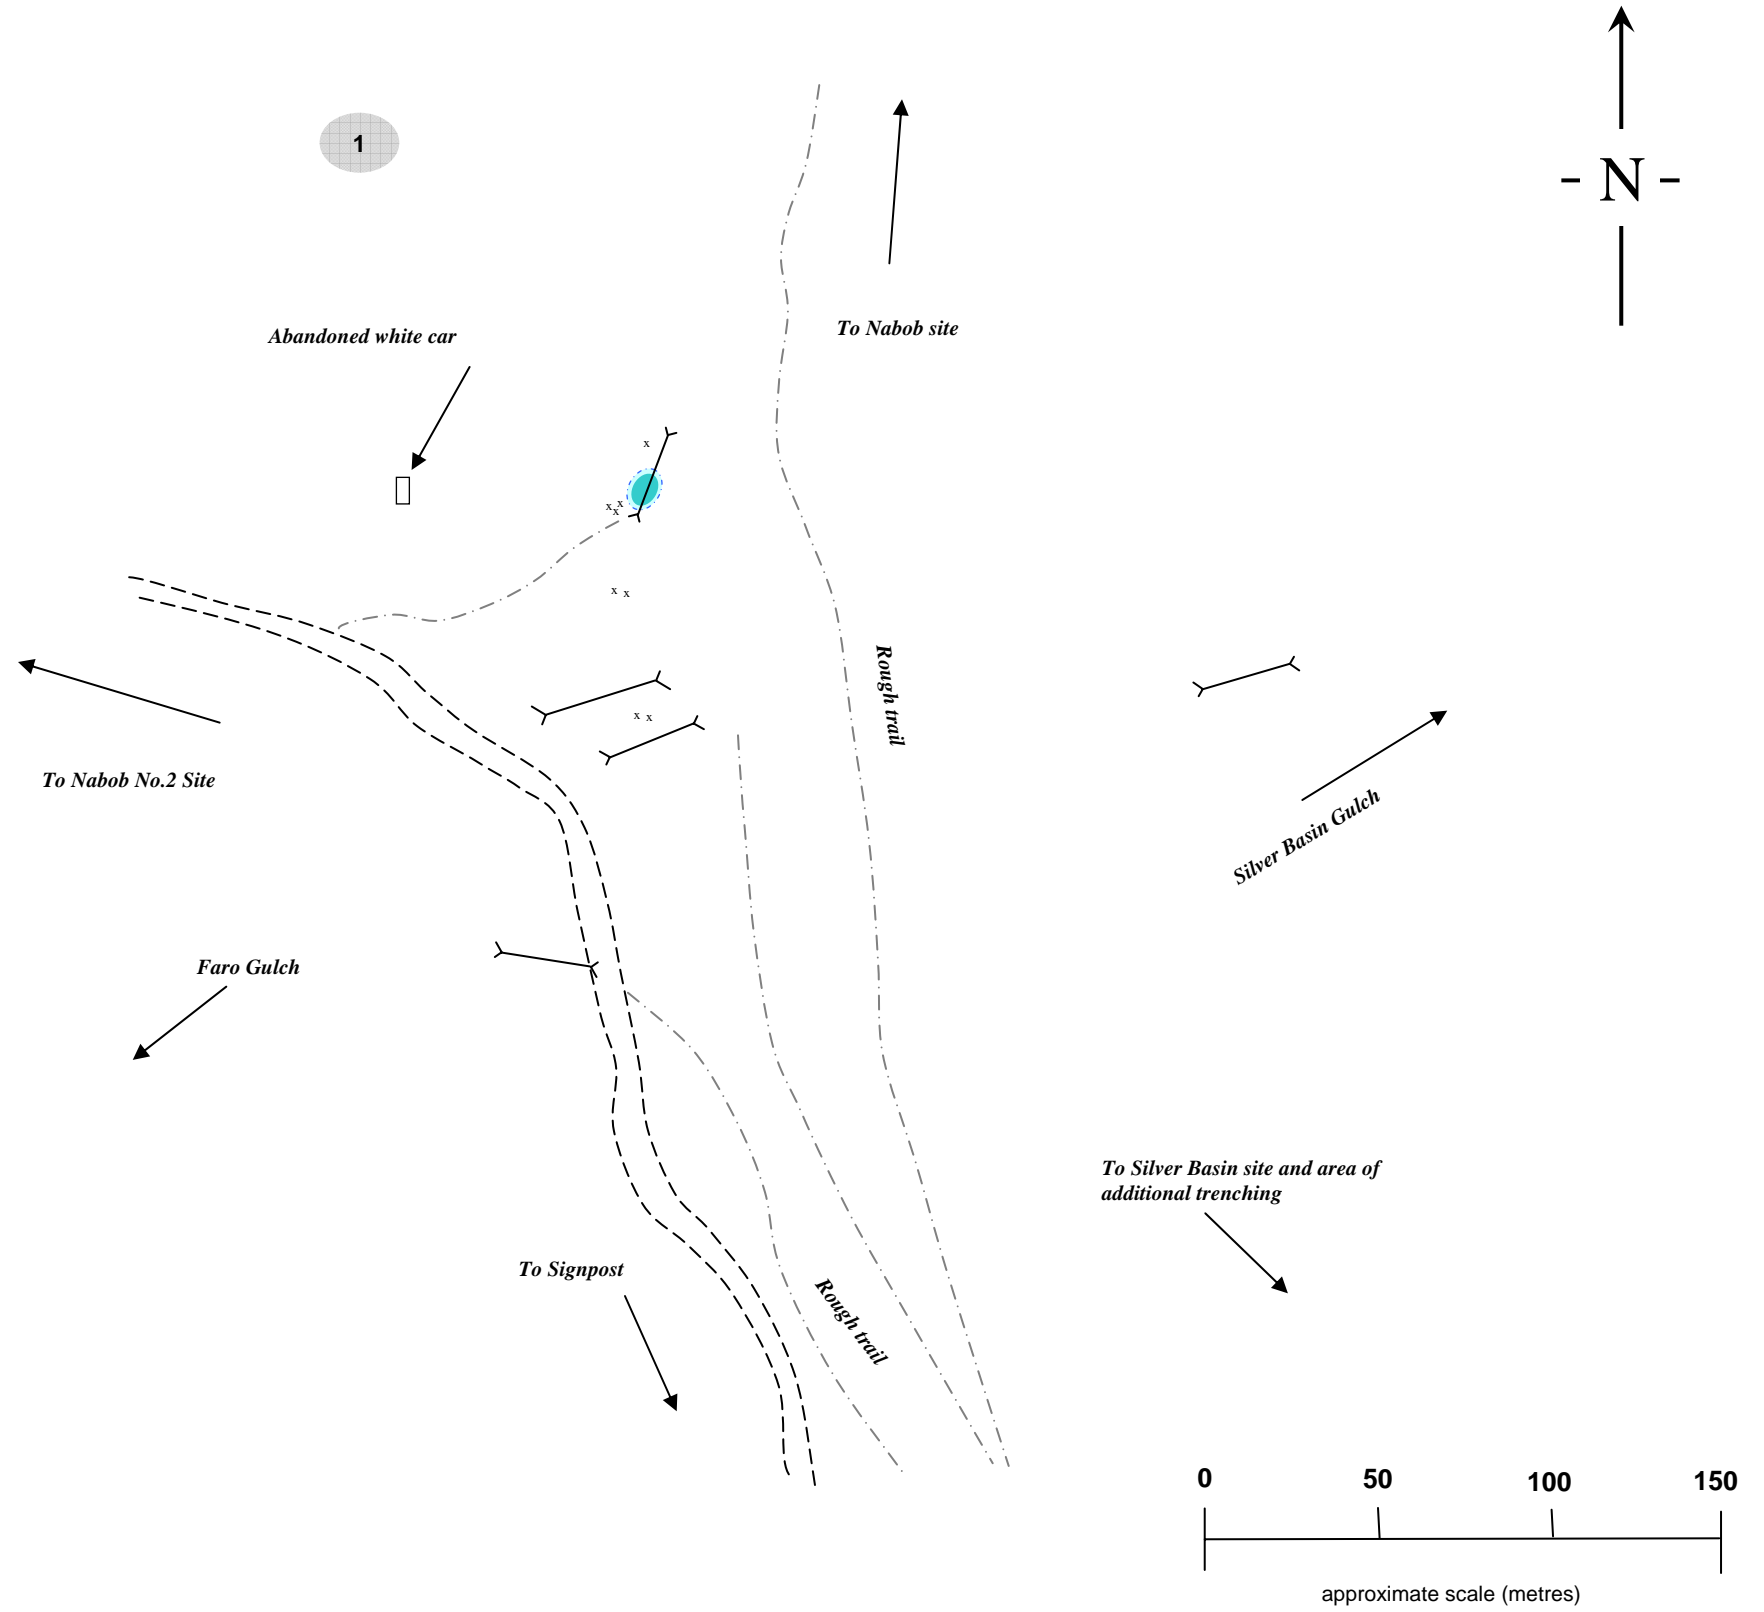
VANCOUVER		  ALEXCO		Fox Site #38		
Job No: ALEX-06-ESP-05		Baseline Environmental Report, United Keno Hill Mines Property				
Filename: Site38_Fox_20070131.ppt				Date: Jan. 2007	Approved:	Figure: <b>120</b>

#1 - Surface topography in this area prevents surface drainage from flowing to north into McKay Gulch. All surface drainage from the Site reports east to Silver Basin Gulch or west to Faro Gulch.

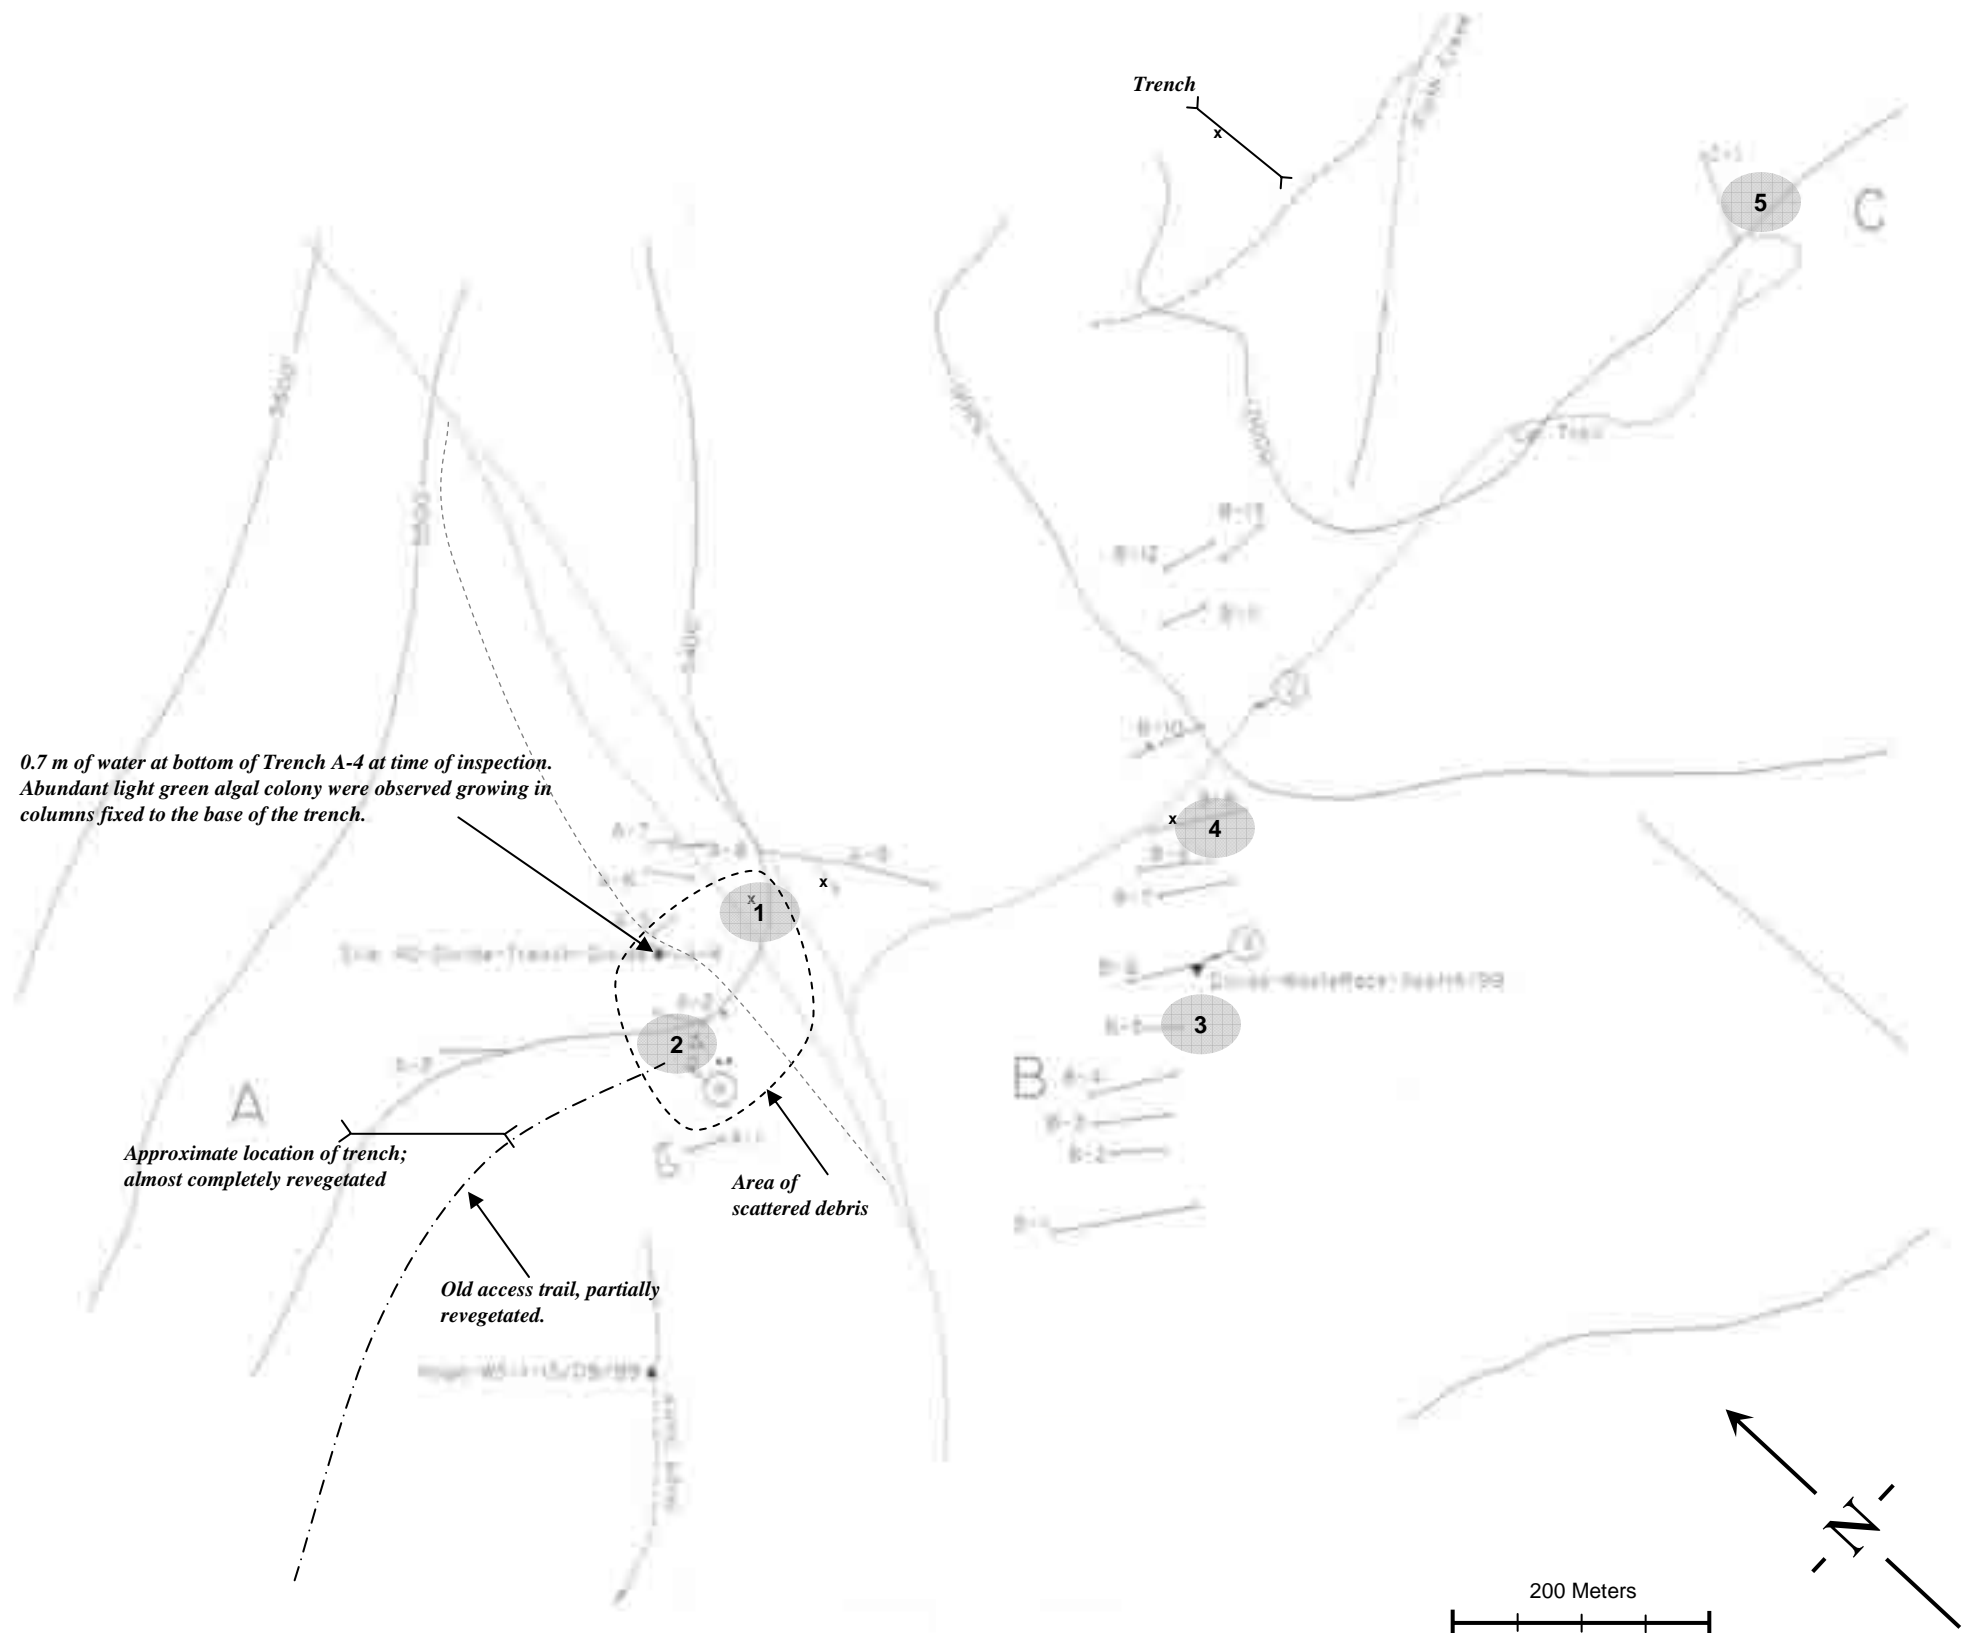
- #1 - Previously unidentified barrel, approximately 50% full of fluid- odour and texture suggests hydraulic oil. No staining observed on adjacent ground.
- #2 - Building reported in PWGSC 2000 was observed to be laying on its side at the north end of Trench A-2.
- #3 - Minor remnant pyrite observed in oxidized material in Trench B-5.
- #4 - Barrel in Trench B-9, not in Trench B-10. Remains ~50-% full of fluid.
- #5 - Solifluction is causing trench infill; process observed at many trenches at this site. Minor revegetation is occurring where fines have accumulated. Trench is free-draining.

0.7 m of water at bottom of Trench A-4 at time of inspection. Abundant light green algal colony were observed growing in columns fixed to the base of the trench.

Area of scattered debris

Old access trail, partially revegetated.

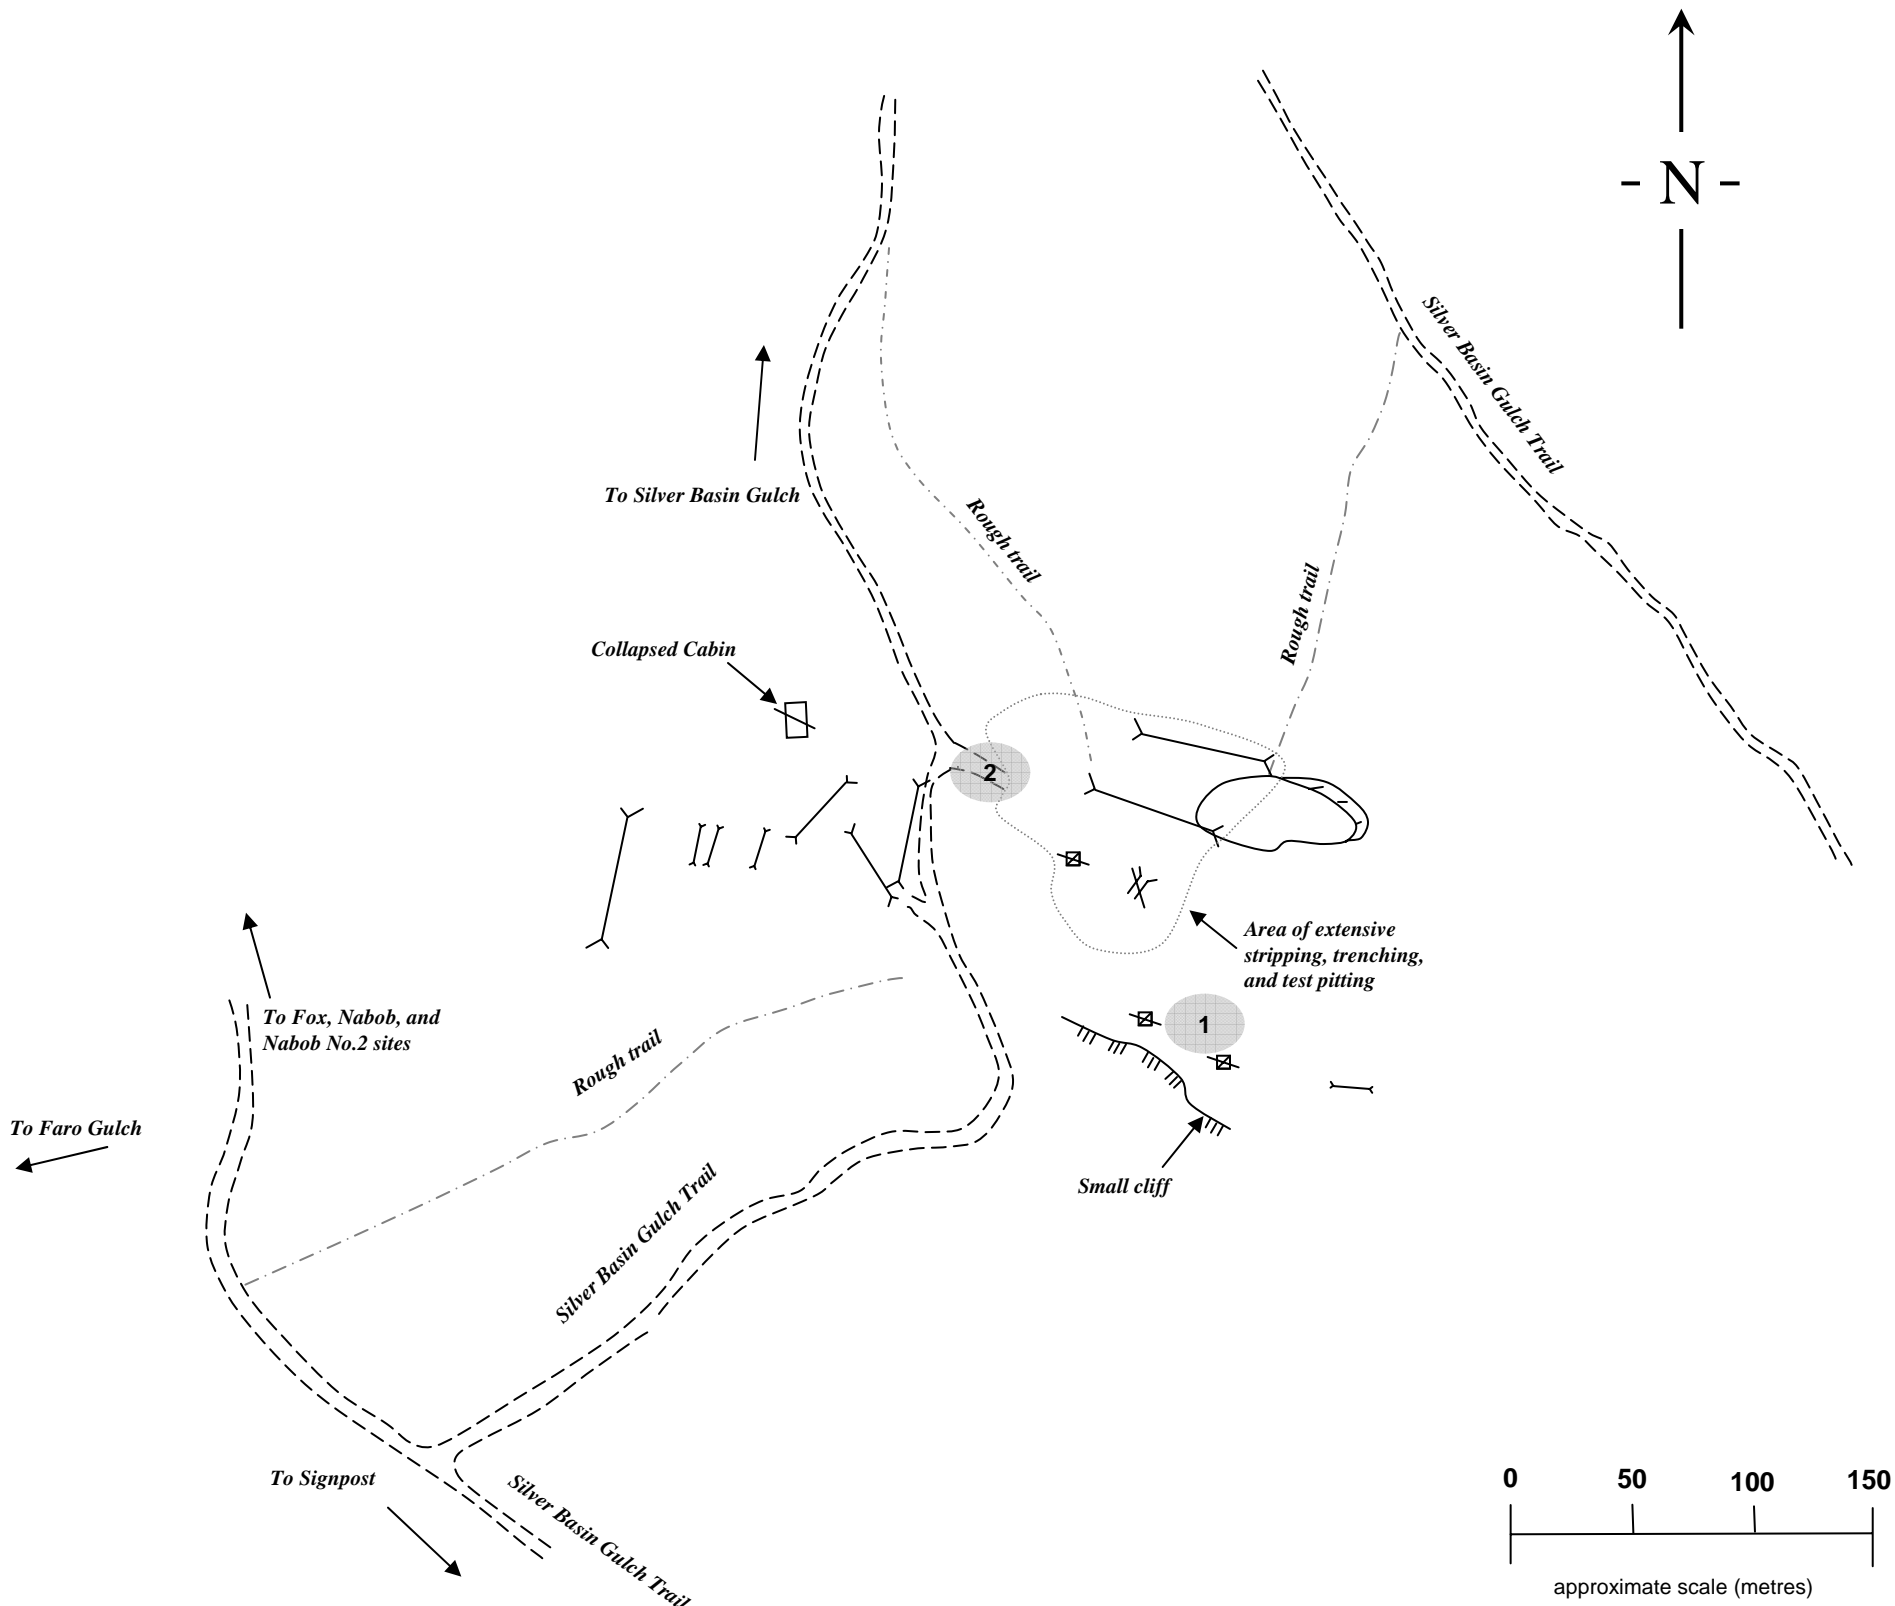
VANCOUVER		  ALEXCO		Silver Basin Site #45		
Job No:	ALEX-06-ESP-05	Baseline Environmental Report, United Keno Hill Mines Property		Date:	Approved:	Figure:
Filename:	Site45_Silver_Basin_20070131.ppt			Jan. 2007		124

- #1 - Two hand shafts at base of small cliff have minor waste piles downslope. Waste pile for southeast shaft extends down shallow surface gully; material is vein quartz, quartz sericite schist, greenstone, carbonaceous phyllite and siderite vein material with purplish black staining.
- #2 - Surface runoff from Silver Basin Gulch Trail channels down surface excavation. Oxidized vein material is exposed in the eroded channel.

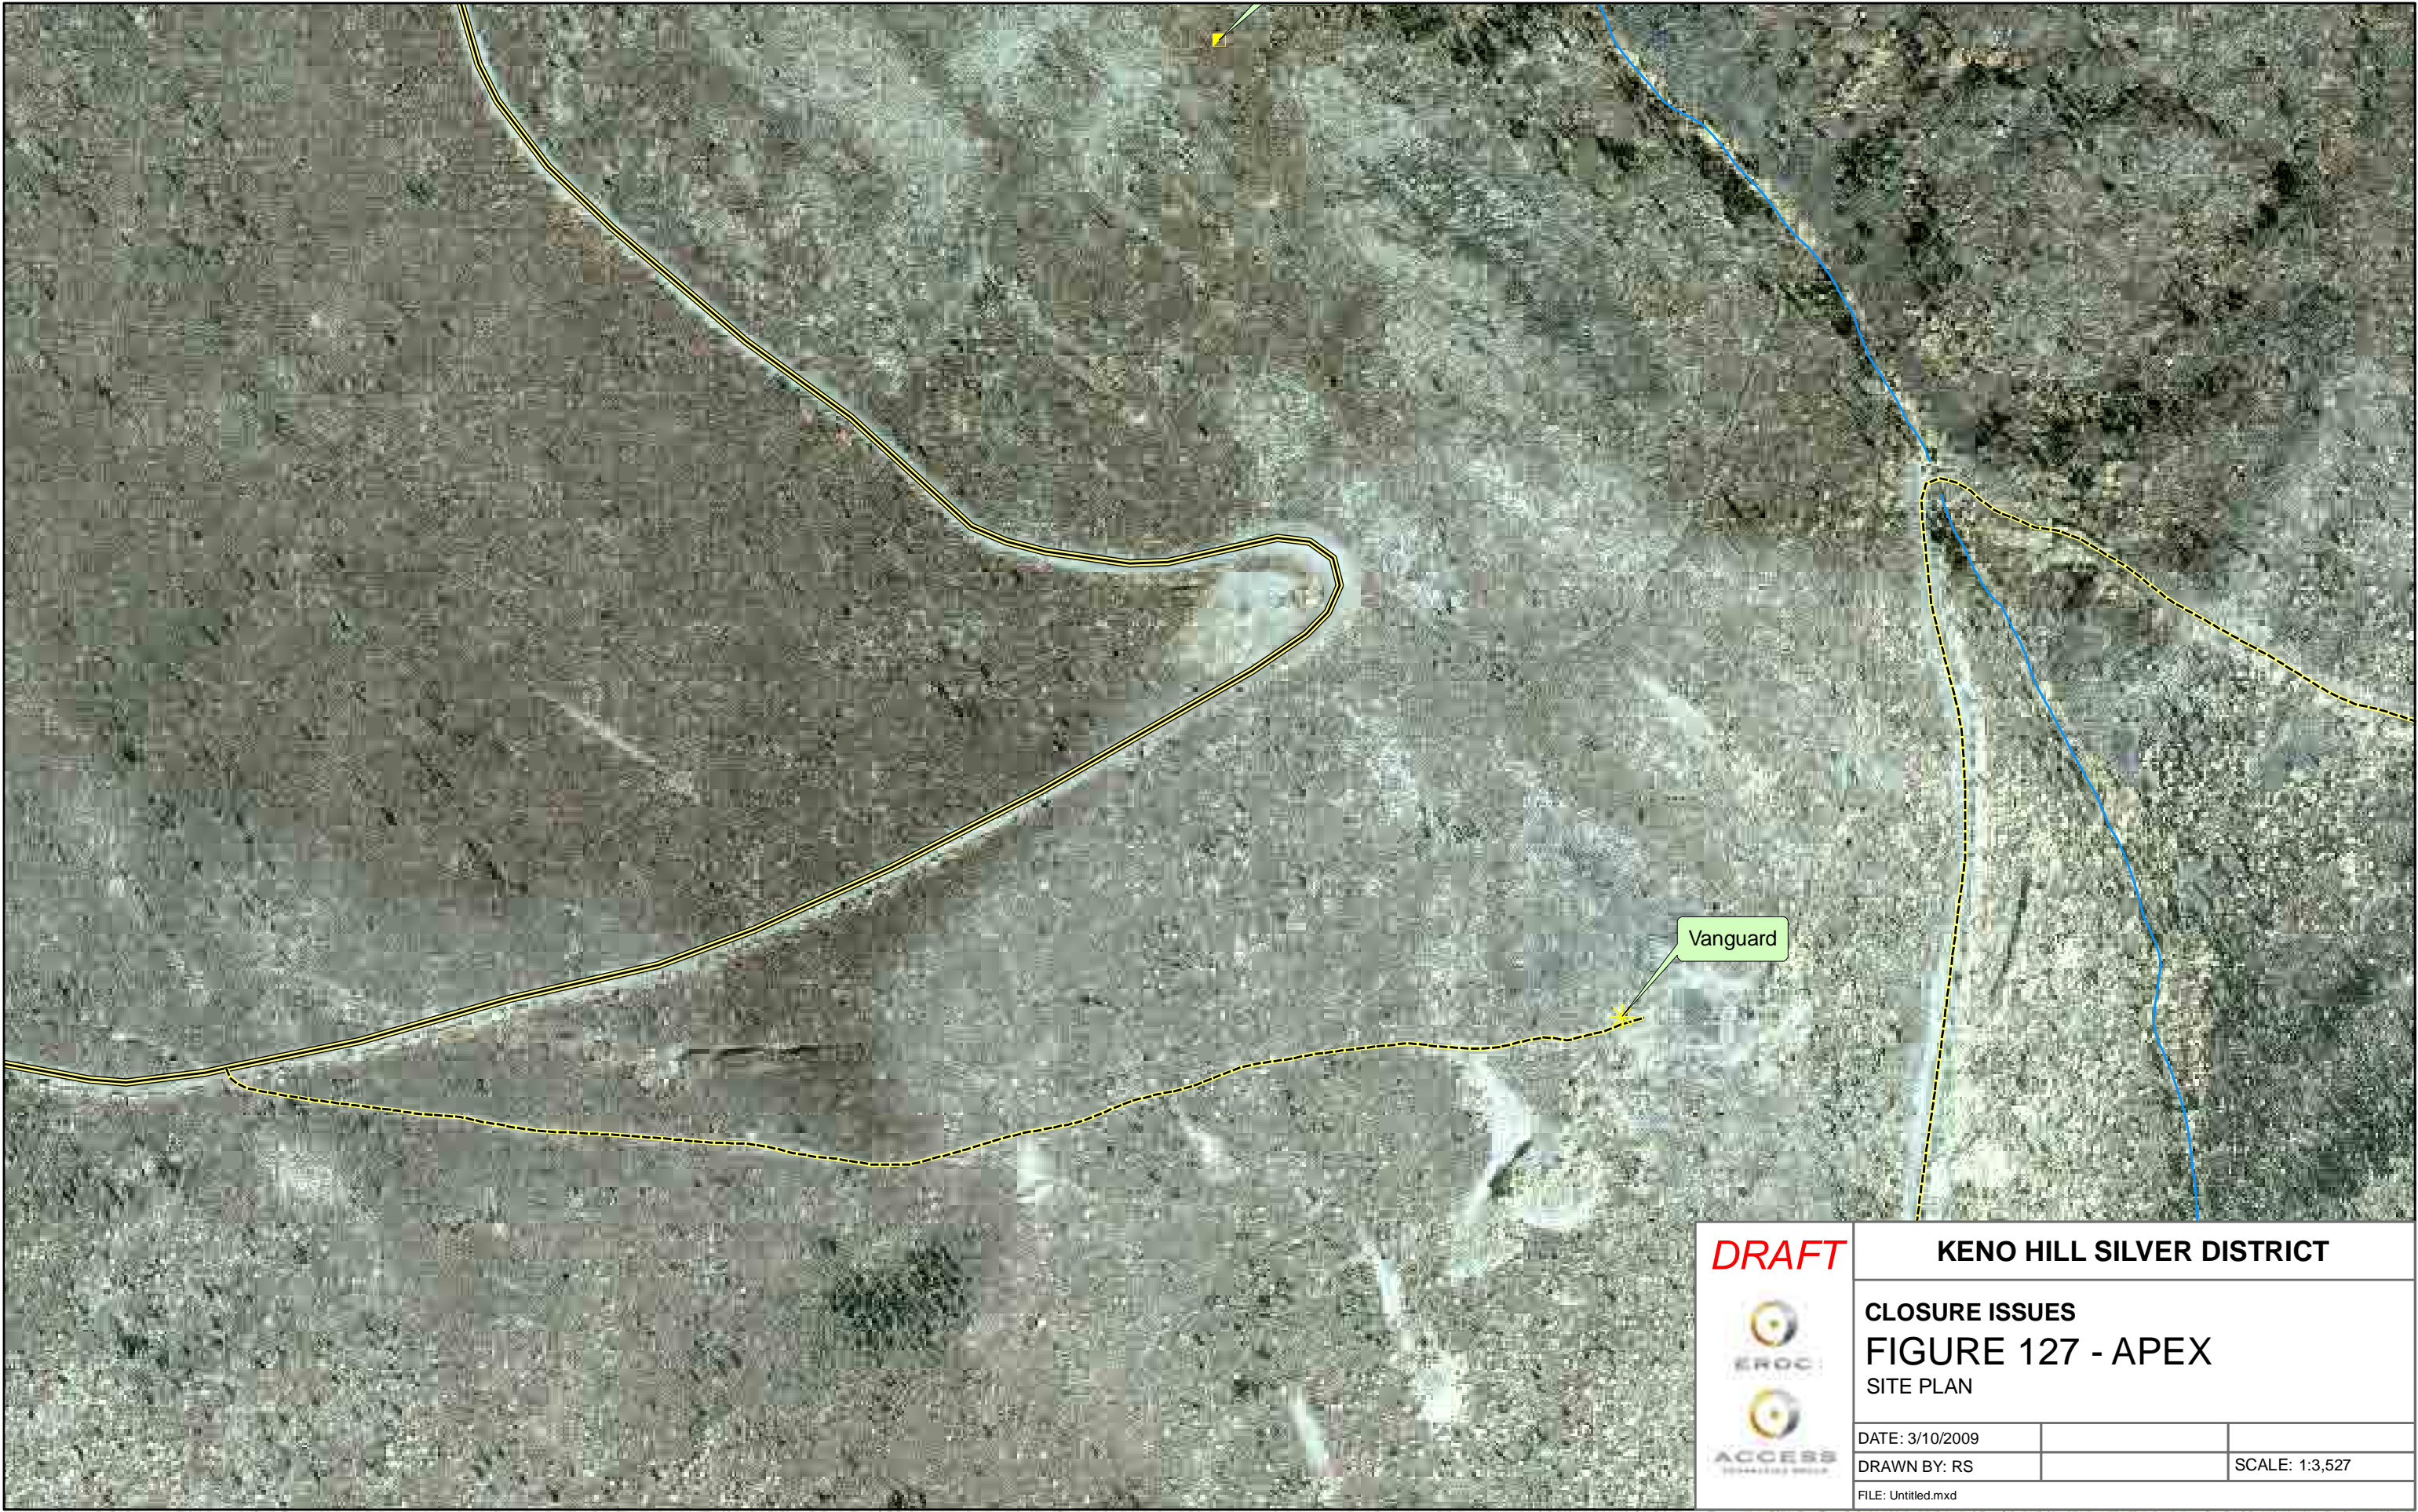
**Table 40 Apex Closure Issues Matrix**

Common Site Name: <b>Apex</b> PWGSC site #: 48 Site coordinates: <u>easting</u> 488531.00 <u>northing</u> 7088988.00      *coordinates are projected to UTM zone 8 N, Nad 1983						
General Location Description	Closure Issue Categories					
	Human & Wildlife Health and Safety	Chemical Control	Water Management	Physical Stability	Community Concerns	Other
Collapsed shaft			✓	✓

#1 - Water drains to shaft. No evidence of ponding. Timber shaft supports are rotten. Shaft collapsed at depth of 2 m. Dark purplish black vein material observed near shaft location.

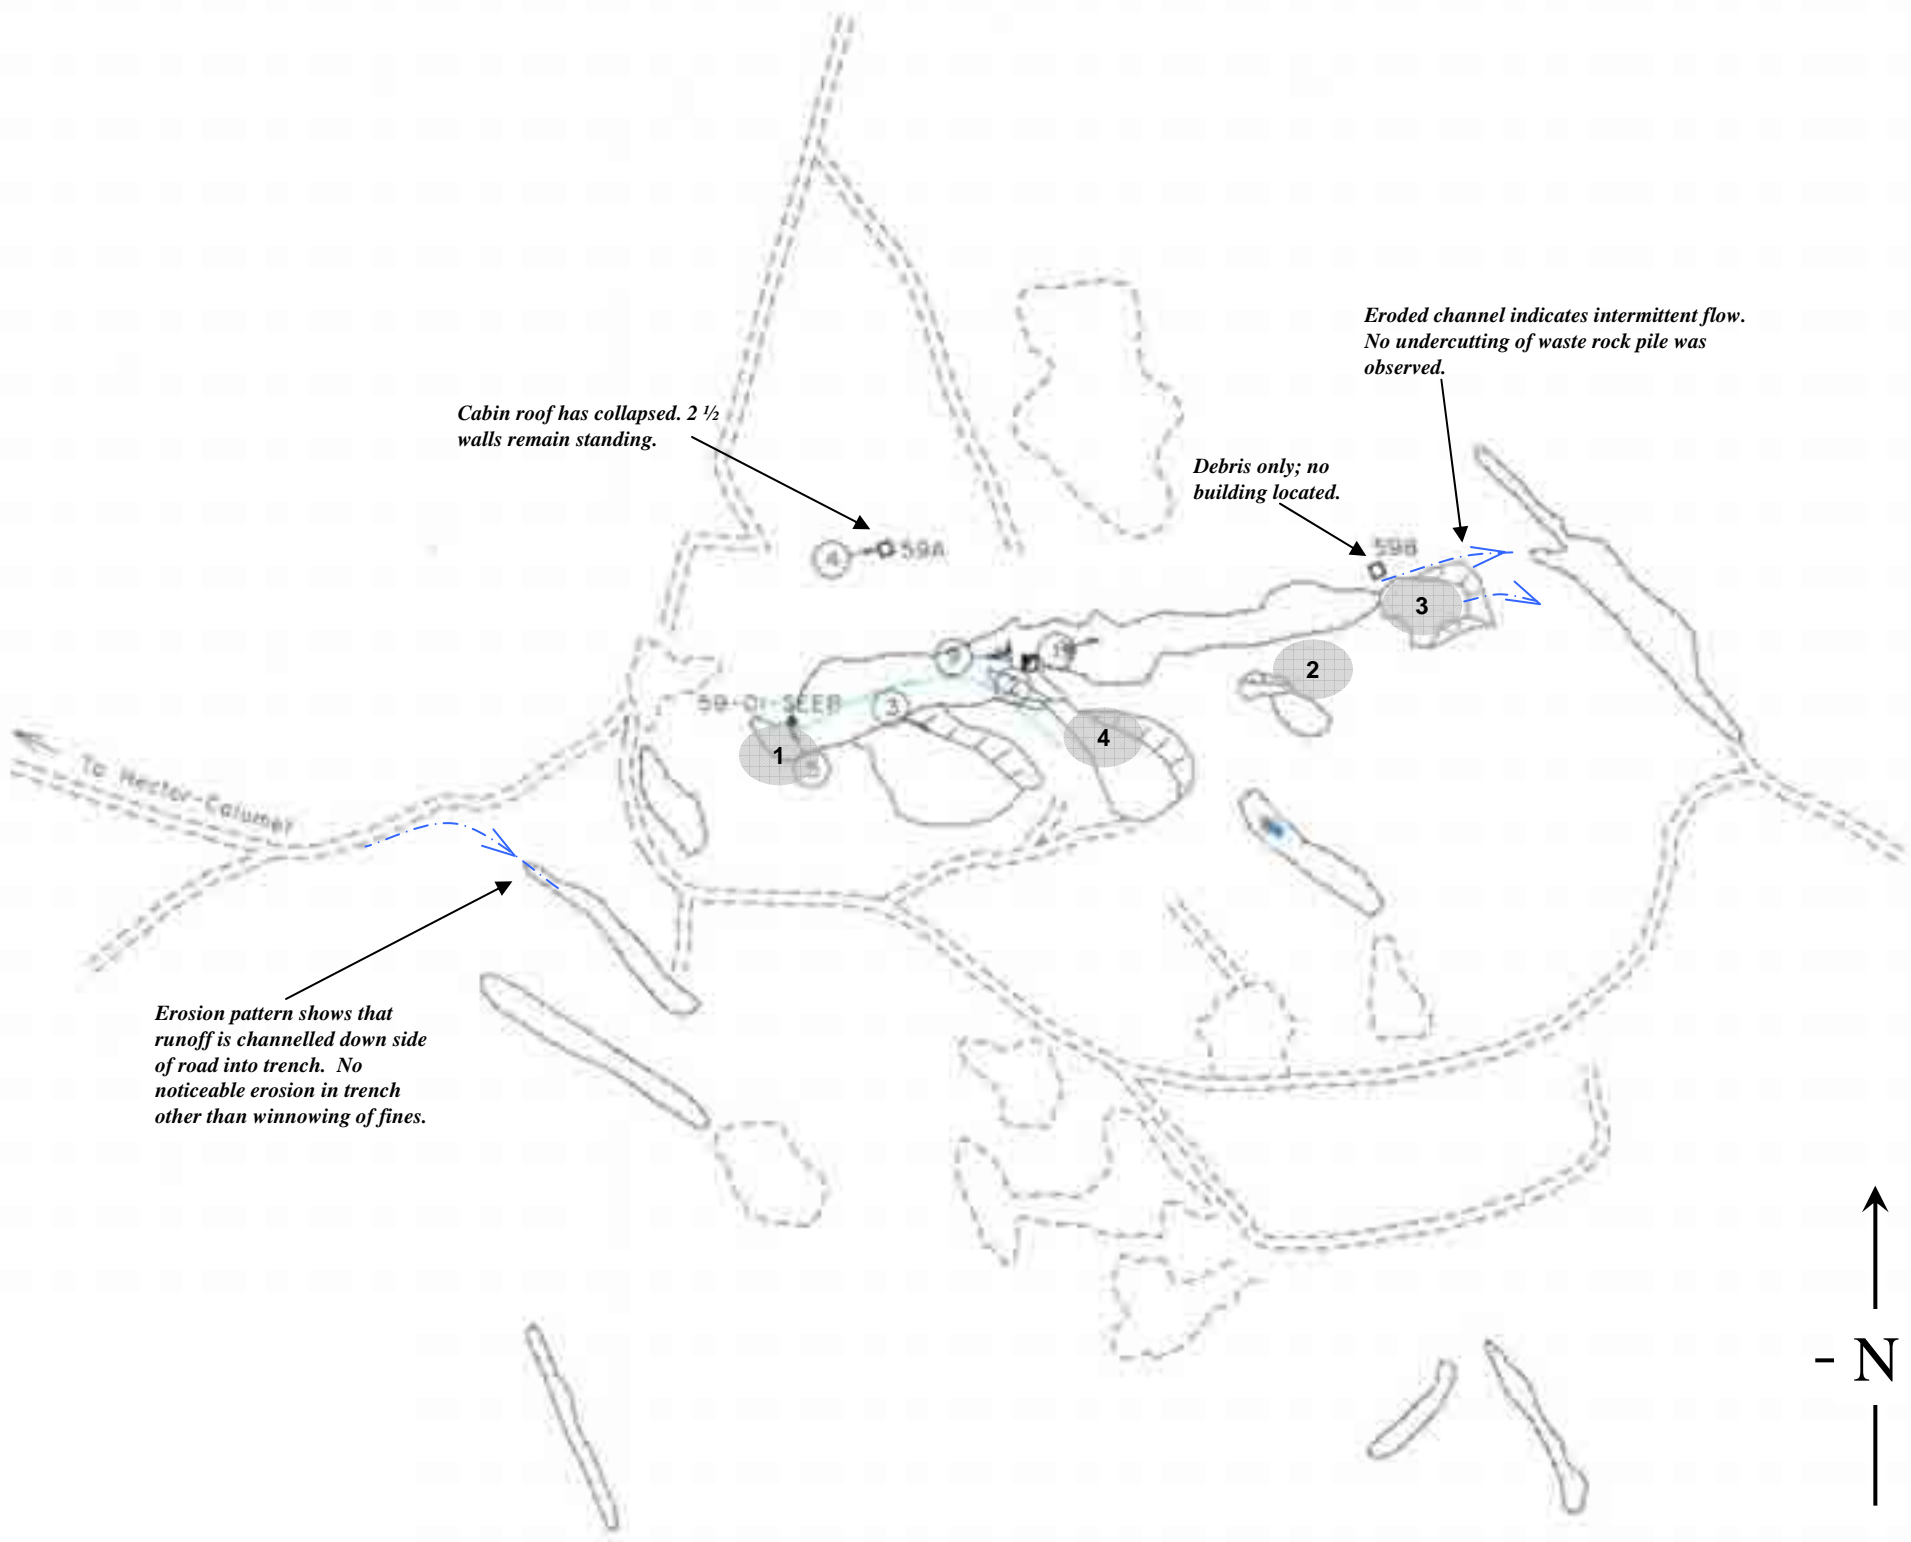
- Sides of trench range from bare to partially-vegetated.
- #2** - Dump composed of acid-generating waste- dark grey schist, quartz vein material and rare quartzite- with rinse pH of 2.6 from the <2mm fraction of a single sample. Light orange staining is common, with less frequent bleached regions (Photos 59-4, 59-5). Keno Hill Quartzite clasts in bleached areas have no stain near contact with underlying material, but have dark purplish brown staining on the tops of the clasts, away from contact with the substrate. Minor limonite observed.

- Local surface runoff flowpaths are stained yellowish brown.
  - No revegetation occurring on this waste pile.
  - Flow lobes, minor crest cracking, and oversteepened toe on north side indicate active instability (Photo 59-6).

- #3** - Flow lobes observed on downhill face of waste pile (Photo 59-7), over area approximately 15 m wide x 30 m long x 4 m high. Minor cracking at crest of pile indicates minor instability; minor erosion channel down dump face and sediment fan extending from toe indicates that waste is transported during runoff events (Photo 59-8). Dump toe is oversteepened. Minor revegetation of dump face- spruce seedlings up to 1 m, grasses, willows.

- #4** - Abundant medium-grained pyrite observed in waste rock (Photos 59-9, 59-10). Staining varied from no staining to light orange to rusty black (Photo 59-11). Revegetation of waste rock piles is generally limited to isolated plants- overall coverage is poor.
