## **KENO HILL SILVER DISTRICT**

## **CLOSURE ISSUES REPORT**

MARCH 2009

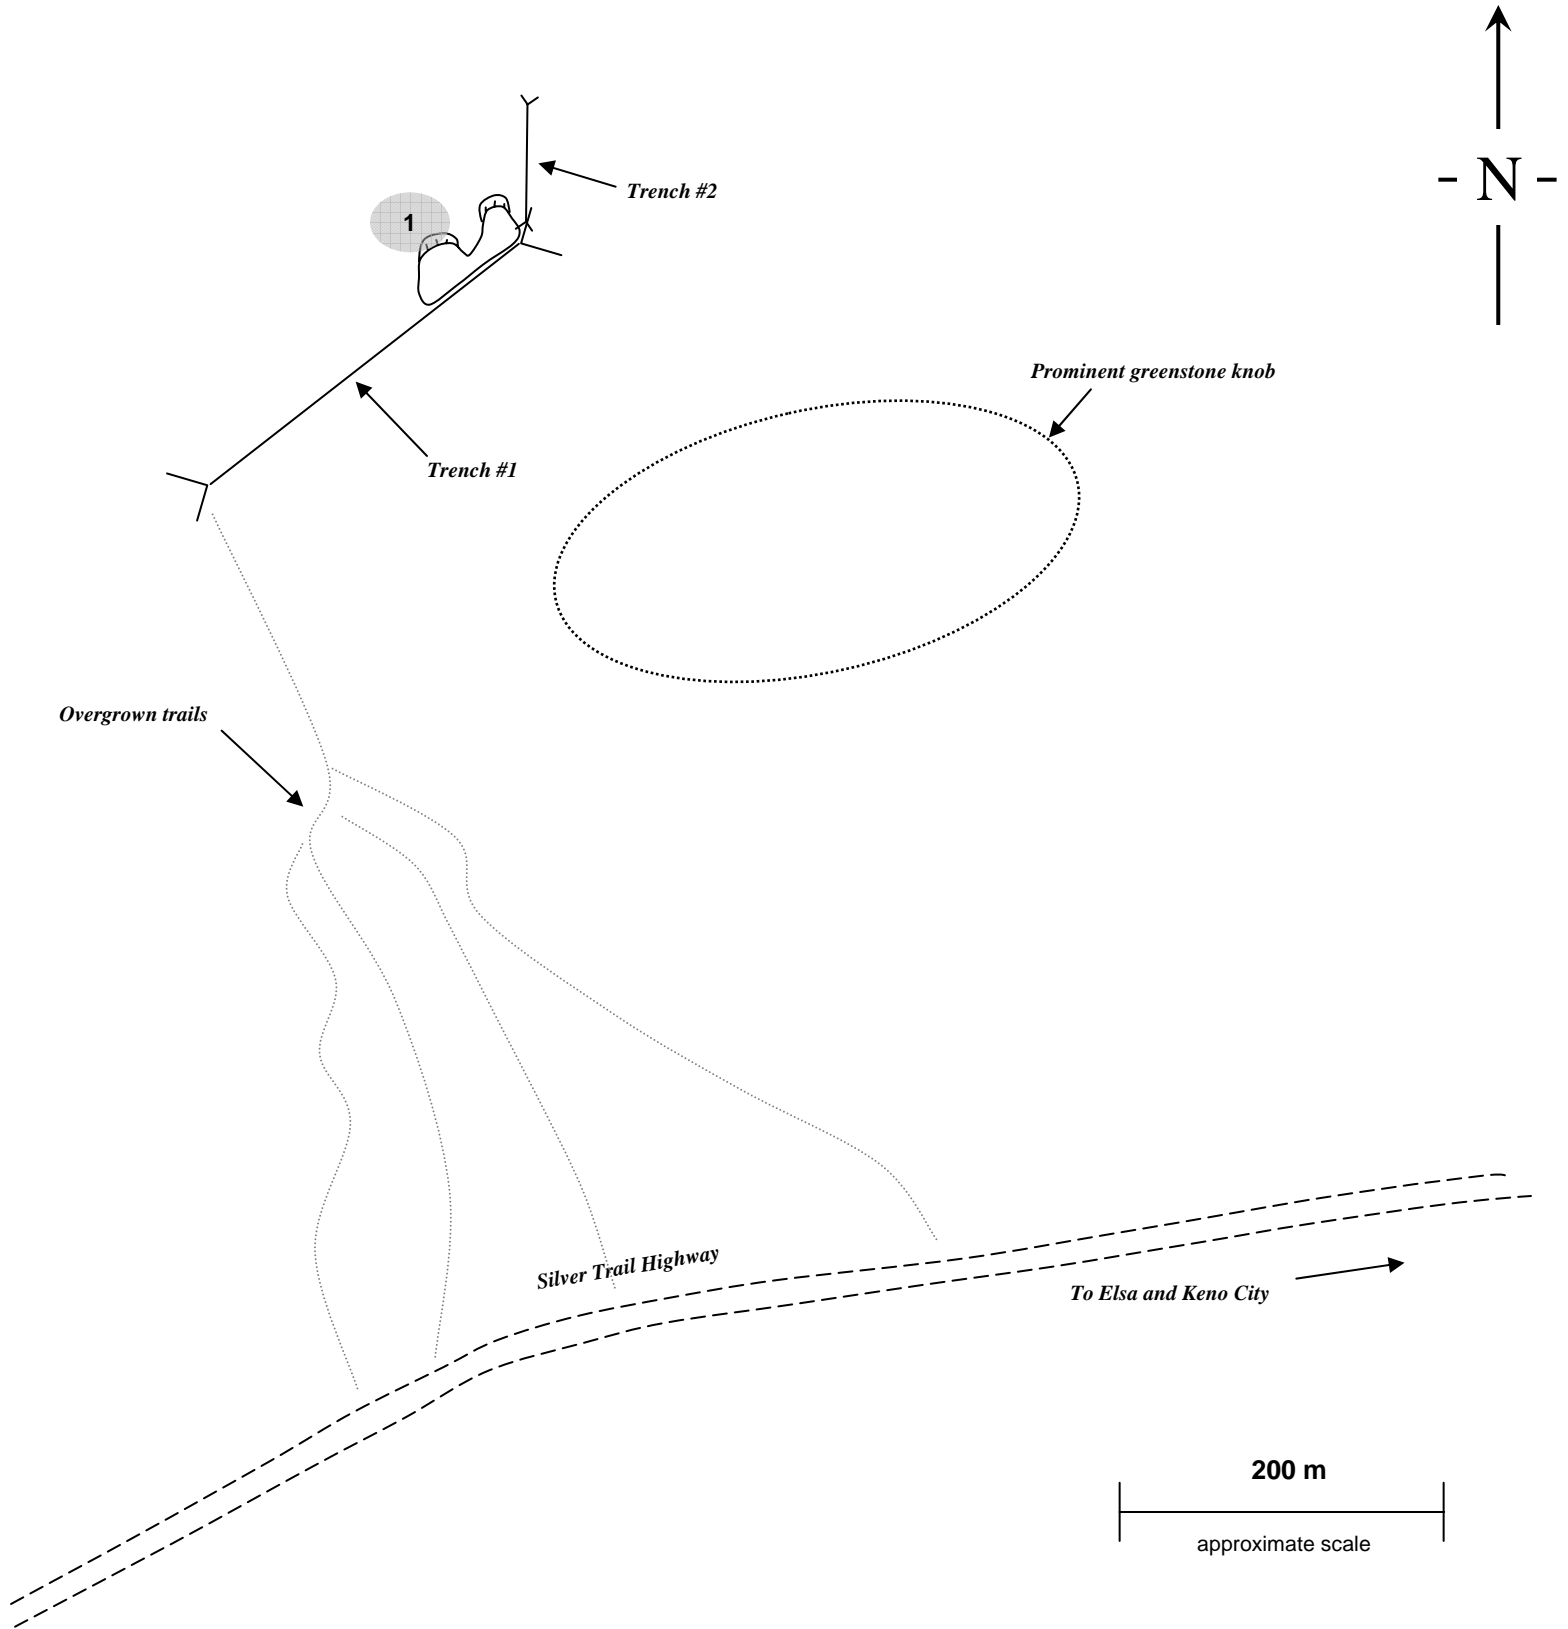
#1 - Waste rock pile at northwest end of Trench #1 has widespread staining (yellowish, yellowish-brown, and rusty orange to rusty brown), as well as areas that appear to be leached (Photos 63-1, 63-3). Abundant medium- to coarse-grained pyrite (up to 5% locally) noted as massive pods and veinlets, as well as disseminated in waste rock.

- Grain relief within clasts and fresh, untarnished appearance of pyrite suggests galvanic protection of pyrite and selective weathering of other sulphides.
- An area of heavily stressed vegetation (2 m wide) was noted north of waste rock pile toe (Photo 63-3).
- Two flow lobes were observed, and an unvegetated flow deposit of waste rock extended to north from toe of pile (Photo 63-4). Small headwall in source region indicates that instability is ongoing (Photo 63-5). Dump height approximately 2 m.

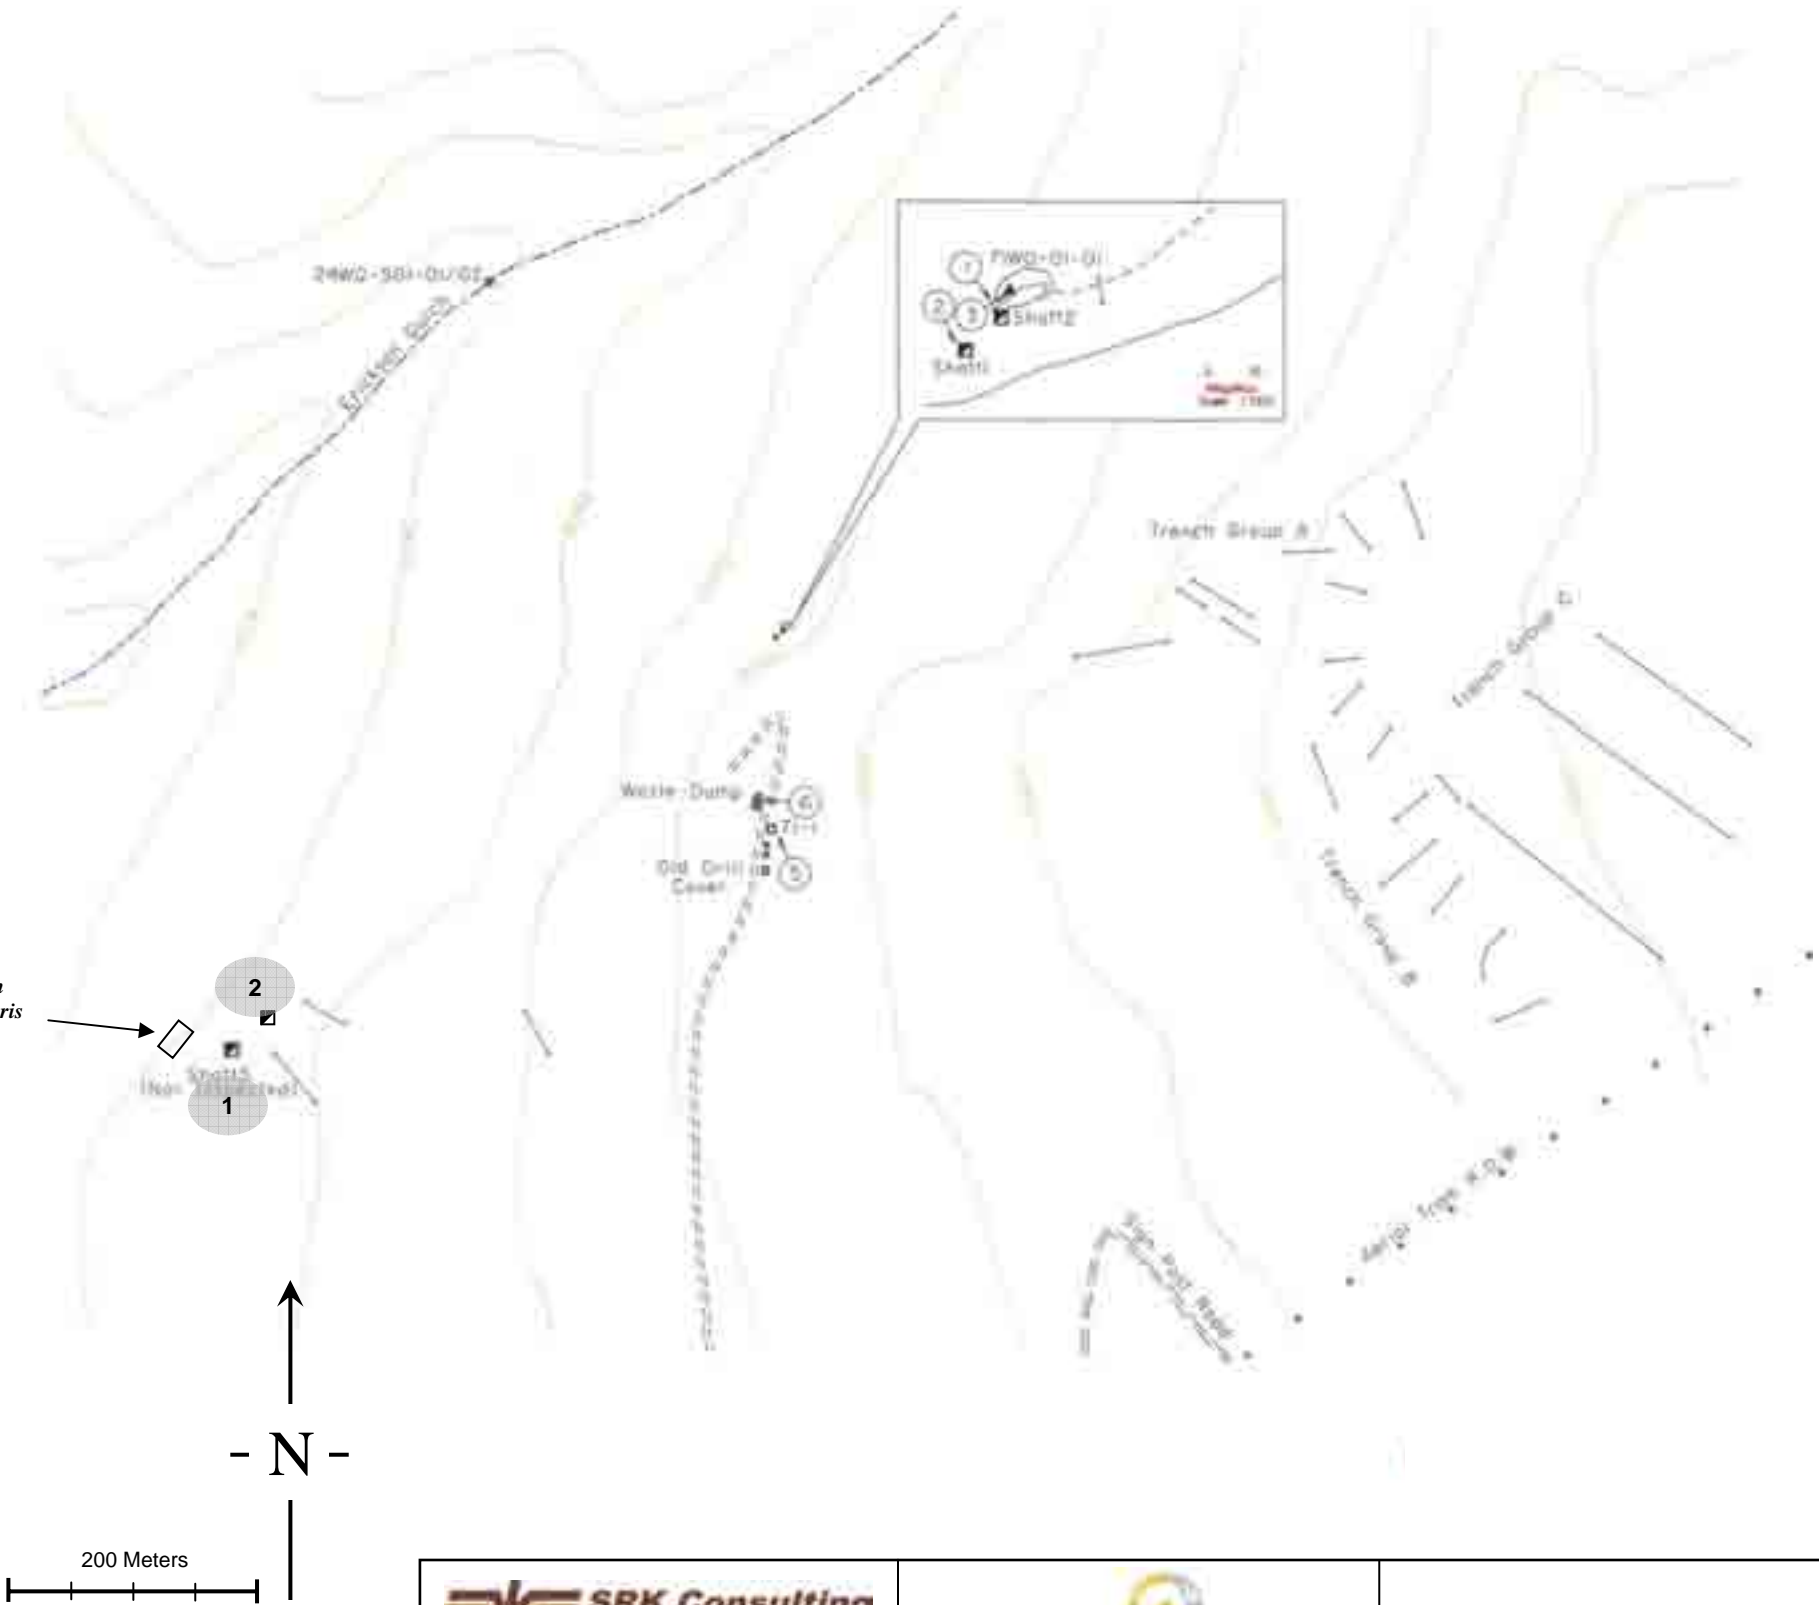
- No staining or oxidation at depth in waste rock. Composition is quartzite, chloritic phyllite, minor siderite and quartz.

Collapsed timber cabin, with metal roofing and metal debris in surrounding area

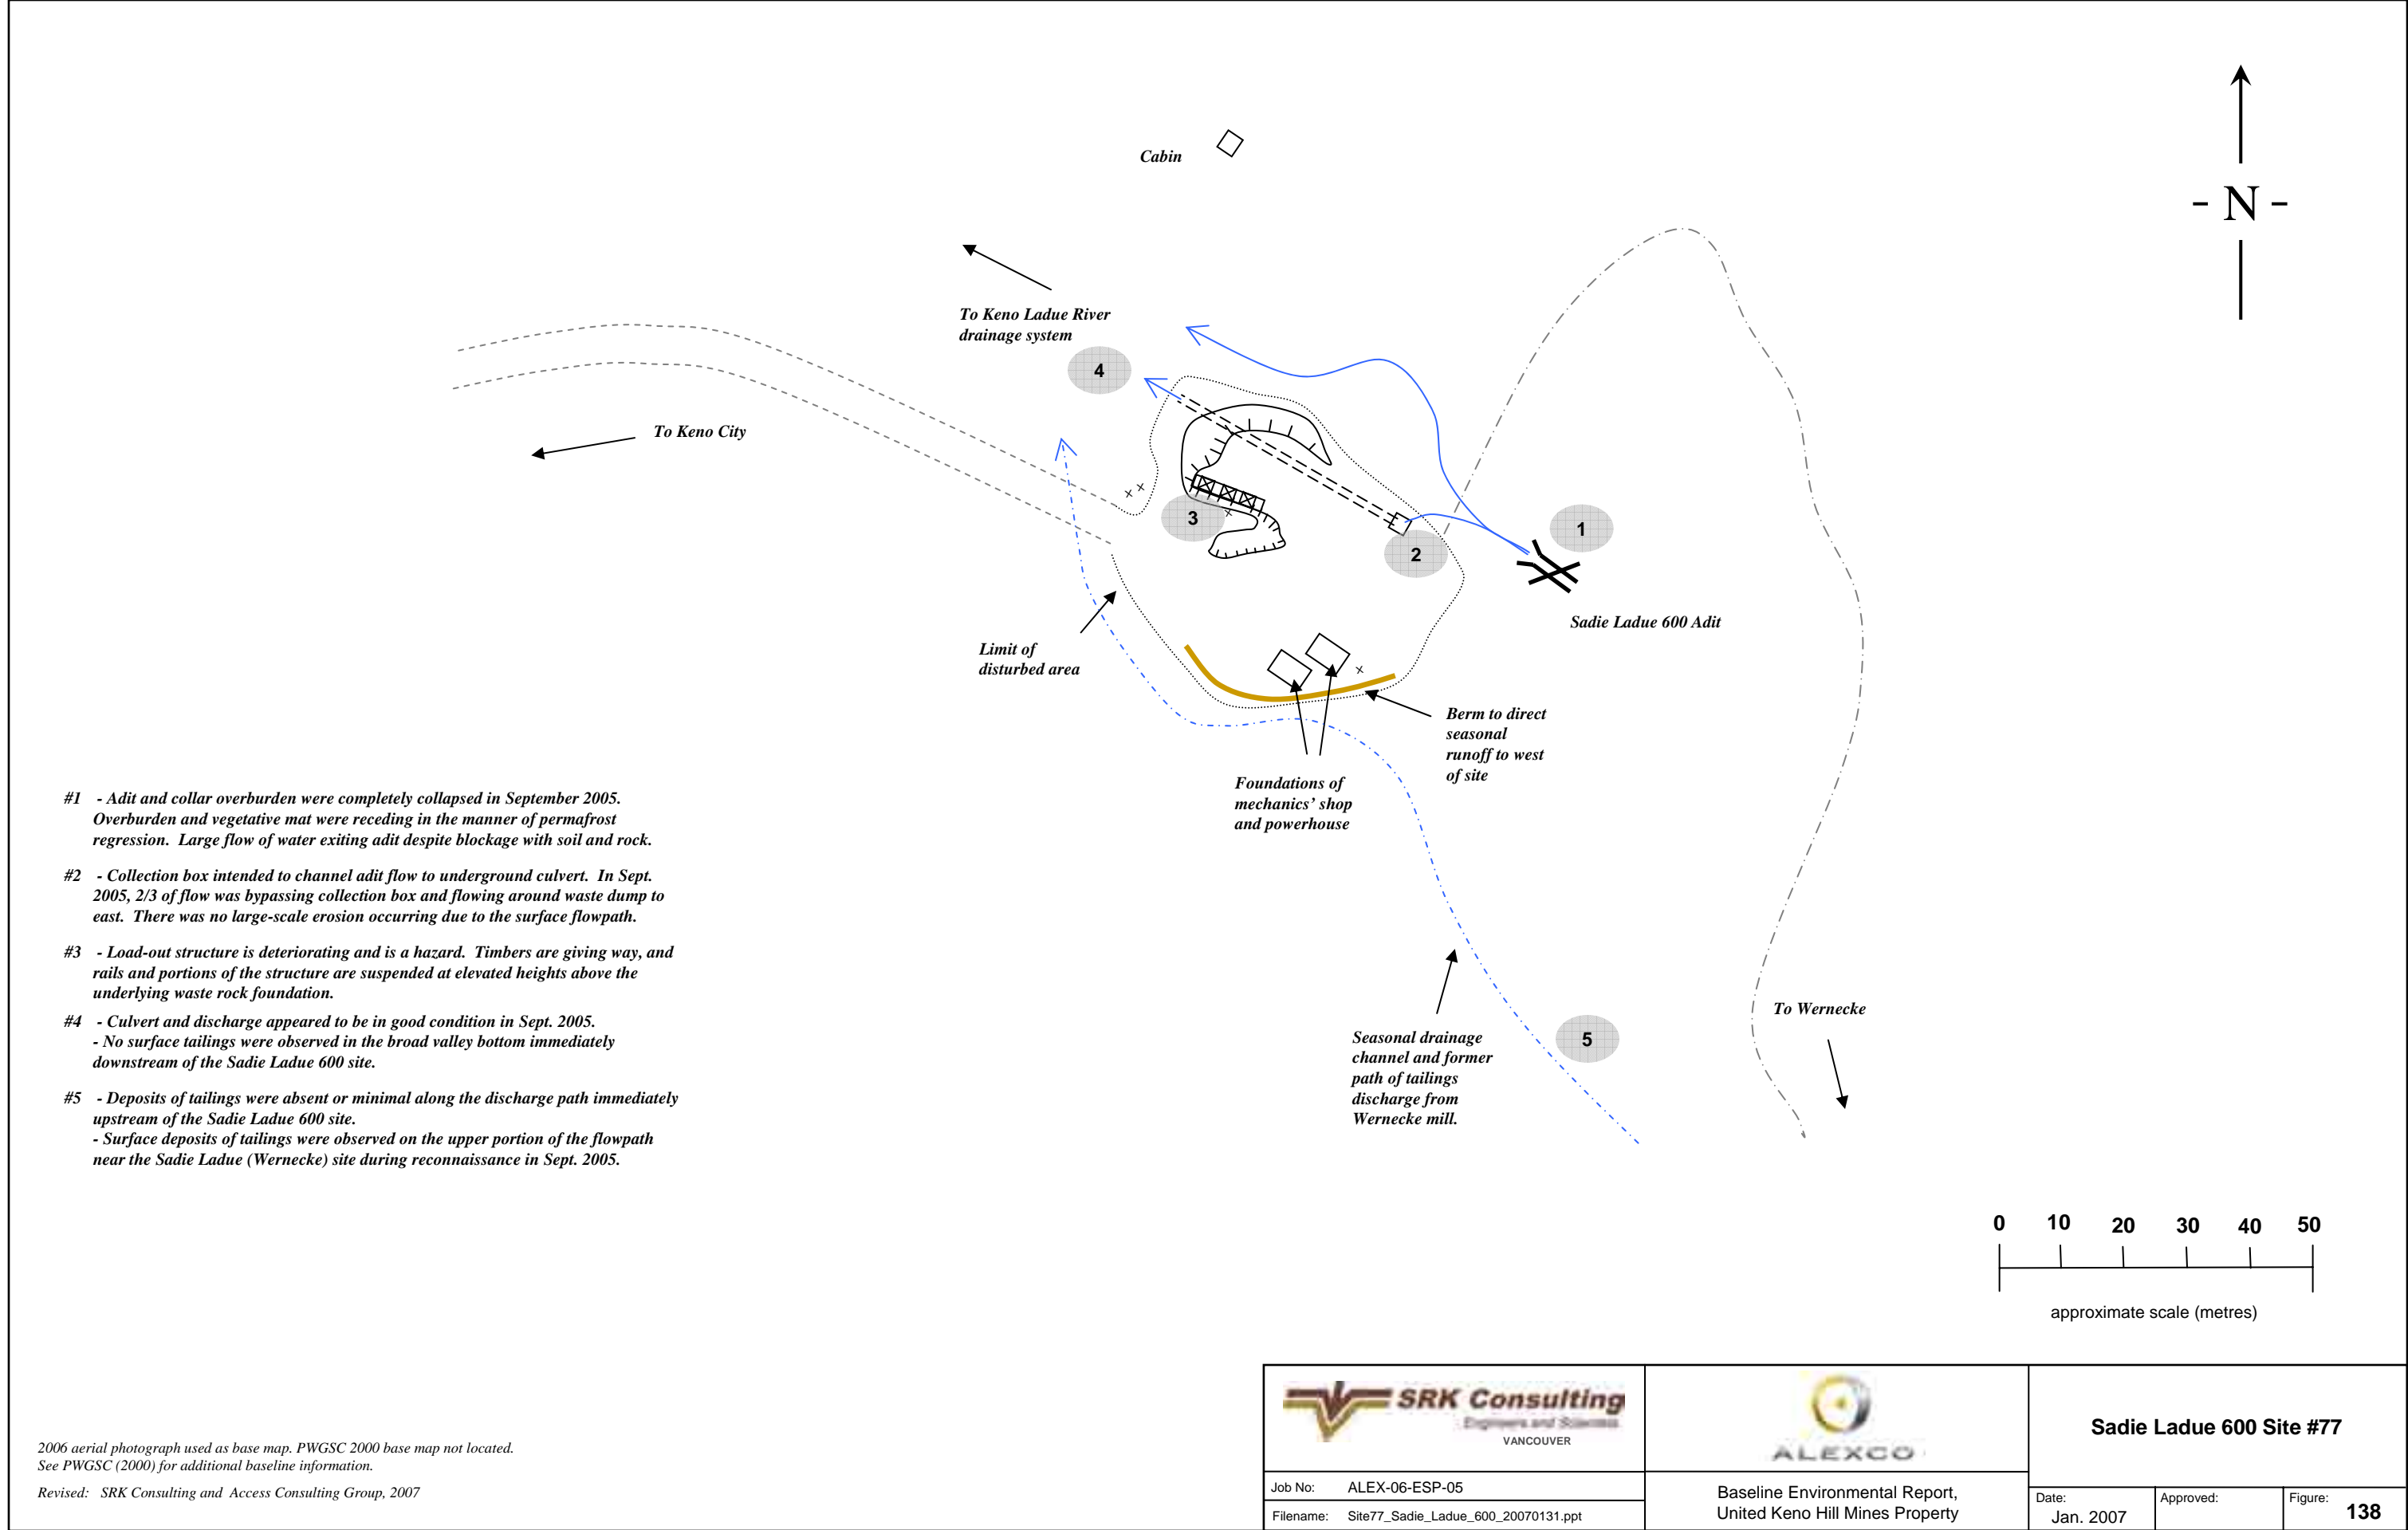
**CLOSURE ISSUES**  
**FIGURE 137 - SADIE LADUE 600**  
SITE PLAN

Common Site Name: <b>Sadie LaDue 600</b> PWGSC site #: 77 Site coordinates: <u>easting</u> <u>northing</u> 486950      7092700      *coordinates are projected to UTM zone 8 N, Nad 1983						
General Location Description	Closure Issue Categories					
	Human & Wildlife Health and Safety	Chemical Control	Water Management	Physical Stability	Community Concerns	Other
Sadie LaDue 600 Adit			✓	✓		
Collection box to underground colvert			✓			
Load-out structure	✓			✓

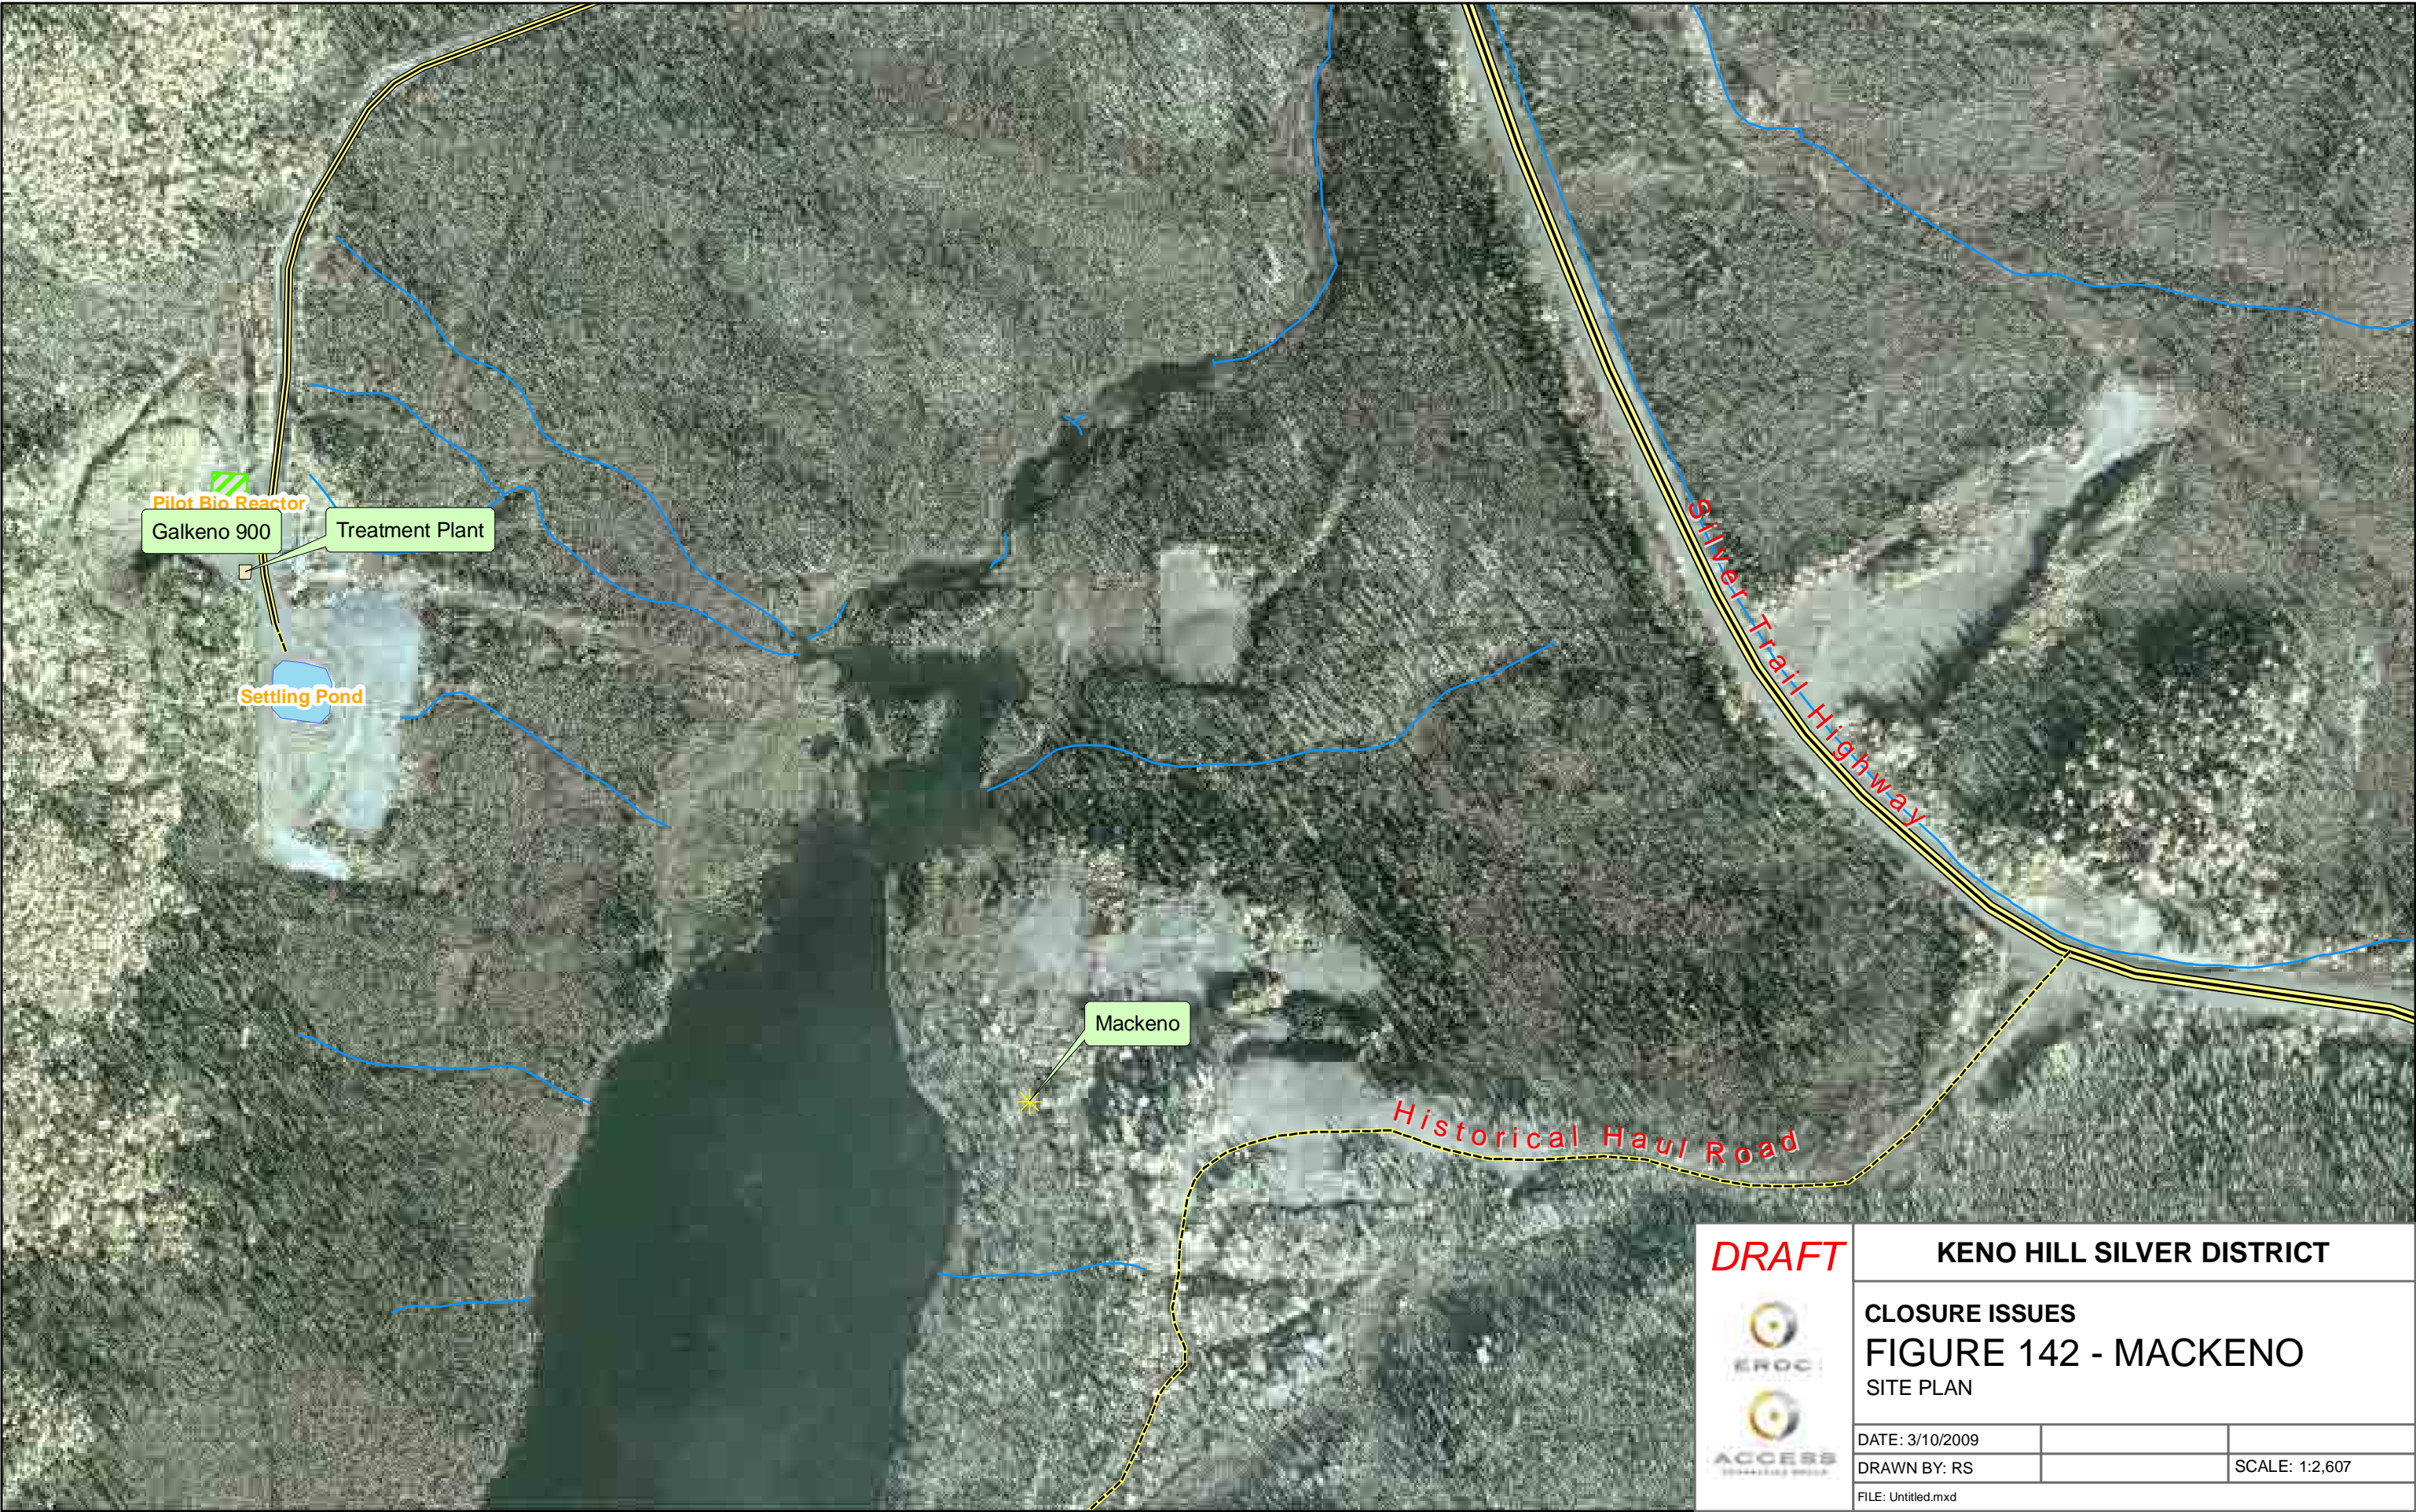
**Table 47 Mackeno Closure Issues Matrix**

Common Site Name: <b>Mackeno</b> PWGSC site #: 81 Site coordinates: <u>easting</u> <u>northing</u> 483803.11      7087670.72      *coordinates are projected to UTM zone 8 N, Nad 1983						
General Location Description	Closure Issue Categories					
	Human & Wildlife Health and Safety	Chemical Control	Water Management	Physical Stability	Community Concerns	Other
Lower Cristal Lake		✓				
Tailings benc - at Cristal Creek			✓	✓		
Christal Creek - from Mackeno tailings down to pool, pool is 20 m upstream of Silver Trail Highway culvert						
Tailings bench - east side beaver dam flooded ground			✓

Significant portion of lake outflow occurring over beaver dam and southeast of island. Tailings beach occupies the right limit of the downstream channel.
