# Community Liaison Committee Meeting

July 7, 2004

# 2004 Care and Maintenance Program

**Subject:** Meeting Minutes - July 7, 2004

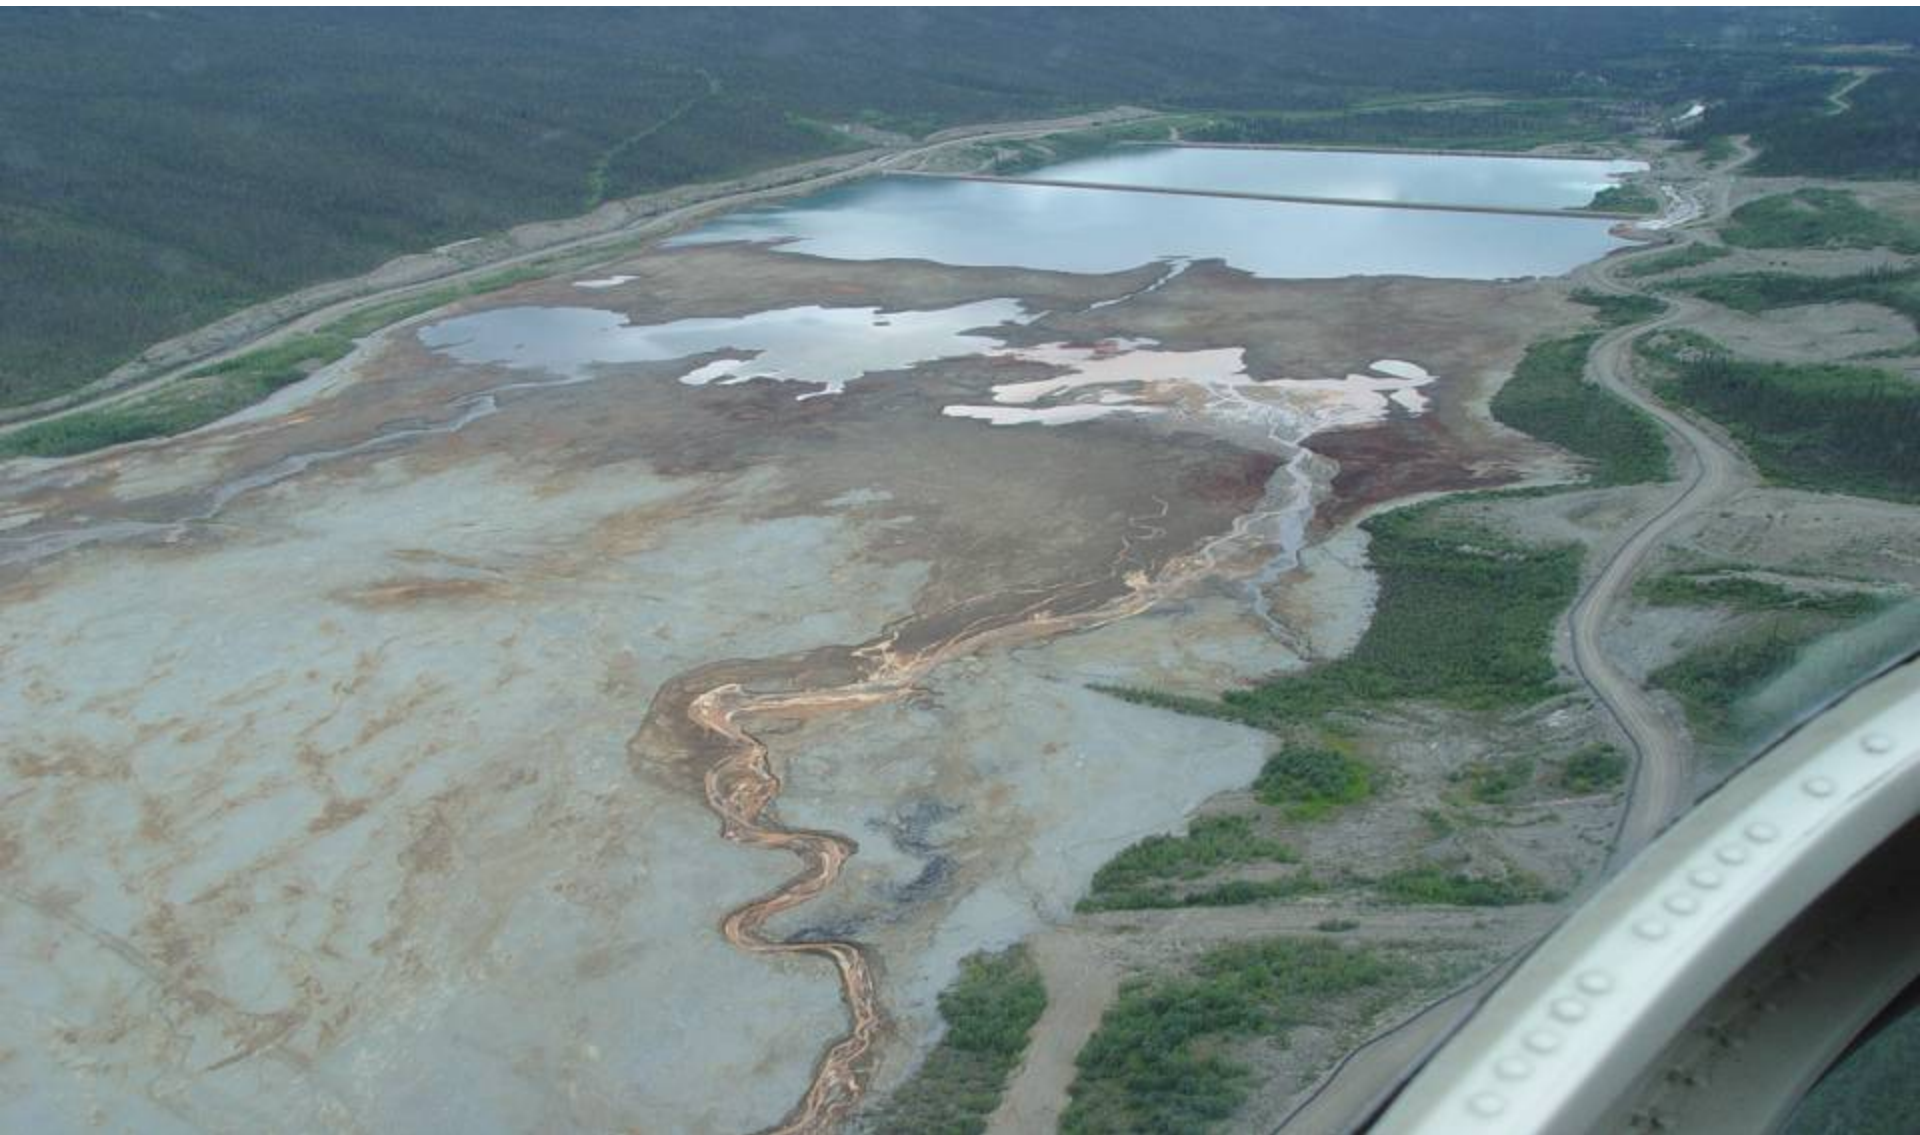
# Intermediate Tailings Impoundment – August, 2003

Picture 23 - Mr. Treleaven pointed out the specific location of the rock covers within the Intermediate Tailing Impoundment. He also advised that under the new Water Use Licence paragraph 56, there is a requirement for a Rose Creek Tailing facility water management plan. Mr. Treleaven indicated that such a plan will be prepared and submitted to the Board by March 31, 2005 and it will address the option of either maintaining a higher level of water within the Intermediate Tailing Impoundment to cover more tailings with water or as is presently being done, in accordance with the recommendation as set out in the 2002 independent Dam Safety Review, that the water level be reduced thus decreasing the pressure on the Intermediate Dam but, however, resulting in increased exposure of tailings to the atmosphere. Mr. Treleaven advised that it is the intention of the Interim Receiver to continue to manage this facility to have as much emergency storage as possible and thus reduce the pressure on the dam in the short term. The results of the study will be reviewed at next year's meeting. Also Mr. Treleaven pointed out the location of the Intermediate Spillway water treatment plant

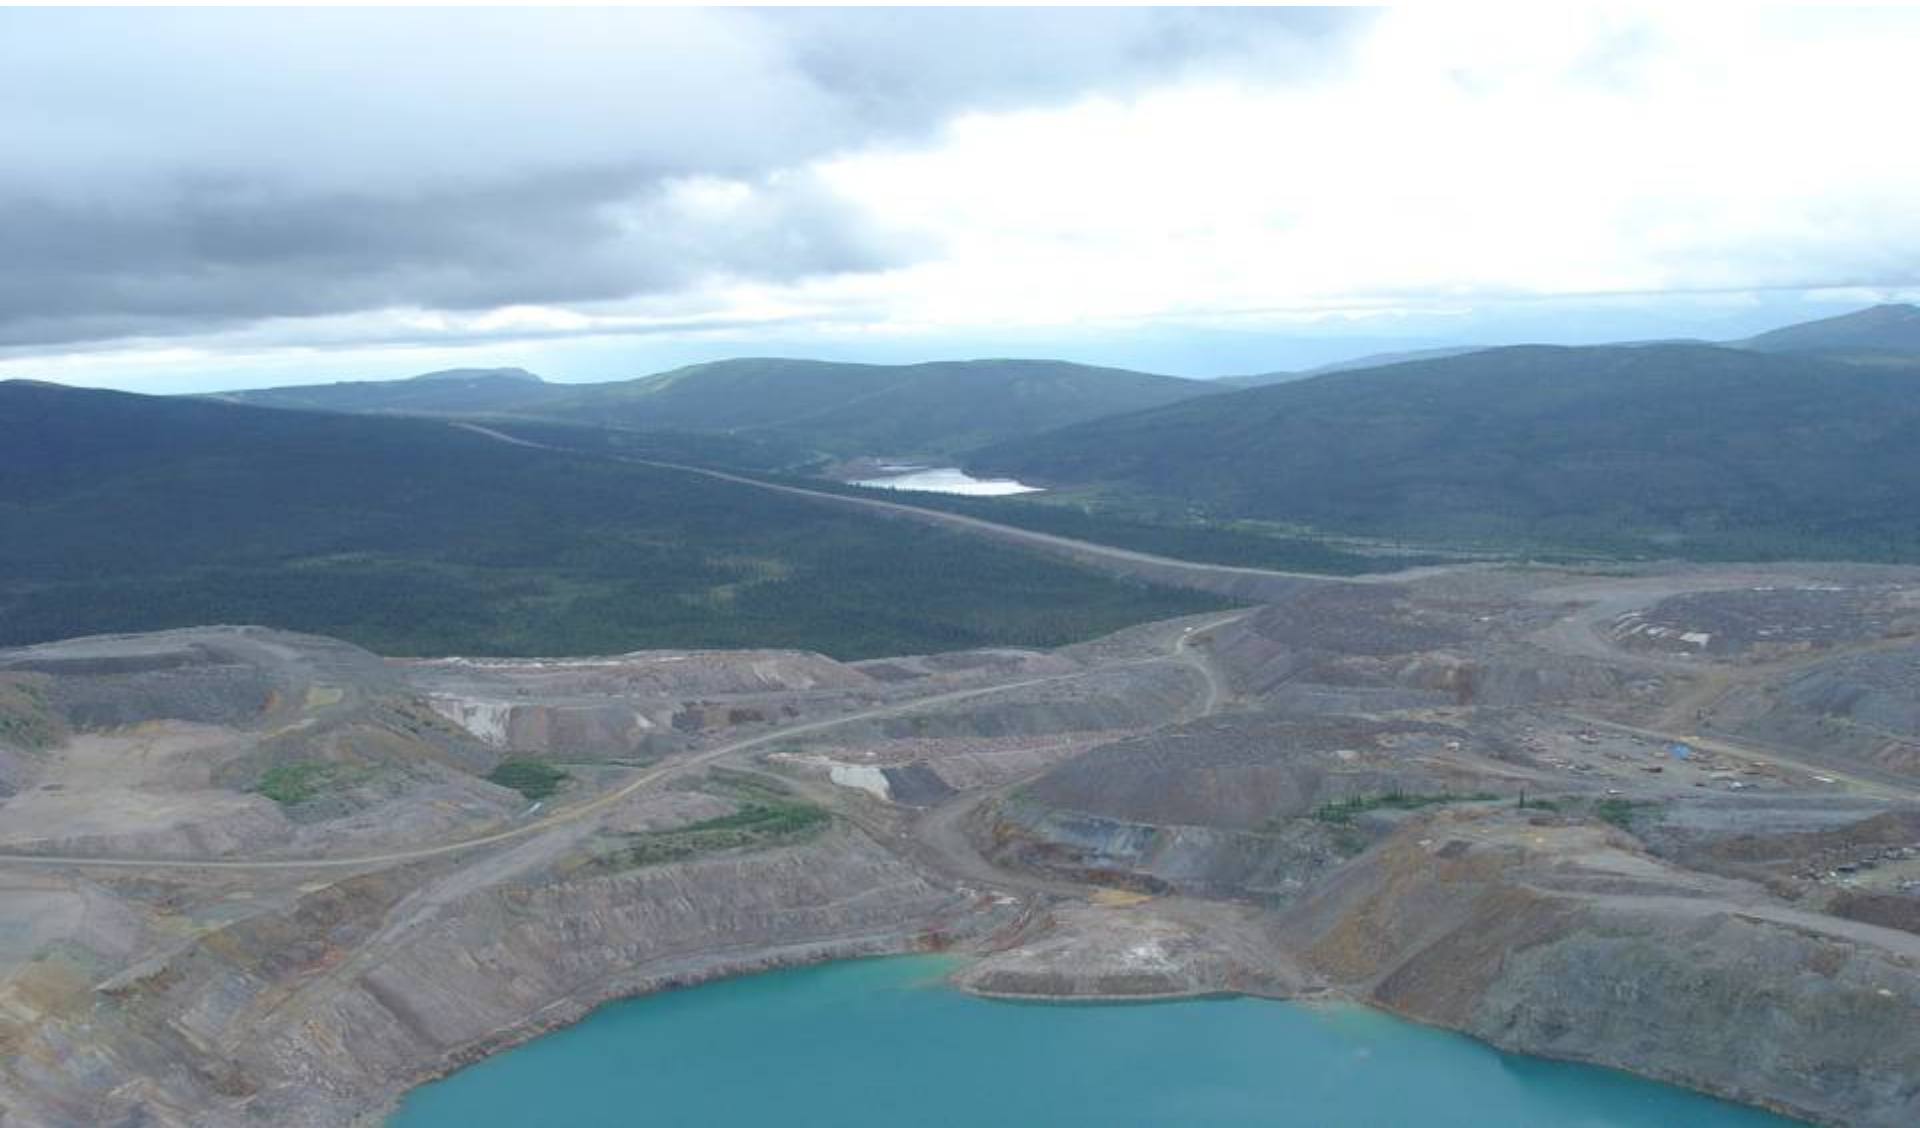
# Faro Zone II Pit – August, 2003

Picture 43 - Mr. Treleaven pointed out the location of the Faro Zone II Pit. He advised that a new pump was installed last year and that a replacement pump is onsite in case of a

pump failure. The Zone II Pit is regularly pumped transferring the water back into the Faro Pit and again a Zone II Pit water level chart was distributed to the participants.

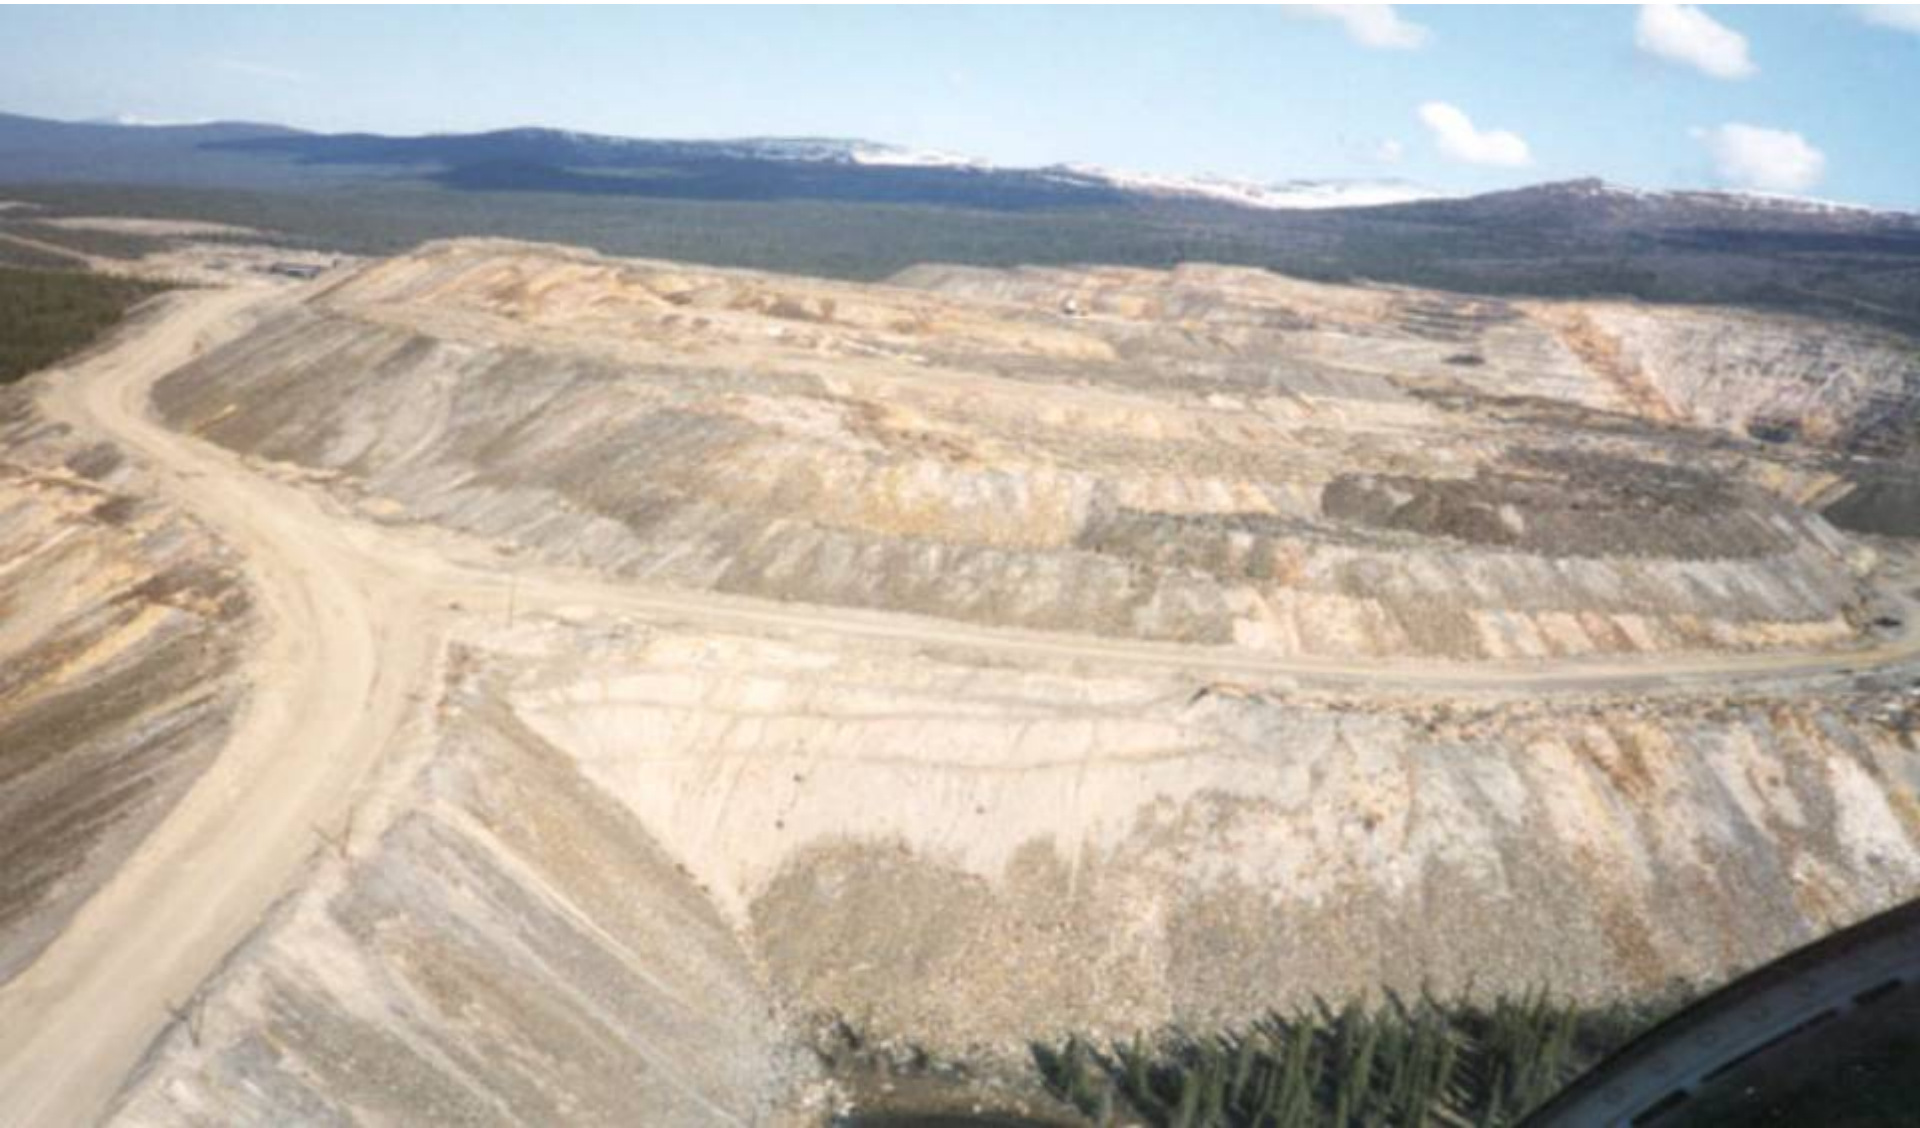
## Faro Intermediate Rock Dump – May, 2003

Picture 44 - Mr. Treleaven advised that there continues to be ongoing investigations relating to the various rock dumps on the property. These involve seasonal readings of temperature and gas monitors which have been installed in the rock dumps. Work is also continuing on improving the dump water balance estimates through investigations to assess the amount of water infiltrating the waste rock dumps as well as investigations to determine the dump water balances.
