Memo to: H.Copland, F. Patch Government of Yukon Type II Mines

From: B. Thrall, R. McIntyre, Alexco Resource Corp.

Date: November 9, 2006

Subject: *Contract for Service for Site Investigation and Improvements United Keno Hill Mine site: Special Projects Update Memo*

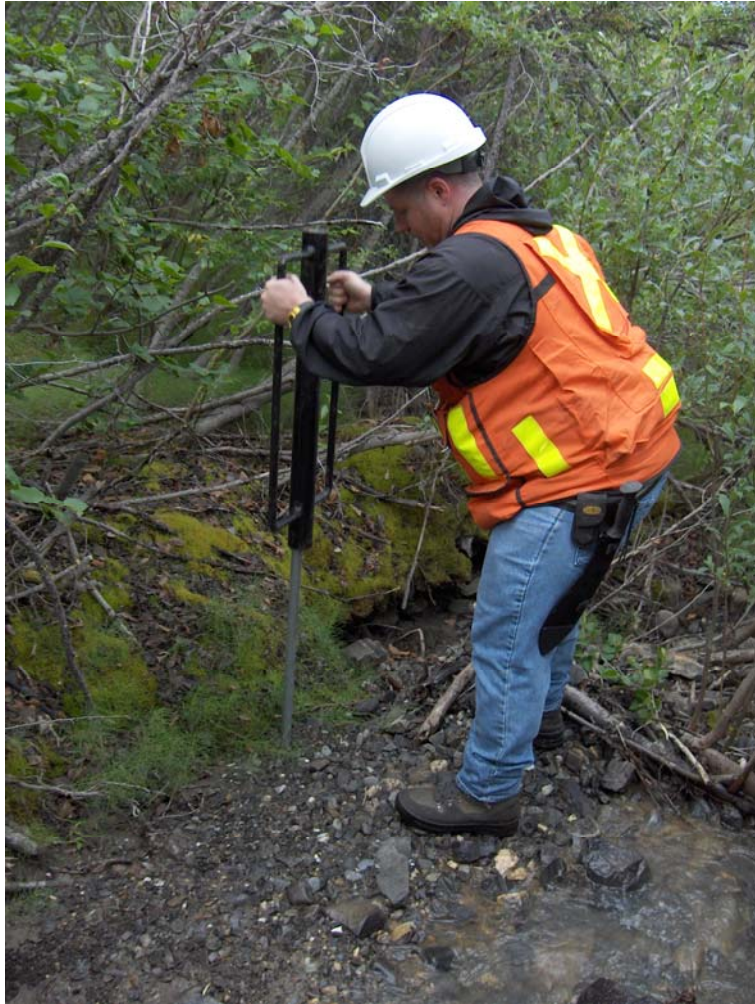
Photo 3: Access employee installing drivepoint piezometer

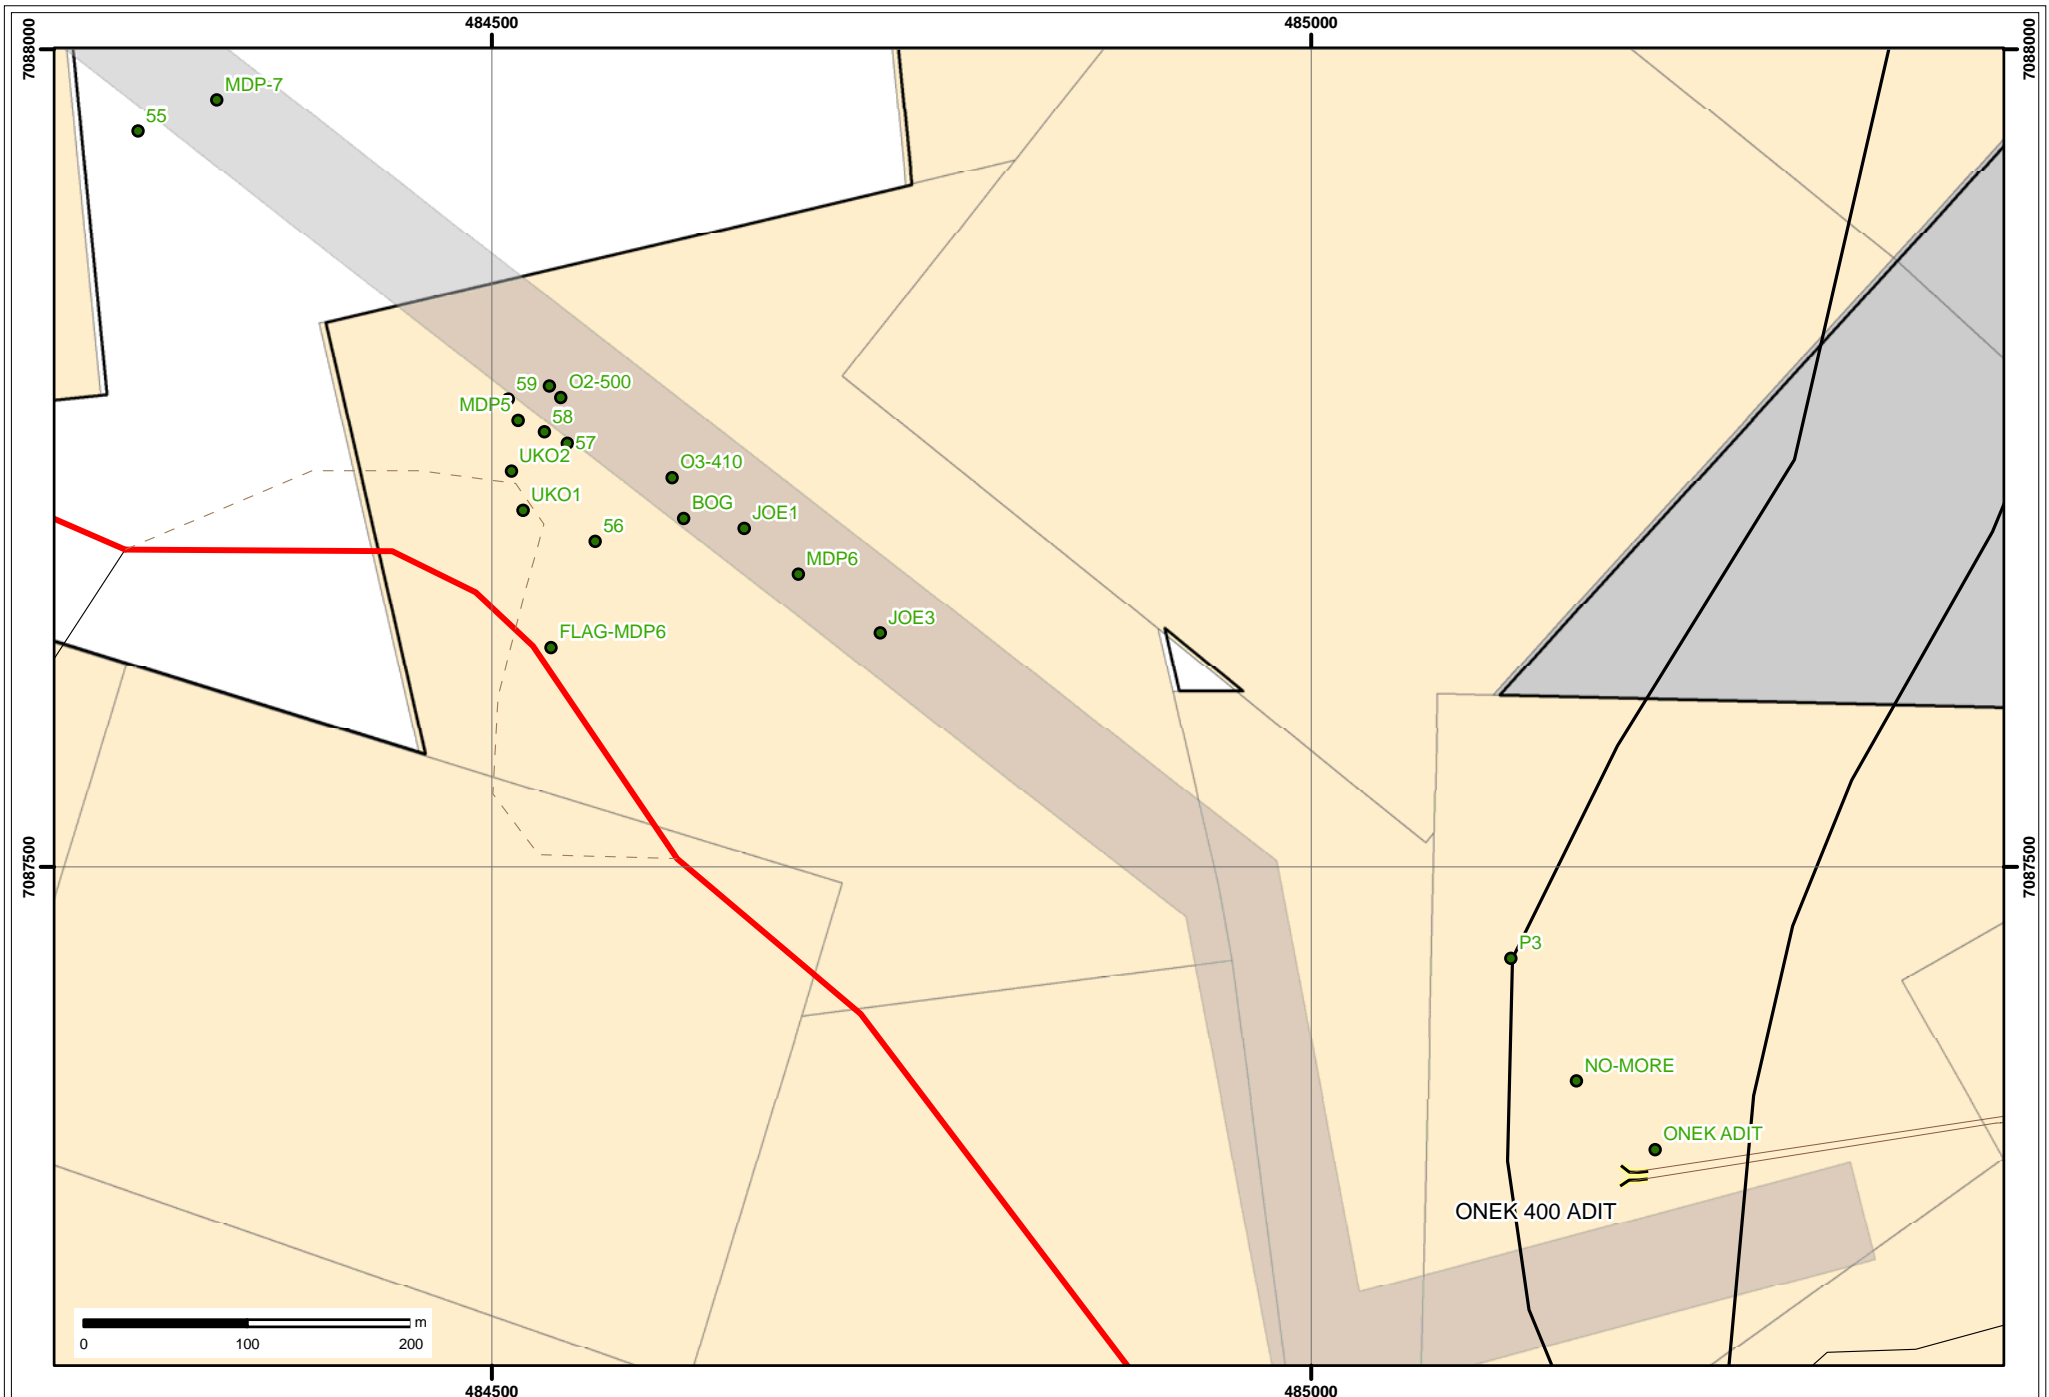
FIGURE 3

Shallow groundwater samples have been taken using drive point piezometers and a transect established to determine zinc loadings down gradient of adit discharge locations. Specifically, shallow groundwater sampling and mapping has been completed down gradient of No Cash, Onek, Galkeno 300 and 900 and Valley Tailings. This data has been incorporated into a site wide groundwater database and sampling locations have been summarized on maps. This work is also useful in the closure planning special project.

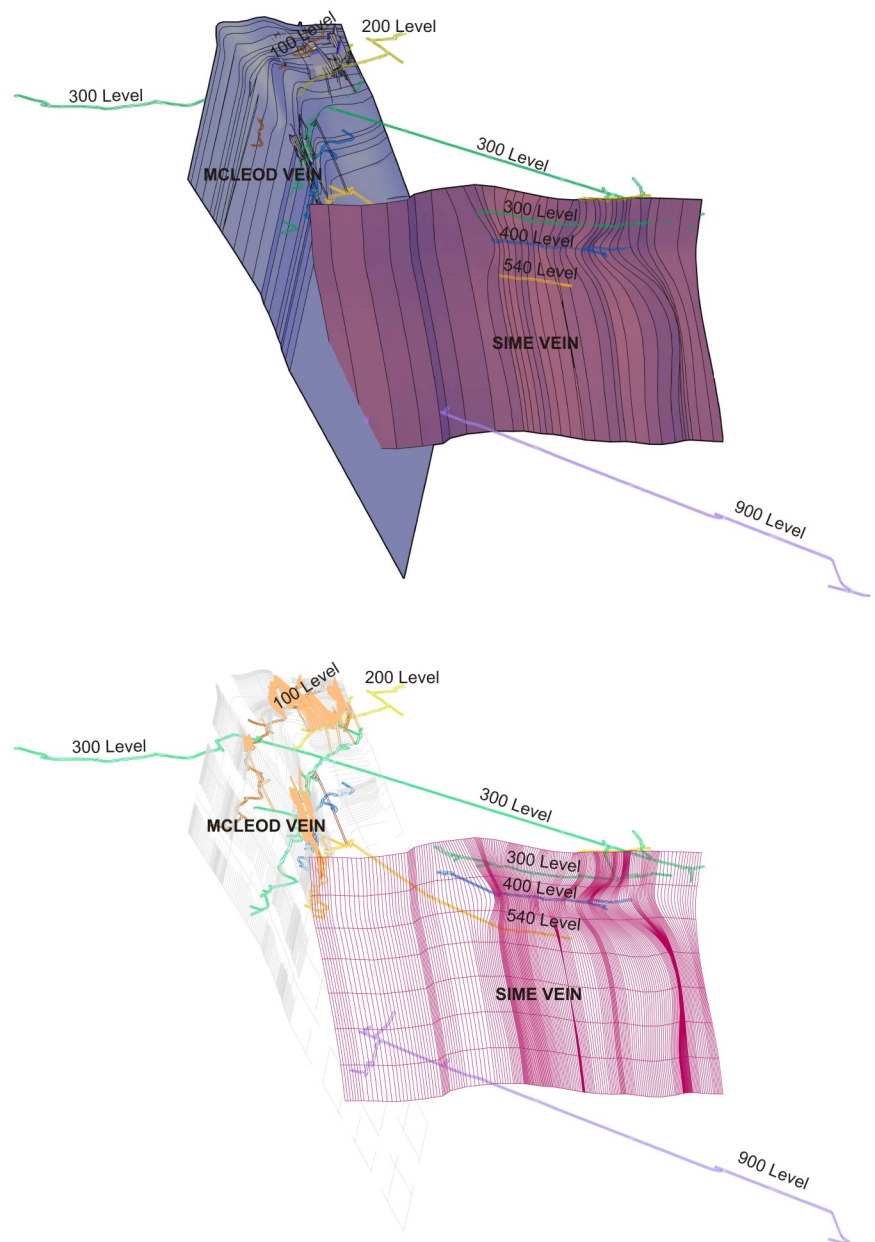
FIGURE 4

A 3-D model of the Galkeno/Hector underground system has been completed in Autocad. The model is conceptual in nature and is a 'best fit' of available survey data (i.e. no mathematical groundwater model will be required for purposes of the BEA). The model incorporates underground workings, veins and major faults into a visual Autocad 3D model. NovaGold geologist D. Brownlee spearheaded these efforts and produced a summary report on the findings of the model and the interconnections of the underground system for Galkeno and Hector.

**Galkeno 300 & 900
3D Model Looking Northerly**

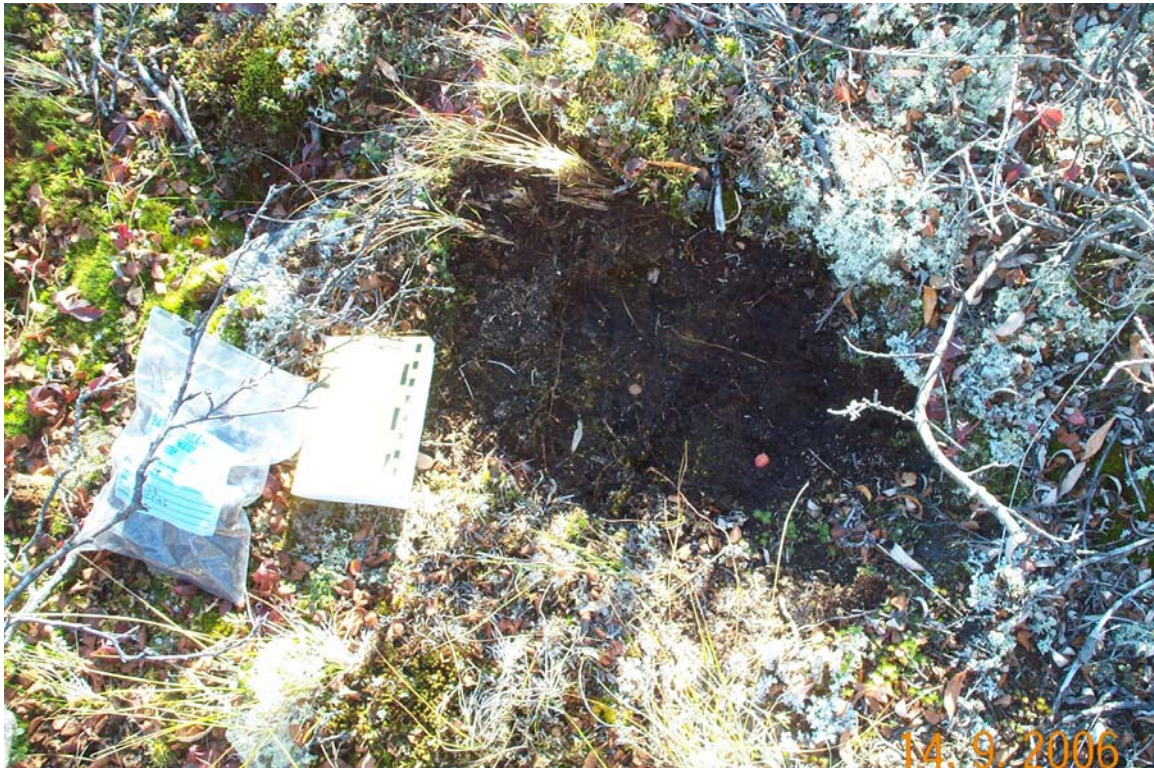
Initial lab results indicate highest metal concentrations (principally zinc, lead and manganese) on Transect 4, Calumet Drive near Dixie adit. Provisional laboratory results have been summarized in Table 2: UKHM Haulage Route Sampling Table; full reporting will be included in the Final Baseline Assessment Report.

Photo 4: Soil sample location near Keno Hill.

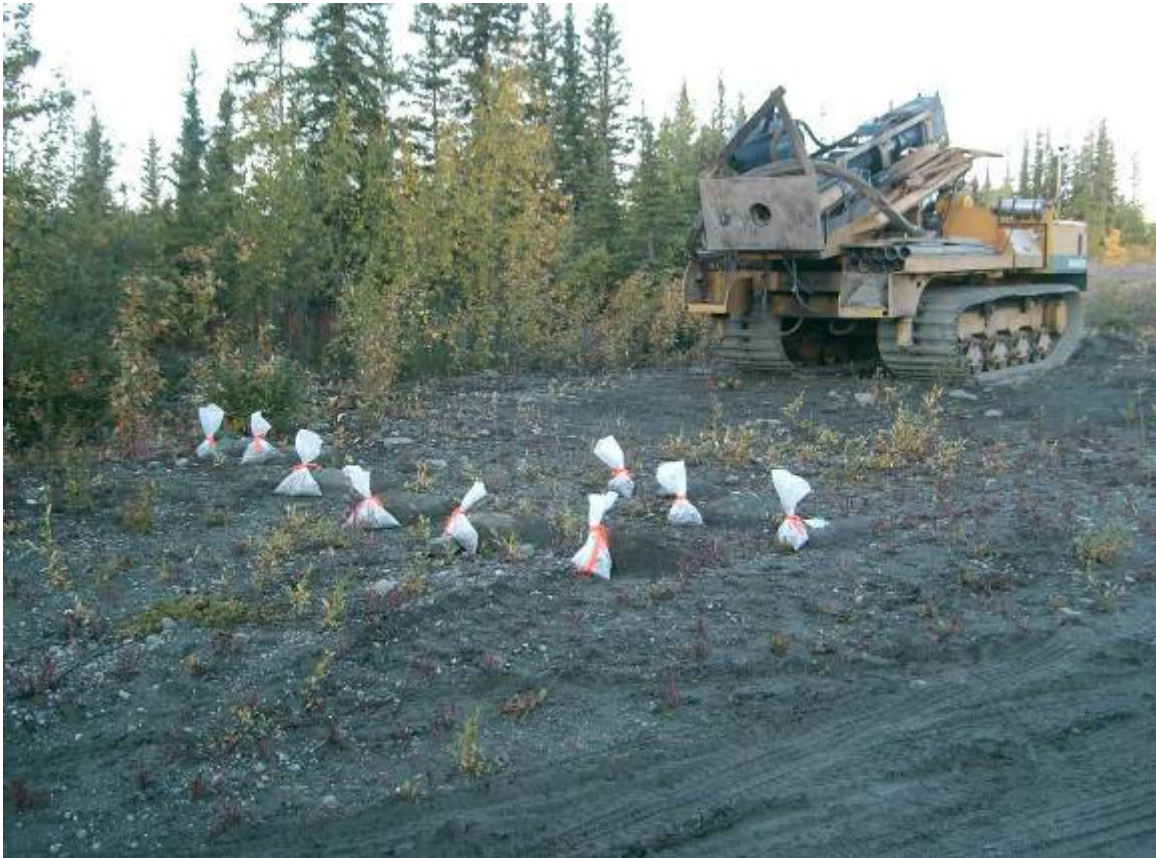
Photo 7: Hammer borehole rig at Valley Tailings

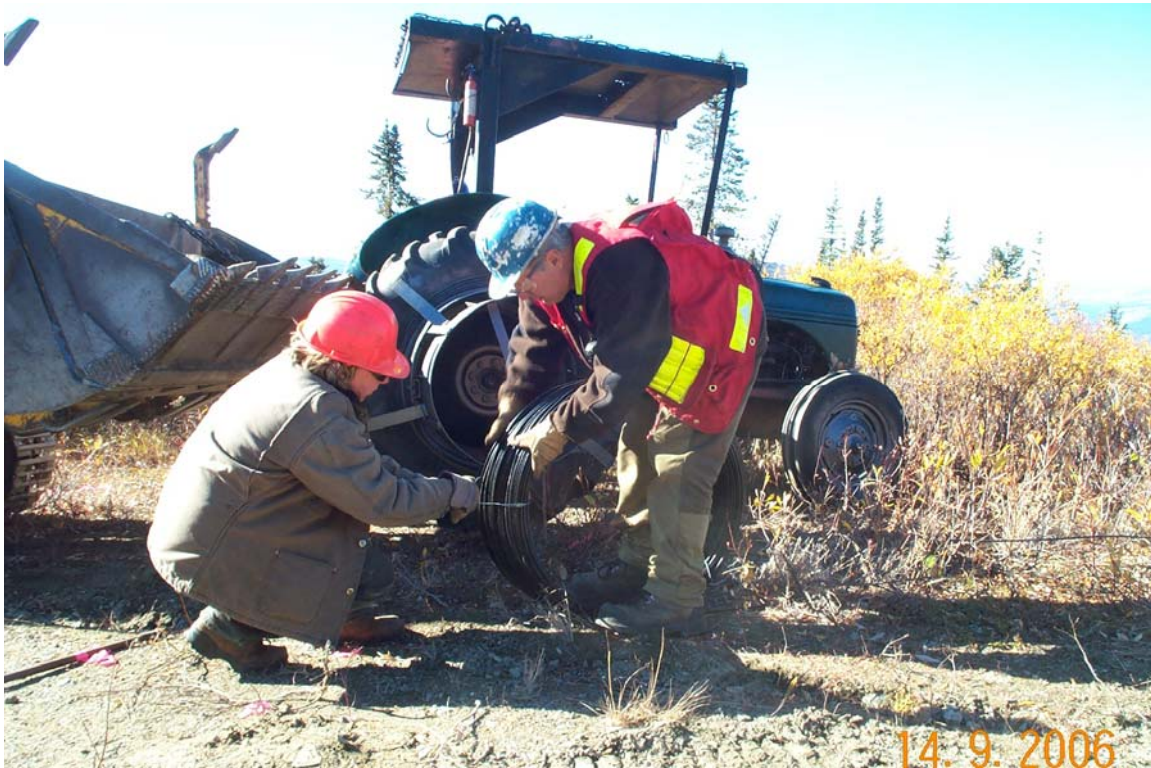
Not as much progress was made in the wire cleanup project as planned. ERDC committed to using NND labor for this special project. In addition to this special project, a number of NND members were employed with the Alexco exploration program. Given all of the demand for local NND labor, not as much wire cleanup was completed due to a shortage of consistent labor available to complete the project.

Photo 11: Alexco employees in the course of wire-cleanup.
