**Dam Safety Assessment
Mount Nansen Tailings Facility near Carmacks, YT**

Project No: 0201-00-14618

May 2002

**EBA ENGINEERING CONSULTANTS LTD.
Whitehorse, Yukon**

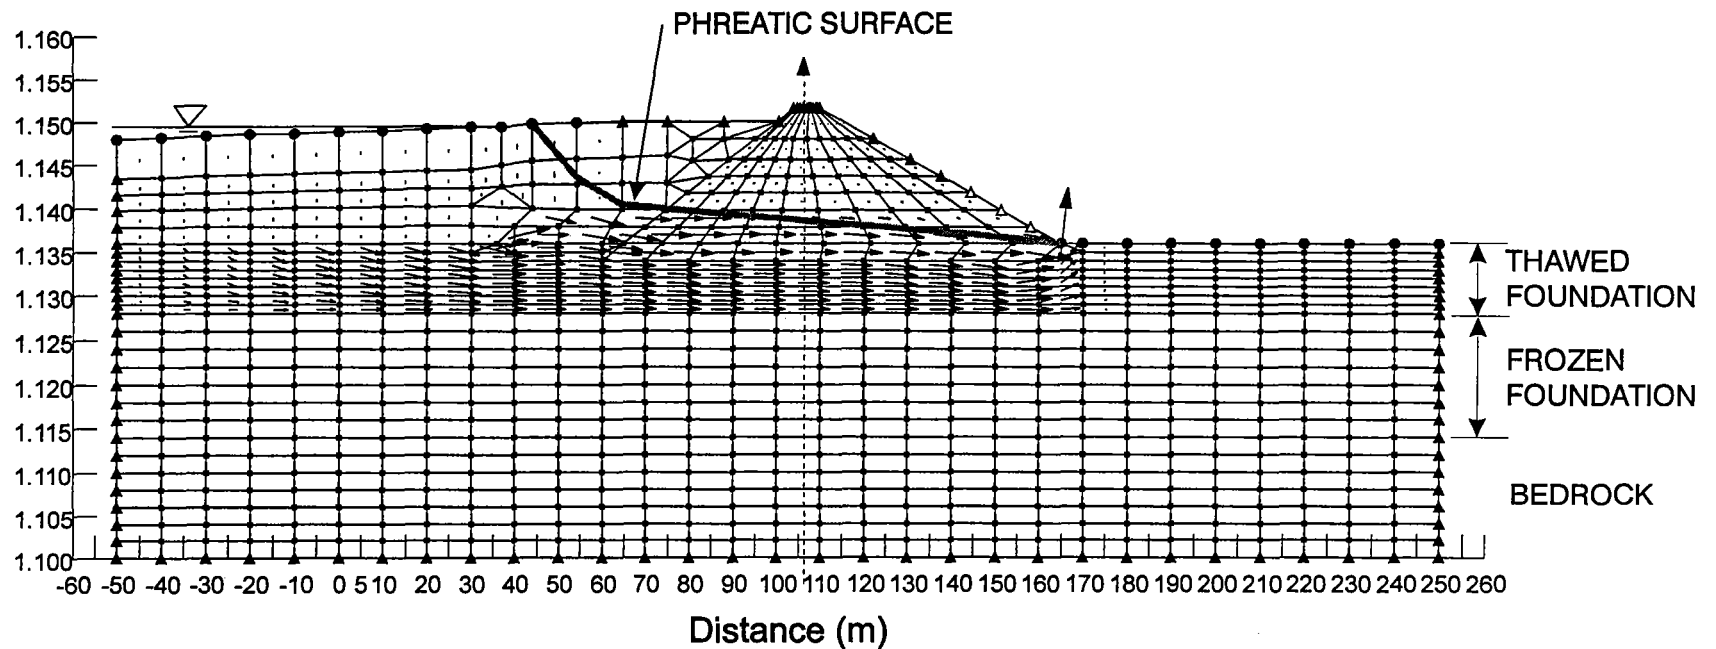
DWNG: FIGURE 1

Figures 1 and 2 show the phreatic surfaces for the Klohn geometry and new EBA geometry, respectively. The seepage parameters below the dam crest were estimated as follows:

201-14618 Mount Nansen Tailings Dam #1 Seepage Analysis
 December 8, 2000
 By: JTCS
 File: DAM-1A.SEP
 Pond @ El. 1149.7 m; Downstream W.L. @ El. 1136.0 m
 Duplicate Klohn-Crippen (1995) seepage analysis, Figure A5-1
 Soil properties same as assumed in Klohn Crippen (1995) report

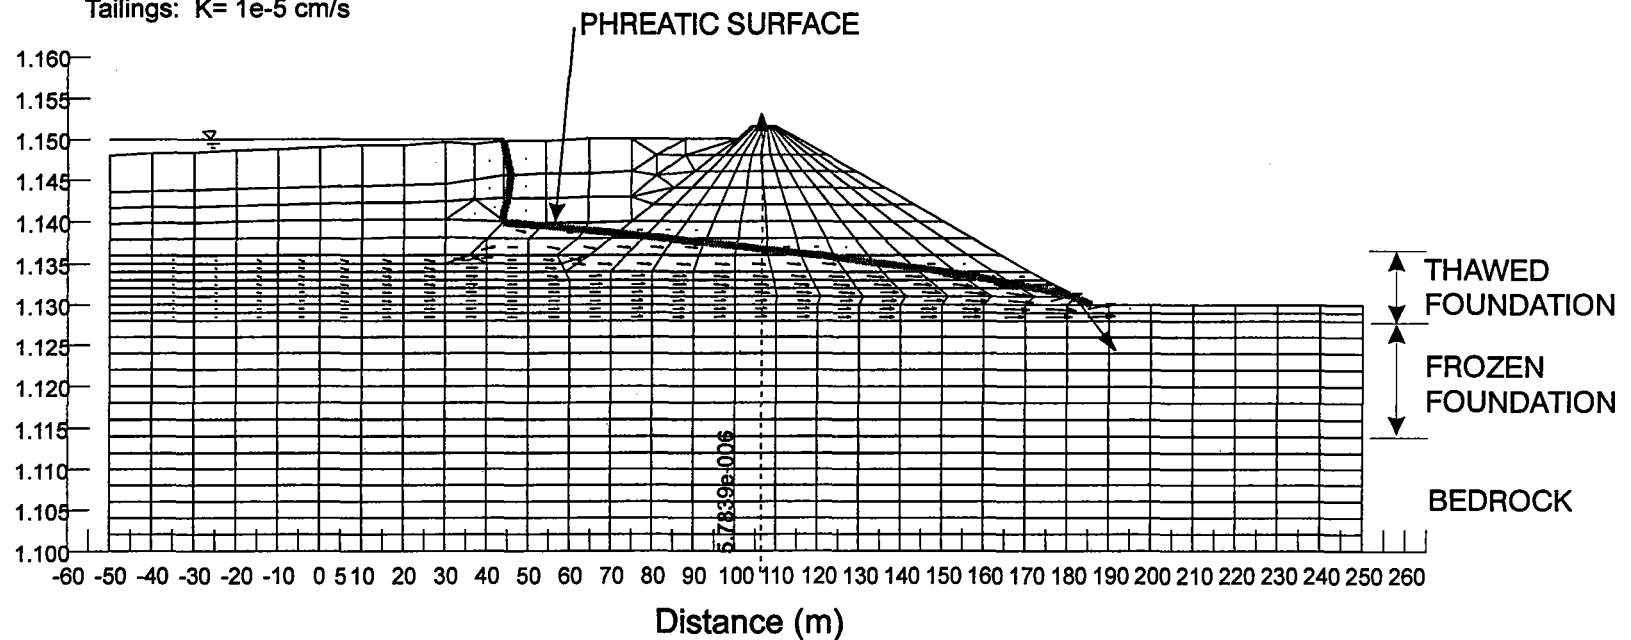
FIGURE 2

The predicted total flux across this section is approximately 1.87×10^{-5} m/s, which is more than three times the flux that would have been predicted for Klohn's mesh and soil properties for a downstream ground elevation of 1130 m (Figure 2). Below the dam crest, the average seepage velocity is approximately 1.6×10^{-6} m/s

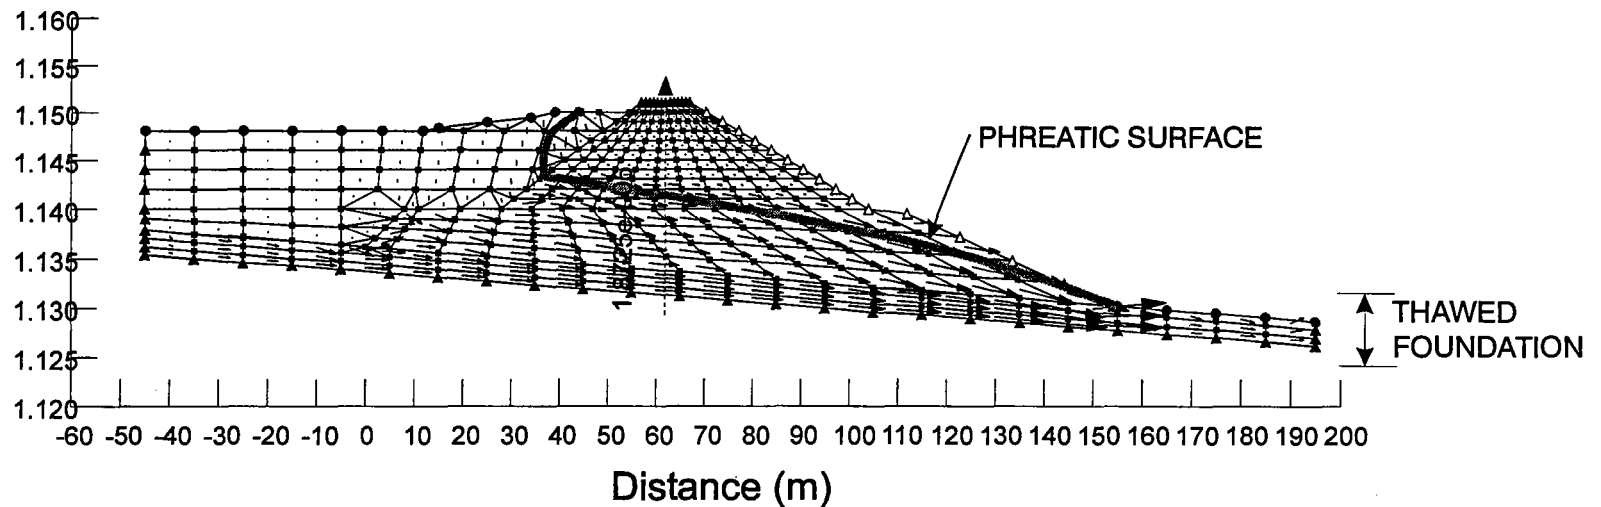
DWNG: FIGURE 3

Parametric analyses were carried out varying the hydraulic conductivities of the tailings and the dam fill/foundation sand to match the measured piezometric levels. Figure 3 shows the predicted phreatic surface for the best-fit results. The seepage parameters that best-matched the measured piezometric levels are as follows:

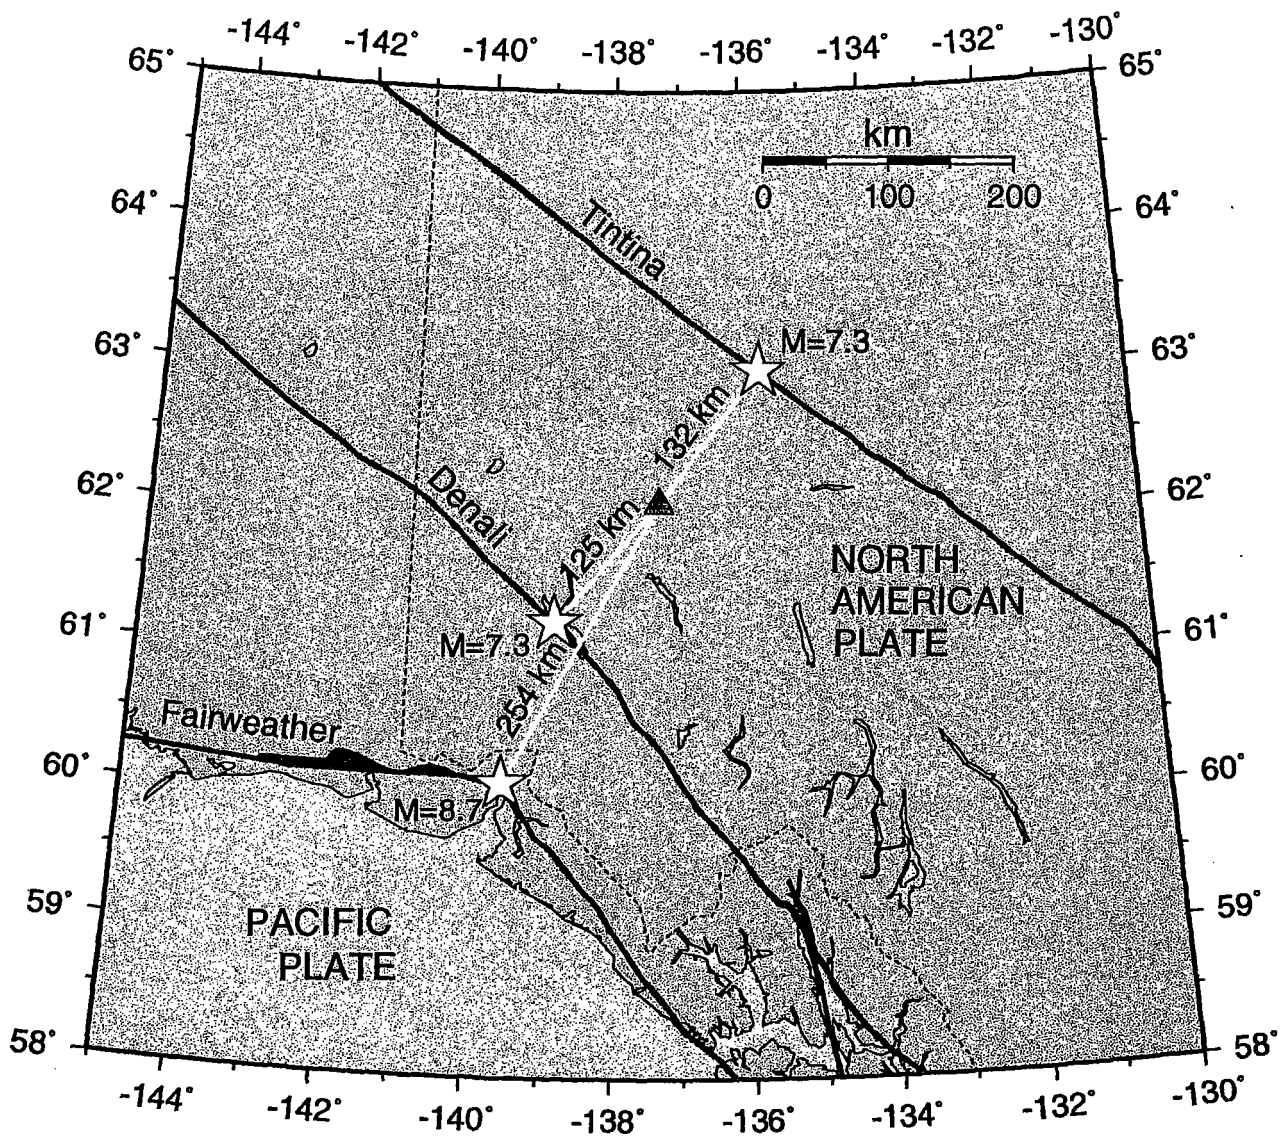
Three faults are examined as posing significant seismic threat to the Mount Nansen site (Figure 1): Fairweather, Denali, Tintina. For the purposes of evaluating the maximum potential ground motion from each of these faults, determined using fault dimensions (Adams *et al.*, 1999), the attenuation relations of Youngs *et al.* (1997) are employed. These calculations provide an *upper* limit of ground shaking. Results are given in Table 2.

Figure 1: Tectonic setting of the Mount Nansen site, with faults of interest to a deterministic analysis of the site. Mount Nansen site is denoted by a red triangle; maximum postulated magnitude and site-fault distances are also noted.

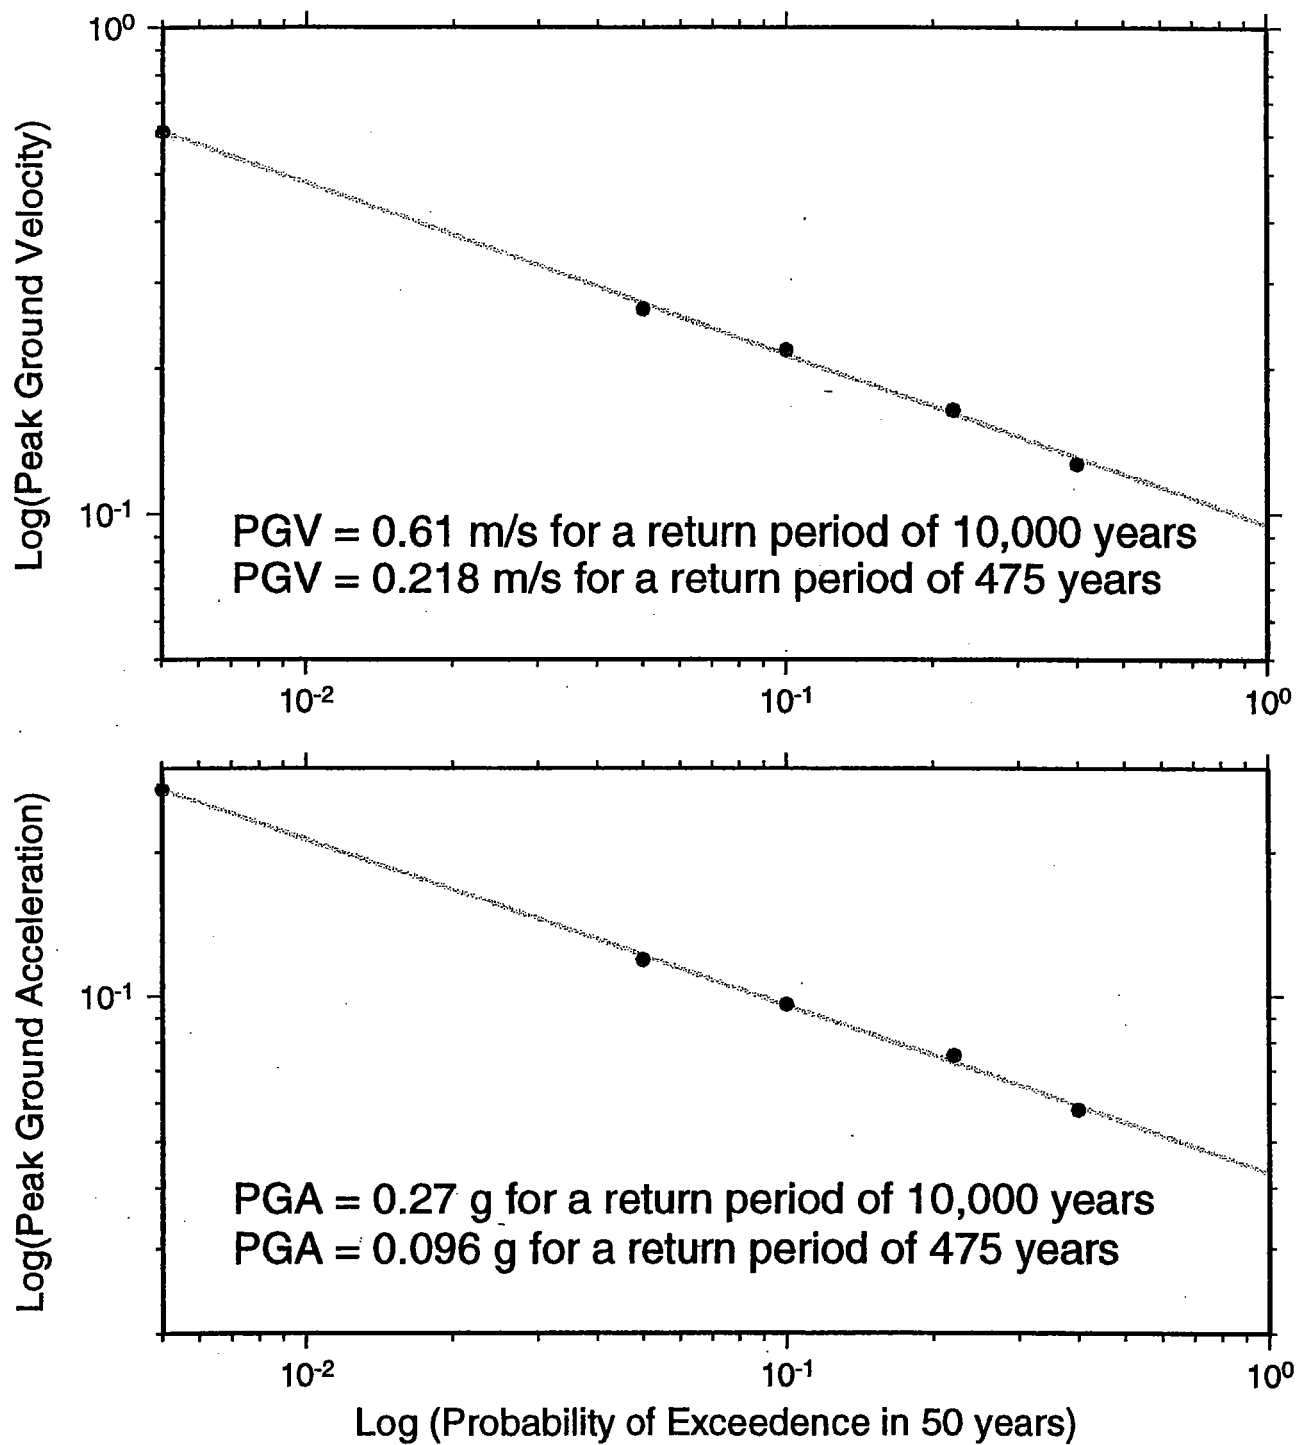
If this data is presented in a log-log plot, it can easily be extrapolated to determine a peak ground acceleration (PGA) of 0.27 g and peak ground velocity (PGV) of 0.61 m/s, for a return period of 10,000 years (Figure 4).

Figure 4: Log-log plots of Peak Ground Velocity and Peak Ground Acceleration versus Probability of Exceedence.
