Engineering Analysis of Vangorda Pit Wall Stability

Project Reference Number:
SRK 1CD003.15

April 2003

STEFFEN ROBERTSON AND KIRSTEN (CANADA) INC.

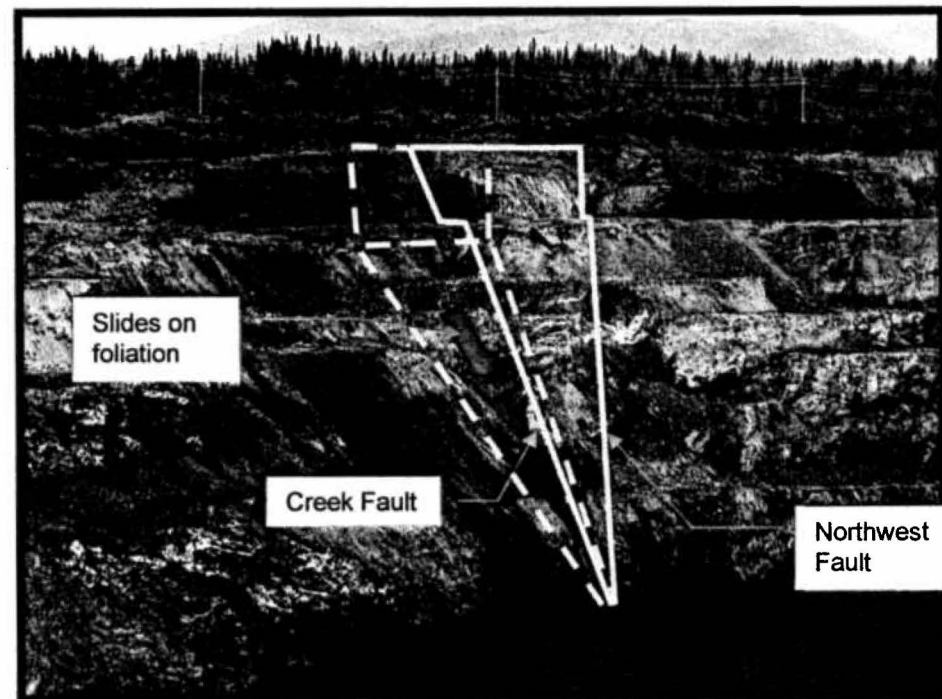
Views of potential block formed by Creek Fault, Northwest Fault and foliation planes

Stability of potential wedge formed by Northwest Fault and Creek Fault – with foliation as sliding plane.
Analysis shows that failure is not kinematically possible – the wedge is tapered towards the free face of the slope and cannot move outwards.
