**DELOITTE & TOUCHE INC.**  
**EVALUATION OF SHORT TERM  
MANAGEMENT OPTIONS**

**VANGORDA DIVERSION FLUME  
FARO MINE, YUKON**

PROJECT NO.: 0257-002-03  
DATE: SEPTEMBER 6, 2000

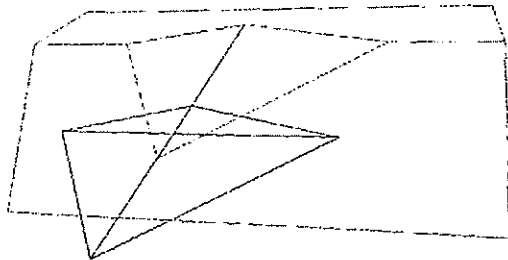
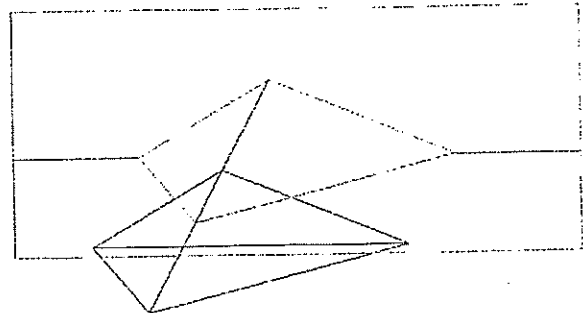
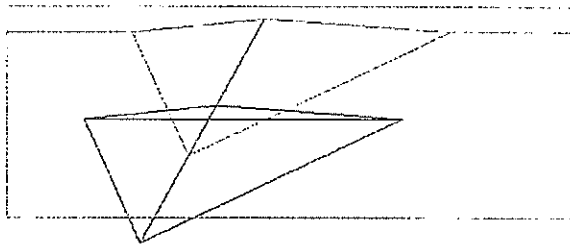
FIGURE 13

It is interpreted that the 1999 rockfall occurred as a wedge failure along the basal foliation plane, joint set 1, and the detachment foliation plane, joint set 2. The orientation of the foliation planes and slope face are shown in Figure 11. The wedge formed by joint sets 1 and 2 did not fail as an intact block, but rather was truncated along a joint dipping back into the slope, joint set 5. It appears that sliding took place predominantly along the basal foliation plane, and this plane appears to be continuous up to the top of the slope. The upstream side of the 1999 wedge failure released along steeply dipping joints that trend into the slope, joint set 4. Photographs of the 1999 rockfall source area are shown in Figure 13. In the lower photograph in Figure 13 the person is standing on the basal foliation plane and pointing to the intersection with the detachment foliation plane. The repeating joints forming the backscarp of the failure can be seen at the top of this photo, and the joints forming the side release can be seen to the far right of the photo.
