DELOITTE & TOUCHE INC.
**EVALUATION OF SHORT TERM
MANAGEMENT OPTIONS**

**VANGORDA DIVERSION FLUME
FARO MINE, YUKON**

PROJECT NO.: 0257-002-03
DATE: NOVEMBER 20, 2000

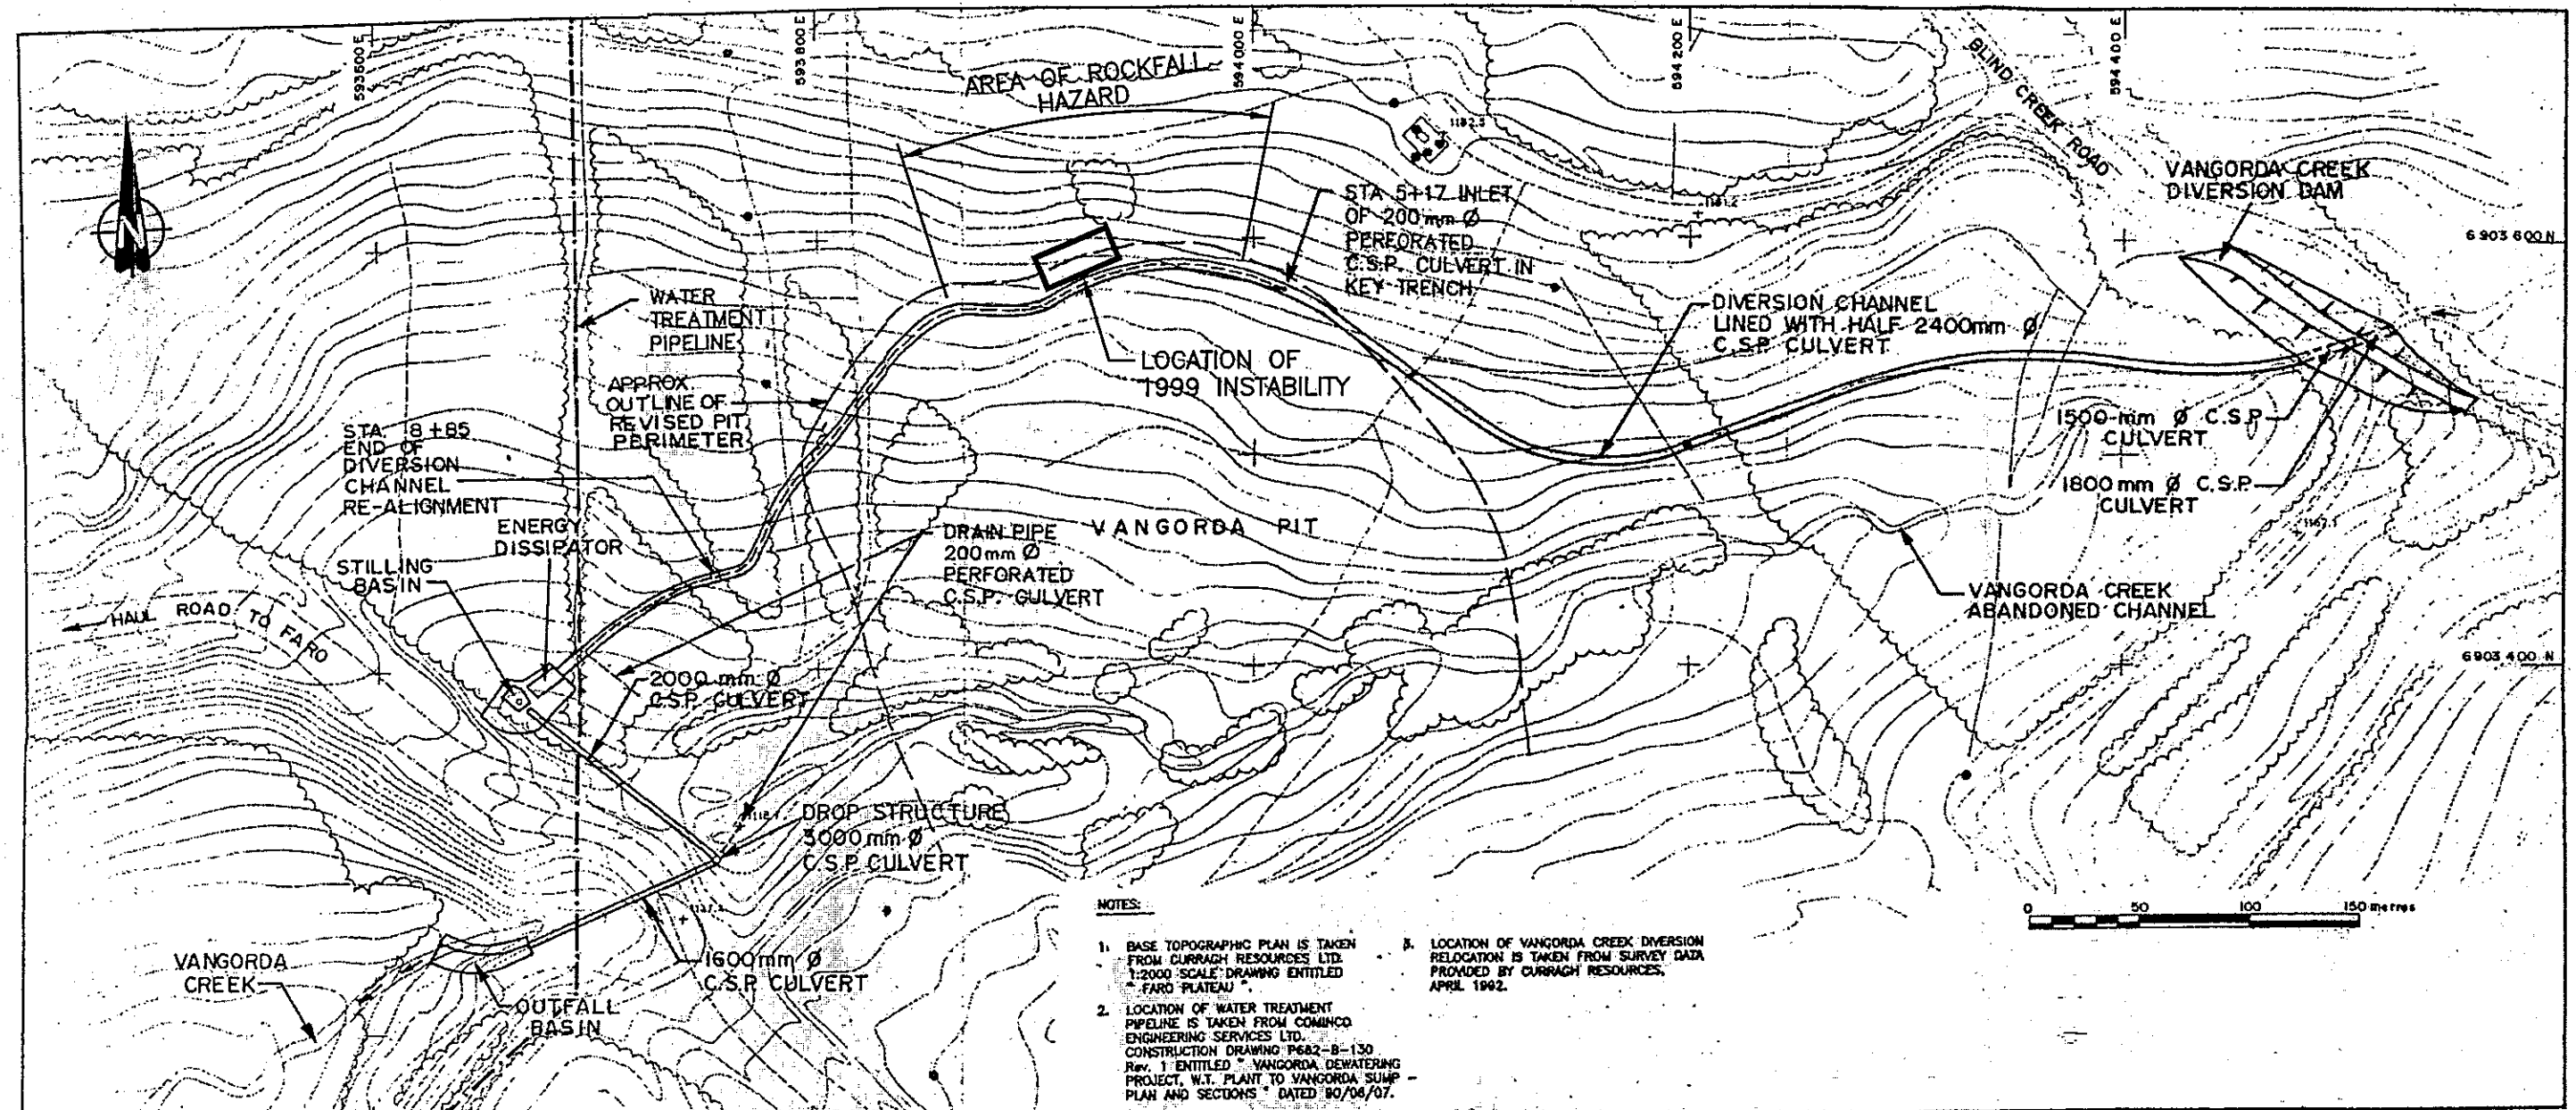
- An 8 m high diversion dam and culvert for the passage of Vangorda Creek discharge.
- An 800 m long diversion channel, lined with a half-section culvert.
- A final stilling basin, drop structure and outfall basin to convey the discharge water back into Vangorda Creek.

Anvil Range (1999) reviewed the June 1999 rock fall event that damaged the flume and resultant repair work. Seven sections of the flume were replaced at the location shown on Figure 3. The cost of the remedial work was estimated to be \$36,000. Seven recommendations regarding flume components and further assessment work were provided. In addition, a smaller rock fall occurred at the same location in September, 1999.

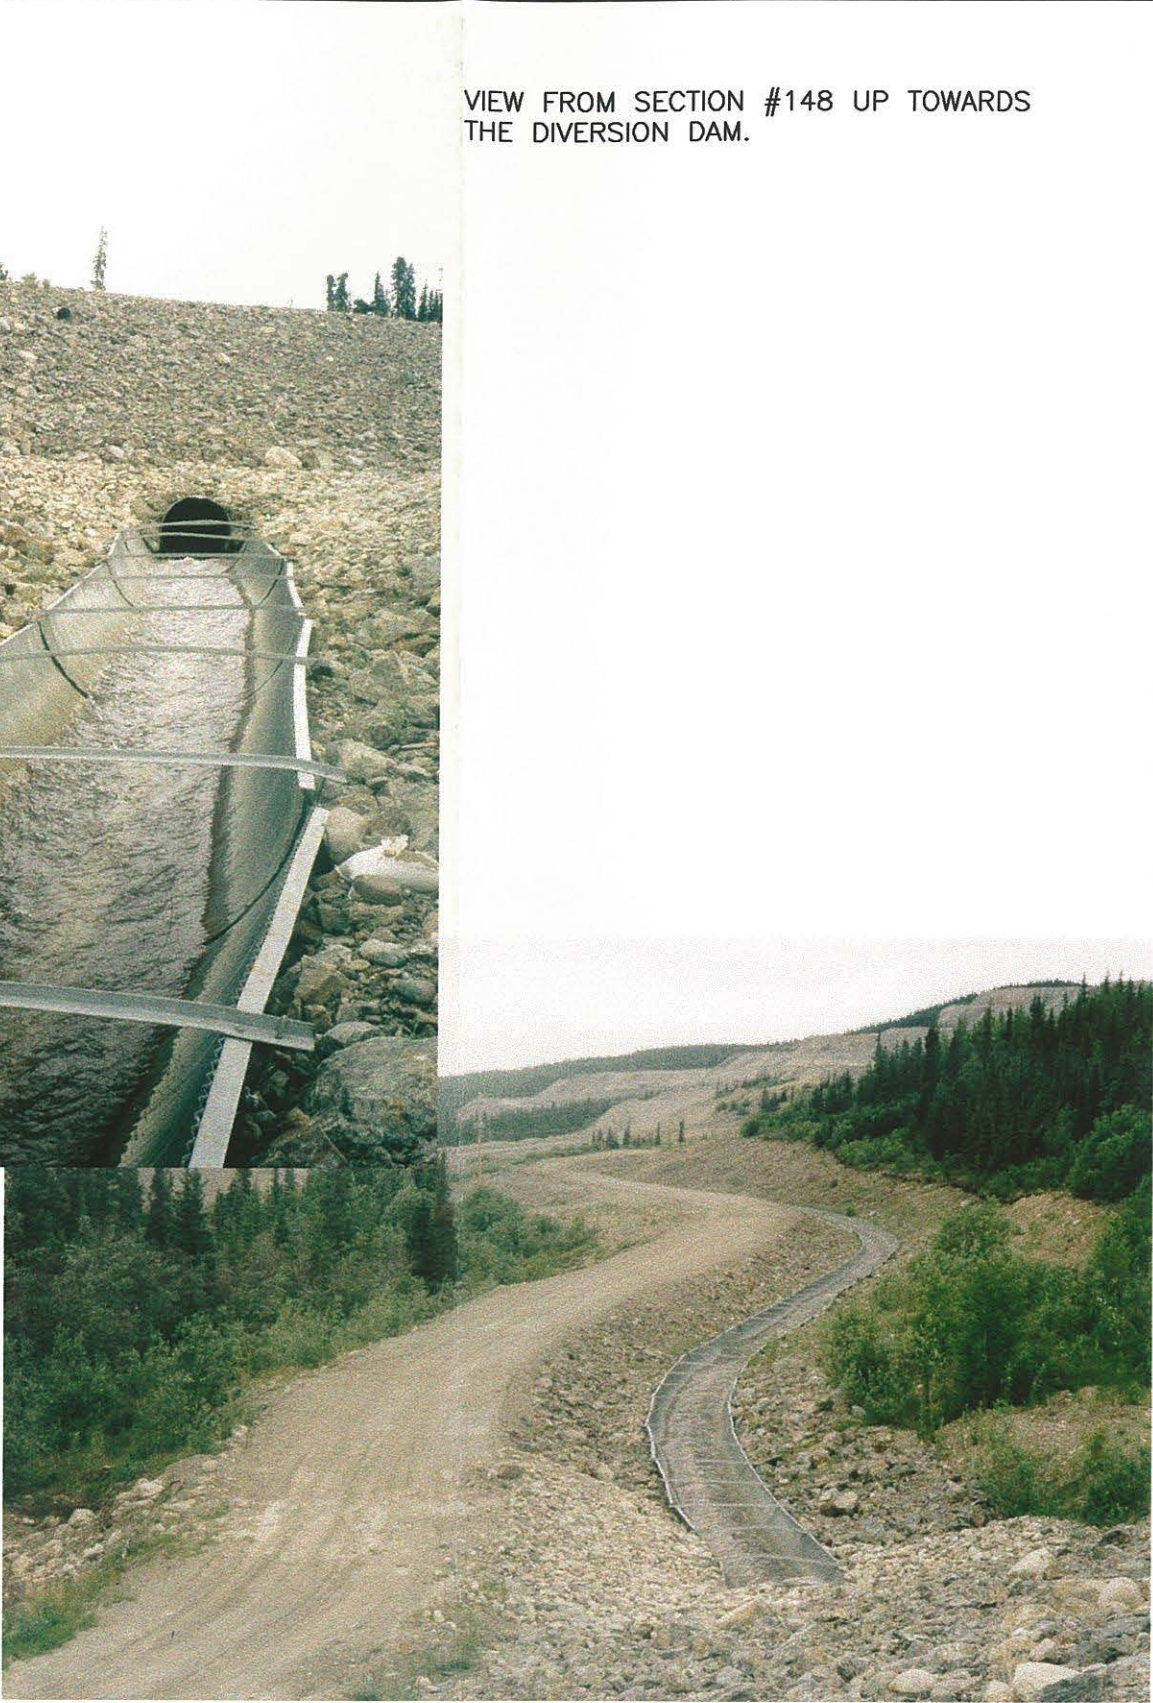
In general, the flume was successfully passing the Vangorda Creek flow and no water was observed outside of the excavated channel. However, the flume's overall condition, especially in the lower portion from Section #1 to approximately Section #20, is deteriorating with time. Several of the cross-braces were damaged by rockfall and de-icing activities. A few small holes were seen in the culvert bottom and gaps have opened at some of the joints. Near the downstream end of the flume, water was seen flowing in the base of the channel outside the corrugated steel half-culvert.

VIEW FROM SECTION #148 UP TOWARDS THE DIVERSION DAM.

VIEW LOOKING DOWNSTREAM ALONG THE FLUME FROM THE DIVERSION DAM.

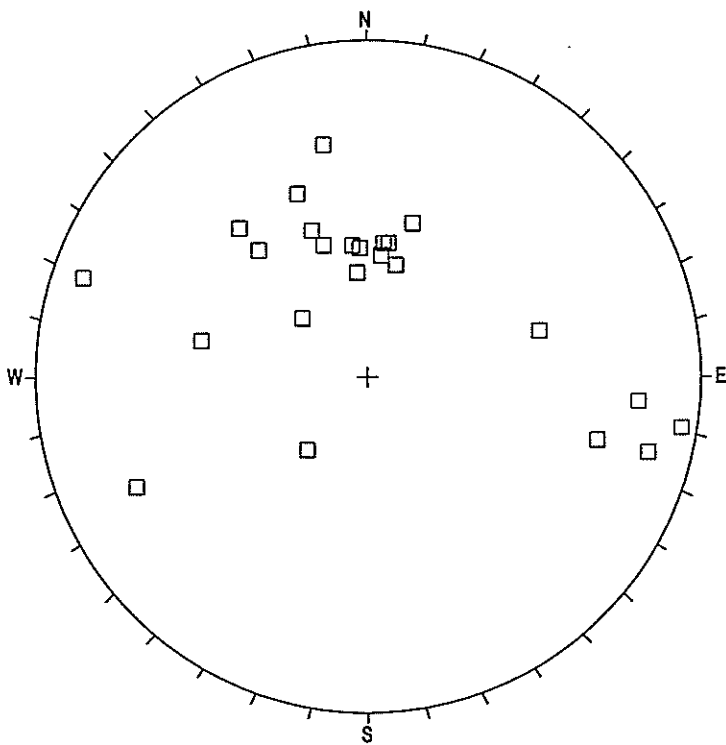
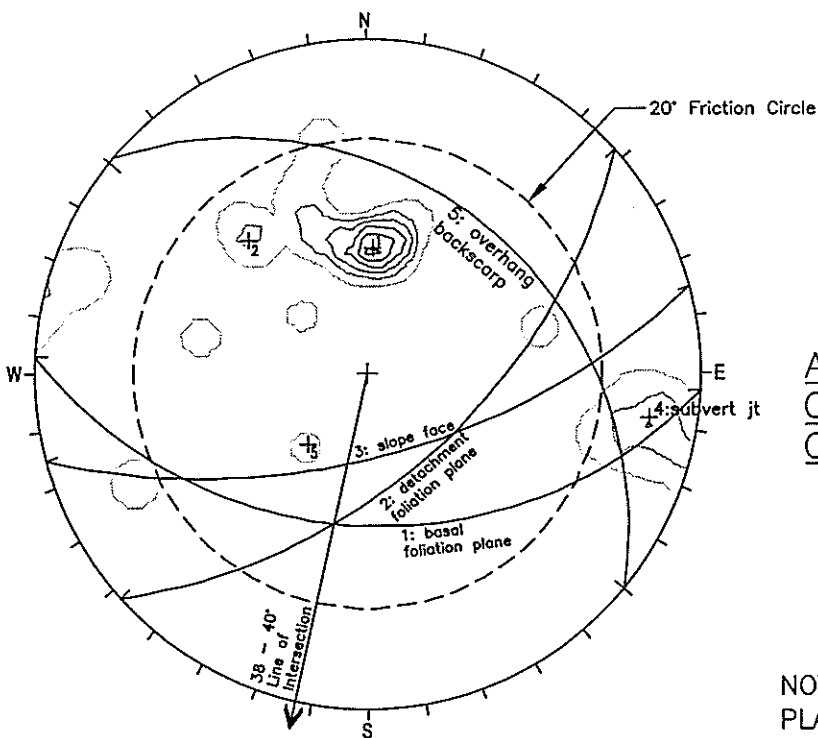
MEASURED POLES TO
DISCONTINUITY PLANES

AVERAGE DISCONTINUITY
ORIENTATIONS BASED ON
CONTOURING MEASUREMENTS

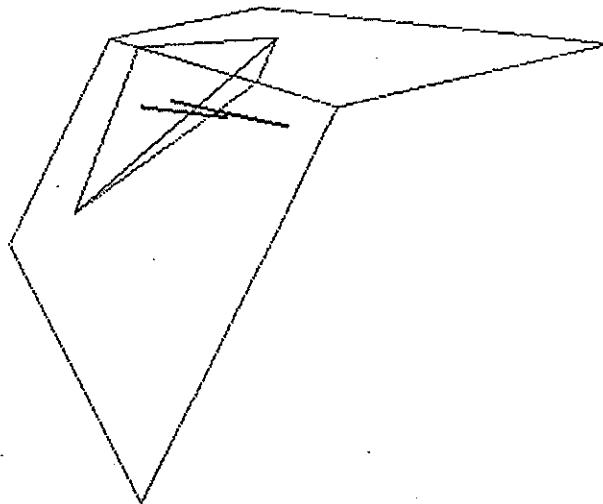
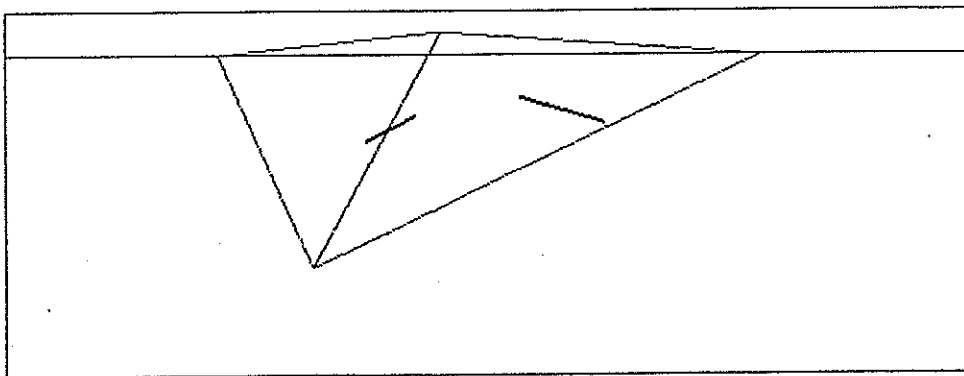
NOTE:
BOLTS SHOWN INDICATE ANALYZED FORCE VECTORS ONLY,
ACTUAL BOLT SPACING PATTERN TO BE DETERMINED.
