MN  
R 199

**EVALUATION OF THE  
MOUNT NANSEN MINE  
SURFACE PLANT, WATER SYSTEM AND MILL FACILITIES  
CARMACKS, YUKON TERRITORY**

**PROJECT NO. 1338-100**

**NOVEMBER, 1984**

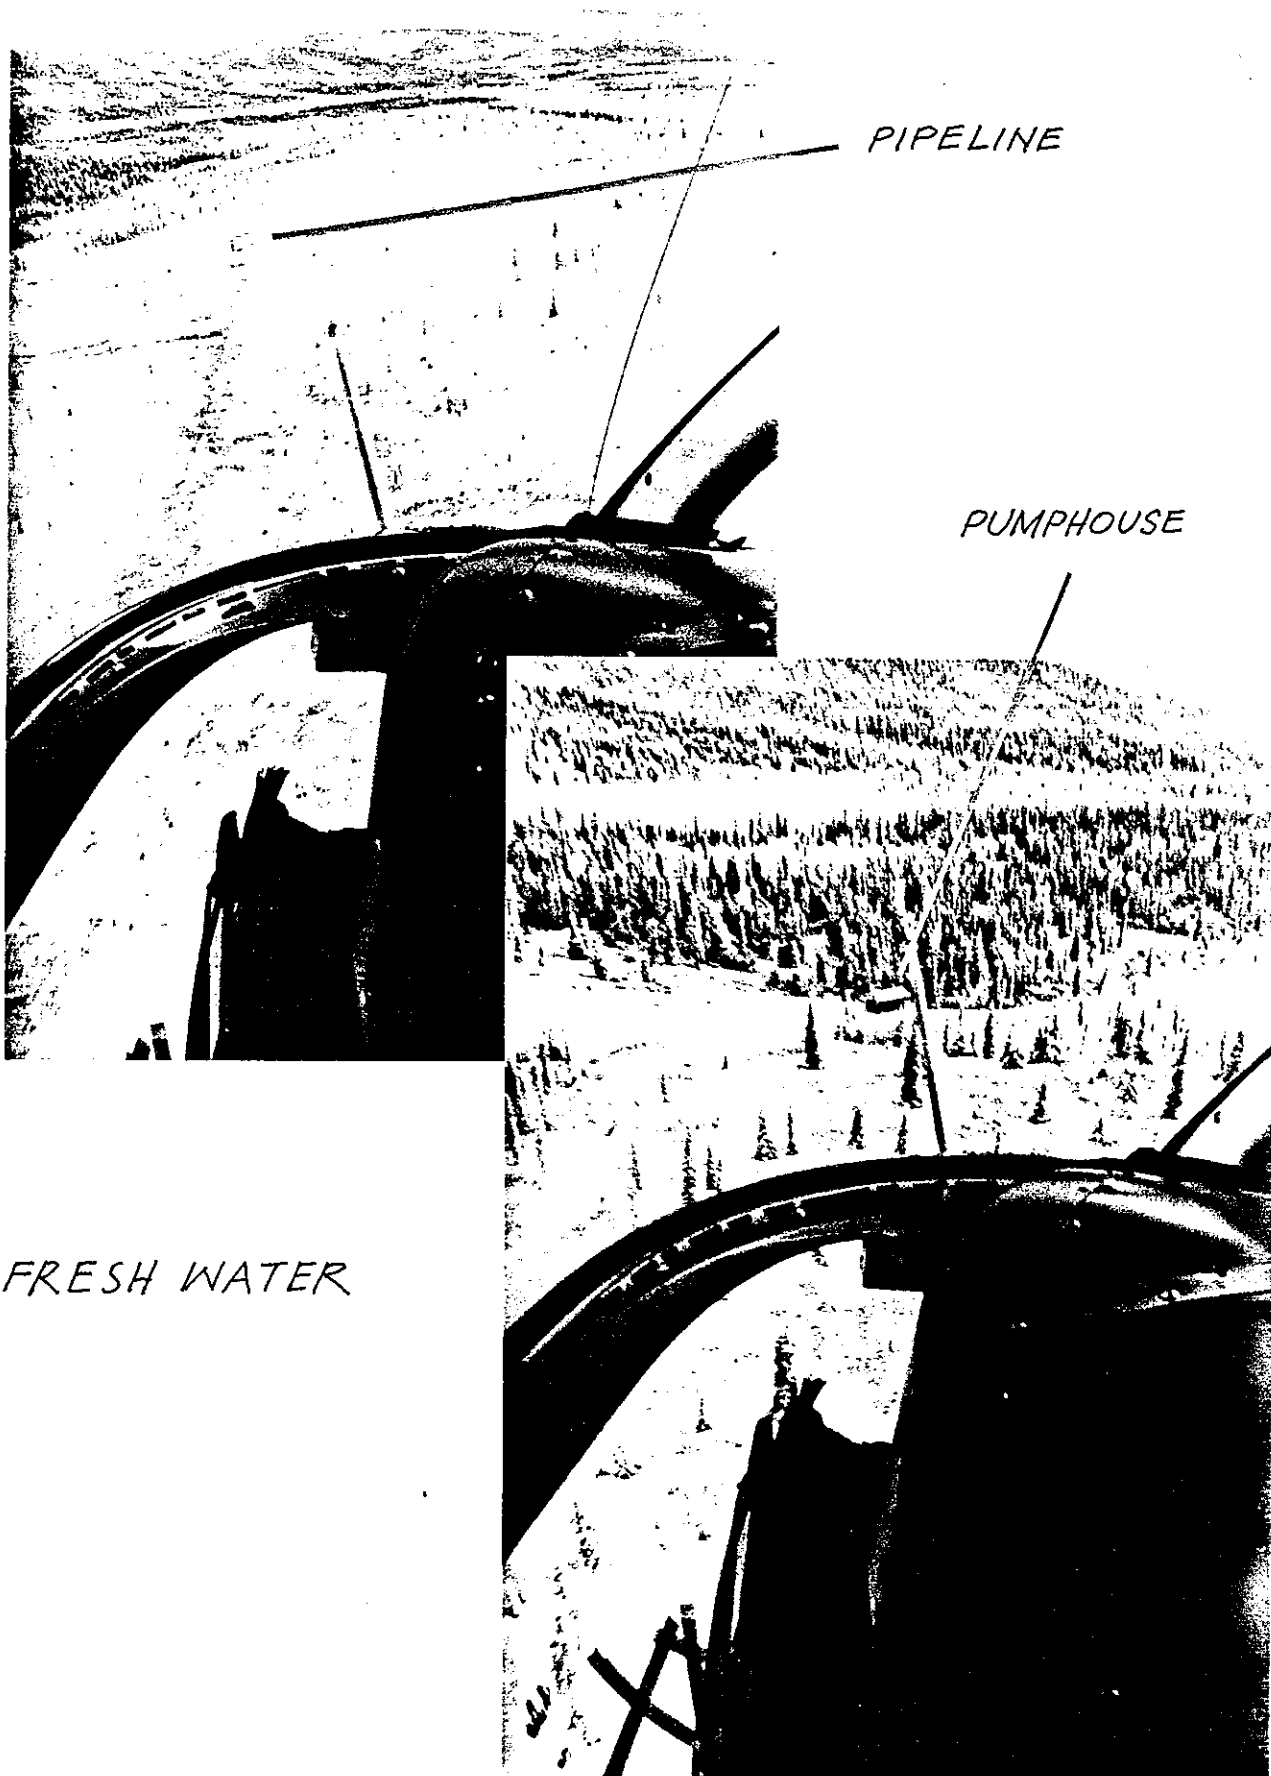
PIPELINE

Item	Description	Estimated Value	Comments
2.2.1	Structural content	-	
2.2.2	Pipeline, 4", Schedule 40, Victaulic joints from pumphouse to storage tank and feed to plant. (Approx. 3 km).	25,000	Only random pieces of pipe were inspected. Some were corroded, some missing. Salvage only.
2.2.3	Electrical transmission line	3,000	Salvage only

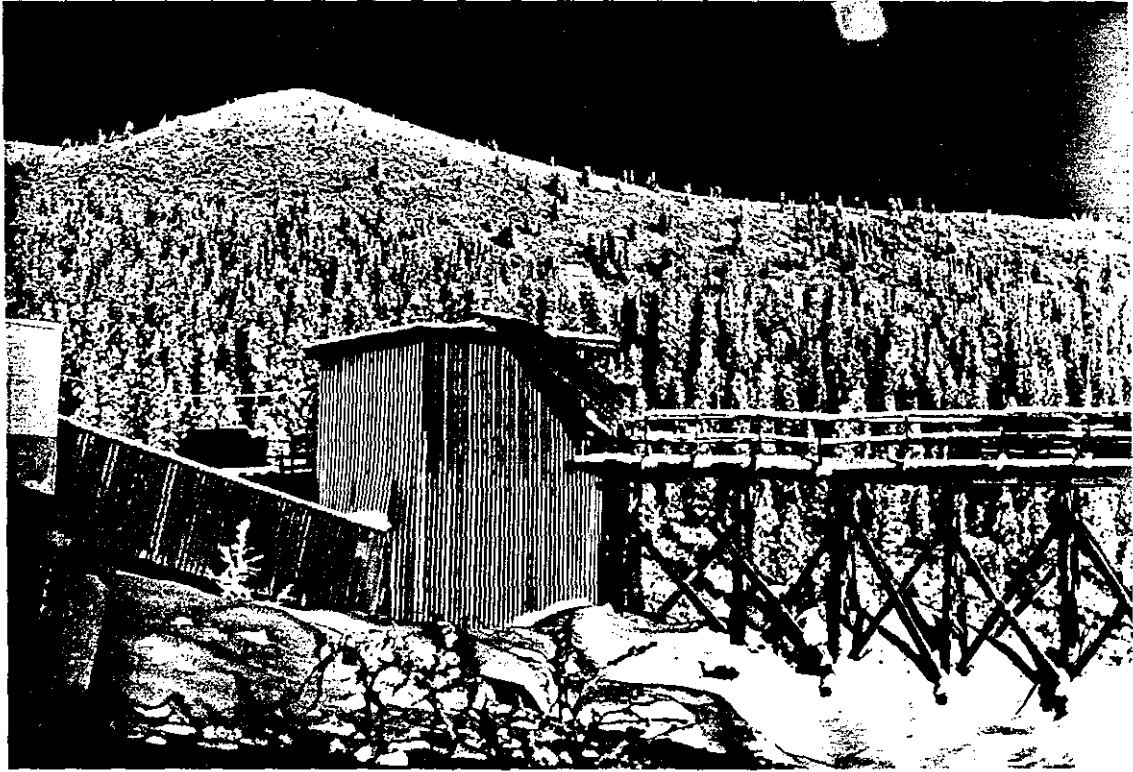
*TAIL END OF CONV. #1*

3.1.7	30' wide conveyor, approximately 200' x 50' rise (#1 conveyor)	32,000	Generally fair condition, drive stripped, no motor.
3.1.8	Vibrating feeder, 42" x 48"	12,000	Appears good.

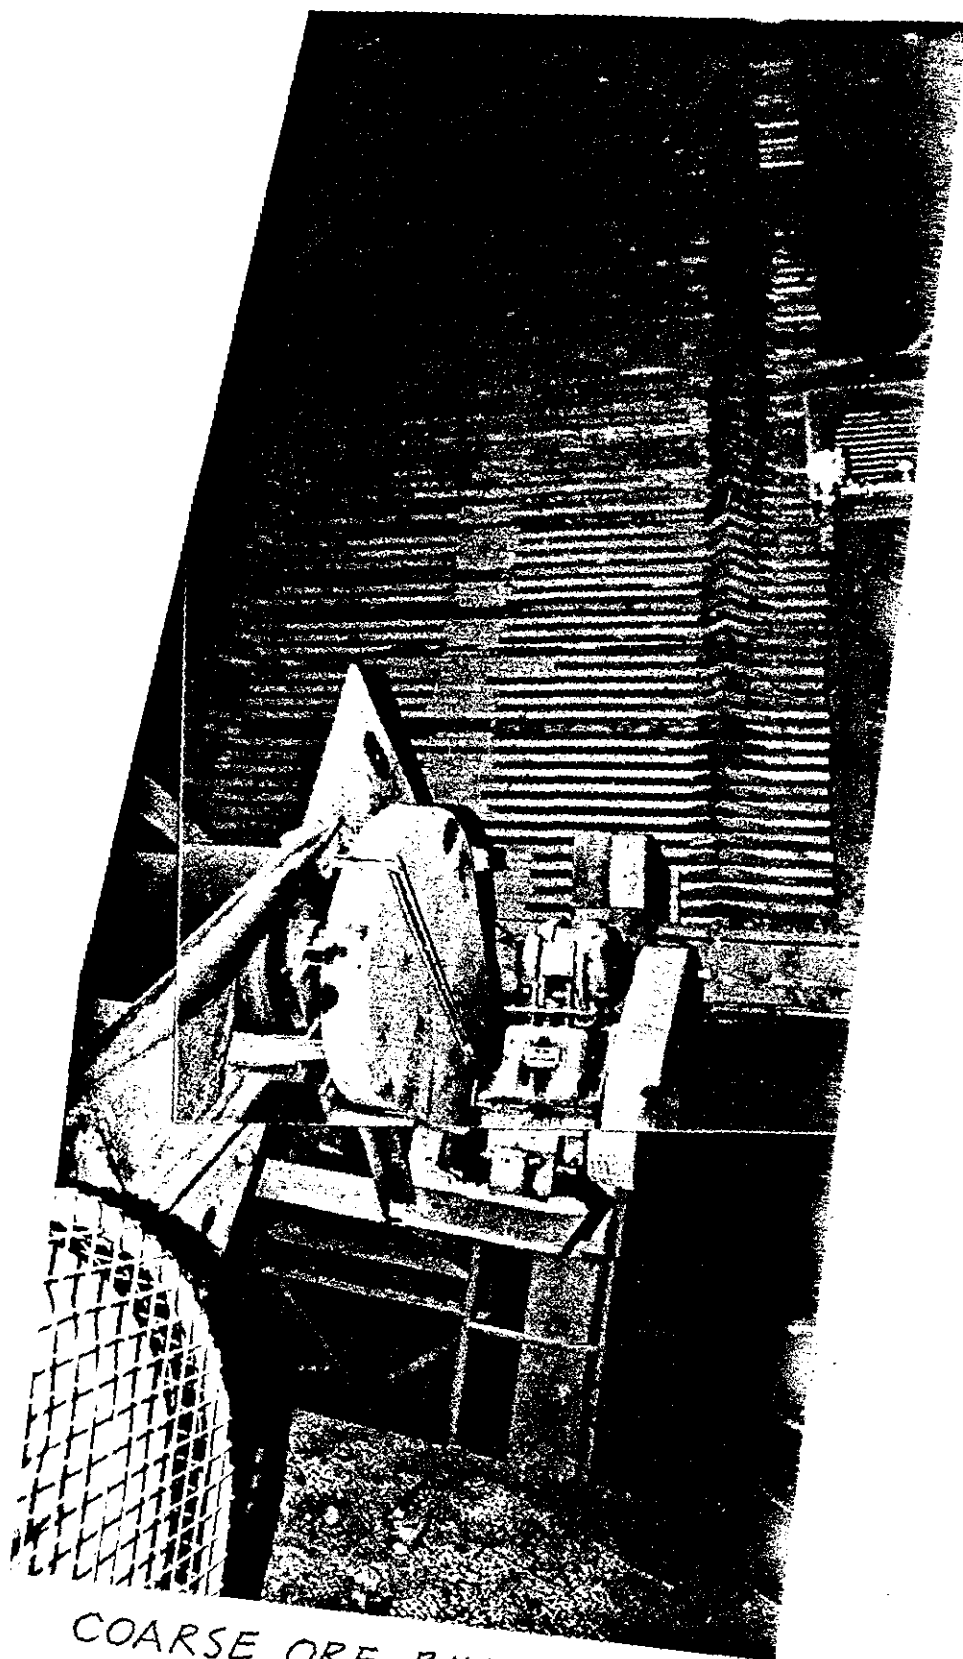
COARSE ORE BIN AND  
HEAD END OF CONV. #2

3.1.3	Coarse ore bin (building and platforms)	99,000	Building and bin do not need much repair. Truck ramp to be reinforced.
3.1.4	Crushing building (building and platforms)	247,000	Needs reasonable amount of repair. Includes overhead crane components.

3.1.9	36" conveyor, 40' x 10' rise, (#2 conveyor), including chutework	12,000	All components apart from the belt are in good condition. Belt needs replacing.

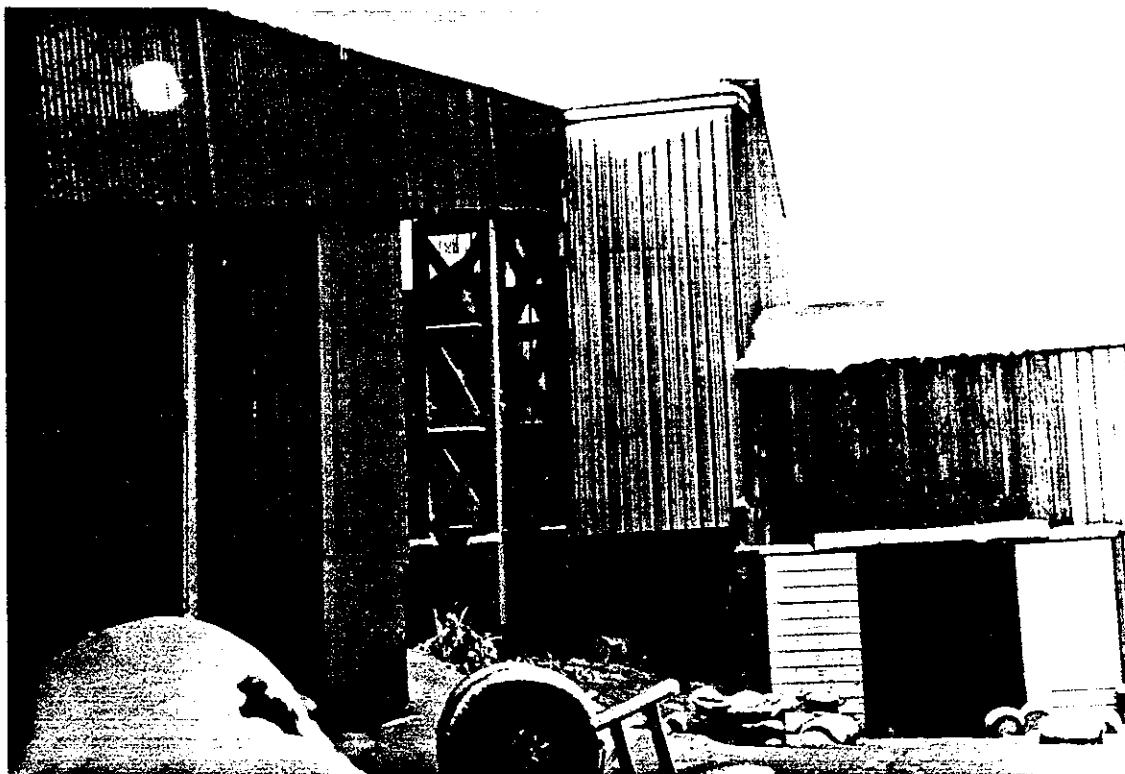
CONVEYOR #5 AND  
FINE ORE BUILDING

3.1.15	18" conveyor, 120' x 32' rise (#5 conveyor)	15,000	Good condition.
3.1.16	18" conveyor, 23' centres, horizontal, reversible (#6 conveyor)	5,000	Good condition.
