# NORTHERN AFFAIRS PROGRAM

## FARO AND VANGORDA PLATEAU MINES

**REPORT  
ON  
1999 INSPECTION**

Prepared by:  
GEO-ENGINEERING (M.S.T.) LTD.  
Calgary, Alberta

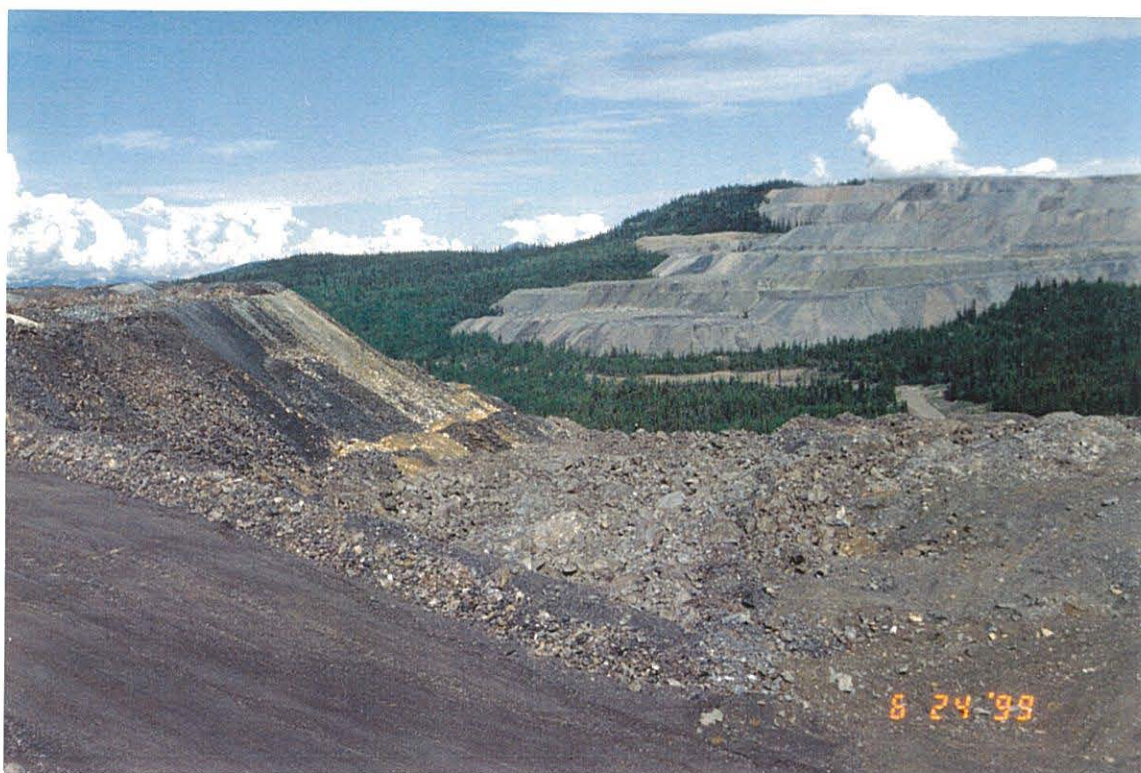
Most of the excavated overburden rock, chiefly phyllite with some till from the slot cut, was deposited into the main waste dump, located on gently sloping ground towards the Vangorda Creek valley. The dump, to date, was developed in six benches (Photo 22). The conceptual design developed by SRK considered placement and encapsulation of sulphide rock in the centre portion of the lower bench. This concept has not been implemented since sulphide rocks are encountered at other locations as well.

Photo 22: Looking from Vangorda dump to Grum waste rock dump.
