Faro Mine Hydraulic Capacity Analysis

Final Report June 2006

northwest hydraulic consultants ltd.

June 2006

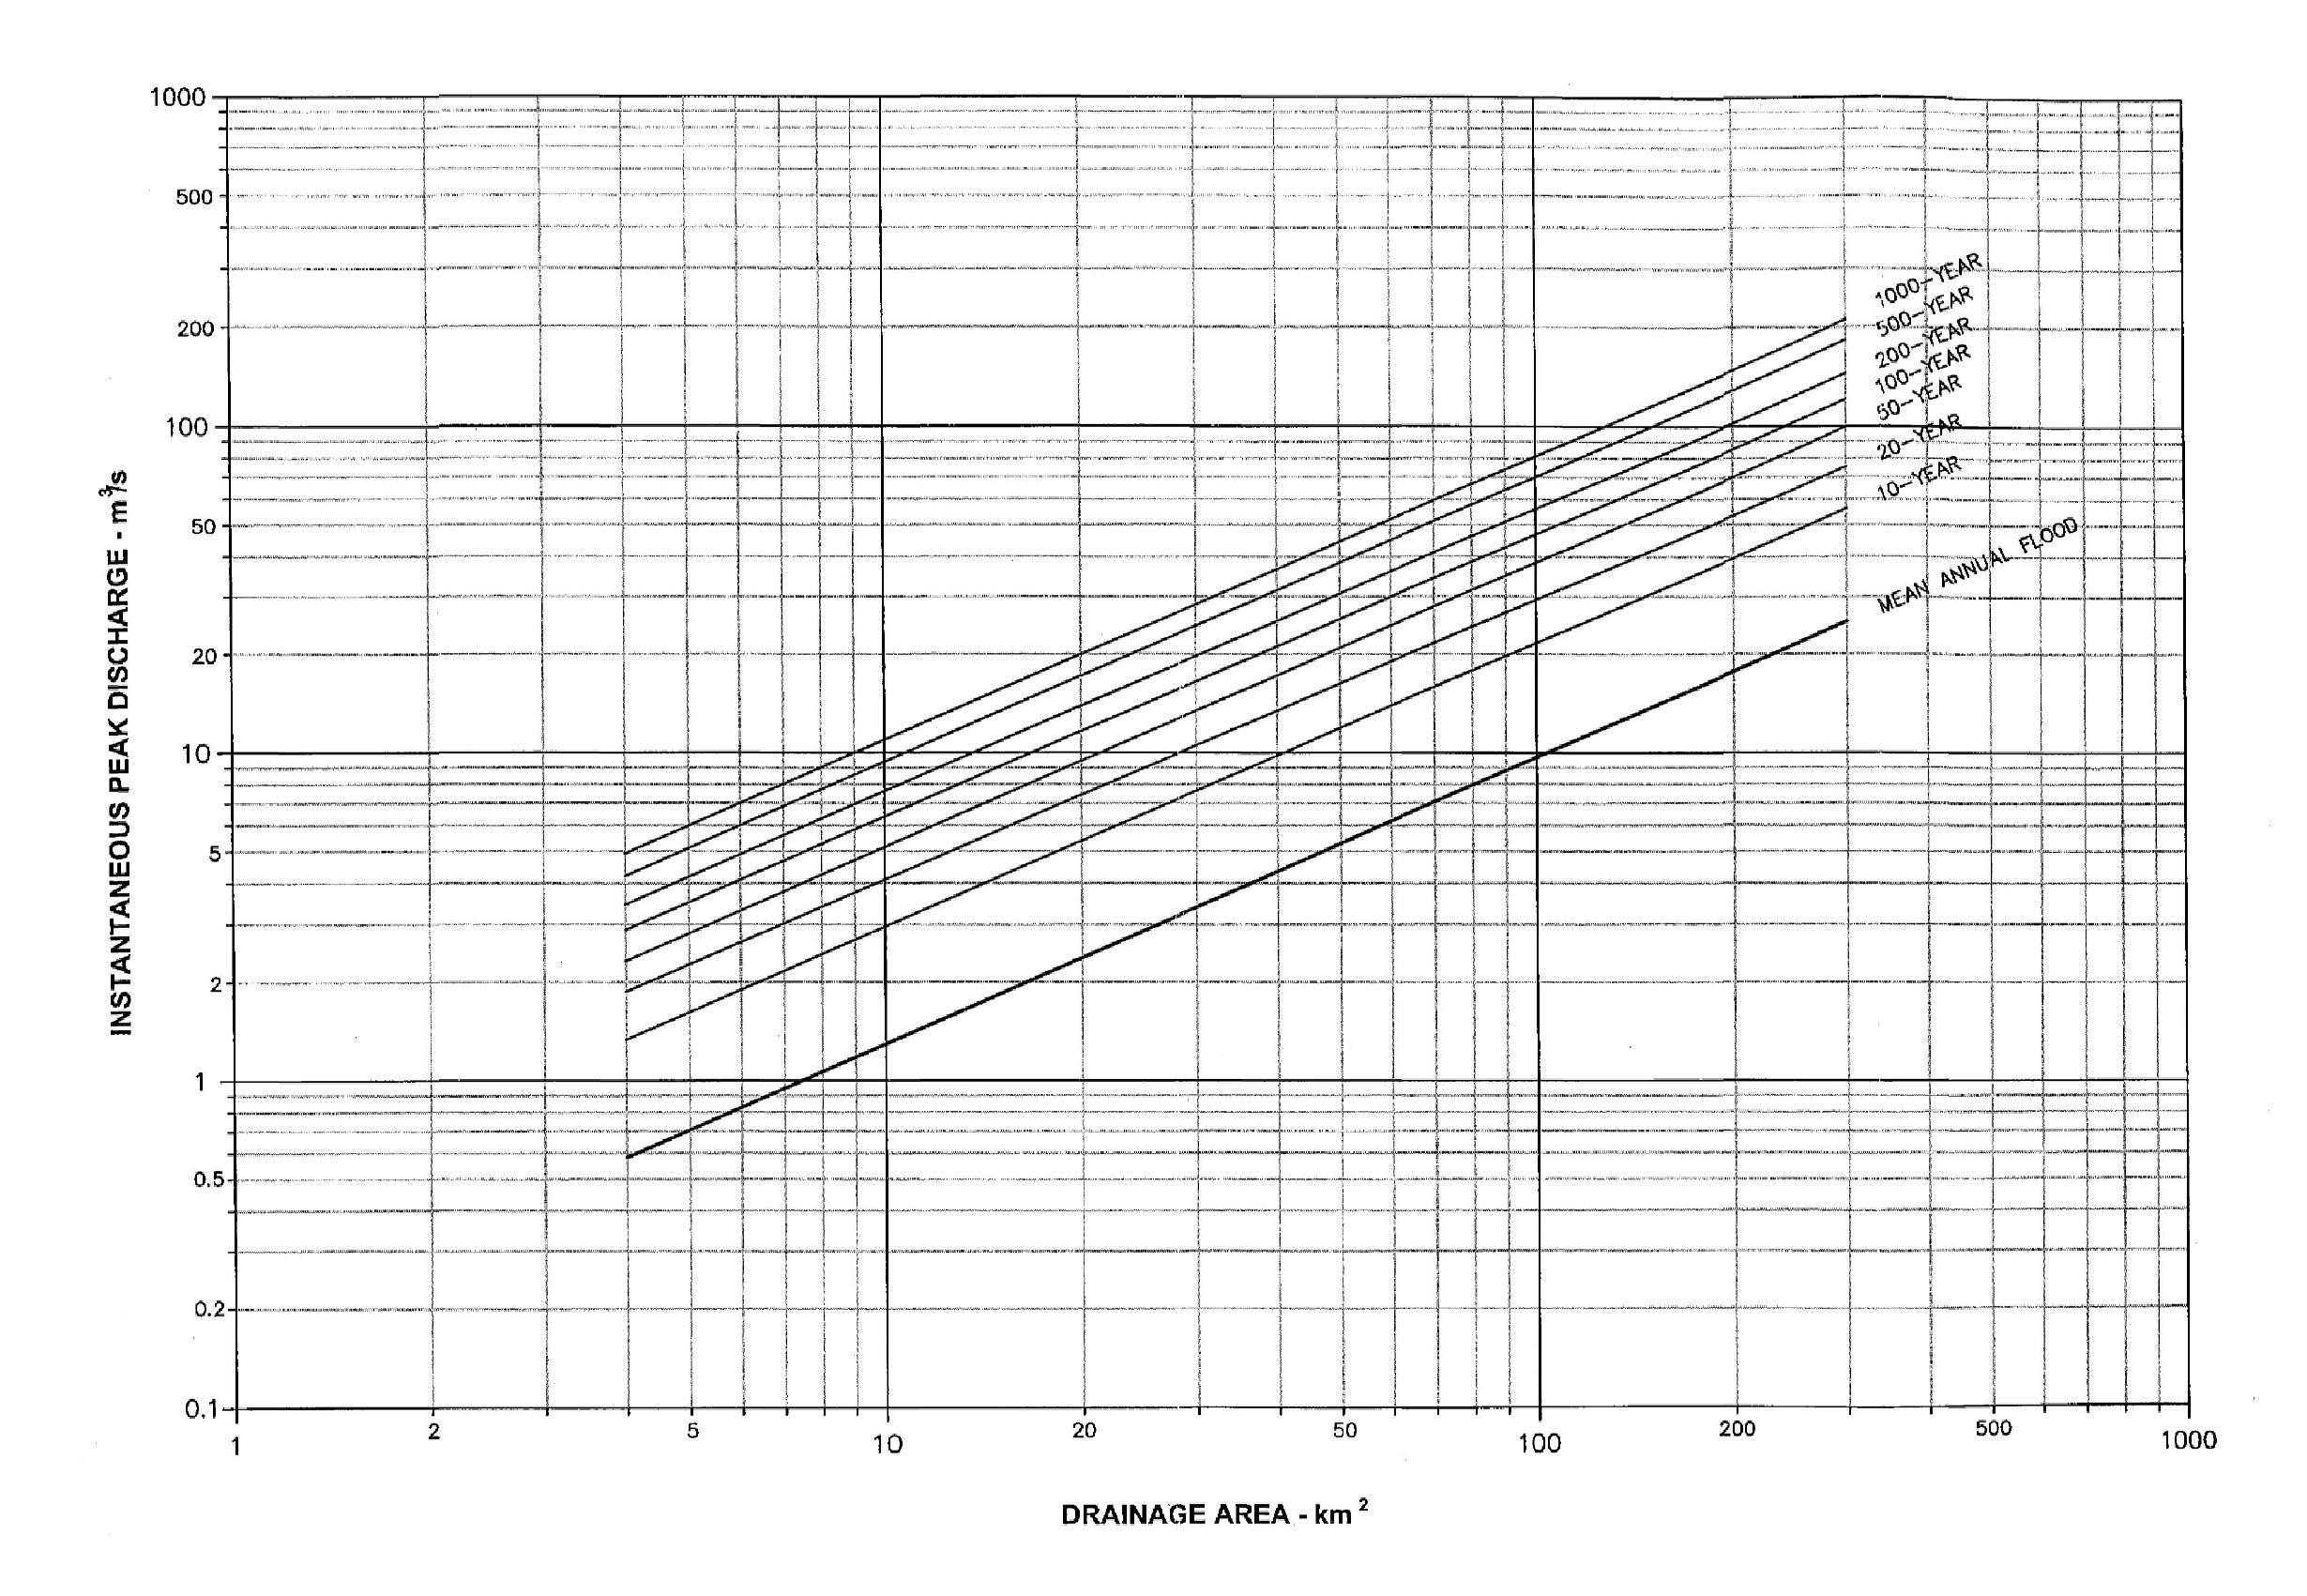
Figure 2: Extreme Flood Curves (nhc, 2004)

The contributing watershed area for the Intermediate Dam spillway was delineated off the aerial photogrammetry generated contours to be 4.9 km^2 assuming failure of the north wall interceptor ditch (Figure 1). From the extreme flood curves (Figure 2) derived for the Faro mine site (**nhc**, 2004) the watershed based inflow to the Intermediate Dam is 5.0 m³/s. Conservatively assuming these peak flood events occur with no lag time between them, the 500-year IDF for the Intermediate Dam spillway is 11.2 m^3 /s.

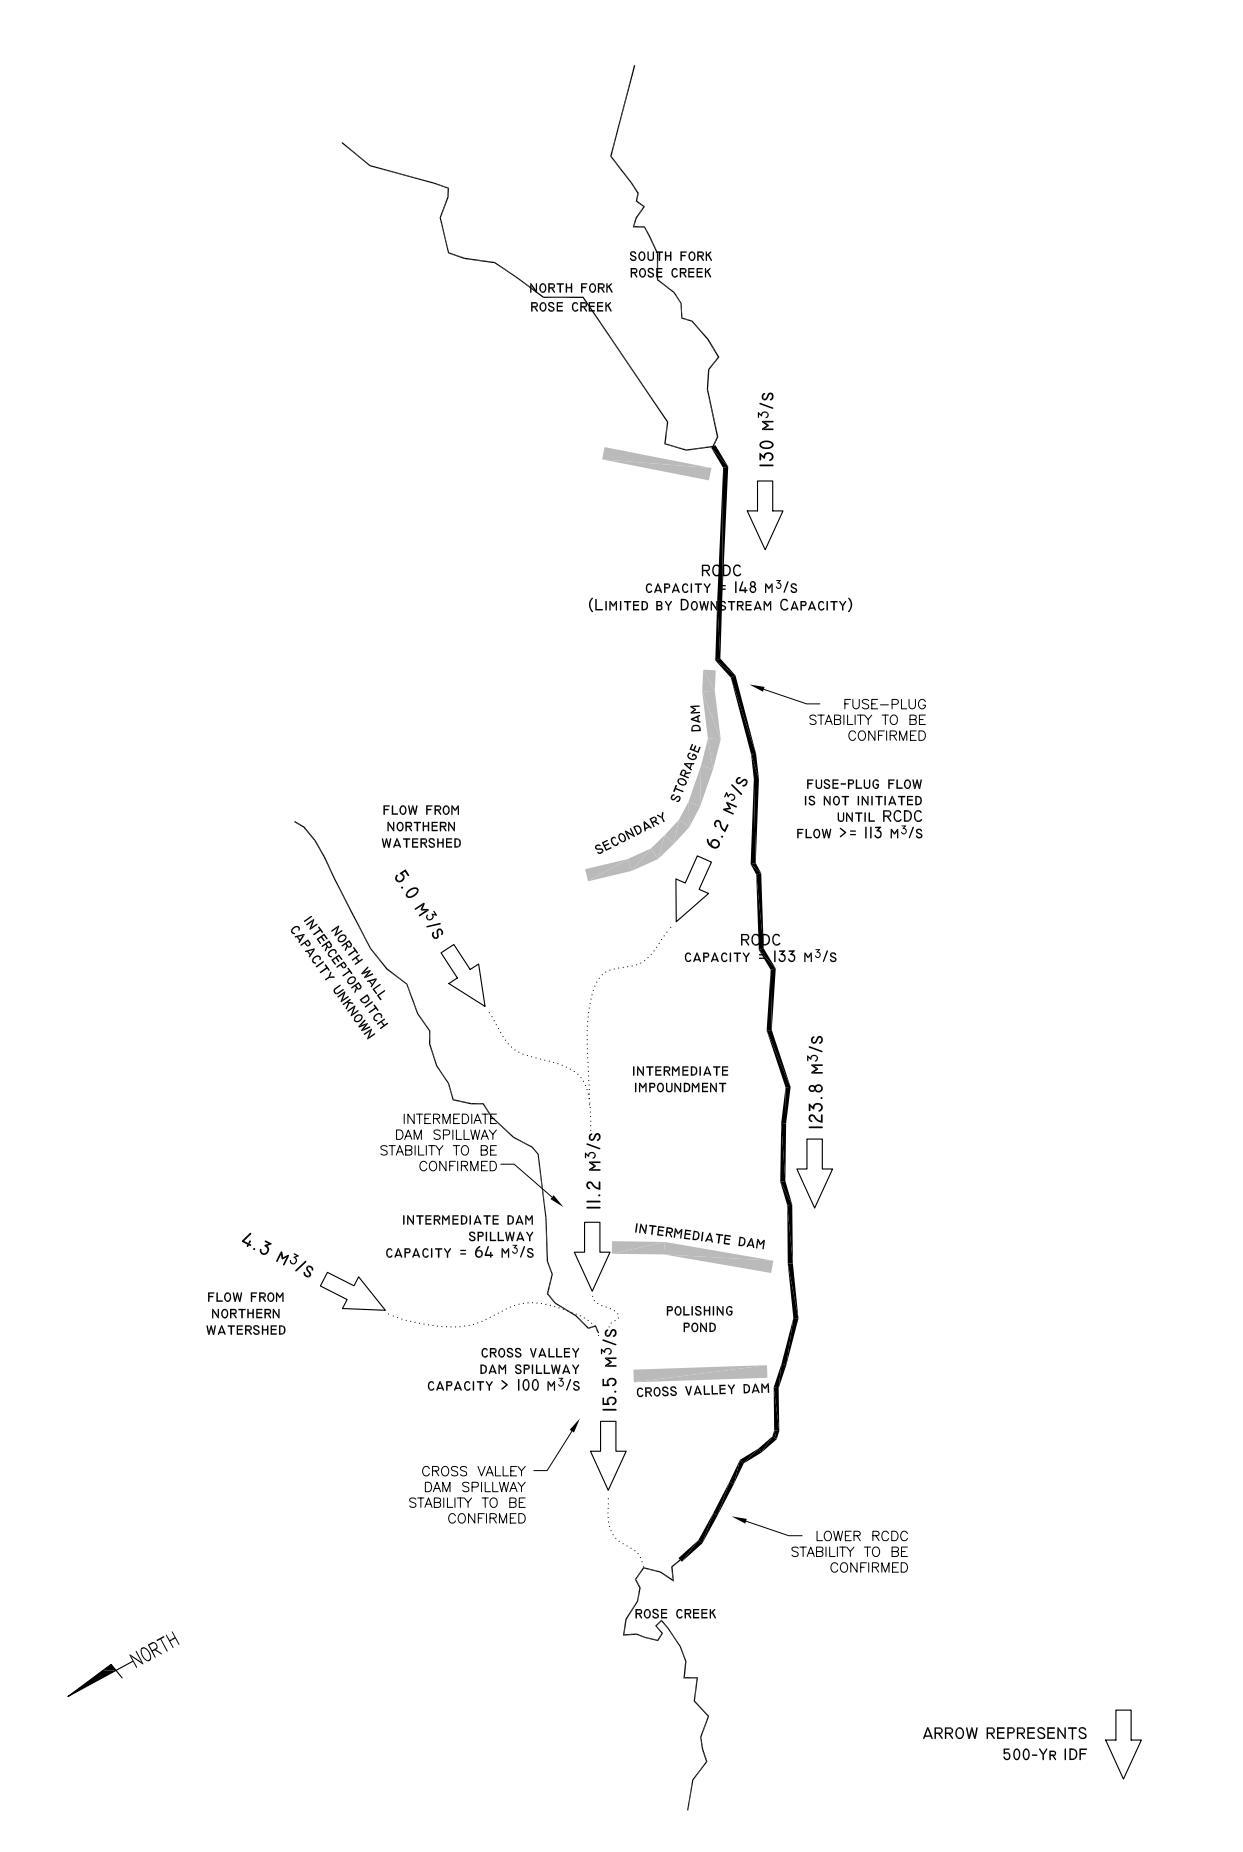
Figure 6: Faro Mine Tailings Area Conveyance Schematic

Using the modelling results, it was determined that the RCDC and the spillways around the north side of the Intermediate Dam and the Cross Valley Dam provide adequate capacity to convey the 500-year IDF. However, stability of the surfacing material has not been checked in detail and should be confirmed through site inspection. Once the field work prescribed in this report is completed the riprap size and placement requirements should be checked and updated if necessary. Figure 6 schematically depicts the design flow paths along with estimated maximum capacity and locations of potential instability.
