Geotechnical Evaluation Borrow Source Assessment – Clinton Creek Area Dawson, Yukon – 2015

Yukon Government Energy, Mines & Resources Assessment and Abandoned Mines

January 8, 2016

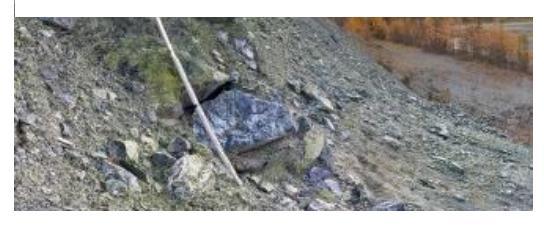
This outcrop was comprised of high grade serpentine which had fractured into 1 meter sized blocks. The spacing of general discontinuities within these blocks measured in the order of 0.2 to 0.3 meters.

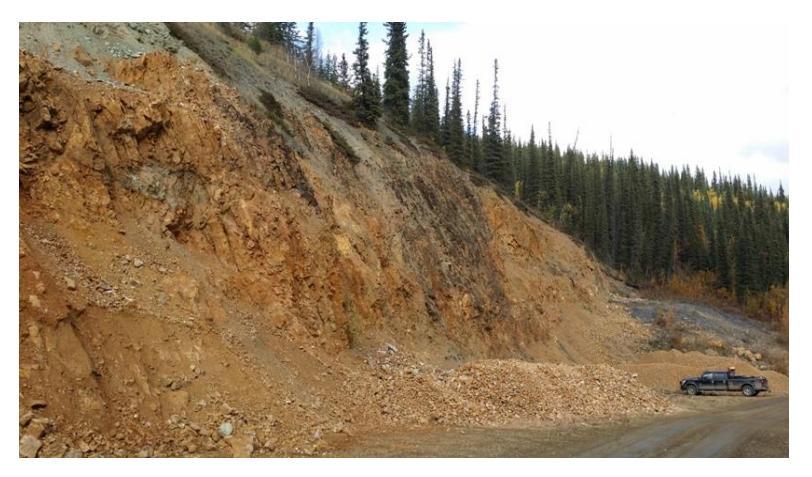
Sept.10, 2015 – Mine Site No.1 (Entrance Pit – quartzite unit) facing east.

The exposed length of the quartz-carbonate rock measured in the order of 200 meters. The top of the quartz unit was estimated to be in the order of 15 meters high relative to the adjacent road elevation.

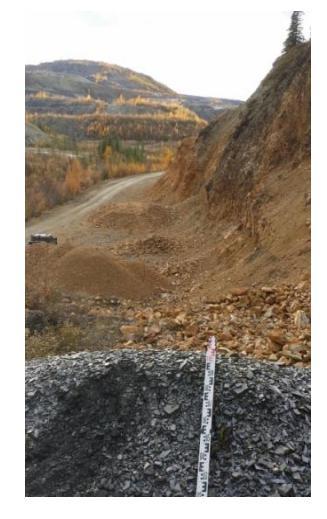
The underlying rock unit was comprised of weakly deformed shale. Sept.10, 2015 - Photo of Shale (foreground) facing west

Outcropping of this unit was difficult to identify as it was in a heavy state of disintegration and the rock face could not be approached due to the potential for rock-fall. Platy particles were however encountered throughout the eastern areas below the quartzcarbonate. The materials measured on average 35-40 mm in size. Maximum particle sizes of 100 mm were noted. The shale material was classified as sandy gravel with a trace of silt following grain size distribution analysis.

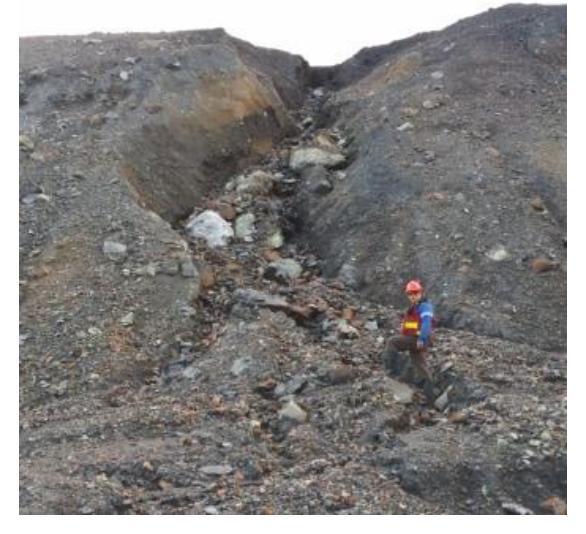
Photo of erosion rill through Waste Rock (Sept.10, 2015)

Some regions of potentially more durable shale rock was also encountered at some locations as larger 300 mm to 400 mm cobble sized materials were also observed. The grain size distribution analysis of two samples classified the material as gravelly silty sand and sandy gravel which contained some silt.

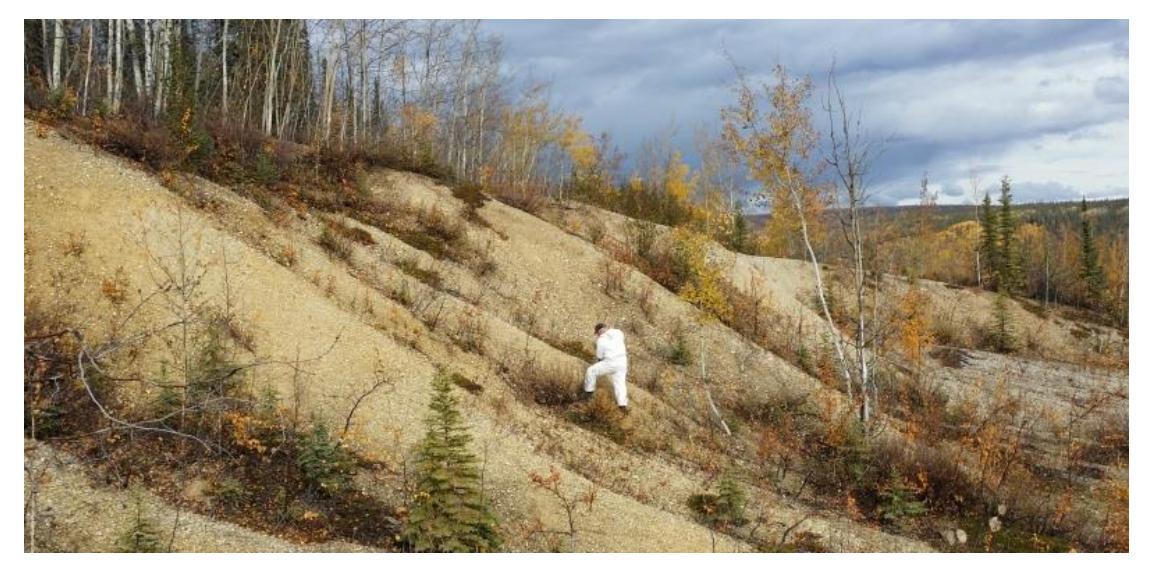
Photo of Mine Site No.5 (Sample 5-2) facing east (Sept.9, 2015)

The results of the grain size distribution analysis of three (3) samples retained from along the working face indicated the composition of the deposit is comprised of predominately sands which contained between 13.2 and 15.7 % silt (by weight). Some oxidation was noted. One of the samples (MS 5-3) was classified as sandy gravel with some silt. The (sub-angular to sub-rounded) gravel near this location measured in the order of 80 mm with only the odd cobble in size to 150 mm. The presence of cobble sized materials throughout the remainder of the visible working face was otherwise scarce. The gravel was comprised of predominately quartz however minor occurrences of gneiss and serpentine were also noted.

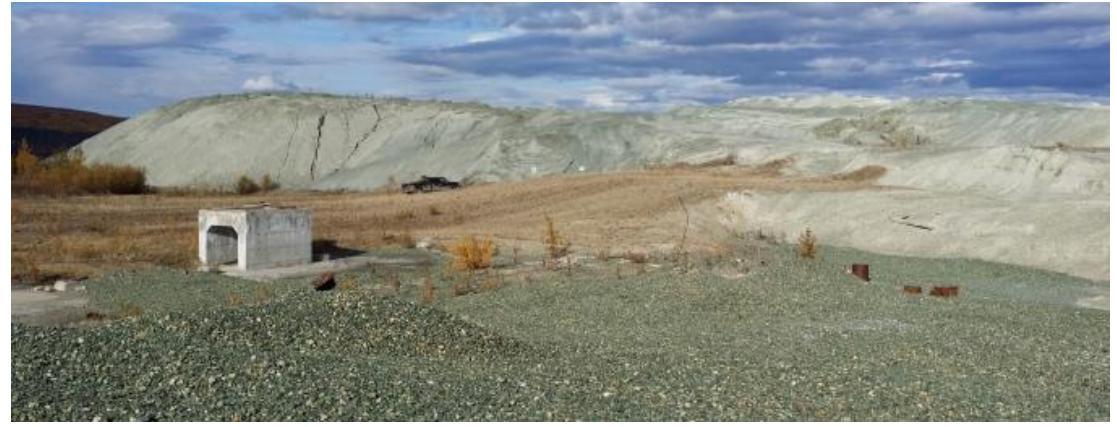
Photo of Mine Site No.6 (Mine Tailings) - Sept.9, 2015 Photo taken from Sample No.6 location facing north (note Figure 3)

A progressive coarsening of the tailing materials was noted between the southern and northern lobes. In brief, the laboratory analysis revealed the gradation of the northern lobe was comprised of (28 mm minus) gravelly sand which contained 13.4 and 15.5 percent silt (by weight), respectively. The moisture contents were noted to be 8.9 and 8.3 percent. By contrast the southern lobe was comprised of (20 mm minus) gravelly sand, which contained 30.1 and 24.5 percent silt, respectively. Higher moisture contents of 12.6 percent were noted. The central area (Sample No.3) was classified as a (20 mm minus) gravelly silty sand. This material contained intermediate amounts of silt (23.9 %) and moisture content (10.3 %). The sample was retained from a region which exhibited polygons in size to 100 mm. Extension cracks up to 75 mm wide were located approximately 3 meters south-east of the sample location.

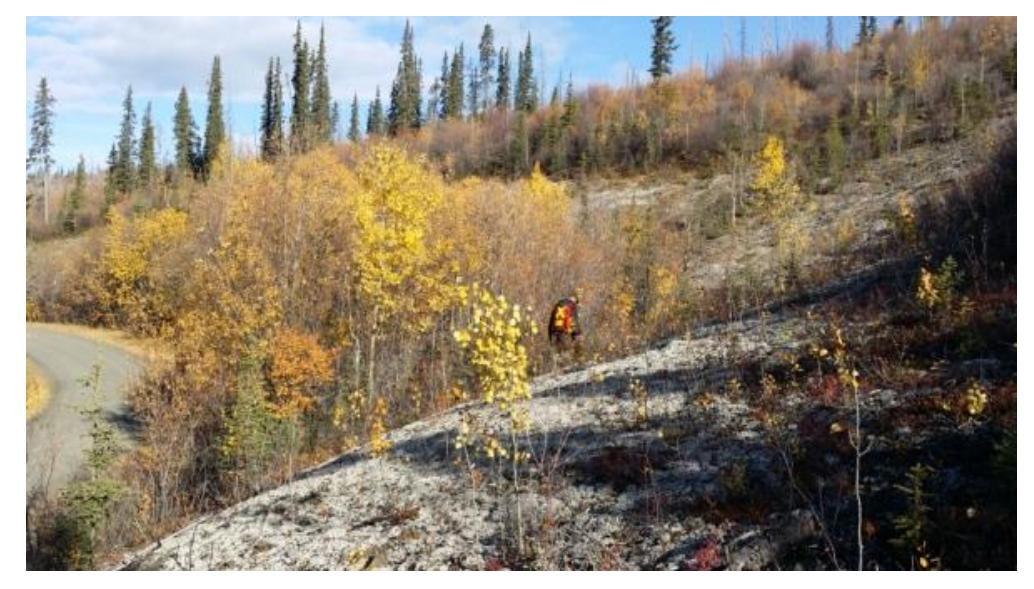
This site was cut into the hill side to depths of approximately 2 meters. Disturbed regions extended up to 50 meters from the road shoulder. A small stockpile ($\sim 100 \text{ m}^3$) was observed near the roadway. A smooth serpentine rock face was present with a dip of approximately 45° to the south-west. The rock type varied from the serpentine rock to a low grade micaceous schist.

Photo of CCR Site 5 facing north – Typical CCR side-cut borrow (Sept.12, 2015)

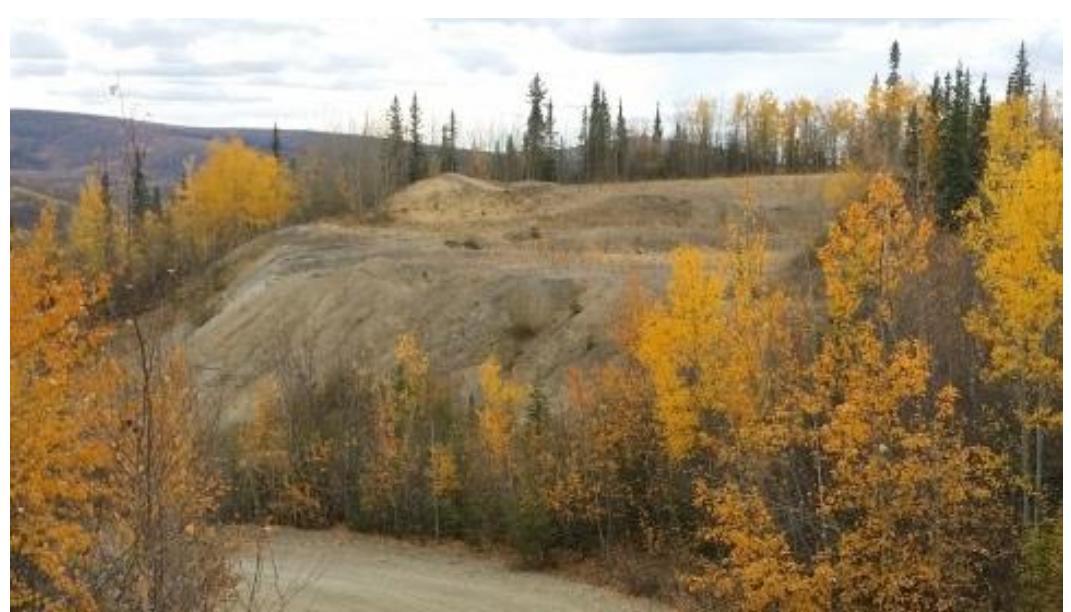
Photo of Site 11 from CCR facing north-west (Sept.11, 2015)

As the south-easternmost area was partially cleared and stripped, visual inspection of the near surface materials noted granular materials throughout the exposed regions. Assuming the granular materials are continuous with depth, the volume of granular reserves which may be available in the south-eastern half of the site was estimated to be in the order of 100,000 m³. The remaining areas likely harbor lesser amounts of granular reserves.

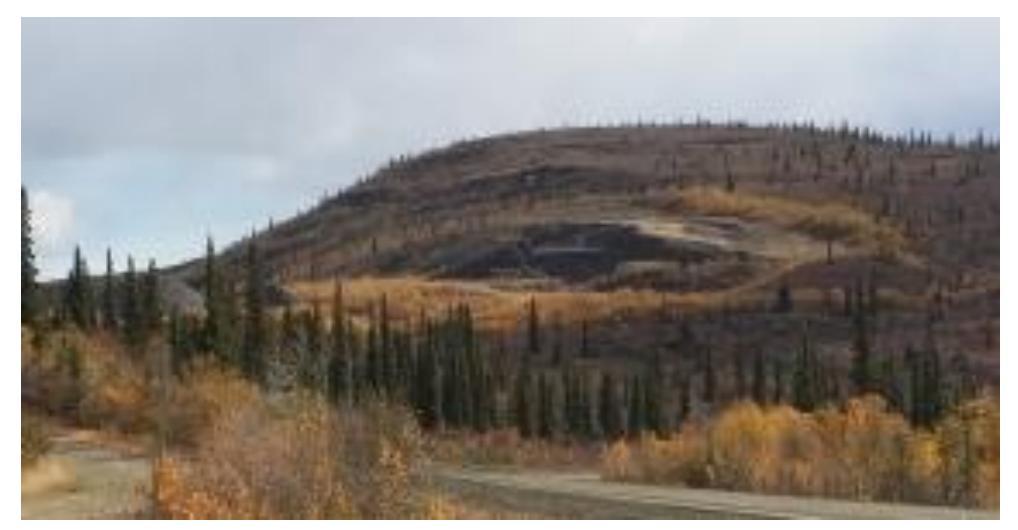
The spacing of discontinuities in the rock was noted to vary. In general, they measured in the order of either 0.1 meter or else 0.5 meters, although some regions of more massive rock were also noted.

Photo of km 46 quarry facing south-east (Sept.12, 2015)

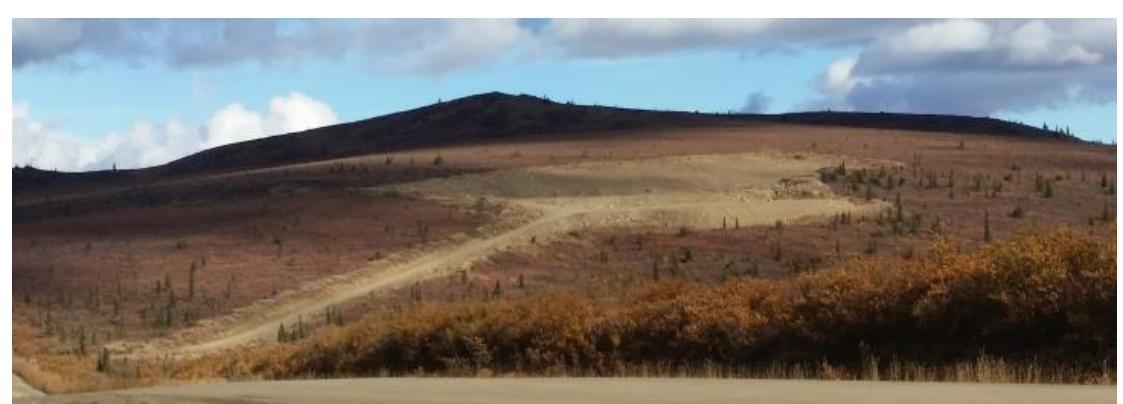
Photo of km 63 quarry facing north-east (Sept.12, 2015)

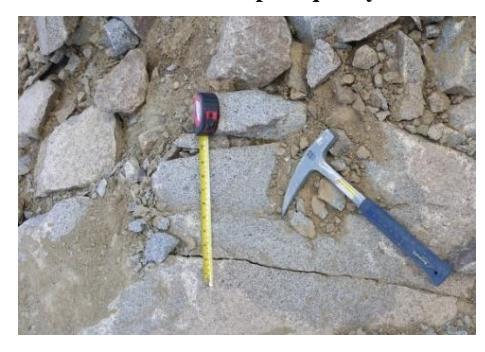
Granodiorite outcrop on quarry floor

The rock was classified as a granodiorite. A sample of the overburden (No.63-1) was classified as silty sand which contained a trace of gravel. Fractured detrital rock fragments in size to 80 mm were noted within the overburden.

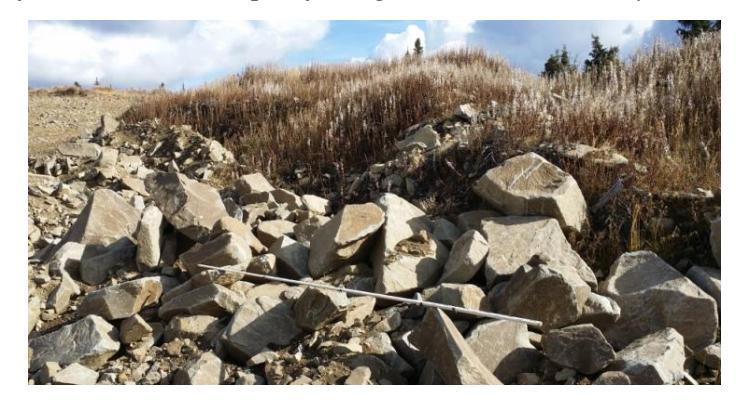
Two oversize rock piles were located within the limits of the quarry. While the western pile was predominately buried with stripping and colluvial materials, (approximately twenty-five) intact fractured boulders in size to 1.4 meters were noted in the eastern pile.

Photo of eastern oversize pile facing north w/4 m survey rod (Sept.12, 2015)

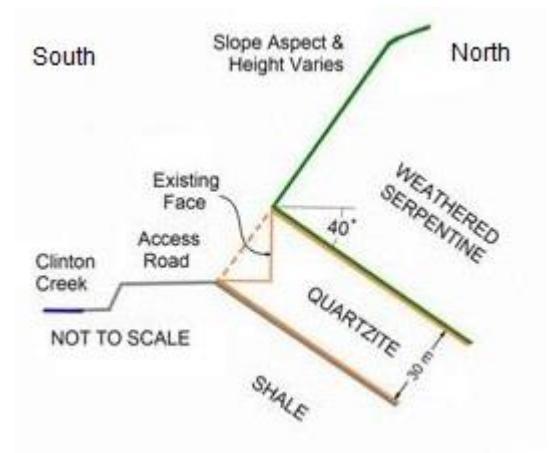
The degree of fracturing and discontinuities noted within the quartz-carbonate rock at Mine Site No.1 (Entrance Pit) was considerable and would limit the

production of rip-rap to Class I sized materials (as was noted onsite). The results of the LA Abrasion and sulphate analysis indicated that crushed (quartz-carbonate) rock will be suitable for use as concrete aggregate. However, the aggregate will not be as competent as material sourced from either ToW – km 46 or ToW – km 63.

The attached cross section illustrates the approximate slope and stratigraphic conditions which are thought to be present at the entrance pit. As noted, the orientation (40° dip) and thickness (~30 m) of the quartzite strata relative to the overlying weathered serpentine rock unit (and colluvial materials) will limit the amount of available quartzite beyond what is readily accessible from the access road (in regions located south of the 'existing face'). Specifically, removal of the overlying materials through mechanical means may prove to be cost prohibitive relative to the amount and quality of available quartzite. The weathered nature and configuration of the deposit would likely restrict or eliminate the need for blasting techniques if the available source is to be optimized. Additional assessment would be required to better characterize the configuration, quality and quantities of the remaining source.

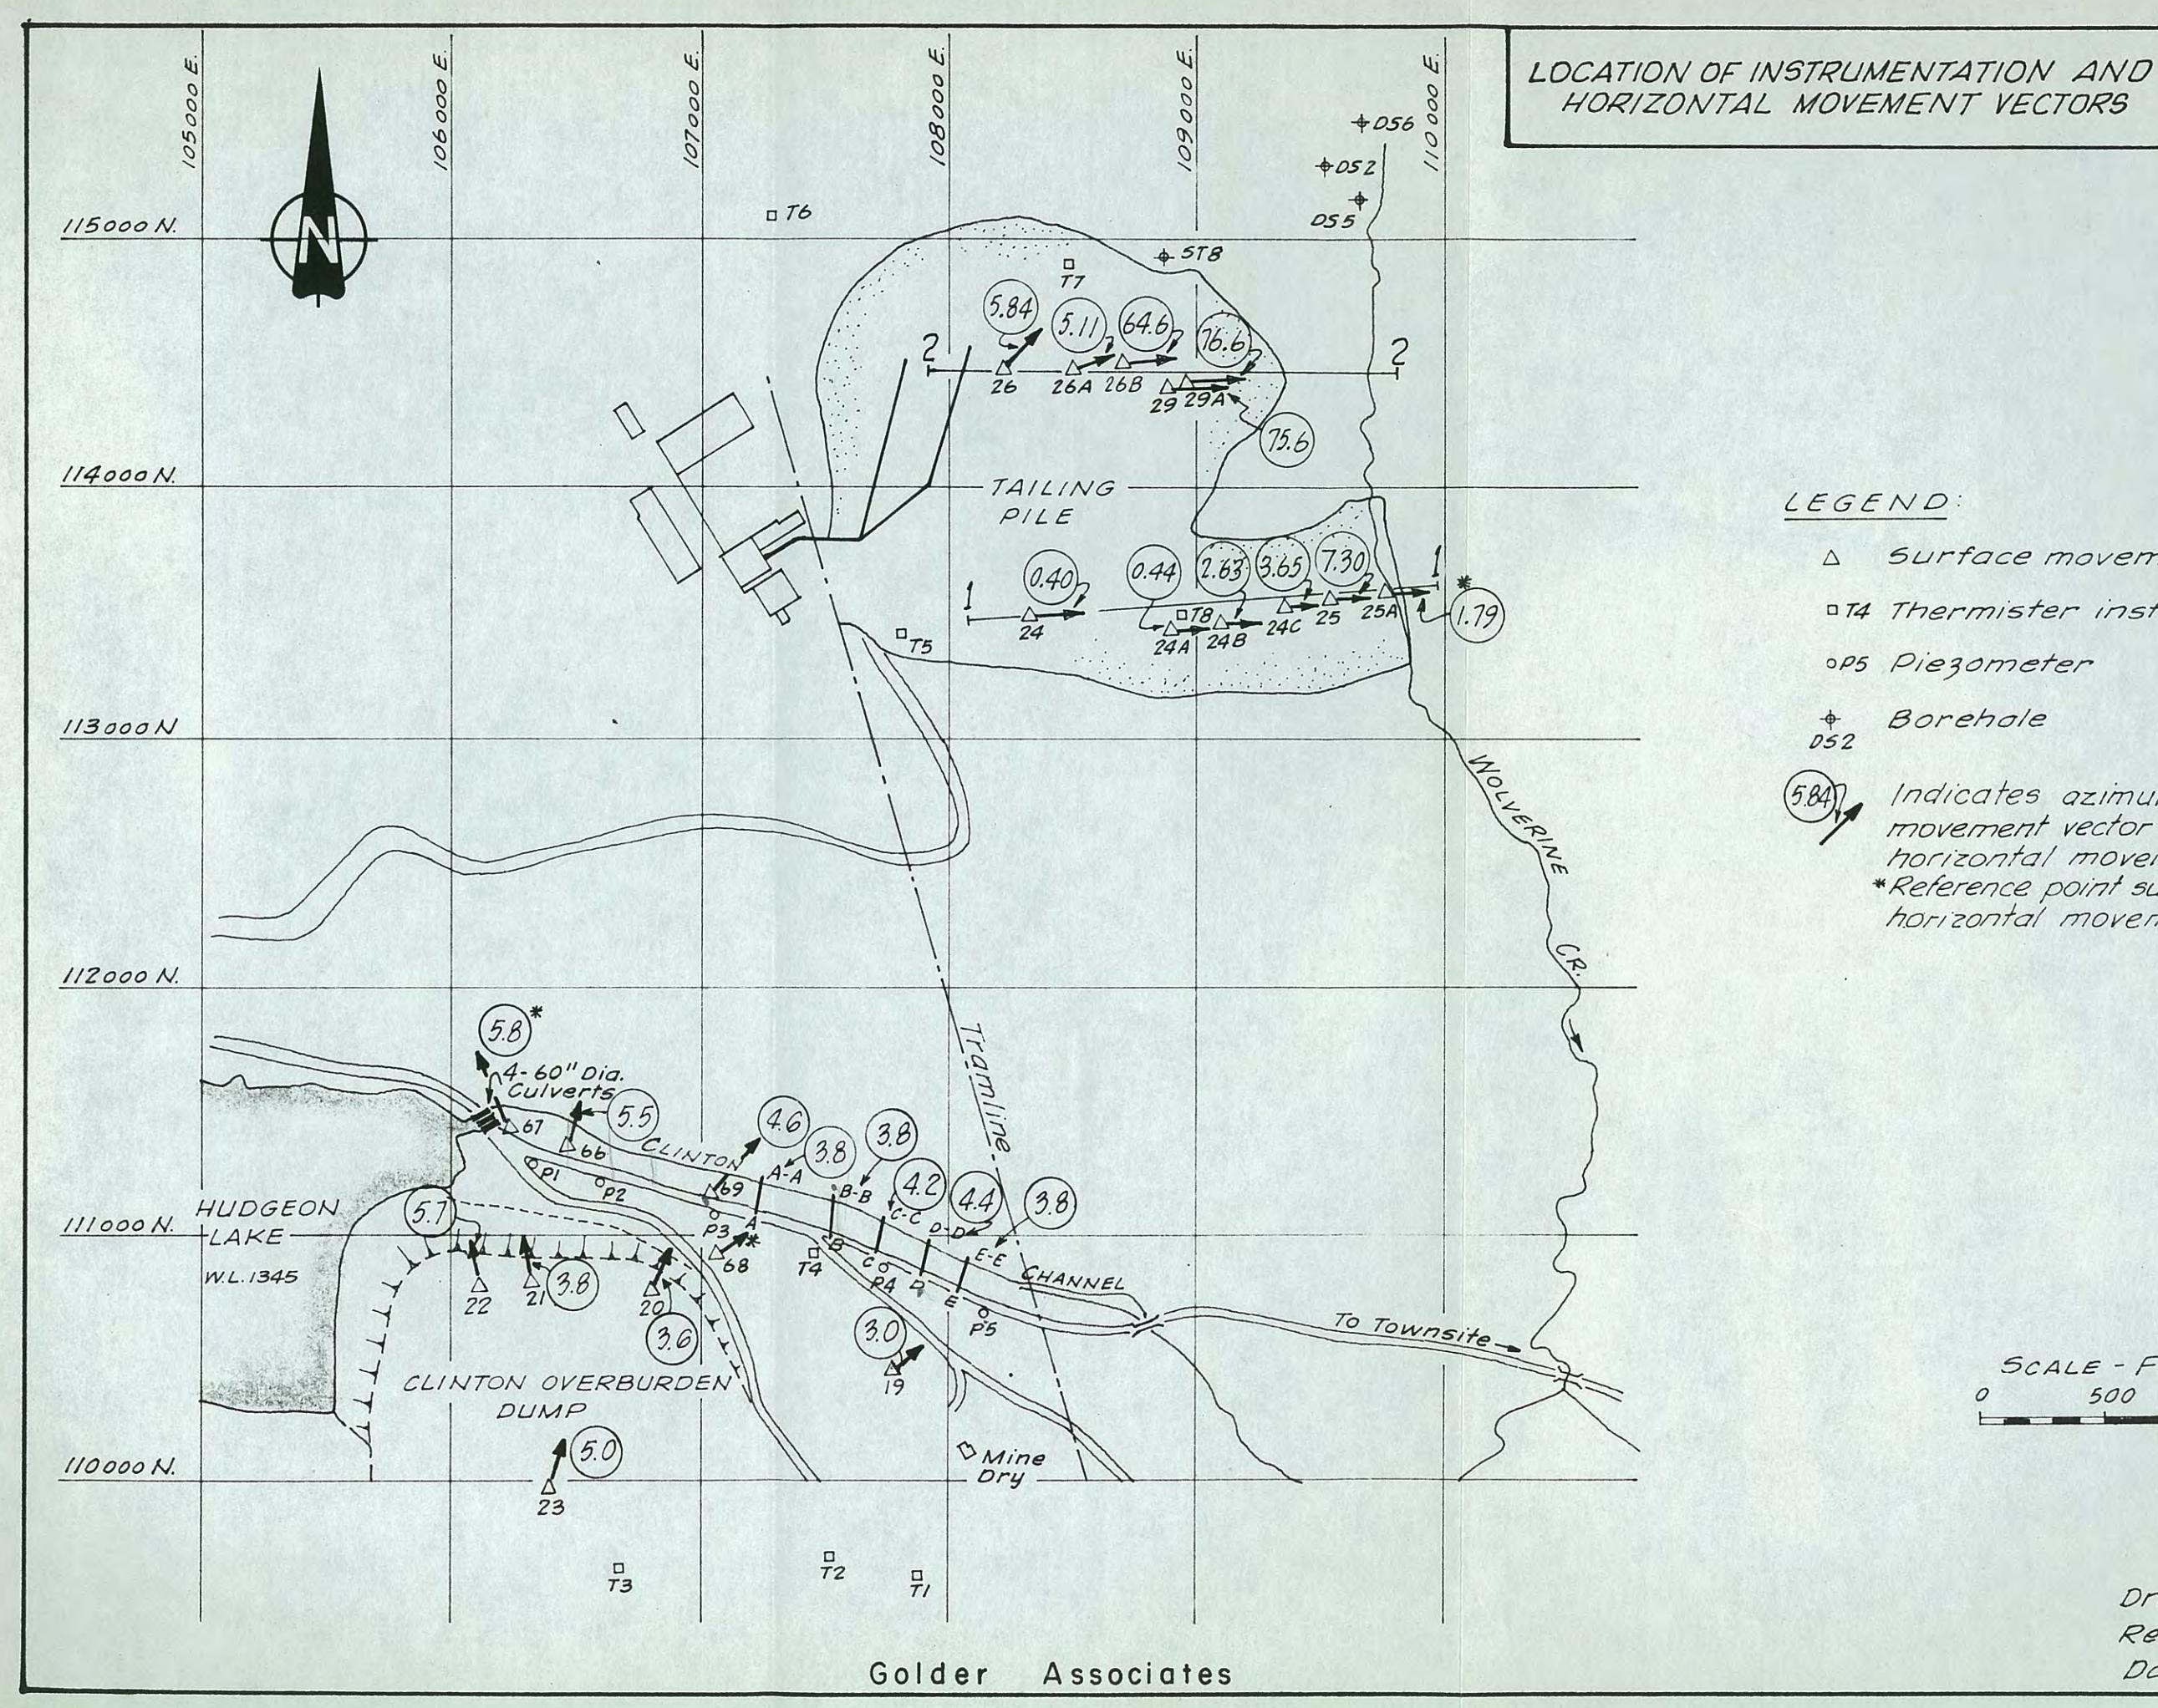
The azimuth of the horizontal movement vectors and rates of horizontal movement in units of feet per year at each of the reference points is indicated by the arrows marked on Figure 3. The data indicate that, in general, surface movements are occurring in directions radially outward from the central region of the dump. Movements toward Hudgeon Lake are also occurring as evidenced by the pressure ridge that developed on the ice surface parallel to the elevation 1345 contour on the western face of the dump during the winter of 1977-78 (see photo No. 1 of Appendix A). In general, the rates of horizontal movement are greater near the perimeter of the dump than they are within the central regions of the dump. Also, the rates of horizontal movement decrease proceeding in the downstream direction.

As indicated on Figure 3, reference points 66, 67, and 69 are located between the northern limit of the dump and the position of the toe of the north valley wall prior to dump development. Thus, the original ground surface beneath the position of these movement gauges slopes upward toward the north. The data for these reference points show that upward vertical movements are occurring currently with development of the horizontal movements. At reference point 66 and 69, the movement vectors are inclined upward toward the north at approximately 12 degrees, which is approximately parallel to the slope of the original ground surface at these locations. The indicated inclination of the surface movement vector at reference point 67 is approximately 6 degrees. This reference point is influenced by localized shear movements within the dump materials adjacent to the right hand side of the Clinton channel. As a result, the indicated rate of horizontal movement is considered to be somewhat greater, and the indicated

The horizontal movement vectors on the surface of the dump, shown on Figure 3, indicate that the northern perimeter of the dump is advancing toward the Clinton channel at rates varying between 3.5 and 4 ft. per year. The plots of horizontal displacement versus time for reference points 19 to 23 inclusive, see Appendix C, show that the rate of movement has decreased by greater than 50 per cent since the autumn of 1977. Materials were last consigned to the dump during the summer of 1977, and no further consignment of materials to the dump will take place. Under these circumstances, we expect that the rates of horizontal movement will continue to decrease in future.

HORIZONTAL MOVEMENT VECTORS

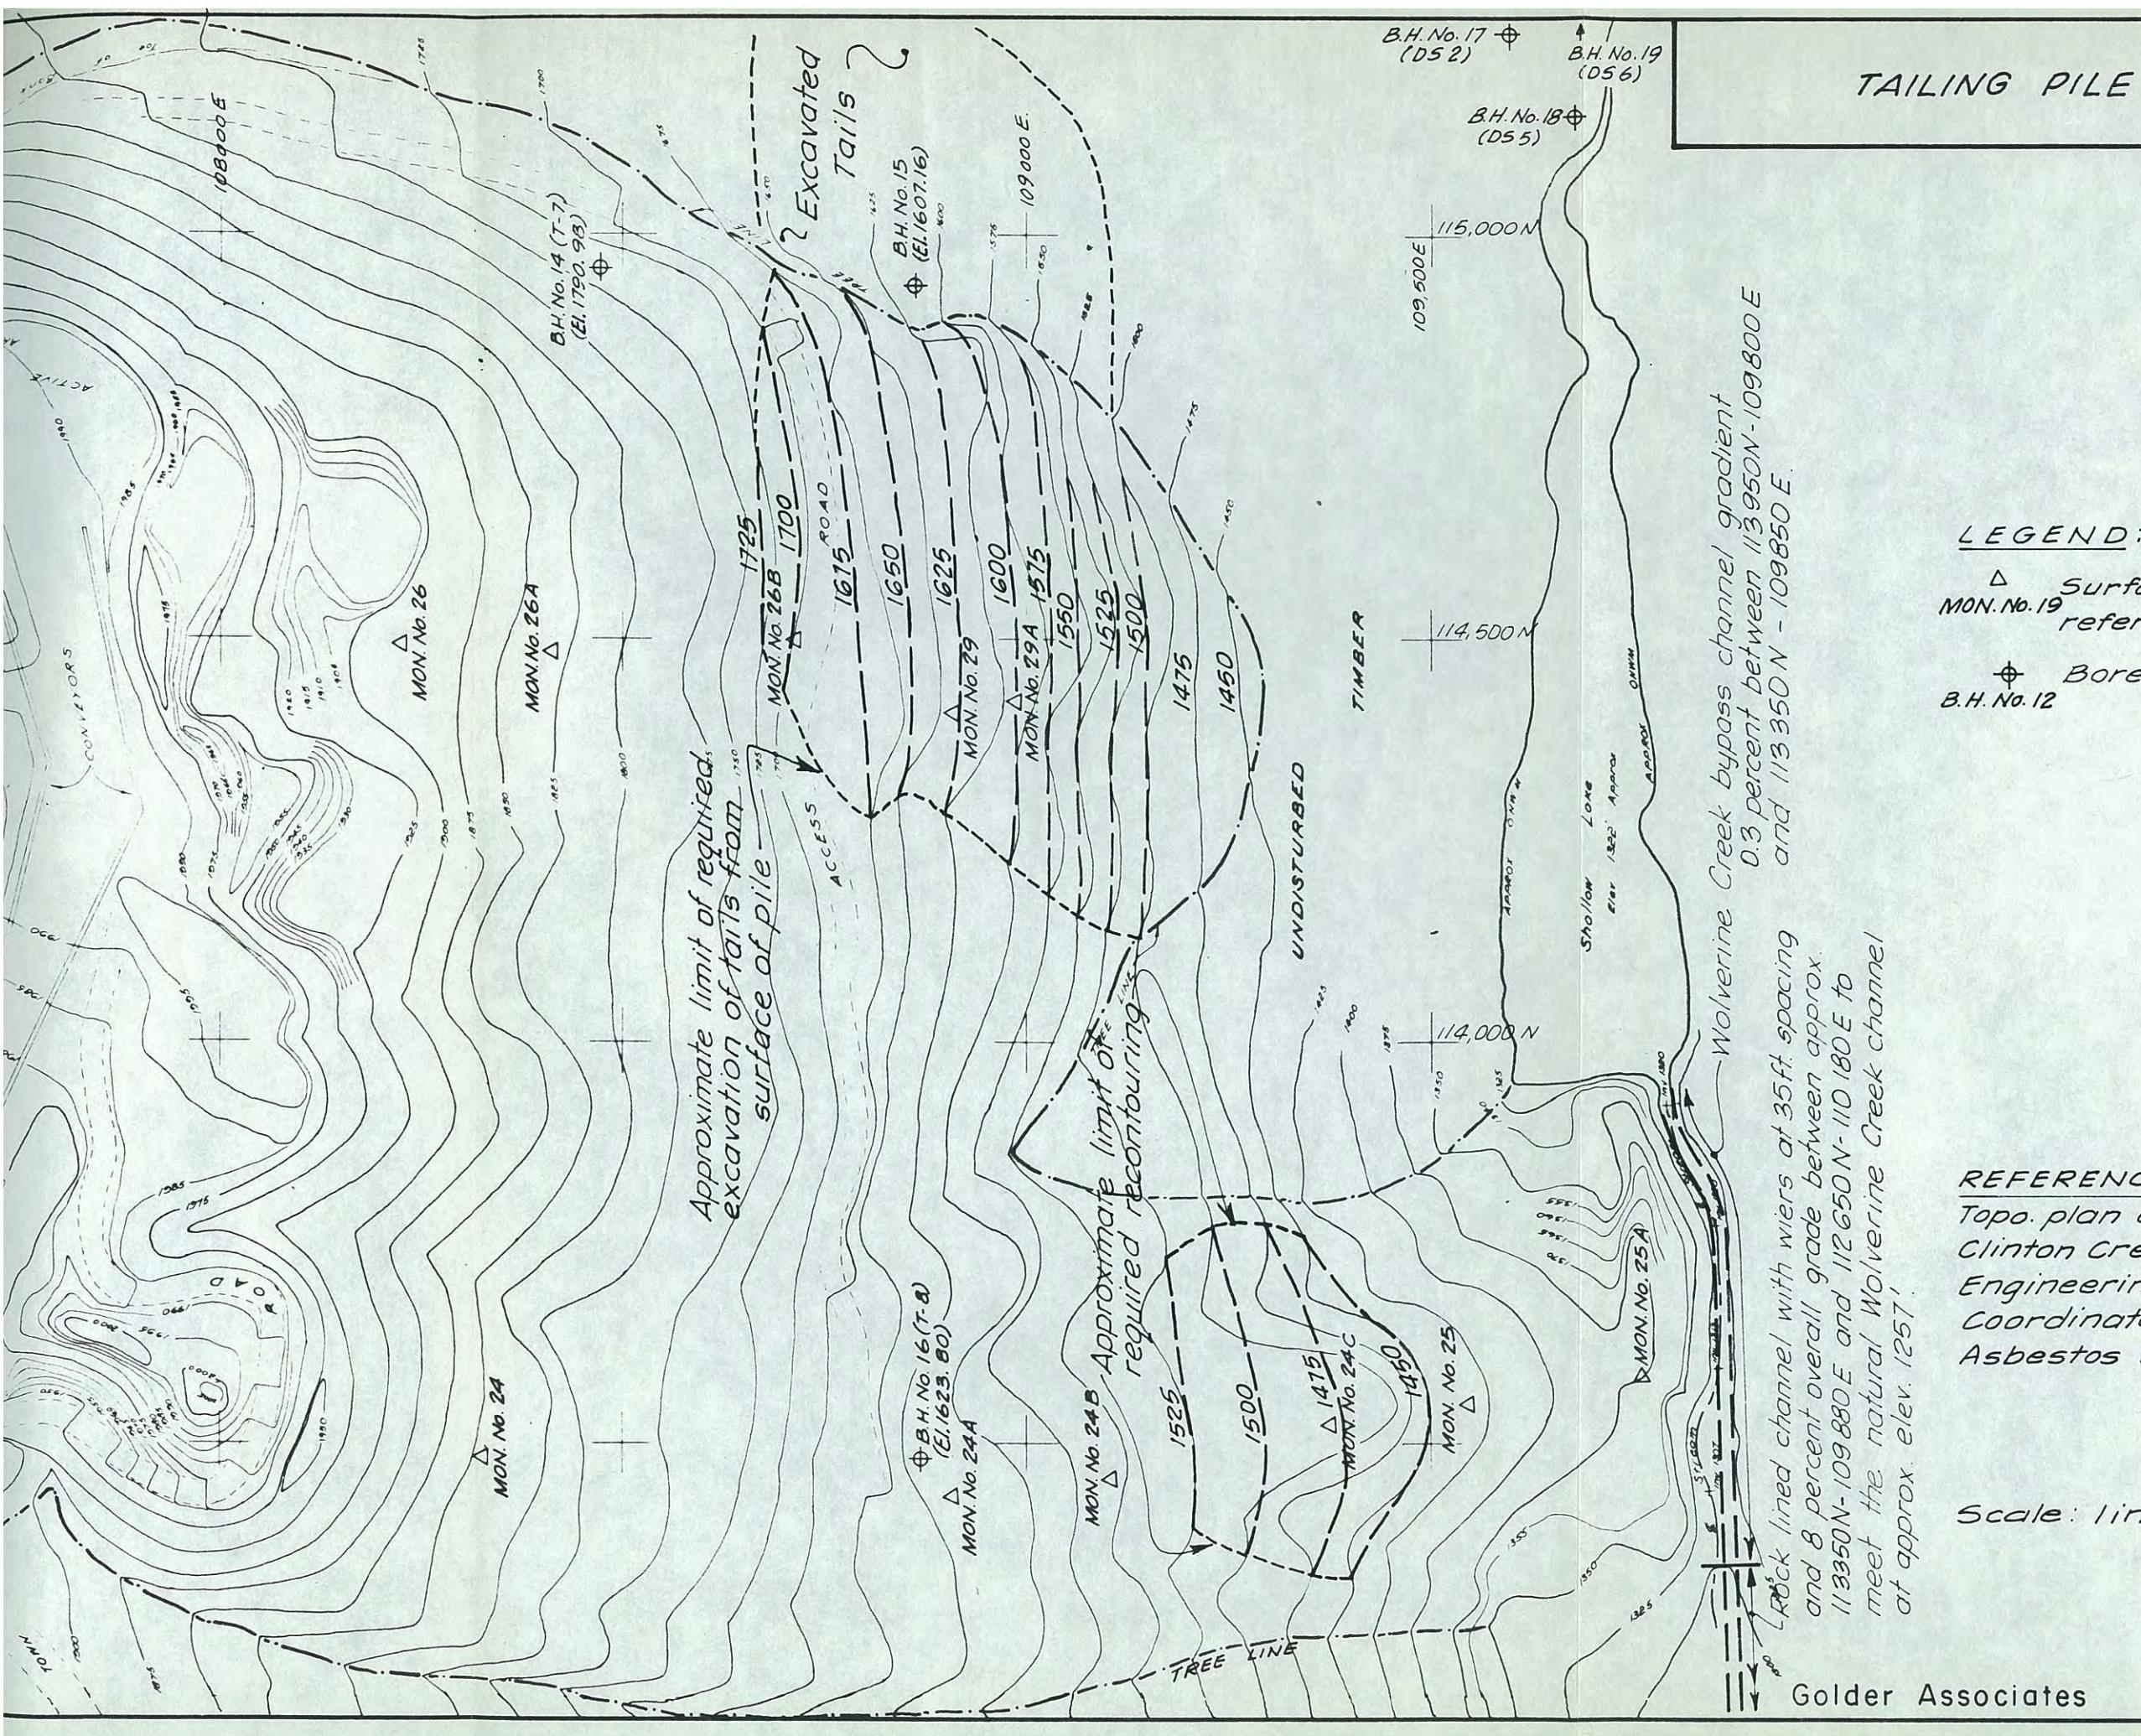
FIGURE 6

Survey monitors to determine the horizontal and vertical displacements on the surface of the tailing pile were installed in late 1976. Additional monitors were installed during the spring of 1978 to provide additional information with regard to these movements. Two lines of monitors were installed. One of these, located close to grid line 113500 N, is approximately along the centerline of the 1974 failure. The second, along grid line 114500 N, is close to the locus of the maximum rates of movement on the segment of the tailing pile to the north of the 1974 failure. The locations of all of the survey monitors on the tailing pile are shown on Figure 6.

The data in Table 5.3.3 for all of the monitors indicate that, in general, the tailing pile along the grid line on which the monitors have been placed is tending to "stretch". (The data relating monitors 26 and 26A are somewhat misleading in this regard insofar as the movement vector at the location of monitor 26 has a dominant component toward the north, whereas the dominant direction of movement for all of the other monitors on this grid line is toward the east, as shown in Figure 3. The net downslope movements for the monitors in this area definitely indicate "stretching" of the tailing pile). If the present rate of movement were to continue, the toe of the tailing pile would reach Wolverine Creek in approximately 4-1/2 years.

configurations, which would lead to improved stability of the failure lobe is given on Figure 7. The analyses lead to the conclusion that trimming of the "knob" upslope from the toe of the failure lobe, as shown on Figures 6 and 7, together with appropriate grading and lining of the Wolverine Creek channel at the toe of the lobe, will provide an adequate safety against further downslope movement of the failure lobe. The factor of safety against downslope movement attendent with this solution is 1.20. Details of the measures required to effect this solution are given in Section 5.7 and 5.8 of this report.

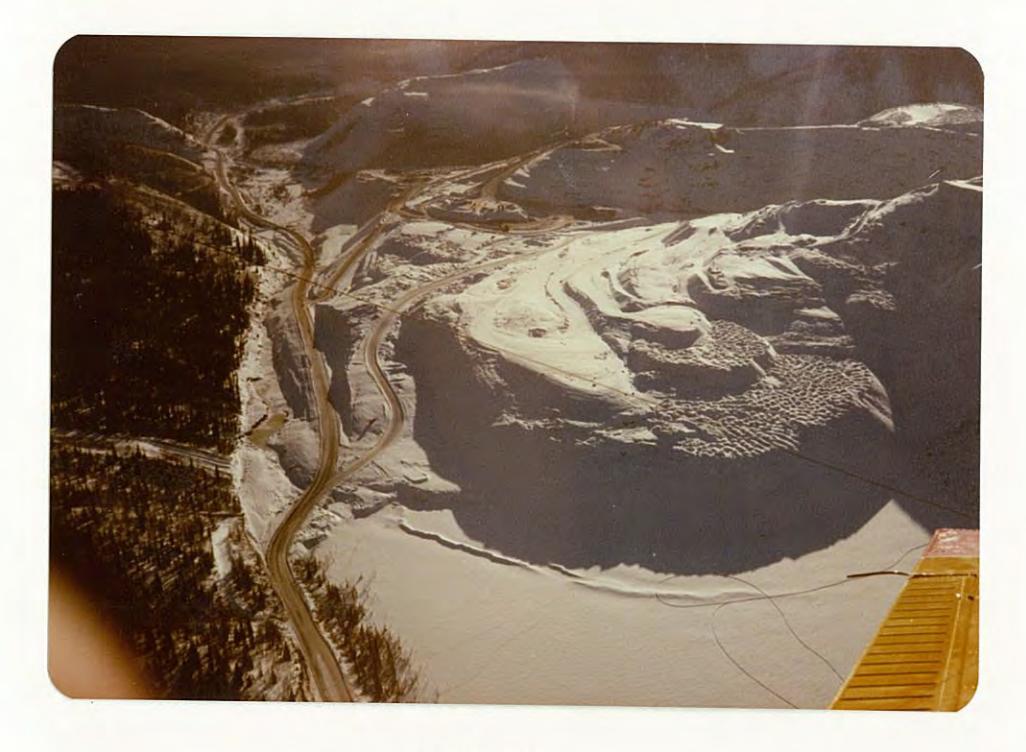
were responsible for development of a pressure ridge on the ice surface of Hudgeon Lake during the winter of 1977-78 (see Photo 1 of Appendix A), and they are also responsible for development of the cracks on the surface of the dump as illustrated on Photos 2 and 3. The mechanism of crack development, the orientation of the cracks, and the implied stress conditions within the dump are discussed in Appendix E.

View of Clinton Dump looking downstream, and showing pressure ridge on ice surface as a result of creep movements during the winter of 1977-78. Date of Photo, March 9th, 1978.

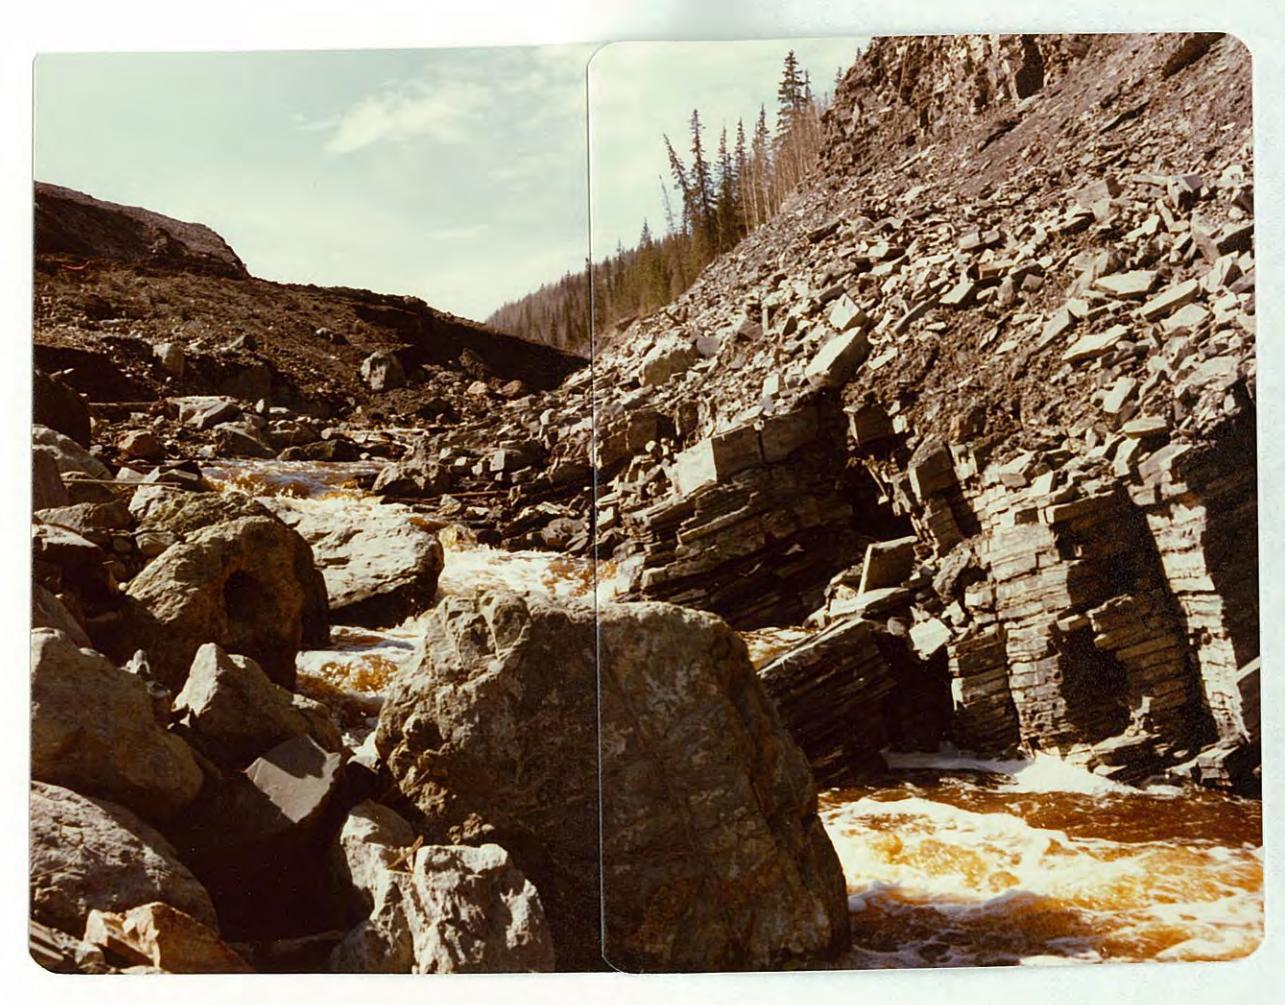
рното 5

View of Clinton Channel looking upstream showing exposed bedrock on north side. Bedding dips at approximately 20 degrees toward the channel, and well developed cross joints are aligned perpendicular to the bedding joints. Large rocks on left side of photo are remnants from the waste dump.

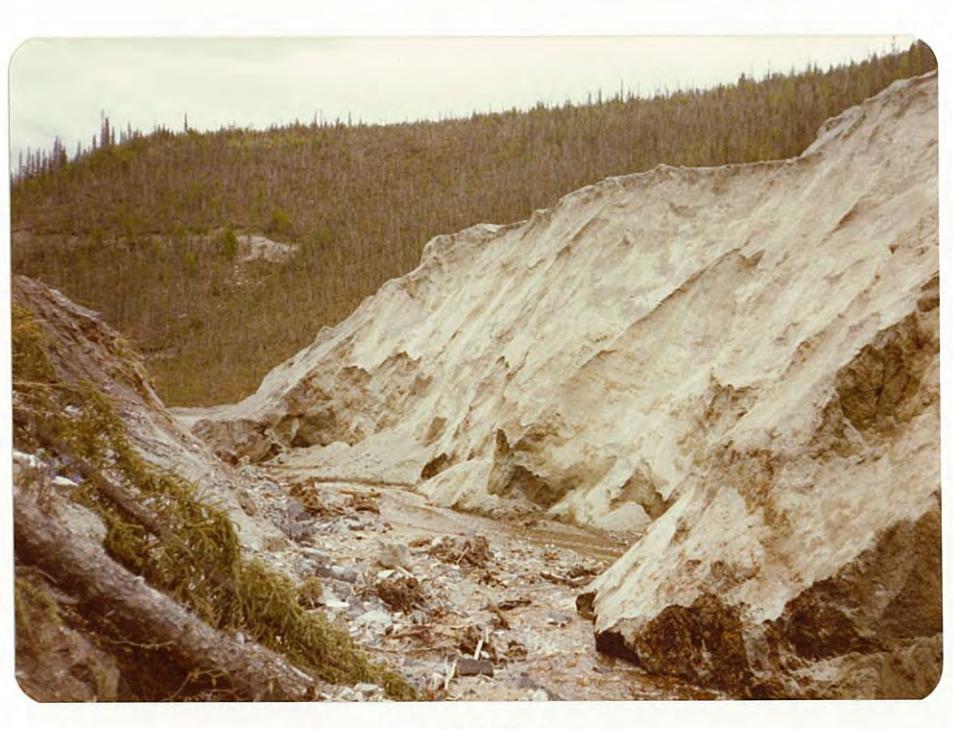
View of Wolverine Creek channel at toe of 1974 failure lobe showing the effects of stream erosion on the tailings.

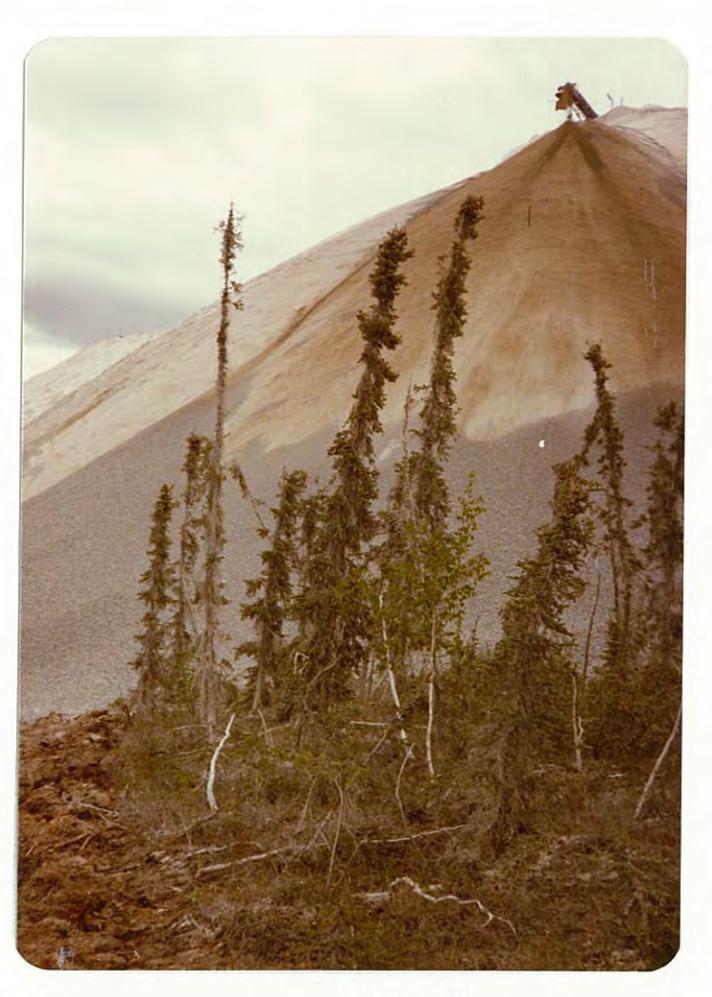
Northwest corner of tailing pile. Note the segregation of particle sizes as the tails travel down the face of the pile.

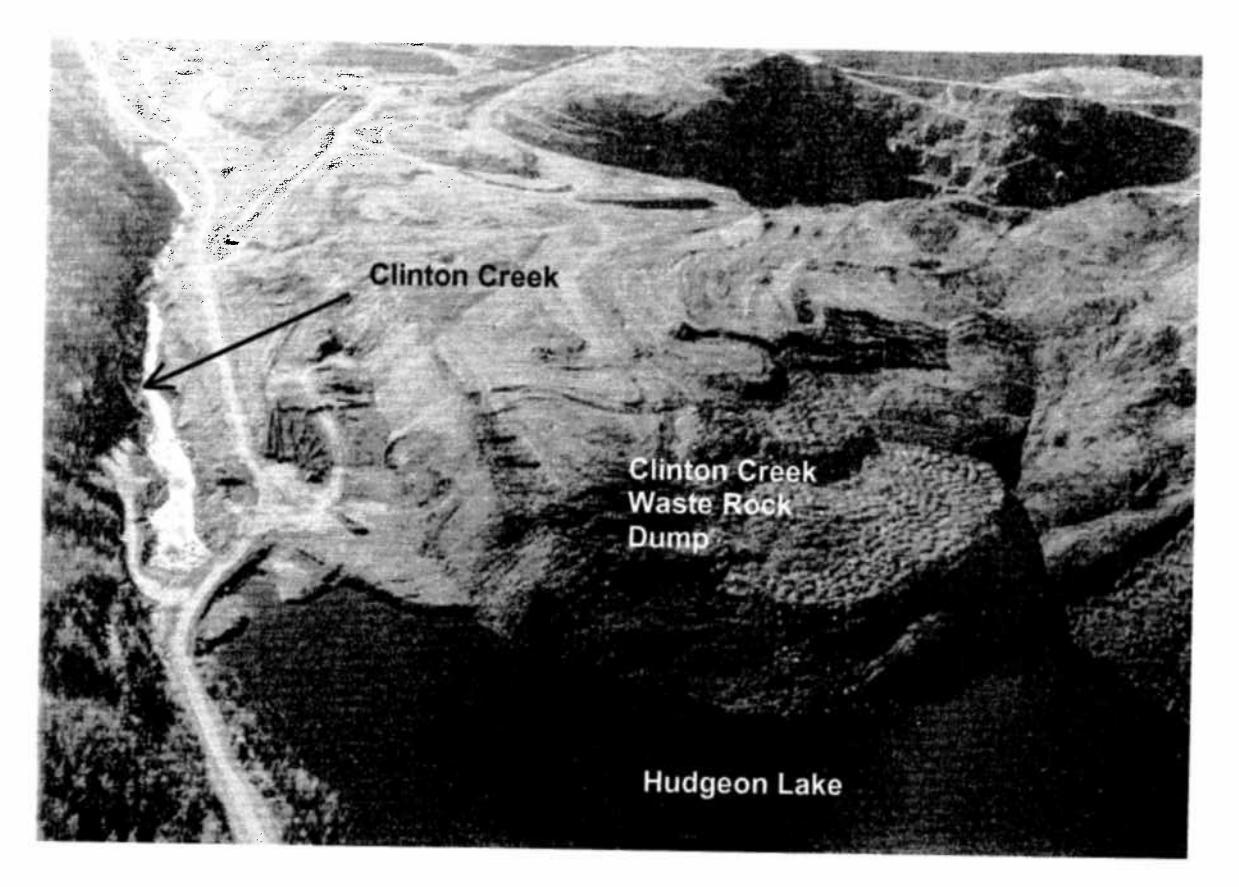
The waste rock from the Porcupine Pit placed along the south slope of the Clinton Creek valley is referred to as the Clinton Creek Waste Rock Dump (Drawing 03). The waste rock dump consists of overburden and argillite waste rock consisting of sand, gravel and cobble sizes containing occasional boulder size material. Significant lateral spreading of the rock fill, in particular at the west end of the dump towards Hudgeon Lake, has occurred as a consequence of instabilities associated with the placement of waste rock during the mining operation. Active movement of the waste rock dump has continued since the mine closure as seen in Photo 1(1986).

Photo 1 Clinton Creek Waste Rock Dump

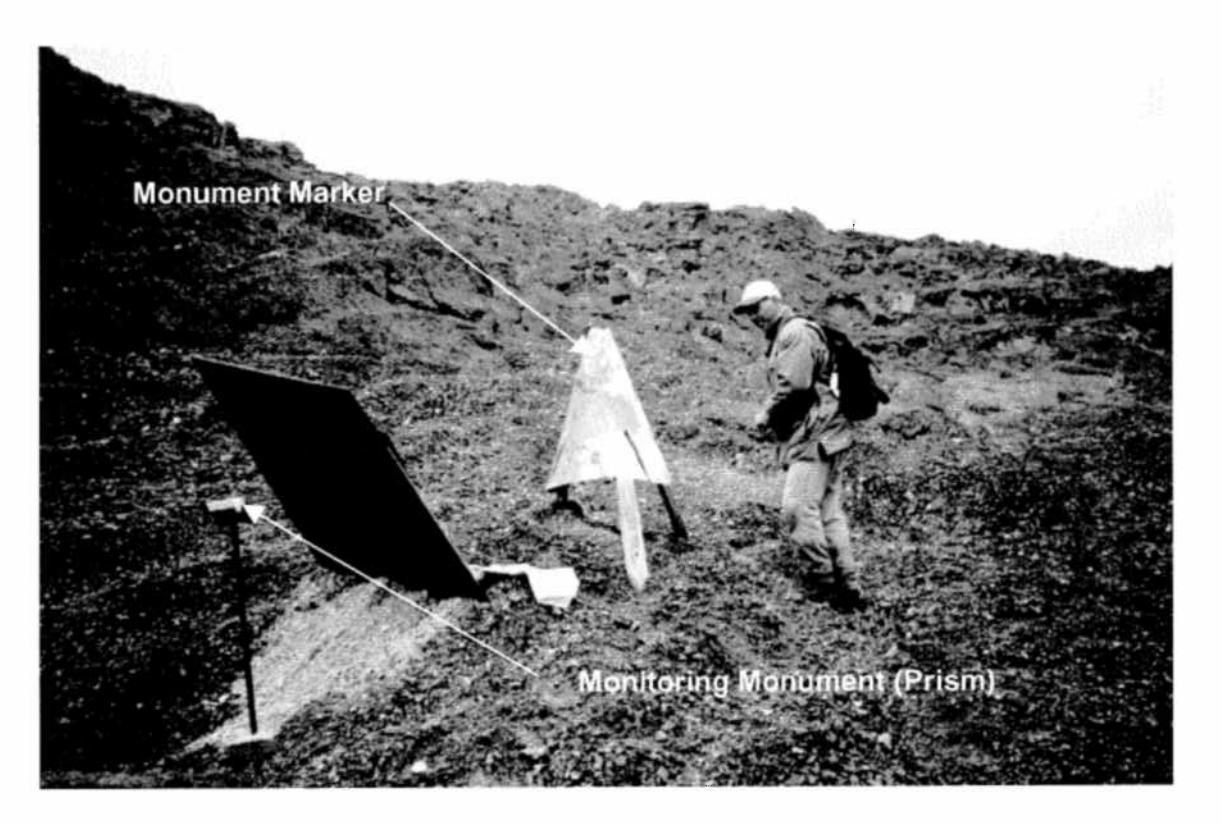
mounted on steel rods which are driven into the waste rock. Most of the monuments are identified with conical sheet metal markers. During the site reconnaissance several of the monuments were observed. Monument locations at the waste rock dump are shown on Drawing 03 and a typical marker (shown on the tailings pile) is shown in Photo UMA 5-12.

Photo UMA 5-12 Typical Ground Movement Monitoring Monument (1998)

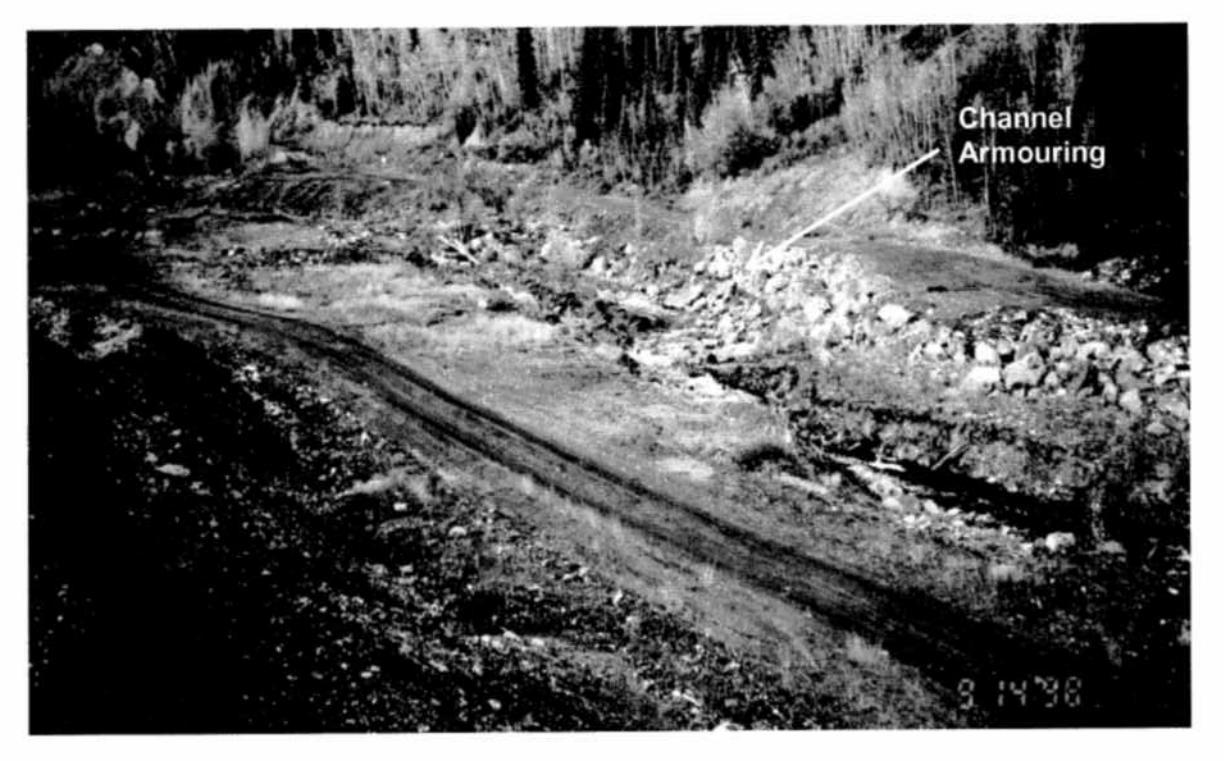
Previous erosion control works (rip rap armouring) constructed in 1979 were almost completely destroyed in the spring of 1997 (Photo RRU-1).

Photo RRU-1 Clinton Creek Channel Immediately Downstream of Outlet (1998)
