Geotechnical Evaluation Borrow Source Assessment – Clinton Creek Area Dawson, Yukon – 2015

Yukon Government Energy, Mines & Resources Assessment and Abandoned Mines

January 8, 2016

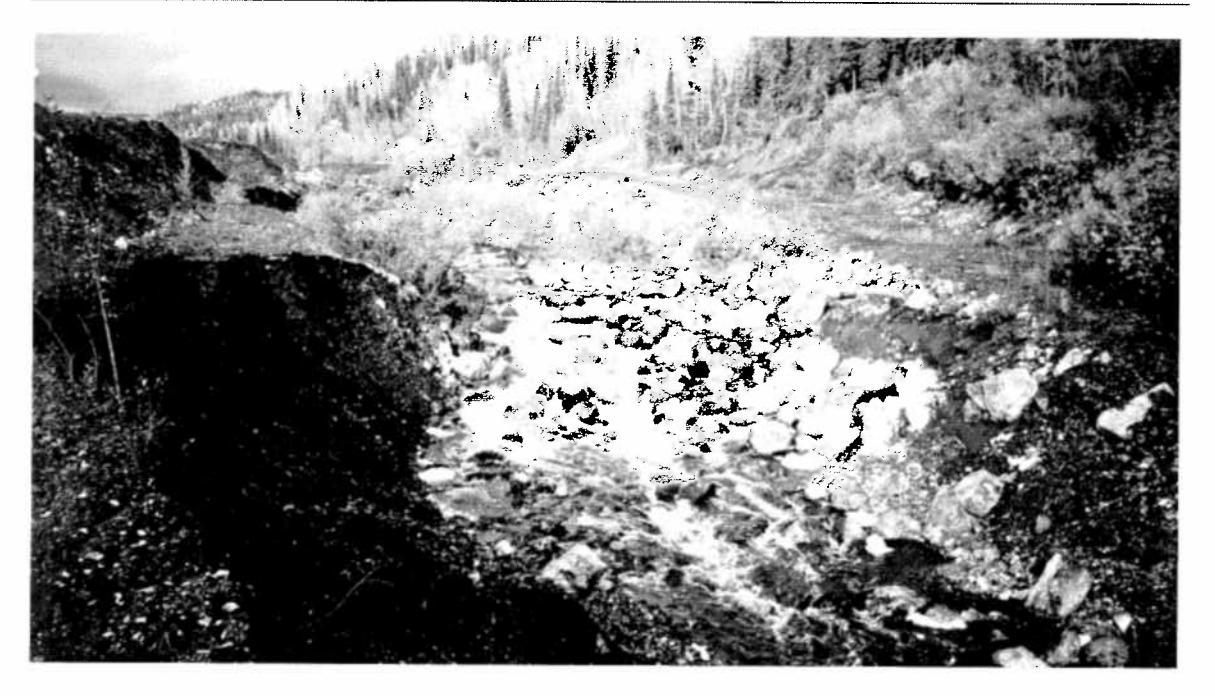
Since 1986, down-cutting near the Hudgeon Lake outlet has occurred (Photo UMA 7-24). Up to 2 to 3 metres of incising has occurred immediately downstream of the outlet where the channel bed is bounded to the south by waste rock and to the north by natural colluvial soils overlying bedrock on the valley slope. Two springs discharge from the waste rock just downstream of the lake outlet. Water from both springs is clear with no evidence of fines. Brown slime was growing over the rocks at the downstream spring and the water had a noticeable hydrogen sulphide odour.

Photo UMA 7-24 Channel Down-cutting Immediately Downstream of Hudgeon Lake Outlet

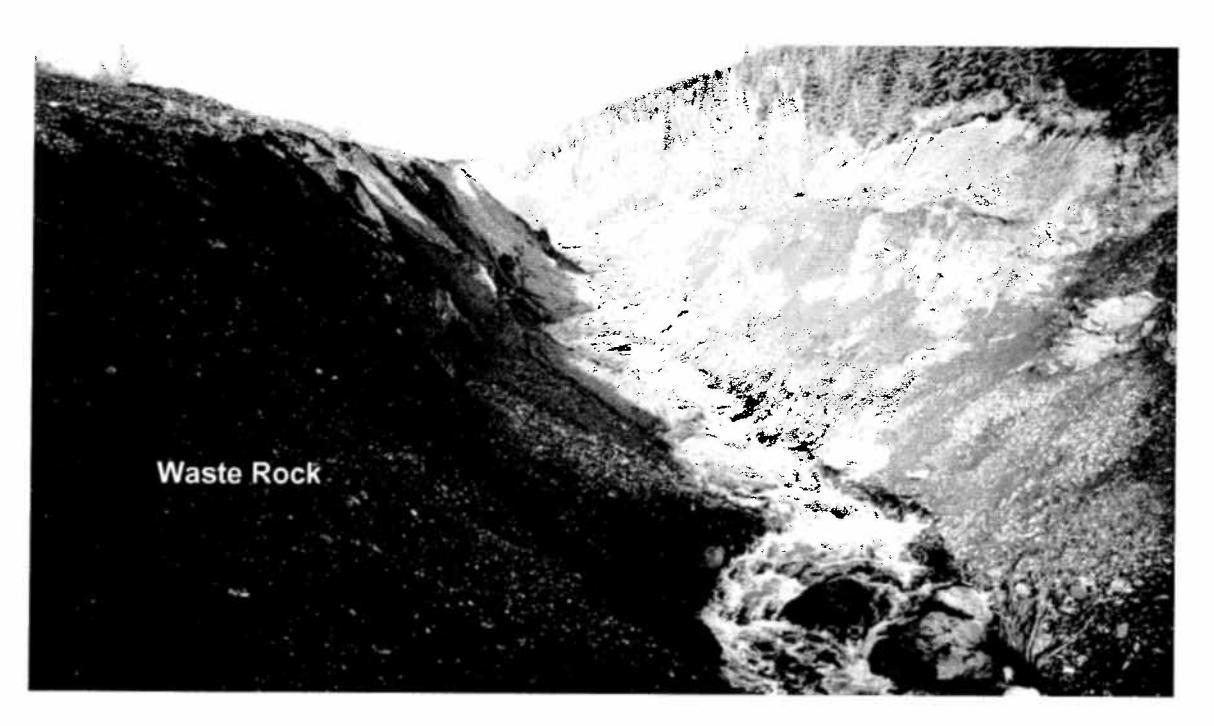
Channel widening and incising is evident throughout the waste rock dump where both waste rock and valley material is being actively eroded (Photo UMA 7-17).

Photo UMA 7-17 Channel Erosion (1998)

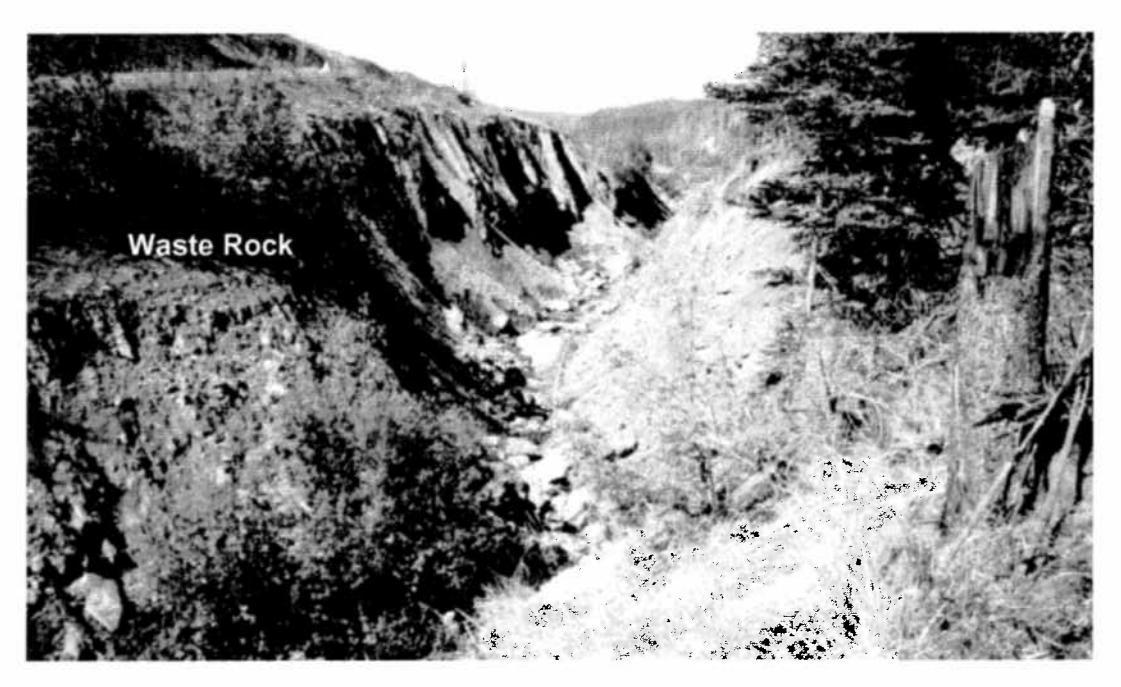
Downstream portions of the creek channel through the waste rock slope have been cut into the weathered argillite bedrock on the valley slope (Photo UMA 14-15). At these locations, the bedrock consists of a weathered weaker bedrock unit overlying a stronger more competent bedrock unit with horizontal to slightly dipping bedding planes.

Photo UMA 14-15 View Upstream Along Creek Channel (1998)

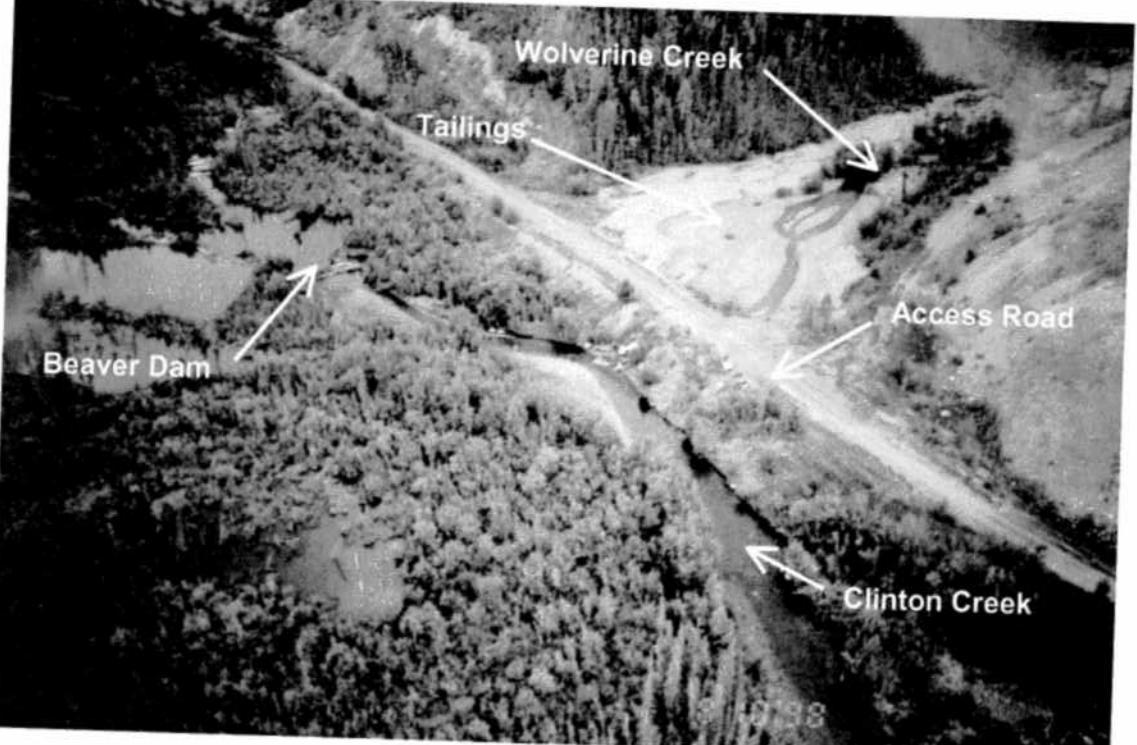
The confluence of Clinton Creek and Wolverine Creek is approximately 500 metres downstream of the washed out bridge. Under normal flow conditions, Wolverine Creek drops approximately two metres into Clinton Creek through a 1600 millimetre diameter steel plate (19 millimetre thick) culvert under the access road. As seen in Photo UMA 2-6, a significant amount of tailings out-wash material has been deposited within the Wolverine Creek channel just upstream of the culverts. Beaver dams several hundred metres downstream of the bridge have flooded a large area near the junction of Wolverine and Clinton Creek.

Photo UMA 2-6 Confluence of Wolverine Creek and Clinton Creek (1998)

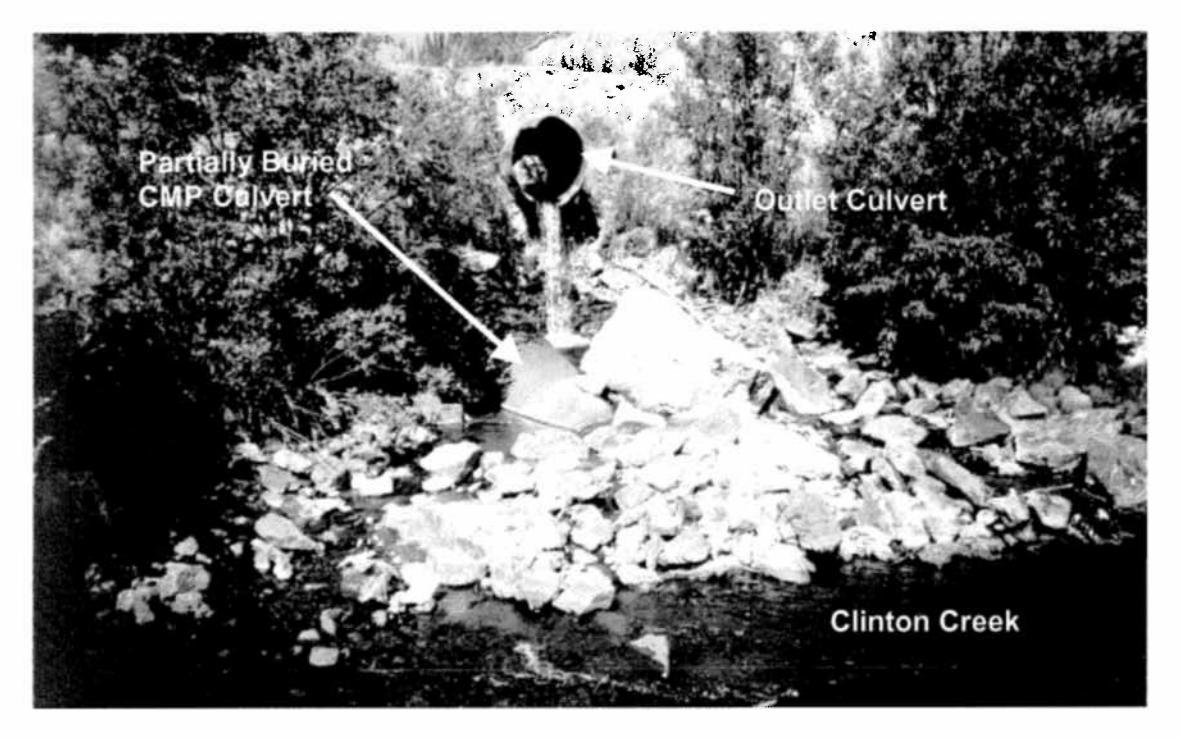
The access road culvert is in good condition. The outlet of a second culvert (corrugated metal pipe) located at a lower elevation was submerged in the Clinton Creek stream bed (Photo UMA 15-10 and 15-8). The invert of a third 1200 millimetre diameter culvert, located immediately south of the Wolverine Creek outlet culvert, is set about 1 metre higher.

Photo UMA 15-10 Wolverine Outlet Culvert at Clinton Creek (1999)

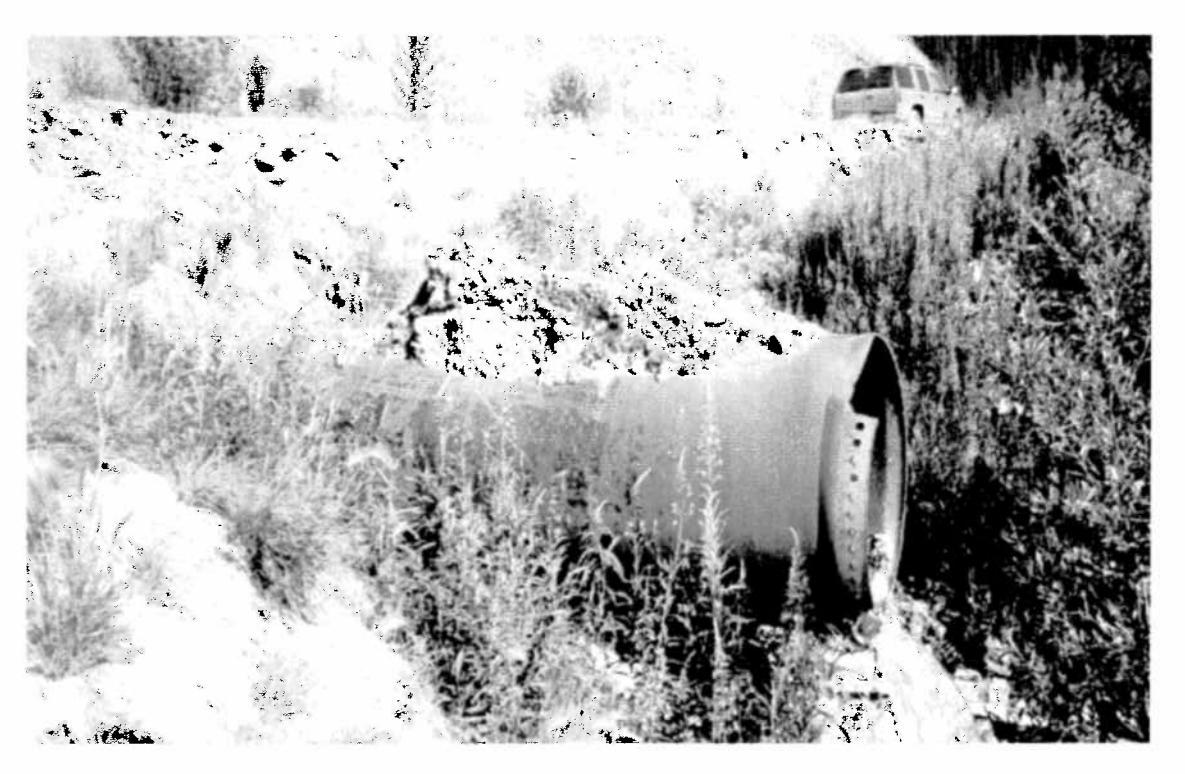
Photo UMA 15-8 Wolverine Creek Outlet Culvert (1999)

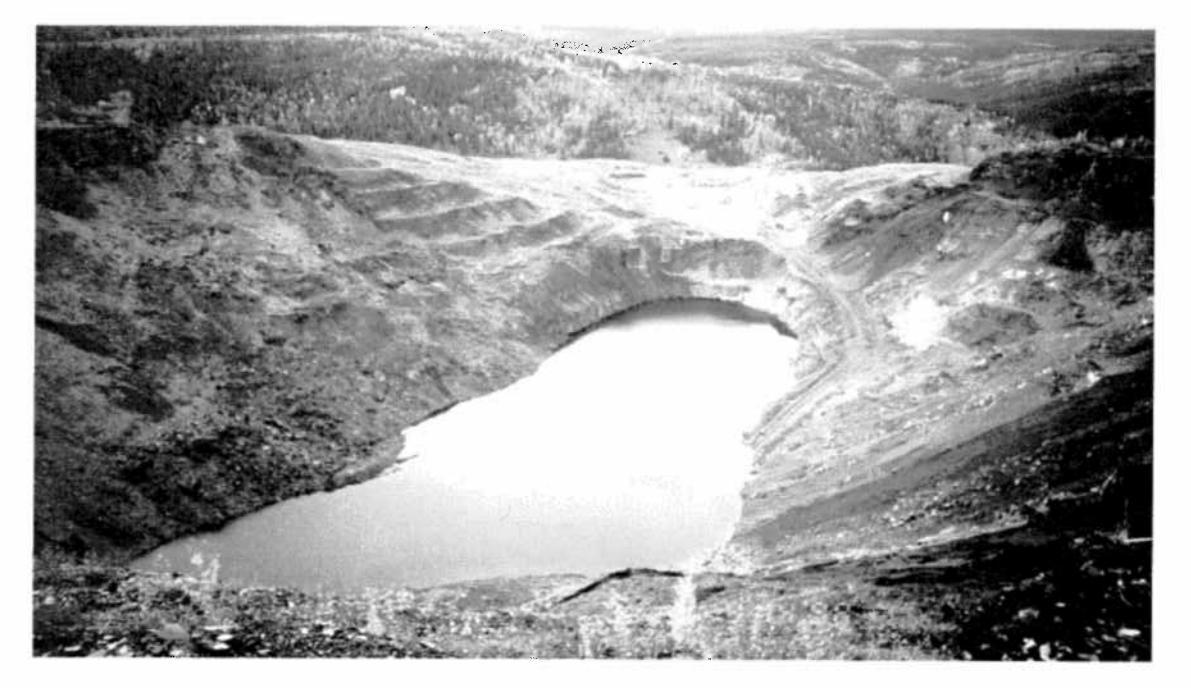
Photo UMA 11-1 View East at Porcupine Pit (1998)

Porcupine pit walls are a maximum height of about 200 metres inclined at approximately 45 to 50 degrees (Photo UMA 11-1). Water is currently ponded in the bottom of the pit at approximately elevation 385 metres. Instabilities of the pit walls are evident, in particular along the north and west sides. The instabilities range from ravelling and small wedge failures along the remnants of the pit benches to deep seated movements along the west side where back scarps and tension cracks well back from the edge of the pit wall are visible. Sloughing of the pit walls is clearly evident and debris could be heard falling into the water during the reconnaissance in the area.

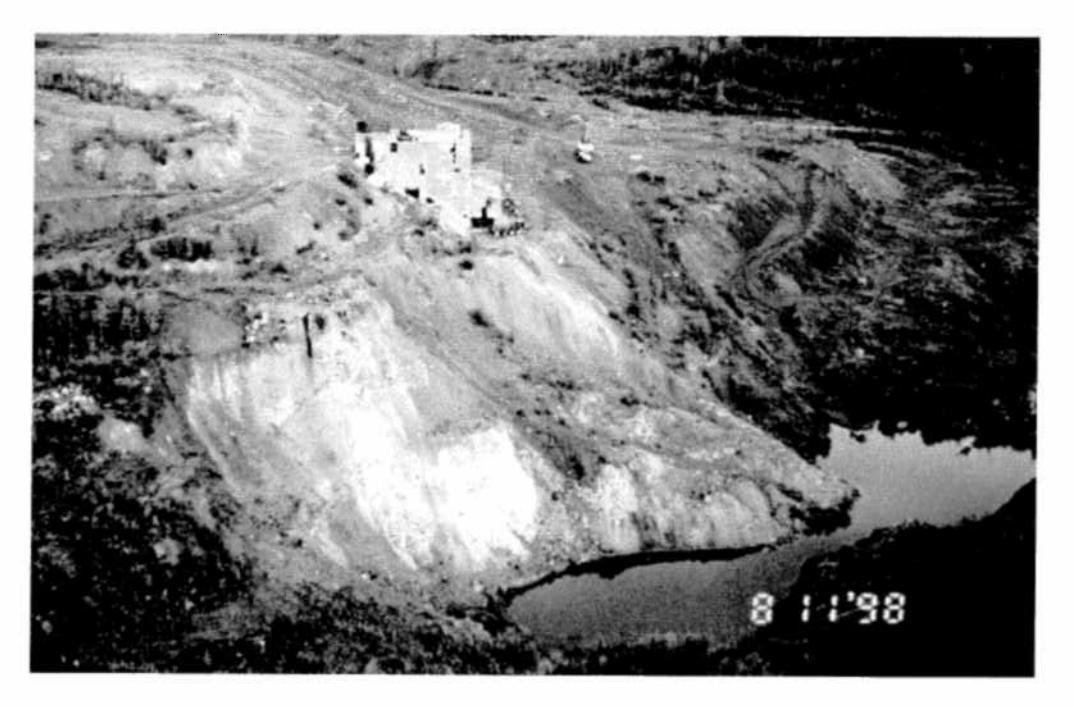
Photo RRU-3 Crusher Building (1998)

The former Crusher Building is situated near the crest between Porcupine Pit and Creek Pit, across the valley from the mill site (Drawing 04, Photo RRU-3 and Photo RRU-4). Large sections of the metal roofing and metal siding are missing and there is scattered debris in the general area. Remnants of what may have been the hydro sub-station are located at the base of the Creek Pit Road.

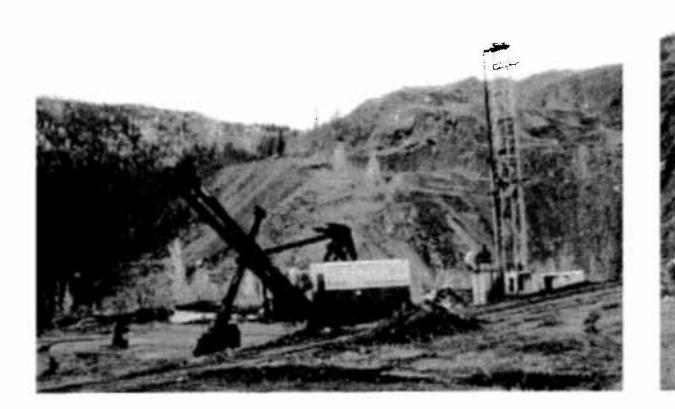
Photo RRU-5 Abandoned Equipment (1998)

Abandoned equipment, including a drag line excavator and a drill rig, are located down slope, north of the Crusher Building (Photo RRU-5 and Photo RRU-6).

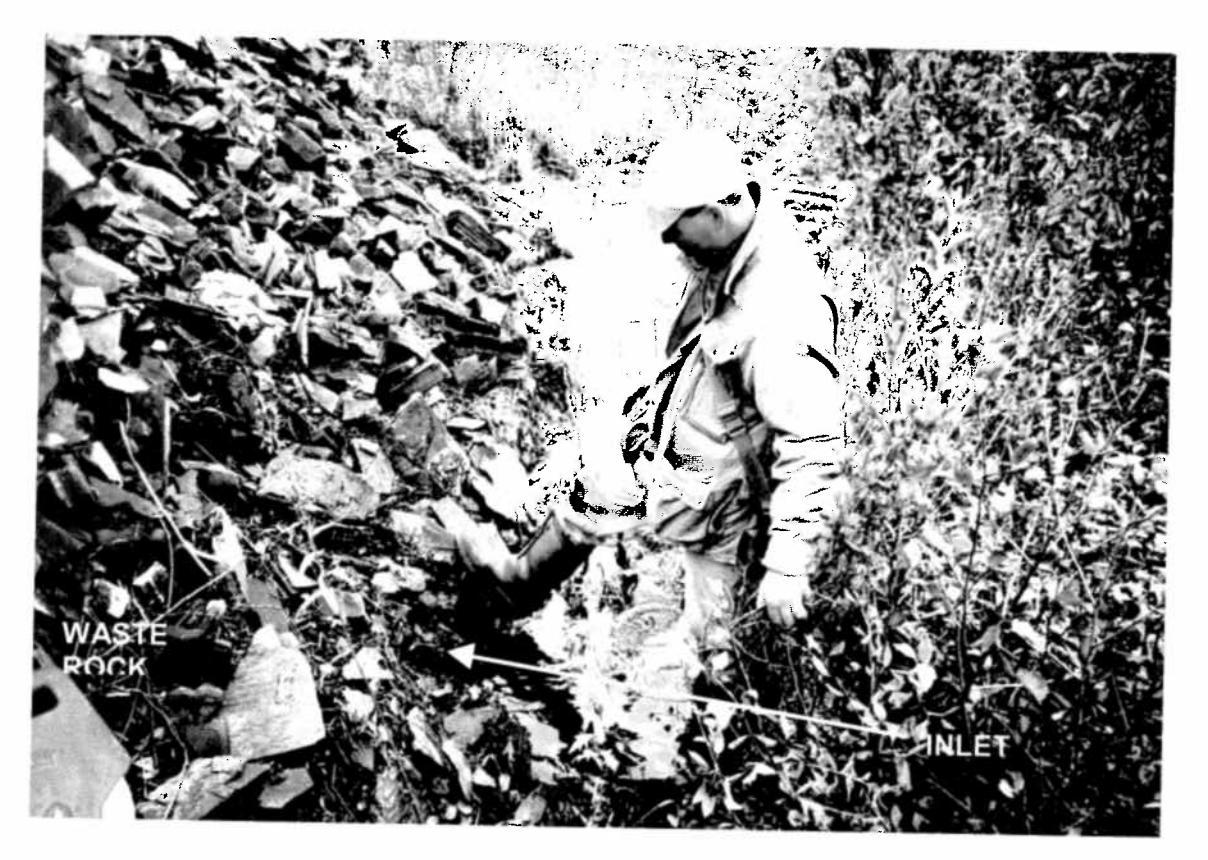
Photo UMA 10-9 Inlet into Waste Rock (1998)

Impounded water upstream of the waste rock dump continues to flow either below or through the waste rock or along the east valley slope in subterranean channels. The majority of flow occurs via a drainage channel incised through the slide debris from the unstable southern portion of the waste rock where it enters the waste rock pile (Drawing 04 and Photo UMA 10-9).

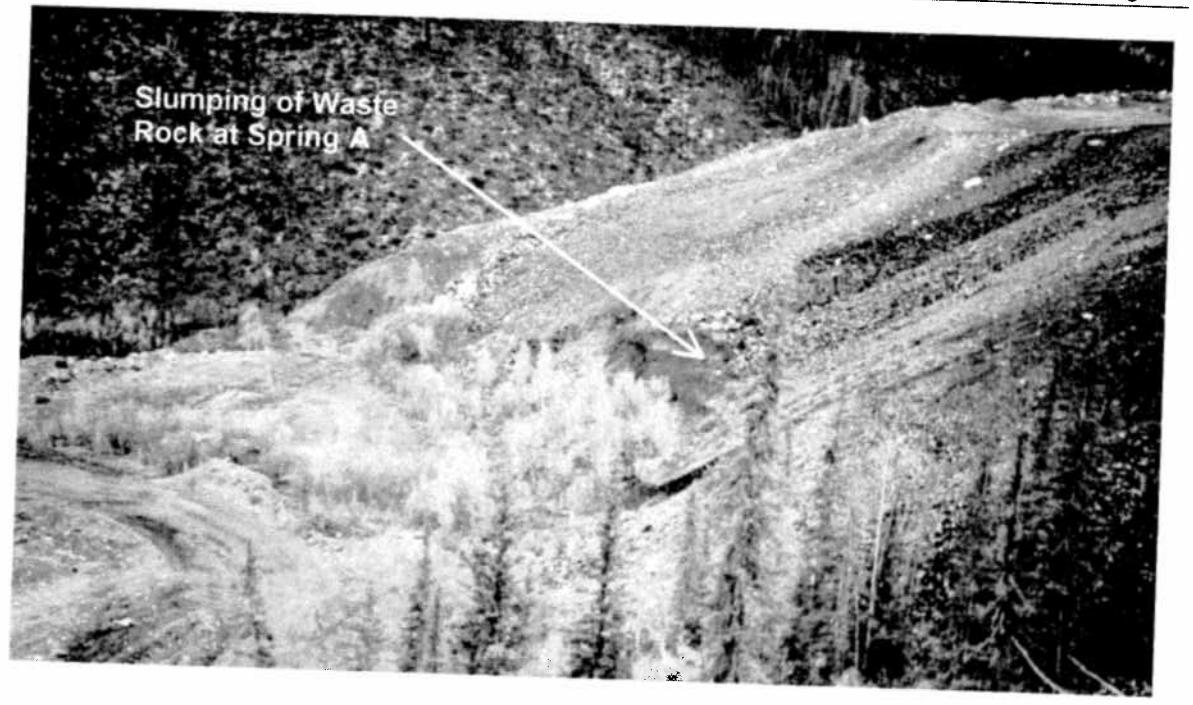
Photo UMA 11-3 Spring A at Porcupine Creek Waste Rock Dump (1998)

Water draining internally through the waste rock discharges through the waste rock about 5 metres above the toe of the north slope, approximately 550 metres to the north of the inlet (Spring A). In September 1998, discharge at Spring A was estimated to be in the order of 10 I/s approximately 5 m above ground surface. Localized slumping of the waste rock is evident at the discharge point as illustrated in Photo UMA 11-3. Water is subsequently conveyed along a drainage channel incised along the south edge of the road where it eventually spills into the Creek Pit.

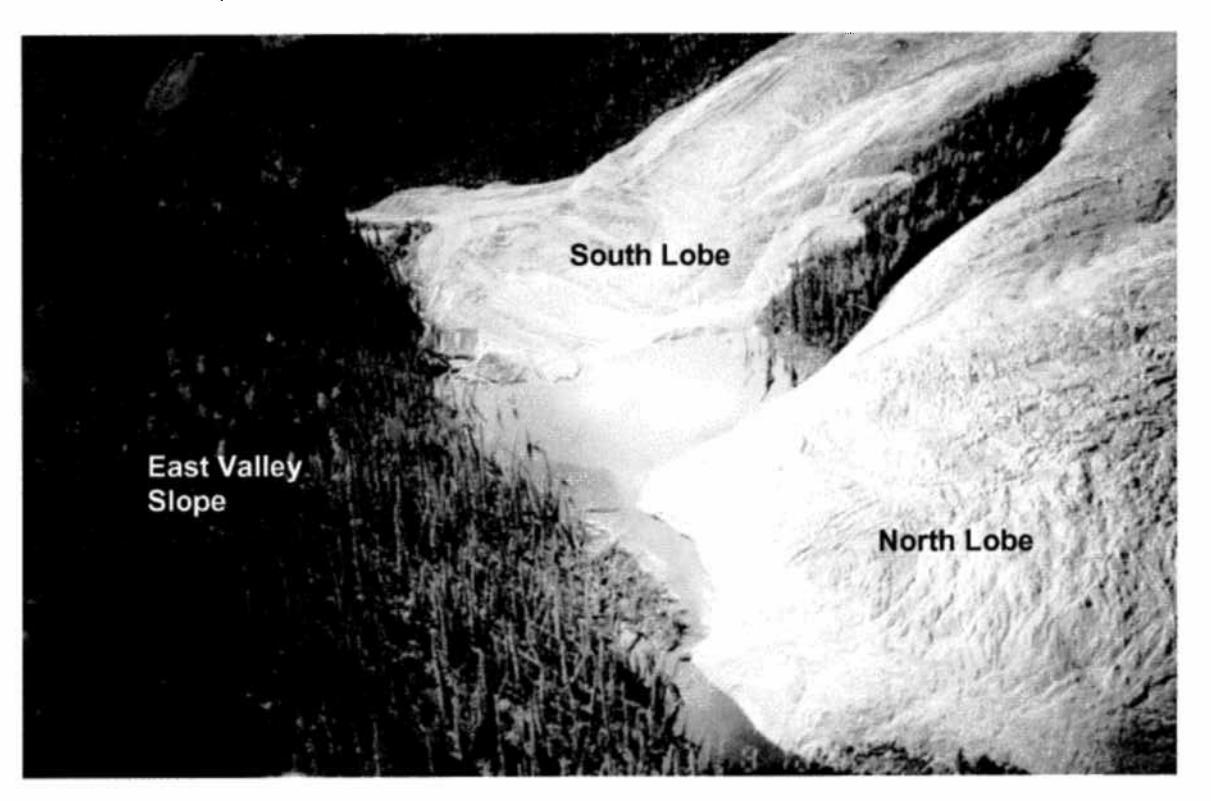
Photo UMA 1-3 North and South Tailing Lobes (1998)

The tailings from the milling process were originally deposited with a stacker conveyor over the valley crest on the west slope of Wolverine Creek (Drawing 05). The mill tailings generally consist of well graded 25 millimetre down crushed serpentine rock with some asbestos fibre not removed during milling. In 1974, a sudden failure of the tailings pile (referred to as the south lobe) lead to a complete blockage of Wolverine Creek. Following the failure of the south lobe, tailings were deposited further north along the west slope of Wolverine Creek. This area is referred to as the north lobe. Gradually, failure of the north lobe lead to another blockage of the creek channel just upstream of the south lobe (Photo UMA 1-3).

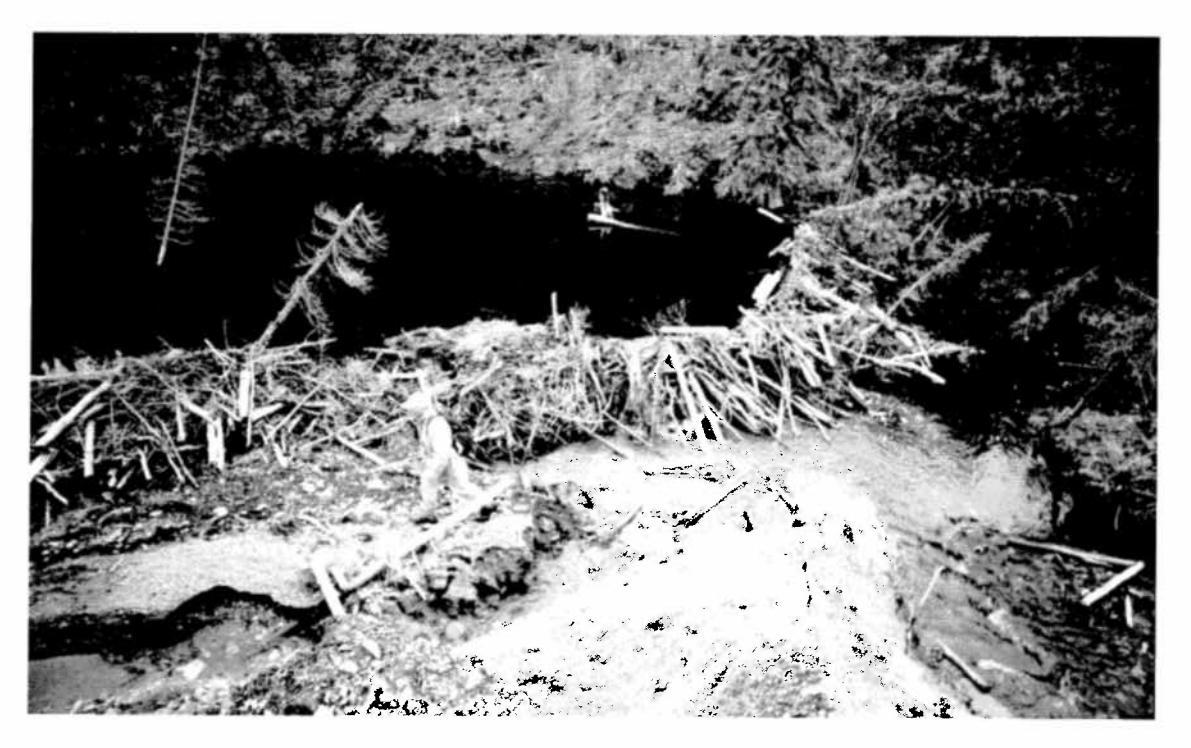
Photo UMA 5-18 Beaver Dam 3, Wolverine Creek (1998)

The second beaver dam, located between the upstream side of a small channel island and the toe of the north tailings lobe, does not impound a significant amount of water. The third beaver dam is located at the upstream end of the south lobe as shown in Photo UMA 5-18 and is responsible for raising the water level in the pond between the two tailings lobes by at least one metre. Beaver dam 4 is located immediately downstream of dam 3.

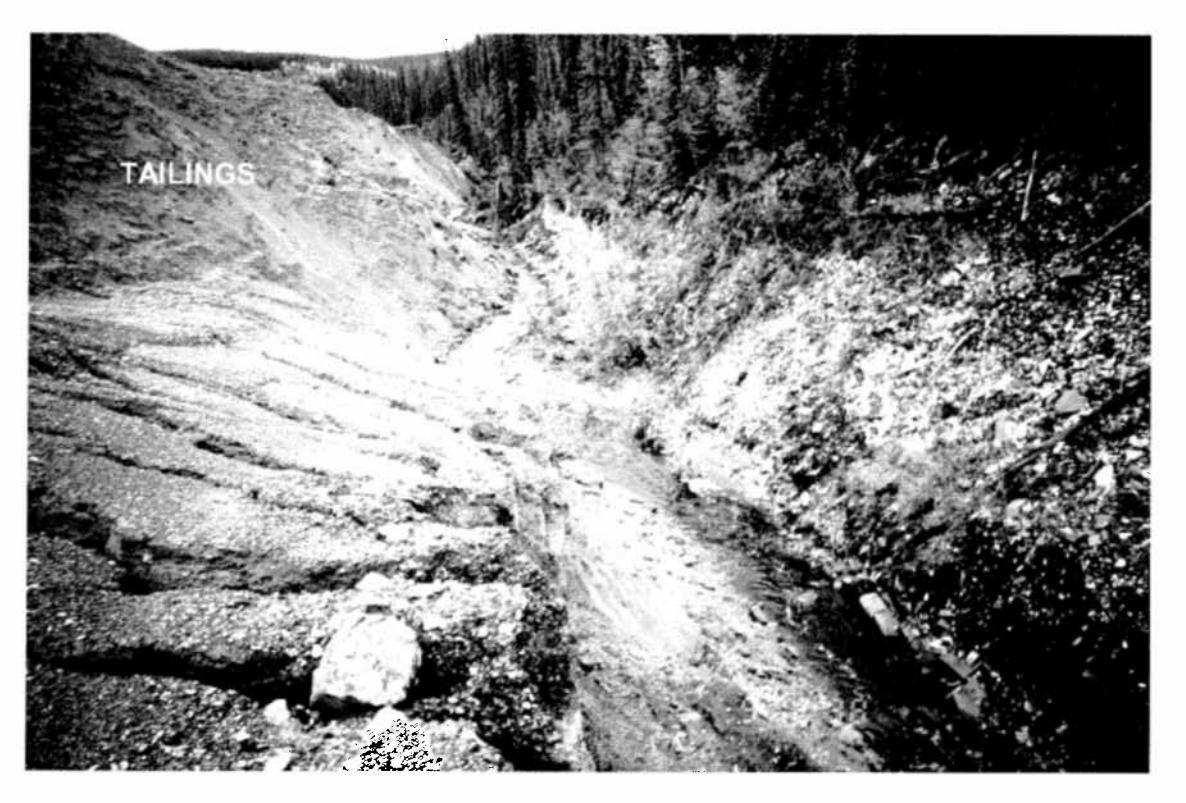
Photo UMA 5-23 View Upstream Along Wolverine Creek (1998)

The four beaver dams have reduced channel velocities and erosion of the channel where the tailings piles meet the toe of the valley slope. Downstream of the beaver dams however, velocities increase significantly as the channel narrows and the gradient steepens. Within this stretch, the channel has down-cut into the underlying weathered argillite bedrock resulting in surficial slumping of the overburden soils (Photo UMA 5-23). A series of rock weirs line the channel immediately downstream of the south lobe. Flow is contained within the channel with no significant erosion or down-cutting observed. Ground vegetation in the areas of the tailings lobes is extremely scarce and plant diversity very low. Mats of chrysotile asbestos were observed in the lower branches of trees at a height corresponding to that of the snow pack.

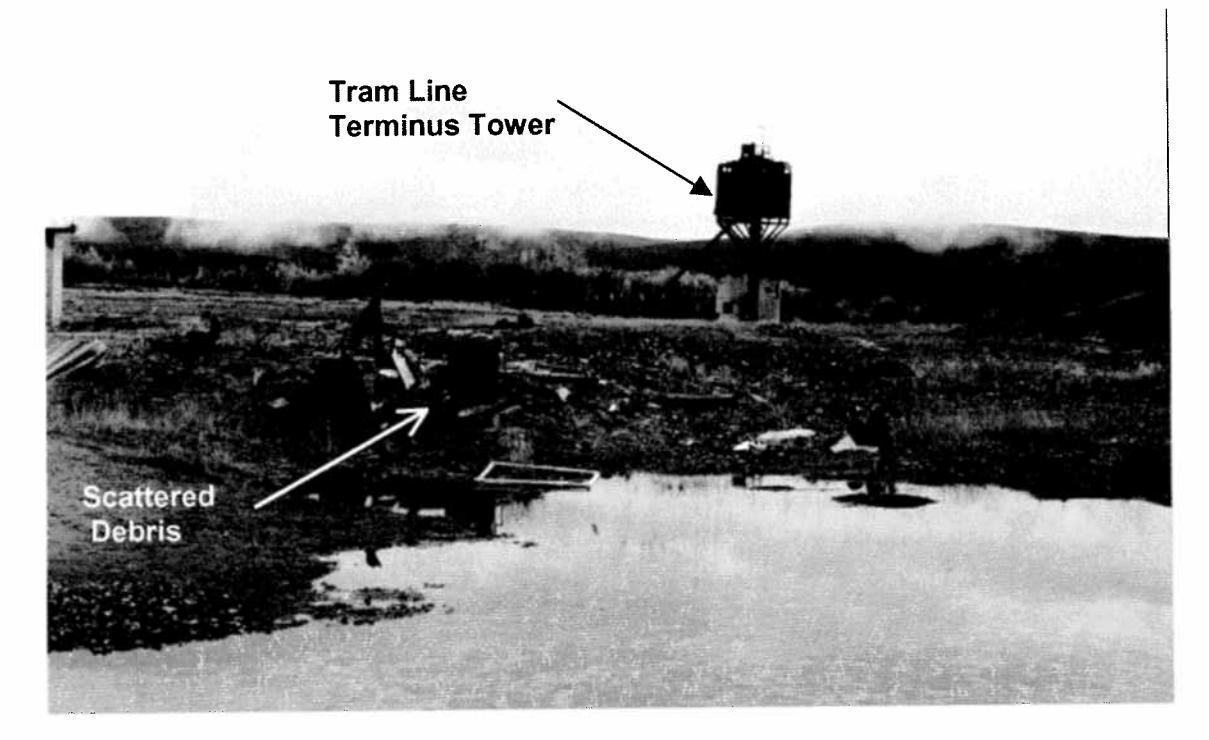
Photo RRU-8 Mill Site Area(1998)

The former aerial tramline terminated at a large steel tower on a suspected concrete footing or piles (Photo RRU-8). Seven intermediate towers are located between the terminus and the Crusher Building as seen in Photo RRU-9 and on Drawing 02. The intermediate towers are steel and are also likely founded on concrete footings or piles.

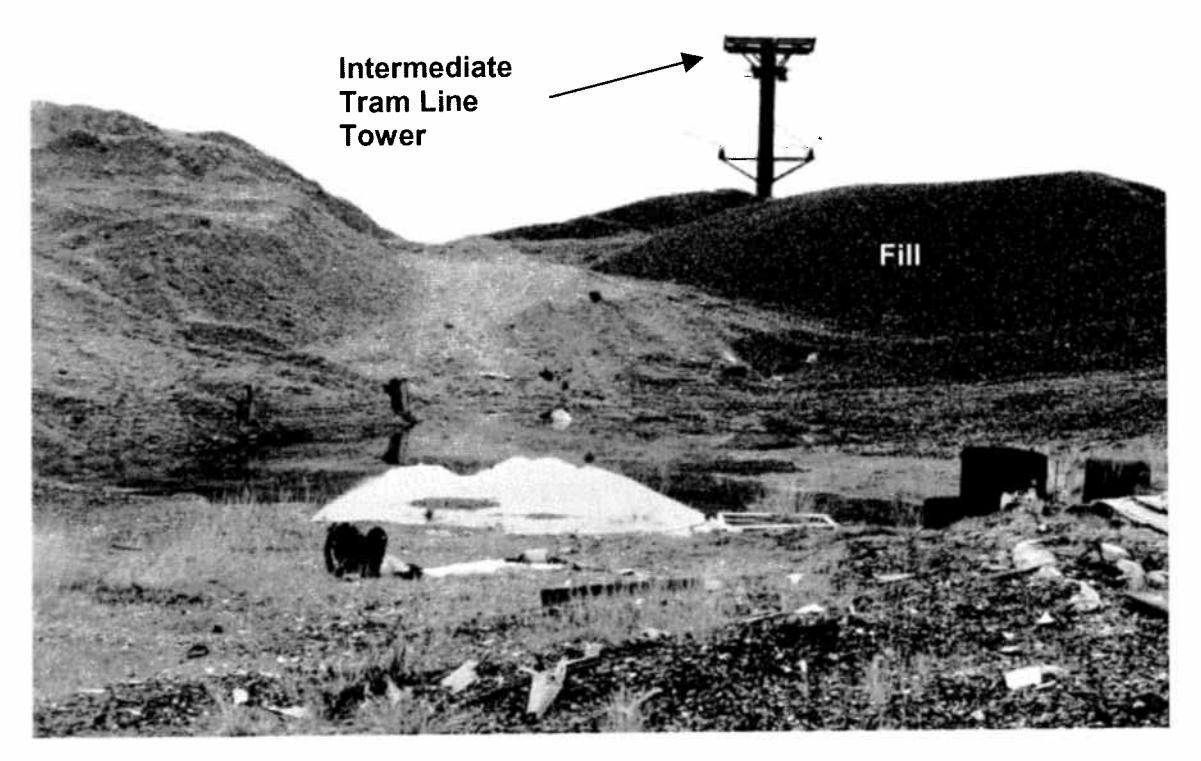
Photo RRU-9 Fill Material Above Fibre Building Foundation (1998)

Sump pits within the foundation slab of the service building are debris filled with a noticeable hydrocarbon odour. Hydrocarbon staining was visible on the surface of the foundation slab which is extensively cracked. A large volume of fill material (likely tailings) has been deposited on the east side of the former fibre building, south of the former dryer building as shown in Photo RRU-9. Demolition debris is scattered throughout the mill site area.
