Geotechnical Evaluation Grum Sulphide Cell Cover Erosion Control Measures Faro Mine Complex, Yukon - 2011

Prepared For: Boreal Engineering Ltd.

Date : June 6, 2011

File No: 100-002-11

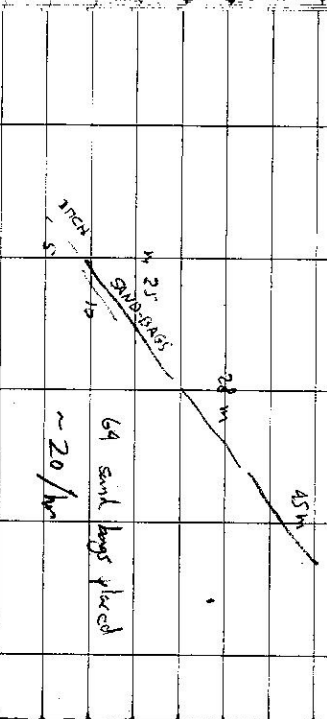
with gravel from the time berm where massive

erosion is occurring

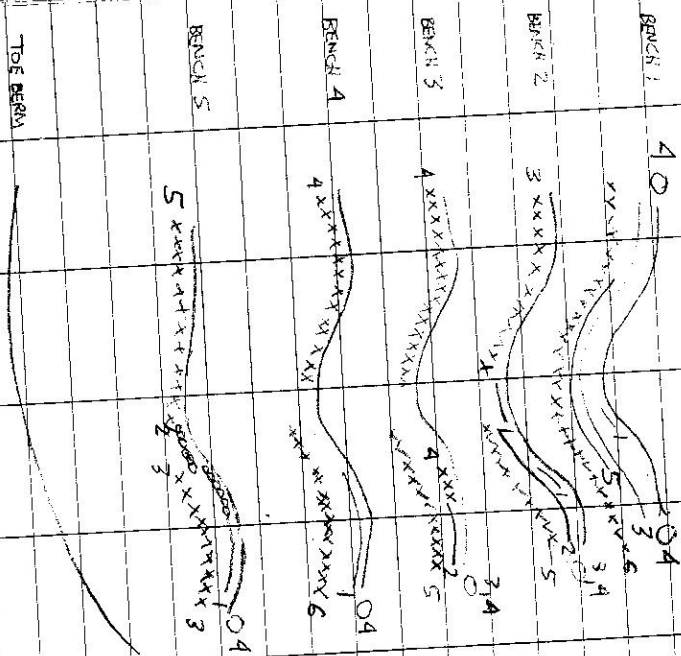
FAKRO GRUHM - ERSATZION SCOUTROL.....
May 18, 2011..... Page 26

1-May 16 2-May 17 3-May 18 4-May 19

○ - Rip-Rap - hand placement at ditch cross-section

grass - Sand Bagging
