# HAZARDOUS MATERIALS CLASSIFICATION MT. NANSEN MINESITE YUKON

# REPORT

DECEMBER 2011 ISSUED FOR USE EBA FILE: W23101481

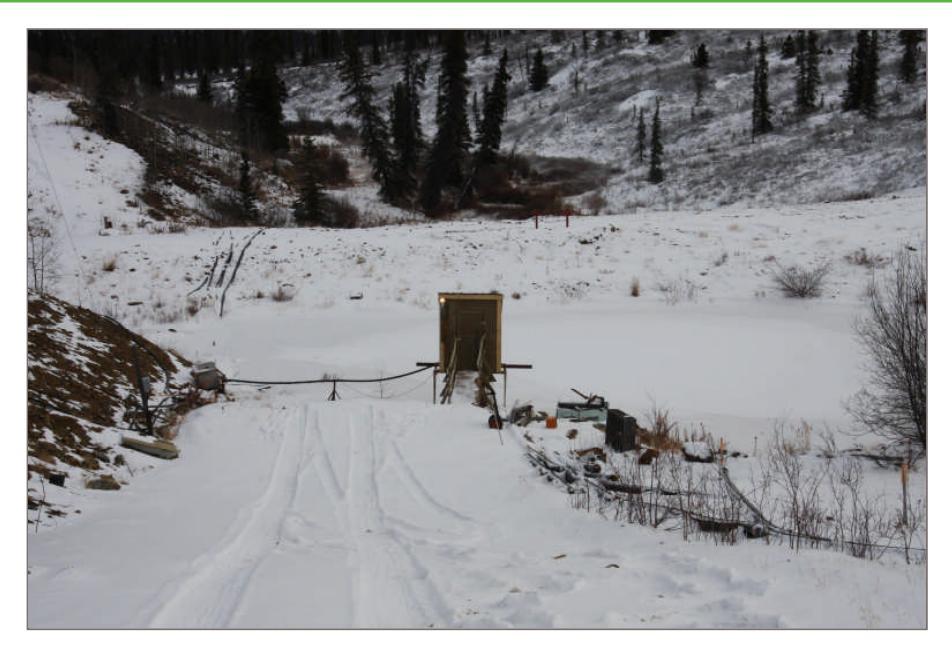
Photo 1: Seepage pond pump house (image supplied by AAM, November 2011)

- Seepage pond pump house shown in photograph No. 1<sup>3</sup>:
  - Raised on wood stilts above collection pond;
  - 2' x 4' frame construction with plywood walls, floor and roofing system;

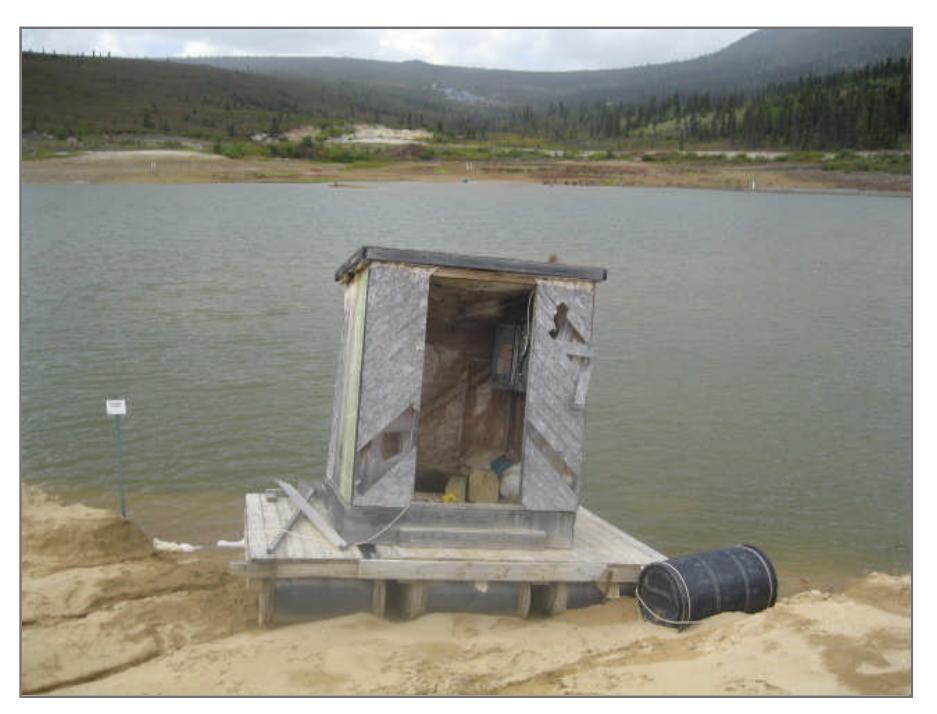
- Reclaim heating pump house #2 shown in photograph No. 4:
  - Located on the eastern side of the reclaim pond;
  - 2' x 4' frame construction with OSB walls, floor and ceiling;

- Approximately 7.5 m<sup>2</sup>;
  - No suspect hazardous materials identified; and,

Photo 4: Reclaim heating pump house #2 located on the eastern side of the tailings dam

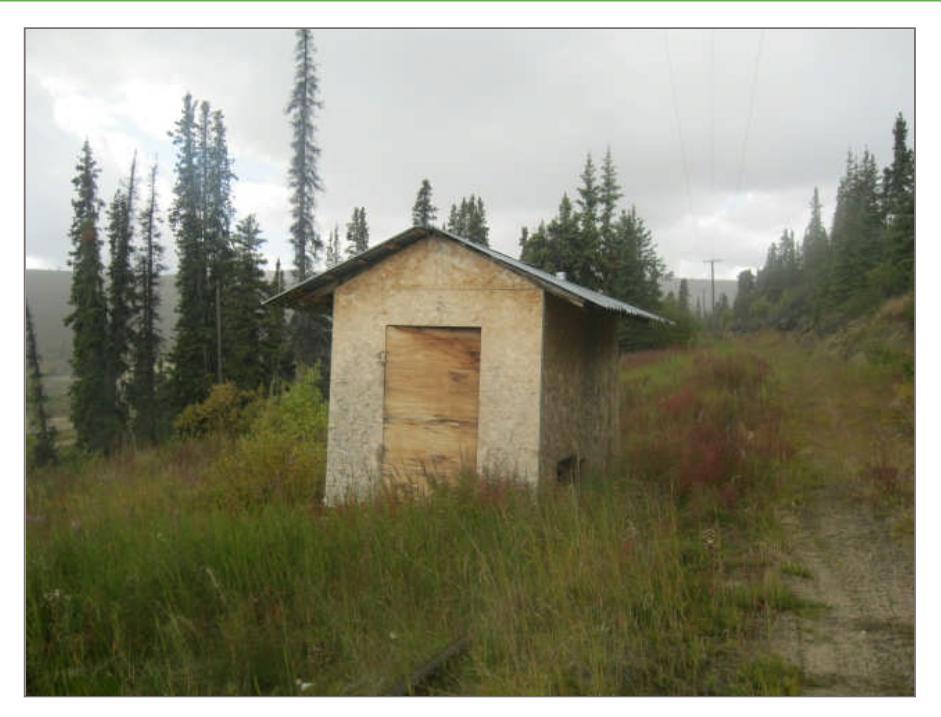
- Components of the structure were intact but visibly impacted by weathering.
- Junction box house shown in photograph No. 5:
  - Located in-line with the transmission towers;

Photo 5: Junction box house in line with the transmission towers north of the tailings dam

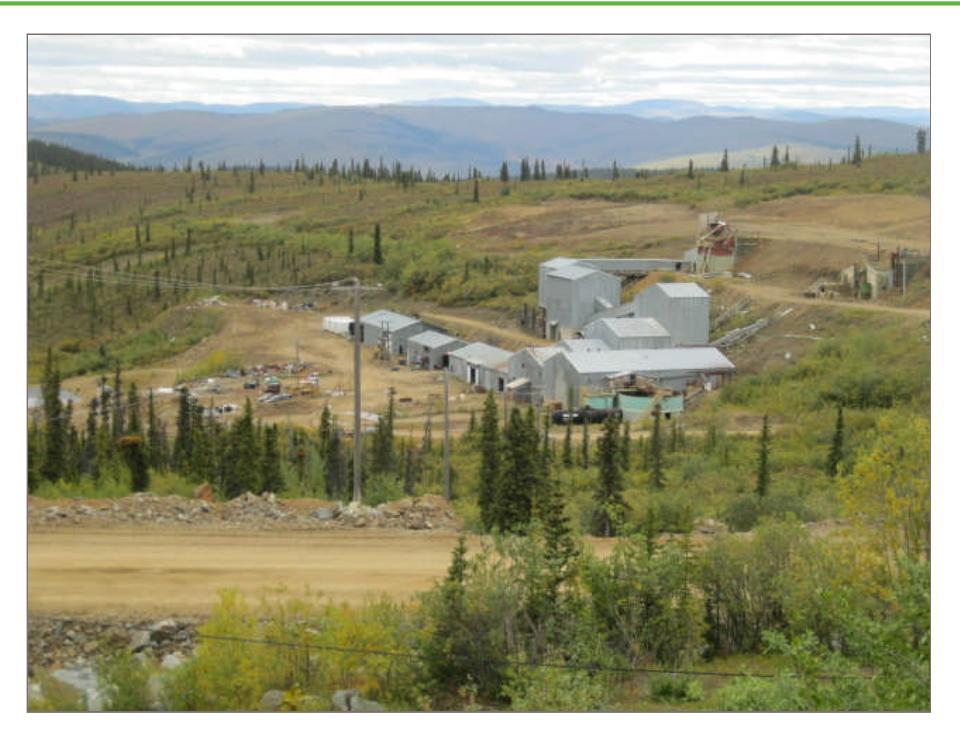
- Components of the structure were intact.
- Ketza mine shop shown in photograph No. 6:
  - Exterior metal q-decking with interior batted insulation covered by plastic sheeting;

Photo 6: Ketza mine machine shop

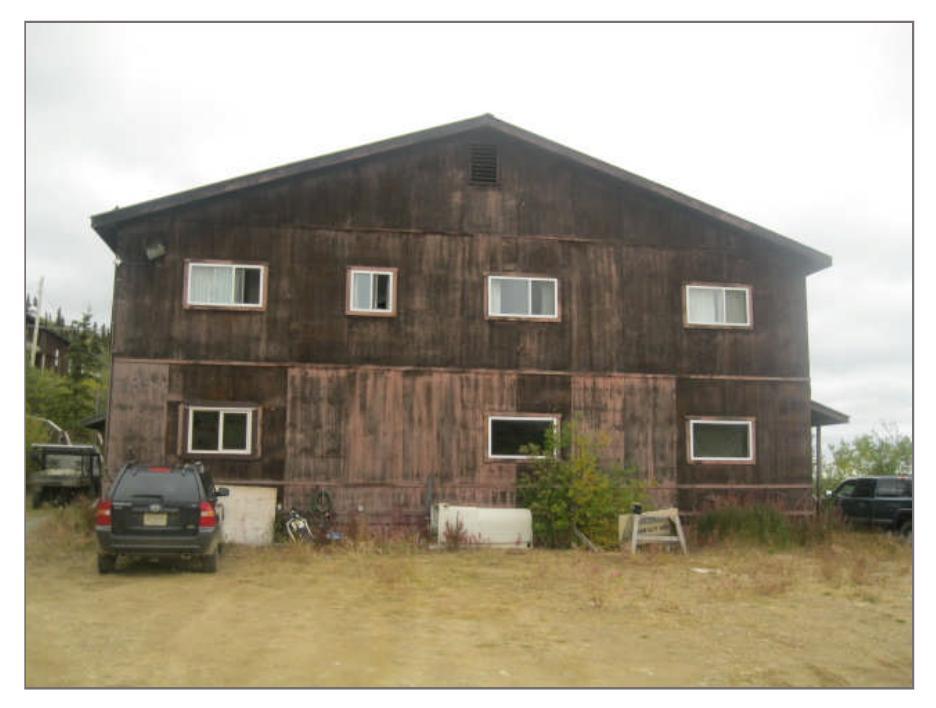
Photo 9: Cookhouse building

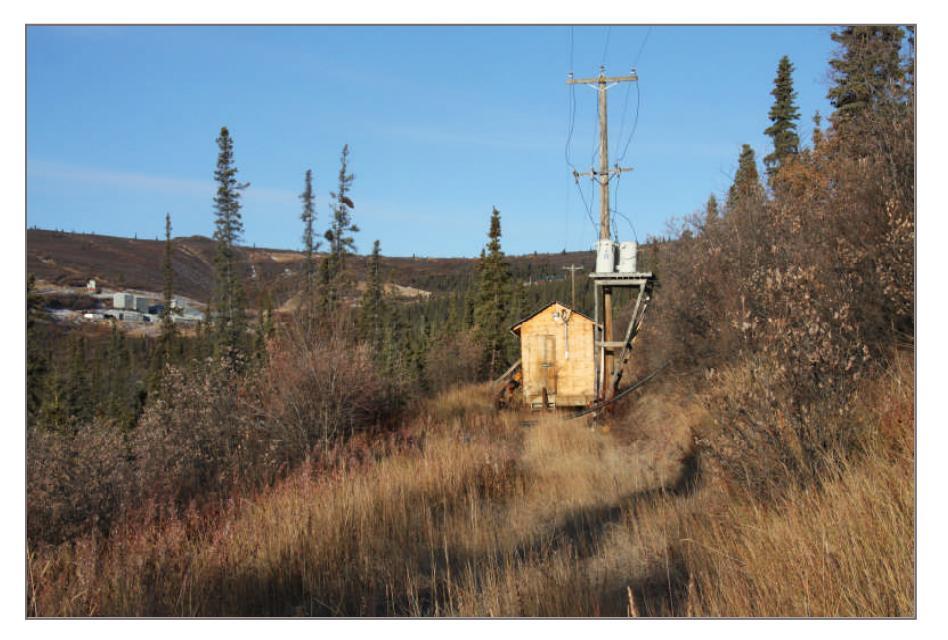
Photo 10: Bunkhouse
